AmeriSpec Inspection Services of Central East Ontario

Inspection Number: 108480 Inspector: Reg Deck
Inspection Date: 10/21/2021
Inspection Address: 430 Eldon Road
Little Britain ON, K0M 2C0
Listing Agent: Krista Craig Real Estate Company: Coldwell Banker RMR

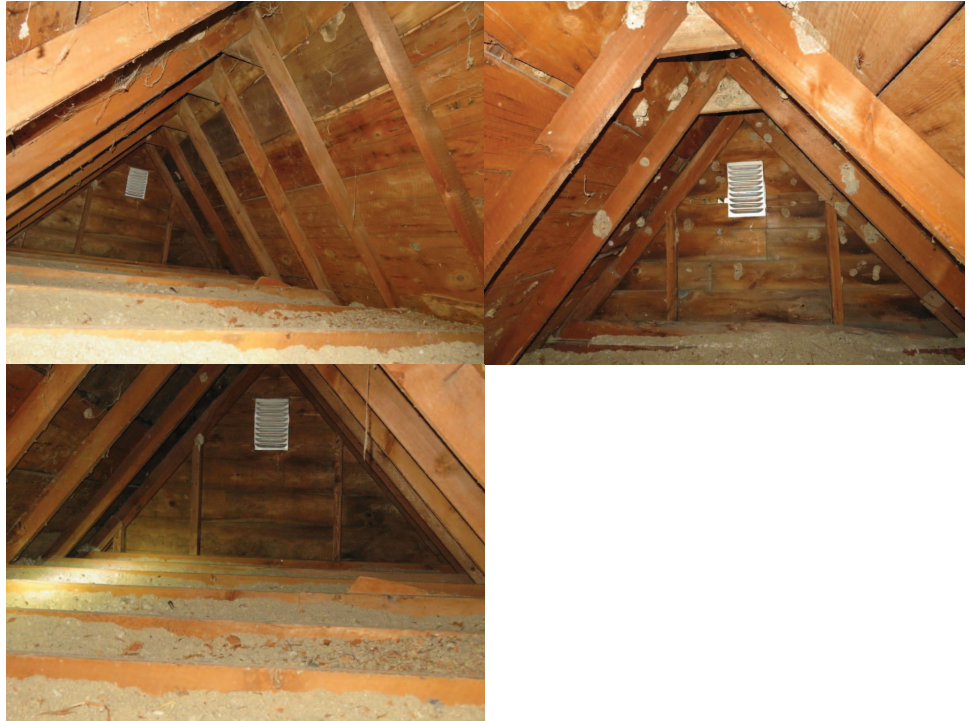
1902. Framing Serviceable. Rafters.

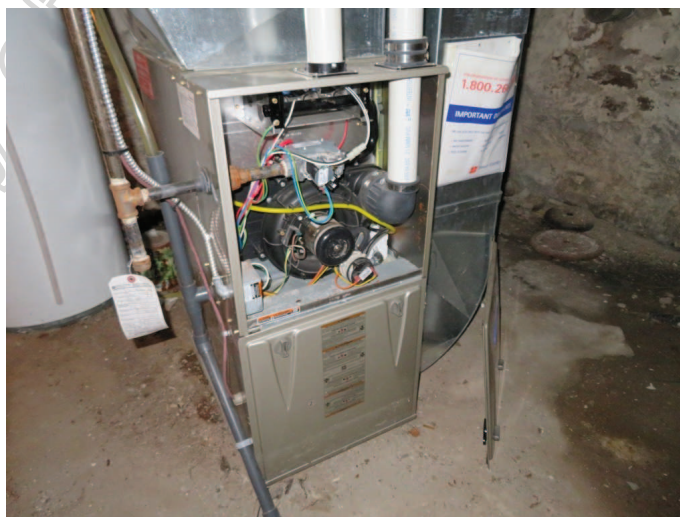
Step #	Component	Comment
2110.	System Location/ Design/Type/ Brand	Furnace. Forced air system. Gas fired unit. Located at the basement. Manufacturer: CARRIER. Serial #: 1814A 50636. Model #: 59SP5A060E17114. Gas shutoff valve and electrical disconnect(s) provided for safety. The furnace is approximately 7 years old.

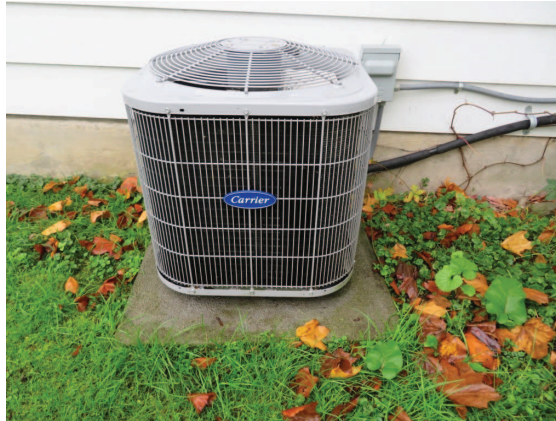
Step #	Component	Comment
2305.	System Location/ Design/Type/ Brand	The air conditioner compressor is located at the left side of the home. Manufacturer: CARRIER. Serial #: 1814E 04219. Model #: 24ABB318A330. An electric disconnect was noted for this equipment. We recommend maintaining the disconnect in a secured (i.e. cable tied or locked) state to prevent tampering.

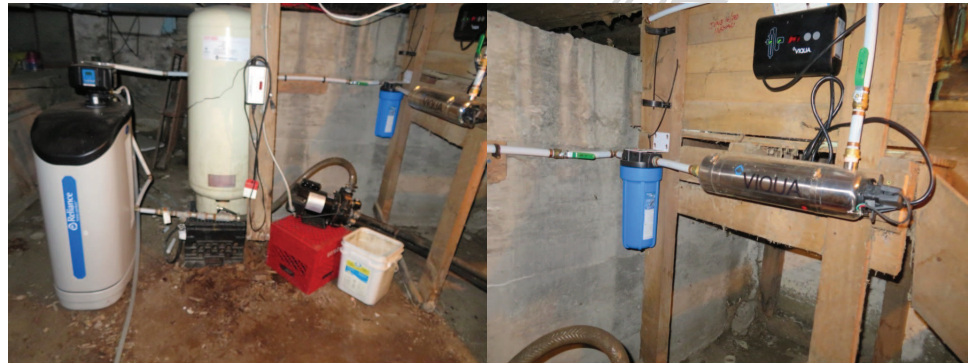
Water treatment equipment consisting of water softening, sediment filtration and ultraviolet sterilization systems were present in the home at the time of the inspection. In accordance with our scope of work, assessment of the home's water treatment system(s) was not completed as part of the home inspection. If concerned, we recommend consulting with the current owner and/or a qualified water treatment contractor prior to closing to determine operations and maintenance requirements for the water treatment system(s) and to verify proper operation.

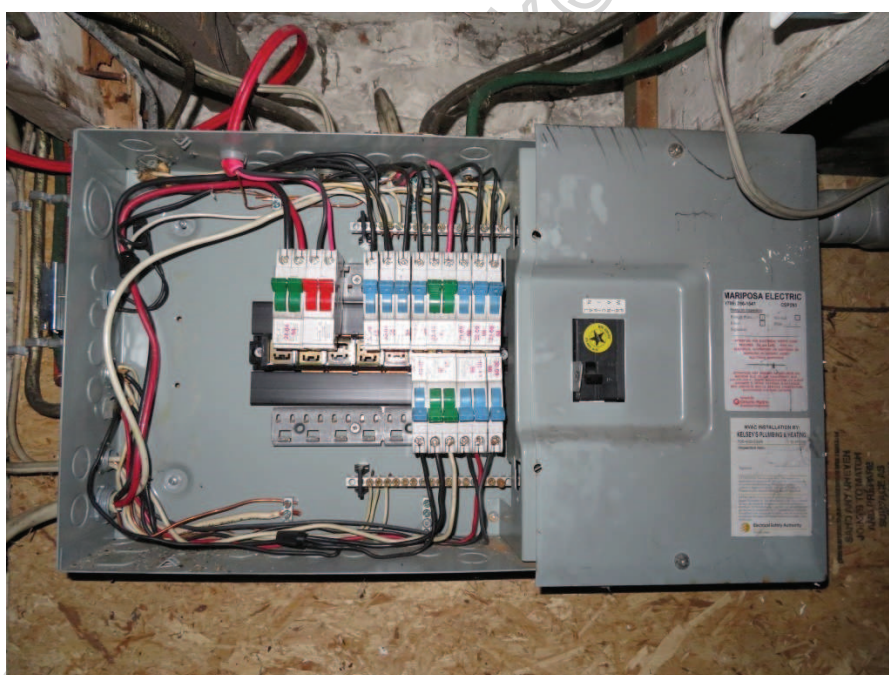
Step #	Component	Comment
2505.	System Configuration	The capacity of the main electrical service provided to the home is approximately 100 amps. 120/240-volt system noted. The main service wires enter the home overhead.
2510.	Main Electrical Panel	Serviceable. Located at the right side of the basement. Manufacturer: FEDERAL PIONEER/STAB-LOK. Main disconnect noted. Overload protection of the main electrical service wires is provided by breakers. The main conductor is copper. Circuit(s) available for future expansion/additional circuitry requirements.

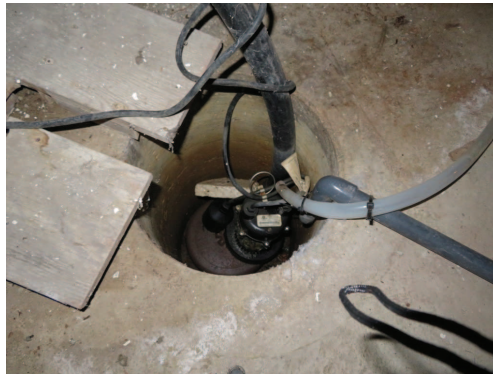
3580. Sump Pit/Pump Serviceable. Sump pits/pumps are designed to collect and properly manage/discharge storm water from rain and snow melt that accumulates around the building. Sump pits/pumps are usually provided in basements where there is a higher risk of subsurface flooding. If installed, exterior perimeter foundation drainage tile may drain into the sump pit. Sump pits/pumps are typically necessary in areas where the water table may become excessively high during certain times of the year. In addition, some municipal building departments require the installation of a sump pit/pump if storm sewers located at the street are higher than the lowest floor level. Sump pump tested operable at the time of the inspection.
