## "Full" Reserve Study

### **Sunflower Condominium Association, Inc. Boca Raton, FL**

**Report #: 39848-0**  
**For Period Beginning: January 1, 2021**  
**Expires: December 31, 2021**

**Date Prepared: September 10, 2020**

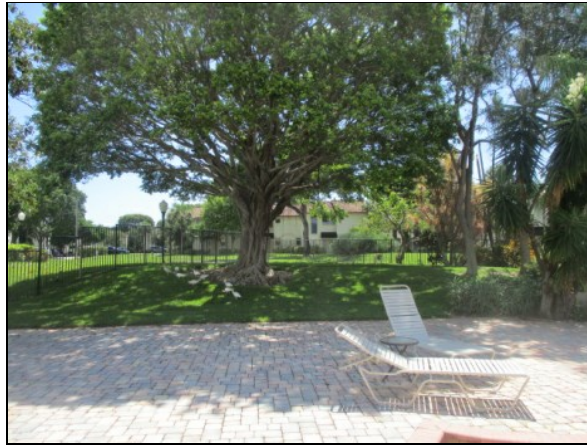
**Comp #: 2771 Pool Fences - Replace**

Comments: Pool fences range from 4' - 5' aluminum and are in declining condition. Fences are shown here to be replaced at same time as pool resurfacing.

Poor condition: Pool fencing determined to be in poor condition typically exhibits more advanced or extensive surface wear and other signs of age, which may include damaged or vandalized sections, loose or missing hardware and other obvious concerns. At this stage, fencing is often an eyesore and replacement from an aesthetic standpoint should be considered, even if fencing is still technically upright and intact.

As a routine maintenance item, fence should be inspected regularly and repaired as-needed to ensure safety. Periodically clean with an appropriate cleaner and touch up paint as needed in between regular paint cycles. When evaluating replacements, be sure to comply with any applicable building codes. Gates and locks should be inspected to make sure they close and lock properly. Faulty perimeter around a pool area can expose the Client to significant liability risk. When possible, replacement should be coordinated with other projects, such as pool deck projects, other fencing/railing work, etc.

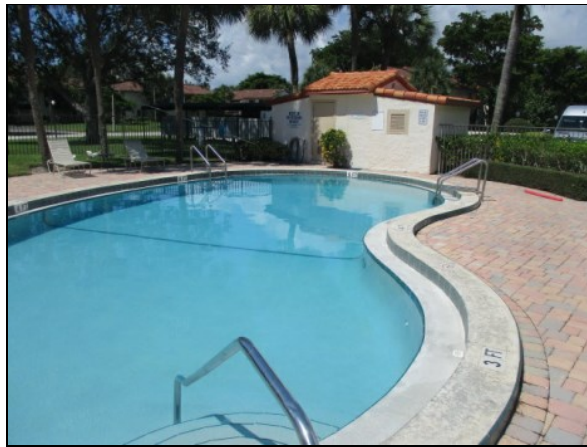
Fair condition: Swimming pools determined to be in fair condition typically exhibit some color fade/discoloration, and roughening of the surface, often more noticeable in the shallow areas and/or at steps. Waterline tiles are in fair condition. Generally believed to be aging normally.

Pool resurfacing will restore the aesthetic quality of the pool while protecting the actual concrete shell of the pool from deterioration. While drained for resurfacing, any other repairs to lighting, handrails, stairs, ladders, etc. should be conducted as needed. This type of project is best suited for slow/offseason to minimize downtime during periods when pool is used heavily. Should be expected at the approximate interval shown below; in some cases, schedule may need to be accelerated due to improper chemical balances or aesthetic preferences of the Client.

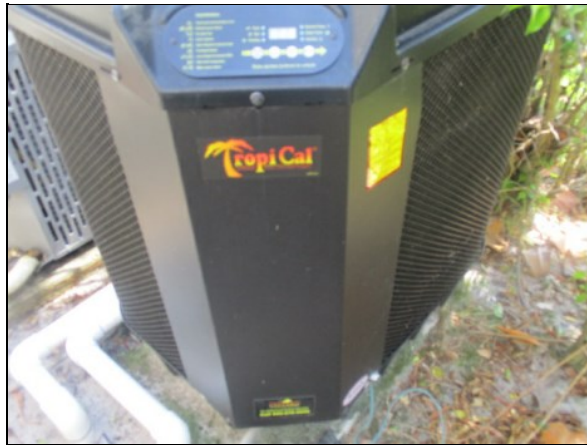
**Comp #: 2781 Pool Heater - Replace**

Comments: Pool vendor should inspect heater regularly to ensure proper function, identify any required repairs, etc. Internal components were not analyzed during our site inspection. Many clients choose not to heat their pools year-round, which can prolong the life of the heater while reducing energy costs. When replacement models are being evaluated, we recommend considering high efficiency models which may have a higher initial cost but will ultimately be less expensive due to reduced energy usage. Minimal or no subjective/aesthetic value for pool and spa equipment. Useful life is based primarily on normal expectations for service/performance life in this location. Unless otherwise noted, remaining useful life expectancy is based primarily on original installation or last replacement/purchase date, our experience with similar systems/components, and assuming normal amount of usage and good preventive maintenance.

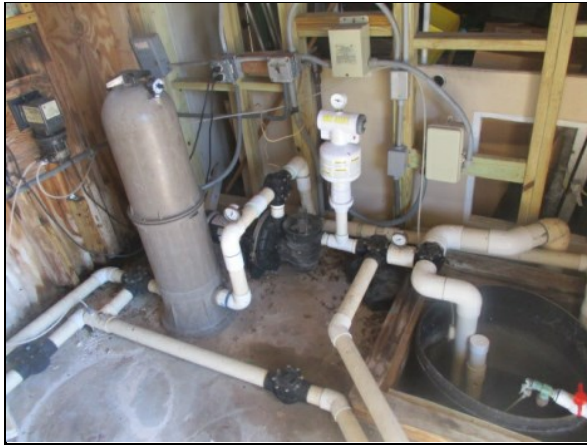
**Comp #: 2787 Pool Equipment - Maintain/Replace**

Pool and spa pumps, filters, chemical feeders, and other miscellaneous equipment can be repaired or replaced for relatively low cost in most cases. However, if multiple repairs or replacements are required at the same time, then it may be warranted to use Reserve funds for these expenses. An allowance for ongoing projects is recommended here based on our experience with other properties. Minimal or no subjective/aesthetic value for pool and spa equipment. Useful life is based primarily on normal expectations for service/performance life in this location. Unless otherwise noted, remaining useful life expectancy is based primarily on original installation or last replacement/purchase date, our experience with similar systems/components, and assuming normal amount of usage and good preventive maintenance.
