SENTRY HOME INSPECTIONS, LLC

COMMERCIAL PROPERTY INSPECTION

714 W Broad Ave
Albany, GA 31701

King Randall
FEBRUARY 3, 2022

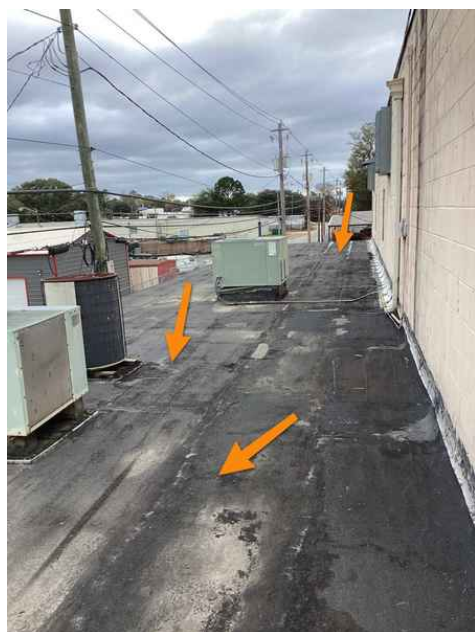
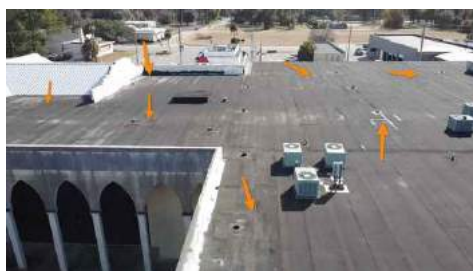
FLAT ROOF AREA SHOWS SIGNS OF WEAR, LEAKING AND WAVING

The flat roof area appeared to have areas of repair and sealant as well as wavy areas. I recommend a roof consult with a qualified roof contractor with repairs/replacement as needed.

Contact a qualified professional.

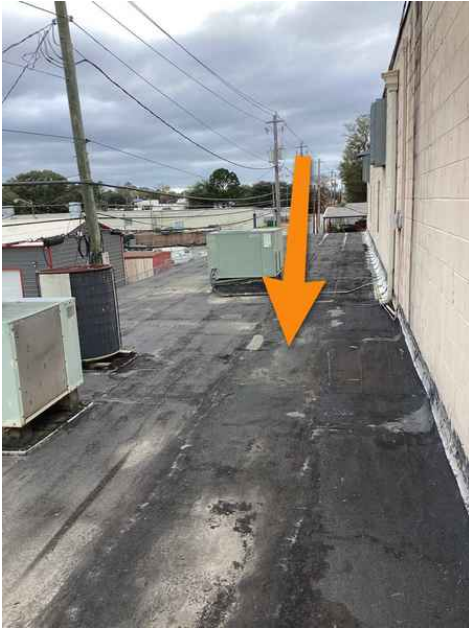
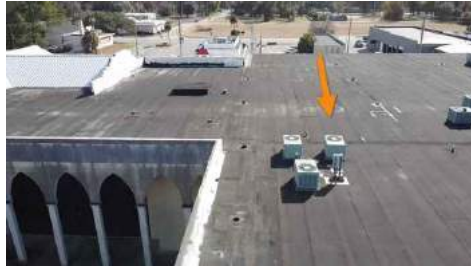
3.1.2 General Info

ROOFING CONSULT

There was significant wear, waving and damage present to the flat roof at the time of inspection. Recommend full roofing evaluation by qualified roofing contractor.

Contact a qualified professional.

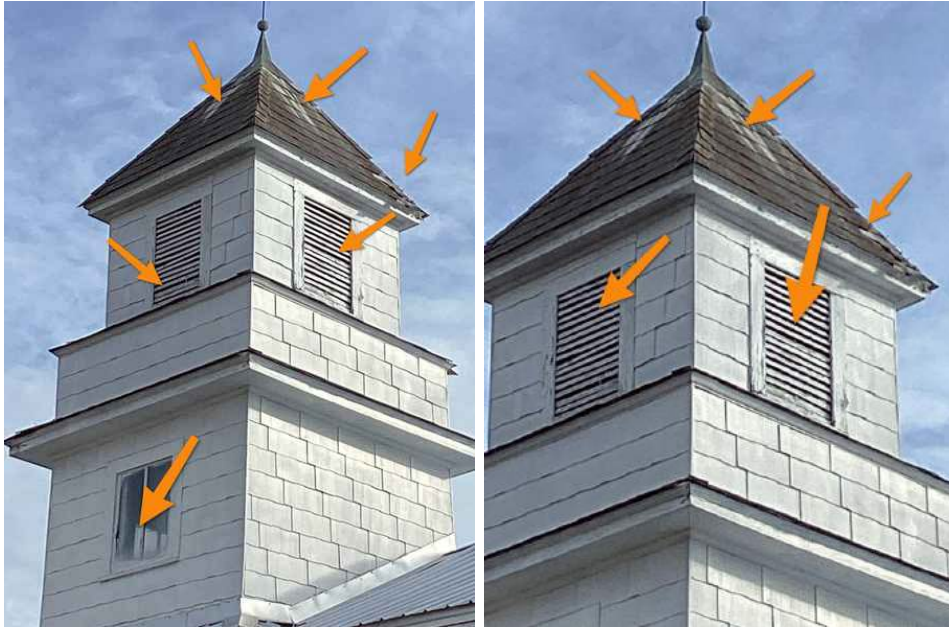
3.1.3 General Info

WATER DAMAGE TO STEEPLES

There was evidence of significant wear, weathering and water damage to the shingles, framing and wooden components of the structures steeples at the time of inspection. Recommend full evaluation by qualified roofing contractor for all needed repairs and replacements.

Contact a qualified professional.

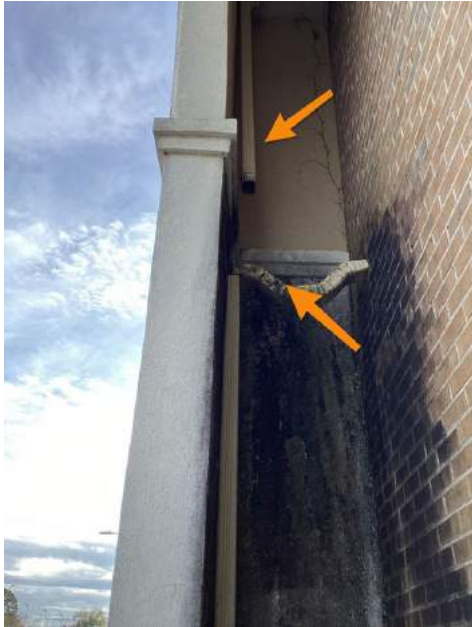
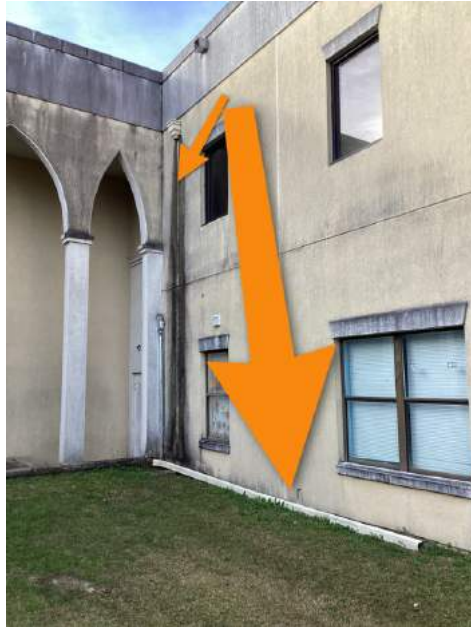
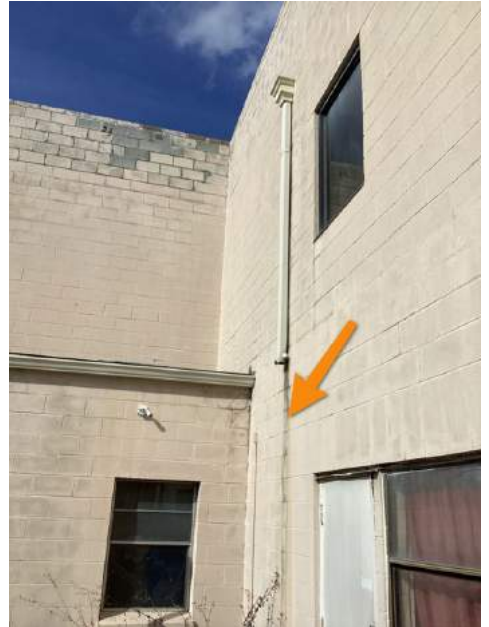
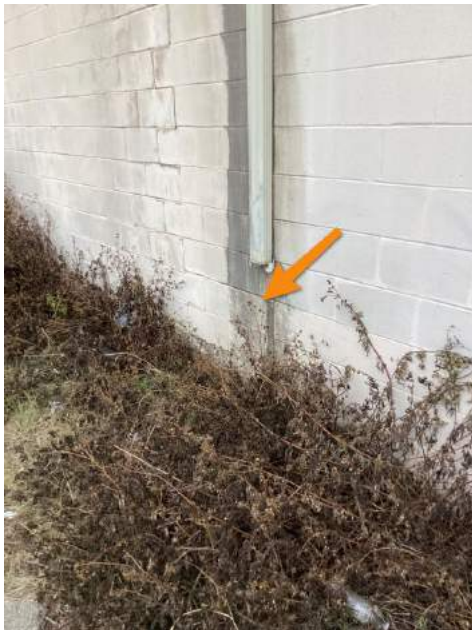
DAMAGED DOWNSPOUT

Damaged downspout(s) were present. Replacement or repairs as needed is recommended by a qualified person.

Contact a qualified gutter contractor

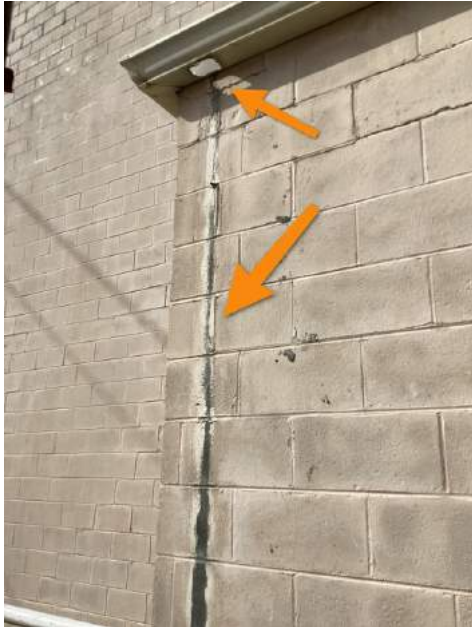
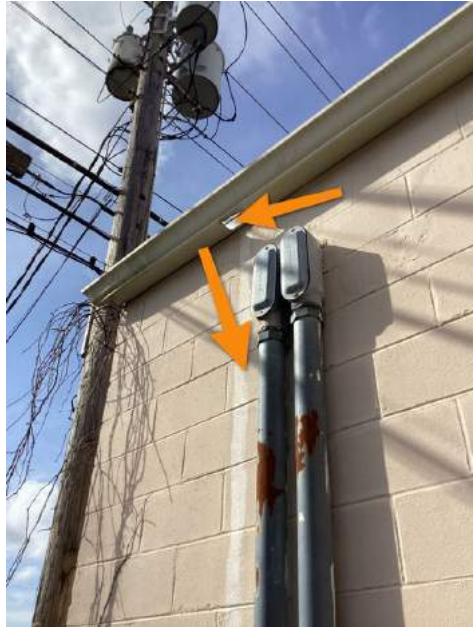
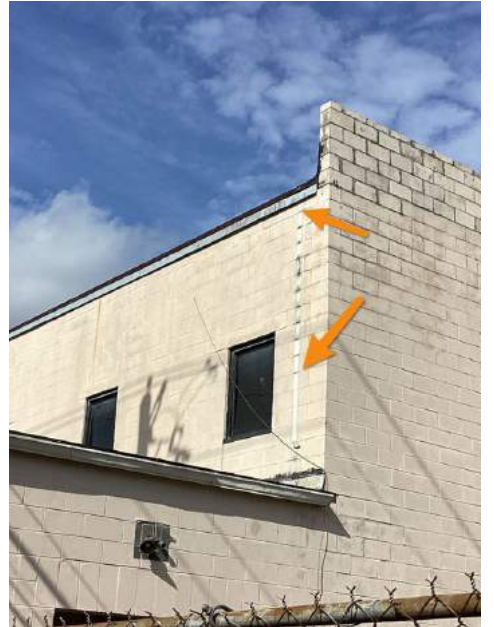
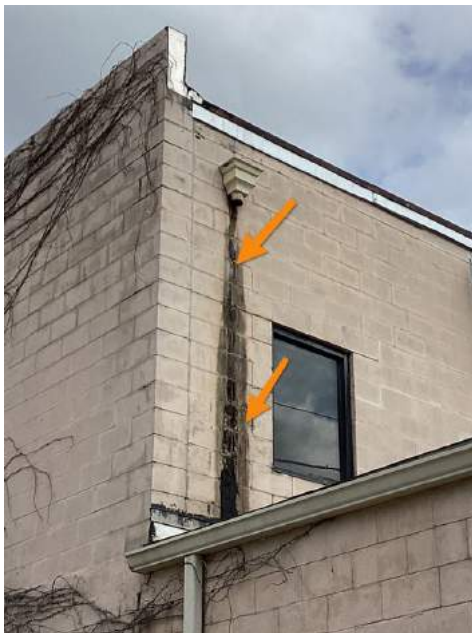
3.7.2 Gutters / Downspouts

MISSING DOWNSPOUTS

There were missing downspouts at the time of inspection. Missing downspouts encourage water/moisture intrusion into the exterior cladding and foundation areas. Recommend replacement by a qualified guttering contractor.

Contact a qualified professional.

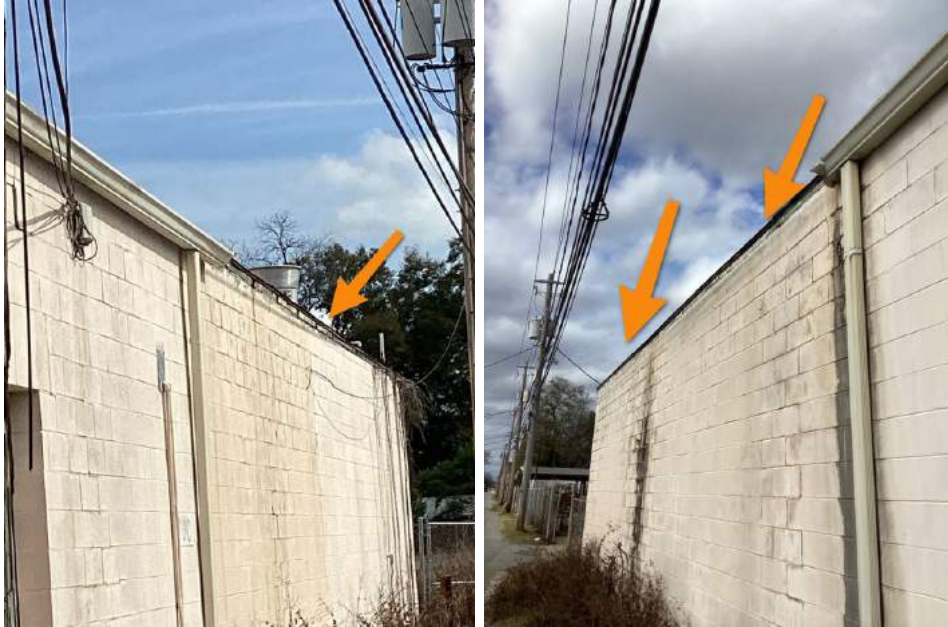
3.7.3 Gutters / Downspouts

MISSING GUTTERS

There were missing guttering at the time of inspection. Missing guttering encourages water/moisture intrusion into the exterior cladding and foundation areas. Recommend replacement by a qualified guttering contractor.

Contact a qualified professional.

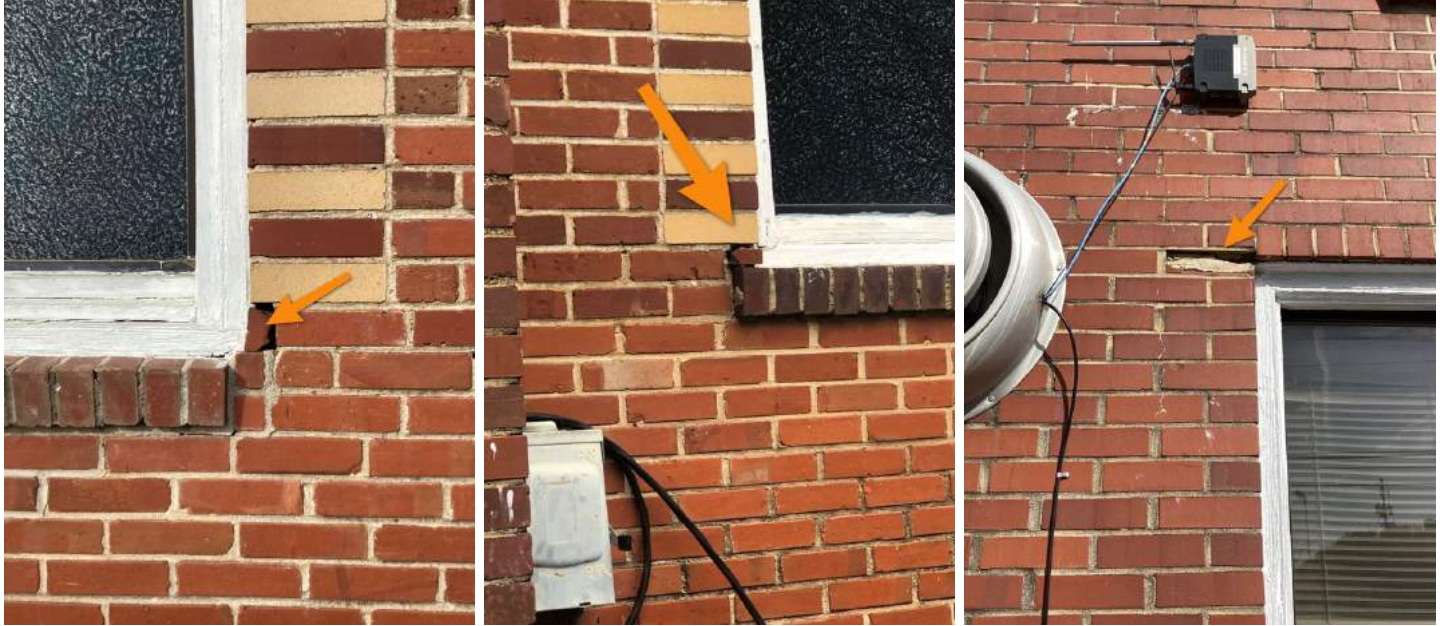
Marginal Defect**DAMAGE TO BRICK EXTERIOR**

There was a large area on the brick exterior cladding that was damaged. Recommend repairs/replacement by a qualified brick mason.

Contact a qualified professional.

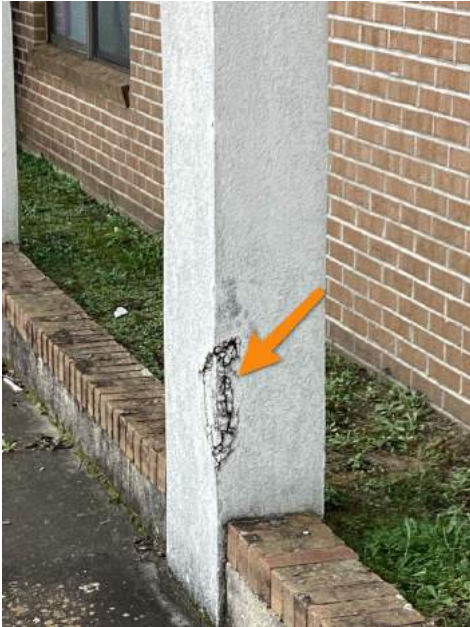
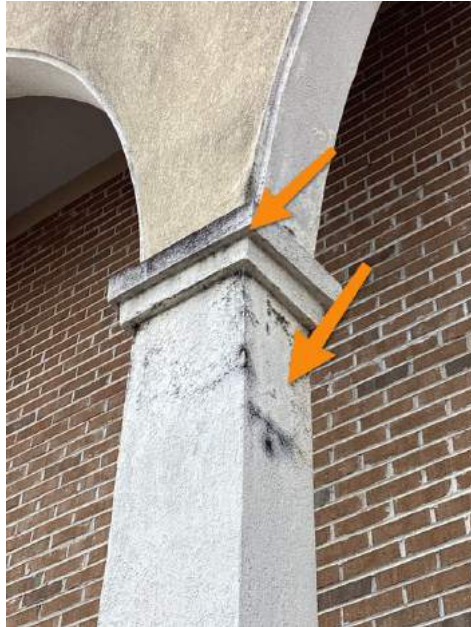
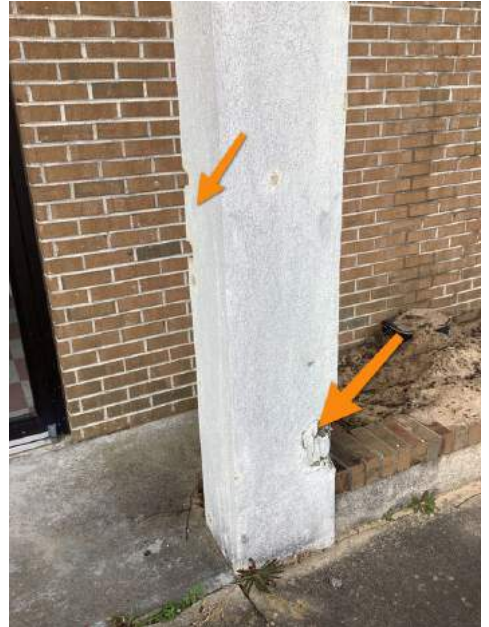
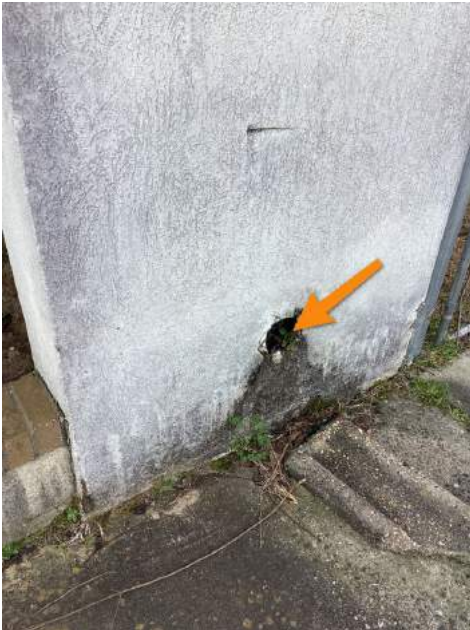
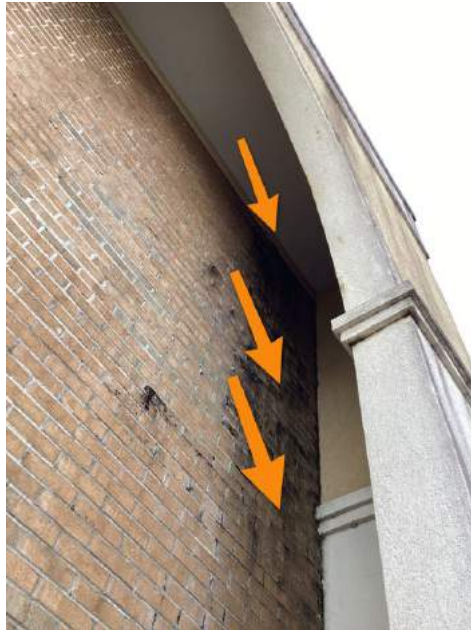
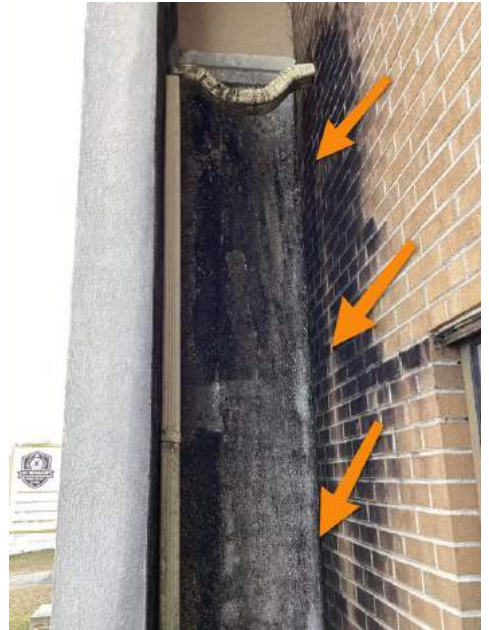
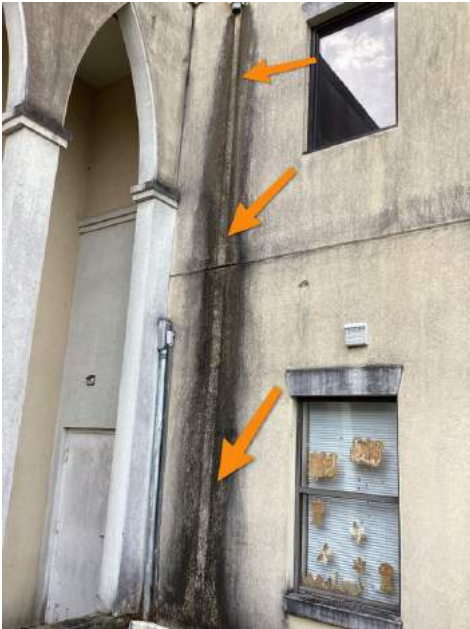
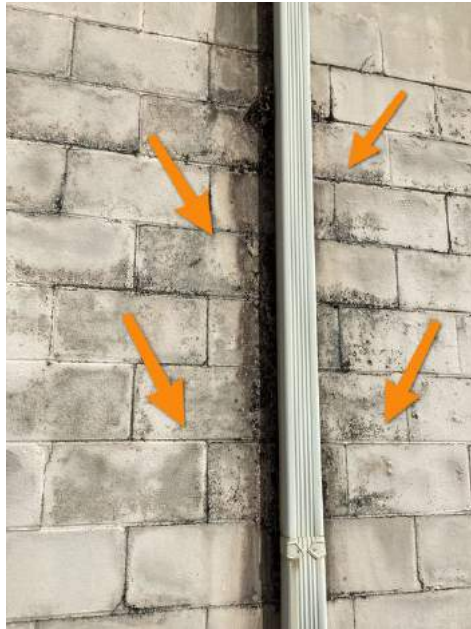
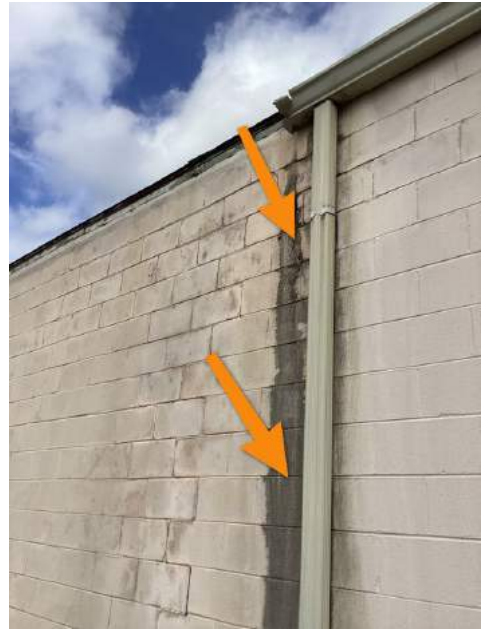
4.2.2 Walls / Cladding

WATER/MOISTURE INTRUSION DAMAGE TO EXTERIOR CLADDING

There were signs of water or moisture intrusion damage to areas of the exterior cladding at the time of inspection. Recommend evaluation by a qualified sparce coat or composition stucco professional with any needed repairs/replacements as necessary.

Contact a qualified professional.

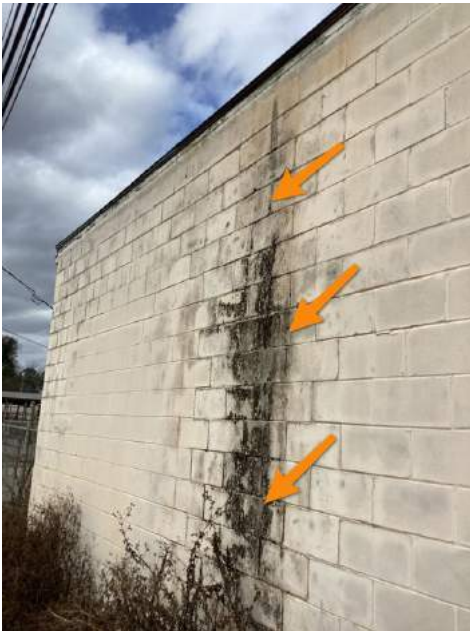
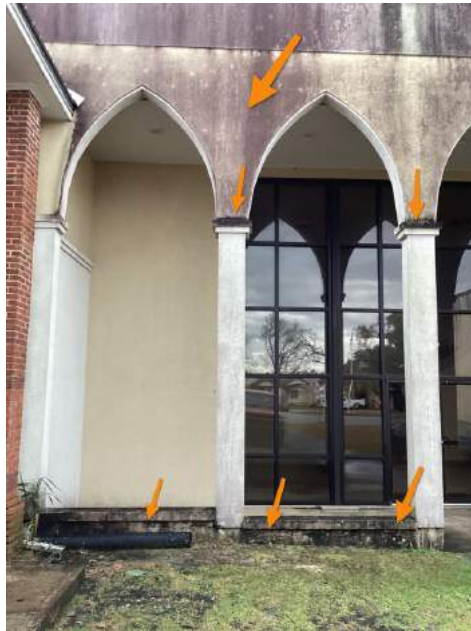
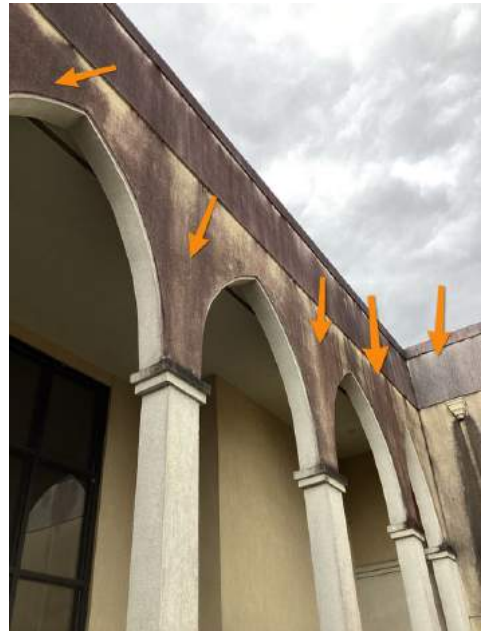
Front Side

Marginal Defect

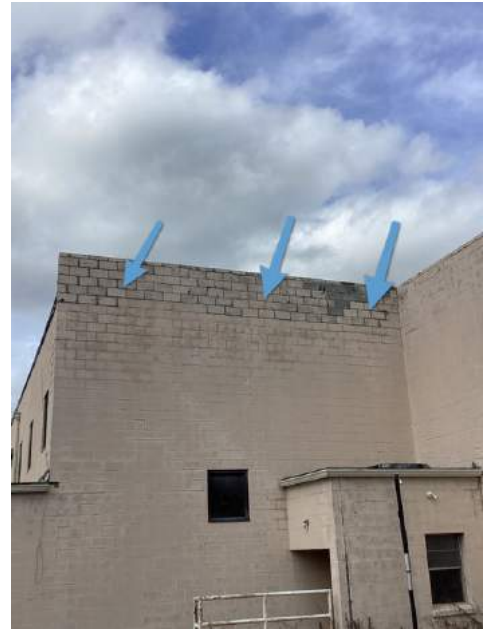
Rear of Structure

4.2.3 Walls / Cladding

**PREVIOUS
REPAIRS TO EXTERIOR CLADDING**

Contact a qualified professional.

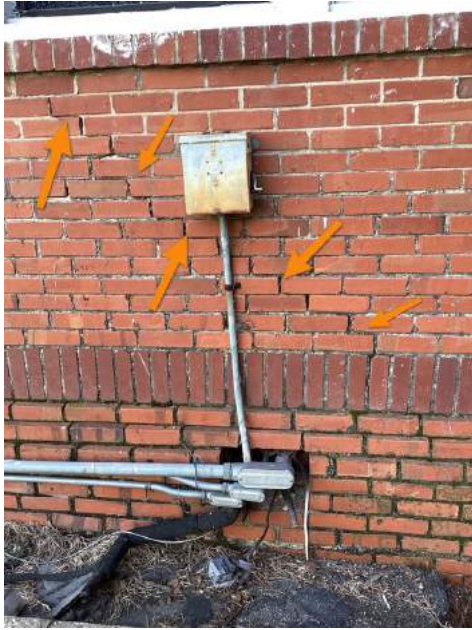
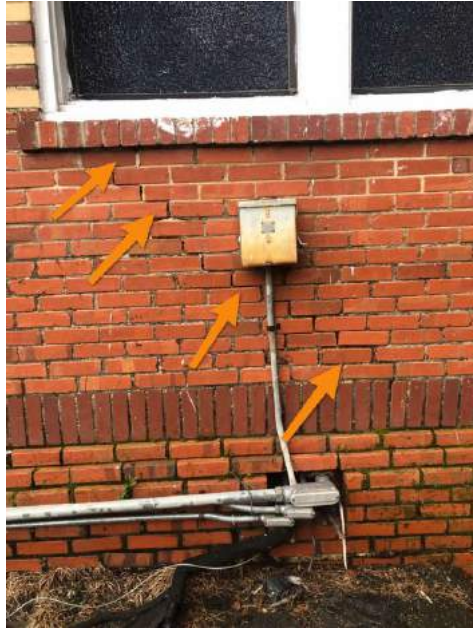
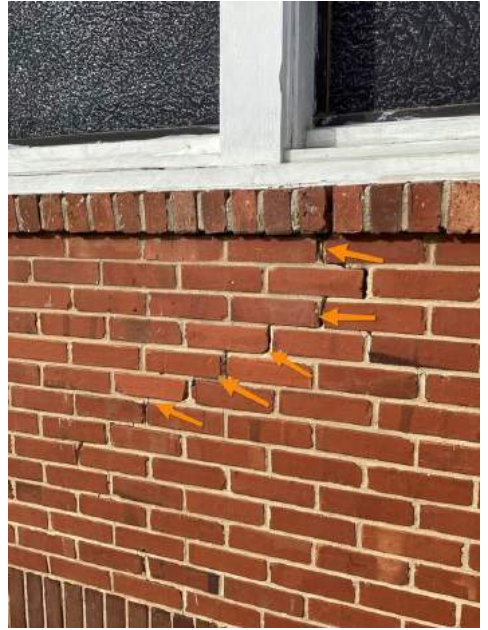
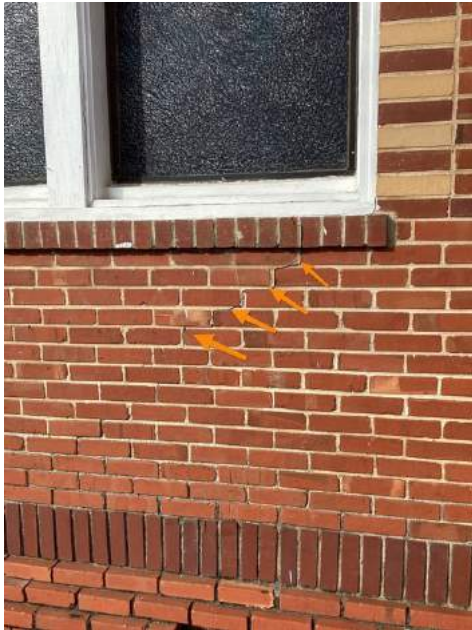
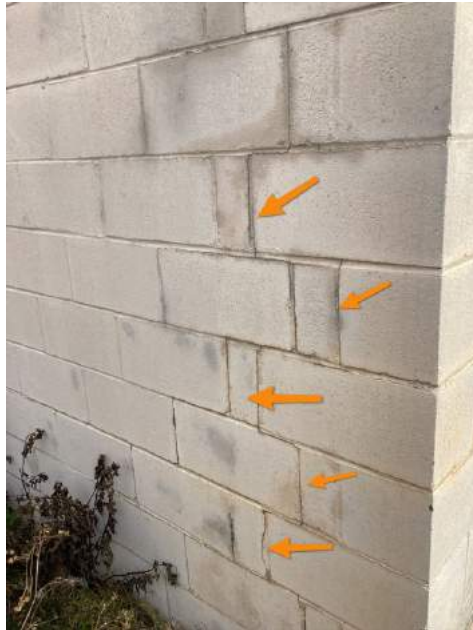
4.2.4 Walls / Cladding

CRACKING DUE TO NORMAL SETTLEMENT

There was cracking evident to the exterior brick cladding at the time of inspection that appeared to be within the range of normal settlement. Recommend having the crack sealed by a qualified individual.

Contact a qualified professional.

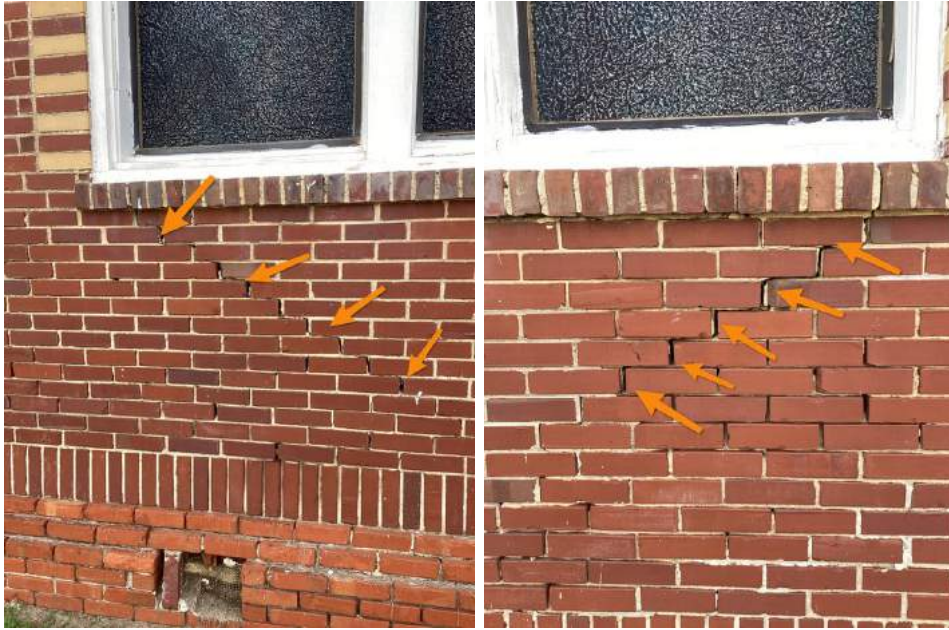
4.2.5 Walls / Cladding

Marginal Defect**CRACKING WITH SOME DISPLACEMENT PRESENT**

There was cracking to the exterior brick cladding with some degree of displacement at the time of inspection. Recommend repairs by a qualified brick mason or contractor.

Contact a qualified professional.

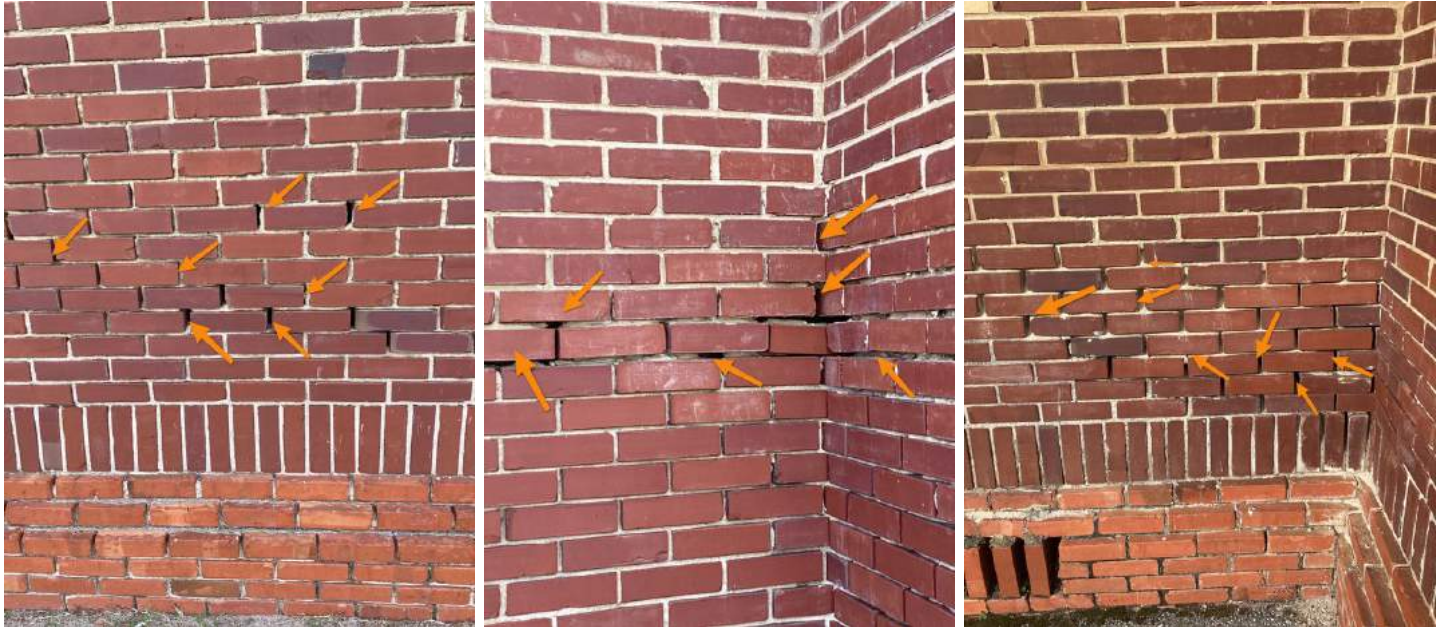
4.2.6 Walls / Cladding

Marginal Defect

There was evidence of mortar breakdown and displacement to the exterior brick cladding at the time of inspection. Recommend repointing and repairs by a qualified brick mason.

Contact a qualified professional.

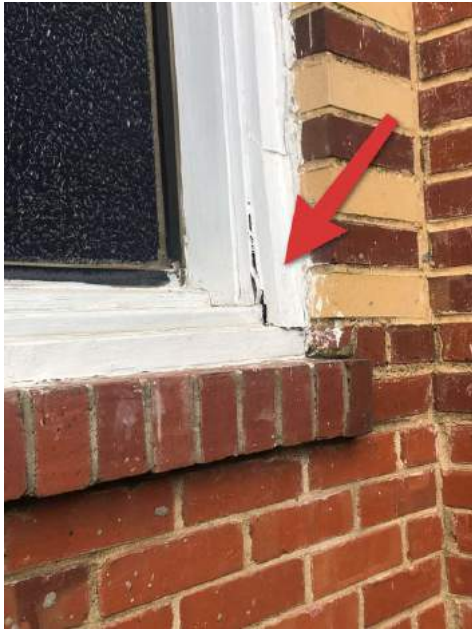
4.3.1 Window Exteriors

WATER DAMAGE TO WOOD

There were windows with water damage present to the exterior trim, sills, and/or sash. An evaluation of the windows with repairs or replacement made as needed is recommended to be conducted by an window or general contractor.

Contact a qualified window repair/installation contractor.

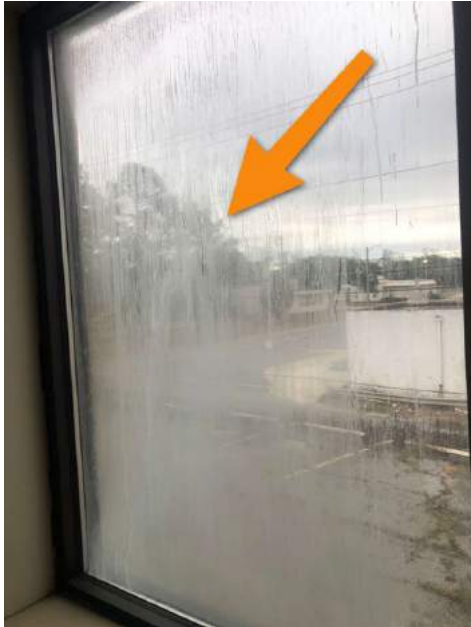
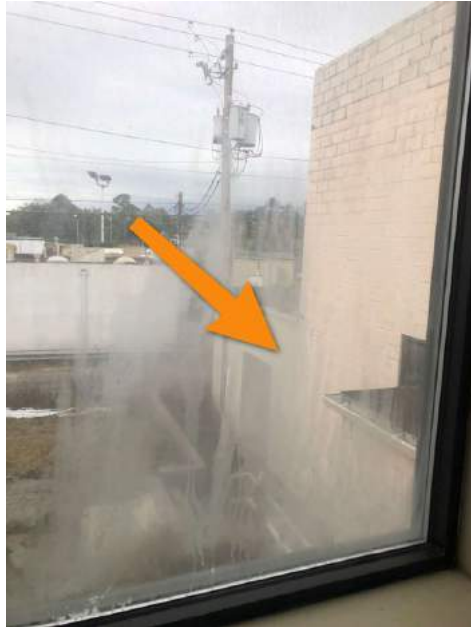
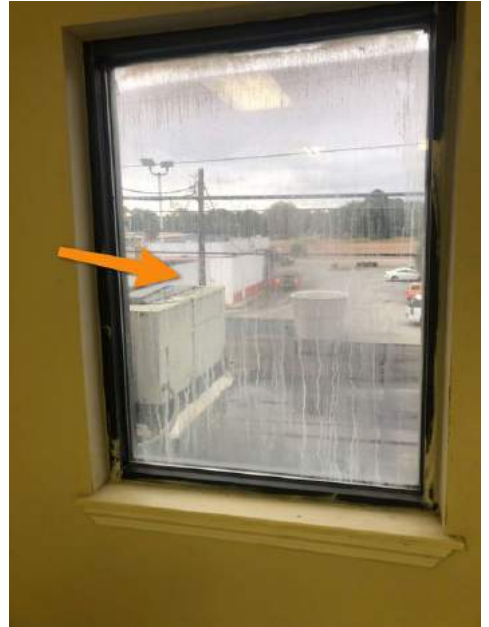
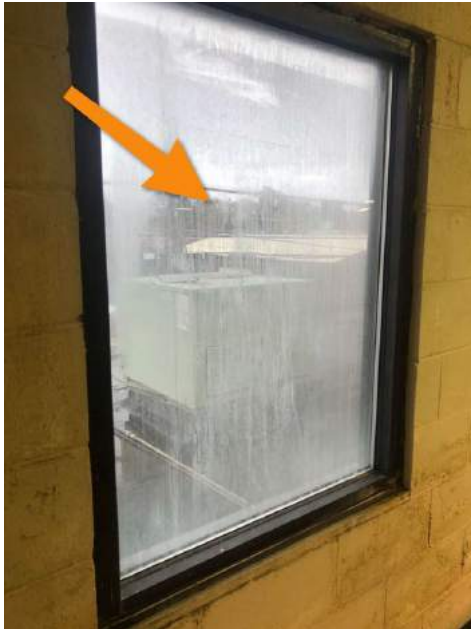
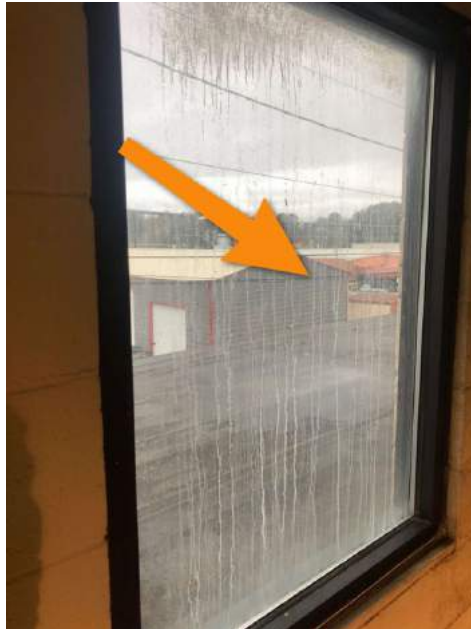
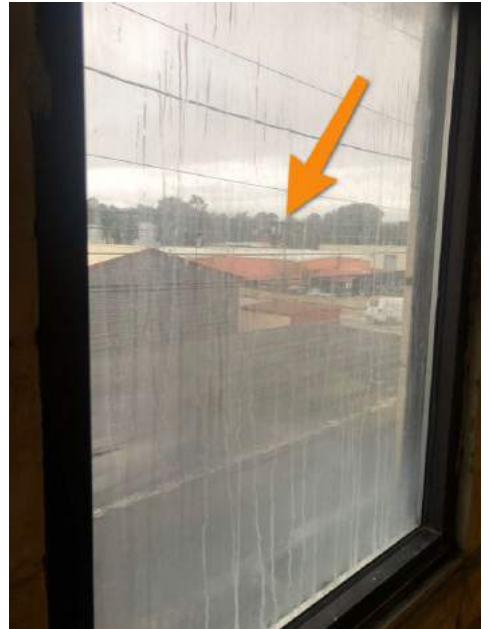
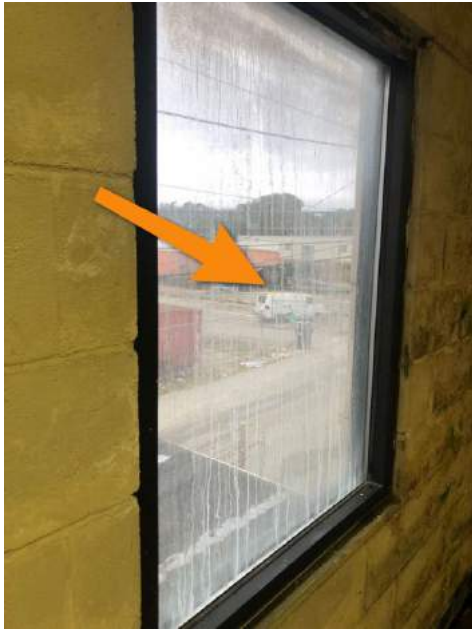
4.3.2 Window Exteriors

Marginal Defect

There were double paned windows present that showed signs of having damaged seals as evidence of moisture was present in-between the glass panes. Recommend replacement of these windows by a qualified window contractor.

Contact a qualified professional.

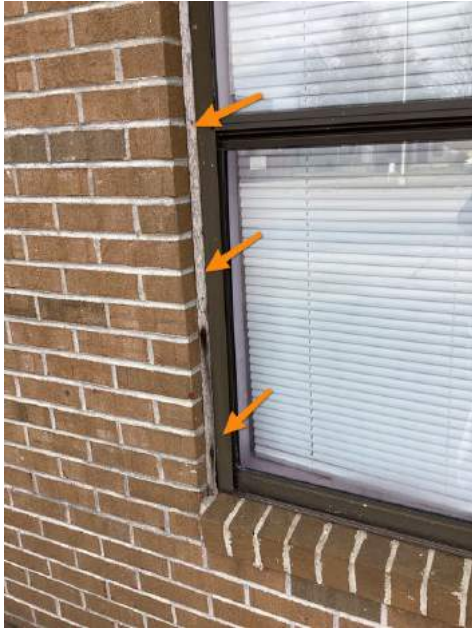
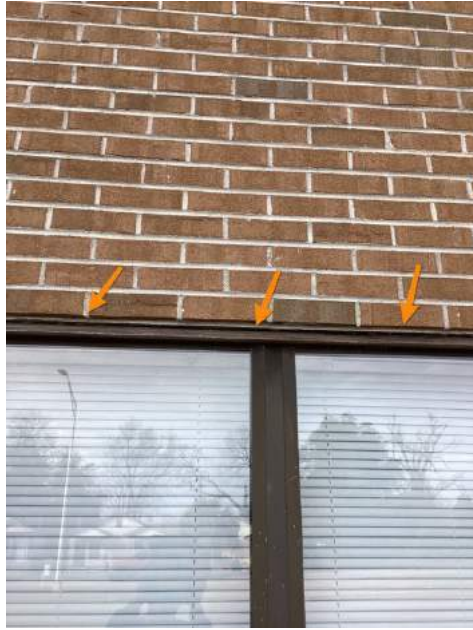
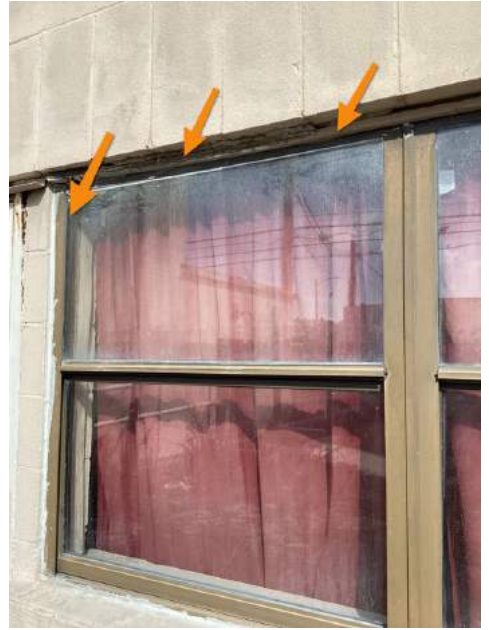
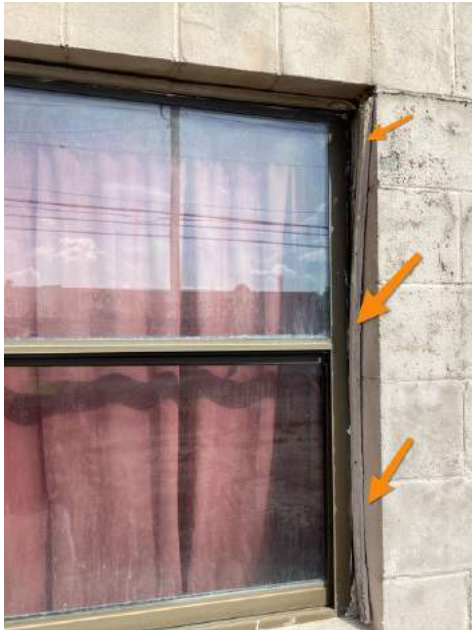
4.3.3 Window Exteriors

DAMAGED AND WEATHERED WINDOW FRAMING

There was heavy weathering and water damage to the wooden framing around the exterior windows at the time of inspection. Recommend repairs/replacements as needed by a qualified individual.

Contact a qualified professional.

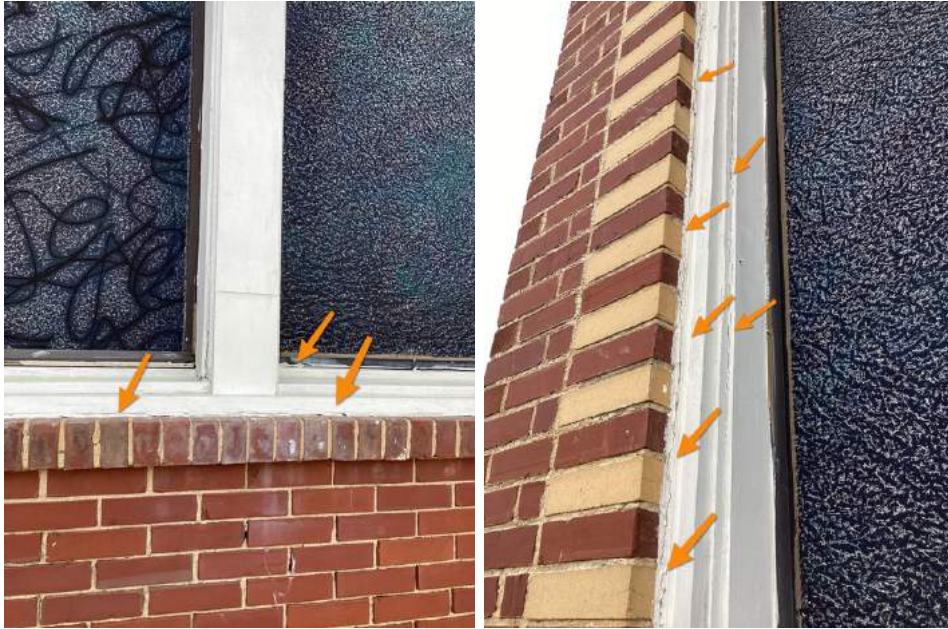
4.3.4 Window Exteriors

CRACKED/WEATHERED/MISSING CAULKING

There was cracked, flaking or missing sealant around the window edges where the windows are seated into the brick at the time of inspection. I recommend removal of old sealant and resealing around all exterior windows by a qualified individual.

Contact a qualified professional.

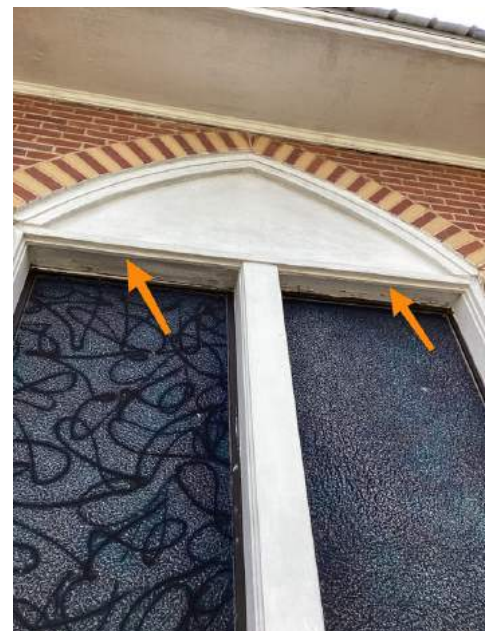
4.3.5 Window Exteriors

There was significant weathering and likely water damage to the exterior upper wooden windows at the time of inspection. Recommend evaluation of all upper windows with repairs/replacements as needed by a qualified individual.

Contact a qualified professional.

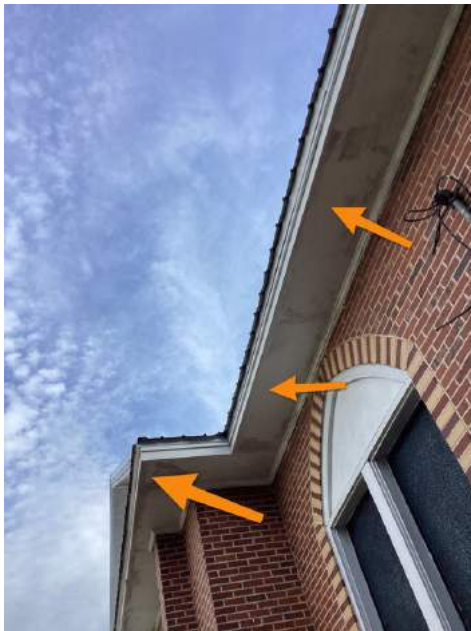
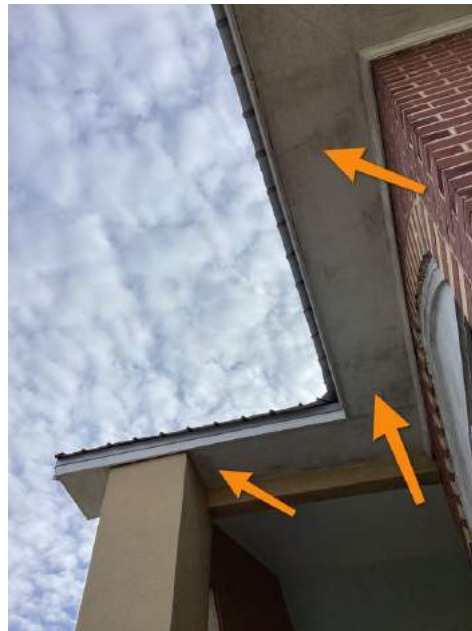
4.5.2 Overhangs / Soffit / Fascia

FLAKING PAINT

Flaking/peeling paint was present in areas on the wood overhangs. Scraping, replacement of any weathered/damaged wood, and repainting these areas as needed is recommended to prevent moisture related damage.

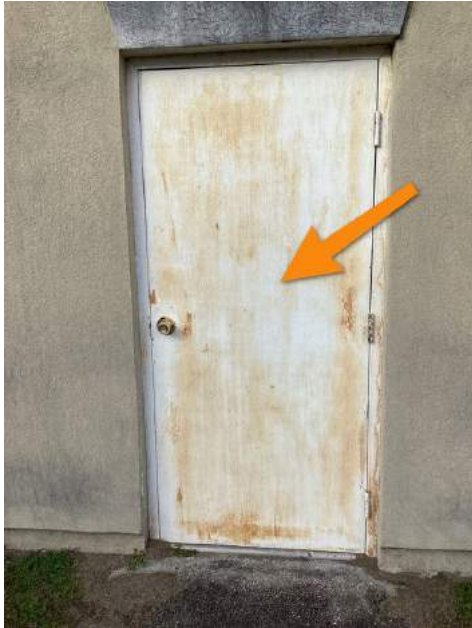
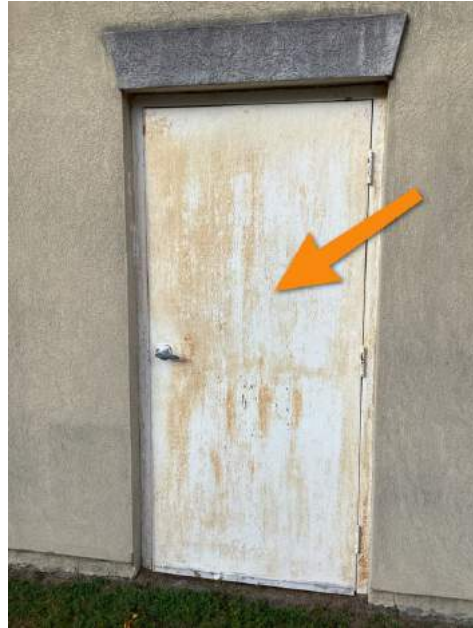
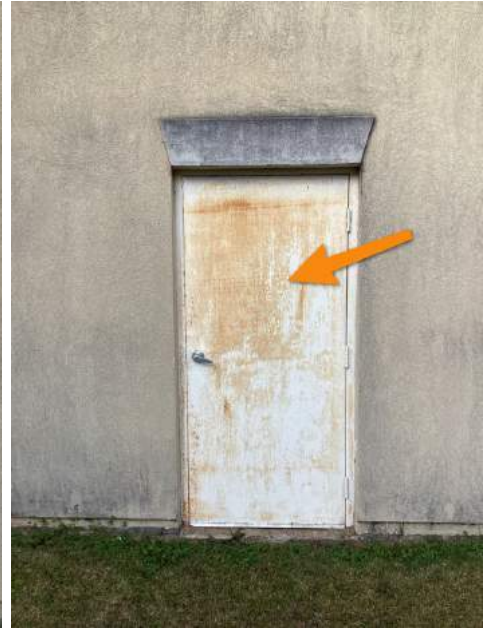
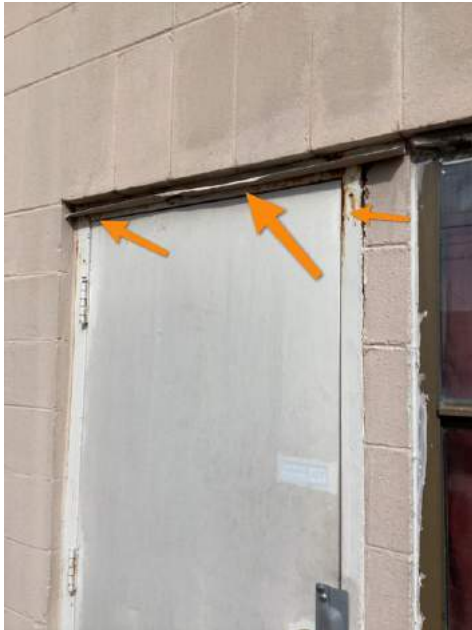
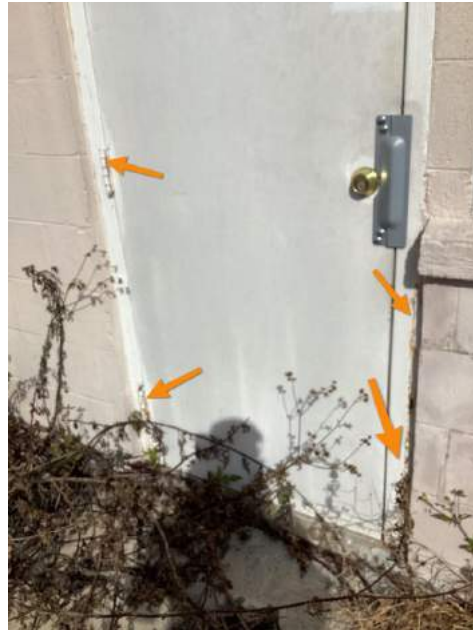
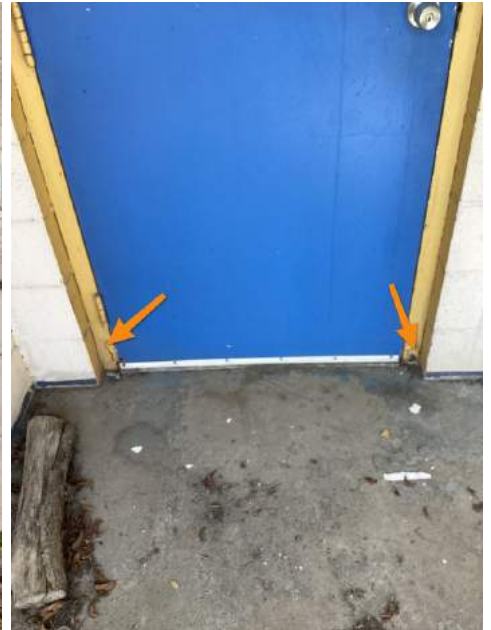
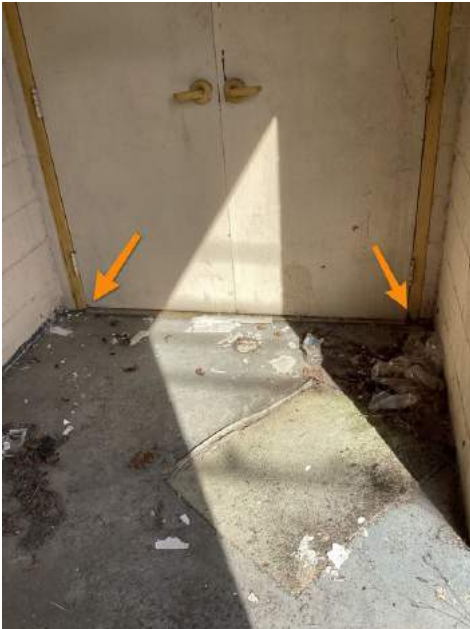
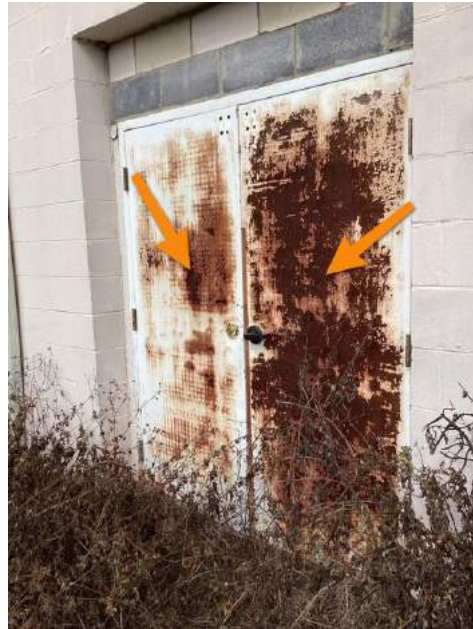
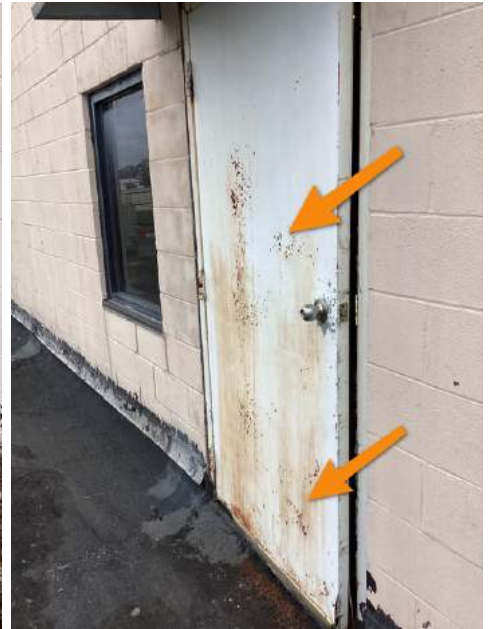
RUST ON STEEL DOOR

Rust was present on the steel door. Repairs or replacement of the slab is recommended as needed by a qualified person.

Contact a qualified professional.

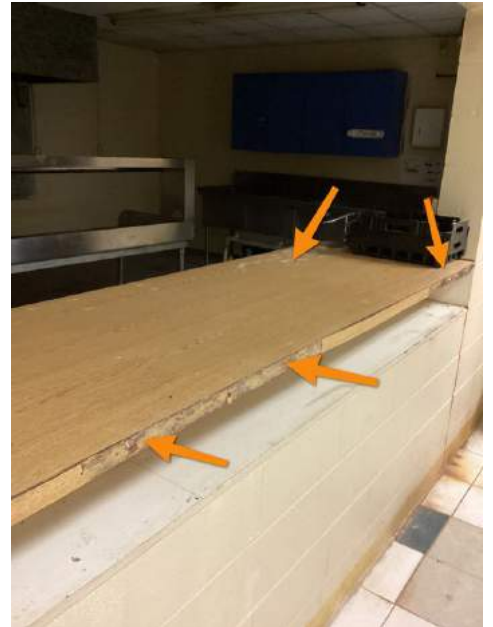
Cafeteria

Marginal Defect**SIGNIFICANT DAMAGE TO CABINETS AND COUNTERTOP**

There was damage present to the kitchen cabinets in Unit A at the time of inspection. Repairs are recommended by a qualified person.

Contact a qualified professional.

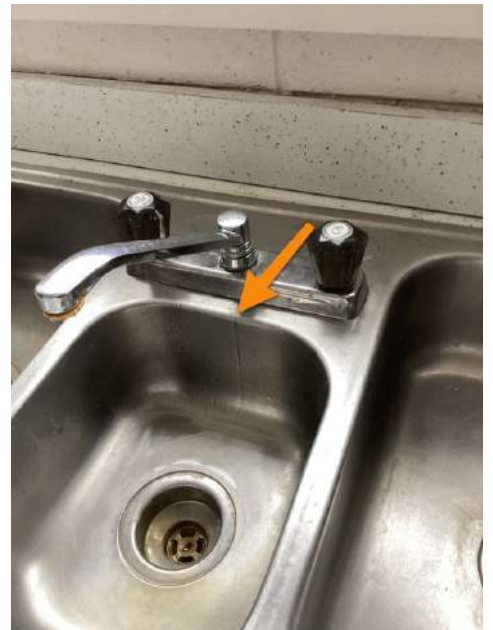
Left Hallway Kitchen

Marginal Defect**LEAK AT FAUCET BASE**

A leak was present from the base of the faucet. Repairs are recommended as needed by a licensed plumber or other qualified person to rectify the leak.

Contact a qualified plumbing contractor.

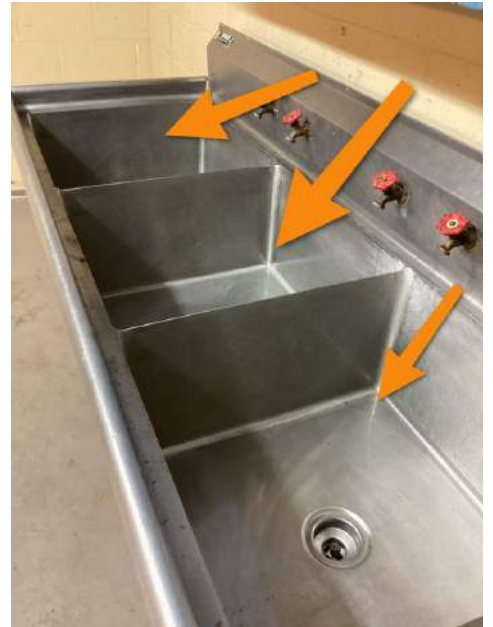
Cafeteria Sinks

There was no hot water produced for the cafeteria sinks at the time of inspection. Recommend evaluation and repairs by a licensed plumber.

Contact a qualified professional.

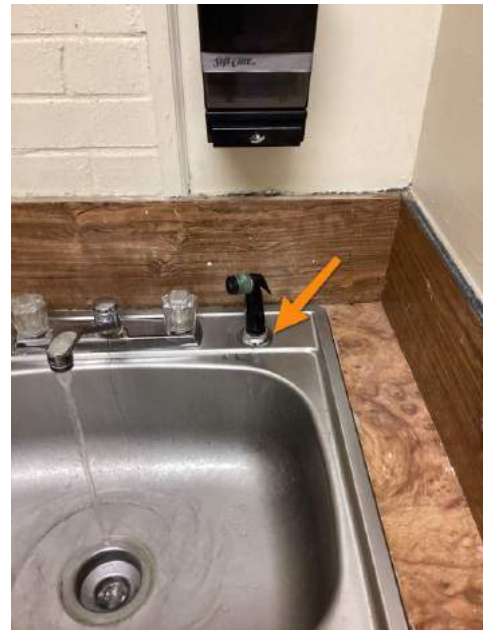
SPRAY AND ANCHOR LOOSE

The spray wand retainer ring was loose at the time of inspection. Recommend repairs by a qualified individual.

Contact a qualified professional.
