SENTRY HOME INSPECTIONS, LLC

COMMERCIAL PROPERTY INSPECTION

714 W Broad Ave
Albany, GA 31701

King Randall
FEBRUARY 3, 2022

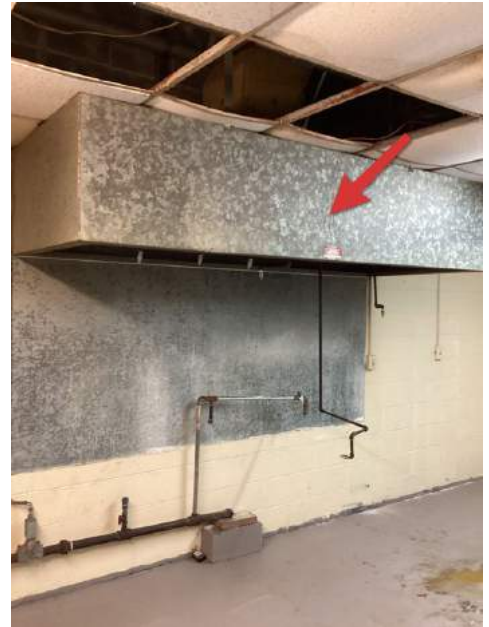
COMMERCIAL GRADE FIRE SUPPRESSION HOOD

Cafeteria Hood Not Inspected

Contact a qualified professional.

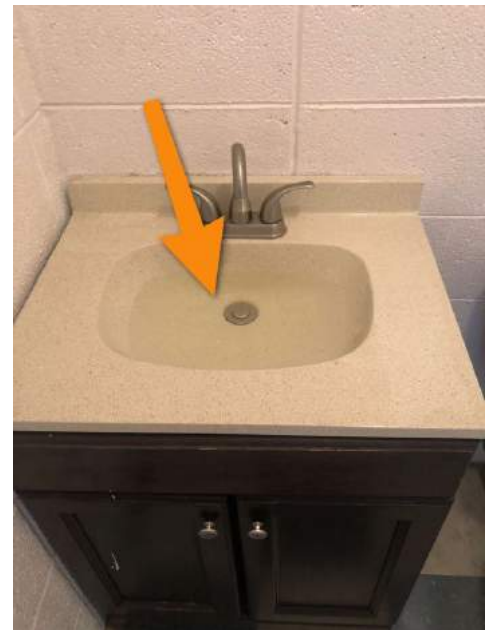
Downstairs Kitchen Bathroom

The sink had slow or hindered drainage. Repairs are recommended as needed by a licensed plumber or other qualified person for proper drainage.

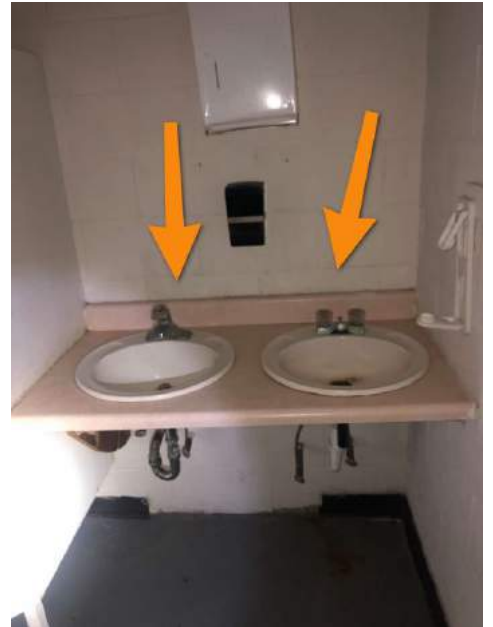
Men's Downstairs Bathroom

There was No Water available at the time of inspection. Recommend reinspection once water service is restored.

Recommendation

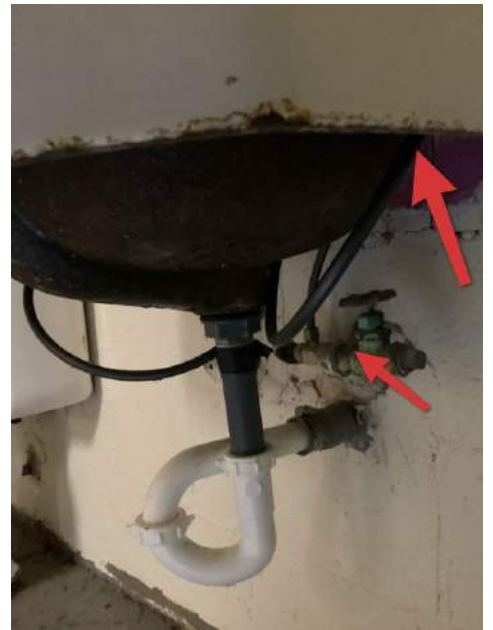
Downstairs Classroom Sink

LEAK AT FAUCET BASE

The sink faucet had a leak at the base. Repairs are recommended as needed by a licensed plumber or other qualified person to rectify the leak.

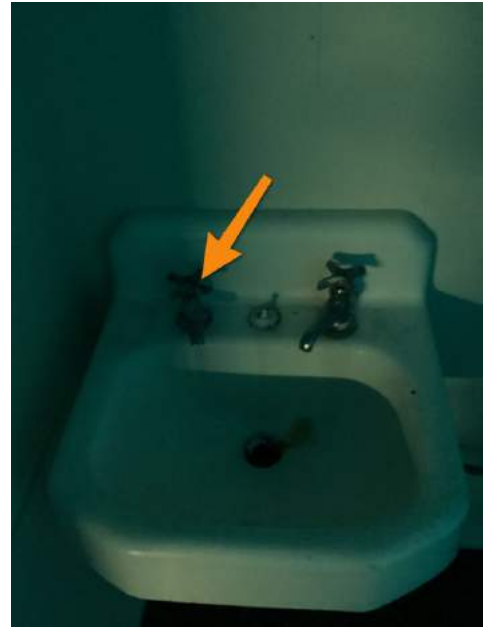
Left Side Mens Bathroom

Hot water supply was not functional at the time of inspection. Evaluation and repairs as needed for proper operation is recommended by a licensed plumber.

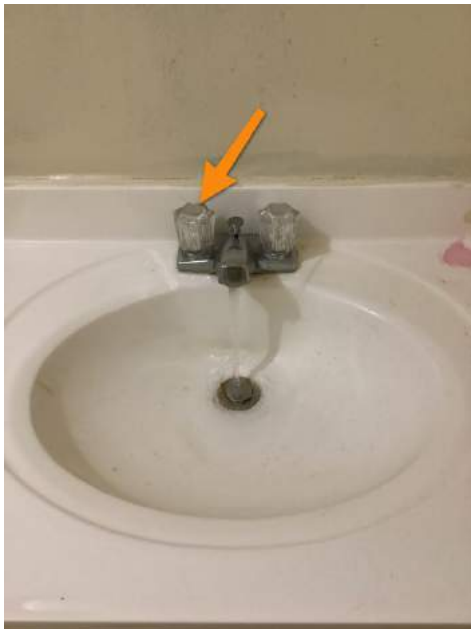
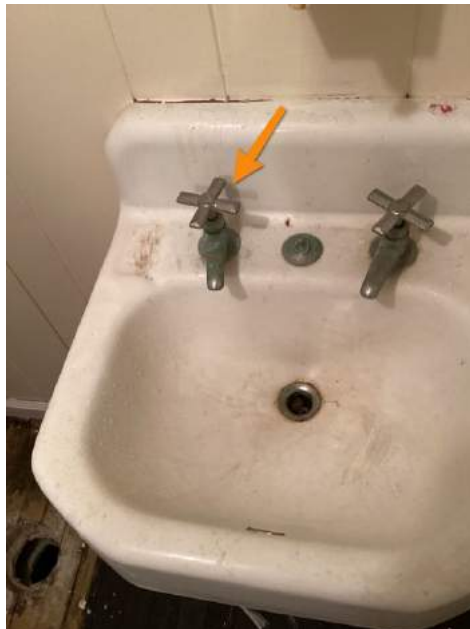
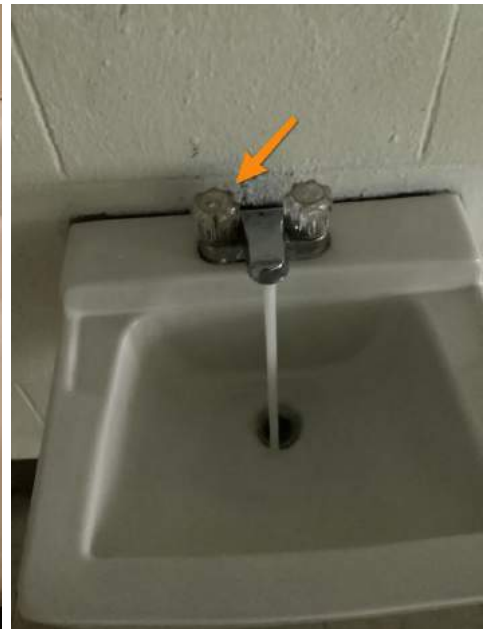
The water was ran for at least 5 minutes and hot water was not produced at the referenced sink at the time of inspection. Evaluation and repairs made as needed to provide hot water is recommended by a licensed plumber.

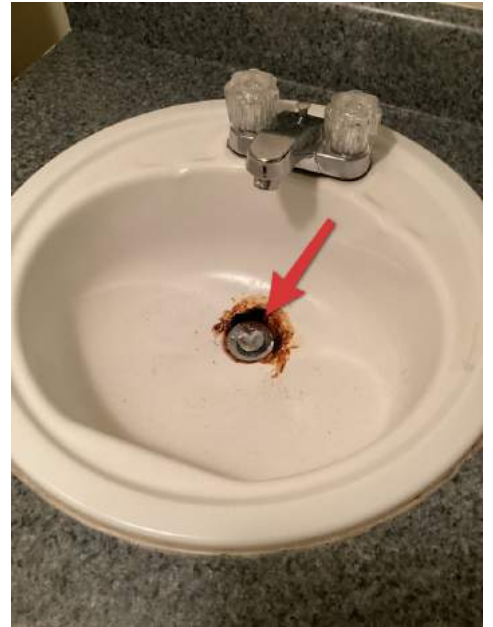
Left Side Womens Bathroom

SIGNIFICANT RUST TO SINKS

The sink was rusted completely through and was leaking at the time of inspection. Recommend replacement of both sinks in the women's bathroom.

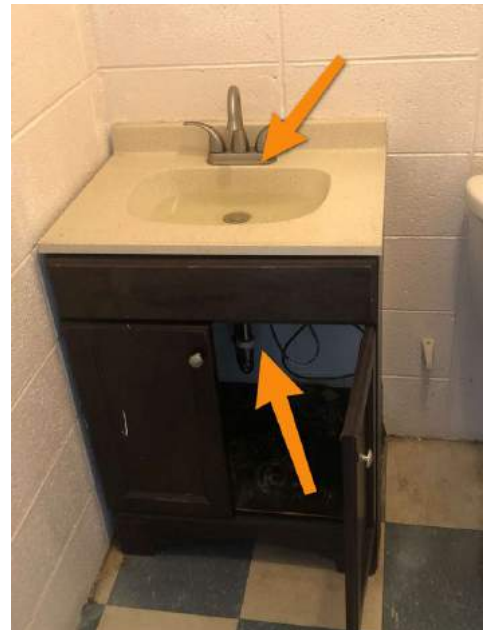
Downstairs Kitchen Bathroom

LEAK PRESENT

There was a leak present under the sink. Repairs are recommended to be conducted as needed to rectify any leaks by a licensed plumber.

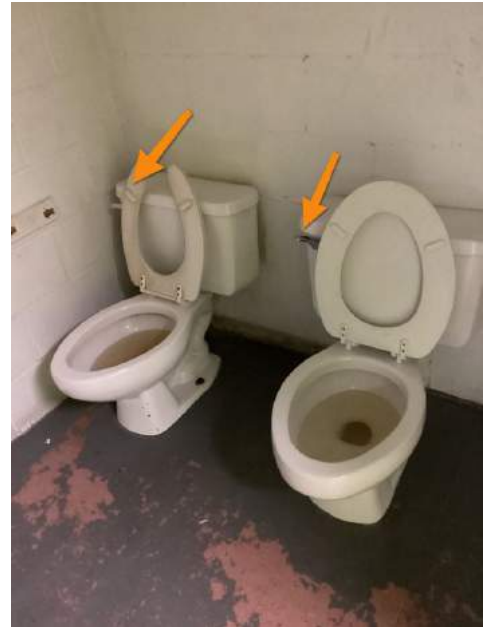
Downstairs Children's Bathroom

Marginal Defect**TOILET HANDLE HAS TO BE HELD DOWN**

The toilet handle had to be held down for the toilet to flush properly. The toilet fill valve or stopper chain may need adjustment or replacement to function properly. Repairs are recommended to be conducted as needed by a licensed plumber or other qualified person for proper operation.

Contact a qualified plumbing contractor.

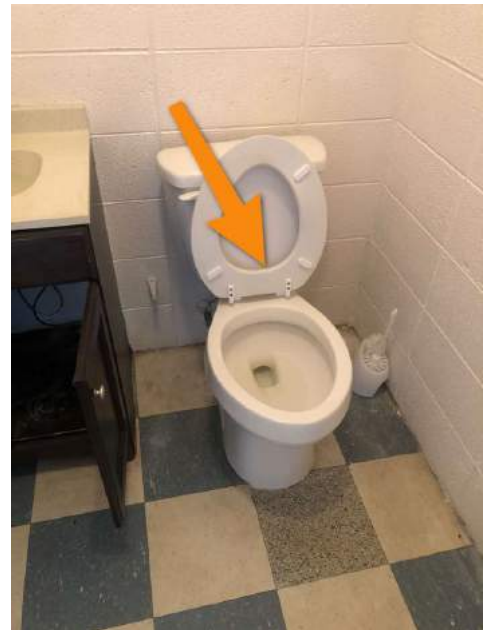
Downstairs Kitchen Bathroom

Marginal Defect**TOILET(S) NOT FLUSHING**

The toilet was not flushing at the time of inspection. Evaluation and repairs as needed for proper operation is recommended by a licensed plumber.

Contact a qualified plumbing contractor.

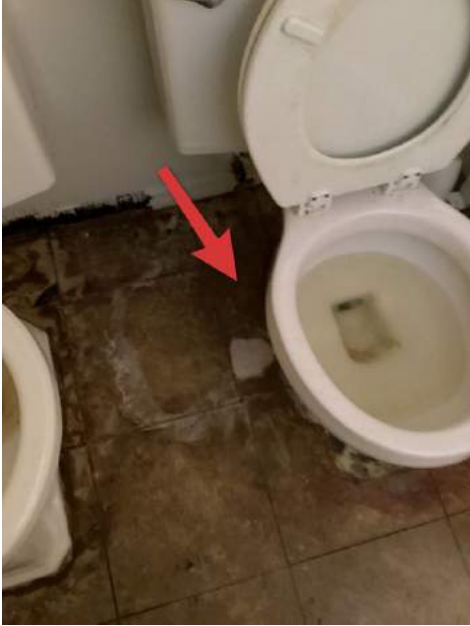
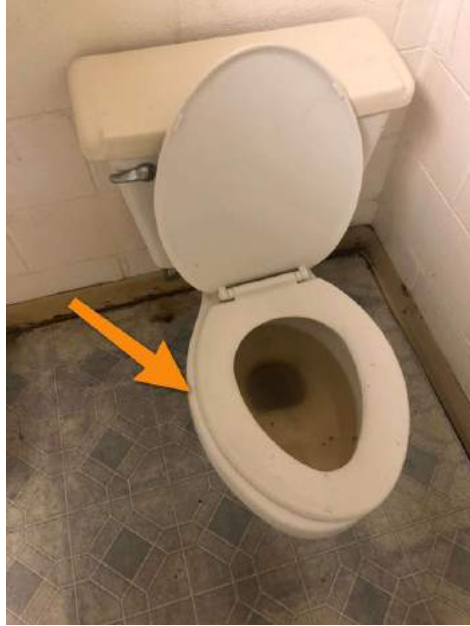
Marginal Defect**LEAK AT TOILET BASE**

A leak was present from the base of the toilet. Repairs are recommended as needed by a licensed plumber.

Contact a qualified plumbing contractor.

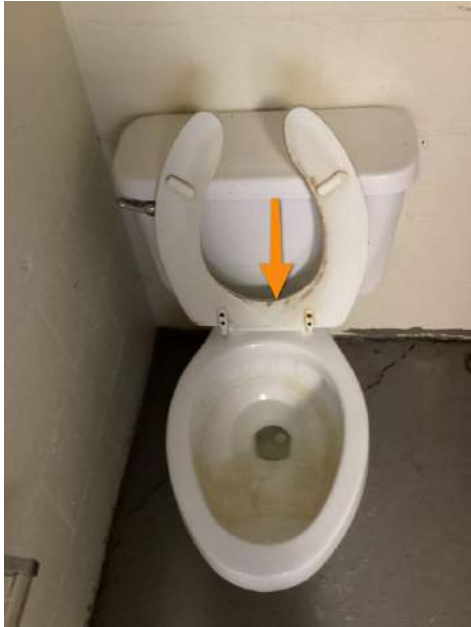
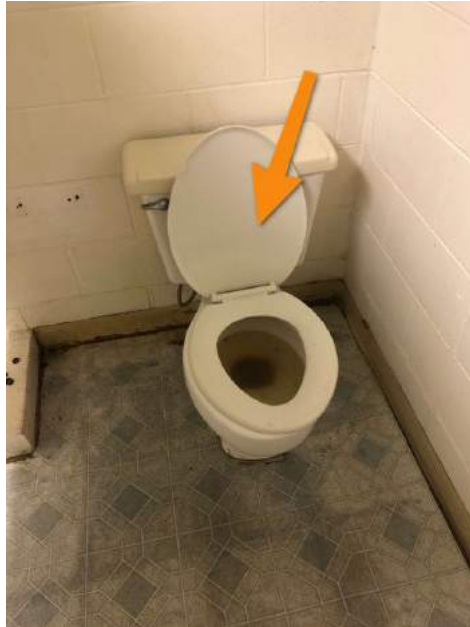
The toilet was not flushing adequately. Repairs are recommended as needed by a licensed plumber for proper operation.

Contact a qualified plumbing contractor.

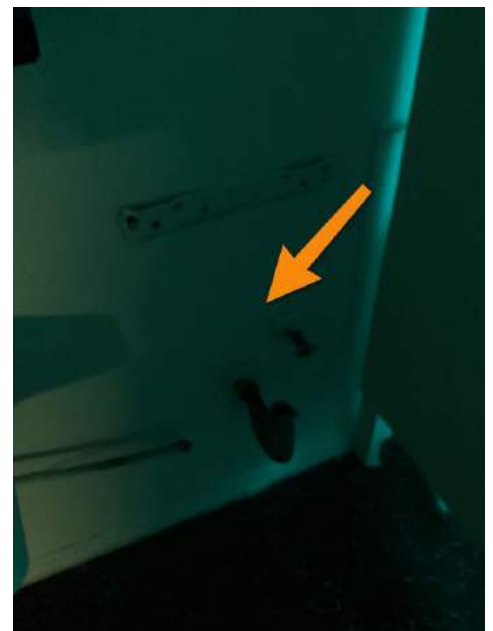
MEN'S URINAL MISSING

There was a missing urinal in the men's bathroom at the time of inspection. Recommend replacement by a qualified plumber.

Contact a qualified professional.

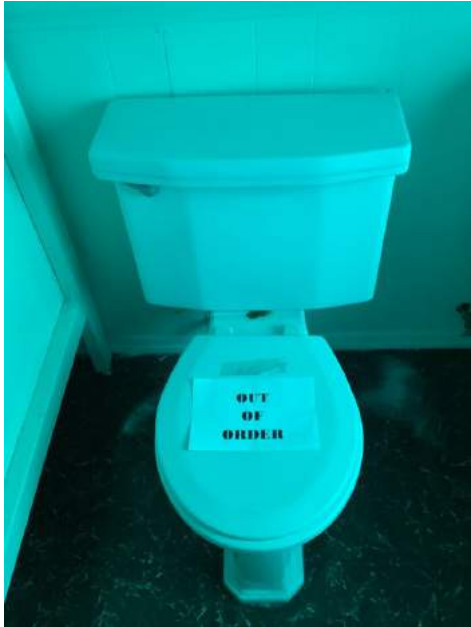
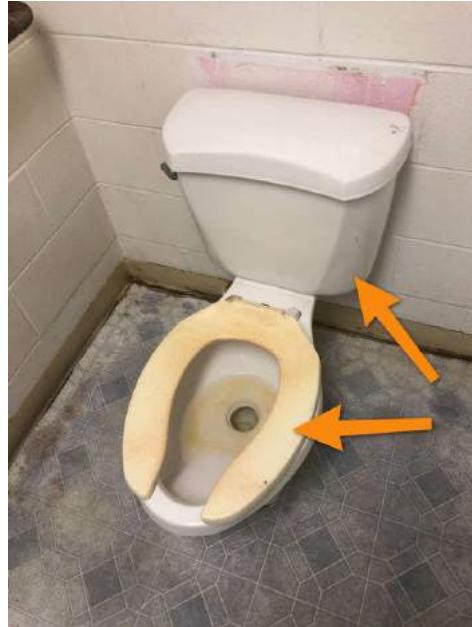
Downstairs Women's Bathroom

TOILET NOT FUNCTIONAL

There was dysfunctional toilet in the men's bathroom at the time of inspection. Recommend repairs/replacement as needed by a qualified plumber.

Contact a qualified professional.

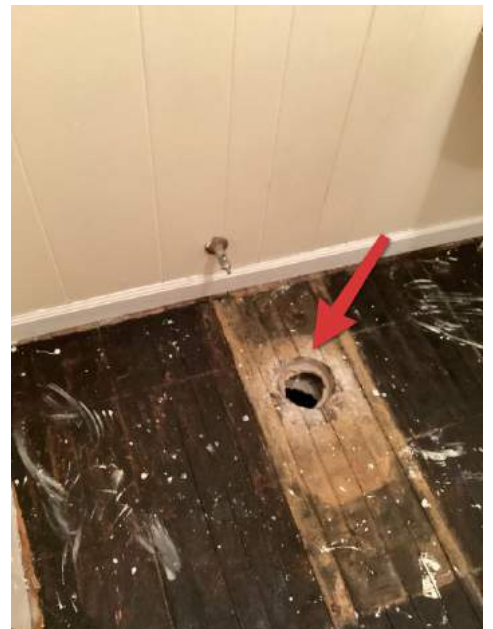
Upstairs Office Bathroom

TOILET MISSING

The toilet was missing in the bathroom at the time of inspection. Recommend replacement of toilet by a qualified plumber.

Contact a qualified professional.

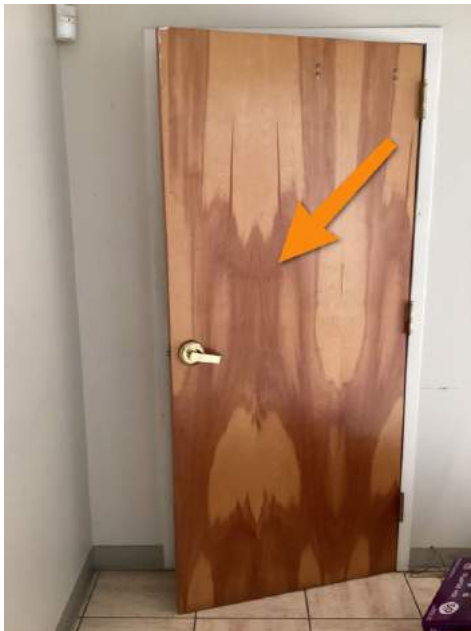
Middle Entry Closet

7.4.1 Interior Doors

BINDING DOOR(S) PRESENT

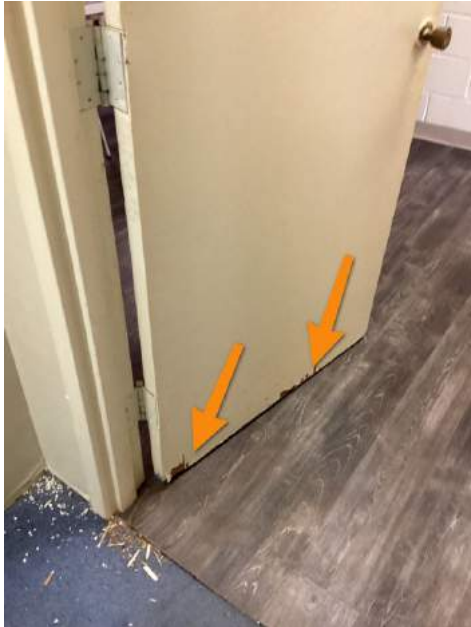
Middle Closet

7.4.2 Interior Doors

DOOR DAMAGED

Contact a qualified handyman.

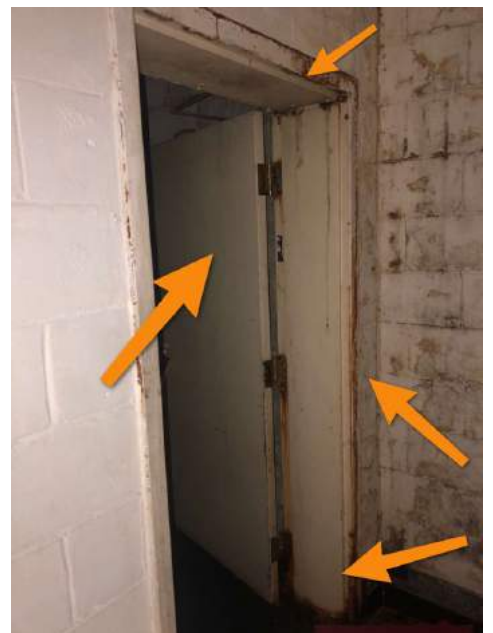
Gym

7.4.3 Interior Doors

DAMAGE TO DOOR

Contact a qualified professional.

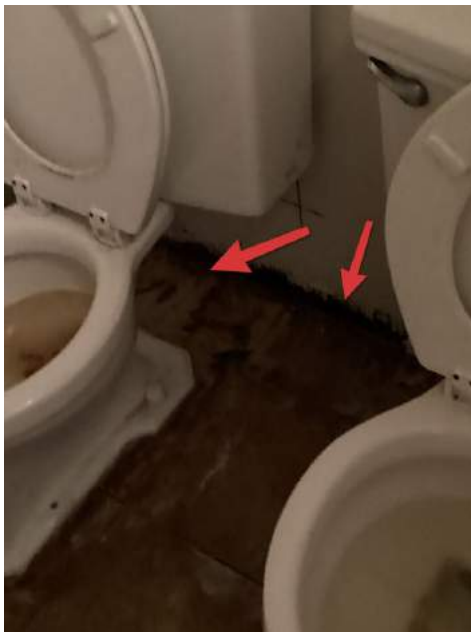
Left Side Womens Bathroom

7.9.3 Wall Condition

WATER DAMAGE PRESENT - NO MOISTURE

Water damage and indications of past/present leaks or water infiltration was present to the referenced wall(s). I recommend consulting with the sellers as to what created the damage to these areas, and what repairs were carried out to address the leaks or moisture infiltration. If the sellers have no information, evaluation is recommended by a qualified contractor to determine the source of the damage, with repairs made to any damage present.

Contact a qualified professional.

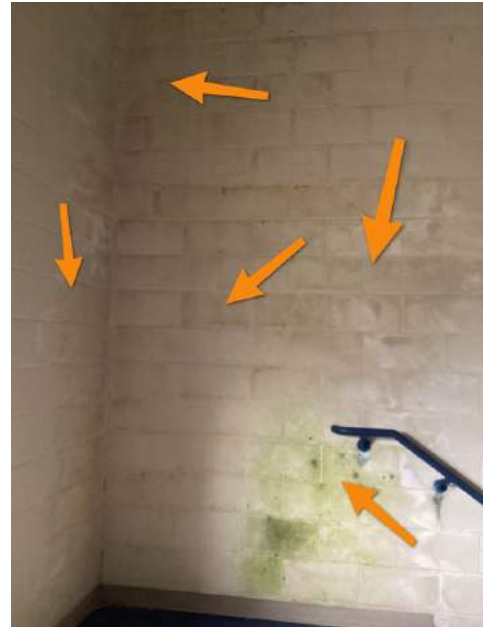
Interior Stairwell

7.9.4 Wall Condition

MOISTURE DAMAGE PRESENT

Damage was present to the wall from past or present moisture. Evaluation and repairs are recommended to both the source of moisture to prevent it from reoccurring, as well as to the damage as needed by a qualified contractor.

Contact a qualified professional.

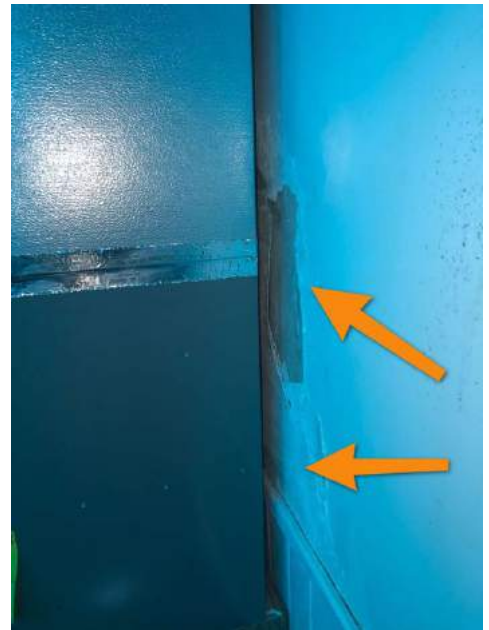
Main Worship Hallway

7.9.5 Wall Condition

DRYWALL DAMAGE

Damage was present to an area of the interior walls. Recommend repairs by qualified individual.

Contact a qualified drywall contractor.

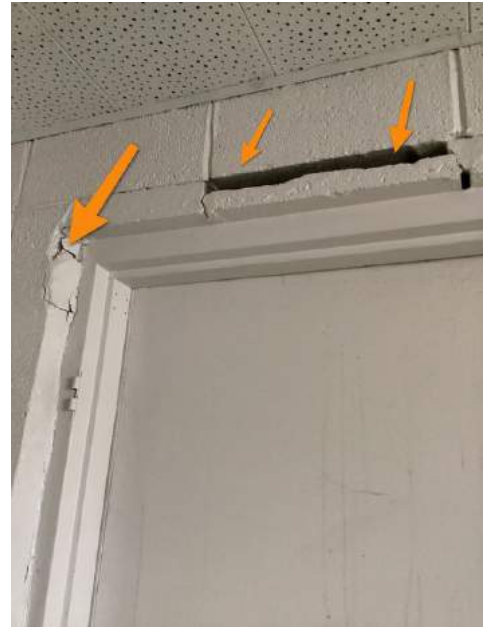
Left Side Hallway Kitchen

7.9.6 Wall Condition

DAMAGE TO WALLS

There was damage present to the interior walls of all units at the time of inspection on varying degrees. Repairs/replacements are recommended by a qualified professional as needed.

Contact a qualified professional.

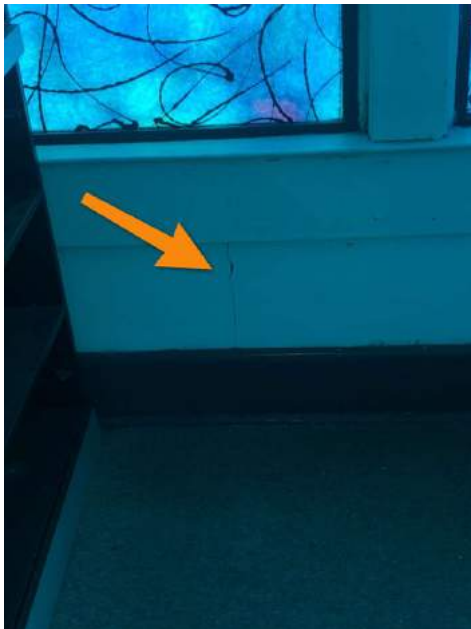
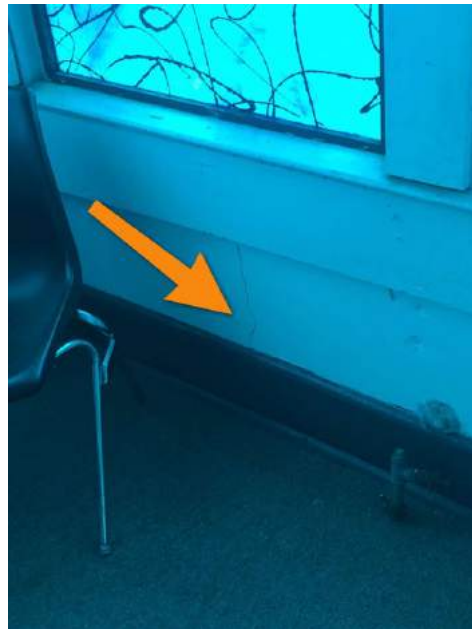
Worship Hall Front Room

7.9.7 Wall Condition

CRACKING TO INTERIOR WALL

There was cracking present on the interior walls at the time of inspection. Settlement cracking is typically expected with older homes and does not necessarily mean that are serious settlement issues. Recommend that wall cracks are filled by a qualified individual and that the cracking be closely monitored for any additional action needed to remedy.

Contact a qualified professional.

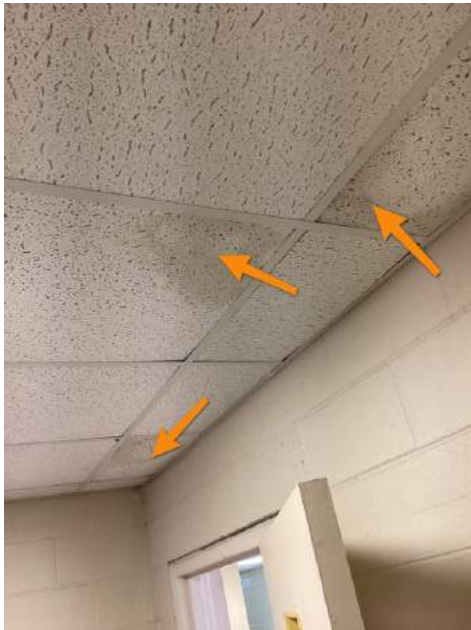
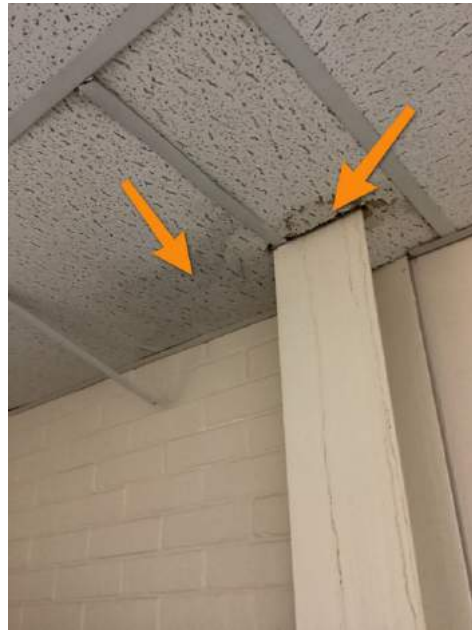
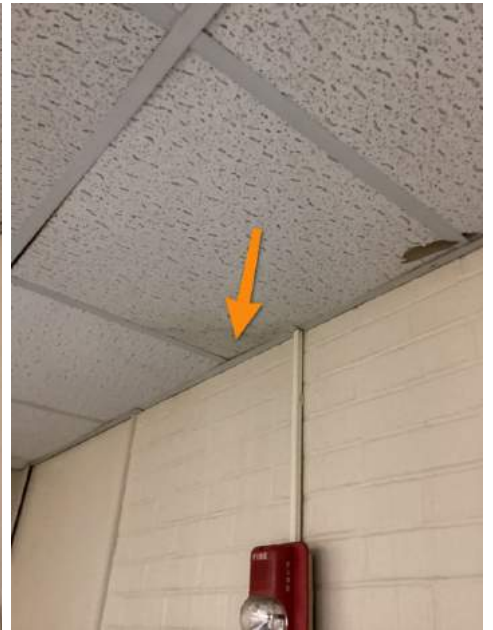
Middle Conference Room

7.10.1 Ceiling Condition

MOISTURE STAINING PRESENT - UNDETERMINED SOURCE

Moisture stain(s) were present on the ceilings in the referenced areas. Although the area(s) were not actively leaking at the time of inspection, moisture stains should be viewed as active leaks until they prove themselves otherwise. I recommend inquiring with the sellers about the stains as they would have firsthand knowledge of why the stain is present, and what repairs were carried out to address it. If they are unsure of the stains, a roofing contractor or plumbing contractor (as applicable) should evaluate and make repairs as needed.

Contact a qualified professional.

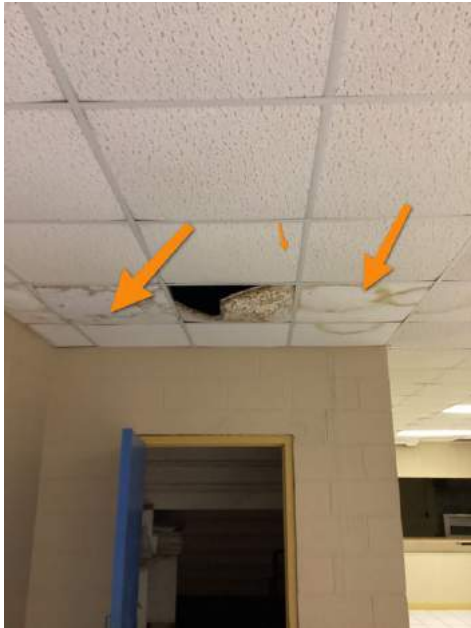
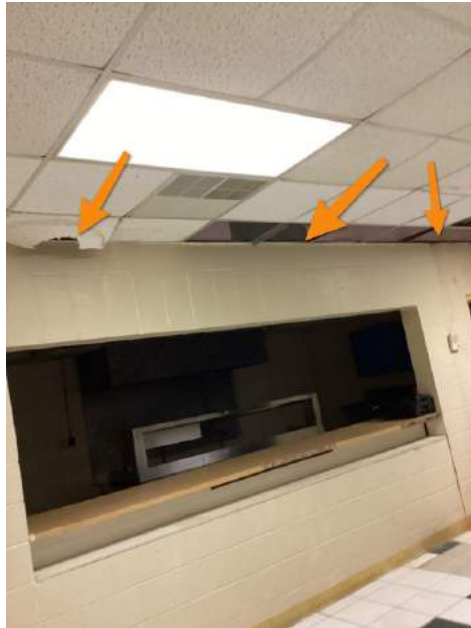
Cafeteria

7.10.2 Ceiling Condition

MOISTURE STAINING/DAMAGE PRESENT

Moisture stain(s) and related damage was present on the ceilings in the referenced areas. Although the area(s) were not actively leaking at the time of inspection, moisture stains should be viewed as active leaks until they prove themselves otherwise. I recommend inquiring with the sellers about the stains as they would have firsthand knowledge of why the stain is present, and what repairs were carried out to address it. If they are unsure of the stains, a roofing contractor or plumbing contractor (as applicable) should evaluate and make repairs as needed. Repairs to any damage is recommended as needed by a qualified person.

Contact a qualified professional.

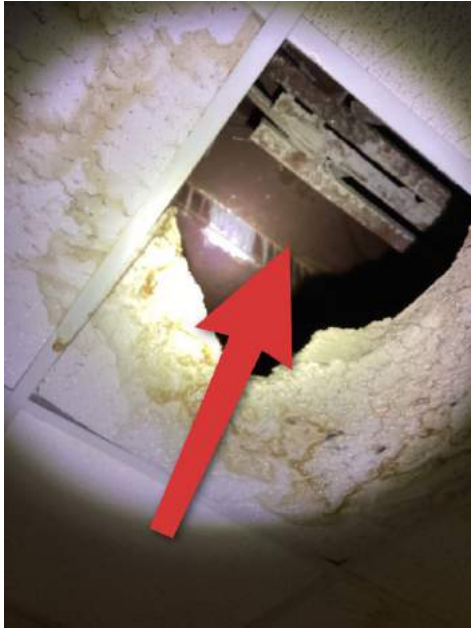
Cafateria

ACTIVE LEAK - ELEVATED MOISTURE CONTENT

An active leak with elevated moisture content was present on the ceiling in the referenced area(s). Repairs to the source of the leak, to the drywall and to any other related damage is recommended to be conducted by qualified contractors as needed.

Contact a qualified professional.

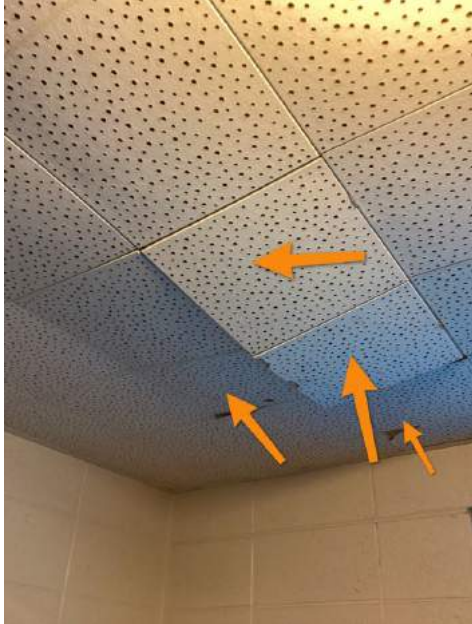
Left Side Hallway Room

DAMAGED DROP CEILING TILES PRESENT

Damaged drop ceiling tiles were present in the referenced area(s). Replacement of any damaged ceiling tiles is recommended by a qualified person.

Contact a qualified professional.

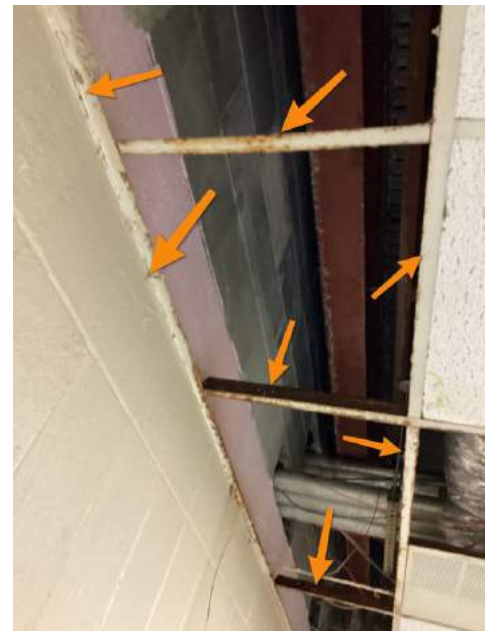
Cafeteria

WATER DAMAGE TO SUSPENDED CEILING FRAME & PANELS

There was evidence of significant water intrusion and rusting to the metal framing and the ceiling tiles of the cafeteria at the time of inspection. Recommend replacement of all damaged framing and ceiling panels by a qualified individual.

Contact a qualified professional.

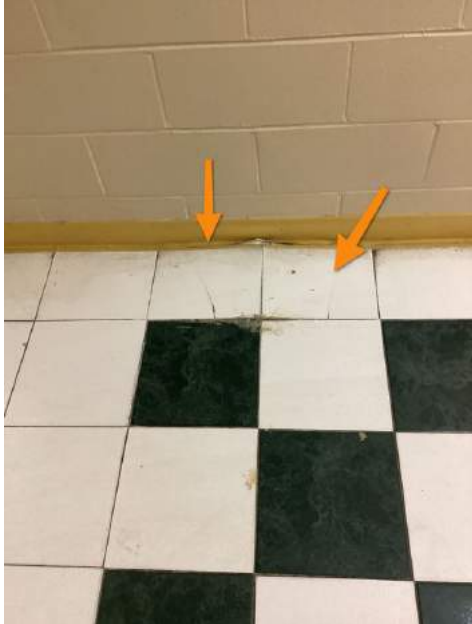
Middle Cafeteria

DAMAGE TO FLOOR TILE

There was damage present to the tile floor at the time of inspection. Repairs/replacement by a qualified professional as needed.

Contact a qualified professional.

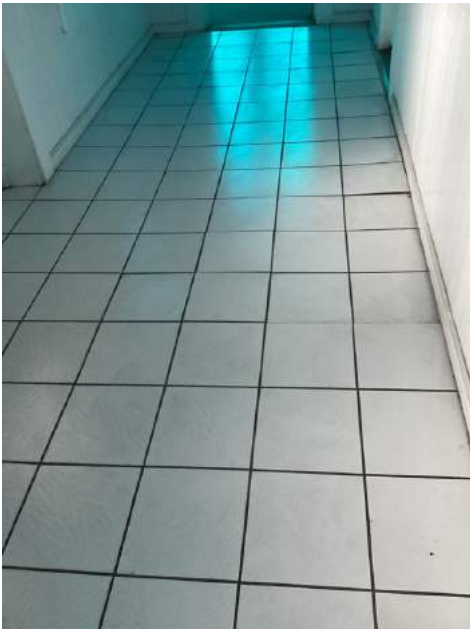
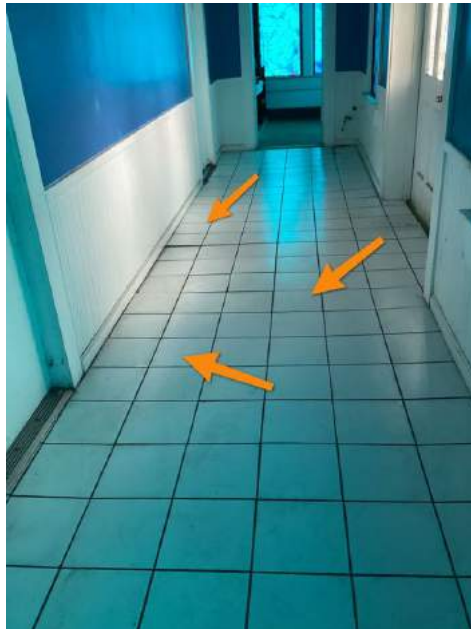
7.11.3 Floor Condition

CRACKING TO CONCRETE FLOOR WITH DISPLACEMENT

There was significant cracking with displacement to the floor of the upstairs classroom. Recommend evaluation and repairs as needed by a qualified concrete contractor.

Contact a qualified professional.

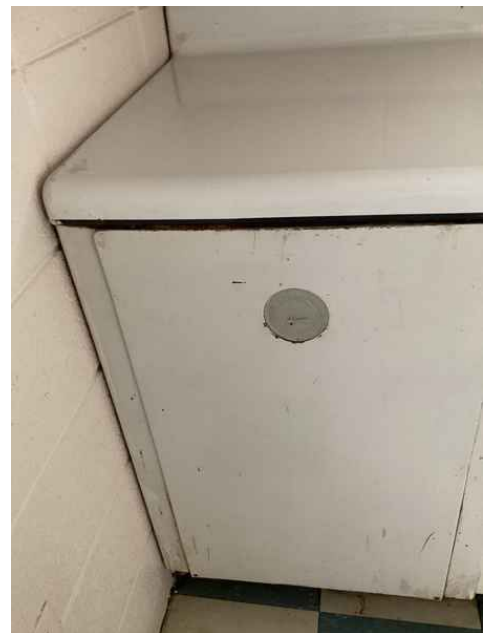
11.1.4 Water Heater Condition

ENCLOSURE RUSTED

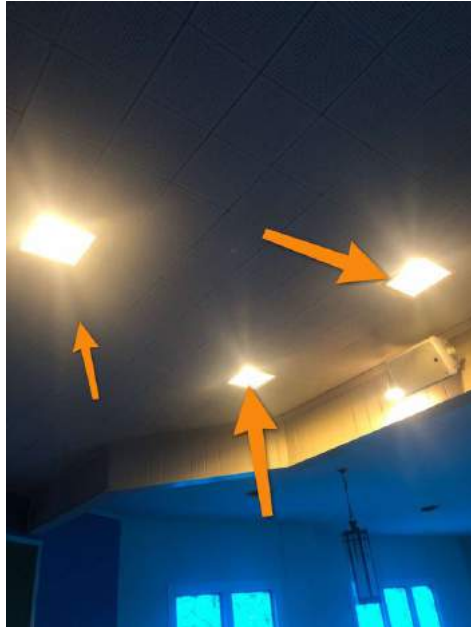
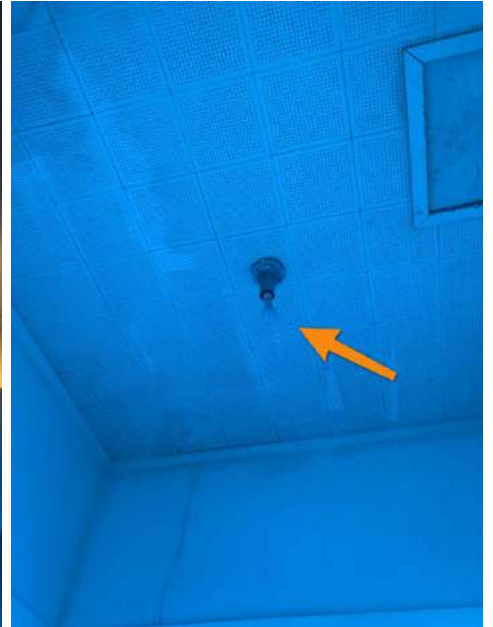
Worship Hall Front Room

13.15.3 Switches, Lights

FLUORESCENT FIXTURE BALLAST BURNED OUT

A fluorescent light fixture ballast was producing an irregular noise, this is typically an indicator that the ballast is at the end of its useful life. Evaluation and repairs as needed for proper operation is recommended by a licensed electrician.

Contact a qualified electrical contractor.

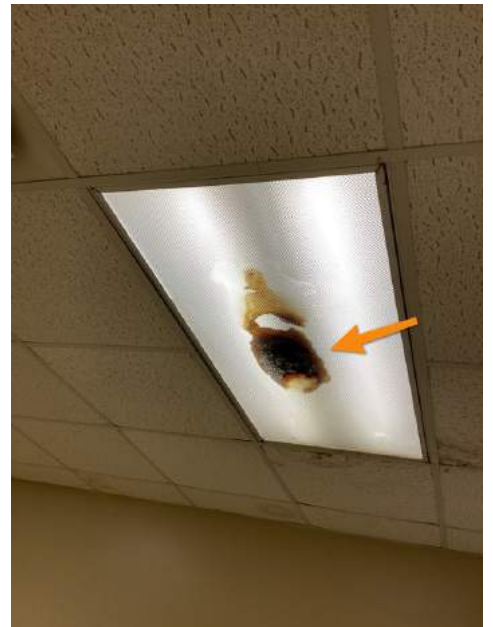
Classroom 217

13.15.4 Switches, Lights

Marginal Defect**DISPLACED LIGHT FIXTURE**

There were light fixture(s) present that were not secured properly. Proper securement of the fixture(s) is recommended to be conducted by a licensed electrician as needed.

Contact a qualified electrical contractor.

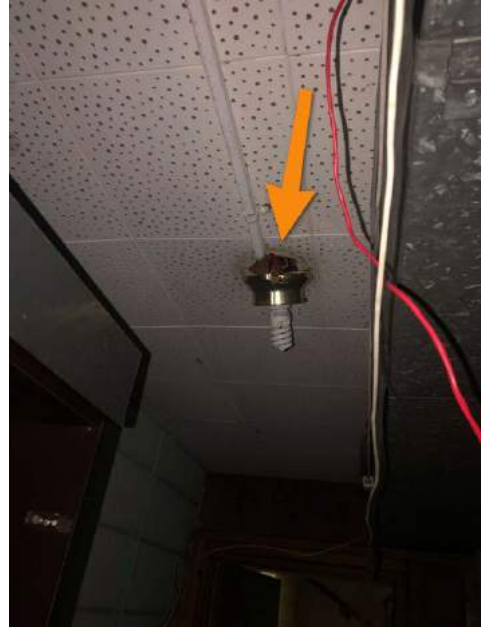
Downstairs Closet

13.15.5 Switches, Lights

Marginal Defect**OVERHEAD LIGHTS NOT FUNCTIONING PROPERLY**

Overhead lights that were not functioning properly (would not stay lit). Repairs are recommended as needed for proper operation by a licensed electrician.

Contact a qualified electrical contractor.

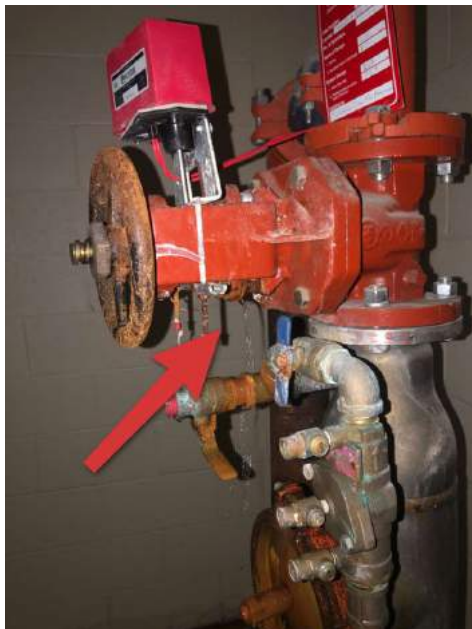
Gym Closet

HYDROLIC FIRE SUPPRESSION SYSTEM LEAKING

There was a full commercial hydraulic fire suppression system in place that was significantly leaking at the time of inspection. Recommend evaluation and repairs as needed to this system by a qualified licensed fire suppression system technician.

Contact a qualified professional.

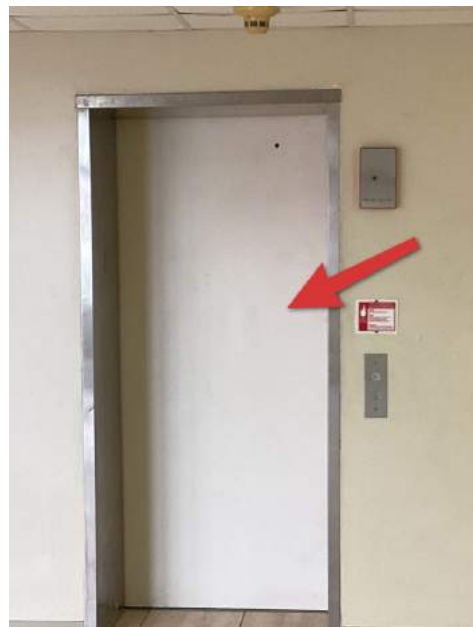
Middle Entry Foyer

13.18.1 Elevator

There was a interior elevator present that was not operable at the time of inspection and was not tested. Commercial elevators require annual inspection and servicing by a licensed elevator contractor to meet local code. Recommend evaluation, servicing, and any needed repairs/replacements if the elevator will be utilized.

Contact a qualified professional.
