Stream Bank/Stream Channel Erosion Study – Shady Creek, Harrison Creek, Walnut River and Cole Creek

Summary Report
April 28, 2017

Upper Walnut/El Dorado Lake Watershed Restoration and Protection Strategy (WRAPS)

Project Number: 2015-W071
Year 3 SFY 16 FFY 15
Project Start/End Dates: 10/01/2015 – 3/31/17
KS Grant #: 2015-W071 – Project ID# 756
EPA Grant #C9007405-21

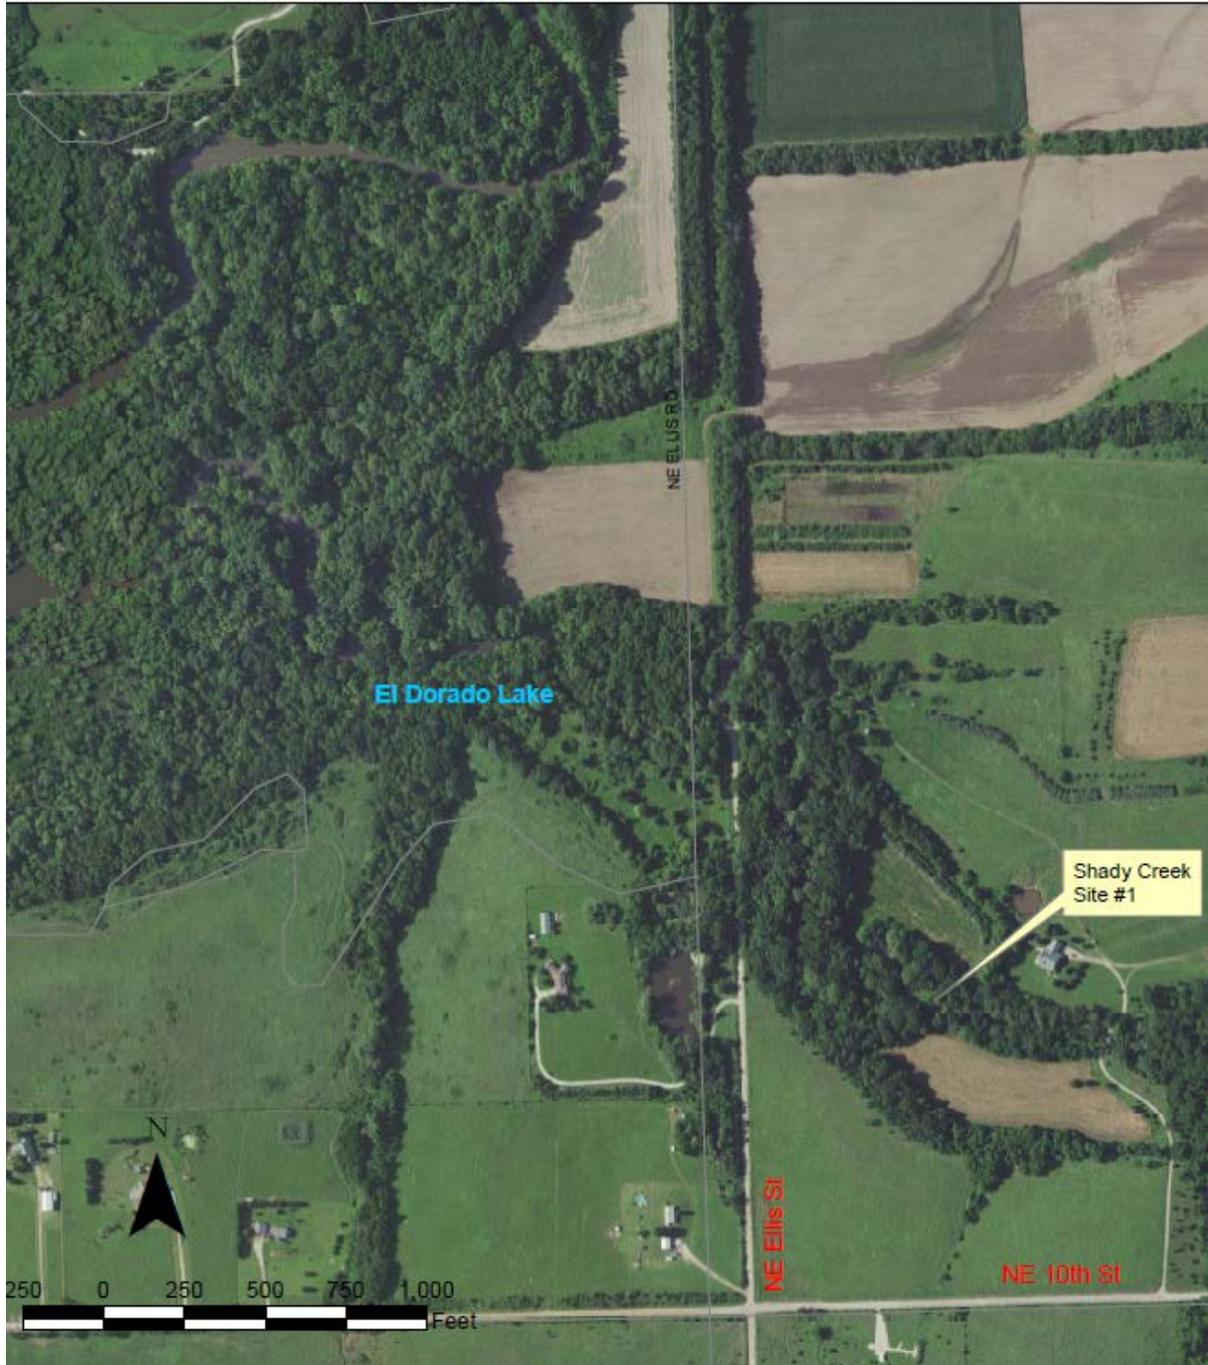
**Streambank/Channel Survey
2010 and 2017
Shady Creek Site #1**

In general, at Shady Creek’s cross section, the survey showed 8.52 square feet (2,360 pounds or 1.2 Ton) of deposition (sediment gained) from 2010 to 2017; the lower bank pin was exposed by 1.68 feet and the upper bank pin was exposed 2.25 feet. Deposition is a naturally occurring process and is to be expected during high flows. Visual observation from 2010 and 2017 showed gravel shifting from one part of the stream to the other and depositing in different places. The stream channel was much wider in 2010 than it was in 2017 (narrower stream channel = more velocity). A deeper channel indicates channel incision and stream bed erosion. More gravel and gravel piled higher on the non-eroding side of the stream bank was observed. The gravel bar deposition or lateral increase normally follows bank erosion. Once the lateral migration (bank erosion) slows, the bar may increase in height. The increase in gravel bar height may be due to excess sediment from upstream, loss of stream power (velocity) in this area due to wider stream channel, or other factors.

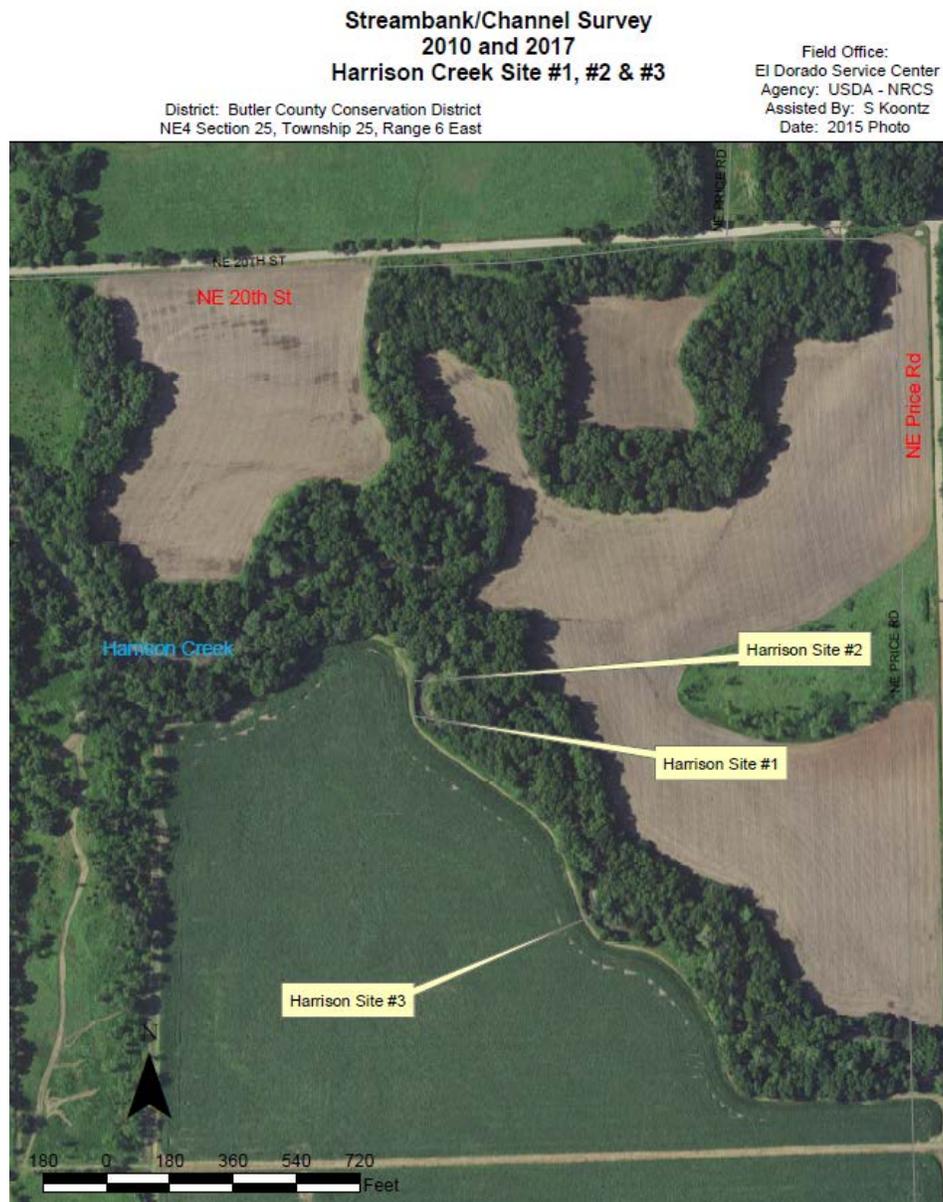
Harrison Creek (Simpson) sub-basin is located north of Shady Creek. According to the SWAT model, the lower part is high priority with a high priority stream reach on the lower 5 miles to El Dorado Lake. Three different sites were surveyed on the lower reach of Harrison Creek. The land use around the 3 sites located in the lower part of the sub-basin is row crop farming. The riparian area is 30 feet or less at the survey sites and the trees have been lost in the area where the surveys were done. The riparian area in general is wider than 30 feet in most areas on this landowner's property. The soil type is Verdigris silt loam, 0-1% slope, occasionally flooded. The stream banks on these sites are 12 feet to 18 feet in height.

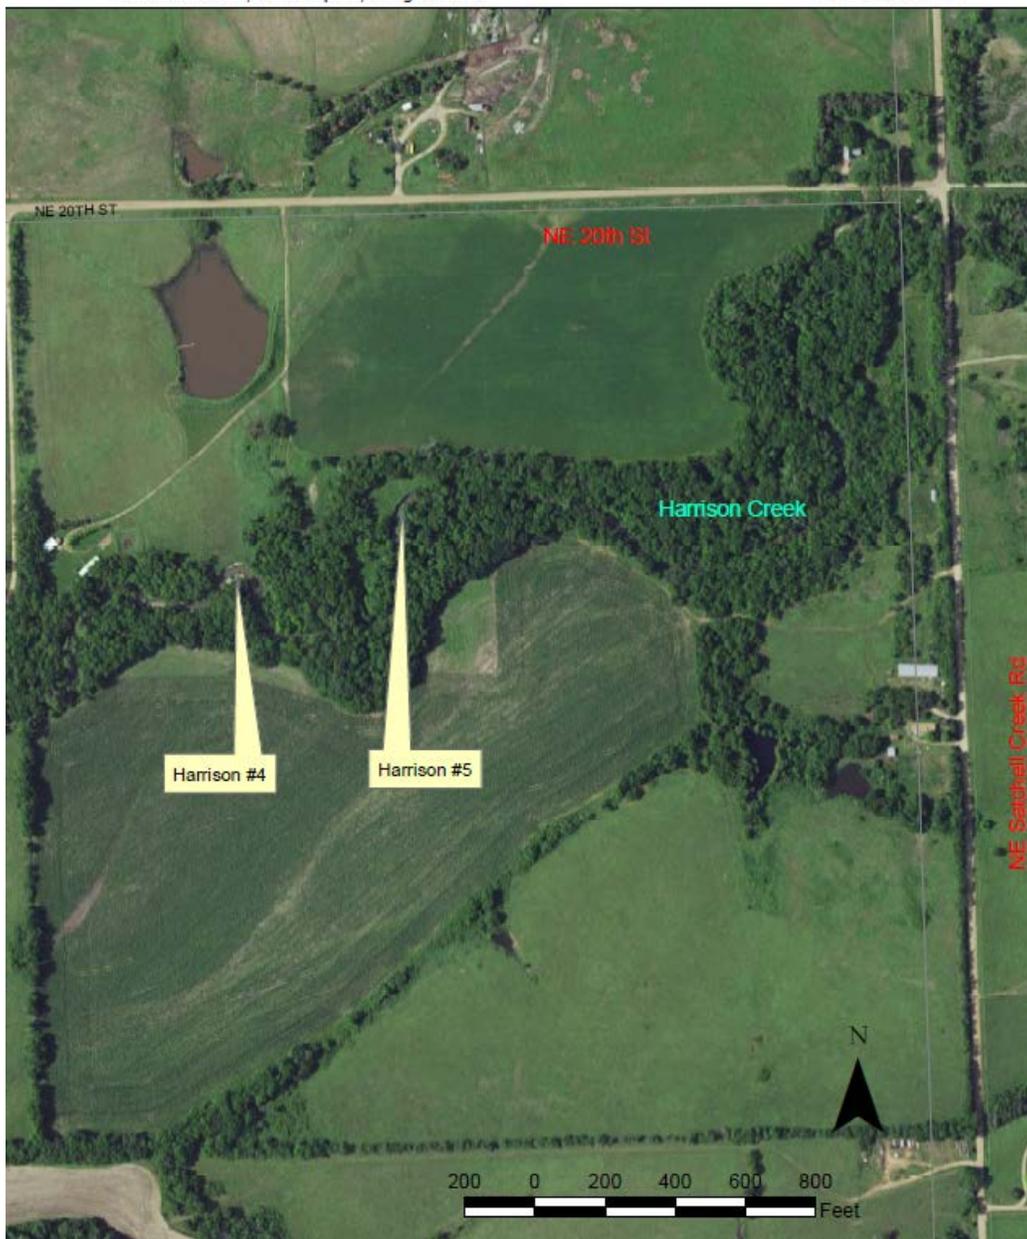
**Streambank/Channel Survey
2010 and 2017
Harrison Creek Site #4, #5**

The Harrison Creek (Moore) upstream site had a lot of deposition occur on the left bank or inside bend, based on visual observation. The stream bank pins (rebar) showed that the brome grass was holding the top of the bank; however, the bottom pin was exposed more so than the top pin which indicates as rainfall saturates the top of the bank and as additional flooding occurs, the top of the bank will eventually fall into the creek and be lost as sediment. This is evidenced by the jagged look of the top of bank as clumps of brome and soil give way. The cross section reveals sediment loss from the stream bank as well as the stream channel. Soil lost at this cross section = 65.07 square feet (49,864 pounds or 25 tons) of sediment lost at this site. The width of the channel changed very little from 2010 to 2017.

The Harrison Creek (Moore) downstream site also showed a lot of deposition through the reach of the cross section on the inside bend similar to the upstream site. From visual observation, it didn't appear the site had lost as much of the stream bank as the upstream site. There was more gravel in the bank below the rebar; gravel may have helped protect the bank from erosion. The change in the cross section was 41.68 square feet (25,573 pounds or 12.8 ton) of sediment lost at this site. This was also verified by the rebar; less rebar exposed. The stream in 2017 appeared much as it had in 2010.

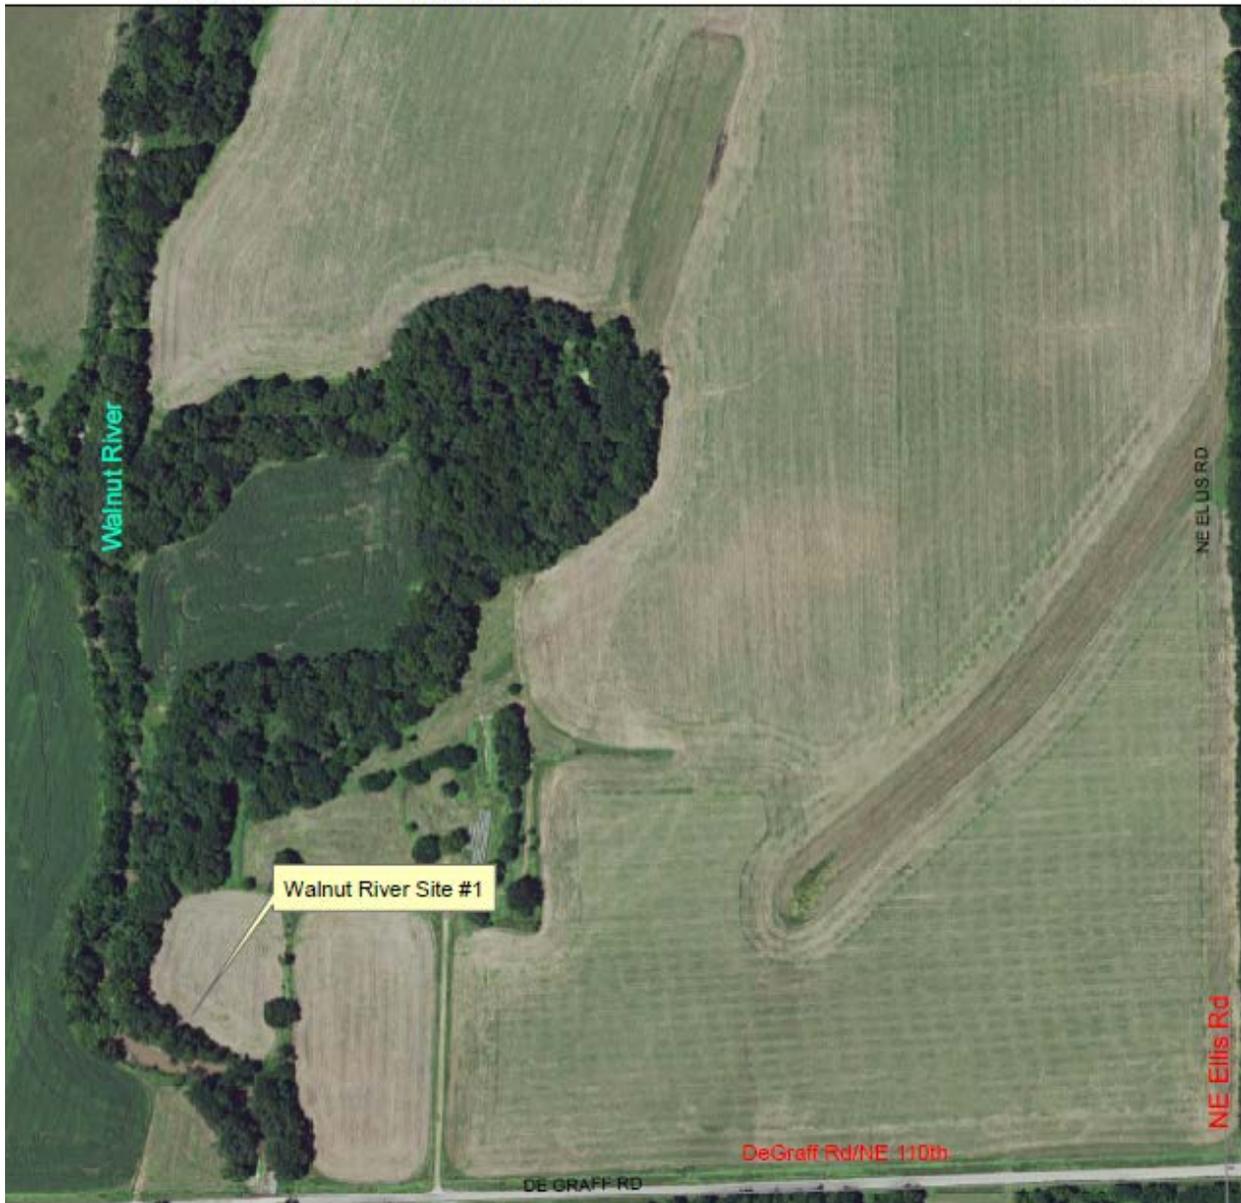
**Streambank/Channel Survey
2010 and 2017
Walnut River Site #1**

The **Walnut River** is the largest of the sub-basins above El Dorado Lake. We surveyed a site that was roughly 3 miles from the upper reaches of the Lake. The site was in a medium priority area as based on the SWAT model as well as considered a high priority stream. The soil type is Verdigris silt loam, 0-1% slope, occasionally flooded. The land use above the survey site is farmed, mainly row crop. There are no trees remaining at the survey site but generally the riparian area throughout this landowner's property ranges from 45-100 feet wide. The stream bank on this site is 12 feet to 15 feet in height.

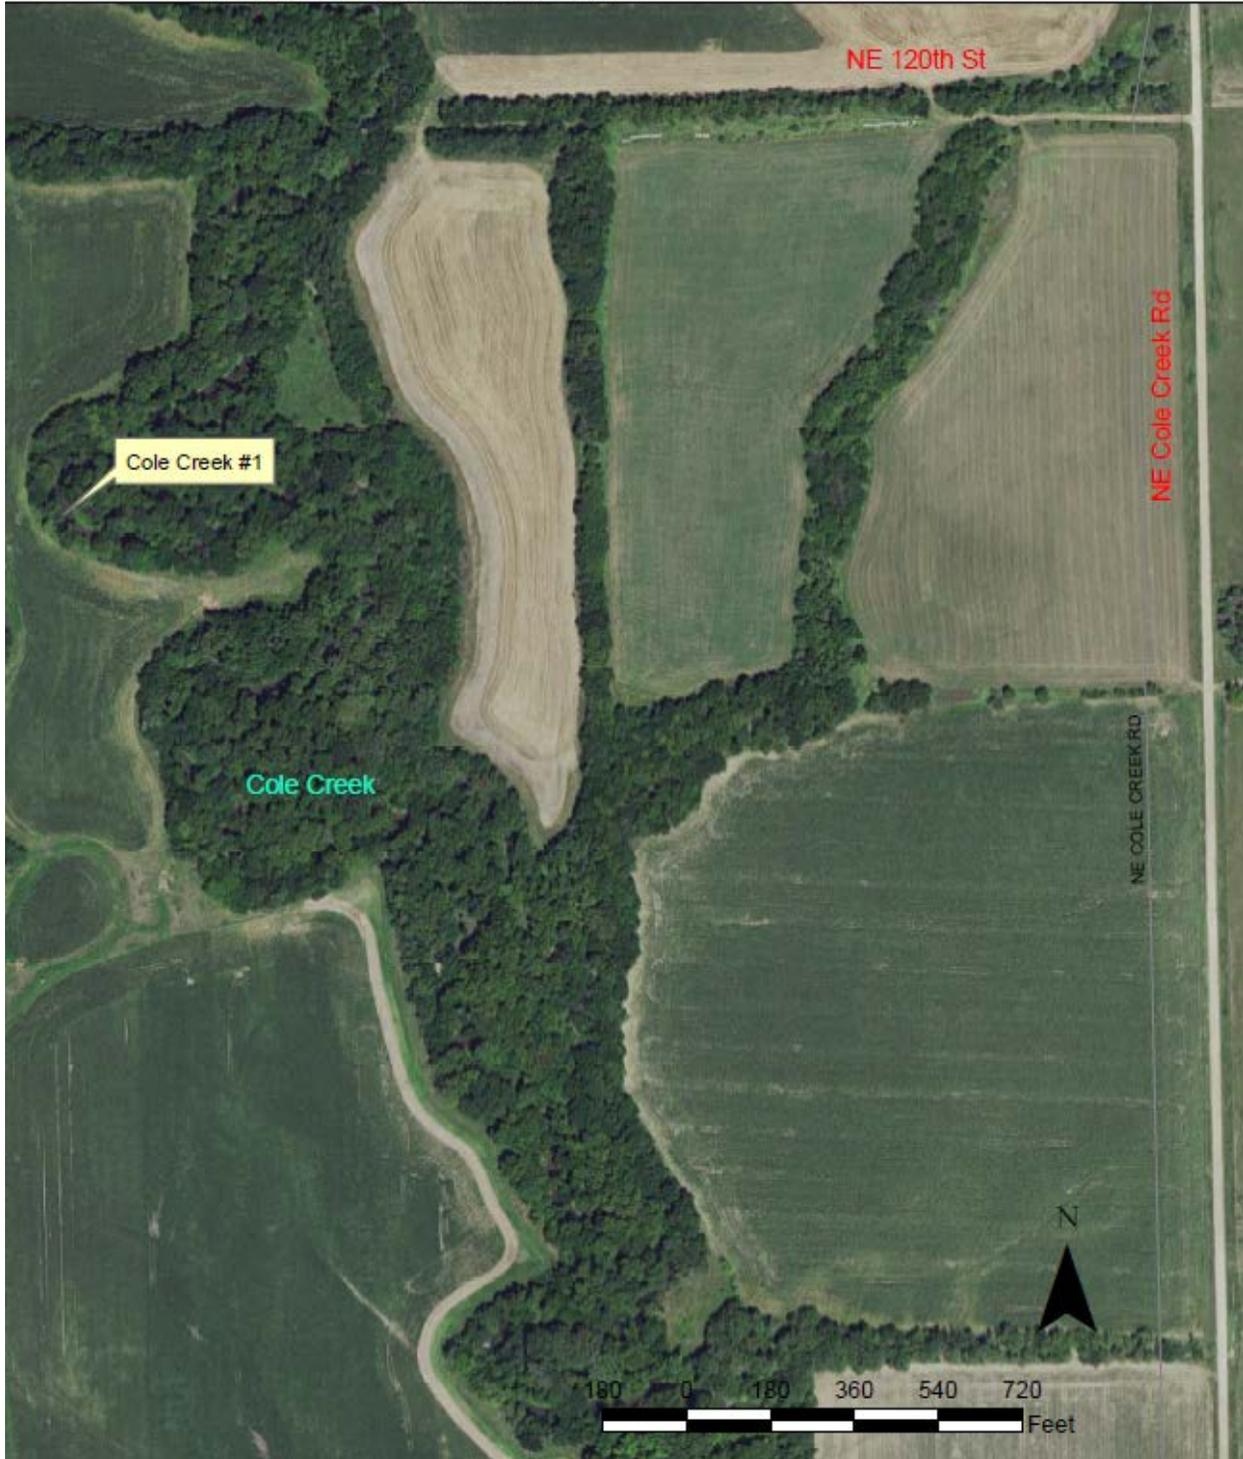
While erosion is evident at the Cole Creek site, large trees and shrubs are still holding in place and preventing large losses of sediment. A gravel shelf is evident at the water line and may be the reason the bank pin at the water line was exposed by 1.78', undercutting this area first. Tree roots are helping to stabilize the upper part of the stream bank in the area upstream and downstream of this cross section. Deposition occurred on the inside bend but erosion was evident as seen by the cross section data and exposed rebar on the right stream bank. In all, 26.75 square feet (13,133 pounds or 6.6 tons) of sediment lost was calculated at this cross section.
