CHERRYFIELD RIVERWALK EXISTING CONDITIONS MEMORANDUM

FEBRUARY 2025

FB Environmental Associates

The Town of Cherryfield, Maine

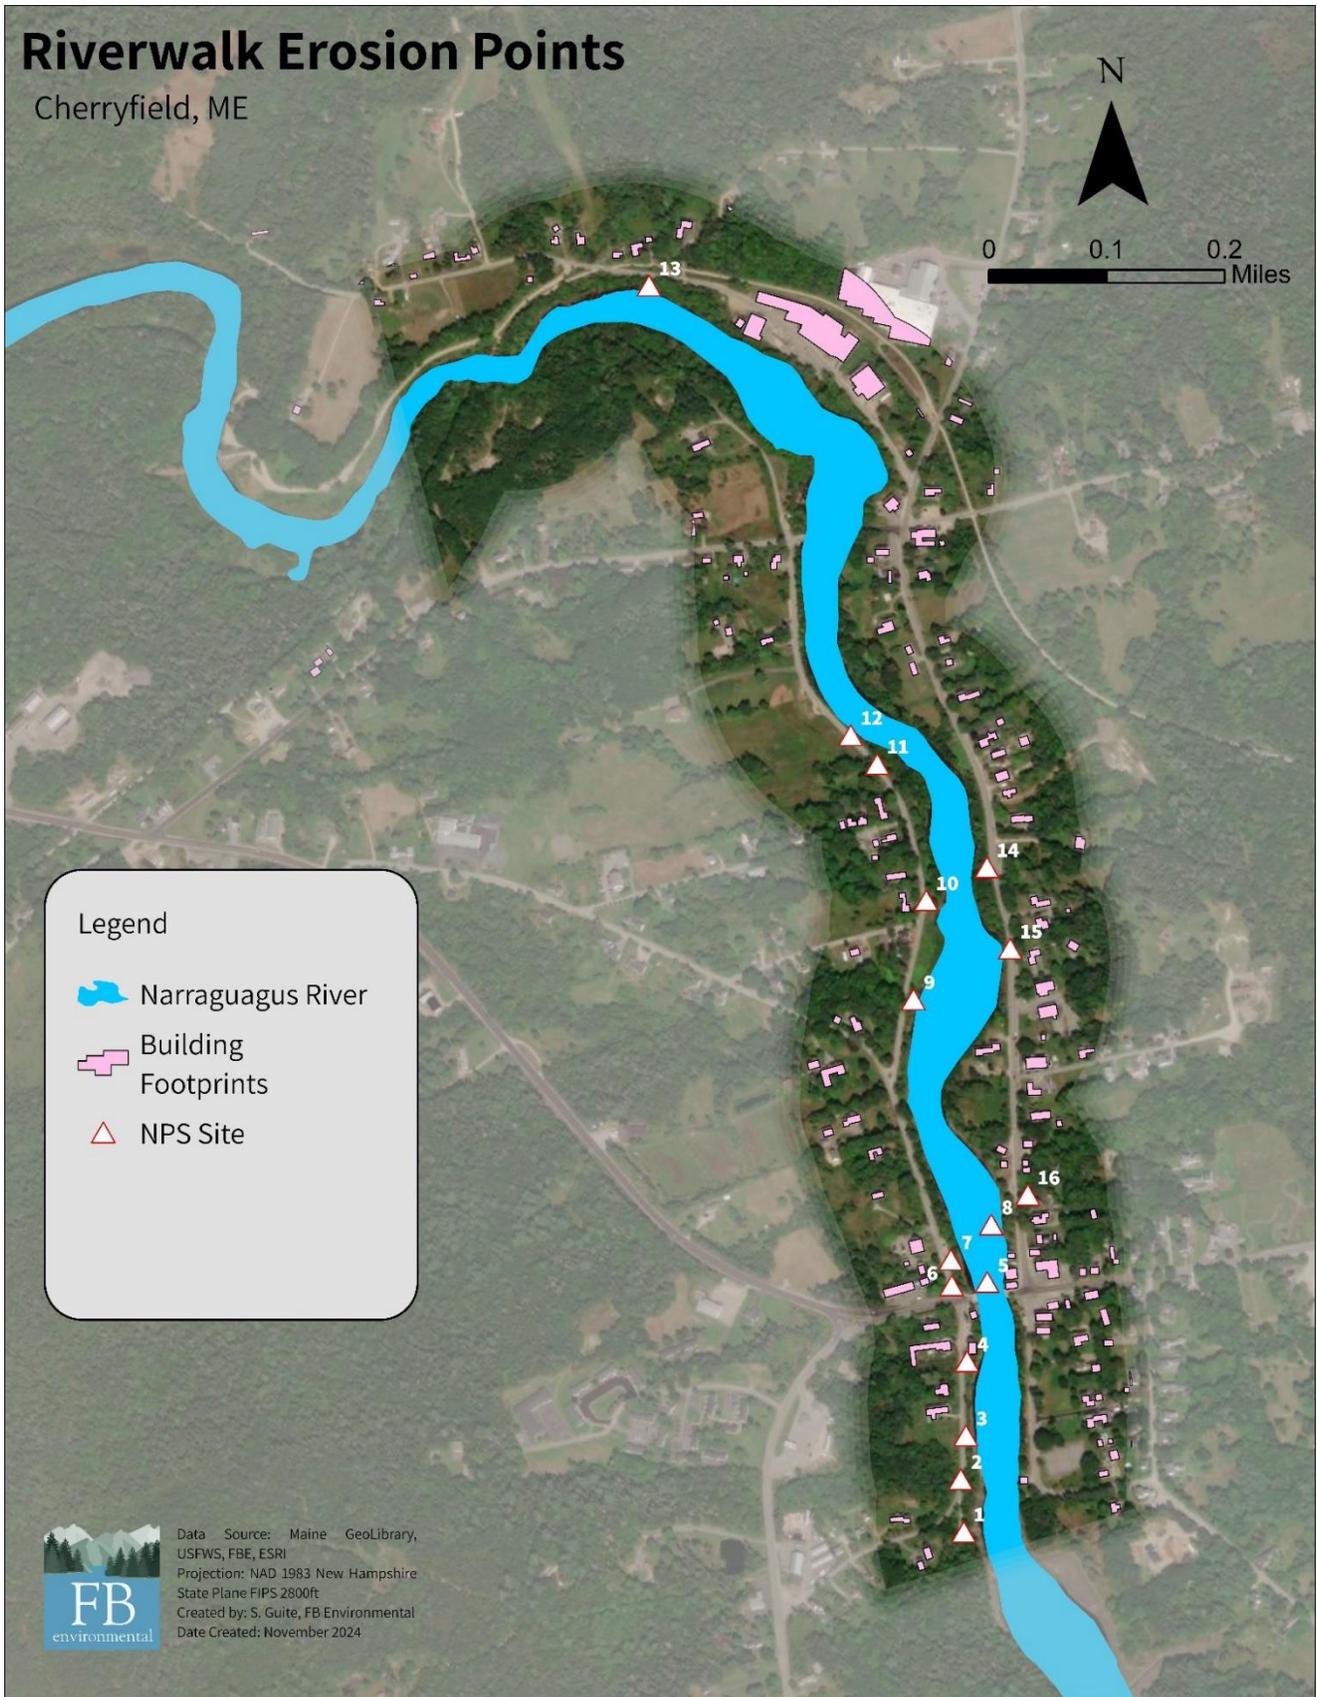
FIGURE 3. MAP OF NPS SITES ALONG THE CHERRYFIELD RIVERWALK IDENTIFIED DURING THE SITE ASSESSMENT ON OCTOBER 1 AND 2, 2024.

The Cherryfield Riverwalk was assessed for sources of nonpoint source pollution during the site visit on October 1 and October 2, 2024. From these observations, 16 NPS inputs were identified (Figure 3). The majority of these sites are found in the southern half of the Riverwalk.

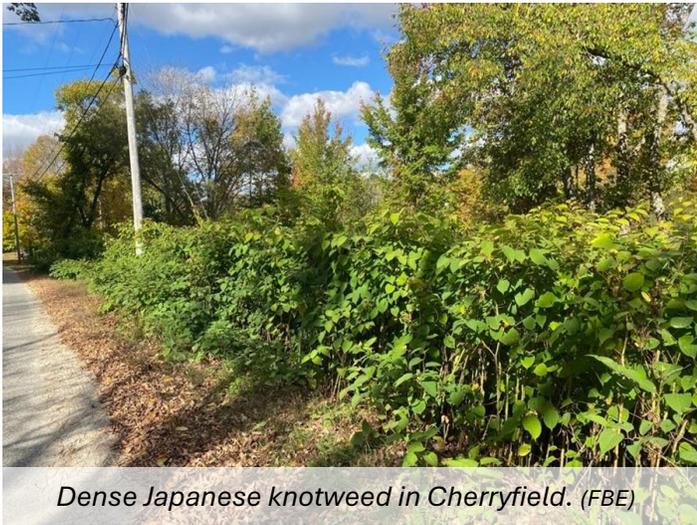
Dense Japanese knotweed in Cherryfield. (FBE)

species is extremely resilient and has minimal natural predators, making it especially difficult to manage. Japanese knotweed was observed in seven different small clumps and two large stands along the Cherryfield Riverwalk.

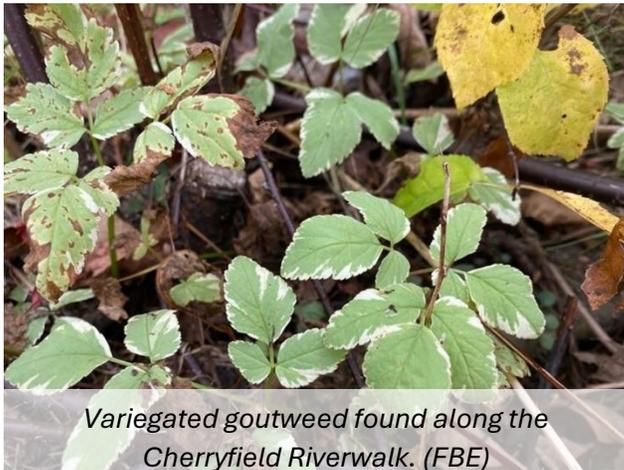
Variegated goutweed found along the Cherryfield Riverwalk. (FBE)

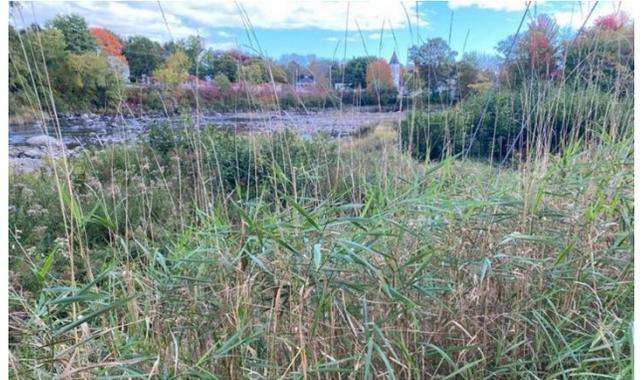
Reed canary grass is a robust perennial grass that can reach up to six feet in height²⁸. It has inflorescences of 3-8 inches that begin forming in early summer. It spreads via seed and rhizome. Seeds may be spread by water. Reed canary grass is native to Eurasia and was brought to the US for erosion control and forage on agricultural pastures. It is typically found along stream and riverbanks, lakeshores, marshes, ditches, and roadsides in moist or wet soils. It has some shade tolerance but prefers full sun. Hand pulling or digging may work for small patches, while mowing is preferred for larger patches. Reed canary grass was observed in three dense clumps along the Cherryfield Riverwalk.

*A patch of reed canary grass in Cherryfield.
(FBE)*
