IVIE RISK SOLUTIONS

2026 RISK CONTROL ASSESSMENT

Property Address:
Full Property Address

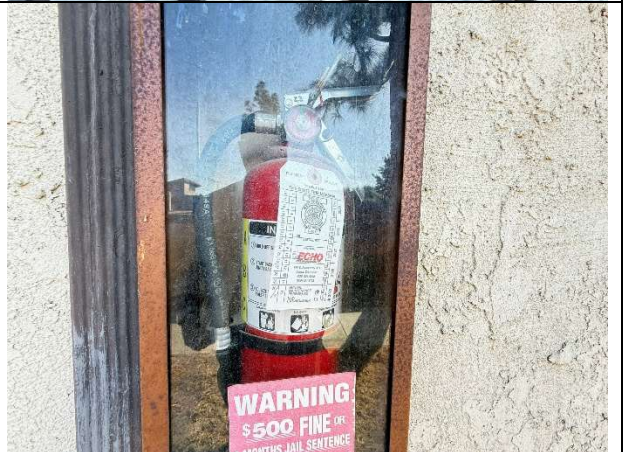
Current fire extinguisher

Recommendation: Insufficient fire extinguisher coverage was observed, including limited units and no extinguishers on second floors. Install additional fire extinguishers of appropriate type and rating (minimum 2A:10B:C typical for this occupancy) to ensure maximum travel distance does not exceed 75 feet. Units should be properly mounted, readily accessible, and inspected and maintained in accordance with NFPA 10.

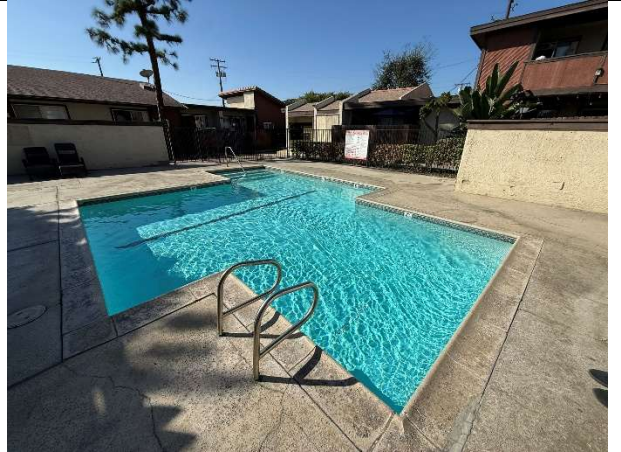
Swimming pool

Recommendation: Exterior pool depth markers were not observed. The absence of clearly visible depth indicators increases the risk of diving-related injuries and reduces user awareness of water depth. Install permanent, clearly visible depth markers at the pool deck and perimeter in accordance with

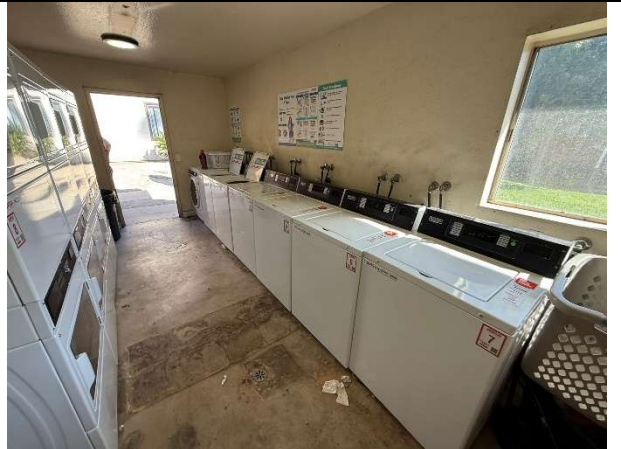
Laundry room

Recommendation: Rubber washing machine supply lines were observed. These types of hoses are more susceptible to deterioration and sudden failure, which can result in significant water damage. As a best practice, consider replacing with braided metal supply lines to improve durability and reduce the risk of leaks.
