# **RISK CONTROL ASSESSMENT**

Prepared by:  
**Ivie Risk Solutions**

## Woodworking Manufacturing Survey

1000 Central Ave, Los Angeles, CA

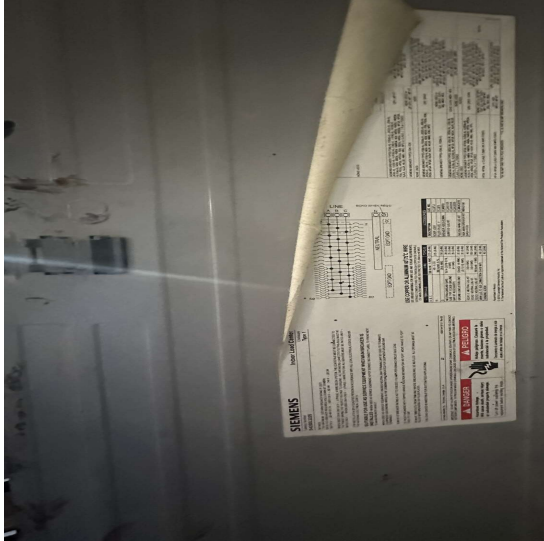
Electric subpanel manufacturer: Siemens

Concerns with electrical panel obstruction were noted at the time of inspection. Electrical panel condition was considered fair due to observed paint/finish overspray residue surrounding breakers and dirty interior cabinet surfaces.
