# Longevity Inspections

## Property Inspection Report

123 Main Street, Senoia, GA 30276  
Inspection prepared for: Example Client  
Real Estate Agent: -

Date of Inspection: 5/8/2025 Time: 2:30 PM  
Age of Home: 2025 Size: 2900  
Weather: Sunny - 79F  
Order ID: 43

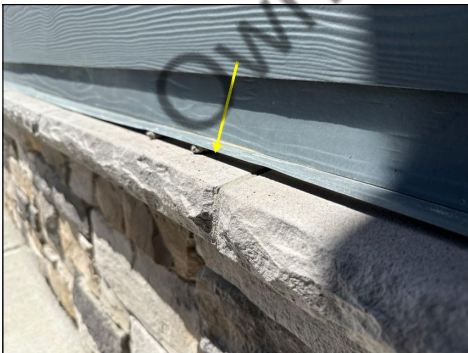
- *Gaps noted on the front and left side of the residence. Recommend further evaluation and repairs.*
- *Loose siding noted around the residence. Recommend further evaluation and repairs.*

Gap - Front Side

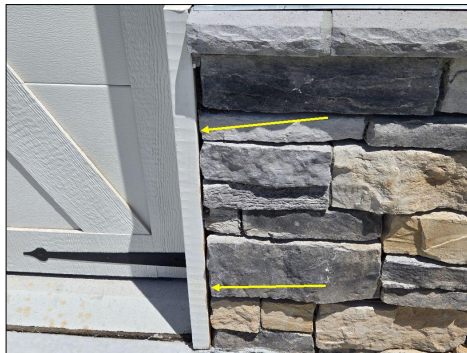
Gap -Front Side

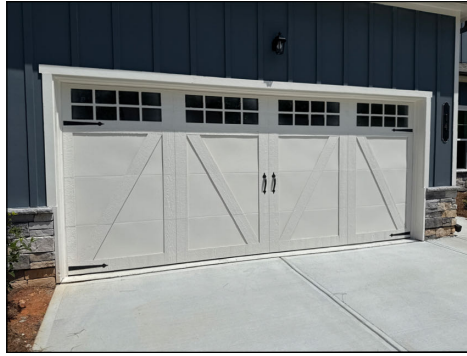
- *No major system safety or function concerns noted at the visible areas during the inspection.*

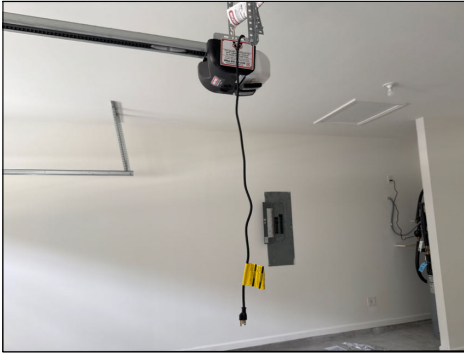
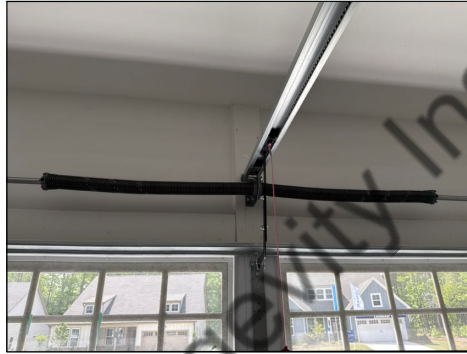
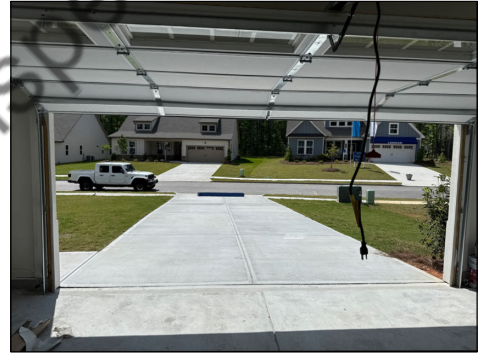
- *Functional garage door(s) noted using normal controls at time of inspection.*
- *The garage door opener was unplugged and the garage door was tested manually. Recommend further evaluation.*

Opener Unplugged

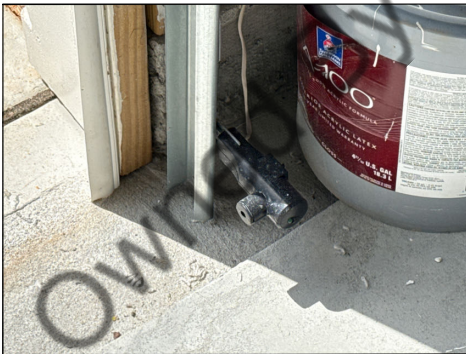
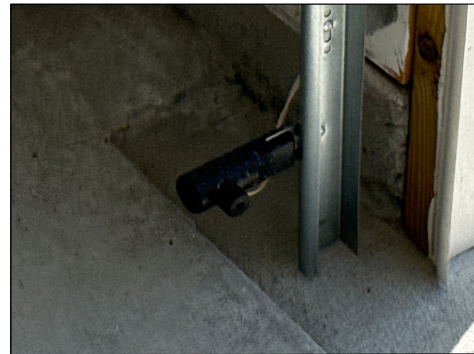
- *No major system safety or function concerns noted at the visible areas during the inspection.*

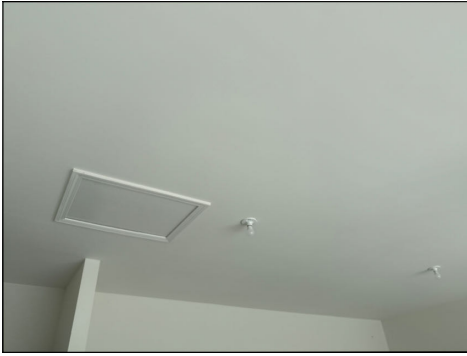
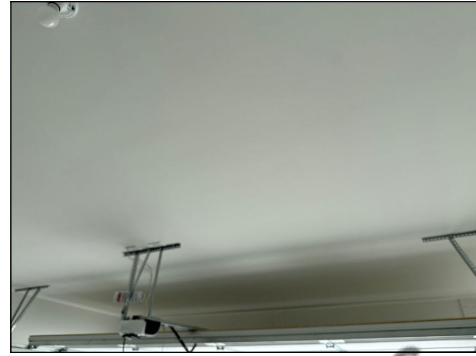
- *No major system safety or function concerns noted at the visible areas during the inspection.*
- *No deficiencies observed at the visible portions of the roof structure.*

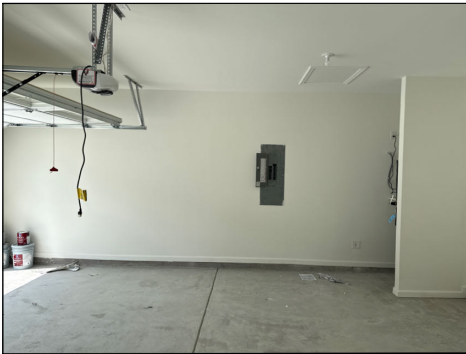
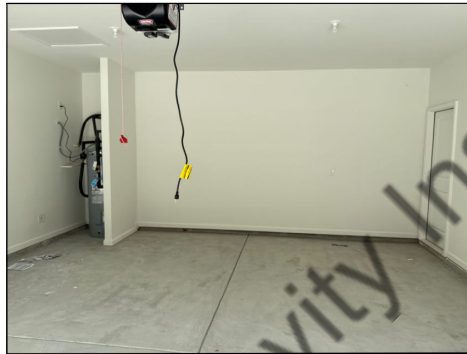
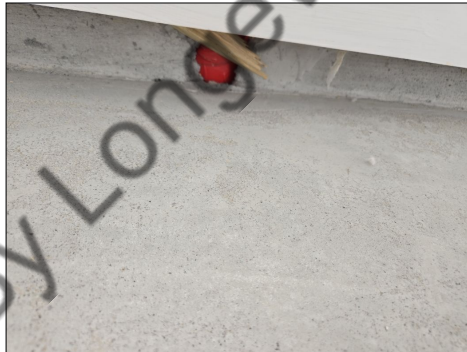
Exposed Pipe - Garage

- *Exposed pipe noted at the garage wall. Recommend further evaluation and repairs.*

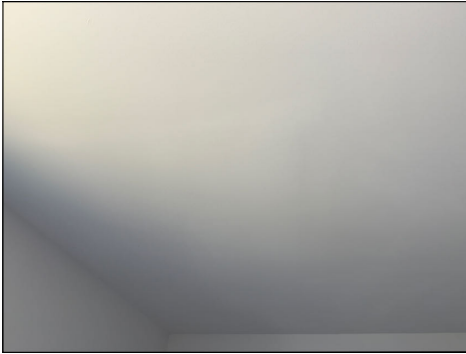
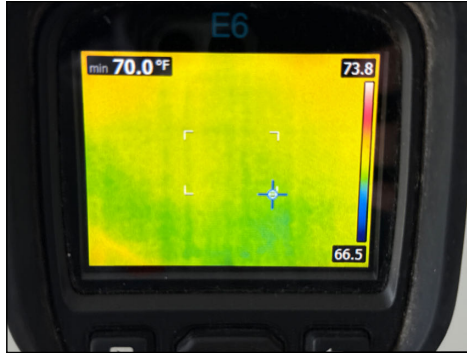
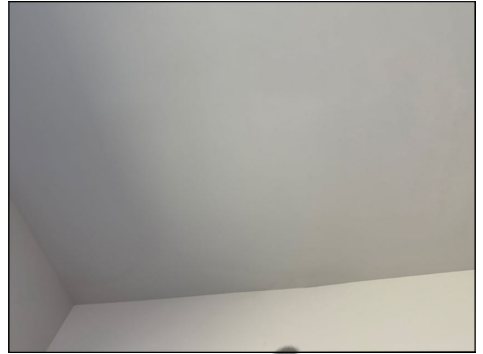
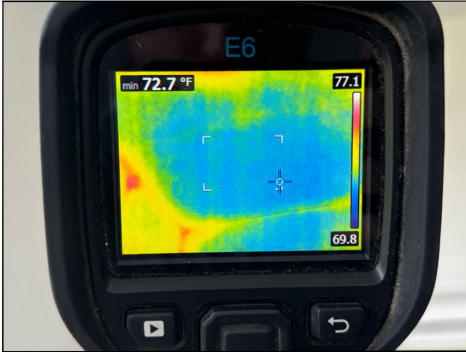
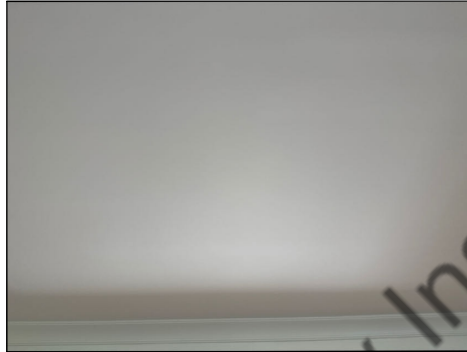
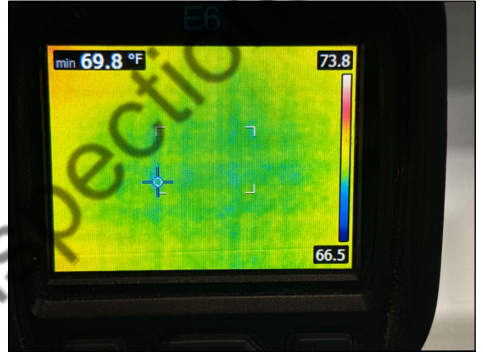
- *No major system safety or function concerns noted at the visible areas during the inspection. All ceilings were scanned using thermal imagery.*

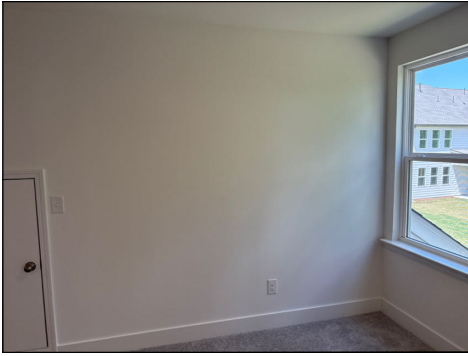
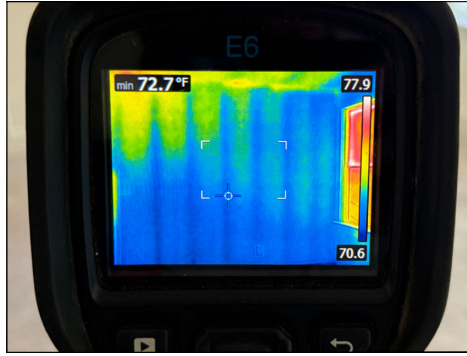
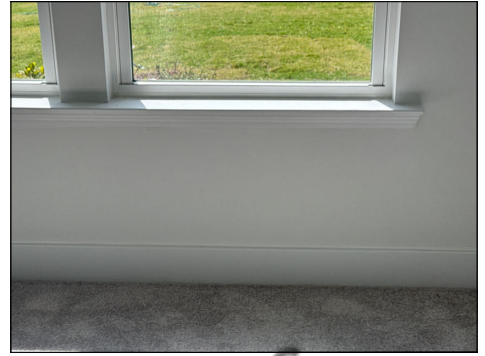
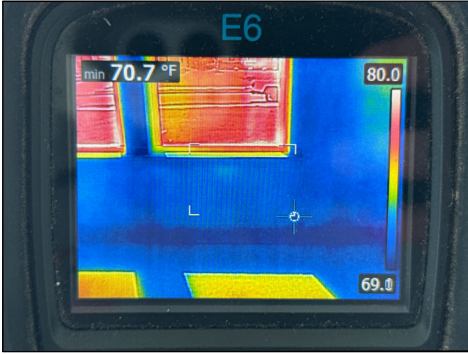
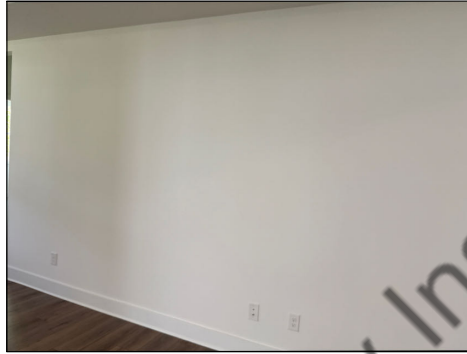
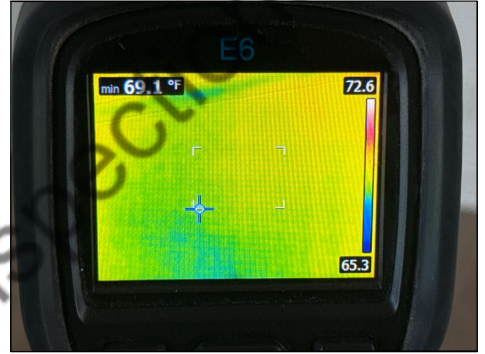
- *No major system safety or function concerns noted at the visible areas during the inspection. All walls were scanned using thermal imagery.*
- *Limited view/accessibility due to finished walls.*

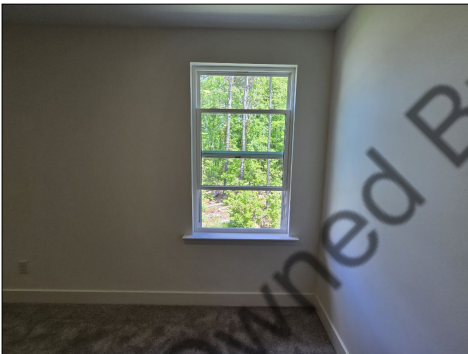
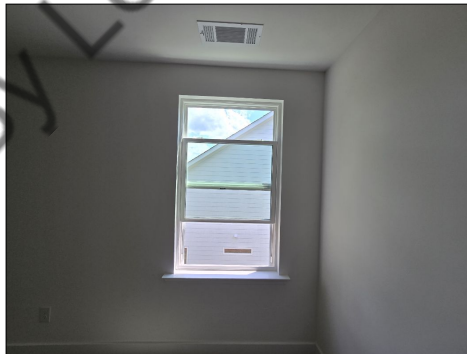
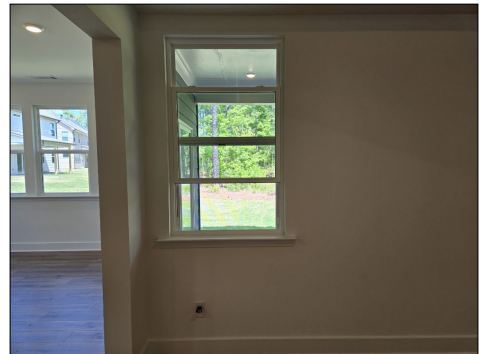
- No major system safety or function concerns noted at the visible areas during the inspection.
- All accessible windows operated. Some windows were not accessible and should be further inspected once items have been removed.

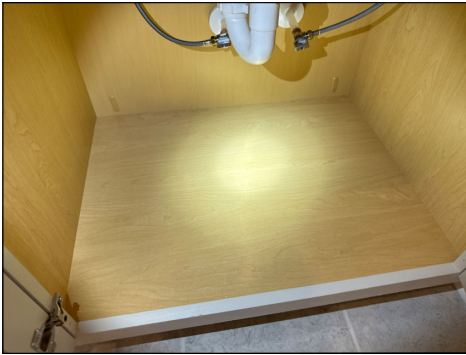
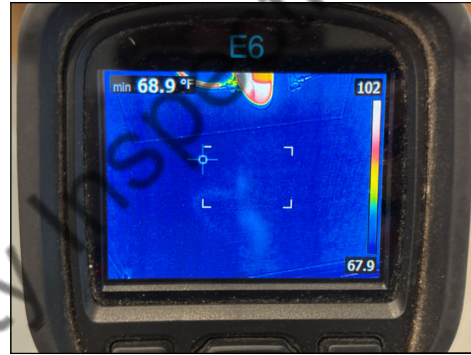
- *No major system safety or function concerns noted at the visible areas during the inspection.*

No Leaks/Damages

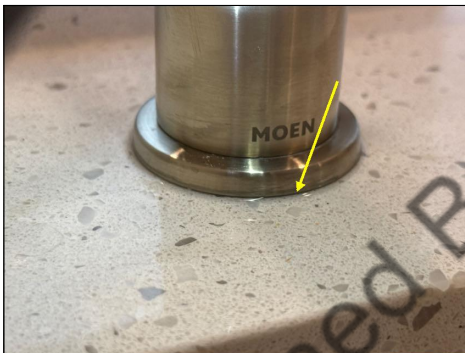
Leaking Faucet - Left Master Sink

- *Faucet(s) leaking at the time of inspection. Recommend further evaluation and repairs.*

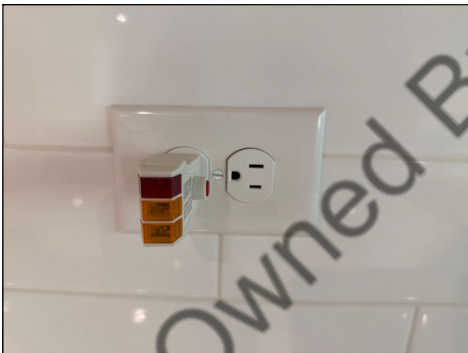
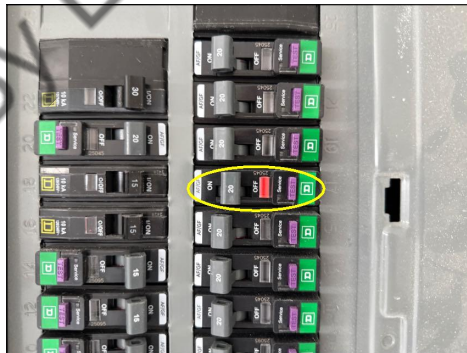
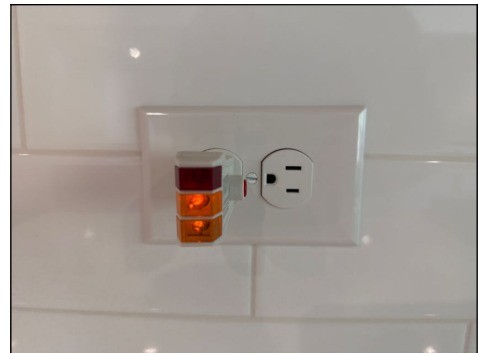
- No major system safety or function concerns noted at the visible areas during the inspection.
- GFCI in place and operational.

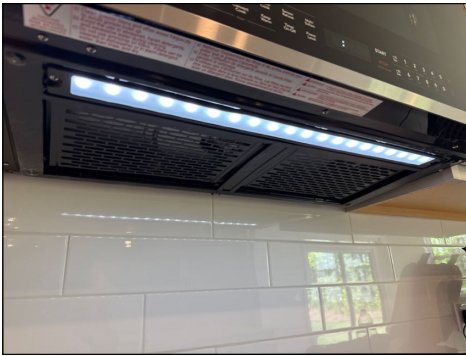
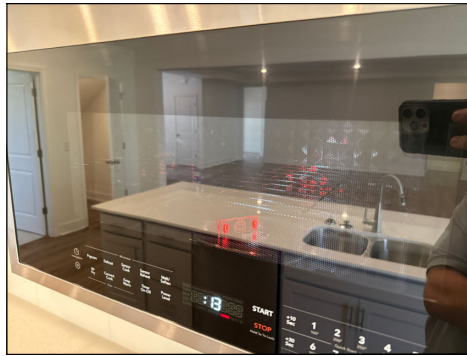
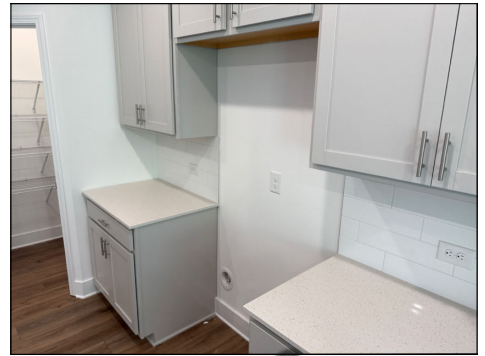
- No major system safety or function concerns noted at the visible areas during the inspection.
- Exhaust fan and surface light were tested and found functional at the time of the inspection.
- Microwave present and operational at the time of the inspection.
- No refrigerator present.

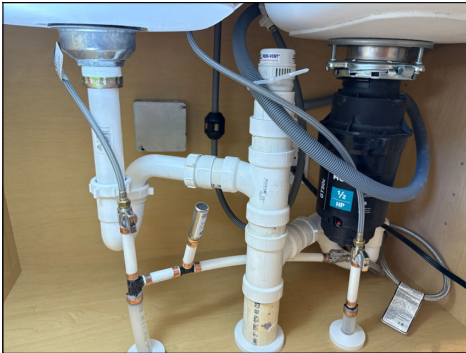
No Leaks Noted

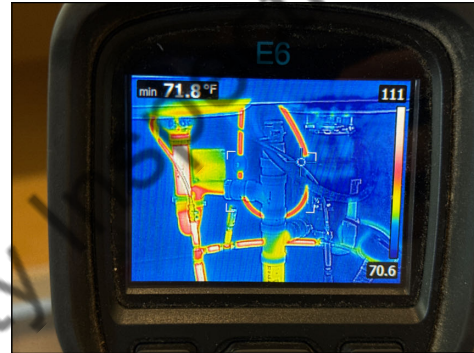
No Leaks Noted

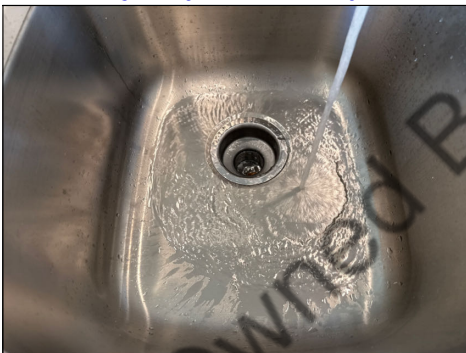
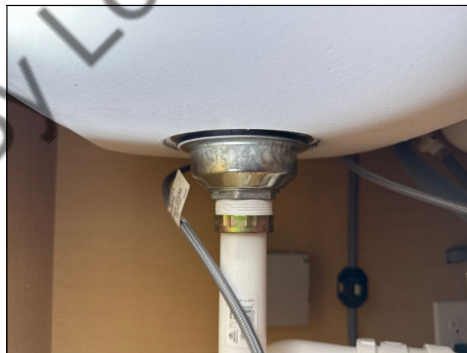
No Leaks Noted

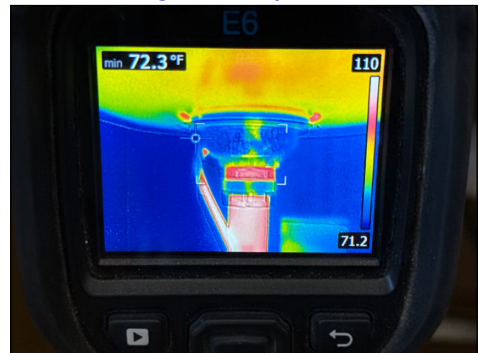
No Leaks Noted

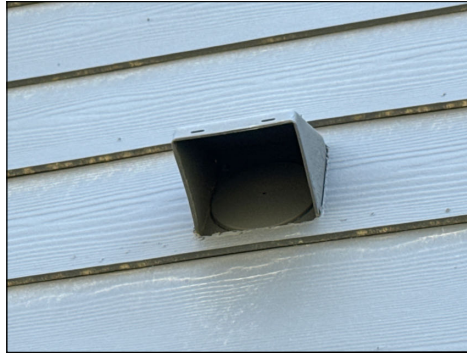
- *No major system safety or function concerns noted at the visible areas during the inspection.*
- *Maintenance Tip: Dryer vent should be cleaned routinely.*

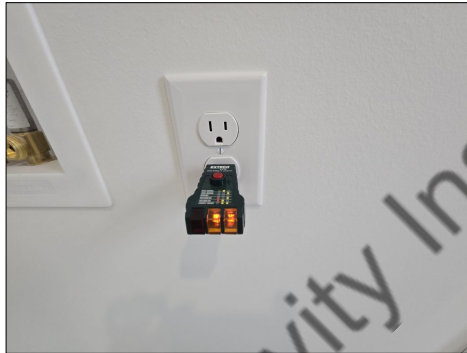
- *No major system safety or function concerns noted at the visible areas during the inspection.*

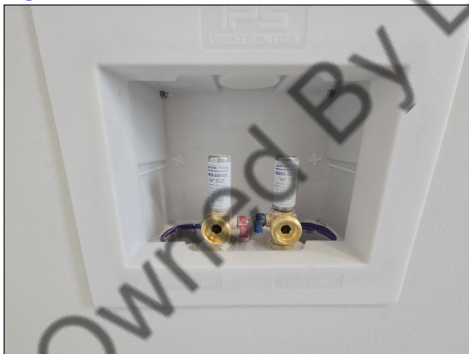
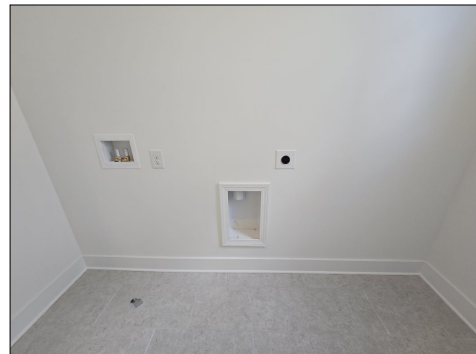
- *No major system safety or function concerns noted at the visible areas during the inspection.*
- *Recommend adding stainless steel lines to the washing machine. Rubber hoses tend to crack/bulge and deteriorate over time.*

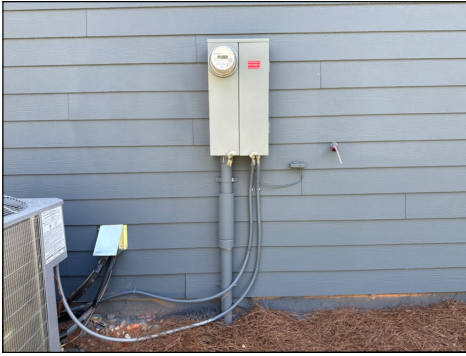
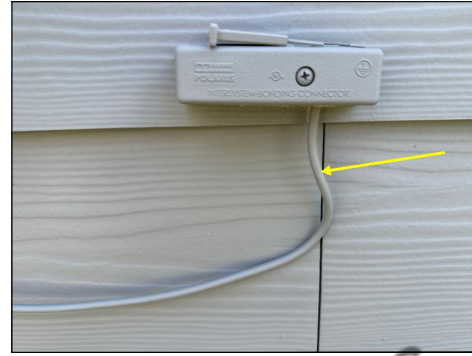
- *No major system safety or function concerns noted at the visible areas during the inspection.*
- *There is an underground service lateral noted.*

Ground wire noted

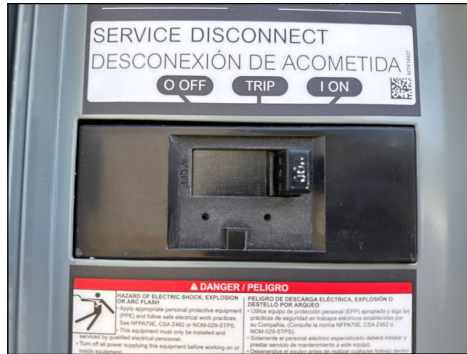
- 200A

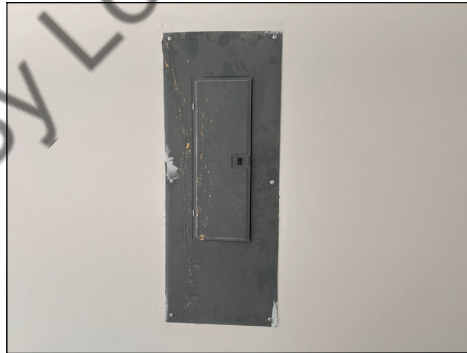
- *No major system safety or function concerns noted at the visible areas during the inspection.*

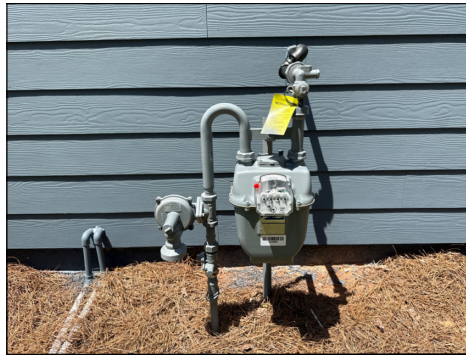
- *No major system safety or function concerns noted at the visible areas.*
- *The gas meter was located at the right side of the structure.*

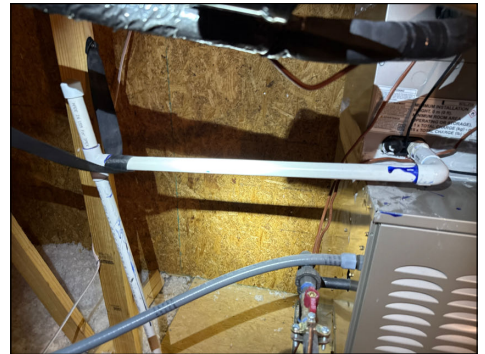
Condensate drain pipe

- The condensate drain pipe or condensate drain tube may not be fully visible and should be further inspected by a HVAC company to ensure there are no damages which can lead to leaks and to ensure the pipes are correctly sloped.

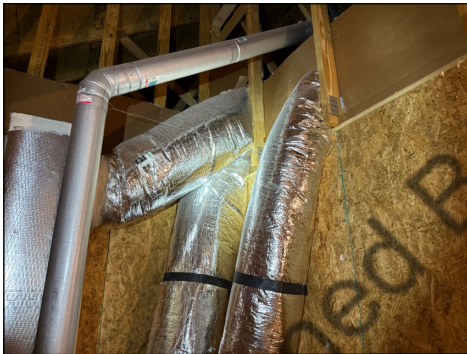
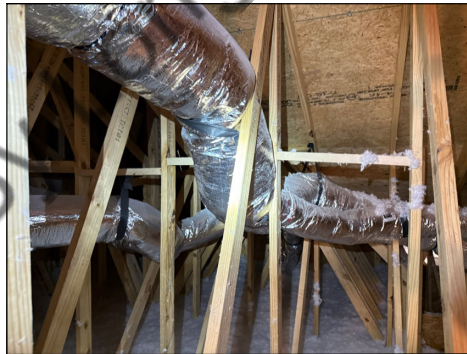
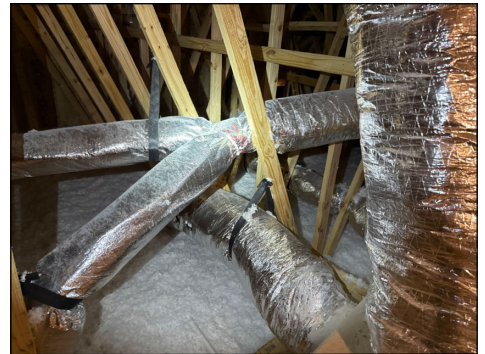
- No major system safety or function concerns noted at the visible areas during the inspection.

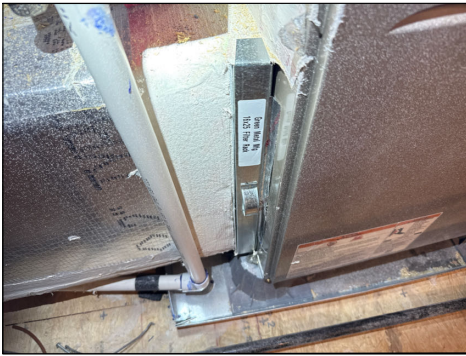
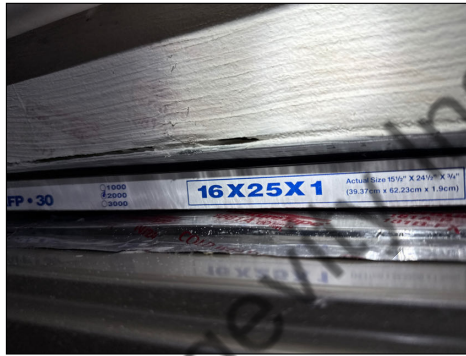
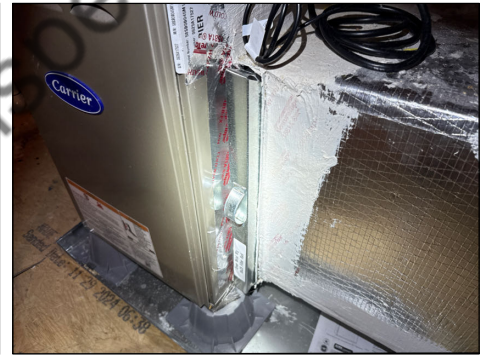
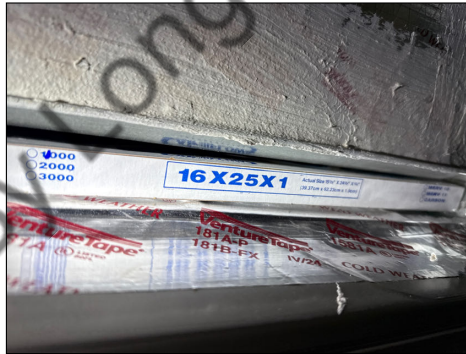
- *No major system safety or function concerns noted at the visible areas during the inspection.*
- *Filter Maintenance: A dirty air filter is one of the most common reasons for HVAC system failure. A dirty filter restricts the air flow into your HVAC systems air handler. This restricted air flow places additional strain on the air handler fan motor and could, over time, burn out the motor and cause your system to overheat and ultimately fail. Filter replacement is a small price to pay to extend to life of one of the biggest financial investments in your home.*

- *MAINTENANCE: 1" air filter(s) should be inspected at least monthly and cleaned or replaced as needed.*
- *Recommend replacing filter(s) once you have moved in.*

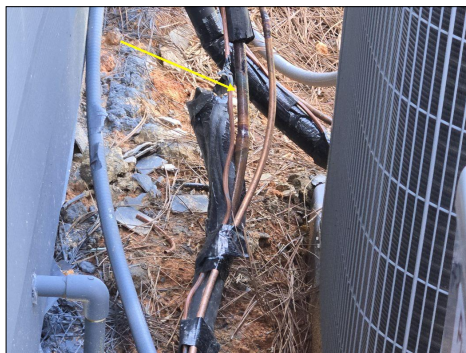
- *Missing/damaged insulation noted on the line set(s) near the A/C compressor. Recommend replacing all missing sections of insulation for energy's sake.*

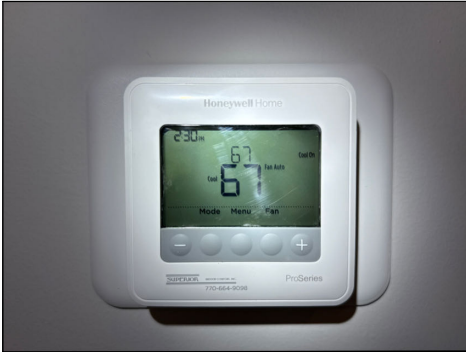
Master Bedroom

- *No major system safety or function concerns noted at the visible areas during the inspection.*
- *Functional at the time of inspection.*

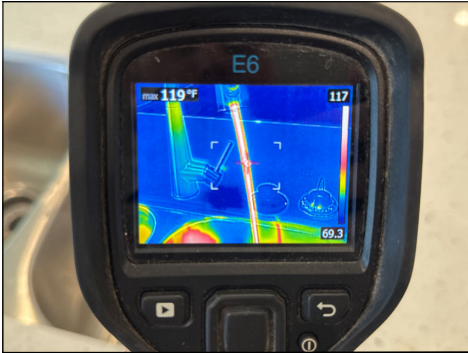
119F

- No major system safety or function concerns noted at the visible areas during the inspection.
- Recommended water temperature should be between 120-130 degrees F. Current water temperature is 119F.

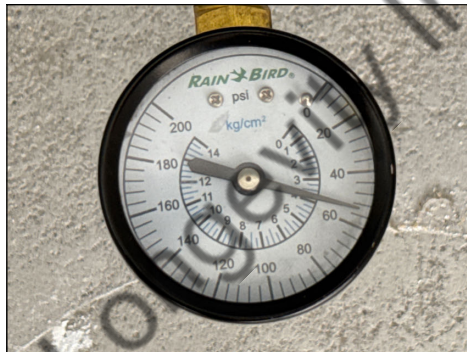
52PSI

- *Recommended pressure is between 40-80 psi. Current pressure noted at 52PSI.*
