# Longevity Inspections

## Property Inspection Report

123 Main Street, Senola, GEORGIA 30267  
Inspection prepared for: Example Client  
Real Estate Agent: -

Date of Inspection: 4/30/2025 Time: 02:30PM  
Age of Home: 56 Size: 3900  
Weather: Sunny - 81F

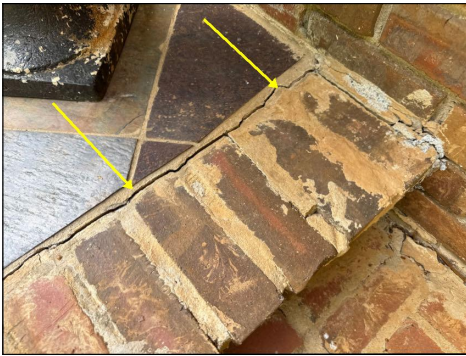
- *Damaged/missing grout noted. Recommend further evaluation and repairs to prevent further deterioration.*
- *Minor settling noted at the front porch. Recommend further evaluation and repairs by a qualified professional.*

Re-point/repair grout - Front Porch

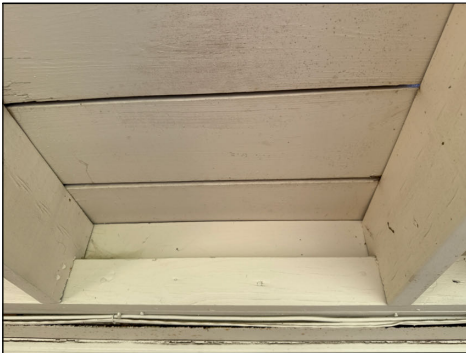
- *Loose handrail(s) noted at the exterior porch and/or deck stairs. Recommend further evaluation and repairs.*
- *Deck ledger board lacking flashing. Flashing protects the ledger and keeps water away from the side of the house and the Rim joist inside the structure. Flashing is required where exterior porches, decks, or stairs attach to a wall or floor assembly of wood frame construction. Flashing should be approved corrosion-resistant flashing shall be applied shingle-fashion in a manner to prevent entry of water into the wall cavity and the flashing shall extend to the surface of the exterior wall finish. Recommend further evaluation and repairs.*

Missing Flashing - Rear Deck

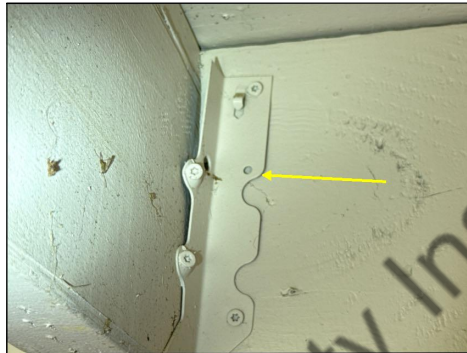
- *Missing/improper fasteners noted at the joist hanger(s). Recommend further evaluation and repairs.*
- *Separation noted at multiple deck floor joist. Recommend further evaluation and repairs.*

Missing Fasteners - Rear Deck

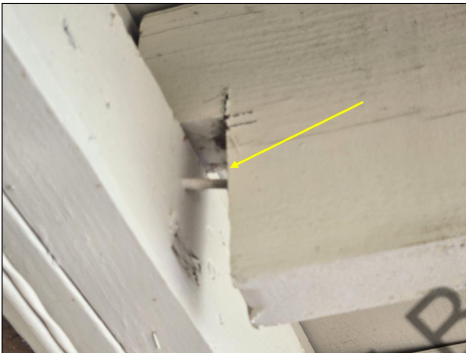
Separating Deck Joist - Rear Deck

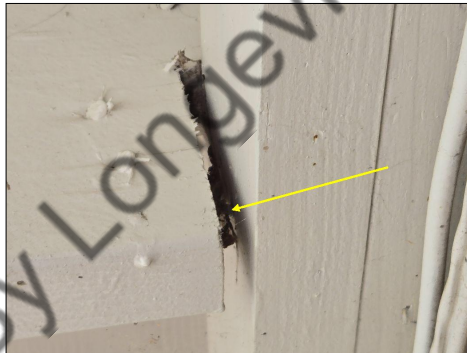
Separating Deck Joist - Rear Deck

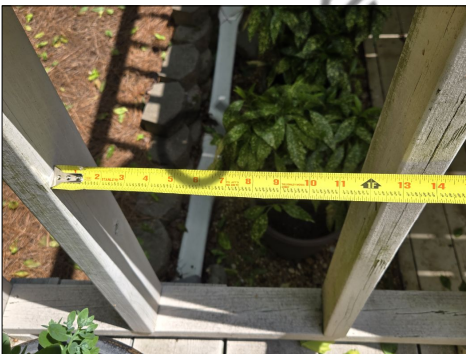
- *Improper vertical picket width noted at the rear deck. A 4" maximum gap between deck and underside of bottom rail and a 4" maximum gap between balusters. Recommend further evaluation by a qualified professional in the interest of safety.*

Improper Vertical Picket Width - Rear Deck

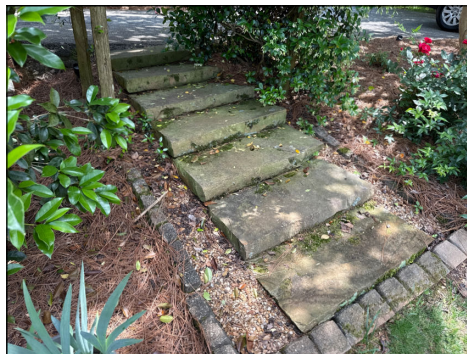
- *Recommend adding graspable handrails in the interest of safety. Continuous and Graspable: Handrails must be continuous along the entire length of the stairway and extend at least 12 inches (30.5 cm) beyond the top and bottom riser horizontally. The handrails should provide a graspable surface with a shape that allows a person's hand to grip it easily.*

Missing Graspable Handrail - Left Side Stairs

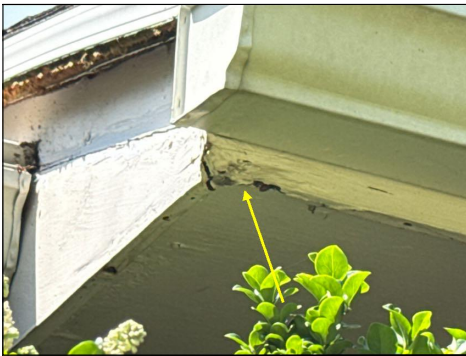
- *Moisture damage/wood rot observed. Recommend repairs/replacement as needed.*

Wood Rot - Front Left Corner

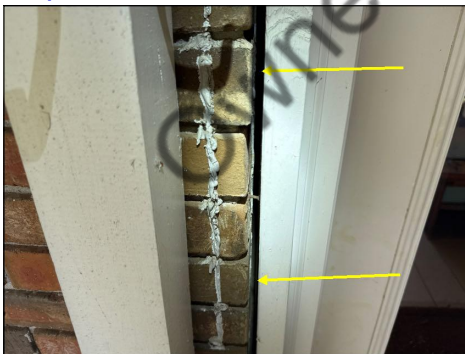
- *Gaps noted around the rear right basement door. Recommend further evaluation and repairs to prevent moisture and insect intrusion.*
- *Gap noted on the left side of the garage. Recommend further evaluation and repairs to prevent moisture and insect intrusion.*
- *Maintenance Tip: Caulking and seal all gaps, cracks and openings is part of routine maintenance to prevent moisture and insect intrusion.*

Gap - Rear Basement Right Door

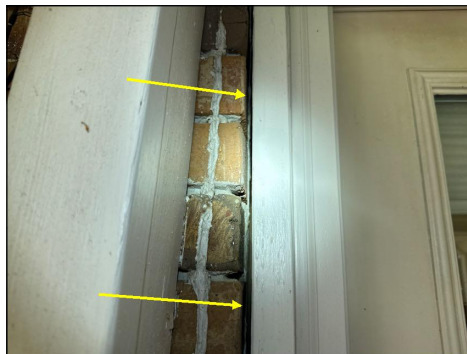
Gap - Rear Basement Right Door

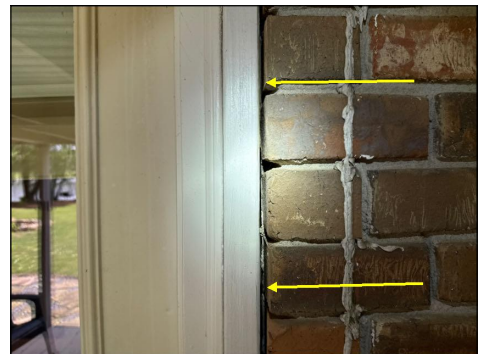
Gap - Rear Basement Right Door

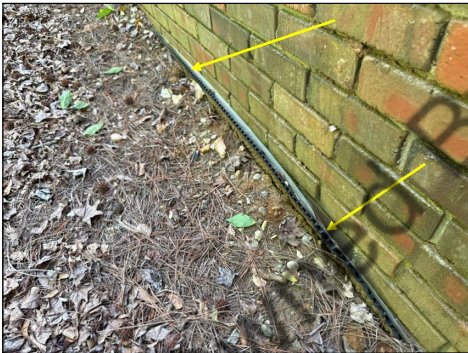
- *Exposed waterproofing material noted on the right side of the residence. Recommend further evaluation.*
- *Efflorescence observed; this is a mineral deposit left behind from previous exterior water infiltration. Recommend a qualified professional further evaluate all areas.*
- *Possible moisture intrusion noted in the foundation wall. Moisture can create high humidity, mold and can damage stored items & finishing materials. Recommend further evaluation by a qualified professional.*
- *Missing foam at the sill plate in the crawlspace. Recommend further evaluation and repairs.*

Exposed Waterproofing Material  
- Right Side

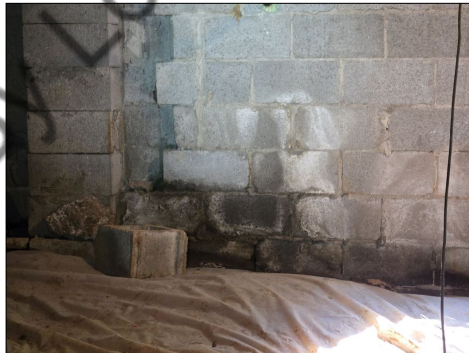
Efflorescence/Possible Moisture  
Intrusion - Left Rear Side

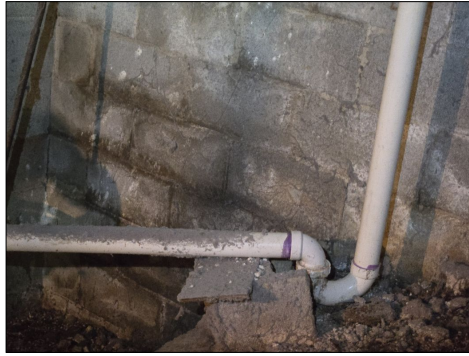
Efflorescence - Front Right Corner

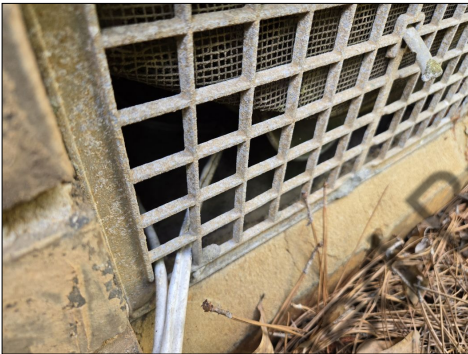
- *Damaged/missing screens noted at the crawlspace vents. Recommend further evaluation and repairs to prevent vermin intrusion.*
- *Damaged/hanging insulation noted in the crawlspace. Recommend further evaluation and repairs.*
- *Missing vapor barrier noted in the crawlspace. Recommend a continuous vapor barrier for the crawlspace to control moisture levels and prevent possible fungal growth.*
- *Blocked crawlspace vent noted on the rear side. Since this vent is blocked there is no longer crossed ventilation in the crawlspace. Recommend further evaluation and repairs by a qualified professional.*
- *The crawlspace stairs are loose and not properly attached. Recommend further evaluation and repairs.*
- *Suspect fungal growth observed. Recommend further evaluation and repairs following an approved remediation process.*

Damaged/Missing Screen(s) - Front Side

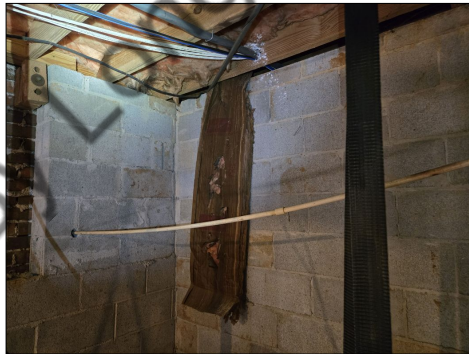
Loose Insulation - Crawlspace

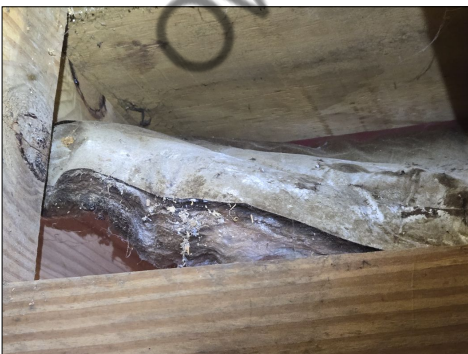
Page 12 Item: 2	Crawlspace	• Suspect fungal growth observed. Recommend further evaluation and repairs following an approved remediation process.
-----------------	------------	---

Suspect Fungal Growth

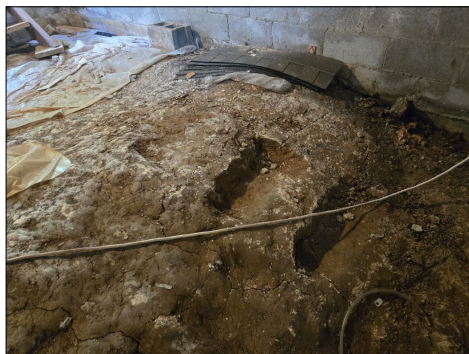
Missing Vapor Barrier

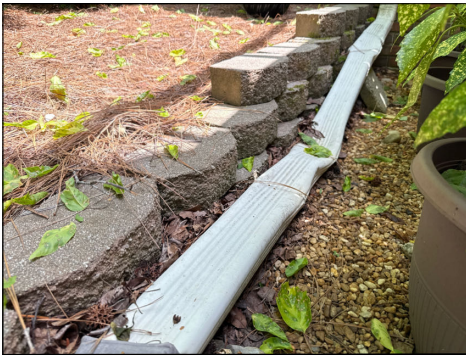
- *Damaged downspout noted on the rear side of the residence. Recommend further evaluation and repairs.*
- *Extensions/splash blocks missing or insufficient. Recommend installation to divert water away from the foundation.*

Damaged Downspout - Rear Side

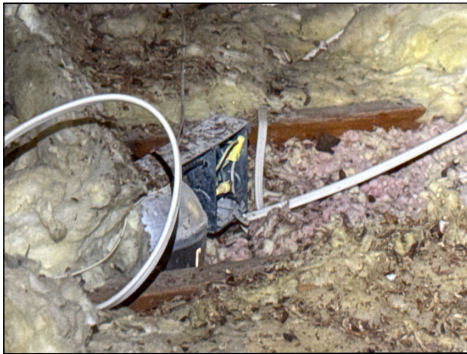
- *Open junction boxes were observed which is a safety concern. Recommend installing covers for safety reasons.*
- *Loose/hanging wires noted. Recommend adding wire nuts to the open-ended wired and then installing inside a junction box.*
- *Connections made outside a junction box which is a potential shock or electrocution hazard. Recommend adding a junction box so the wire connections are completely enclosed inside these boxes.*

Open Junction Box

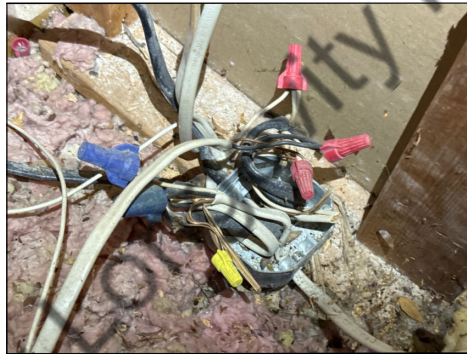
Open Junction Box

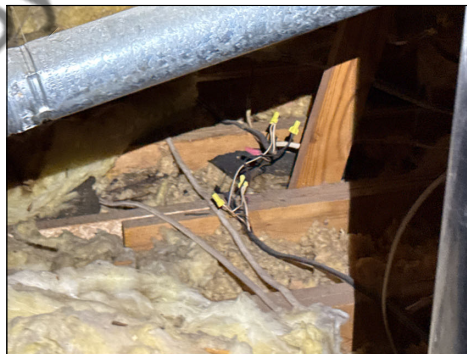
Wires Outside of Junction Box

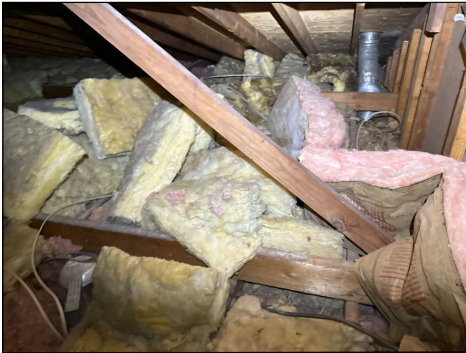
- *Insulation levels are adequate and achieve the desired/recommended minimum R-30 levels.*
- *Pile of insulation noted in the attic. Recommend further evaluation and repairs.*
- *Vermin trails/tunneling observed in the attic. Vermin can damage insulation & electrical wiring. Recommend a professional pest contractor evaluate for treatment.*

Pile of Insulation

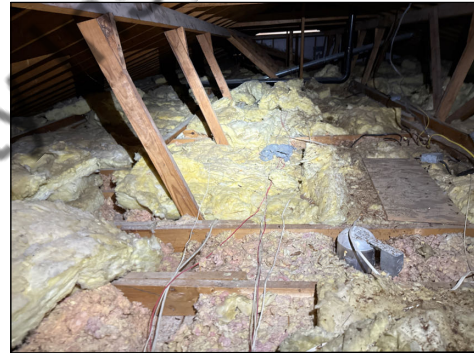
Vermin Holes/Trails

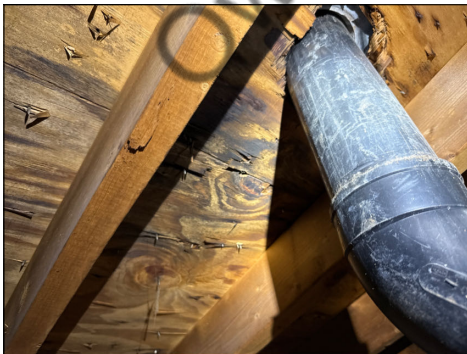
- *Moisture stains on the roof decking indicate a past or present leak. Area(s) were tested via electronic moisture meter/thermal imagery and found to be dry at the time of inspection. Recommend a qualified professional further evaluate for possible repairs.*
- *Gaps/holes in the attic should be sealed to prevent vermin and insect intrusion. Recommend further evaluation and repairs.*
- *Could not access all areas of the attic due to limited space.*

Moisture Stain - Right Side Vent Stack

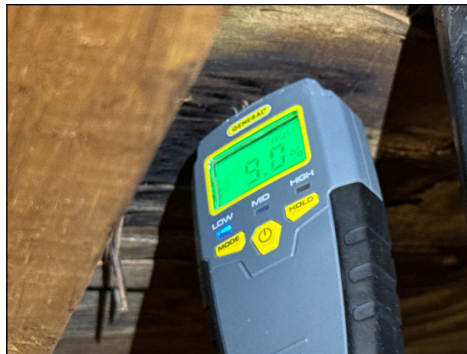
Dry

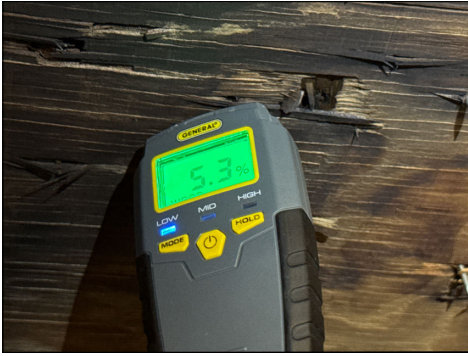
Dry

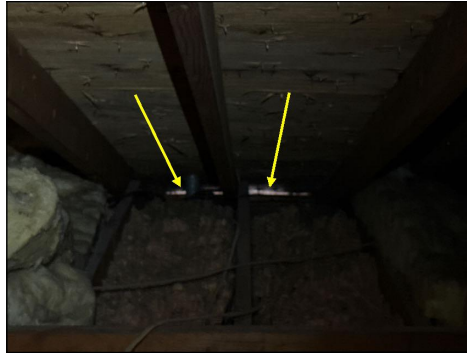
Gaps/holes - Rear Side

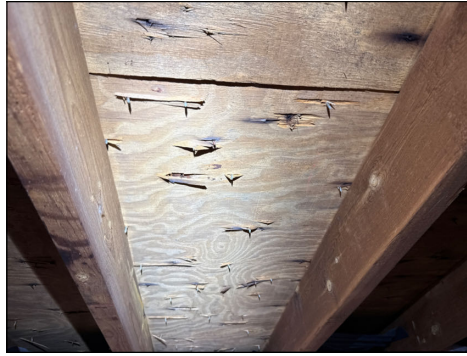
- Ridge exhaust venting noted.
- Under eave soffit inlet vents noted.
- Gable louver vents noted.
- Turtle Vents noted.
- Attic is appears to be inadequately vented. Roof ventilation may be inadequate; this may contribute to premature roof failure, conducive conditions for mold growth in attic, and/or high heating / cooling bills. Recommend further evaluation by qualified contractor. Recommend review by a qualified professional for repair as necessary to ensure proper ventilation.

Signs of Over Heating

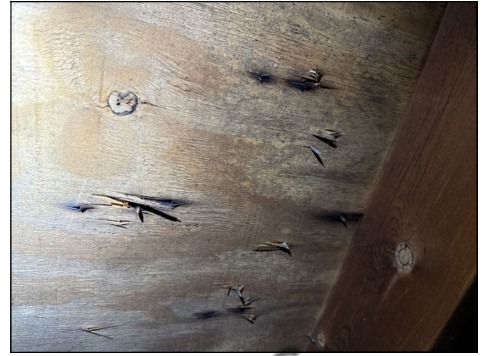
Signs of Over Heating

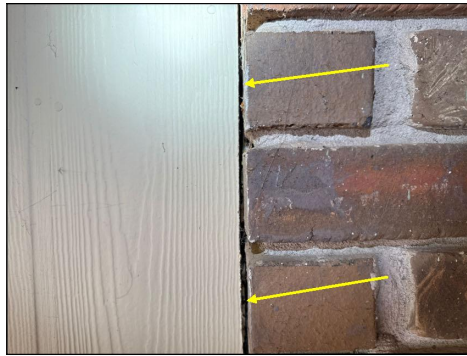
- Gaps noted in the left garage wall. Recommend further evaluation and repairs.
- Personal items prevented complete inspection. Recommend further inspection once items have been removed.

Gap - Left Garage Wall

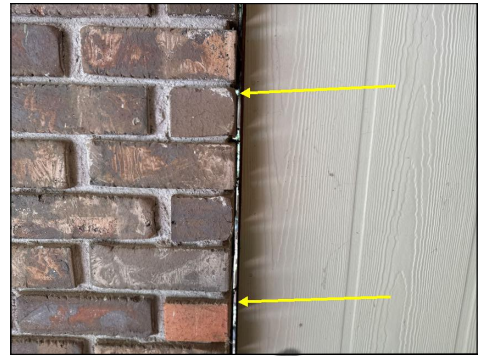
Gap - Left Garage Wall

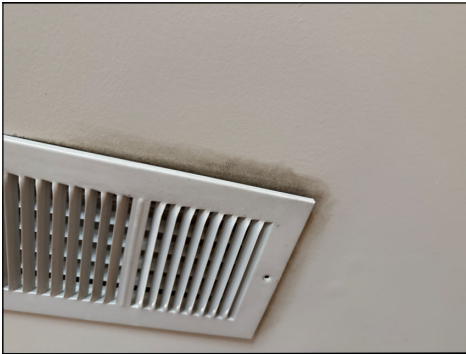
- *Suspect fungal growth stains present on the ceiling. Recommend further evaluation and repairs.*
- *Moisture stain(s) noted on the Master ceiling were tested using thermal imagery and found to be dry at the time of the inspection. Recommend further evaluation and repairs.*
- *Moisture stain(s) noted on the ceiling were tested using an electronic moisture meter/thermal imagery and found to be active with moisture at the time of the inspection. Recommend further evaluation and repairs.*

Suspect Fungal Growth -  
Basement Living Room

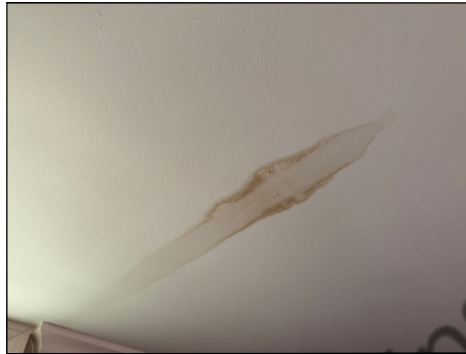
Moisture Stain - Front Right  
Basement Bedroom

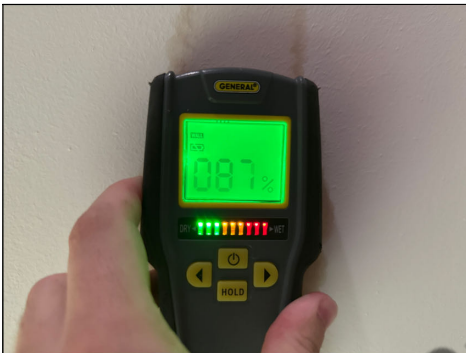
Wet

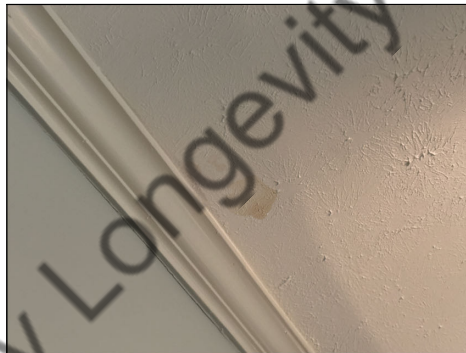
Moisture Stain - Master Bedroom

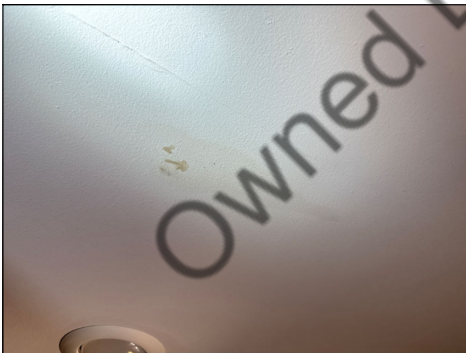
Moisture Stain - Basement Living  
Room

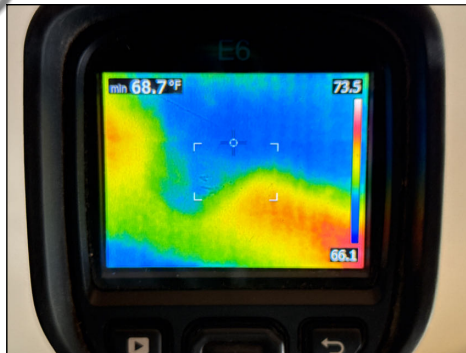
Wet

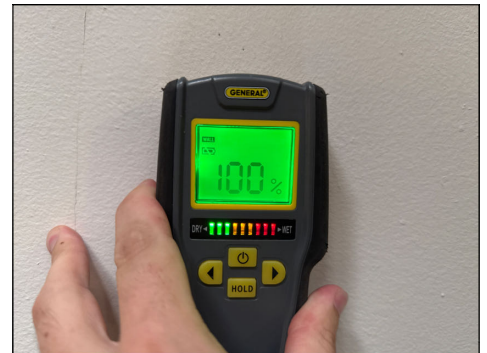
Wet

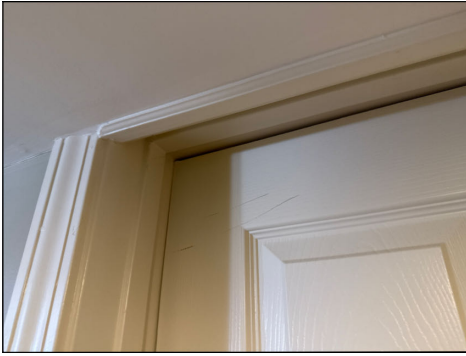
- *Door(s) conflict with the jamb. Recommend further evaluation and repairs.*
- *Door(s) would not latch. Recommend adjustments for proper closure.*

Conflict with Door Jamb - Front Right Basement Hallway Door

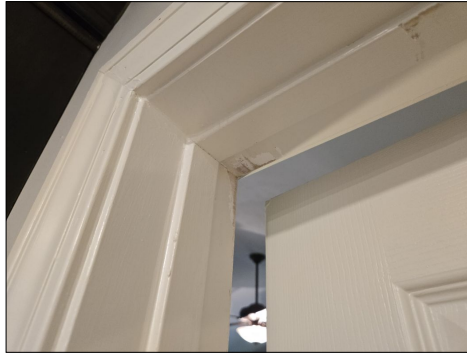
Conflict With Door Jamb - Master Bedroom

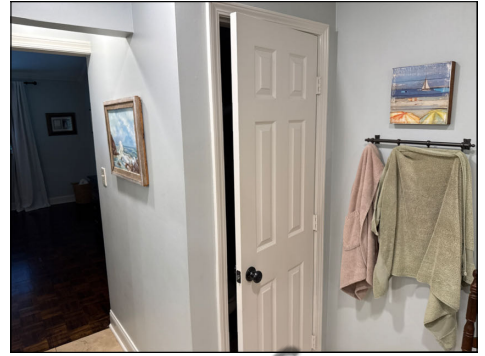
Did Not Latch - Master Bathroom Door

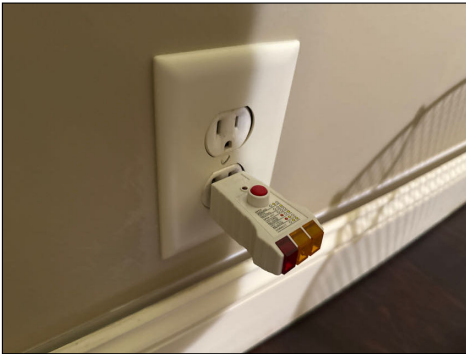
- *Open junction boxes were observed which is a safety concern. Recommend installing covers for safety reasons.*
- *No power noted at the outlet. Recommend further evaluation and repairs.*

No Power - Front Right Basement Bedroom

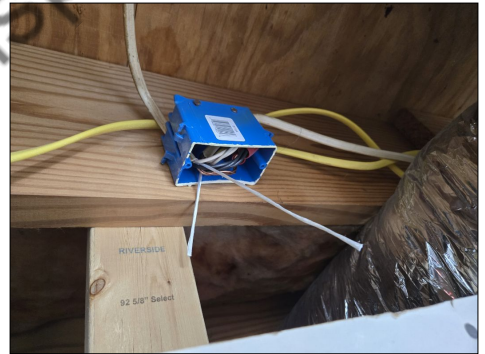
Open Junction Box - Basement Hall Closet

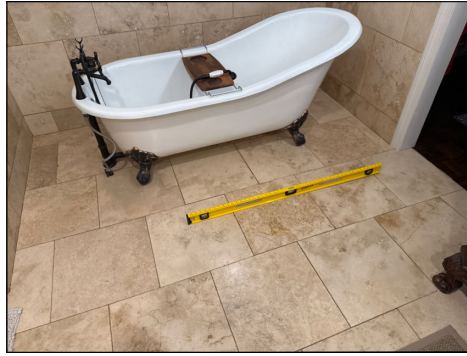
- *Uneven floor(s) noted. Recommend further evaluation by a licensed/qualified professional.*
- *Gap in flooring noted at the front door. Recommend further evaluation and repairs.*
- *Cracked tiles noted. Recommend further evaluation.*

Uneven Floor(s) - Master Bathroom

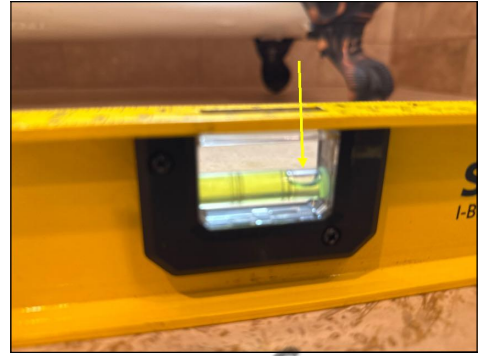
Uneven Floor(s) - Master Bathroom

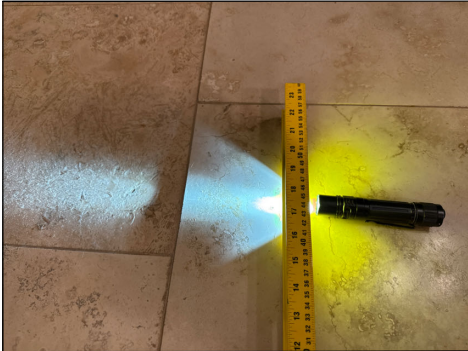
Uneven Floor(s) - Master Bathroom

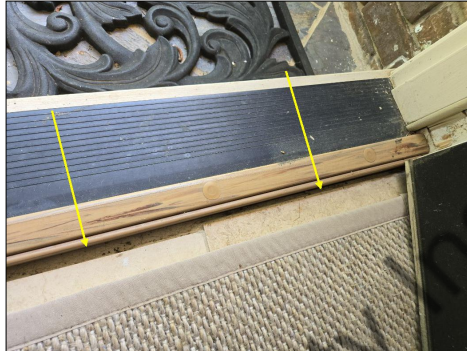
Gap in Flooring - At Front Door

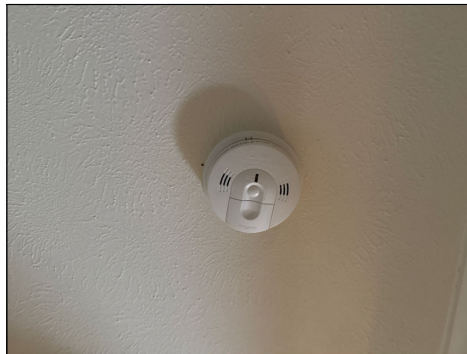
- *Old detector(s) noted. Smoke detectors last 6-10 years. Recommend replacing.*
- *IMPROVE: The National Fire Protection Association recommends homes should have smoke alarms installed inside every bedroom, outside each sleeping area and on every level of the home, including the basement.*
- *IMPROVE: There are no visible CO (Carbon Monoxide) detector(s) in the home. The Consumer Product Safety Commission recommends that every residence with fuel-burning (gas) appliances be equipped with a UL Listed CO alarm. CO is colorless and odorless and thus impossible to detect without a proper electronic detector. At a minimum, put an alarm near the sleeping rooms on each level in your home.*

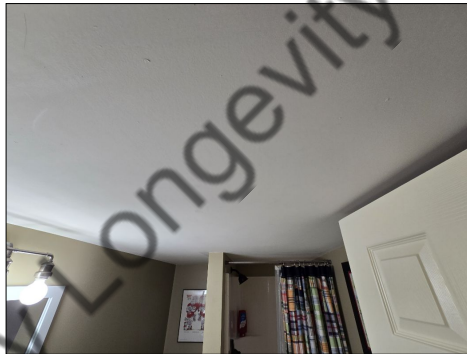
- *Guidelines state that either exhaust fan or window should be in all bathrooms to ensure ventilation of moisture. Lack of ventilation observed. Recommend further evaluation and repairs.*

Missing Fan/Window - Basement Bathroom

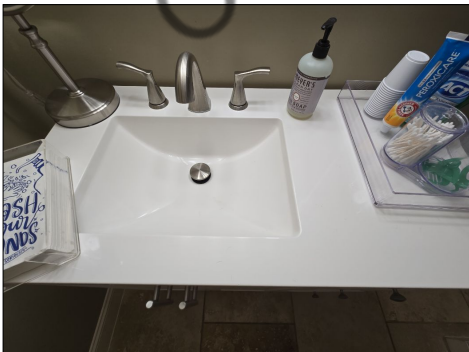
- *Loose cabinet noted and was not properly secured to the floor/wall. Recommend further evaluation and repairs to prevent possible damages to the plumbing.*
- *Due to personal items the cabinet base was not fully accessible. Recommend further inspecting once items have been removed.*

Loose Cabinet - Basement Bathroom

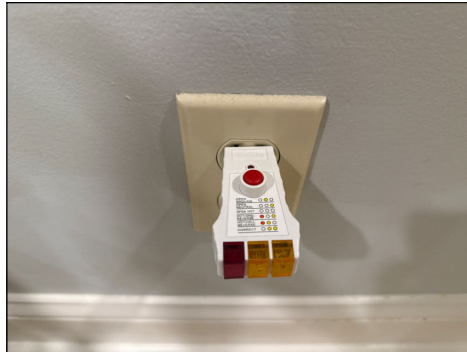
- *Outlet has no power. Unable to determine if it is connected to a GFCI or if it just does not have power. Recommend further evaluation by a qualified professional.*

No power - Master Bathroom

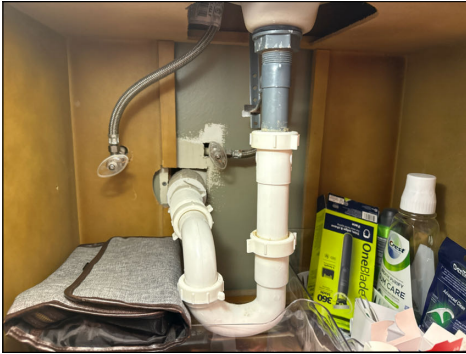
- *Flex drains are subject to frequent clogging. Recommend replacing with a non-flexible **PVC** pipe.*

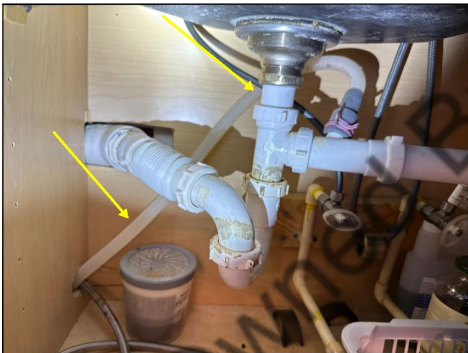
- *Missing high loop noted. A high loop is a method of backflow prevention where the drain line runs from the dishwasher to the highest point beneath the sink. The loop is affixed to the underside of the counter with a bracket, then drains down into the garbage disposal or sink drain. Recommend repairs.*
- *Dishwasher was tested and found operational at the time of the inspection.*
- *The dishwasher is not properly fastened. Recommend further evaluation and repairs.*

Missing High Loop

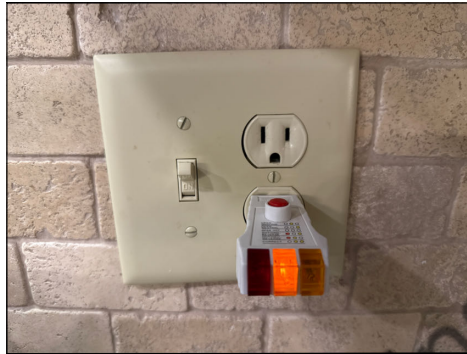
- *Open ground (or 2-wire) outlets present. This means that the 3rd (round) part of an appliance plug is not getting ground protection. This may be a concern with items such as computers and electronic devices. Recommend further evaluation.*

Open Ground - Right of Kitchen Sink

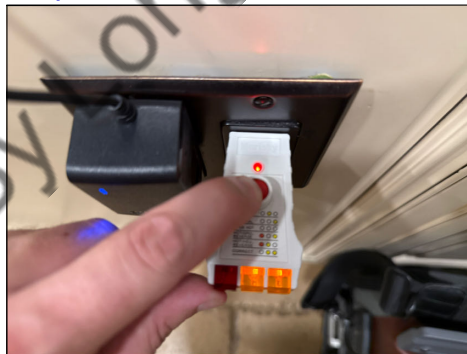
- *GFCI protected receptacles may not have been required (1987) when the house was built. We suggest buyer consider upgrading with GFCI's at all receptacles near water sources. Recommend further evaluation.*
- *The kitchen outlet(s) are not GFCI protected. Recommend further evaluation and repairs.*

Did Not Trip/Reset - Kitchen

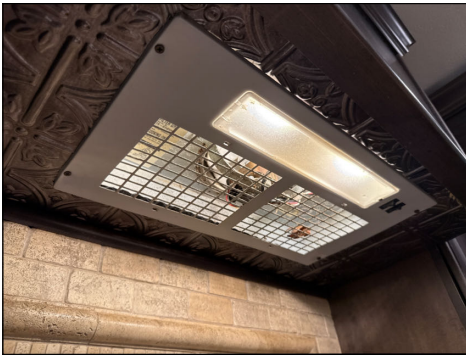
- *Exhaust fan is noisy and should be further evaluated.*
- *Microwave present and operational at the time of the inspection.*
- *Refrigerator present and operational at the time of the inspection.*

Noisy/Loud Fan

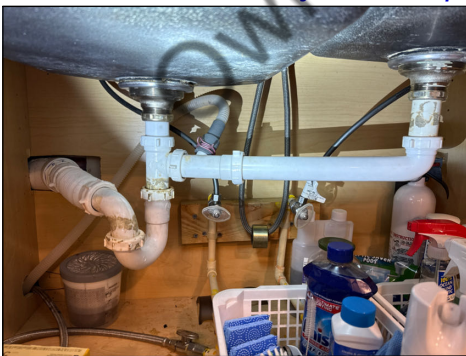
- Flex drains are subject to frequent clogging. Recommend replacing with a non-flexible PVC pipe.

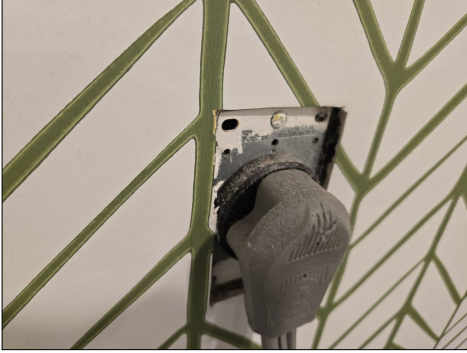
- *Switch/outlet cover missing/damaged and should be replaced for safety reasons.*

Missing Cover - Laundry Room

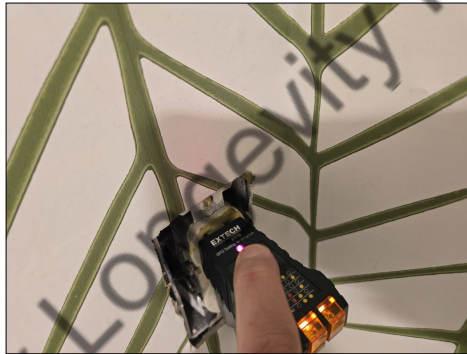
- *GFCI protected receptacles may not have been required (2014) when the house was built. Recommend buyer consider upgrading with GFCI's receptacles near water sources (within 6 feet).*
- *The laundry room outlet(s) are not GFCI protected. Recommend further evaluation and repairs.*

Did Not Trip/Reset - Laundry Room

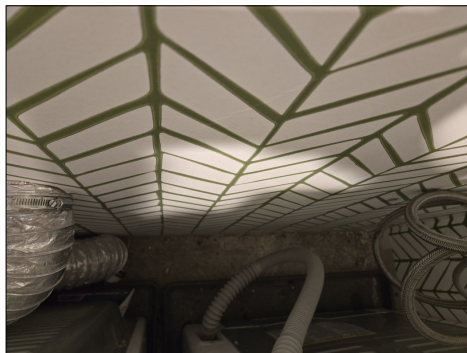
- *The gas line is not visible. Recommend further evaluation once personal items have been removed.*

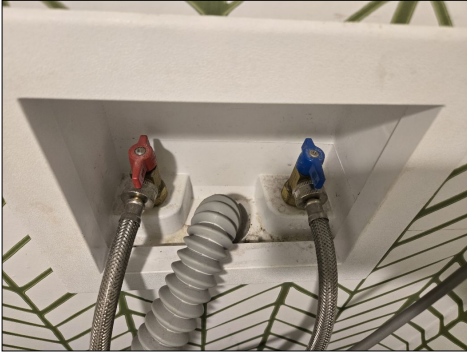
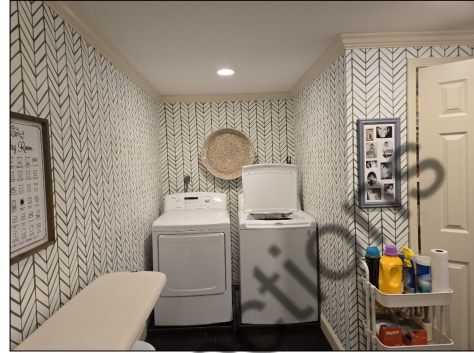
- *No major system safety or function concerns noted at the visible areas during the inspection.*
- *Recommend adding stainless steel lines to the washing machine. Rubber hoses tend to crack/bulge and deteriorate over time.*

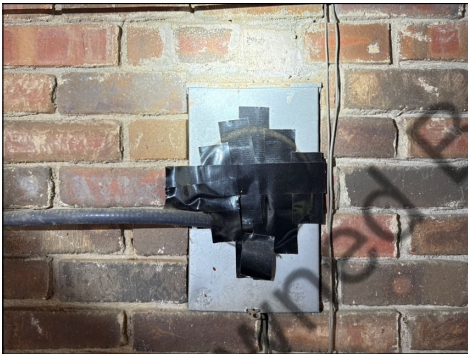
- *Tape over electrical meter noted on the rear side of the residence. Recommend further evaluation and repairs by a qualified professional.*
- *There is an overhead service drop noted.*

Tape over Electrical Meter -  
Rear Side

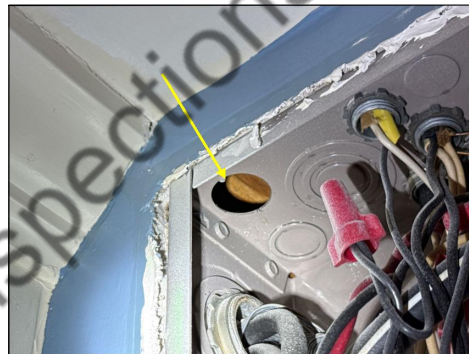
- *It is always good practice to have a licensed electrician further evaluate all electrical due to building codes changing constantly and their expertise on everything electrical. This was a basic inspection to determine if there is aluminum wiring, double-taps, burned/scorched wires and openings. Anything beyond this should be further inspected by a licensed electrician.*
- *Opening noted in the electrical panel. Recommend further evaluation and repairs.*

Opening - Electrical Panel

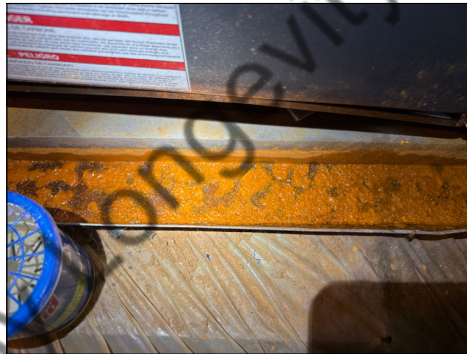
- *Rust accumulations in the overflow pan indicate a past or present malfunction with the unit. Recommend further evaluation by a qualified professional.*

Rust in Overflow Pan

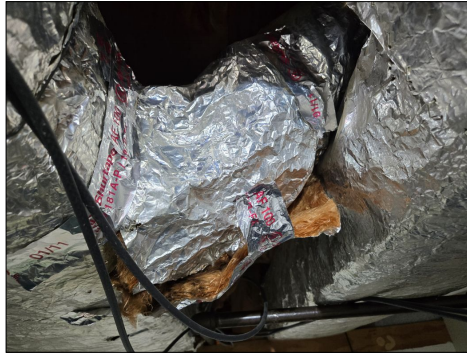
- *Insulation wrapping is torn/damaged in areas and should be addressed for energy efficiency. Recommend further evaluation.*
- *Insulation is missing/damaged and should be replaced/repared. Recommend further evaluation by a HVAC company.*

Torn/Damaged Ductwork -  
Crawlspace

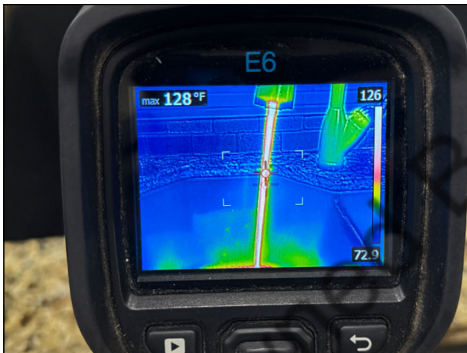
128F

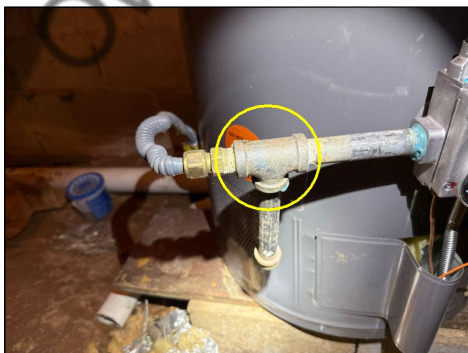
- *Recommended water temperature should be between 120-130 degrees F. Current water temperature is 128F.*
- *Tee fitting is improperly installed and should be further evaluated by a HVAC company. The bottom leg of the tee should be installed towards the furnace. The top of the Tee valve should vertical to allow the gas to come in from the top of the valve and the drip leg/sediment trap installed at the lower portion of the valve. Recommend further evaluation and repairs.*

Improper T Fitting

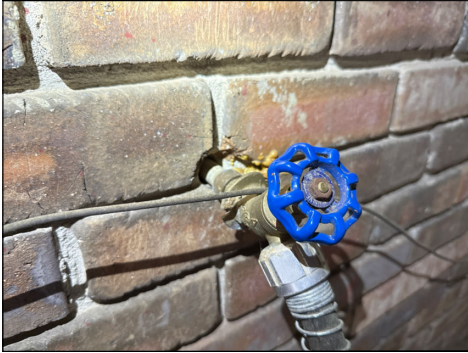
- *Functional at the time of the inspection.*
- *Hose bib(s) are loose at the structure. Recommend repairs to prevent possible damage to the supply line.*
- *Recommend upgrading to a frost proof type hose bib to prevent possible damage due to cracking of water line in below freezing temperatures. A frost-proof hose bib, also known as a frost-free spigot or freeze-proof faucet, is a type of outdoor faucet that's designed to prevent water from freezing and potentially causing damage to pipes.*

Loose at wall - Rear Side

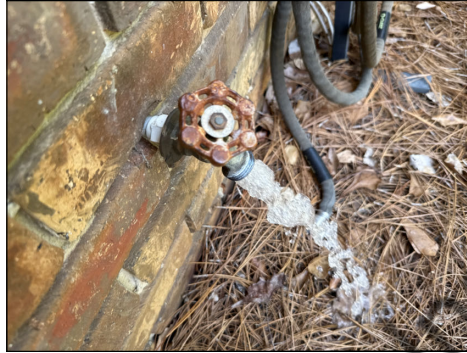
Loose at wall - Front Side

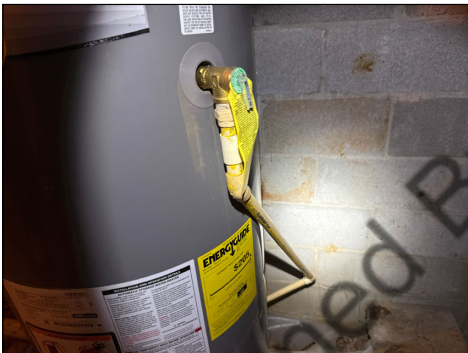
- *TPR discharge pipe is not properly installed and should be further evaluated and repaired by a qualified professional.*

Improper TPR Install

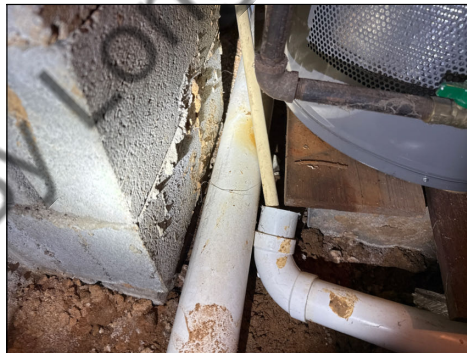
Improper TPR Install

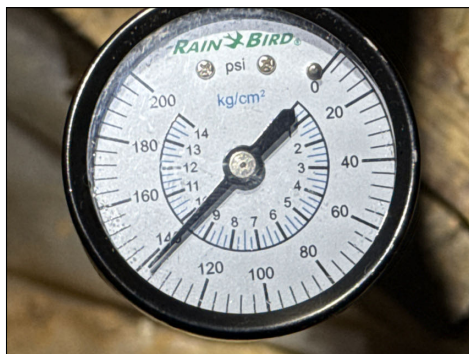
- *High pressure noted. Water pressure tested at 140 psi. Recommend a licensed plumber adjust the water pressure between the recommended 40-80 PSI.*

140PSI

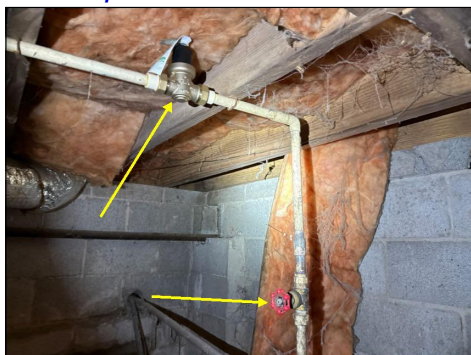
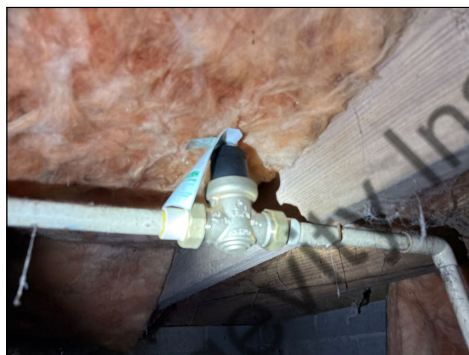
- *Pressure reducing valve and main water shut off is located at the front left corner of the crawlspace.*

Pressure reducing valve (PRV)

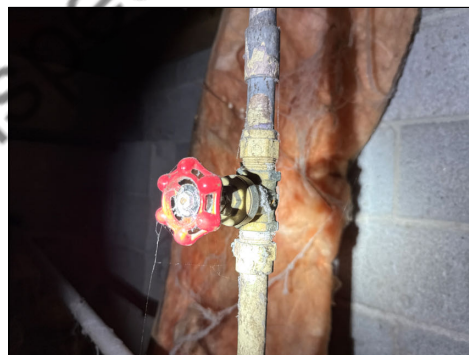
Main water shutoff
