Inspection Report

Michael J. Turner Home Inspections LLC

1234 Home Inspection Street

Property Type Single Family Home - **New Construction**

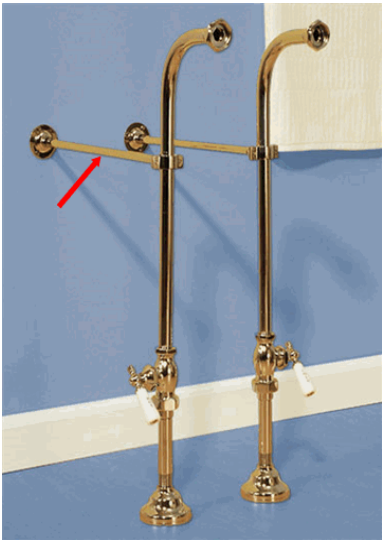
1. The master bath tub and floor mount faucet was loose. Secure tub and install wall mount bracket at faucet to prevent movement. Most of these baths are acrylic and without water are easy to nudge and can be a concern to the waste pipe below "leaks". You can place a bit of silicone sealant under which will restrict the bath tub from being moved while empty but also means that when it comes to maintenance, unnecessary force has to be used! Bracket arms can help to stabilize water faucet riser stand.
2. Dyer vents under home. To prevent lint and moisture related damage - dryer vent should be routed to exteriors and secured. Flex lines should "not" be used - hard metal smooth wall pipe to prevent clogs.
3. Water meter @ curb was leaking as evident from standing water. Contact City or

Example of support for master bath riser

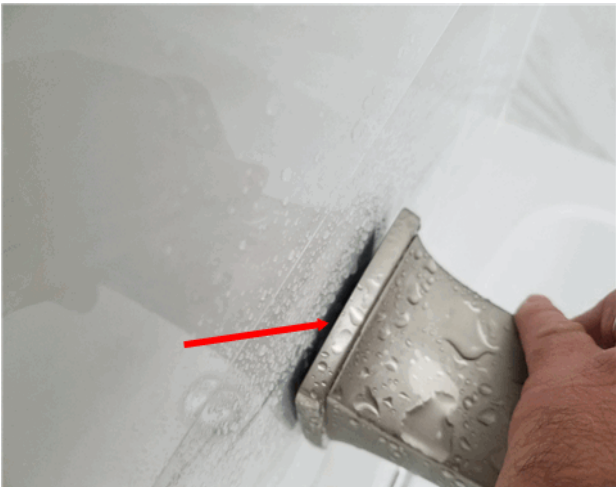
Bracket arms help to stabalize faucet

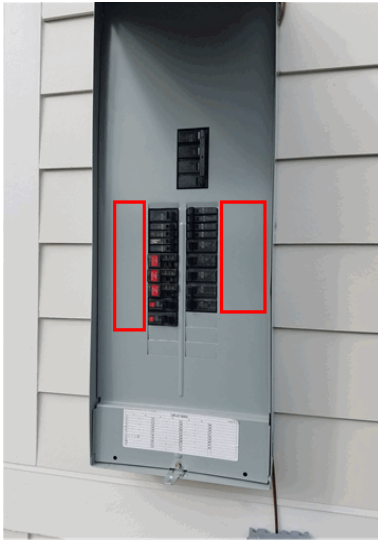
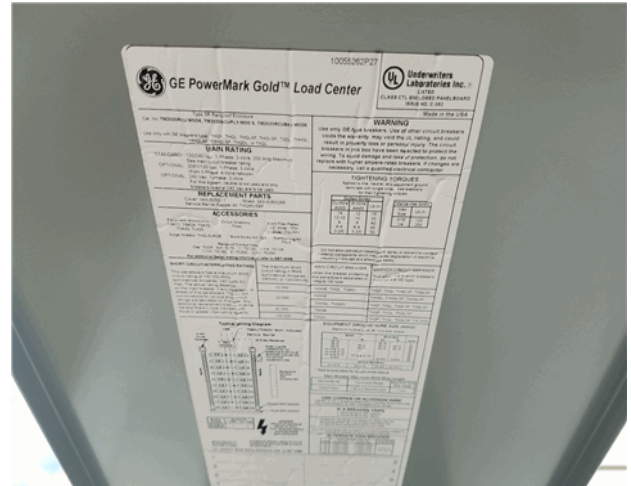
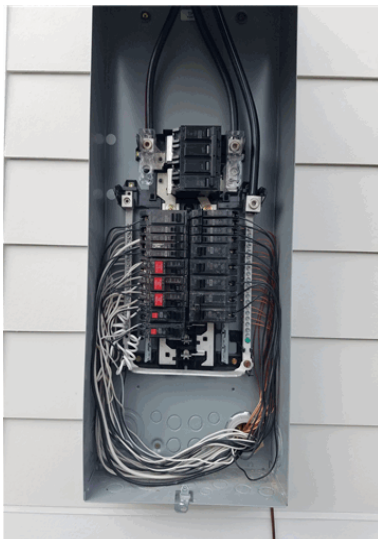
7) Repair Conditions	<ol style="list-style-type: none"> 1. Missing labels @ electrical panel box. Recommend an electrician trace circuits and properly label panel. 2. For added safety, we recommend Arc Fault (AFCI) breakers (a safety device which trips when a spark is present) at all bedrooms and living areas for increased safety and to meet current safety standards (code).
-----------------------------	---

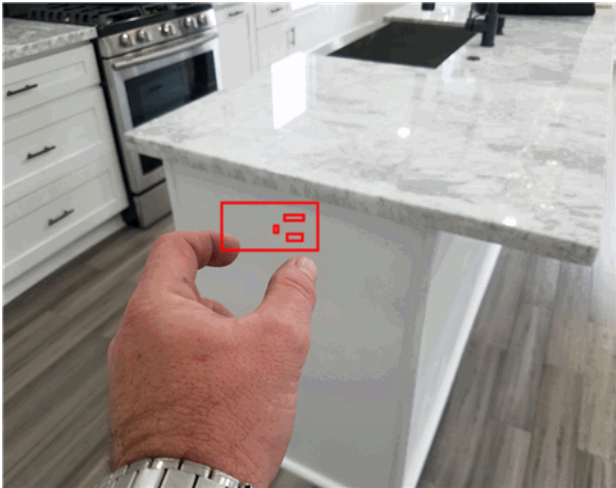
1. Cover plate missing at master bath outlet under cabinet. Recommend installing covers on all junction/switch/outlet boxes for safety.
2. Loose kitchen counter outlet on right side of refrigerator wood panel. Secure outlet and install outlet cover plate.
3. Trim kit for recessed can at back-left was missing. Install trim kit (LED)
4. The service outlet was not protected by GFCI in attic. Recommend a GFCI device be added for safety.
5. Kitchen island was missing outlet(s) with GFCI protection. Recommend GFCI be installed @ both sides of cabinet island. The GFCI under kitchen island counter-top is not for use for kitchen appliances since counter-top extends more than 6-inches and outlet was lower than 12-inches from top of counter-top. Refer to illustration photo's

Counter-top extend out pass cabinet by 9.5 inches

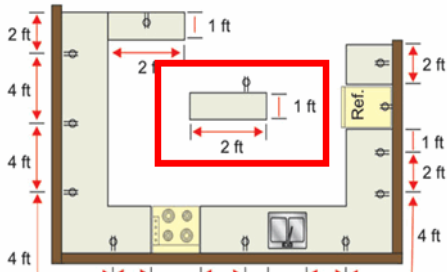
No point on wall countertop spaces more than 600 mm (24 in.) from a receptacle outlet (measured along the backsplash)
Receptacle outlet required for wall space 300 mm (12 in.) or greater in width

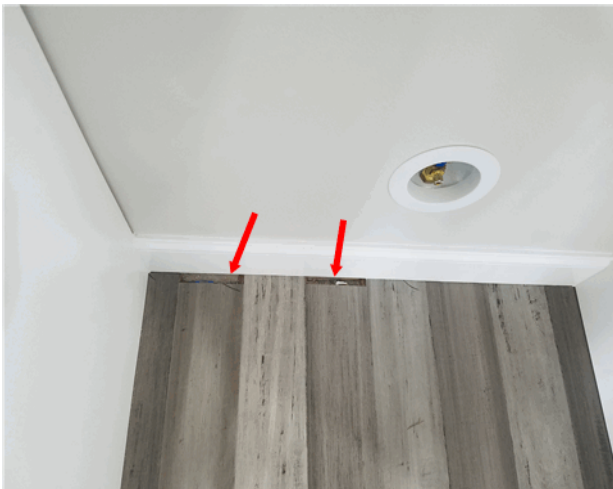
1. Laminate wood flooring did not fully extend under base trim @ refrigerator opening.
Suggest floor covering be applied at opened areas.

Small gaps @ interior kitchen floor -
refrigerator area

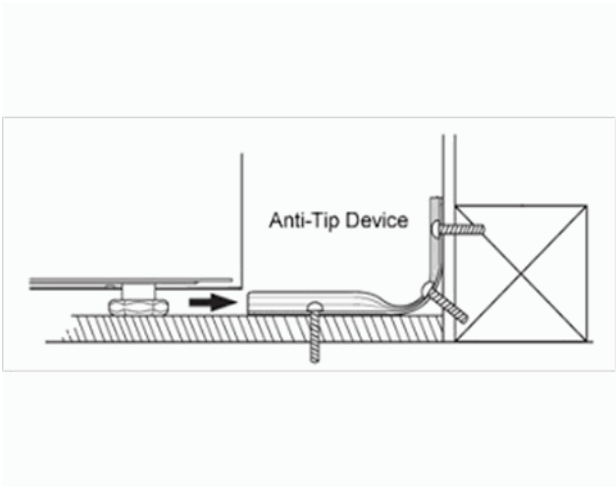
Anti-tip bracket was missing @ range.
Install to prevent tipping
