Inspection Report

Michael J. Turner Home Inspections LLC

FRENCH QUARTER New Orleans, Louisiana 70116

1 Report Information

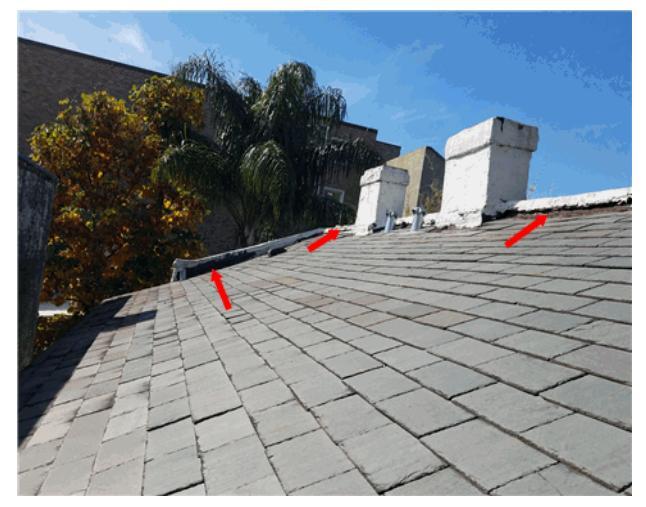
1) Roof - Repair Conditions	1. The slate roof had little to no head-lap at the edge. Natural slate starter course was installed upside down or with the back side facing down. The starter slate is normally installed with the back side (smooth surface) facing up in order for the beveled edge to merge flush with the beveled edge on the first course. The starter slate is the only slate on the roof with the back side facing up. Although this will not adversely affect the function of the roof system it does indicate non-professional installation. Further evaluation by a licensed expert slate roofing company.

1. Natural slate strater course was installed upside down. Large head lap opening

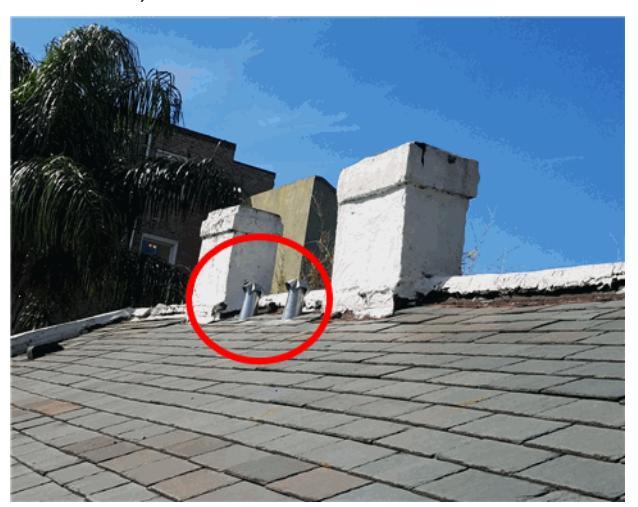
2. The gas flue vent for the furnace does not vent pass the roof jack, rather stopping inside the roof jack. This type of venting is no longer performed today. Recommend the vent pipe penetrate through the roof jack and into the atmosphere. The vent pipe for the gas furnace was touching the wood sheathing in attic. Recommend a one inch clearance be provided and the pipe secured/strapped for safety.

2. Daylight - Opening @ roof. Improper 1-inch clearance to wood (combustible material)

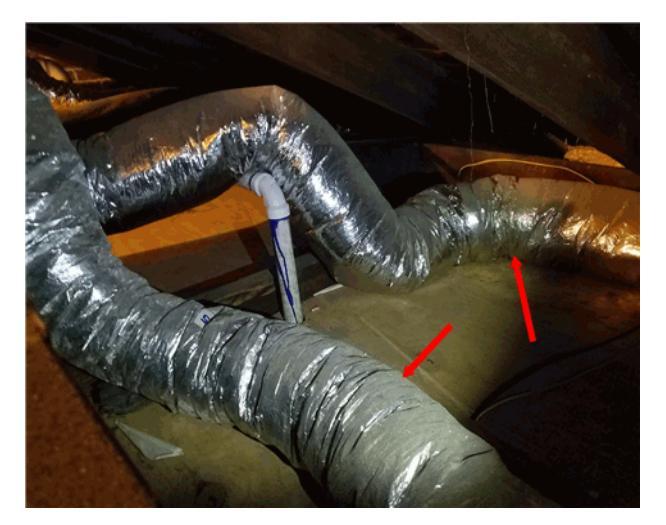
1. Some flex duct work and/or branch lines were lying flat on surface of attic and /or kinked from lack of support straps. Recommend support straps be added to raise the ducts off surface to prevent condensation from occurring.

1. Some flex duct work and/or branch lines were lying flat on surface of attic and /or kinked from l

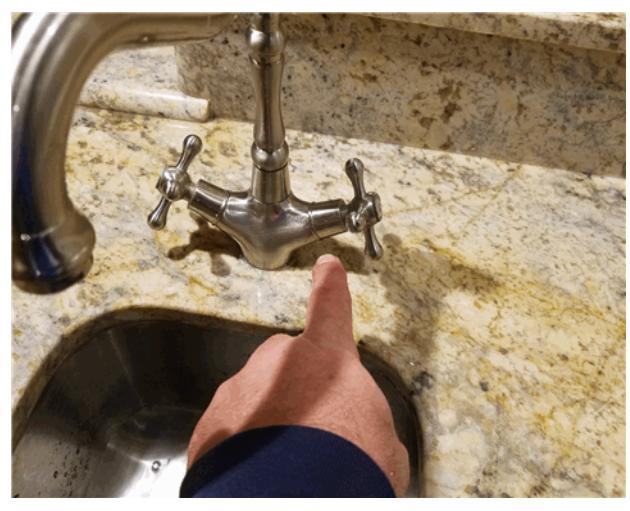
5) Plumbing - Repair or Safety Conditions	1. First floor wet bar sink faucet was loose and leaks when turning cold side handle. Recommend repairs to secure loose threaded sleeve and secure fixture with locking washer and nuts from underneath counter-top.

1. First floor wet bar sink faucet was loose and leaks when turning cold side handle.

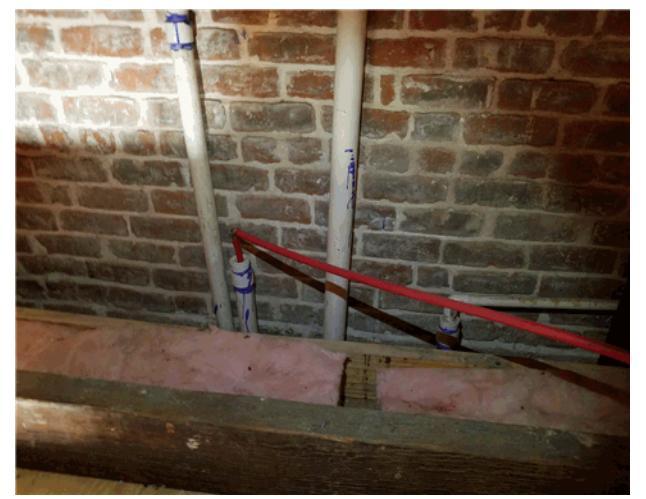
2. Attic areas: Multiple areas of the plumbing drain, waste and vent lines lacked support straps, limited slope to drain water. Horizontal to horizontal connection was noted at condensate drain line without using proper WYE or 1/8" bend radius and lacked P-trap @ back building. Evaluate and repair

2. Attic areas: A few areas of the plumbing drain, waste and vent lines had a lack of support straps

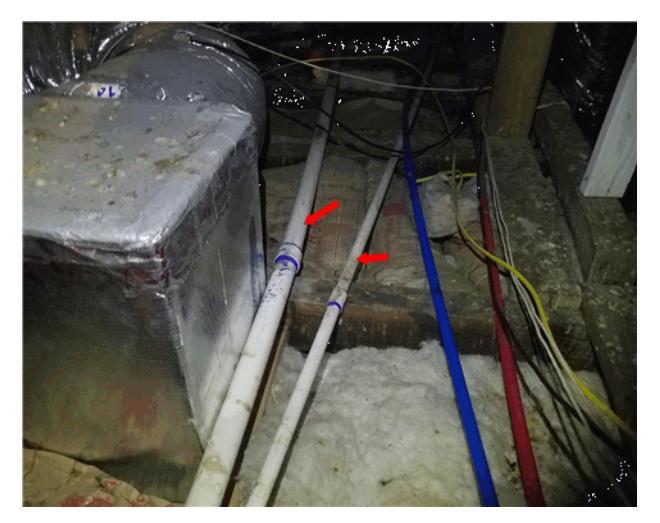
2. Attic areas: A few areas of the plumbing drain, waste and vent lines had a lack of support straps

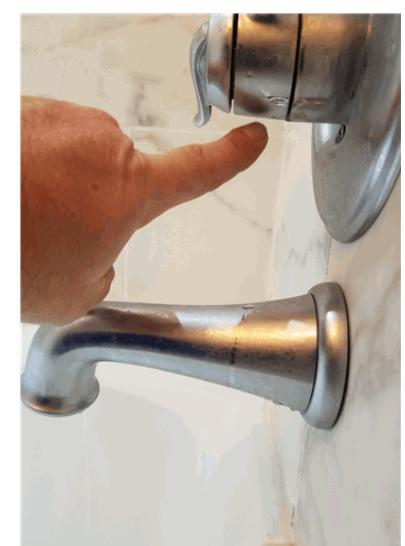
3. Second floor bath shower valve / handle leaks intermittently and the tub spout leaks which has a gap at wall, in which water can enter. Evaluation suggested

3. Second floor bath shower valve / handle leaks intermittently and the tub spout has a gap in which

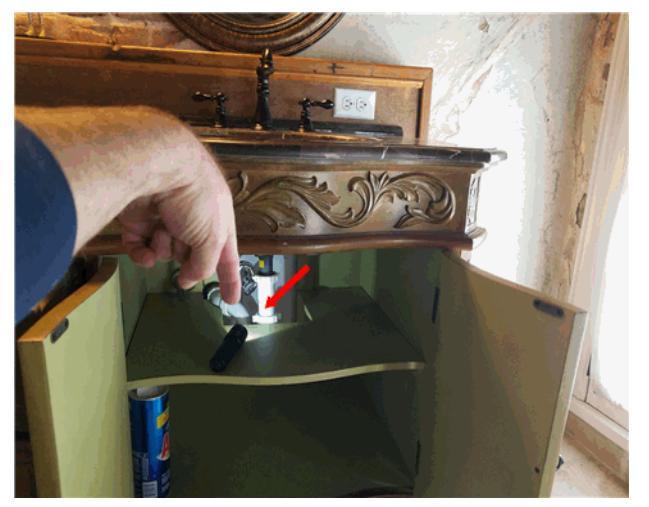
4. Toilet on second floor was not operated as stated by the listing agent, "do not use". Evaluate cause - repair
	5. Leak at drain line under main buildings master bath sink in back. Repair to prevent moisture damage

5. Leak / seepage at drain line under main building bath sink master bath in back.

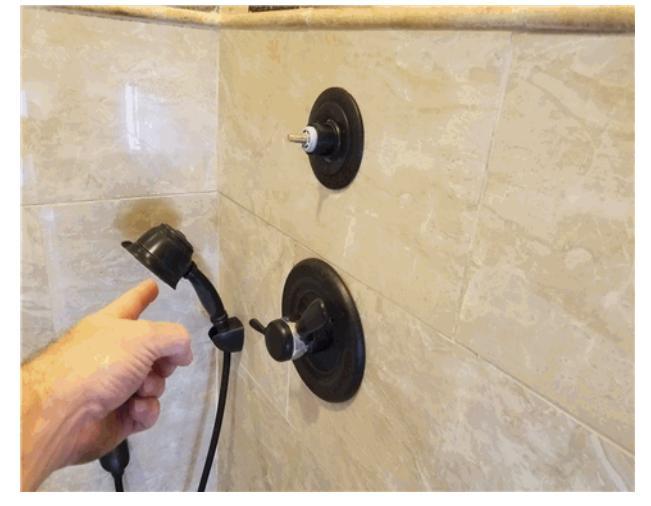
6

6. Master shower showed hair clog @ drain when viewing through drain plate - conditions behind the clog in the drain were not observed. The handle diverter which changes positions from ceiling shower to spray wand was missing therefore, components in relation to this system were not inspected. Unknown pipe stub-out noted at shower (possible tub spout to be installed). Verify with owner and have improvements & repairs.

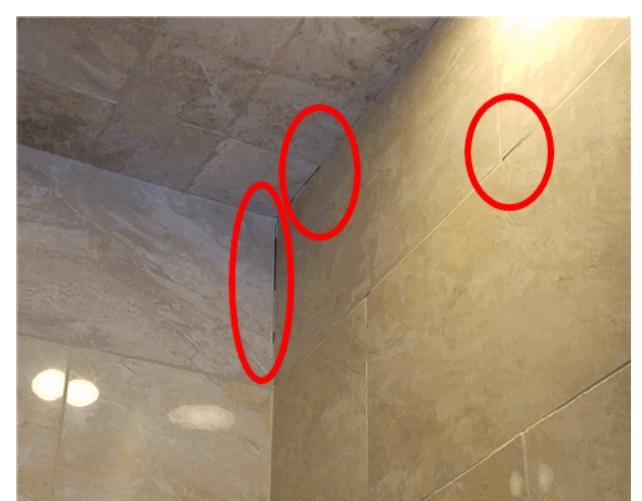
7. Multiple gaps / openings noted @ grout lines @ shower tiles. To prevent moisture related damage.

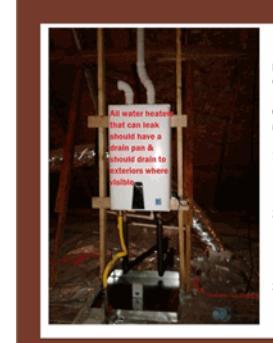
1. Drain or catch pan was not present under the on demand water heater in attic of main building. This can cause damage if the water heater leaks. Suggest a licensed plumber install this emergency water heater drain pan in attic with a pipe to drain to exteriors where visible. If a pipe cannot be installed due to location an audible alarm can be installed with a water shut off valve tied into the water system and alarm and warning float switch. Evaluation and repairs suggested

1. Drain or catch pan was not present under the on demand water heater in attic of main building.

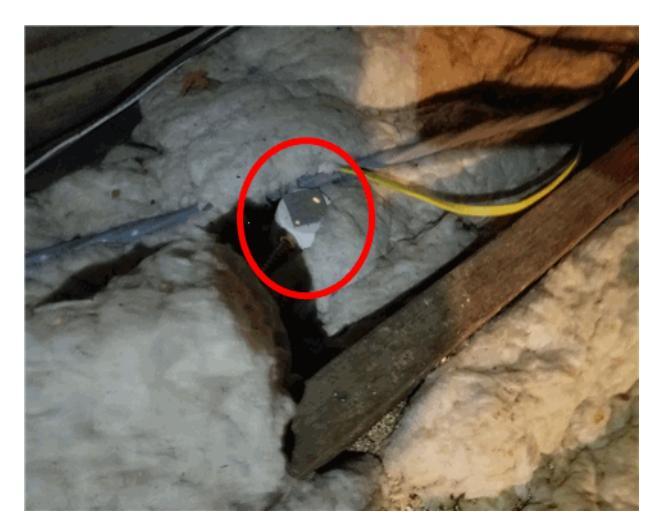
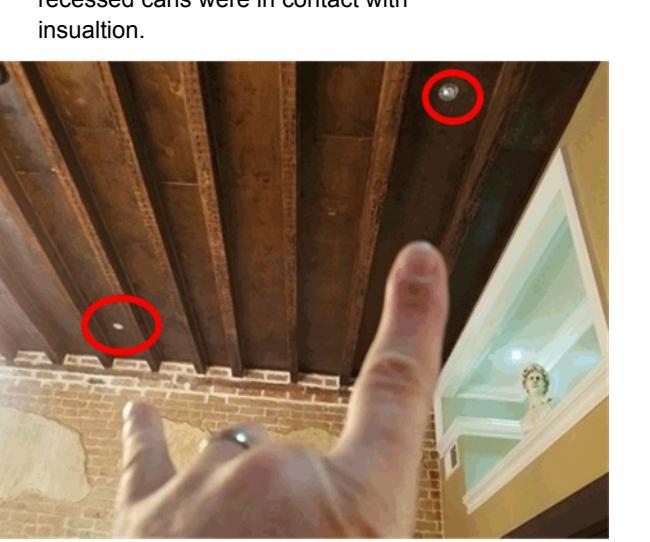
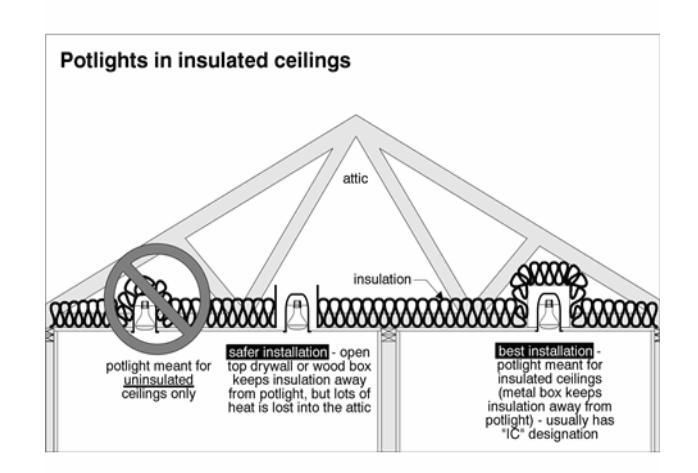
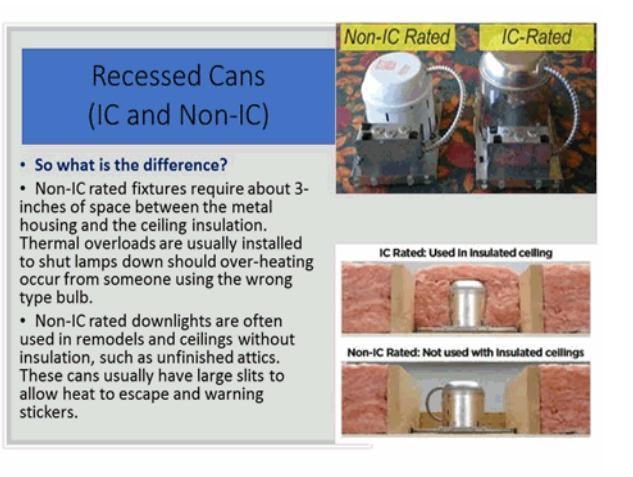
11) Electrical - Repair or Safety Conditions	1. The retro fit pop-in remodeling recessed cans were in contact with insulation. There are two type of recessed cans "pot lights". IC rated which means the potlight can touch insulation and Non IC rated which means potlights need clearance from insulation usually about 3 to 6-inches but follow the manufacturer's label located inside or on top of recessed can. Repairs for safety to prevent over-heating is recommended.

2. Recessed can lighting at front living area, flickers at main building. Lamps were checked for tightness. Since these cans are non IC rated and insulation covers can, along with heat from bulb is causing overheating. Insulation and wiring in each can should be checked for over-heating. Evaluate cause - repair for fire safety

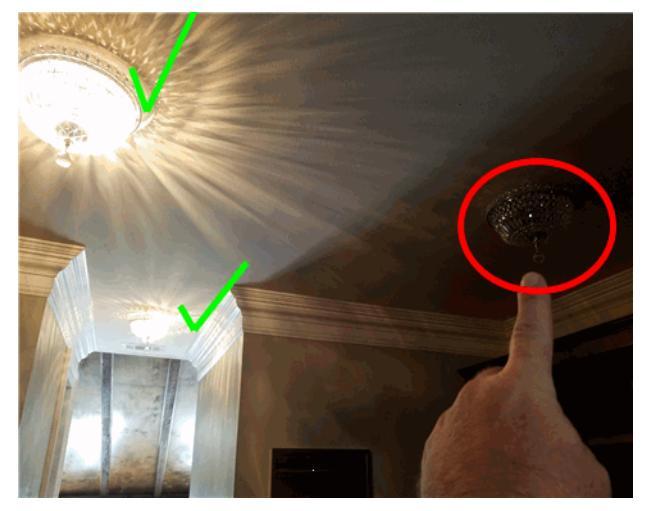
7. Light at 2nd floor closet light and study room ceiling surface mount light was inoperable using normal switch controls and pull chain. Power was present @ the fixture when tested with volt meter at the light fixture. Replace lamp and test before closing

7. Light at 2nd floor closet was inoperable using normal switch controls and pull chain.

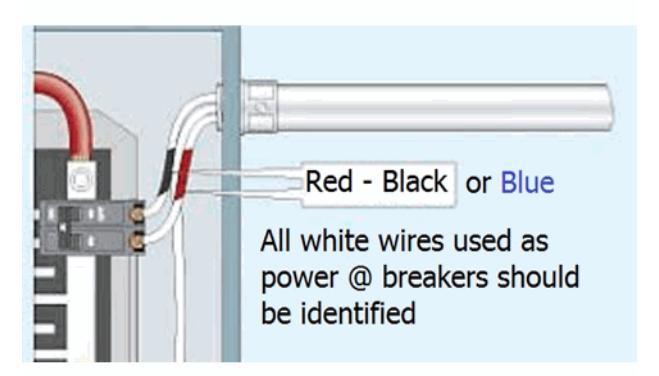
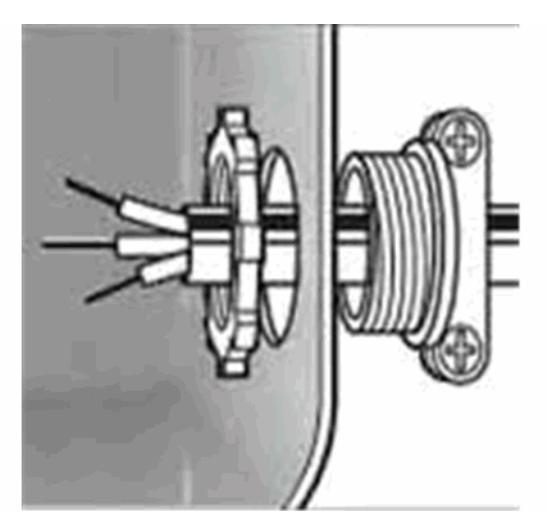
6. The wires were loose in attic. Securing wires every 4-5 feet with proper staples and keeping away from metal

6. The wires were loose in attic.

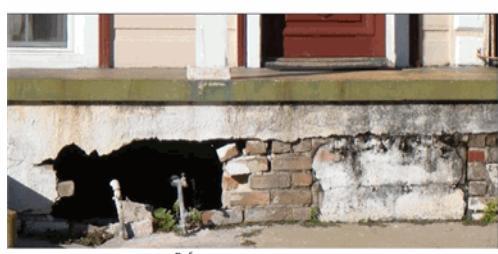
The stucco plaster has not been maintained and the bricks under the porch post are collapsing. The dislodged bricks can lead to structural problems at the porch if not repaired.

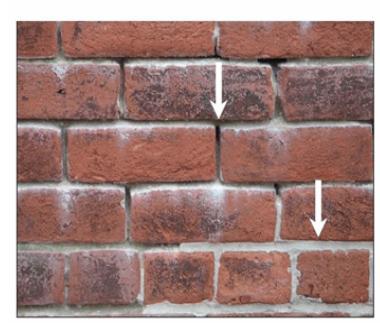
Disintegration of mortar from masonry surface – The mortar between the bricks has deteriorated particularly at the vertical joints, increasing the potential for moisture infiltration. The area at the lower right of the photograph has been recently repointed and mortar smeared into joints rather than properly tooled.

Recommendation – Repoint open joints with compatible mortor as soon as possible to minimize storm water entering wall. Consider repointing lower right section to ensure a tight bond with compatible mortar.

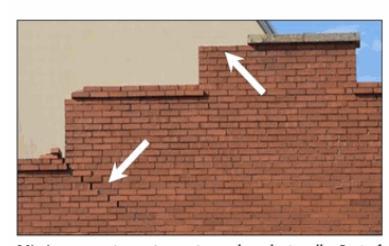
Missing parapet cap stone, stepped crack at wall – Part of the cast stone cap stone is missing at the top of the wall and there is a step crack following the mortar joints that suggests building movement.

Recommendation – Review wall structure to verify whether it has shifted or is bulging in response to movement or settlement. Repaint mortar joints with compatible mortar and install new matching cap stone to keep water from entering the top of the wall. Inspect crack every few months to see if joint has reopened, which suggests the movement is still occurring.

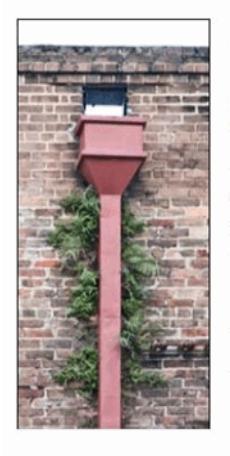
Plant growth and staining at

downspout- Plants are growing in the mortar joints around the top of the downspout and there is dark brick staining below. Both conditions suggest the presence of moisture and saturation of the brick wall.

Recommendation –Verify that the downspout is clear and draining. Remove plant growth. Repoint open mortar joints with compatible mortar.

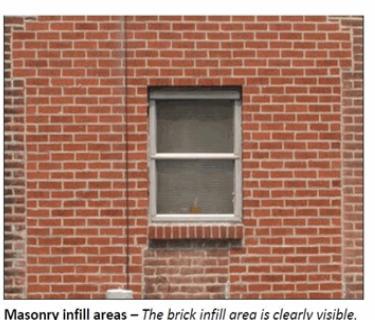
Masonry intill areas – I he brick infill area is clearly visible. The infill area uses bricks of a different size and color than the historic bricks and is outlined by a thicker mortar joint rather than being "keyed" into the adjacent brickwork. Recommendation – The bricks and mortar used in the infill areas should be the same size, color, texture, appearance, profile and hardness as the adjacent historic bricks. The repair should also be "toothed" into the adjacent brick to appear continuous with the wall surface.

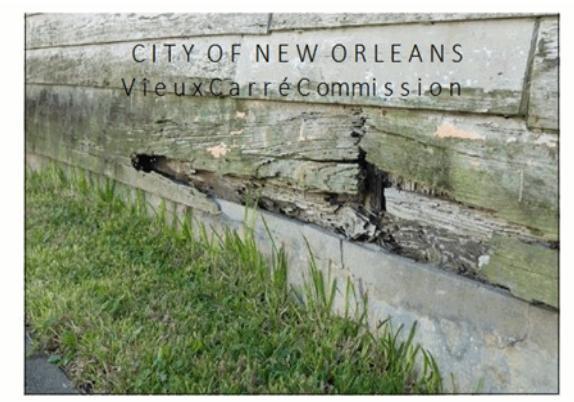
Wood located on or next to a brick or a concrete foundation or pier is more likely to absorb moisture and rot as well as attract termites.

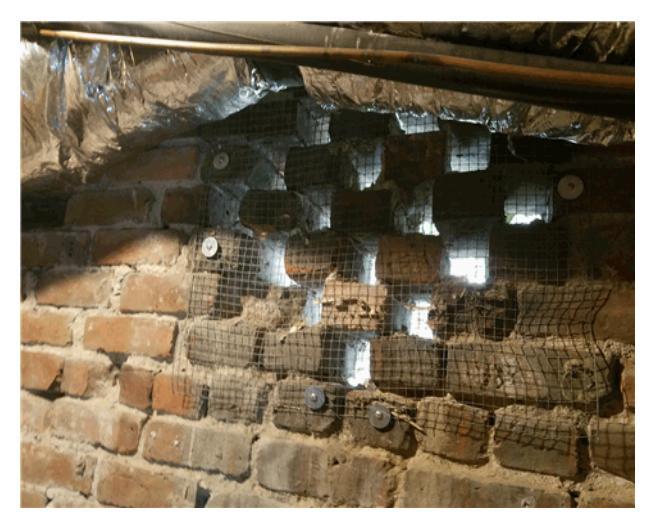
Open gable vent installed into true masonry brick wall in attic has no means to prevent wind driven rain from entering buildings structure. Metal screen wire was attached to cover openings to deter birds and large pest however, the remains of nesting (e.g. grass, hay) and debris remains in the attic. Historical district does allow venting methods using special designed vents that prevent rainwater entry and pest from entering. Recommend a retro-fit with newer approved gable wall vent.

Photo of gable wall vent with meal screen wire

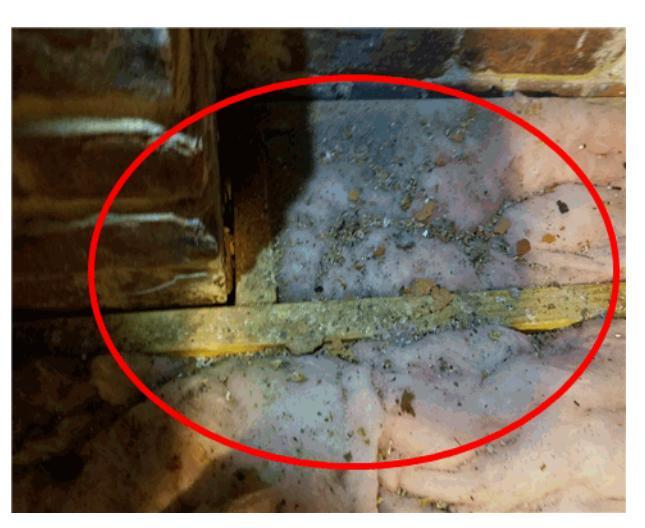
Debris in attic under gable wall vents

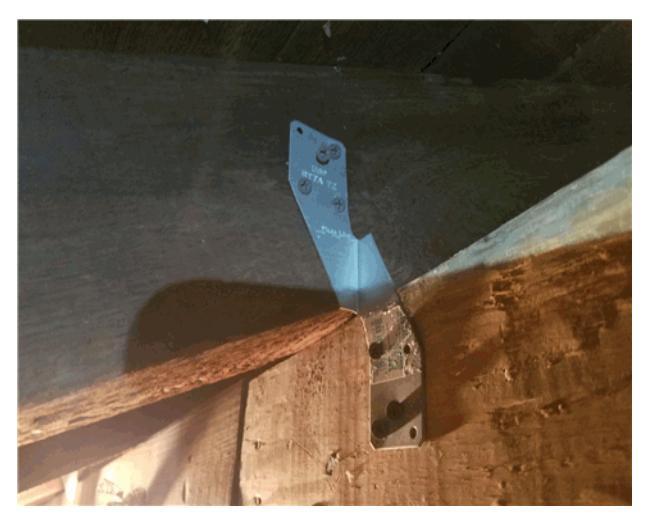
Hurricane straps installed with drywall screws rather hot dip galvanized. Improve

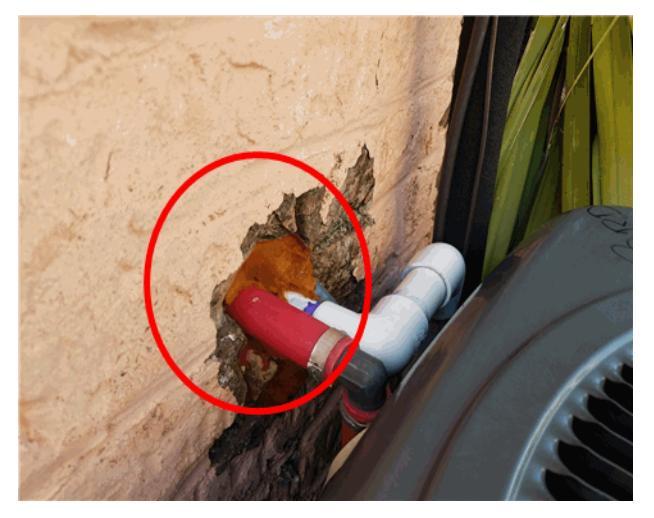
Spray foam exposed - This should be sealed with proper materials since foam can hold water

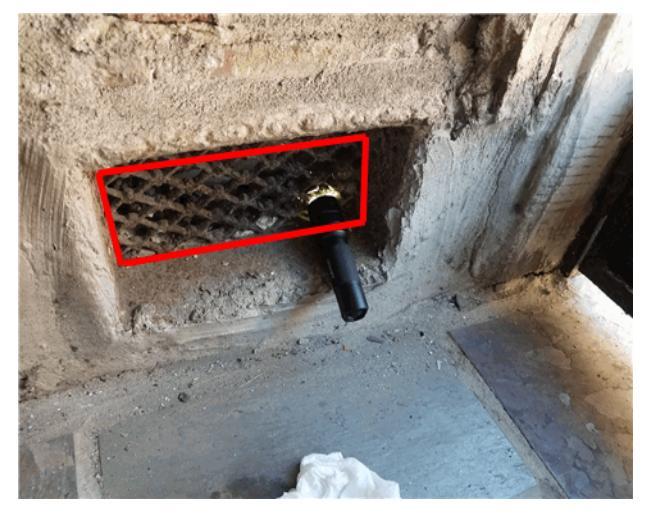
Crawlspace was not entered. Piers, framing and other components were not inspected. Recommend an access hatch sized 18" x 24" be installed to allow a full inspection. Photos have been provided as a reference but does include all wall surfaces and only highlight areas of concern. The evaluation and repairs should not be limited to only photos in this report but from a full and complete evaluation of the licensed contractor. Other photos have been provided taken from the New Orleans Historical Society which has put together a list of common defects and remedies. This is a great opportunity to learn about your unique home and characteristics.

Crawlspace was not entered. Piers, framing and other components were not inspected.

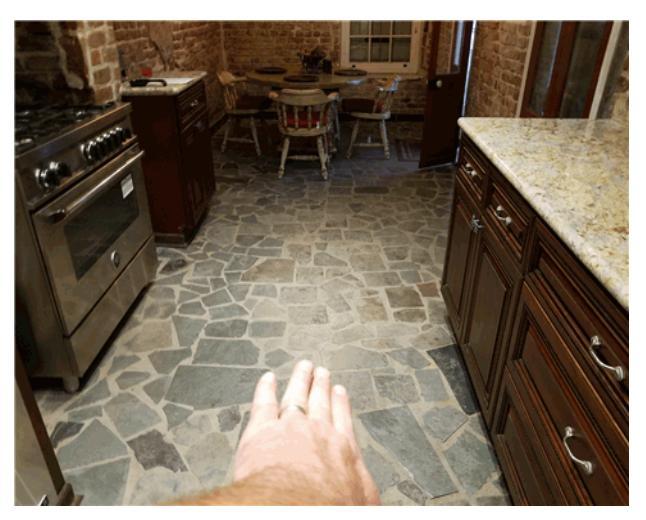
Typical sloping of floor system at back building

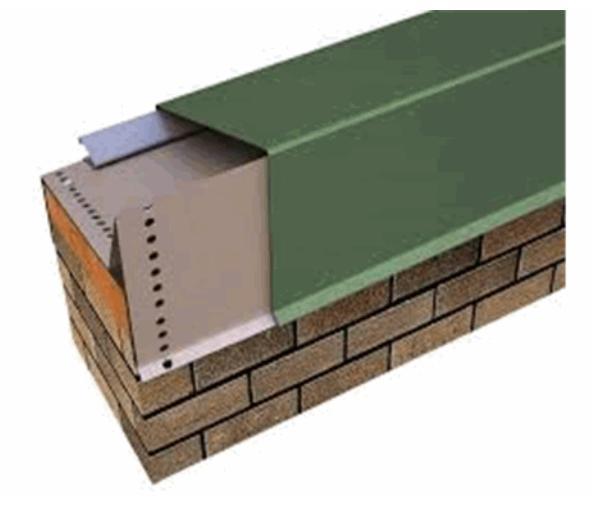
Cap Flashing for Parapet Walls

Flash and Counter Flash the Ends of Shed Roofs

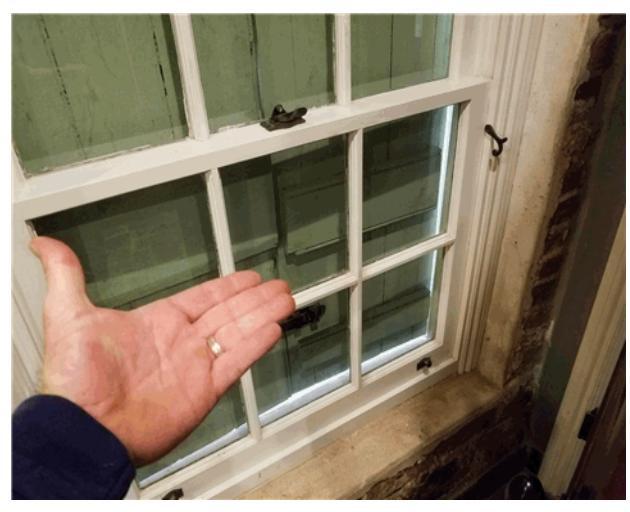
15) Interiors - Repair or Safety Conditions 1. All single pane - single hung wood framed windows at back building would not remain open. The sash cords were missing. Improve for safety

1. The windows at back building would not remain in the open position.

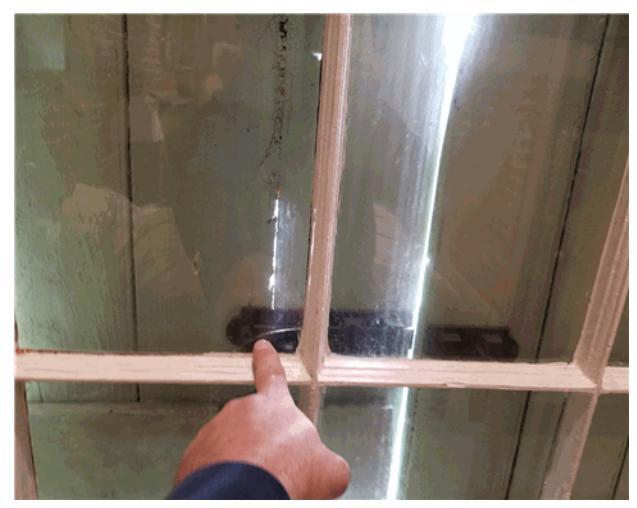
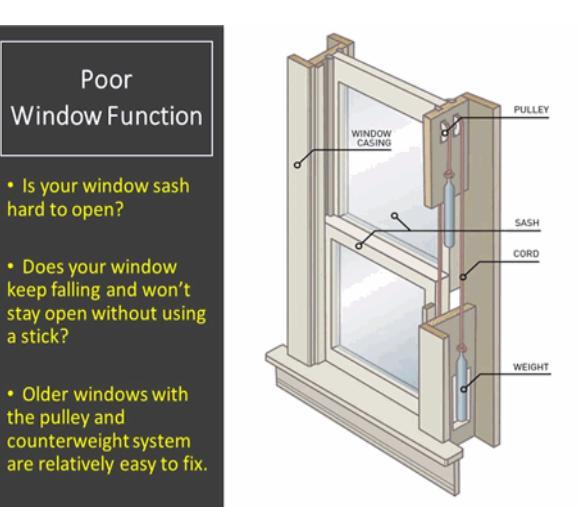
2. Cracked glass pane was observed @ back building overlooking courtyard. Recommend replacement

2. Cracked glass pane(s) were observed @ abck building.

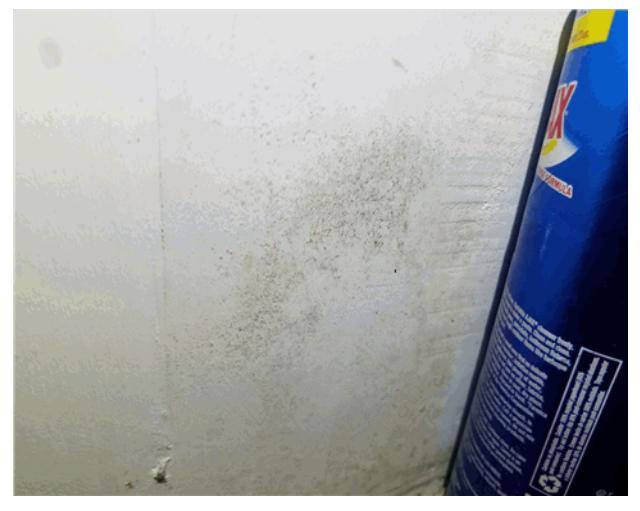
1. Suspected mold was noted to the interior wall inside the bath vanity sink of front home.

1. Suspected mold was noted to the interior wall inside the bath vainty sink of front home.

Cleaning and treatment with a fungicide is suggested to prevent the chances of microbial growth after repairs have been made and/or evaluated

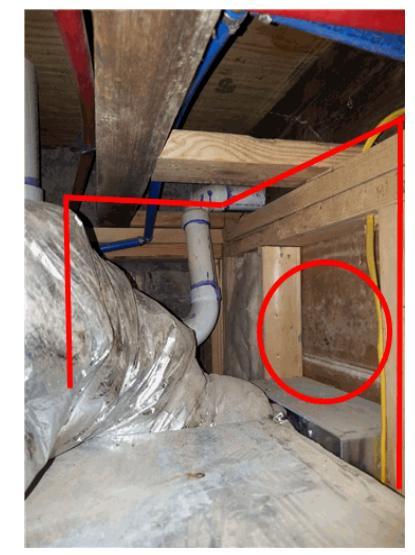
Growth noted on back of interior drywall as viewed in attic. Missing wall insulation

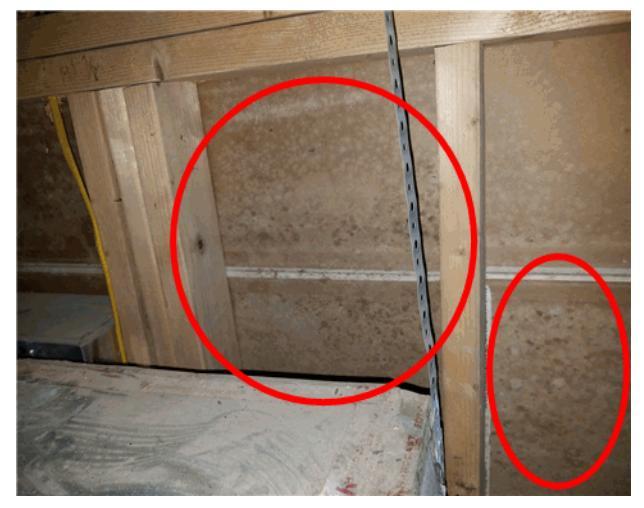
3. Further evaluation is needed at the main home 2nd floor attic including but not limited too - AC condensate drain lines where insulation was missing, stains and suspected mold growth noted to walls, floors, sub-floors, near plumbing drains, joist and air ducts that lay on the ground can create condensation and stains to floor. Strong musky odor noted in attic - walls were damp, moist, wet and more. A full and

3. Further evaluation is needed at the main home 2nd floor attic

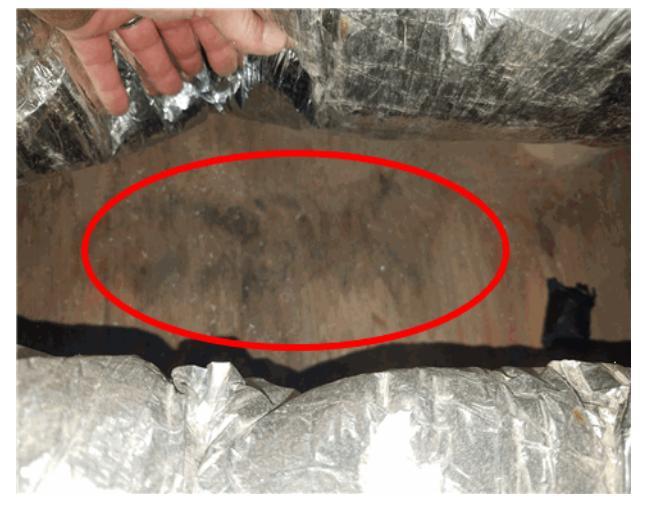
3. Further evaluation is needed at the main home 2nd floor attic

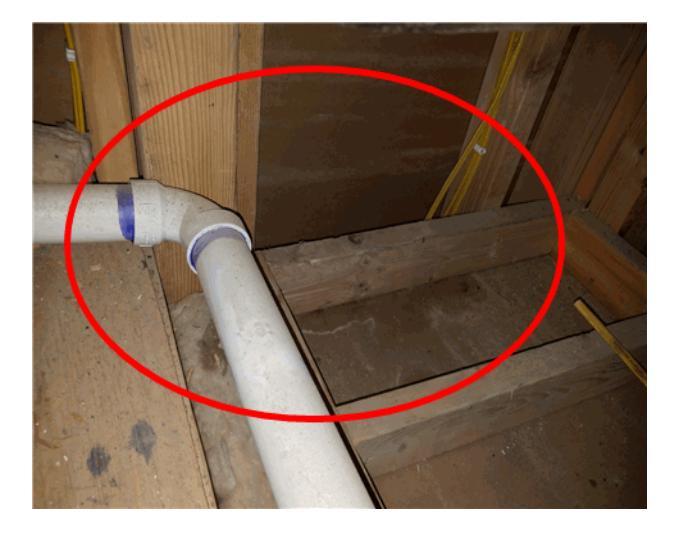
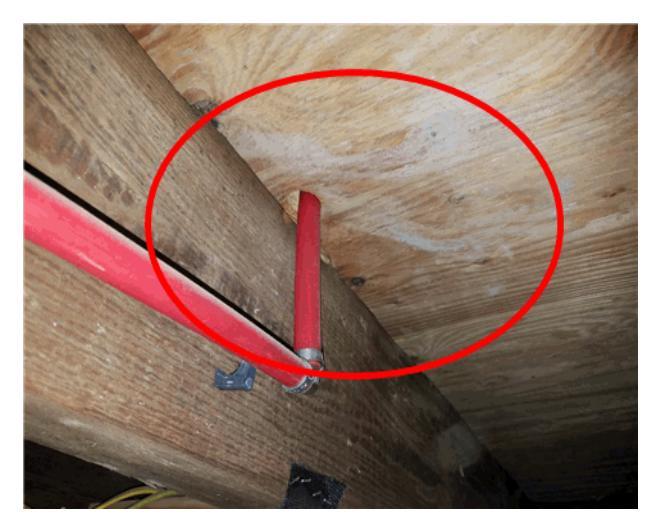
3. Further evaluation is needed at the main home 2nd floor attic

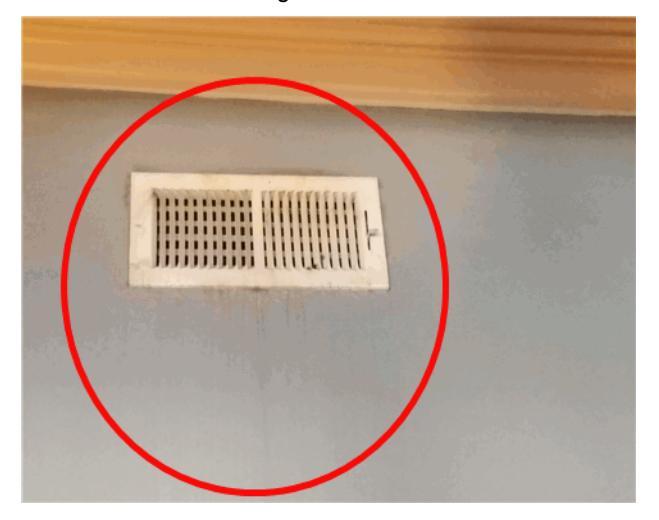
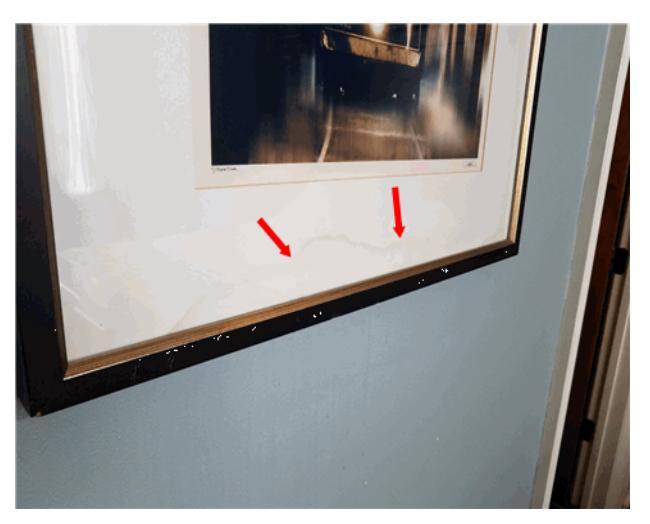
5. Many walls under air registers showed condensation drips with rust noted to metal air registers. Ar leaks and lack of insulation is the most common cause. Evaluate cause - repair damage

5. Many walls under air registers showed condensation drips with rust noted to metal air registers.

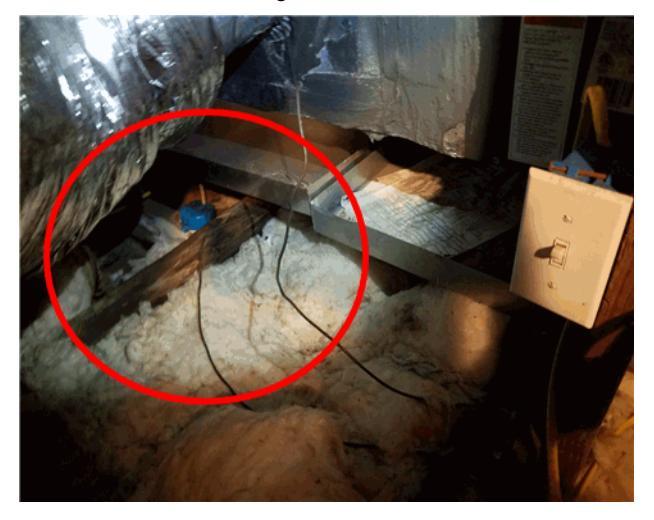
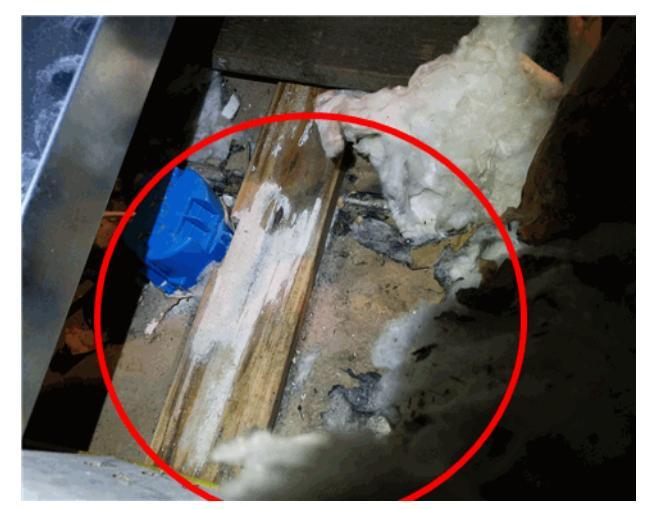
7. Evaluate and repair cause and damage to suspected mold growth in back building attic.

7. Evalaute and repair cause and damage to suspected mold growth in back building attic.7. Evalaute and repair cause and damage to suspected mold growth in back building attic.

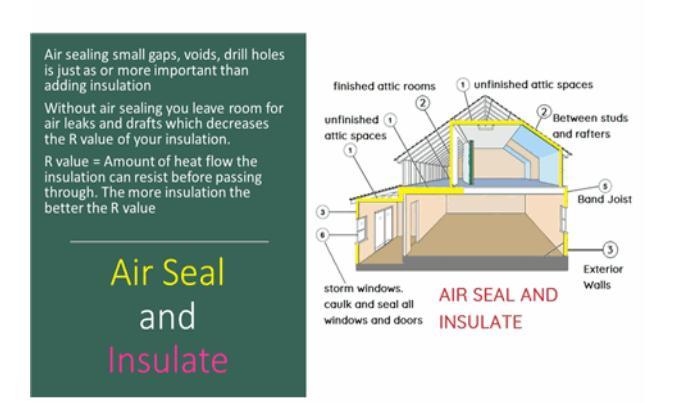
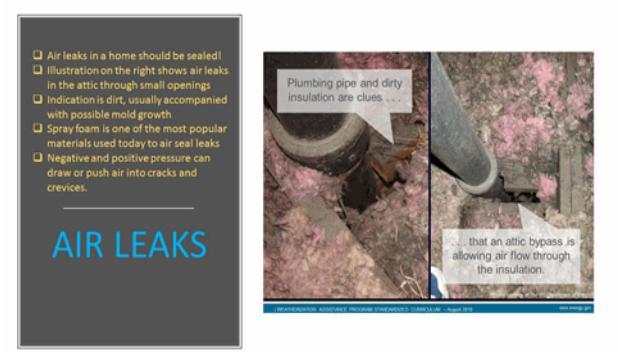
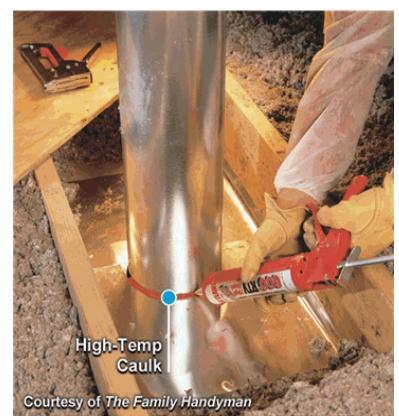
Notice the "suspected" mold growth is not in the duct system but on the drywall around the duct system · In most cases this is caused from lack of insulation and air sealing of the duct system.

If this was caused from water droplets being blown onto the ceiling the ceiling register would show growth and possible rust as well

Close off and Seal ALL opened chases. To Prevent possible mold (hot and cold air)

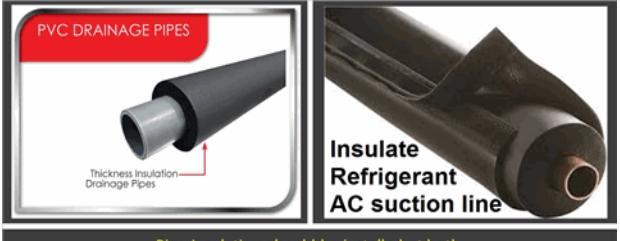
1. The insulation @ refrigerant line was partially missing @ all indoor evaporator coils. To prevent condensation from dripping onto ceilings and attics and to increase the efficiency - Suggest pipe insulation be added. (Refer to Interiors - Suspected Mold section)

1. The insulation @ refrigerant line was missing, torn @ indoor evaporator coils. 1st floor

Pipe Insulation should be installed at both <u>condensate drain line</u> and <u>AC refrigerant "suction" line</u> Installing insulation on both the condensate drain and refrigerant line prevents condensation from dripping, which can cause "suspected mold growth", water damage. Insulating the refrigeration line increases efficiency by preventing heat loss through evaporation.

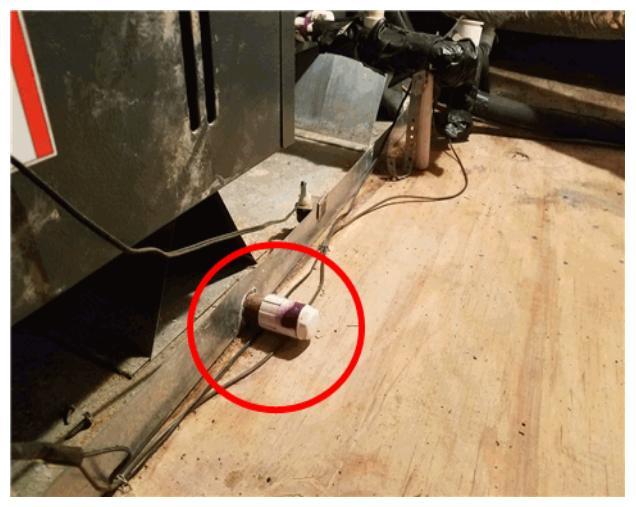
a. Emergency AC condensate drain pans in attics were all capped. Although safety float switches are installed @ both primary drain line and emergency pan - mechanical devices have a tendency to fail or pans warp and leak before raising floats. Recommend a drain line be installed & ran to a visible location. Even if the float switches did work - who wants to suck out standing water from the pan?

Emergency AC condensate drain pans in attics were all capped.

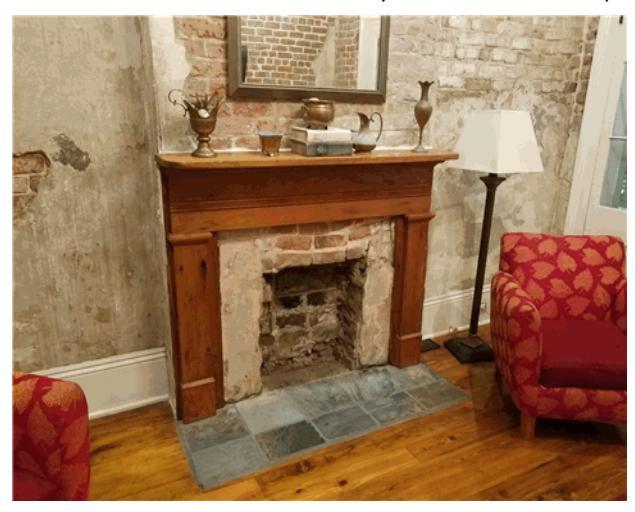
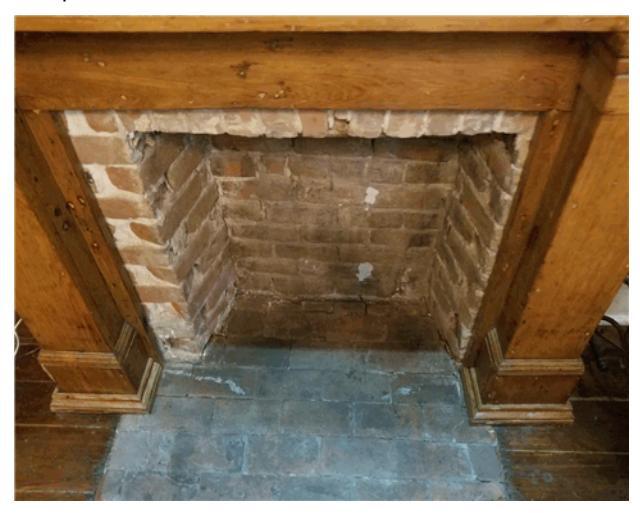
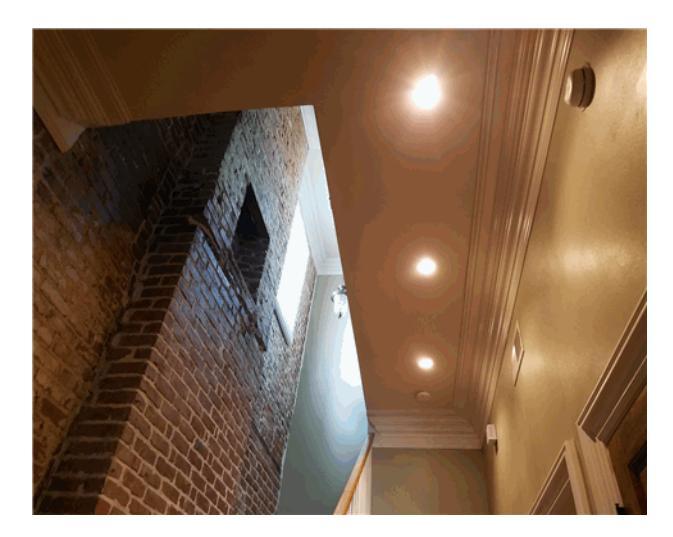
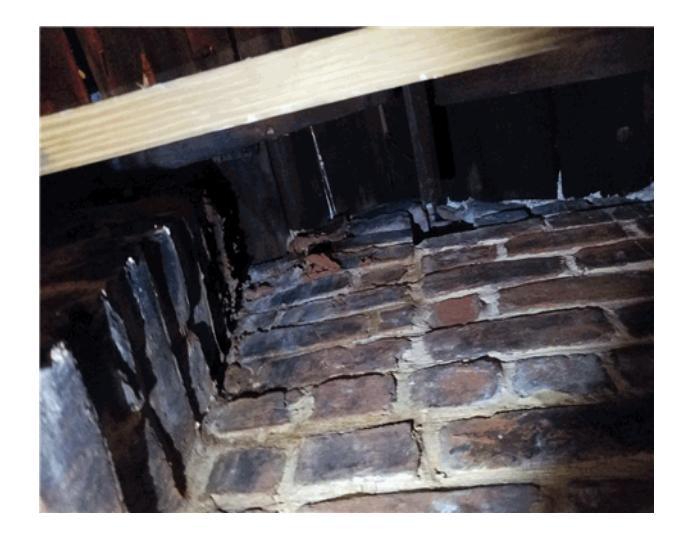
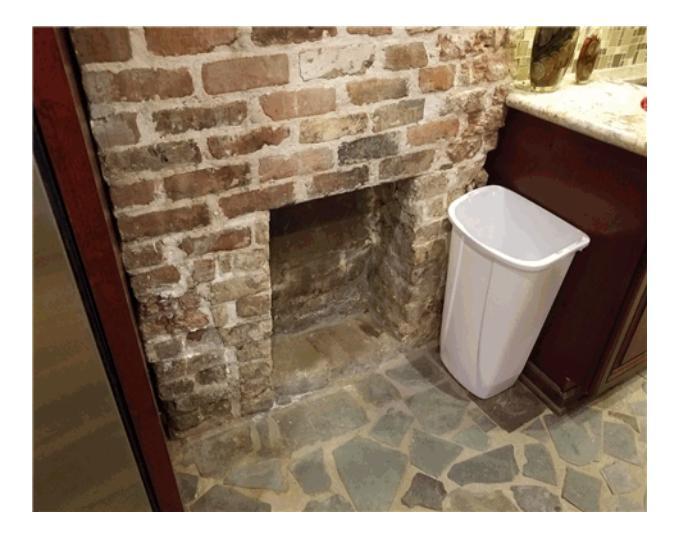
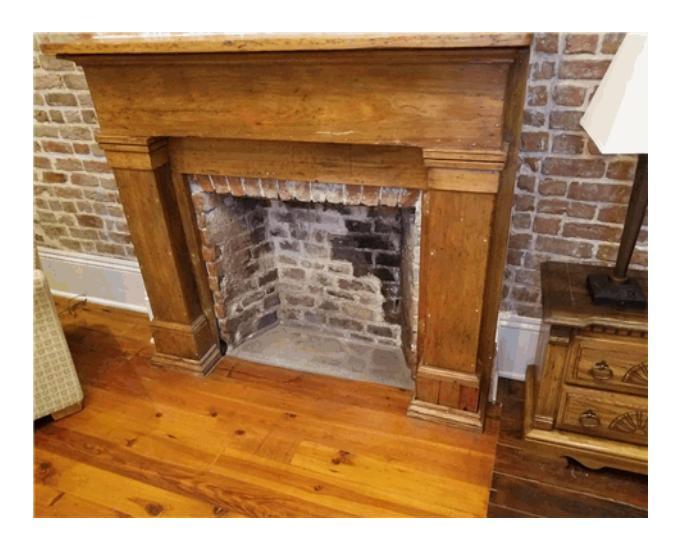
Fireplace and chimneys should not be used - appearance only. All brick chimneys should be properly capped @ roof to prevent moisture intrusion, along with improvements to tuck and point brick mortar joints where deterioration was visible. Seal all stucco and roof flashing where stated in this report under roof and structural systems. Evaluation -Improvements and repairs recommended

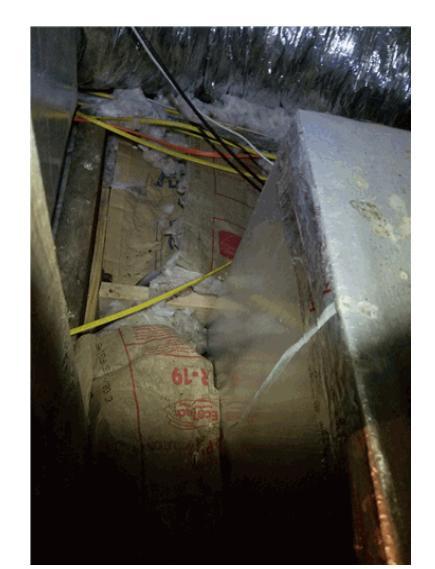
2. Some fiberglass batt insulation in the attic was installed with the vapor barrier 'paper" reversed. This condition may present moisture problems. Recommend reversing the insulation to allow vapor barrier (paper) to face the heated "controlled" space.

2. The insulation in the attic was installed with the vapor barrier 'paper' reversed.

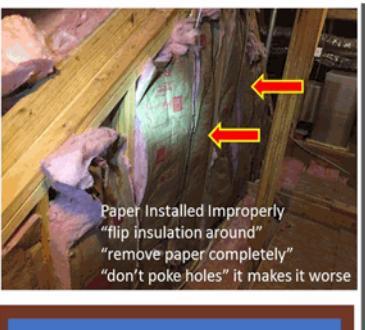
Vapor Barrier "Attic Walls" Vapor barriers "kraft paper" should always face the interior controlled space to prevent moieture

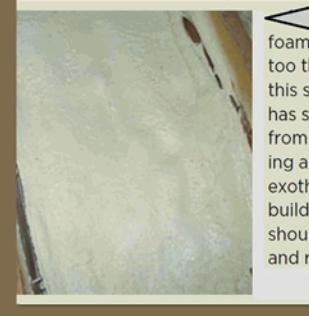
foam was sprayed too thick into this stud bay and has shrunk away from the framing as a result of exothermic heat build-up. The foam should be removed and replaced.

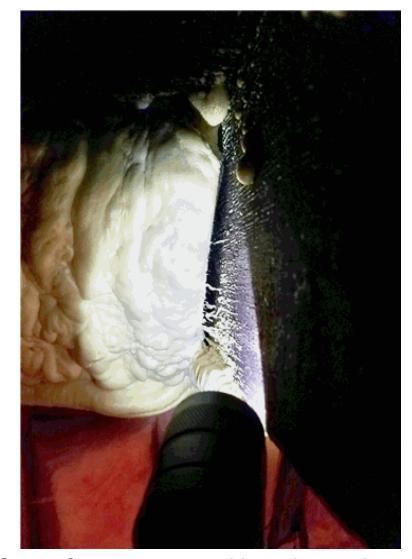
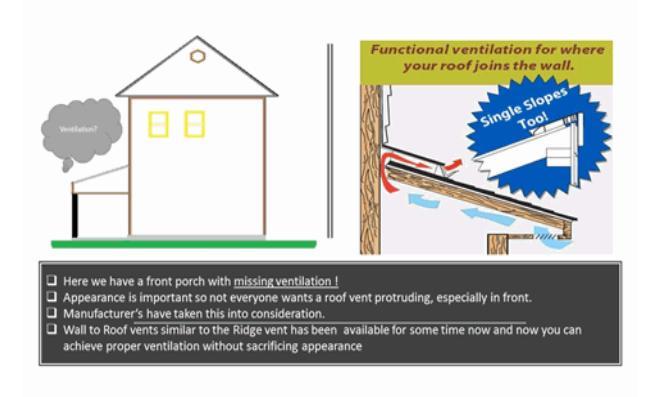
1. Spray foam was noted in attics and near eaves. Some separation was noted where foam pulled away from wood framing. This usually indicates moisture conditions or installation error when mixing A and B SPF. In some cases, the foam can separate from the substrate, because of the difference in temperature between the two materials "Humidity". When relative humidity levels are high, moisture can combine with the liquid components of rising foam and affect the foam's cell structure. Recommend removing separated sections and apply new coatings.

1. Spray foam was noted in attics and near eaves. Separation was noted where foam pulled away

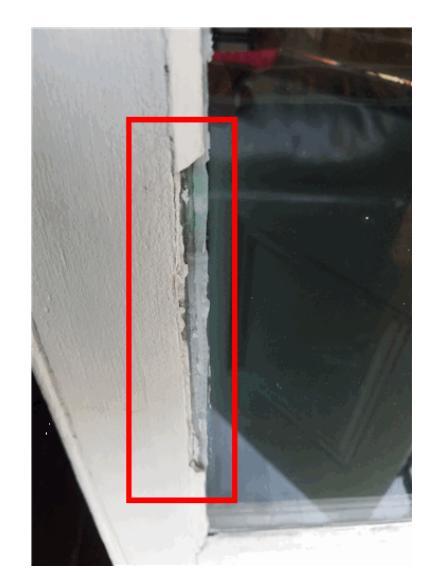
1. Horizontal bottom wood trim at front balcony shutter was lying on the wood deck, horizontal shutters missing and glazing on the windows / doors deteriorated. Improve as part of general maintenance

1. Wood trim at balcony shutter was lying on the wood deck, horizontal shutters missing and glazing

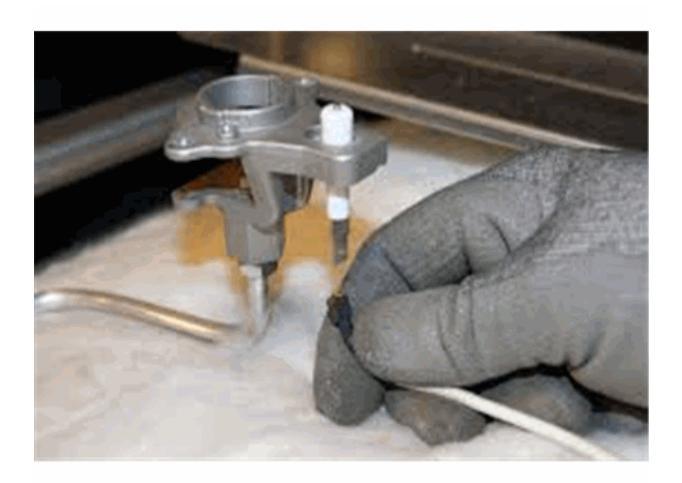
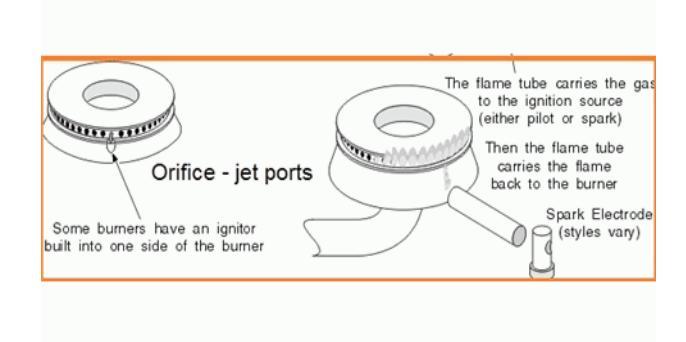
2. Multiple gas burners were inoperable @ gas range due to spark igniters. Using a Bid lighter - burner was manually tested. Uneven and distorted flame pattern noted. Recommend replacing igniter's and port - flame tube adjustments. Evaluate and repair

2. Uneven and distorted flame pattern noted
