November 10, 2009

RE: Crystal Pond Dam – Eastford
Emergency Repairs Construction Report

CRYSTAL POND ASSOCIATION
 AREA OF EMERGENCY REPAIR
 CRYSTAL LAKE DAM EMERGENCY REPAIRS

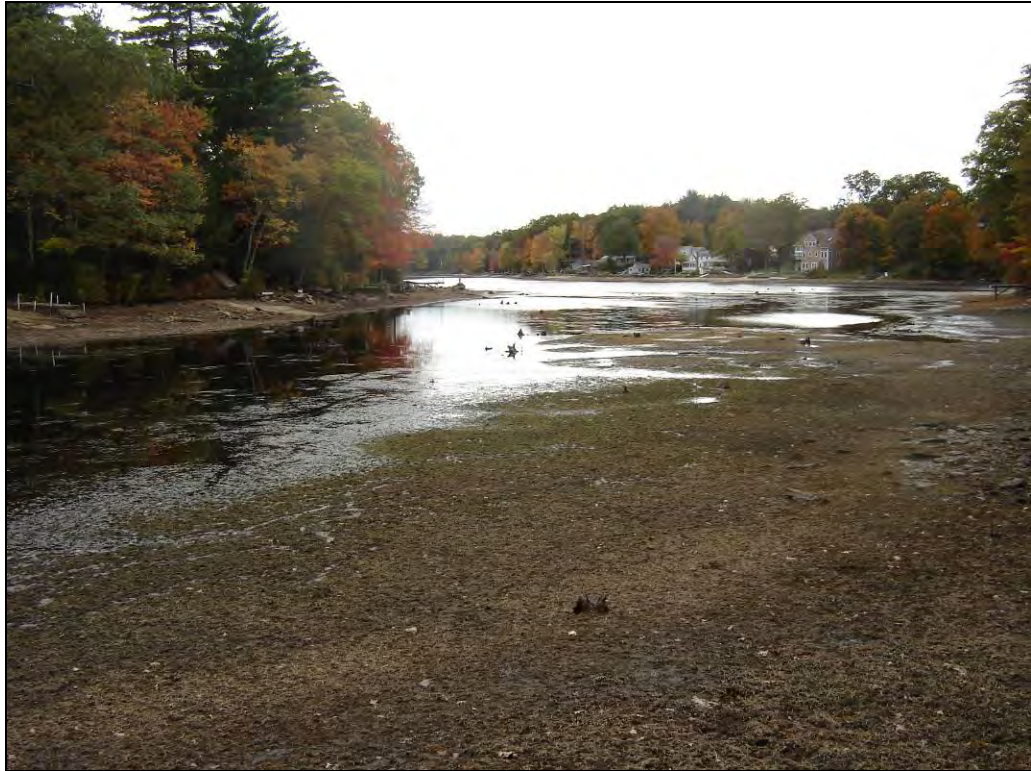
Photo 1: Overview of Crystal Pond from Dam. Pond is drawn down approx. 5 feet.

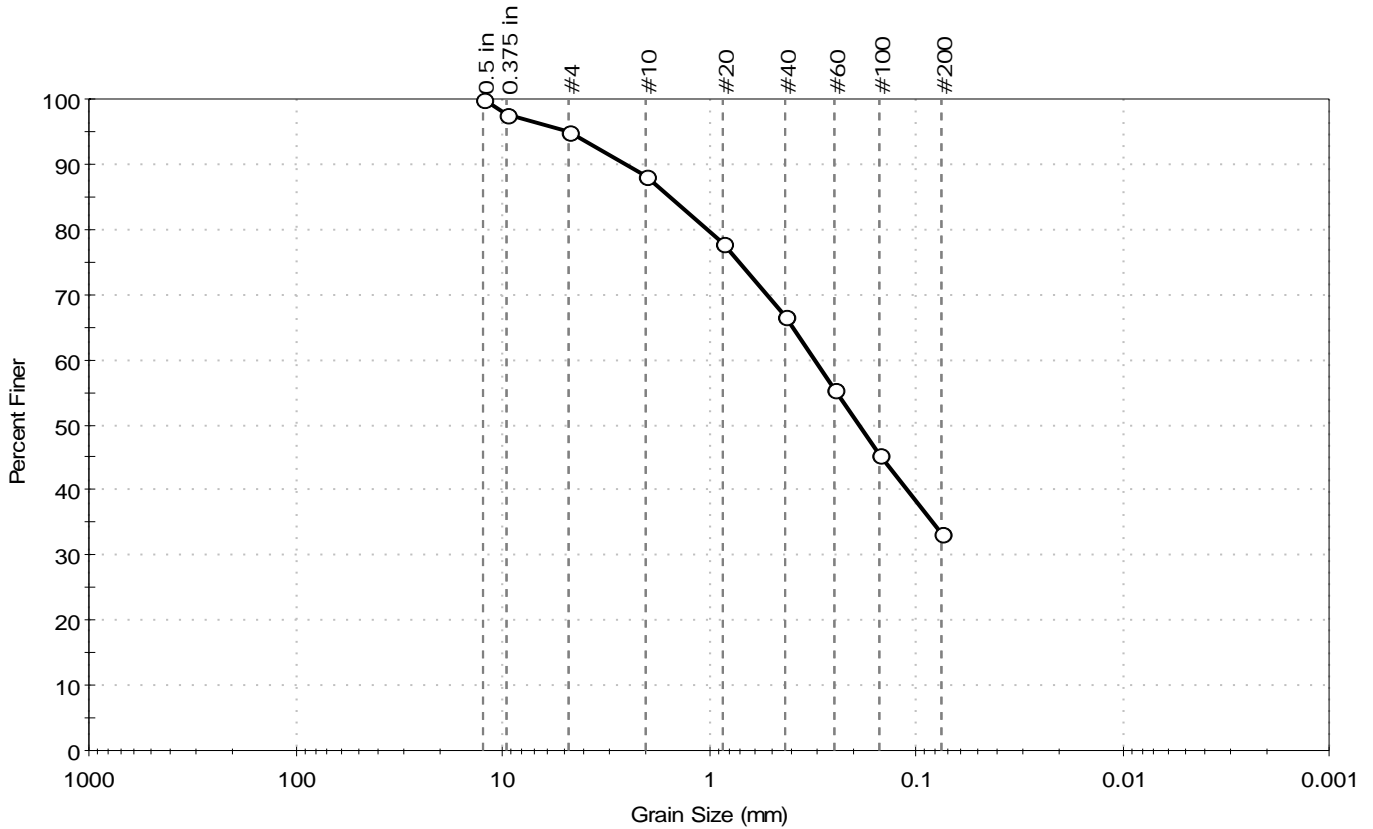
Client: Fuss & O'Neill, Inc	Project: Crystal Pond Dam Emergency Repairs	Location: Eastford, CT	Project No: GTX-9343
Boring ID: ---	Sample Type: bag	Tested By: jbr	Checked By: jdt
Sample ID: B-6	Test Date: 09/24/09	Test Id: 164536	
Depth: ---	Test Comment: ---	Sample Description: Moist, dark olive brown silty sand	Sample Comment: Organics noted in sample

% Cobble	% Gravel	% Sand	% Silt & Clay Size
---	5.1	61.7	33.2

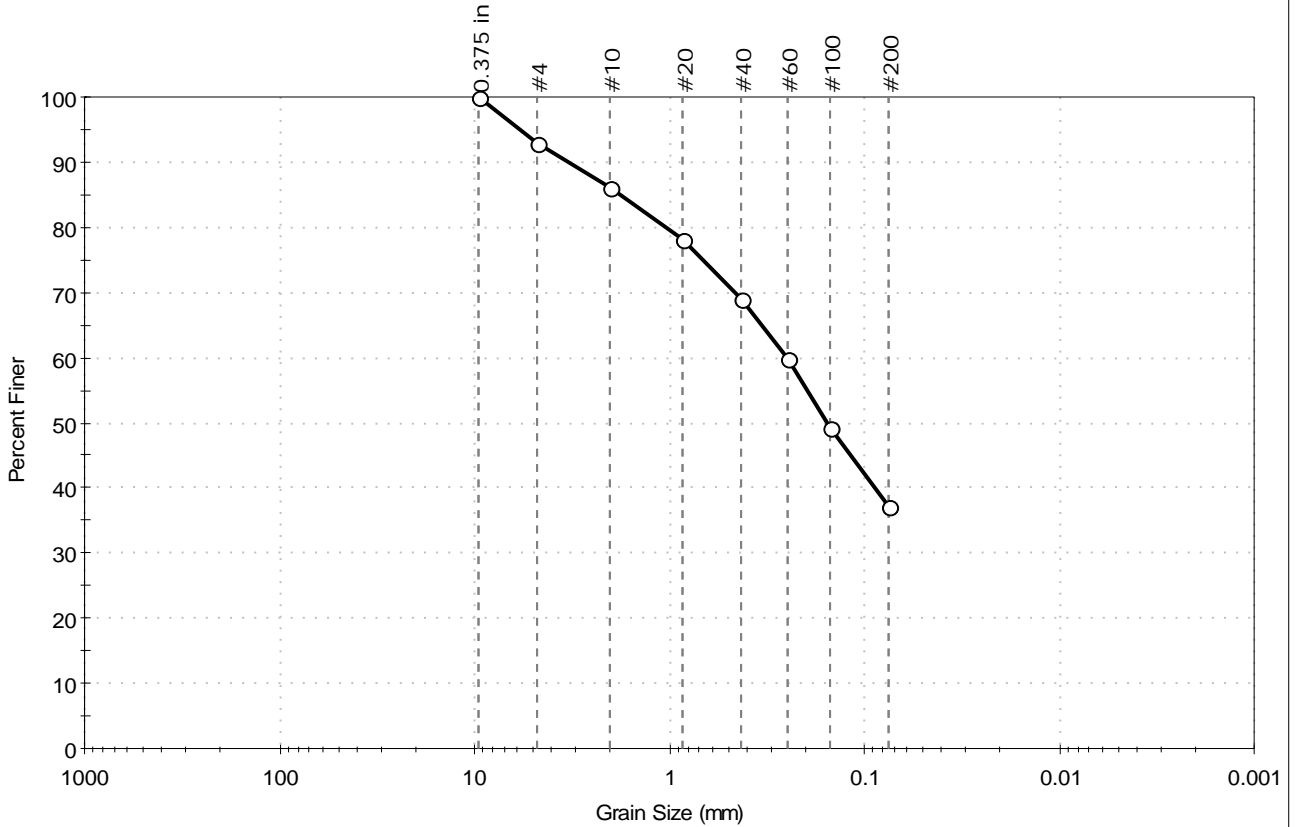
Client: Fuss & O'Neill, Inc	Project No: GTX-9343	
Project: Crystal Pond Dam Emergency Repairs		
Location: Eastford, CT		
Boring ID: ---	Sample Type: bag	Tested By: jbr
Sample ID: B-7	Test Date: 09/24/09	Checked By: jdt
Depth: ---	Test Id: 164537	
Test Comment: ---		
Sample Description: Moist, light brown silty sand		
Sample Comment: ---

% Cobble	% Gravel	% Sand	% Silt & Clay Size
---	7.1	55.7	37.2

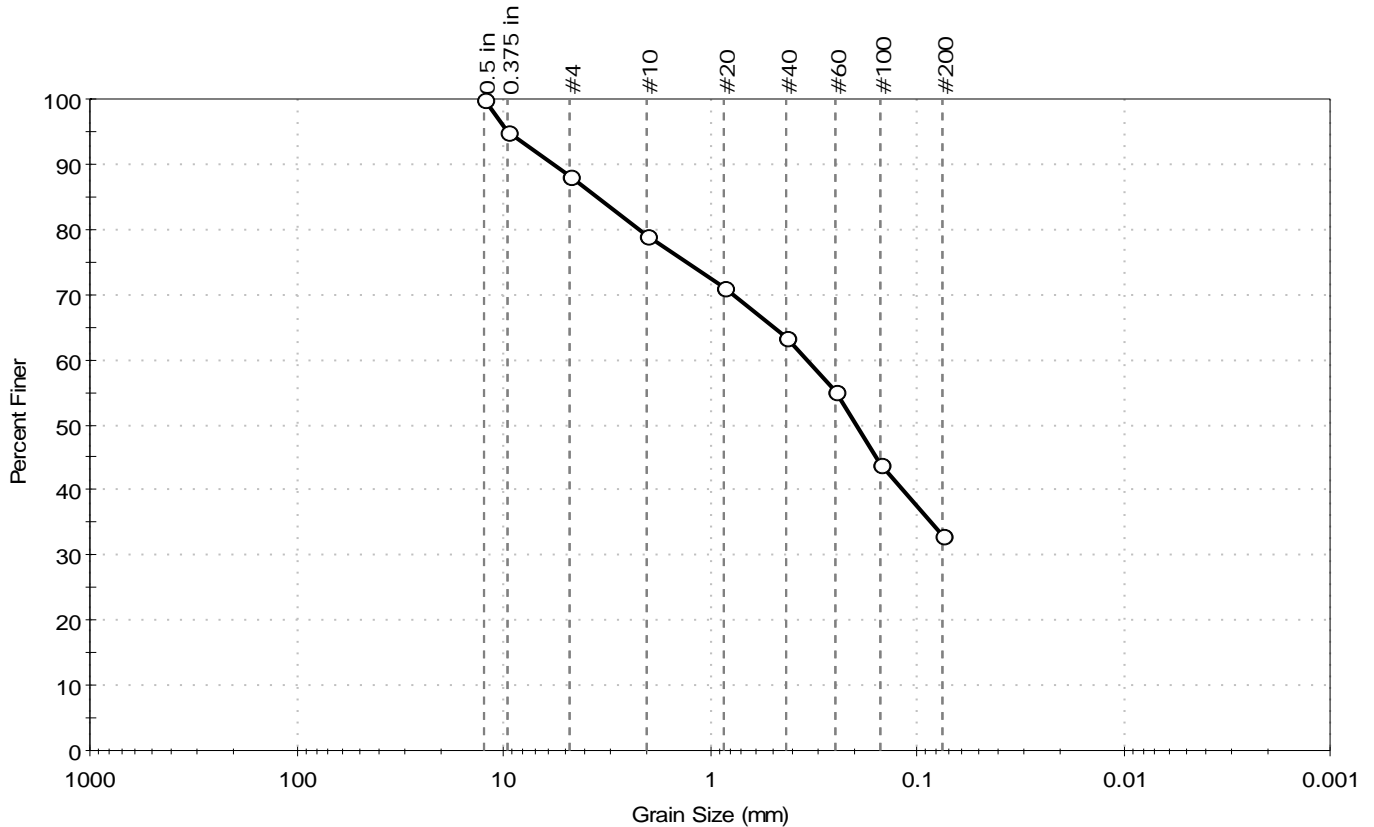
Client: Fuss & O'Neill, Inc	Project: Crystal Pond Dam Emergency Repairs	Location: Eastford, CT	Project No: GTX-9343
Boring ID: ---	Sample Type: bag	Tested By: jbr	Checked By: jdt
Sample ID: EC-A	Test Date: 10/05/09	Test Id: 165449	
Depth: ---	Test Comment: ---	Sample Description: Moist, yellowish brown silty sand	Sample Comment: ---

% Cobble	% Gravel	% Sand	% Silt & Clay Size
---	11.8	55.1	33.1

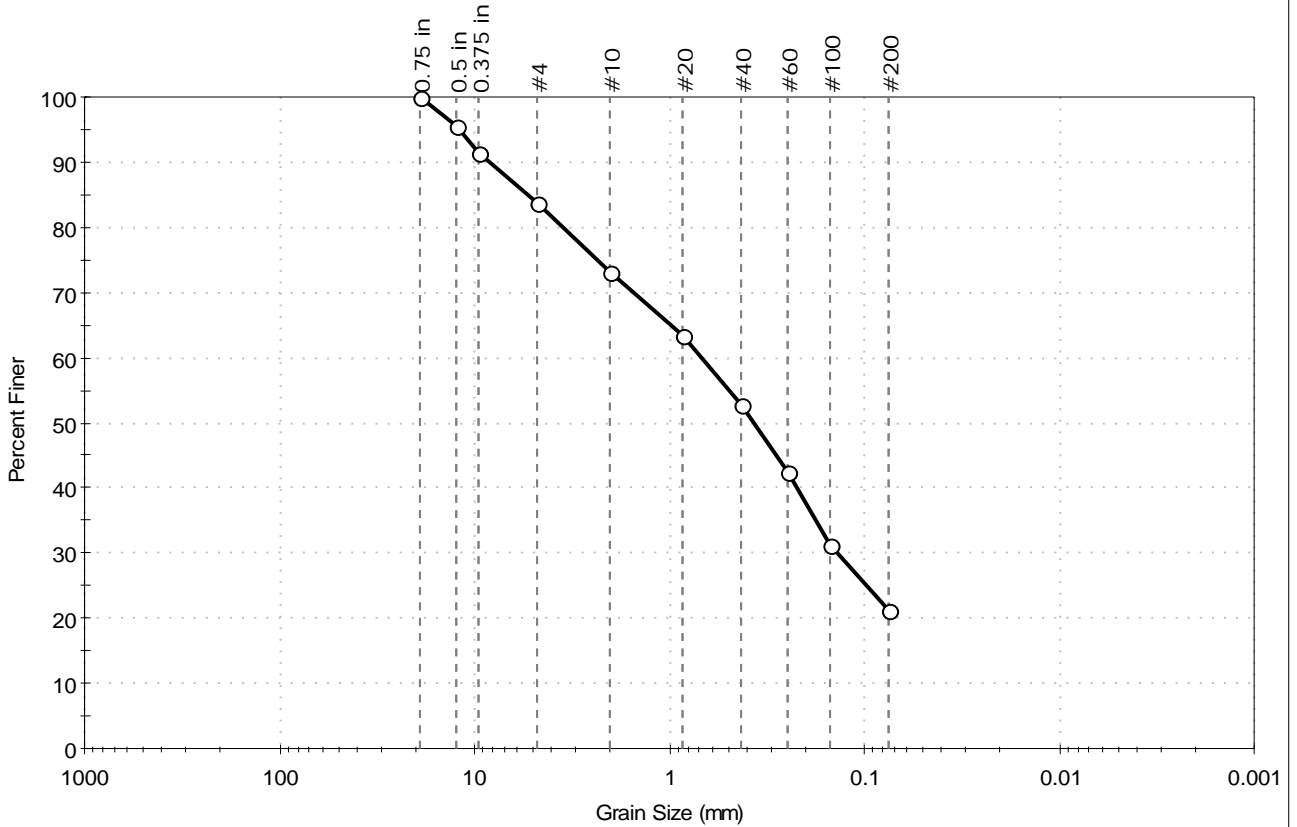
Client: Fuss & O'Neill, Inc	Project No: GTX-9343	
Project: Crystal Pond Dam Emergency Repairs		
Location: Eastford, CT		
Boring ID: ---	Sample Type: bag	Tested By: jbr
Sample ID: EC-B	Test Date: 10/05/09	Checked By: jdt
Depth: ---	Test Id: 165450	
Test Comment: ---		
Sample Description: Moist, light yellowish brown silty sand with gravel		
Sample Comment: ---

% Cobble	% Gravel	% Sand	% Silt & Clay Size
---	16.3	62.5	21.2
