## Saddlebrooke at Rock Creek HOA *Superior, CO*

Report #: 33508-3  
Beginning: January 1, 2025  
Expires: December 31, 2025

# RESERVE STUDY

## Update "With-Site-Visit"

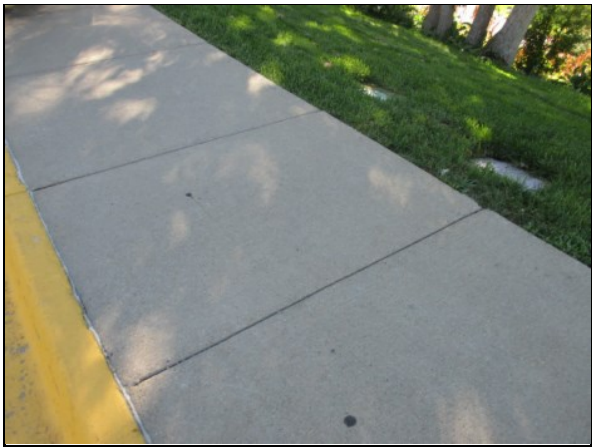
**Comp #: 21090 Concrete Walkways - Repair - 5%**

Useful Life:  
5 years

Remaining Life:  
3 years

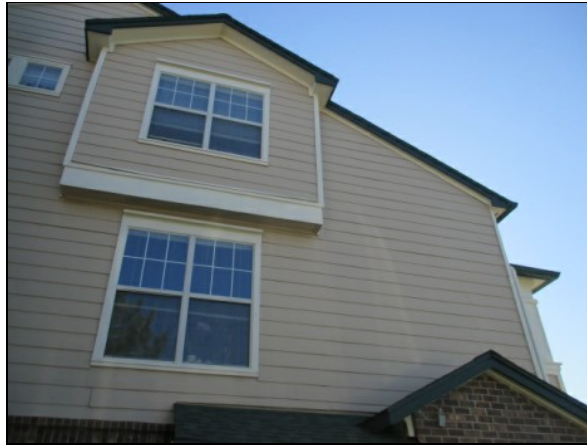
**Comp #: 23390 Fiber Cement Siding - Replace****Quantity: ~ 181200 GSF**

Comments: The surfaces appeared in fair condition. No broken or missing sections observed. Minimal evidence of cracking, fading, and peeling observed. Siding was horizontal clapboard. Surface was painted. Actual material of siding was not confirmed since we conducted only a limited visual review. Siding is believed to be fiber cement. The largest manufacturer of fiber cement siding is James Hardie Building Products, Inc., and [www.jameshardie.com](http://www.jameshardie.com) is a good source of information for best practices related to installation, care and maintenance of the product. At this time, there is no well-defined limit to the useful life of fiber cement siding. The client should review any available warranty documents to ensure proper steps are taken to maintain applicable warranties. As the product ages, the client should conduct more detailed inspections beyond the scope of the visual inspection conducted during this engagement. Currently Hardie offers the choice of a 30-year non-prorated. James Hardie recommended maintenance tips include: • Patching - Dents, chips and cracks can be filled using a good quality cement patching compound (acrylic mortar patch) which can be found at your local Home Center or Hardware Store. • Mold/Mildew - Remove using a commercial mold/mildew remover. Consult your paint manufacturer's recommendations before applying any mold or mildew remover. • Loose Siding or Soffit- Re-nail using a properly-sized corrosion-resistant fastener. • Caulk Replacement - When sealant is in need of replacing, carefully remove existing caulk and replace with a high quality, paintable latex caulk. For best results use a latex caulk that complies with ASTM-C- 834, ASTM C920 or better. Caulking should be applied in accordance with the caulking manufacturer's written installation instructions. • Paint Maintenance - Remove any damaged, chipped or cracked paint. Prior to repainting make sure that the surface area is properly cleaned and prepared. Repaint immediately using 100% acrylic paint. • Note: For best results please refer to your paint manufacturer's written specifications for application rates and required topcoats or refer to James Hardie's Technical Bulletin, No. S-100. The underlying waterproofing will degrade over time and may require replacement. No view of underlying waterproofing was part of our limited visual review. The client should plan for eventual replacement at roughly the time-frame below. Inspect and repair as needed using operating and maintenance funds.

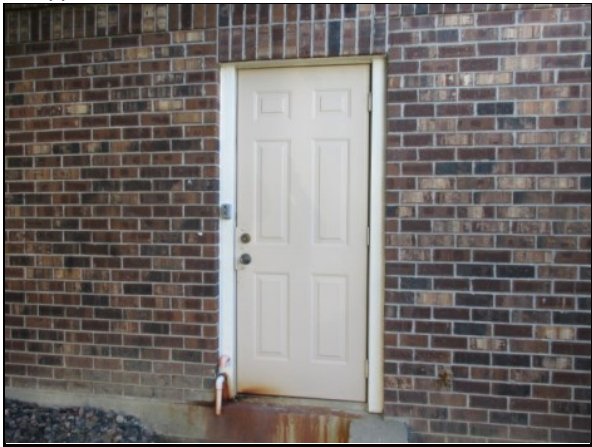
**Comp #: 23480 Utility Doors - Replace**

Comments: Utility doors determined to be in fair condition typically exhibit more signs of wear and tear and noticeable aesthetic decline. Doors are still functional. At this stage framework sometimes has issues with rust and expansion causing doors to stick. Utility doors should have a very long useful life expectancy in most cases. However occasional replacements may be required especially for doors located in more exposed areas. Inspect periodically and repair as needed to maintain appearance security and operation with maintenance funds. Should be painted along with building exteriors or other painting/waterproofing projects to preserve appearance and prolong useful life. Based on our experience with comparable properties we recommend planning for ongoing partial replacements at the approximate interval shown here.

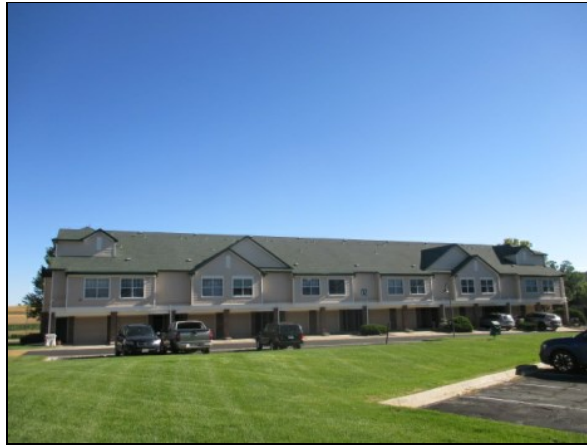
**Comp #: 23570 Roof: Composition Shingle - Replace****Quantity: ~ 243200 GSF**

Open valleys were observed. Ventilation (the lack of which can greatly reduce the roof's useful life) was observed at the eave and ridge. Eave venting consisted of soffit holes between the rafters. Ridge venting appeared to be provided by roof jacks. Visible portions of roof flashing were observed at the rake, headwall, and sidewall. No portion of flashing was observed at the rake. Diverter (kick-out) flashing was not observed. Gutters blocked the view of eaves, so eave flashing was not confirmed. Debris was not observed on the roof surface. Asphalt shingle roofs determined to be in fair condition and typically exhibit normal signs of wear and deterioration, including some loss of granule cover, and light to moderate curling/lifting, especially in most exposed areas. Overall believed to be aging normally. A reserve study conducts only a limited visual review, and many of the critical waterproofing and ventilation items of the roof are not readily viewable. For a full evaluation have a professional roof consultant/contractor perform a thorough up-close survey of your entire roof system, including attic inspection (if any). Costs below factors replacement with an architectural grade laminated shingle. As routine maintenance, many manufacturers recommend inspections at least twice annually (once in the fall before the snow season and again in the spring) and after large storm events. Promptly replace any damaged/missing sections or any other repair needed to ensure waterproof integrity of roof. Keep roof surface, gutters, and downspouts clear and free of debris. At the time of re-roofing, we recommend that you hire a professional consultant to evaluate the existing roof and specify the new roof materials/design, provide installation oversight. We recommend that all clients hire qualified consultants whenever they are considering having work performed on any building envelope (waterproofing) components including: roof, walls, windows, decks, exterior painting, and caulking/sealant. There is a wealth of information available through Roofing Organizations such as: National Roofing Contractors client (NRCA) <http://www.nrca.net>. Asphalt Roofing Manufacturers client (ARMA) <http://www.asphaltroofing.org/> Roof Consultant Institute (RCI) <http://www.rci-online.org>

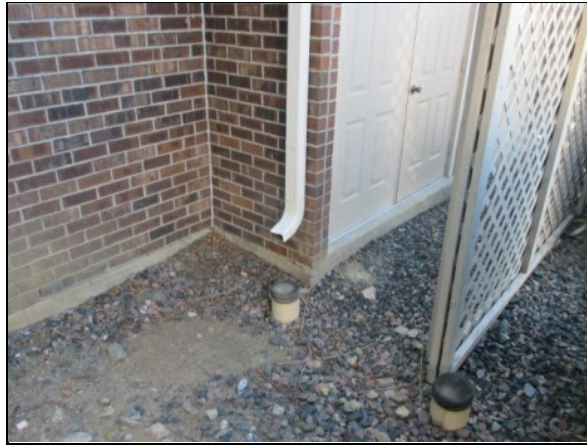
**Comp #: 23650 Gutters/Downspouts - Replace**

Comments: Gutters and downspouts determined to be in fair condition typically exhibit some normal wear and tear but drainage away from the roof and building appears to be adequate. Generally believed to be aging normally. Gutters and downspouts are assumed to be functioning properly unless otherwise noted. As routine maintenance inspect regularly keep gutters and downspouts free of debris. If buildings are located near trees keep trees trimmed back to avoid accumulation of leaves on the roof surface which will accumulate in the gutters and increase maintenance requirements while reducing life expectancy. Repair or replace individual sections as needed as an Operating expense. We generally recommend that the gutters and downspouts be replaced when the roof is being resurfaced/replaced. National Roofing Contractor client (NRCA) roofing standard includes installing eave flashings at the gutters. We suggest to plan for total replacement of gutter and downspouts at the same intervals as roof replacement for cost efficiency. Unless otherwise noted costs shown here assume replacement with similar type as are currently in place.

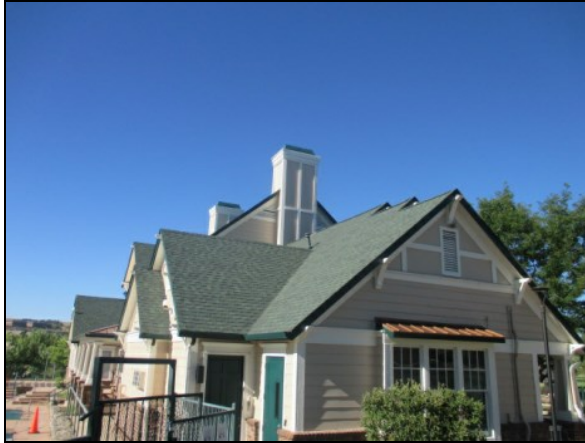
**Comp #: 23710 Chimney Covers/Flue Caps - Replace**

Should be inspected maintained and repaired periodically to ensure good function. Inspect periodically for leaks around frame and repair as needed. In general costs for replacement are expected to be included in the client's Operating budget. No recommendation for Reserve funding at this time. However any repair and maintenance or other related expenditures should be tracked and this component should be re-evaluated during future Reserve Study updates based on most recent information and data available at that time. If deemed appropriate for Reserve funding component can be included in the funding plan at that time.

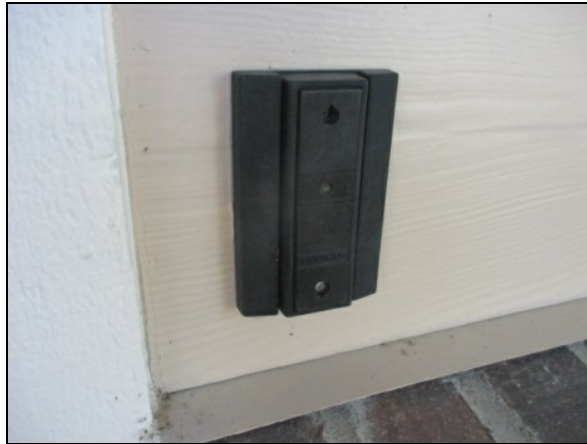
**Comp #: 25010 Fob Reader System - Replace****Quantity: ~ (3) Units**

Minimal or no subjective/aesthetic value for this component. Useful life is based primarily on normal expectations for service/performance life in this location. Unless otherwise noted remaining useful life expectancy is based primarily on original installation or last replacement/purchase date our experience with similar systems/components and assuming normal amount of usage and good preventive maintenance. Card/fob reader devices were/were observed to be functional during site inspection. Due to use exposure and advancements in technology plan to replace devices and control system at the approximate interval shown here. Individual readers can often be replaced as an Operating expense due to damage or localized failures. To ensure a functional compatible system and obtain better pricing plan on replacing all devices together as one project.

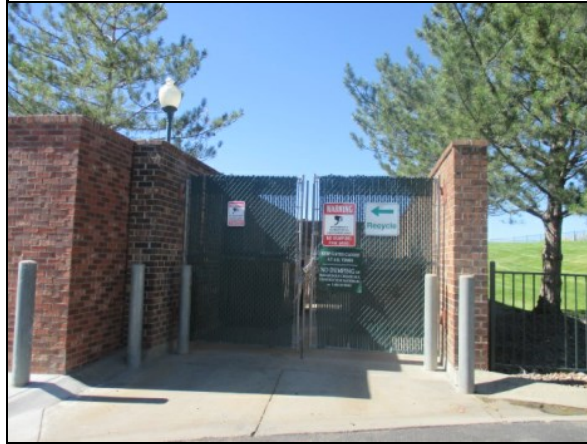
**Comp #: 25011 Trash Enclosure Keypad System - Replace****Quantity: ~ (1) Unit**

Comments: Access/intercom system was not inspected internally during site inspection. Should be checked and repaired as needed by servicing vendor as routine maintenance. Individual components can often be replaced for relatively low cost as an Operating expense. Plan for complete replacement at the approximate interval shown here for functional and aesthetic considerations.

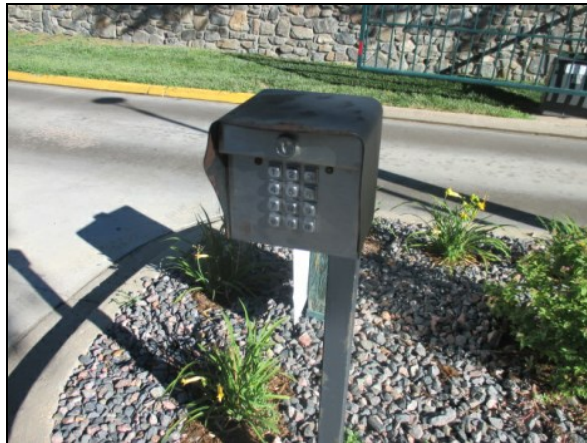
**Comp #: 25012 Entry Keypad System - Replace****Quantity: ~ (1) Unit**

Comments: Access/intercom system was not inspected internally during site inspection. Should be checked and repaired as needed by servicing vendor as routine maintenance. Individual components can often be replaced for relatively low cost as an Operating expense. Plan for complete replacement at the approximate interval shown here for functional and aesthetic considerations.

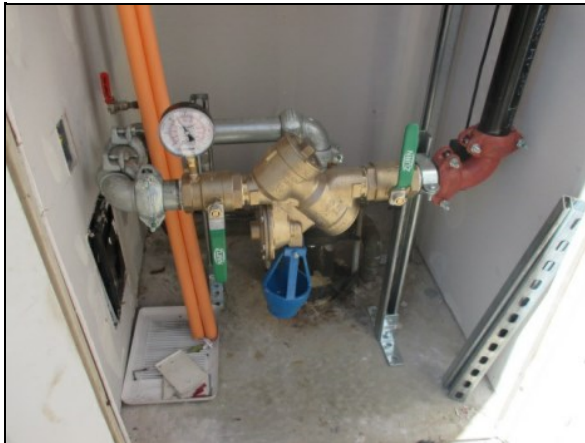
**Comp #: 25220 Fire Riser Heating – Replace****Quantity: ~ (48) Units**

Comments: In general costs related to this component are expected to be included in the client's Operating budget. No recommendation for Reserve funding at this time. However any repair and maintenance or other related expenditures should be tracked and this component should be re-evaluated during future Reserve Study updates based on most recent information and data available at that time. If deemed appropriate for Reserve funding component can be included in the funding plan at that time.

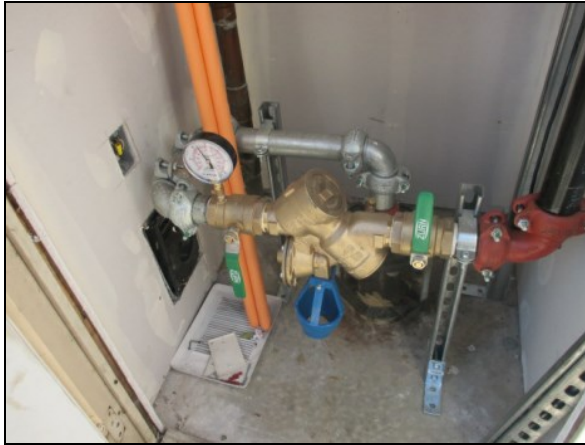
**Comp #: 25280 Fire Riser PRVs - Replace**

Comments: Expect eventual need for tear down and rebuild (more cost-effective than buying new units) at roughly the interval below. Treat smaller repair / replacement below the reserve funding threshold (< 1% of the annual operating expenses, excluding reserves) as general maintenance item(s) within operating budget.

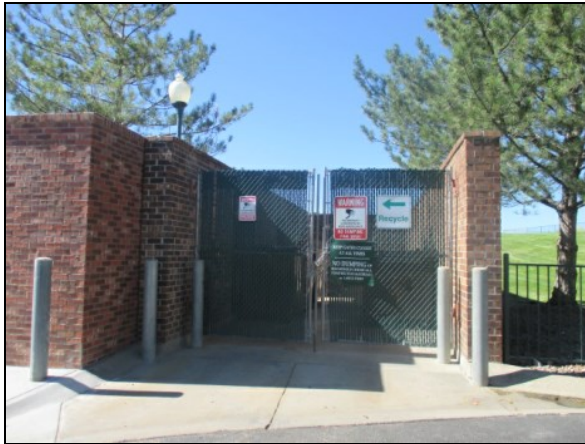
**Comp #: 25310 Trash Compactors - Replace**

Comments: Units are leased. No reserve funding is recommended.

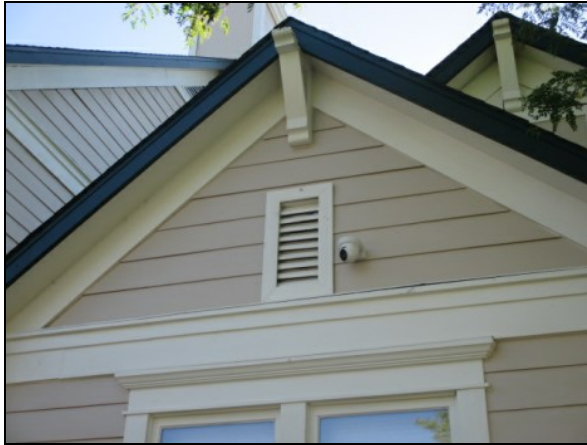
**Comp #: 25330 Surveillance System–Upgrade/Replace**

Per the client, this equipment is leased. No reserve funding is recommended.

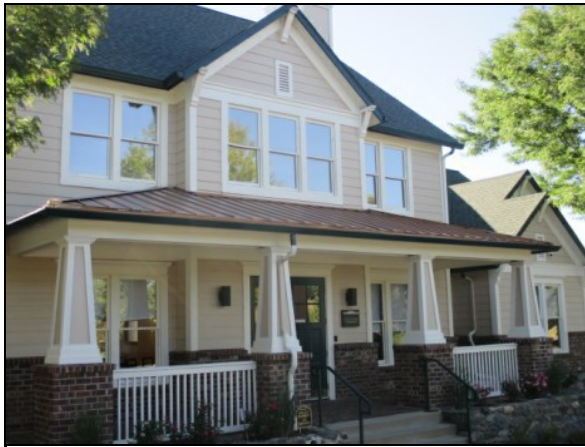
**Comp #: 23600 Clubhouse Roof: Metal - Replace****Quantity: ~ 590 GSF**

Typically metal roofs are either Pro-Panel sealed roofs or Standing Seam roofs. Pro Panel roofs are installed with exposed metal screws and fasteners while Standing Seam will snap lock panels over the mechanical seam with no penetrations to the underlayment. Advantages of metal roofs include long life expectancies with relatively low need to repair. Metal roofing is typically a long-lived component assuming it was properly installed and is properly maintained. As routine maintenance many manufacturers recommend inspections at least twice annually (once in the fall before the rainy season and again in the spring) and after large storm events. Promptly replace any damaged/missing sections or conduct any other repair needed to ensure waterproof integrity of roof. We recommend having roof inspected in greater detail (including conditions of sub-surface materials) by an independent roofing consultant prior to replacement. There is a wealth of information available through organizations such as the Roof Consultant Institute <http://www.rci-online.org> and the National Roofing Contractors client (NRCA) <http://www.nrca.net/>. If the roof has a warranty be sure to review terms and conduct proper inspections/repairs as needed to keep warranty in force.

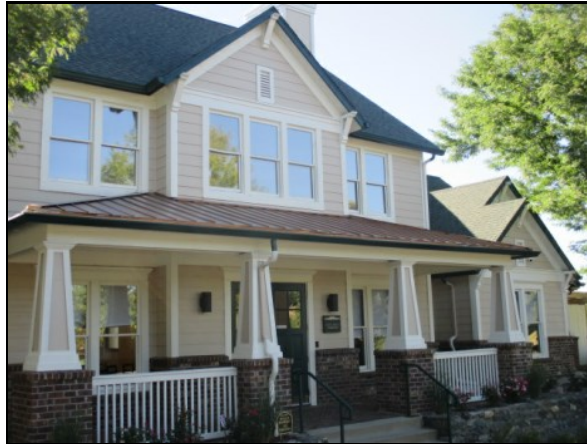
**Comp #: 27060 Clubhouse Windows - Replace**

Comments: Windows determined to be in fair condition typically exhibit normal signs of wear for their age, including more surface wear to framework and hardware, but no advanced corrosion or other concerns. At this stage, windows and doors are believed to be functional and aging normally, but more advanced technology may be available. Windows were metal frames with horizontal sliders, and fixed operation. Inspect regularly, including sealant, if any, and repair as needed. Proper sealant/caulking is critical to keeping water out of the walls, and preventing water damage. With ordinary care and maintenance, useful life is long but difficult to predict. Many factors affect useful life including quality of window installed, waterproofing flashing details, exposure to wind driven rain. In many cases, windows are replaced on an ongoing basis to select areas as-needed rather than to an entire building at one time. This component should be re-evaluated as the building ages and more problems develop, and funding recommendations should be adjusted accordingly. An allowance for partial replacements may be warranted if certain windows are more deteriorated than others. Consult with vendors to ensure replacement windows are compliant with all applicable building codes. Note there are many types of windows available in today's market and costs can vary greatly.

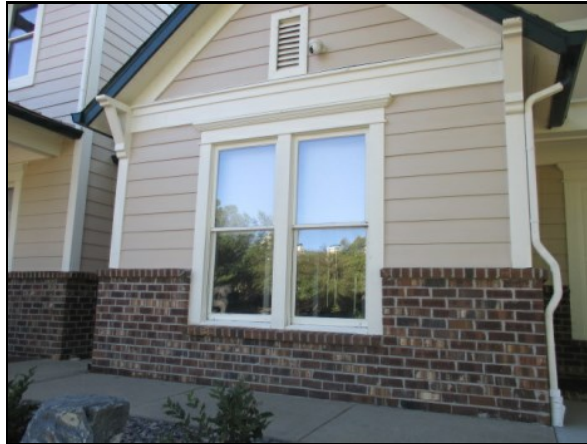
**Comp #: 27061 Clubhouse Windows - Replace (2023)**

History: Replaced in 2023, per the client

Comments: Windows determined to be in good condition typically exhibit normal signs of wear for their age, including more surface wear to framework and hardware, but no advanced corrosion or other concerns. At this stage, windows and doors are believed to be functional and aging normally, but more advanced technology may be available. Windows were vinyl with horizontal sliders and fixed operation. Inspect regularly, including sealant, if any, and repair as needed. Proper sealant/caulking is critical to keeping water out of the walls, and preventing water damage. With ordinary care and maintenance, useful life is long but difficult to predict. Many factors affect useful life including quality of window installed, waterproofing flashing details, exposure to wind driven rain. In many cases, windows are replaced on an ongoing basis to select areas as-needed rather than to an entire building at one time. This component should be re-evaluated as the building ages and more problems develop, and funding recommendations should be adjusted accordingly. An allowance for partial replacements may be warranted if certain windows are more deteriorated than others. Consult with vendors to ensure replacement windows are compliant with all applicable building codes. Note there are many types of windows available in today's market and costs can vary greatly.

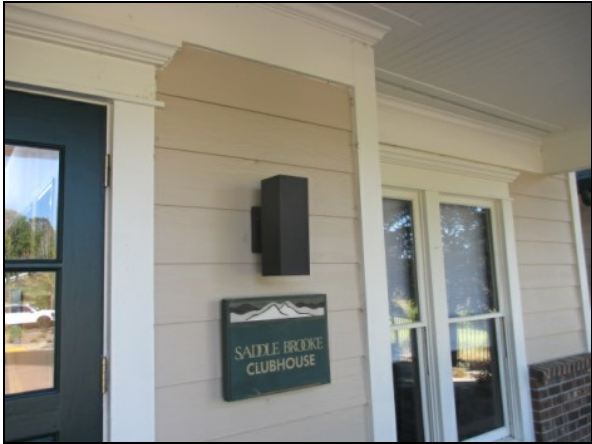
**Comp #: 27100 Clubhouse Ext. Lights - Replace**

Comments: Observed during daylight hours but assumed to be in functional operating condition. As routine maintenance clean by wiping down with an appropriate cleaner change bulbs and repair as needed. In general costs related to this component are expected to be included in the client's Operating budget. No recommendation for Reserve funding at this time. However any repair and maintenance or other related expenditures should be tracked and this component should be re-evaluated during future Reserve Study updates based on most recent information and data available at that time. If deemed appropriate for Reserve funding component can be included in the funding plan at that time.

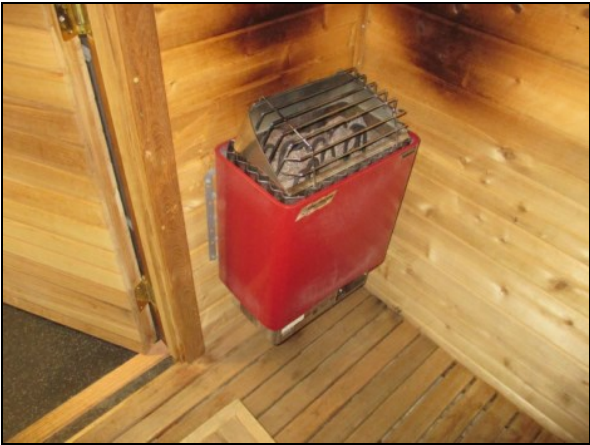
**Comp #: 27190 Sauna Heater - Replace**

Sauna heater was not tested during site inspection. Should be inspected and repaired as needed as an Operating expense. Assumed to be functional and in good working condition. Life expectancy can be very long and will depend on level of use. Funding recommendation shown here is based on our experience with similar properties.

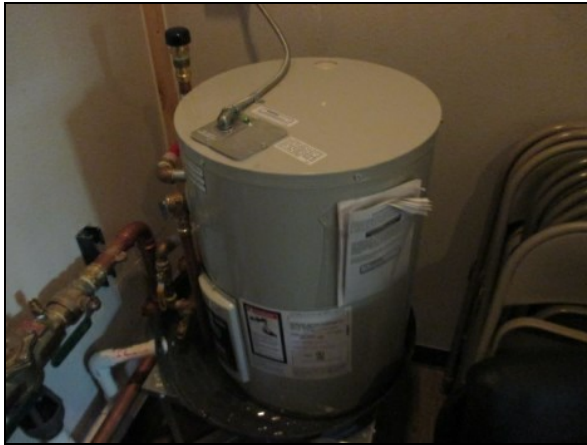
**Comp #: 27270 Clubhouse Water Heater - Replace**

Minimal or no subjective/aesthetic value for this component. Useful life is based primarily on normal expectations for service/performance life in this location. Unless otherwise noted remaining useful life expectancy is based primarily on original installation or last replacement/purchase date our experience with similar systems/components and assuming normal amount of usage and good preventive maintenance. Water heater life expectancies can vary greatly depending on level of use type of technology amount of preventive maintenance and other factors. Should be inspected and repaired as needed by servicing vendor or maintenance staff. Unless otherwise noted expected to be functional. Plan to replace at the approximate interval shown below. When evaluating replacements we recommend choosing high-efficiency or tankless models if possible in order to minimize energy usage.

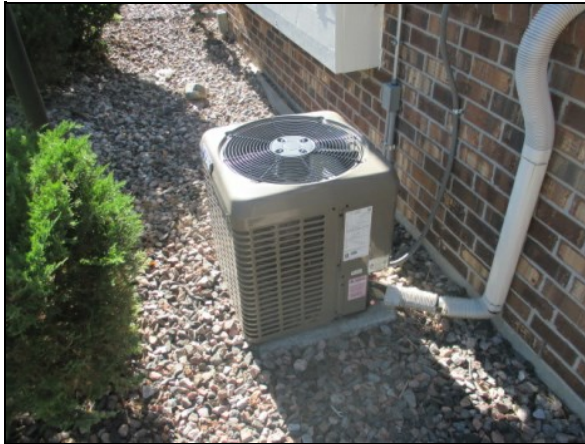
**Comp #: 27280 Clubhouse HVAC - Replace**

Minimal or no subjective/aesthetic value for this component. Useful life is based primarily on normal expectations for service/performance life in this location. Unless otherwise noted remaining useful life expectancy is based primarily on original installation or last replacement/purchase date our experience with similar systems/components and assuming normal amount of usage and good preventive maintenance. We recommend that routine repairs and maintenance such as filter replacements system flushing etc. be budgeted as an Operating expense. Useful life can often be extended with proactive service and maintenance. Unless otherwise noted funding for system with same size/capacity as the current system. For split systems we recommend budgeting to replace the entire system (condensing unit and air handler) together in order to obtain better unit pricing and ensure maximum efficiency refrigerant compatibility etc. If additional costs are expected during replacement such as for system reconfiguration or expansion ductwork repairs electrical work etc. costs should be re-evaluated and adjusted as needed during future Reserve Study updates.

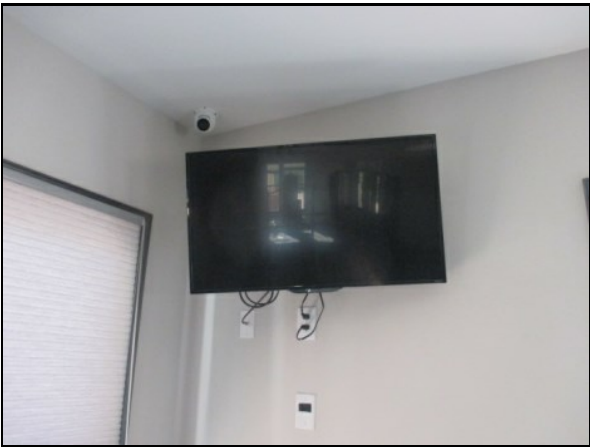
**Comp #: 27290 A/V Equipment - Replace**

Minimal or no subjective/aesthetic value for this component. Useful life is based primarily on normal expectations for service/performance life in this location. Unless otherwise noted remaining useful life expectancy is based primarily on original installation or last replacement/purchase date our experience with similar systems/components and assuming normal amount of usage and good preventive maintenance. A/V equipment have a relatively short useful life (depending on the application and level of use) due to advancements in technology. Plan to replace/upgrade the existing equipment at the approximate interval shown here to ensure proper function and uninterrupted service. Keep track of any partial replacements and include cost history during future Reserve Study updates.
