Update "With-Site-Visit" Reserve Study

Civano I, Neighborhood I HOA Tuscon, AZ

Report #: 9304-2
For Period Beginning: January 1, 2020
Expires: December 31, 2020

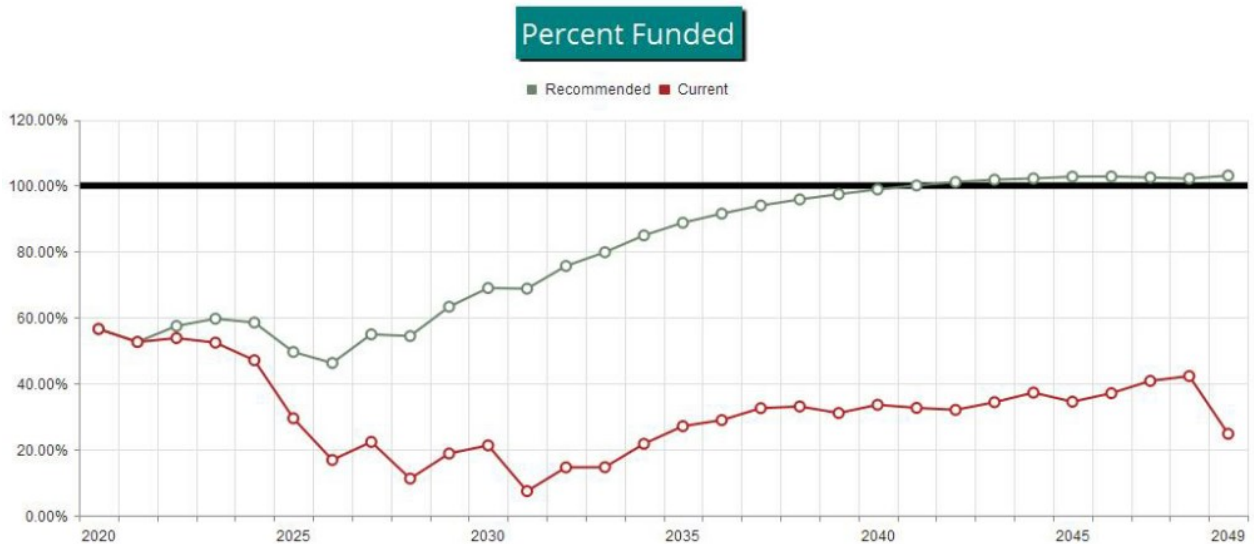
Figure 4

This chart shows the same information plotted on a Percent Funded scale. It is clear here to see how your Reserve Fund strength approaches the 100% Funded level under our recommended multi-year Funding Plan.

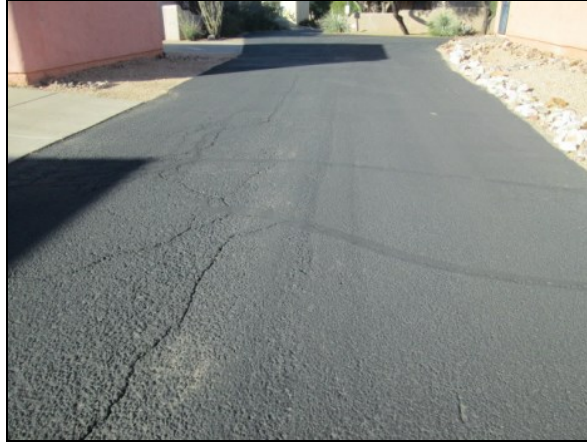
Useful Life:
30 years

Remaining Life:
10 years

Best Case: \$ 139,000

Worst Case: \$ 175,000

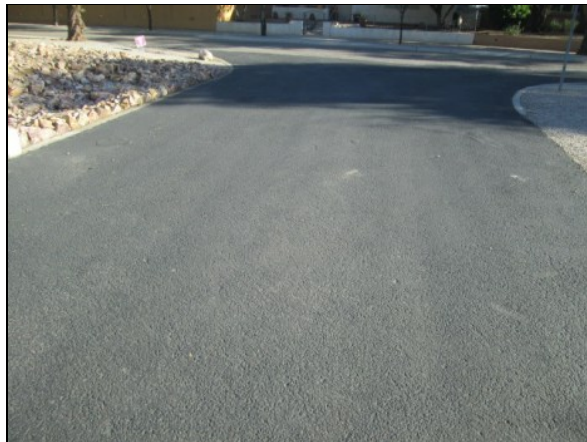
Useful Life:
7 years

Remaining Life:
4 years

Best Case: \$ 13,000

Worst Case: \$ 16,700

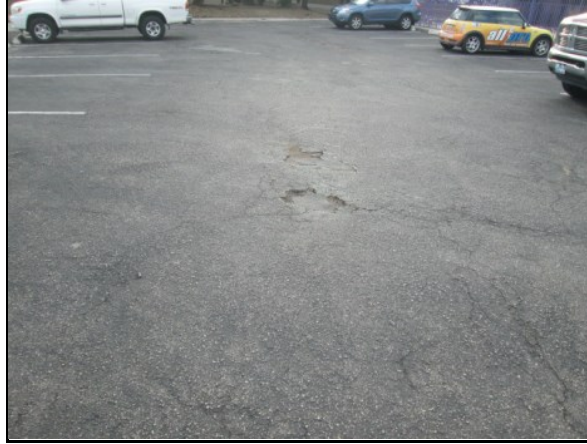
Useful Life:
24 years

Remaining Life:
0 years

Best Case: \$ 32,000

Worst Case: \$ 39,000

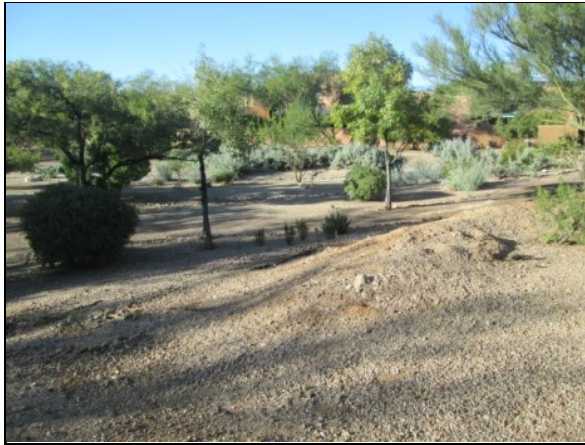
Useful Life:
25 years

Remaining Life:
3 years

Best Case: \$ 120,000

Worst Case: \$ 150,000

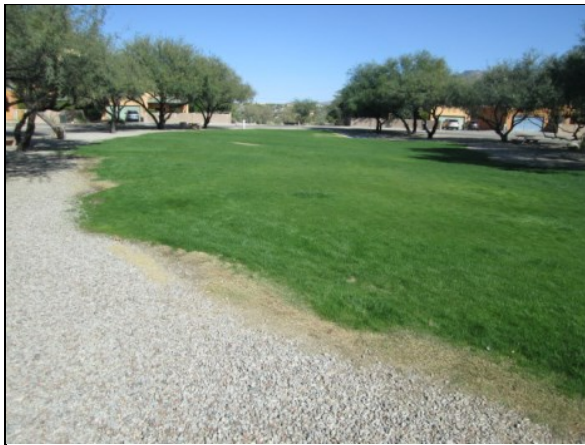
Useful Life:
25 years

Remaining Life:
5 years

Best Case: \$ 120,000

Worst Case: \$ 150,000

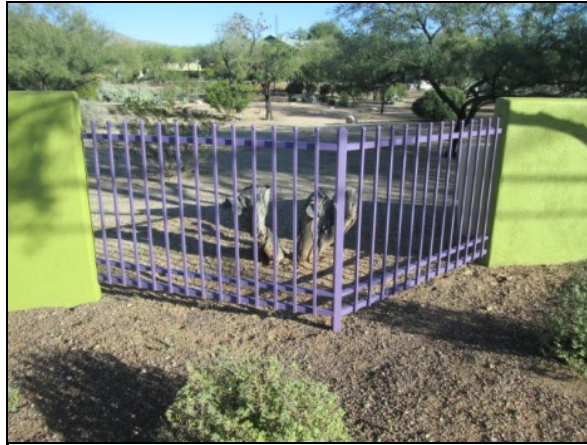
Comp #: 420 Metal Fence - Replace

Comments: Posts are securely mounted and fence appears to be in good condition. No signs of rusting or deterioration.

Useful Life:
30 years

Remaining Life:
9 years

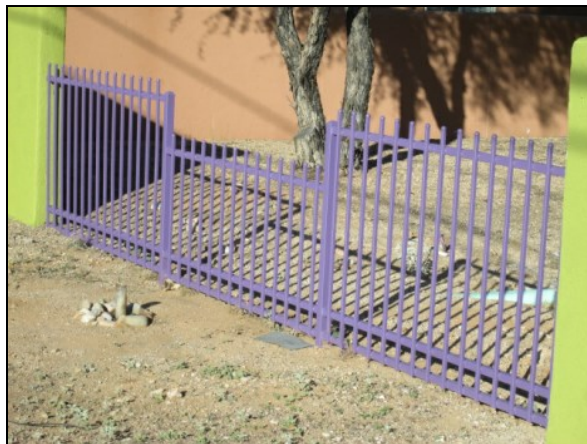
Comments: Paint surfaces are newer and in good condition. Unlike the walls at this perimeter, HOA is responsible for the metal fences.

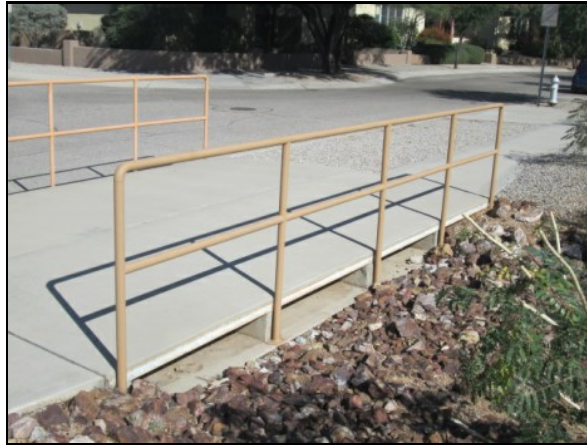
Comp #: 425 Metal Rails (1999) - Replace

Comments: Securely mounted with no significant rusting or deterioration. Long life expectancy under normal circumstances. In good condition.

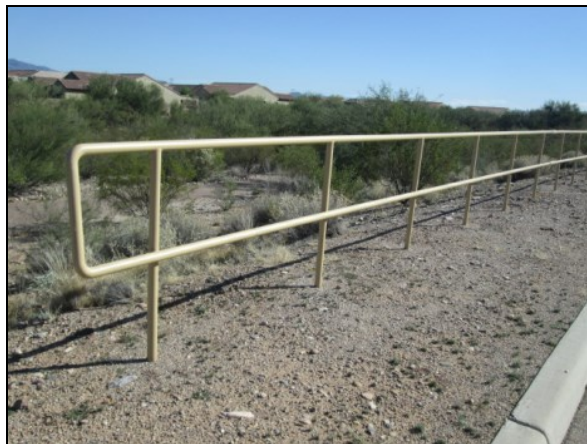
Comp #: 427 Metal Rails (2008) - Replace

Comments: Securely mounted with no significant rusting or deterioration. Long life expectancy under normal circumstances.

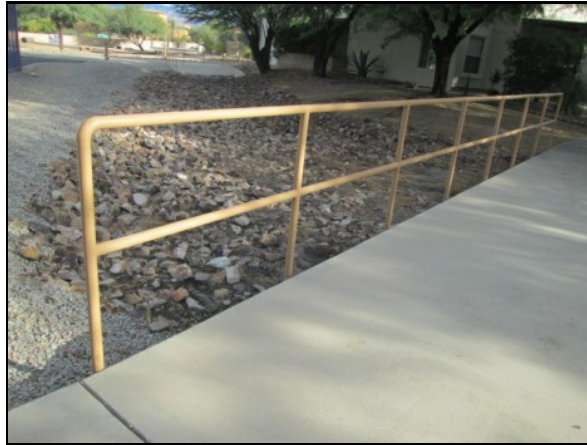
Comments: Both painting projects we have record of did not account for painting all of the rails. Recommend painting all of the rails at the same time in the future.

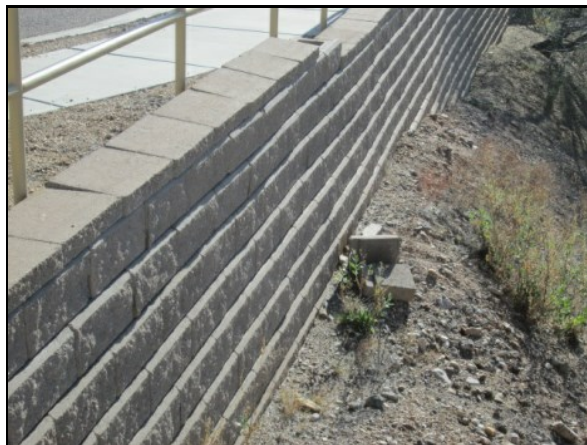
Comp #: 430 Retaining Walls - Repair

History: Minor repairs reported in 2013 for \$1,500.

Comments: HOA is reportedly responsible for retaining walls behind homes built on a slope. Walls and fence mounted on top of the retaining walls are the owners responsibility. There is no expectancy to replace these walls under normal circumstances. They should be professionally inspected by an engineer if there are any concerns. This component funds an allowance for periodic, minor repairs. No issues have been reported.

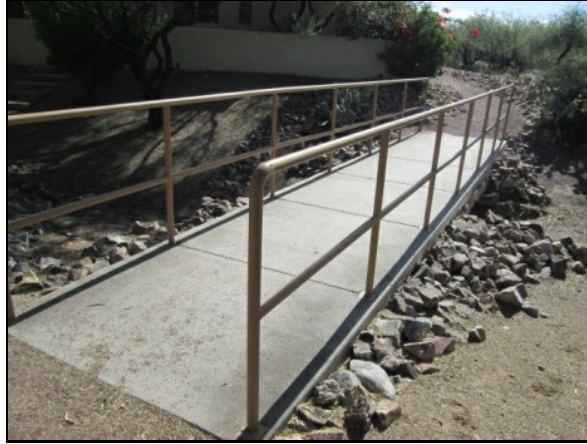
Comp #: 460 Fingerway Bridges - Repair

Comments: The bridges have approximately 5,400 sq ft of concrete surfaces and 760 LF of metal rails. Rails are included under #425 and 428. There is no expectancy to completely replace these bridges. This component funds an allowance for periodic repairs.

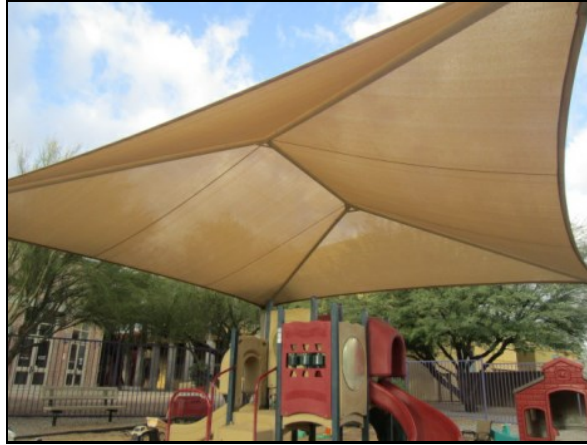
Comp #: 501 Playground Shade - Replace

Comments: There is no expectancy to replace the structure under normal circumstances. This component funds to periodically replace the shade screen. No holes or tears were noted. Still appears to be in good shape.

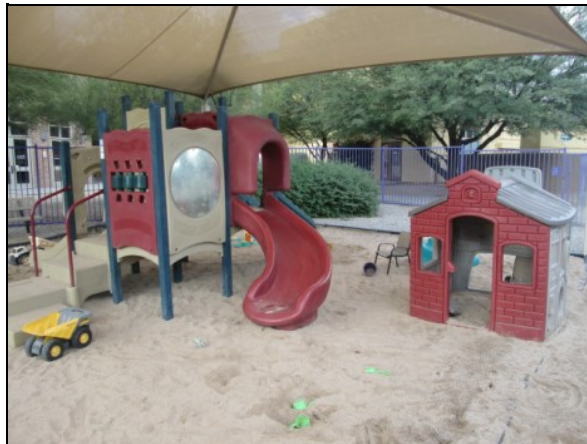
Comp #: 502 Playground Equip - Replace

Comments: Equipment includes (1) Miracle play structure, (1) swing-set, (3) spring riders, (1) crawl tube, and plastic curbing around perimeter of the tot lot. There is also a lot of plastic play toys that are inexpensive and should be replaced as a maintenance expense when needed. Still in fair condition overall. No signs of excessive wear or damage.

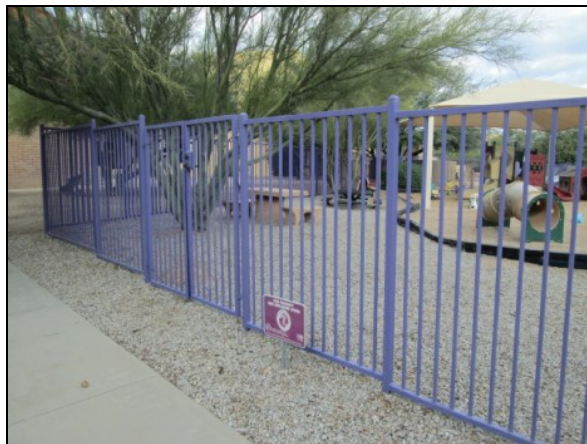
Comp #: 506 Playground Fence - Replace

Comments: This is a 6' perimeter metal fence. Securely mounted and in good condition, although some spots do shake easier than others.

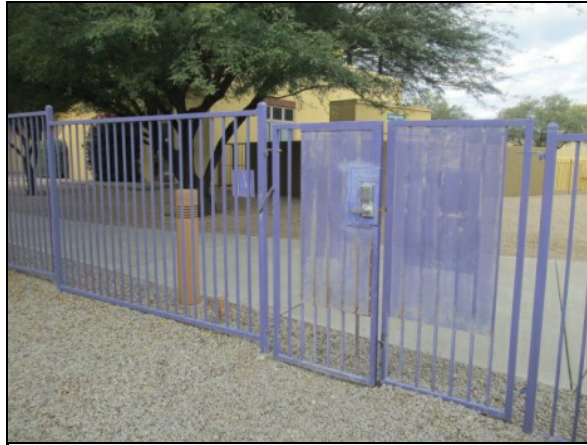
Comments: Poor condition. Paint finish is old and peeling off in spots. Some rusting noted too.

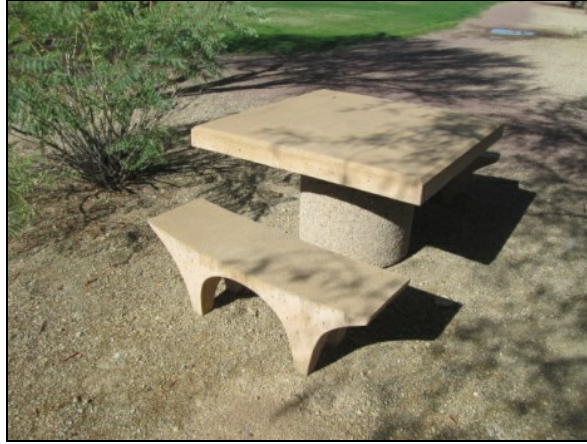
Comp #: 514 Park Furniture - Replace

Comments: Quantity per original Reserve Study includes: (19) concrete benches, (10) concrete picnic tables, (21) concrete trash cans, (1) metal bench, (4) metal picnic tables, and (5) bike racks. Ages vary along with styles and conditions. They look older with some wear plus rusting on the metal pieces. Recommend planning complete replacement to maintain a consistent and uniform quality throughout the community.

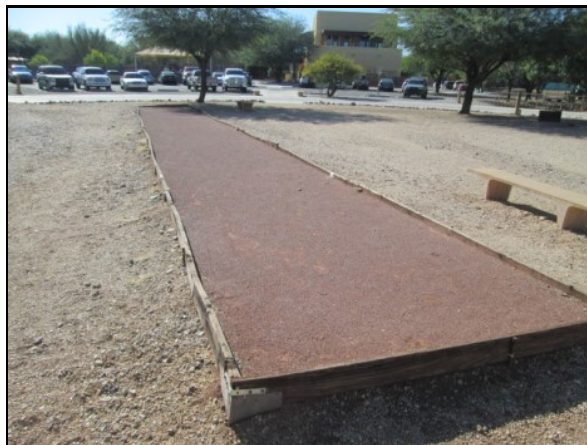
Comments: Bocce ball has a clay/dirt surface with wood borders. Borders are old and warped. Court needs some work. This component funds an allowance to replenish the surface and replace/repair the border as needed.

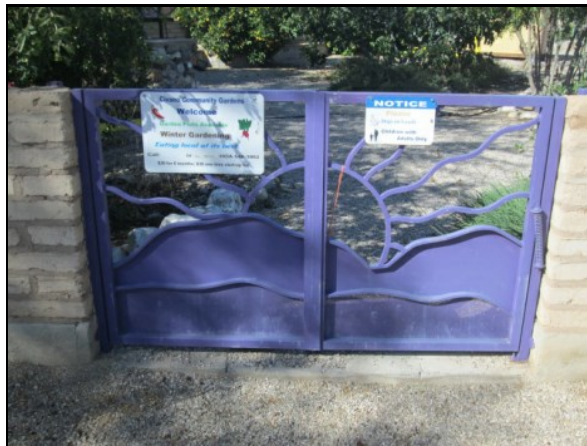
Comp #: 530 Garden Fence - Replace

Comments: Community Garden has sections of metal fence and gates around the perimeter. Still intact and in good to fair condition.

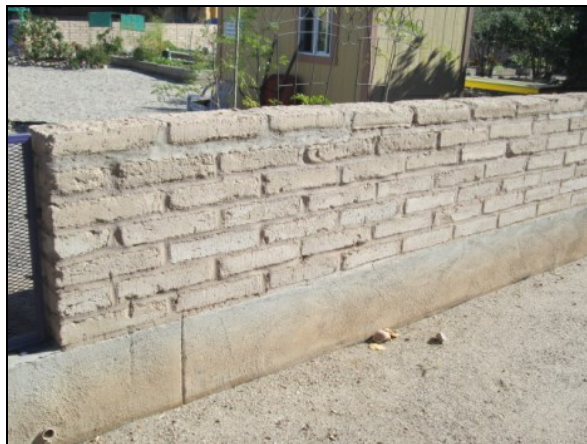
Comp #: 534 Garden Wall - Seal/Repair

History: Repaired and sealed in 2013 for \$2,878. Installed during 2000.

Comments: Perimeter garden wall is made of Adobe block. Some past repairs were noted. Wall should be sealed periodically to preserve the block as is scheduled for the Activity Center. Quantity includes both sides of the wall.

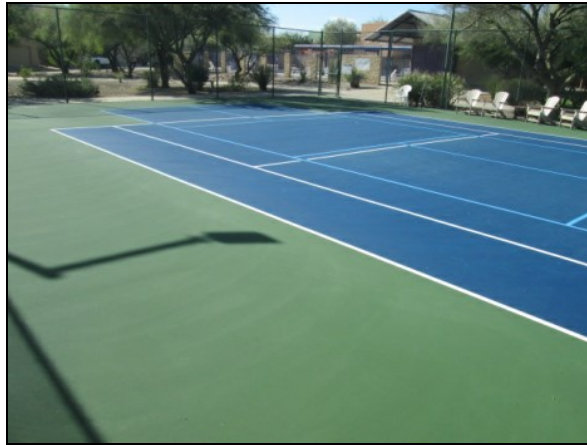
Comp #: 540 Tennis Court - Replace

Location: North Pool/Recreation area on Rust Lane

Comments: This is an asphalt based tennis court. Surface has several large cracks that have been patched, plus there are cracks around the perimeter. Older asphalt courts will continue to crack until they are replaced. Funding is based on replacing with a post-tension concrete court as a one-time expense. Combine with resurface component for the total budgeted cost.

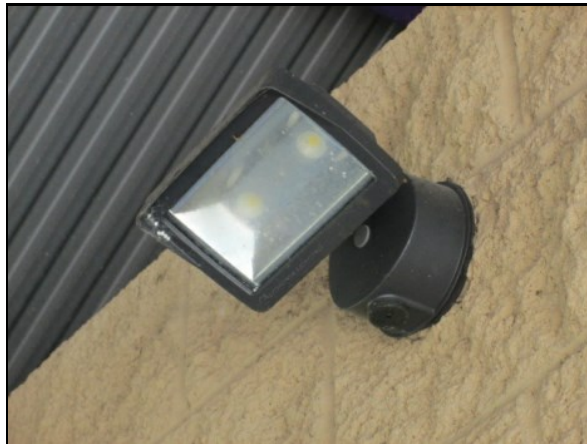
Comp #: 718 Exterior Lights - Replace

Location: North Pool on Rust Lane - mounted to exterior walls of the pool building & shade structure

History: Replaced 5/2014 for \$4,920. Previously original from 1999.

Comments: Lighting still looks newer and is in good condition. Repair or replace individually as a maintenance expense when needed.

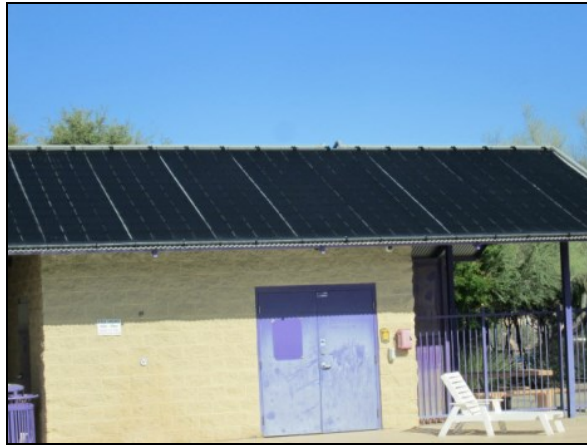
Comp #: 736 Solar Panels - Replace

Location: North Pool on Rust Lane - rooftop of the pool building & shade structure
Funded?: Yes.

History: Replaced 1/2019 for \$12,650. Previously installed around 2001.

Comments: Solar panels are newer and expected to be in good condition. However, they are already leaking. We expect any repairs or corrections will be made under warranty or as a maintenance expense. Per the contract, this pool has (13) HC50 4'x12.5' and (16) HC30 4'x8' panels.

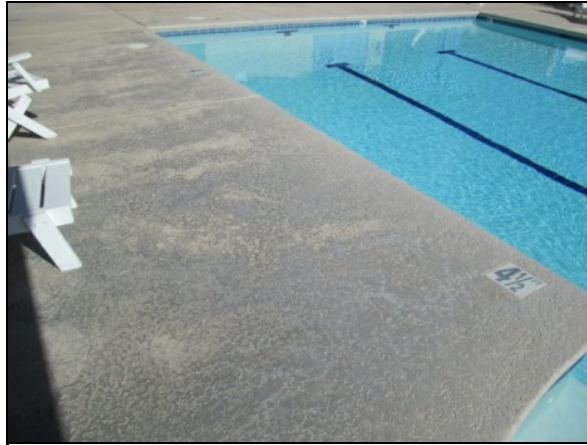
Comp #: 742 Pool Deck - Seal/Repair

Location: North Pool on Rust Lane

Comments: Deck coating is old, stained, and discolored.

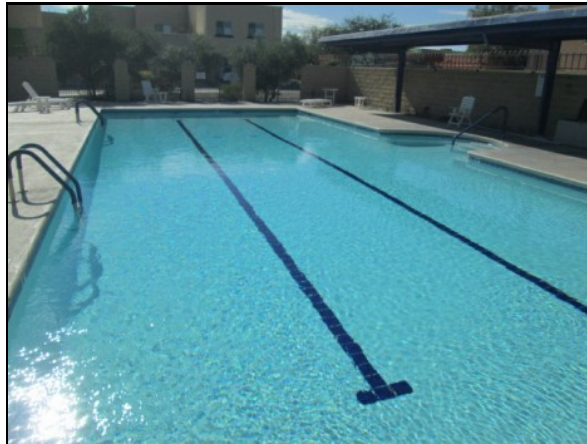
Location: North Pool on Rust Lane

Comments: Pool has a white plaster surface with waterline tile. It is clean and in good condition.

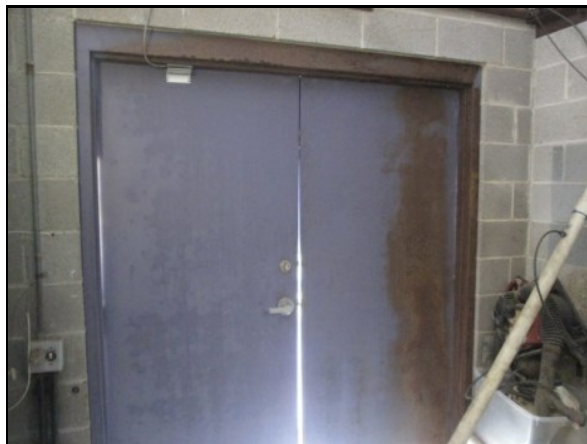
Comp #: 760 Equip Doors - Replace

Location: North Pool on Rust Lane - pool equipment room

Comments: Equipment room has steel doors that are rusted. Frame is also rusting out. Replacement will be needed at some point in the near future.

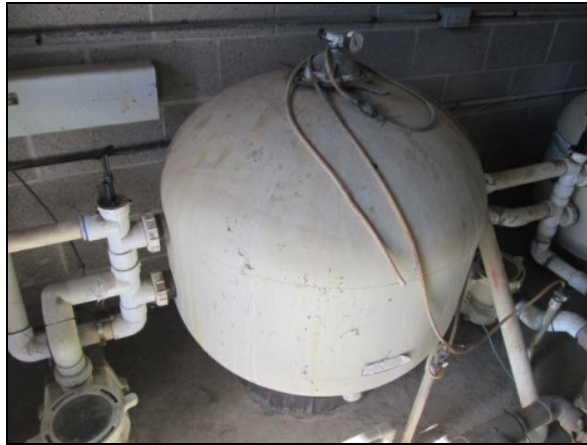
Comp #: 761 Pool Filter #1 - Replace

Location: North Pool on Rust Lane - pool equipment room

Comments: This filter is older but still intact and functional. No problems observed or reported. HOA is planning to replace all of this pool's equipment at the same time in the near future.

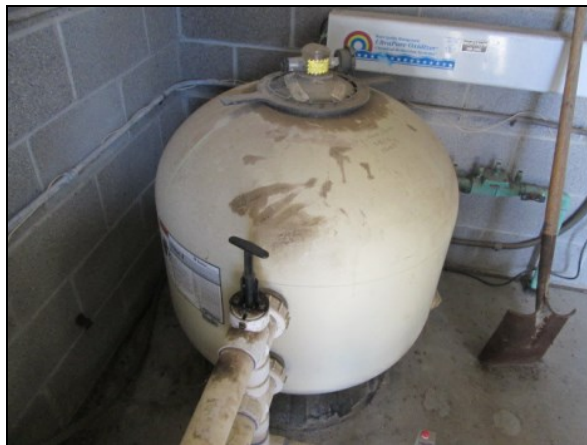
Comp #: 762 Pool Filter #2 - Replace

Location: North Pool on Rust Lane - pool equipment room

Comments: This filter has a smaller capacity than #1. No problems observed or reported.

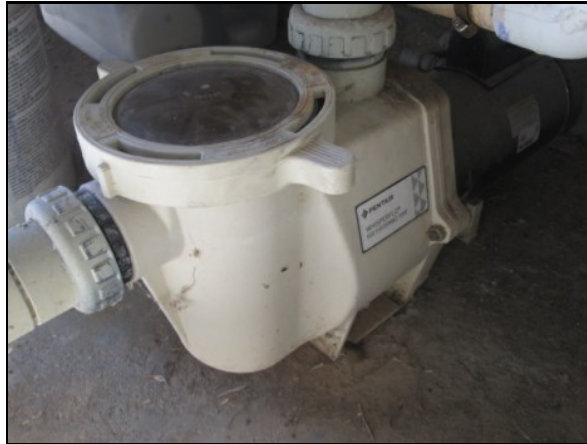
Comp #: 764 Pool Pump #1 - Replace

Location: North Pool on Rust Lane - pool equipment room

History: Replaced 7/2014 for \$1,551.

Comments: This pump works with the larger #1 filter. HOA is planning to replace all of this pool's equipment at the same time in the near future, so this pump will be replaced soon despite its age. Periodic repair and motor replacement should be addressed as a maintenance issue. This component funds for replacement of the pump and motor assembly.

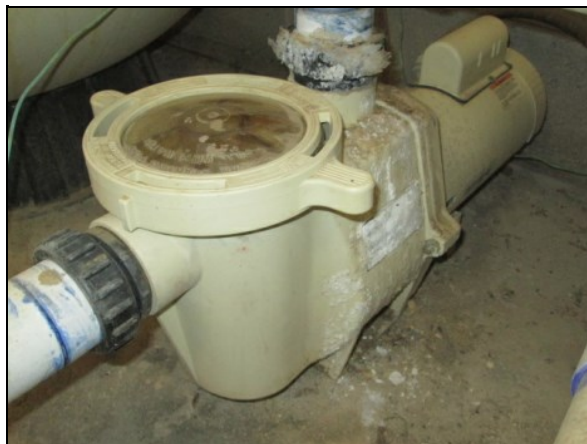
Comp #: 765 Pool Pump #2 - Replace

Location: North Pool on Rust Lane - pool equipment room

History: Replaced in 2014. Previously original from 1999.

Comments: This pump works with the #2 filter. HOA is planning to replace all of this pool's equipment at the same time in the near future, so this pump will be replaced soon despite its age. Periodic repair and motor replacement should be addressed as a maintenance issue. This component funds for replacement of the pump and motor assembly.

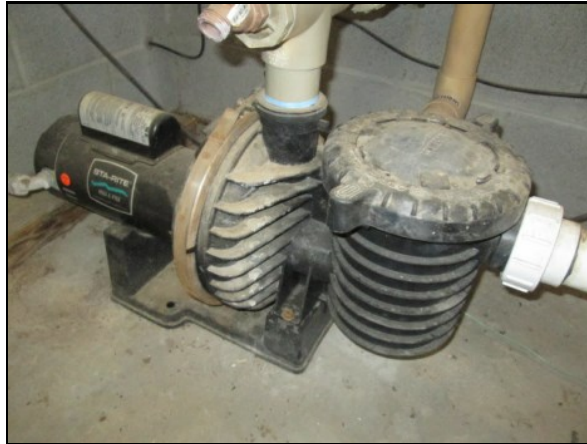
Comp #: 766 Solar Pump - Replace

Location: North Pool on Rust Lane - pool equipment room

History: Replaced in 2015.

Comments: This pump circulates water between the pool and solar panels. HOA is planning to replace all of this pool's equipment at the same time in the near future, so this pump will be replaced soon despite its age. Periodic repair and motor replacement should be addressed as a maintenance issue. This component funds for replacement of the pump and motor assembly.

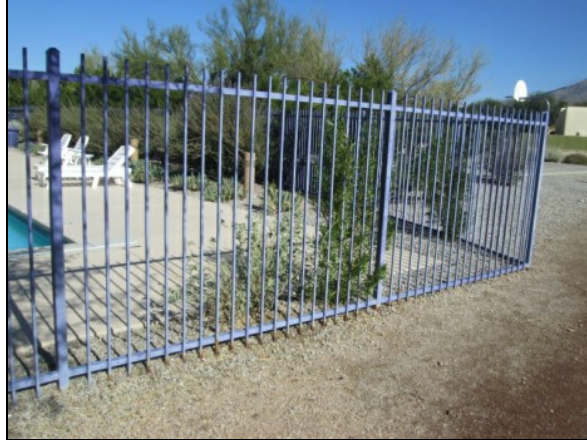
Comp #: 901 Metal Fence - Replace (A)

Comments: Quantity includes 270 LF of pool fence & gates plus (4) 3 LF gates at the enclosure in front of the pool area and trash enclosure next to the parking lot. Fence still feels securely mounted, but some of the posts are rusted out at the base. Fence surfaces are also faded and rusty.

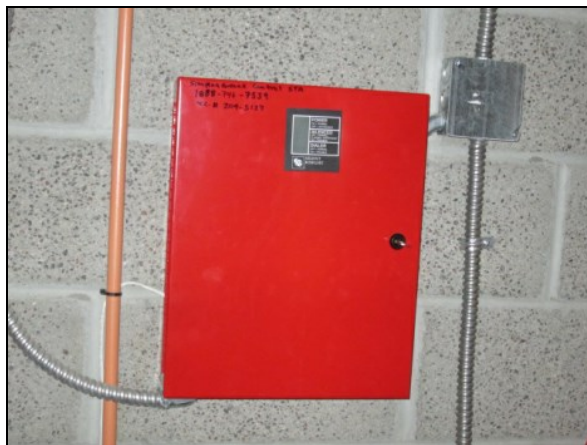
Comp #: 1128 Fire Sprinkler System - Repair

Comments: Simplex Grinnell reports that the Activity Center does not have a fire alarm system, but it has a fire sprinkler system. The Silent Knight panel is a digital alarm communicating transmitter, not an alarm panel. It is required to be professionally inspected annually. There is no expectancy to completely replace this system. Funding is an allowance for repairs and parts replacement.

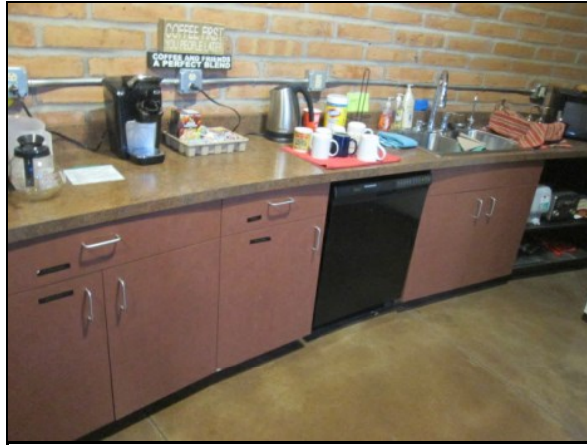
Comments: Kitchen has laminate cabinets and counters. There is some visible wear and chipped spots. Looking older and dated.

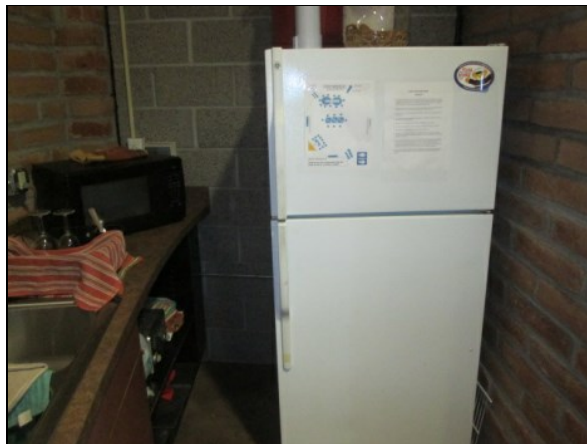
Comp #: 1142 Kitchen Appliances - Replace

Comments: Appliances appear to be older, possibly original. Refrigerator is a G.E. brand (model TBX181ABARWW, serial #MT505820), and dishwasher is a Frigidaire (model FDB2410HIB2A, serial #KH14700829). Microwave and coffee maker are inexpensive and should be replaced as a maintenance expense when needed.

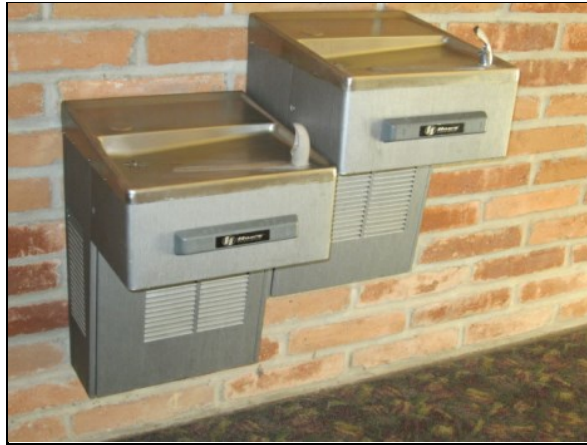
Comp #: 1146 Drinking Fountain - Replace

Comments: This is a chilled water, bi-level drinking fountain. Still functional and looks fair. However, it is old and had low water flow or pressure. It should be nearing time for replacement.

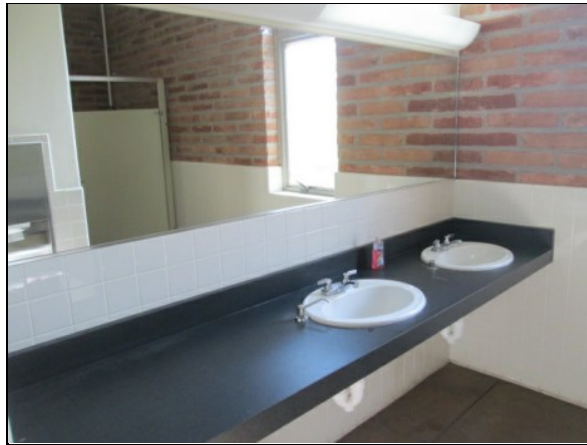
Comments: These are relatively basic and simple restrooms. Still clean and attractive. No signs of excessive wear or damage. This component funds to eventually replace the counters, sinks, lights, mirrors, toilets, stalls, and urinals.

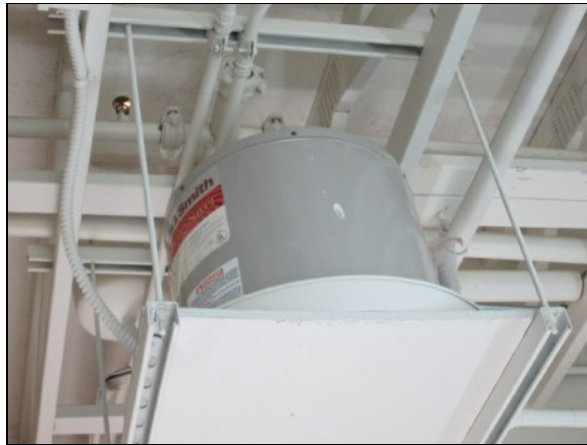
Comp #: 1149 Water Heater - Replace

Funded?: No. Water heater is mounted at ceiling level in the men's restroom. Replacement cost is below the Reserve expense threshold, so no funding has been allocated.

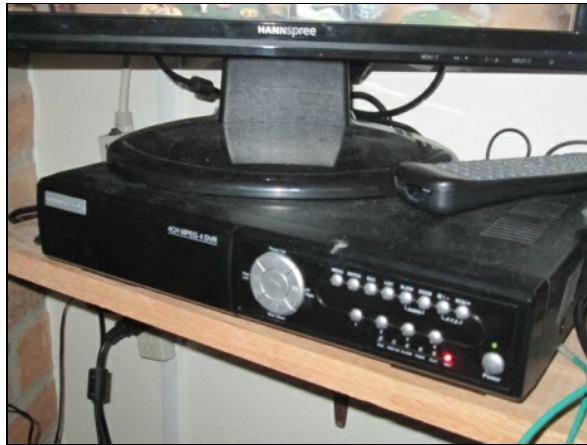
Comp #: 1158 Camera System - Replace

Comments: This is a small 4-channel camera system from RoHS. Relatively inexpensive system overall. Replacement cost assumes cameras will not have to be re-wired. System is older and reportedly needs to be replaced.

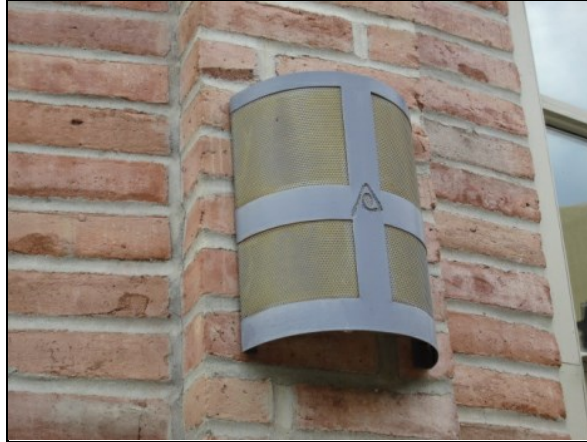
Comp #: 1166 Exterior Lights - Replace

Comments: These are large fixtures with custom metal covers. They are decorative, but the surfaces are faded. There is also some surface rust. Recommend painting them as a maintenance project or combining with other painting projects.

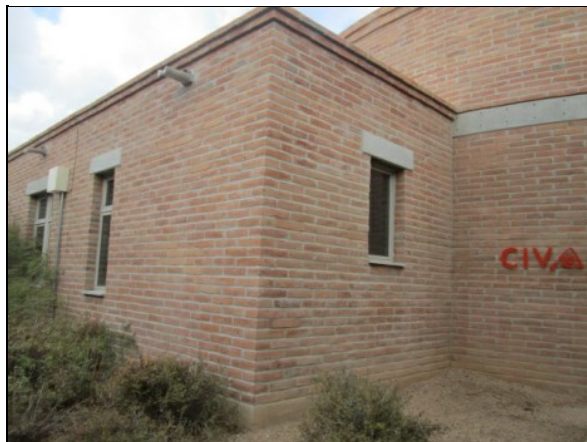
Comments: Exterior building walls are primarily Adobe block. These surfaces need to be periodically inspected, repaired as needed, and sealed. This component funds primarily just for the sealing work. Based on timing of the last project, HOA should consider sealing again in the near future.

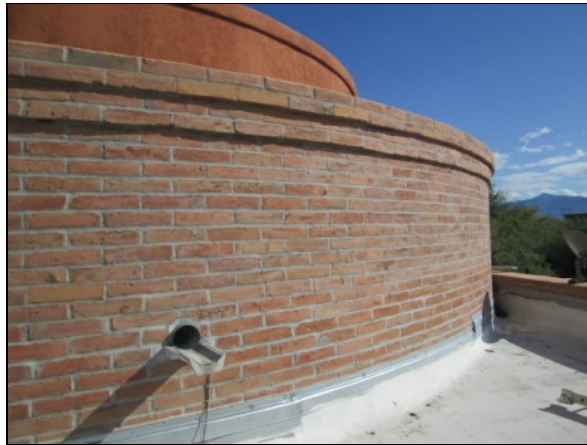
Comp #: 1171 Adobe Walls - Repair

History: Repairs were last completed with sealing 9/2010 for \$12,841.

Comments: This component funds a longer-term allowance for Adobe repairs. Expect repairs to coincide with future sealing projects under #1170.
