March 28, 2025

Subject: **Phase I Environmental Site Assessment Report**
Remington Arms Plant
14 Hoefler Avenue
Ilion, New York
HRP Project Number: TUR3501.MC

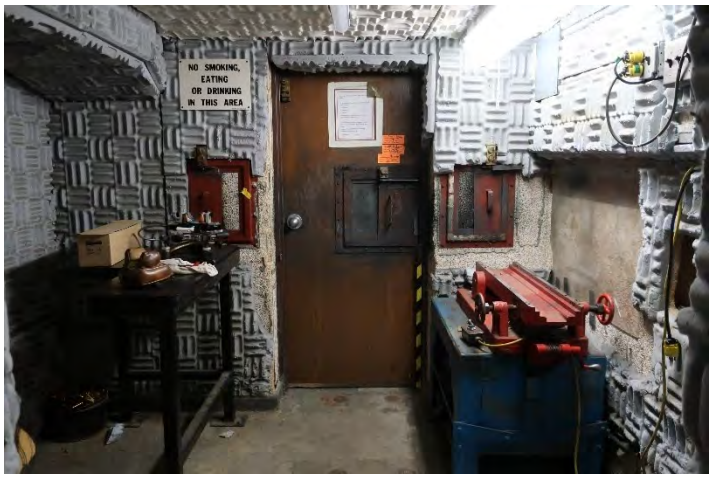
Building 52- Suspect ACM

Damaged Suspect ACM

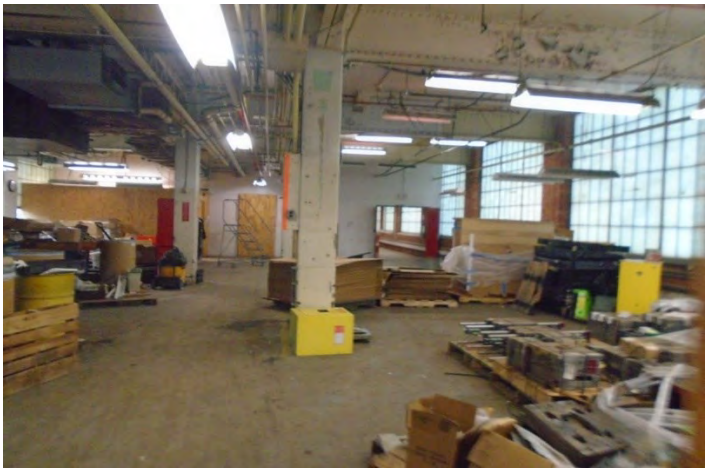
Damaged Suspect ACM

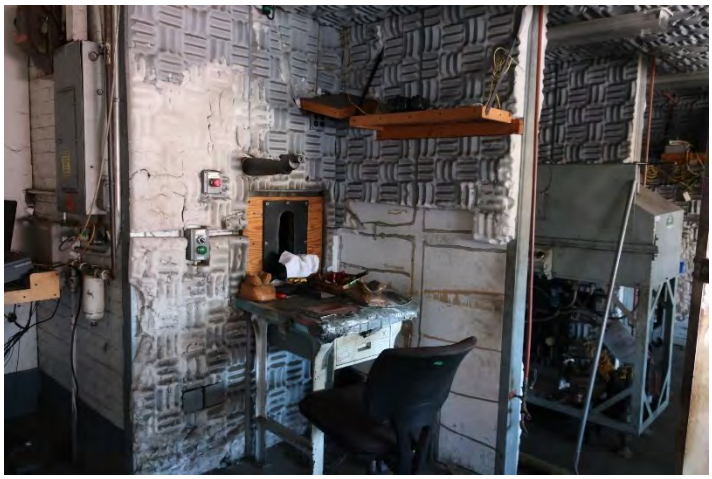
Typical Area of Peeling Paint

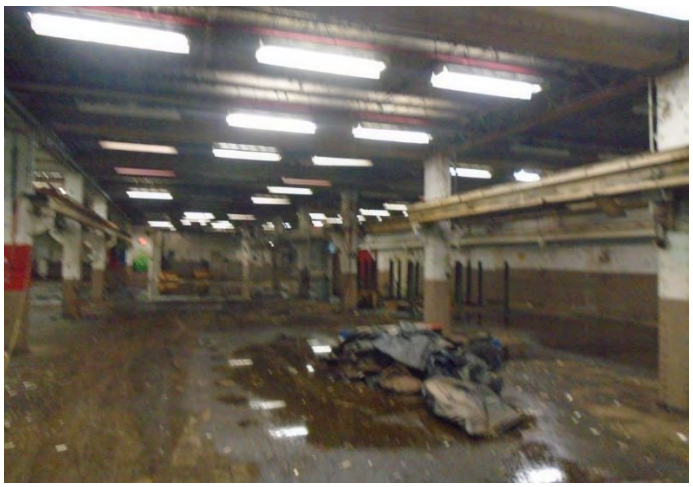
Building 76- Oil Staining

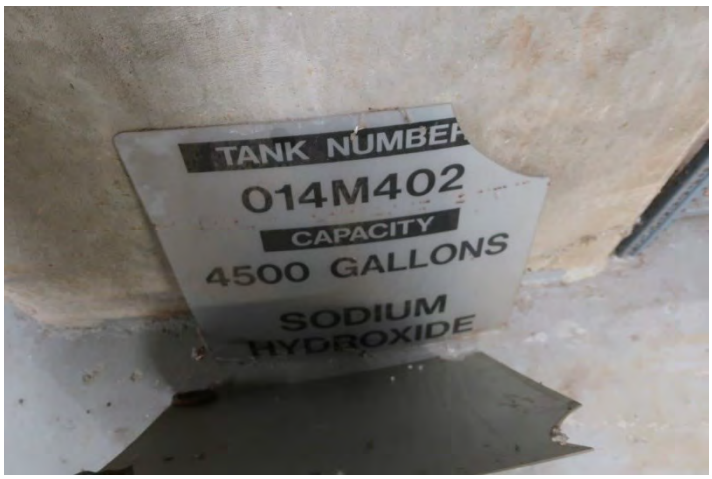
Steam Plant- Boiler Chemicals

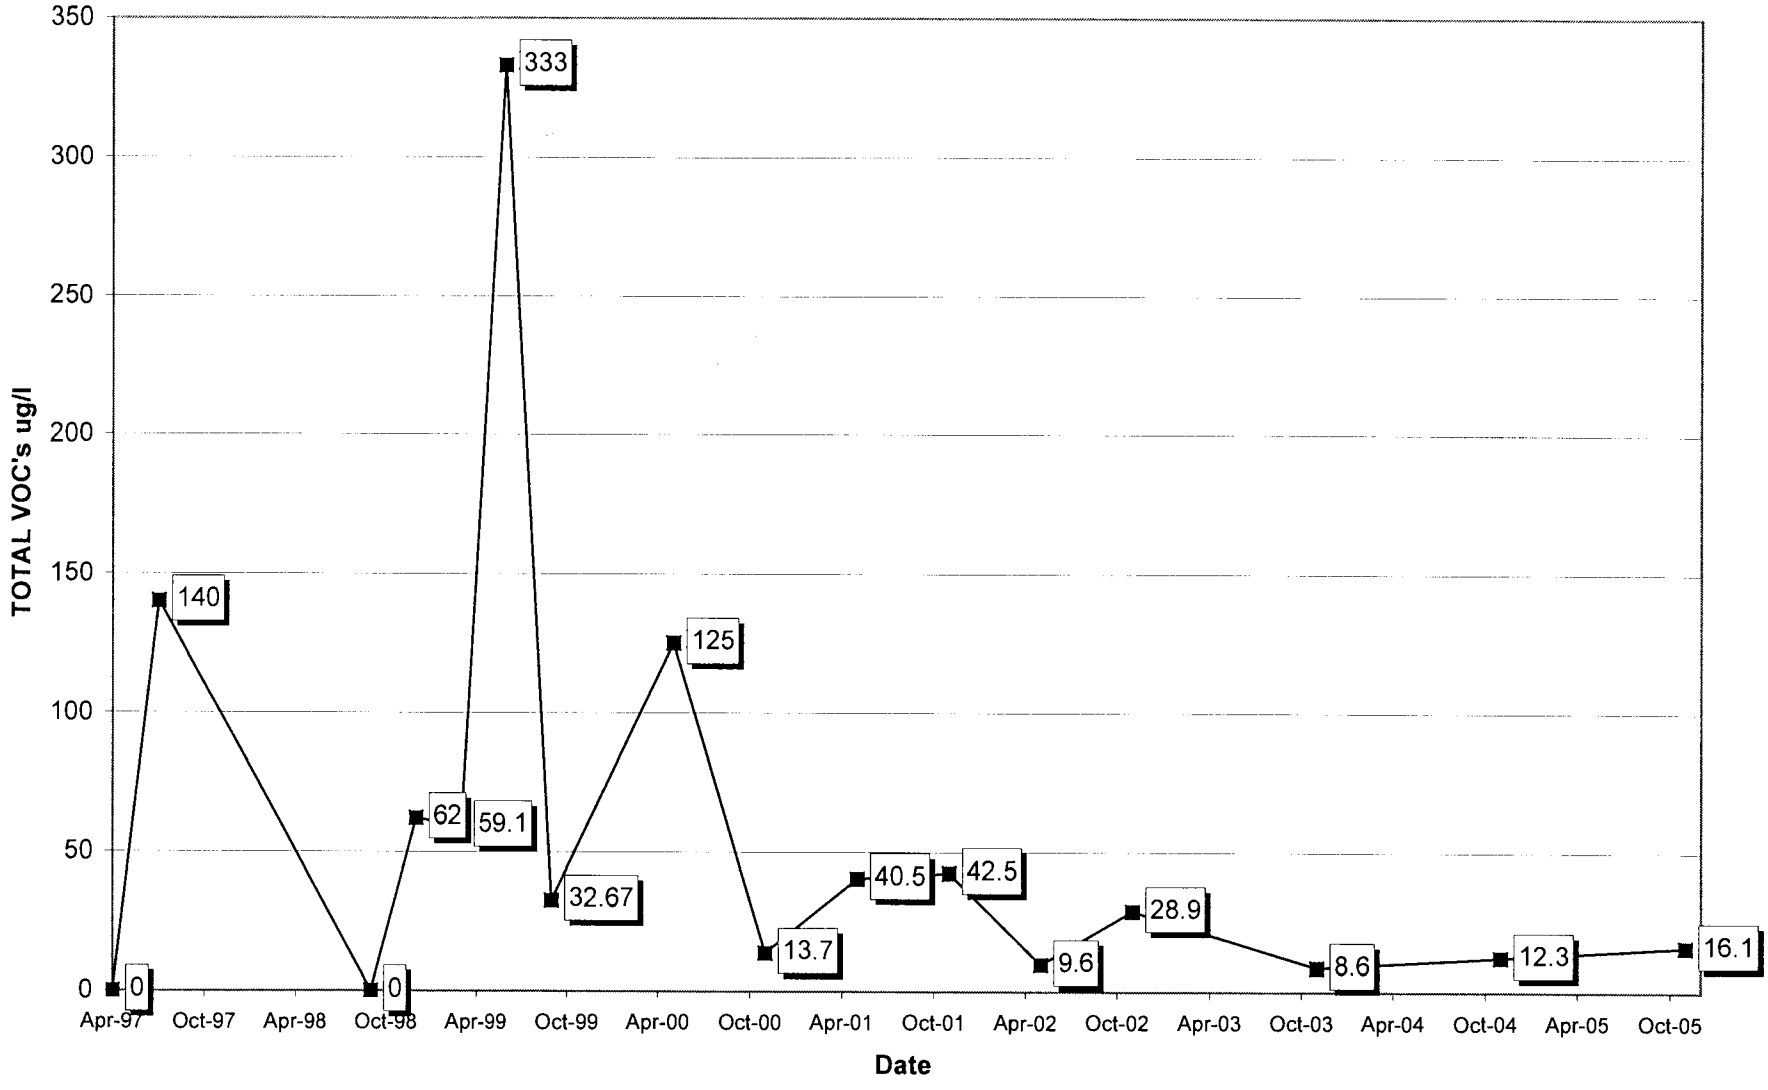
MW-6

Because the results of the annual monitoring program continue to indicate a stable and decreasing plume, natural attenuation is occurring at the site, and the 2005 analytical results show only two isolated constituents at concentrations slightly above guidance values, DuPont is formally petitioning NYSDEC to terminate this groundwater monitoring program and to close out Spill No. 9506245. This petition is supported by the significant downward trends in analytical concentrations observed in the 10 years of monitoring conducted on the site.
