# Corrosion Control of Buried Piping

**James T Lary**

**Corrpro**

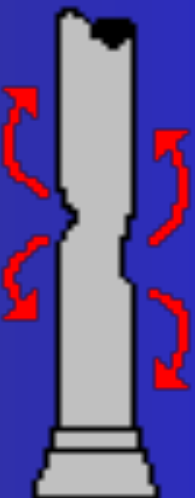
# Corrosion - A Natural Process

IRON OXIDE +

REFINING

MILLING

IRON, STEEL, PCCP

CORROSION

IRON OXIDE

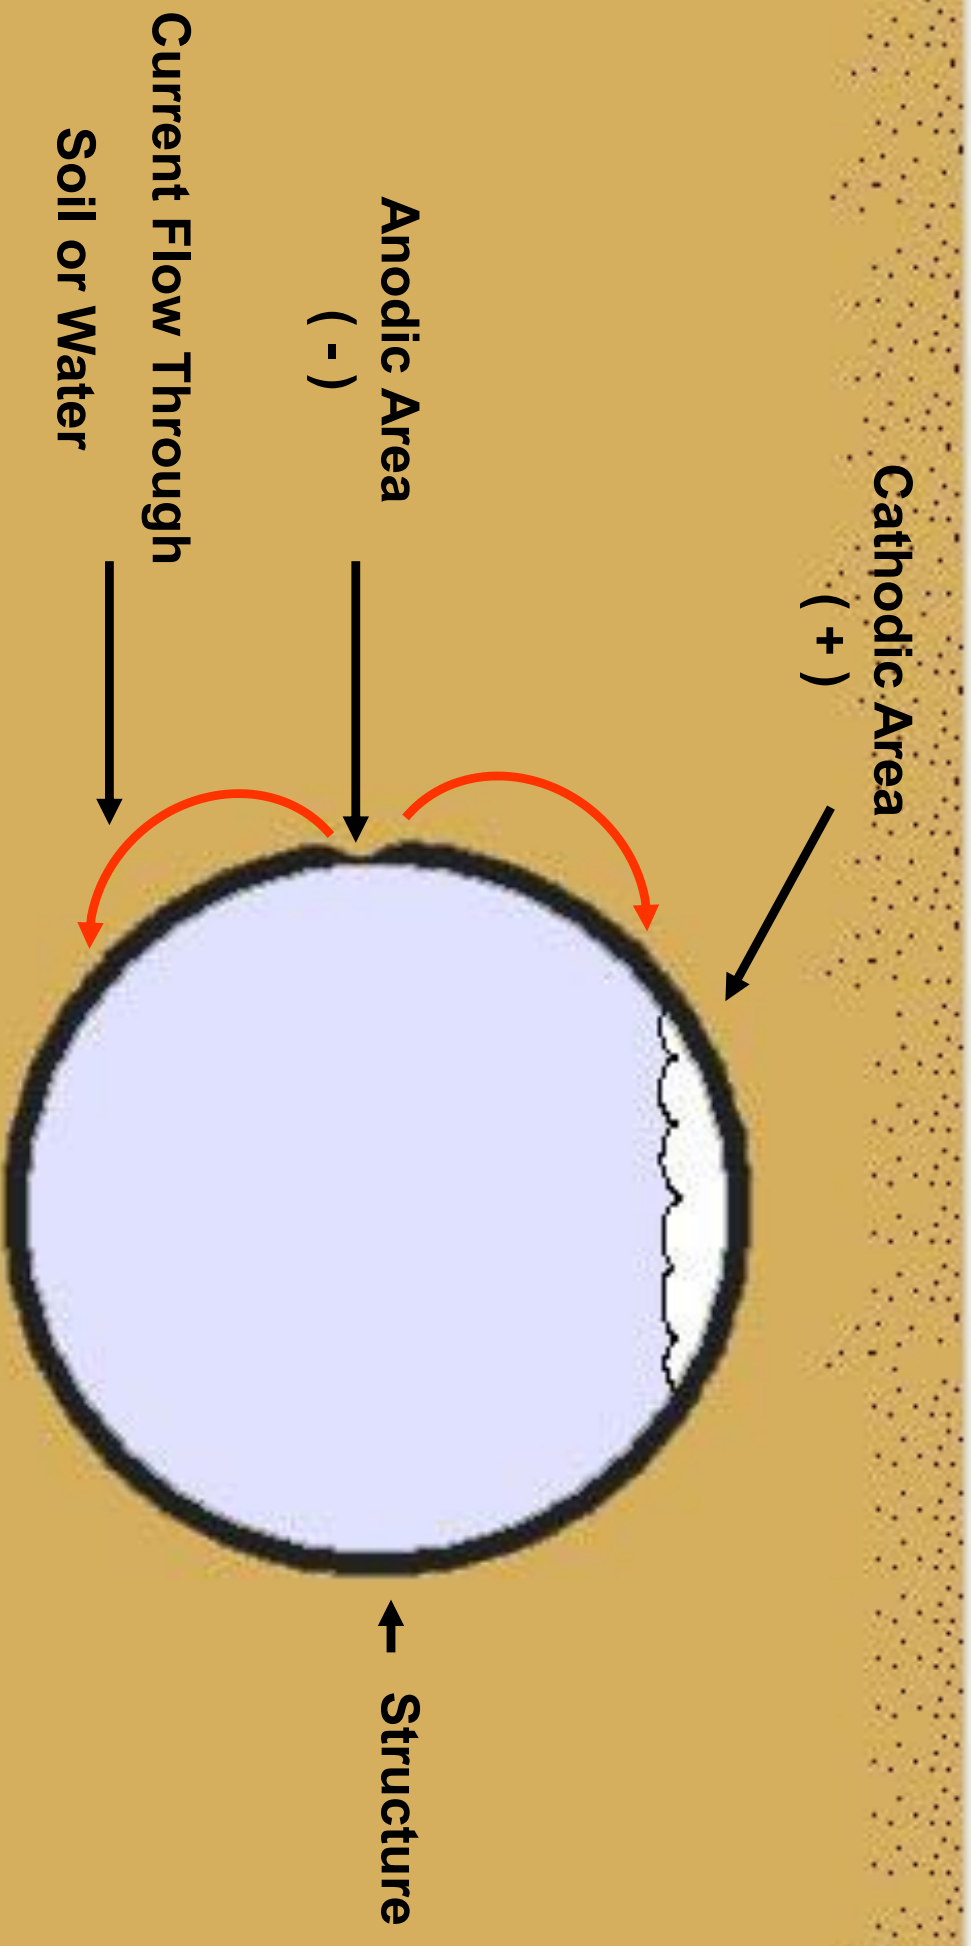
# Corrosion Cell on Buried Piping

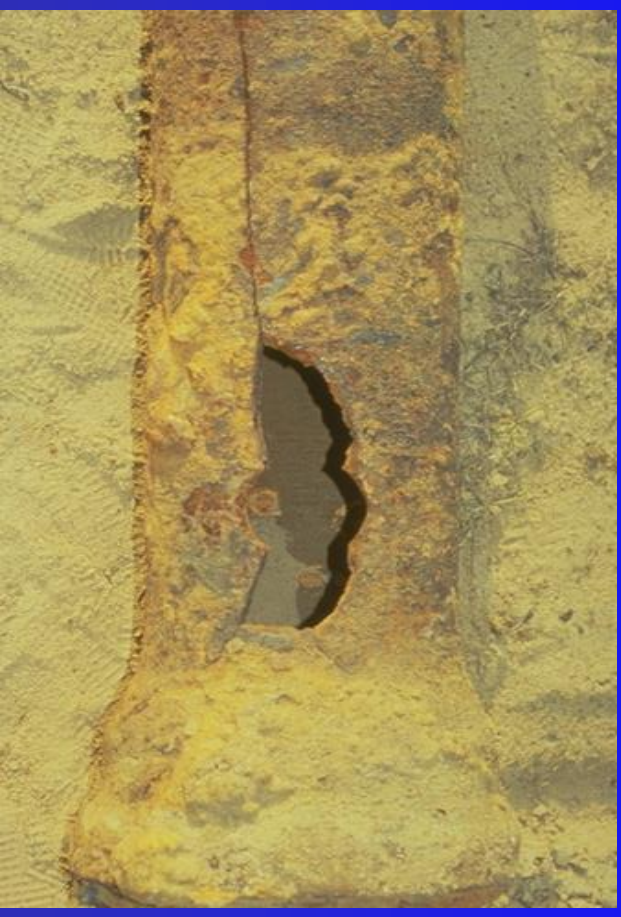
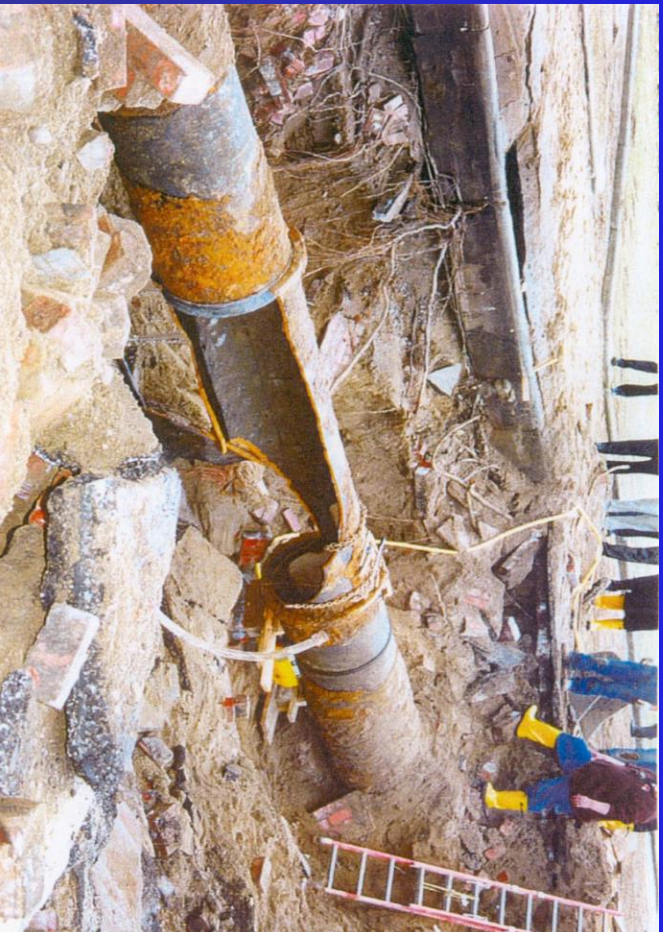
## Cast (Grey) Iron Failures

Graphitization leaves pipe brittle and weakened.

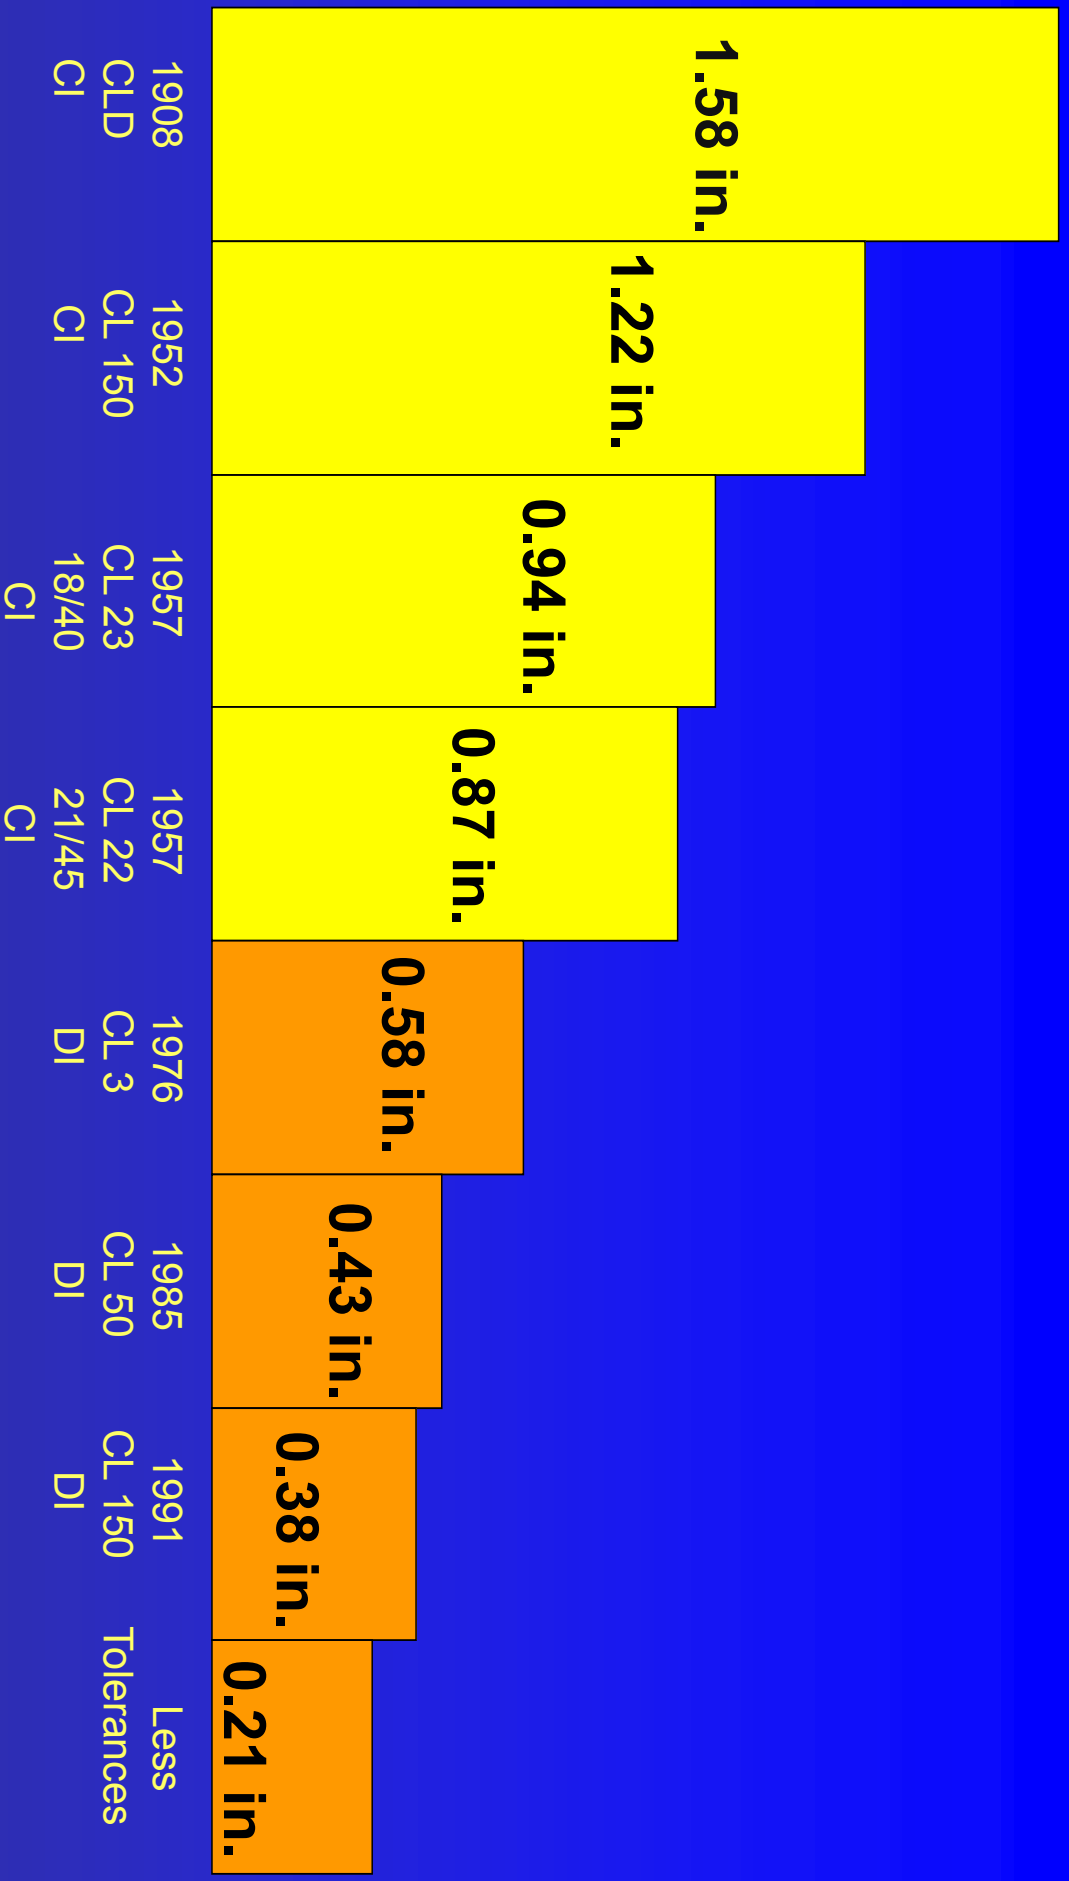
Actual size of AWWA Specification Thickness Reductions for 36-inch Diameter Cast and Ductile Iron Pipe - 1908 to Present (150 PSI Operating pressure)

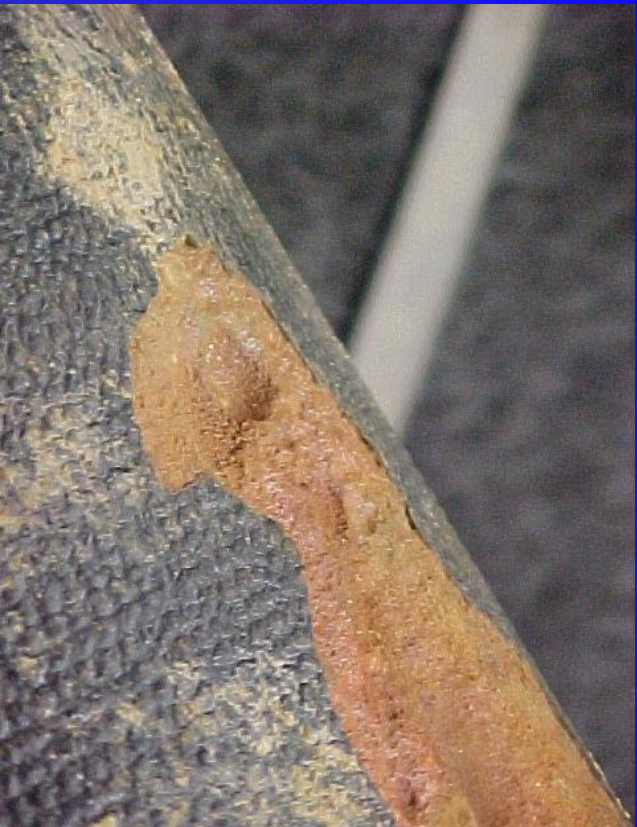
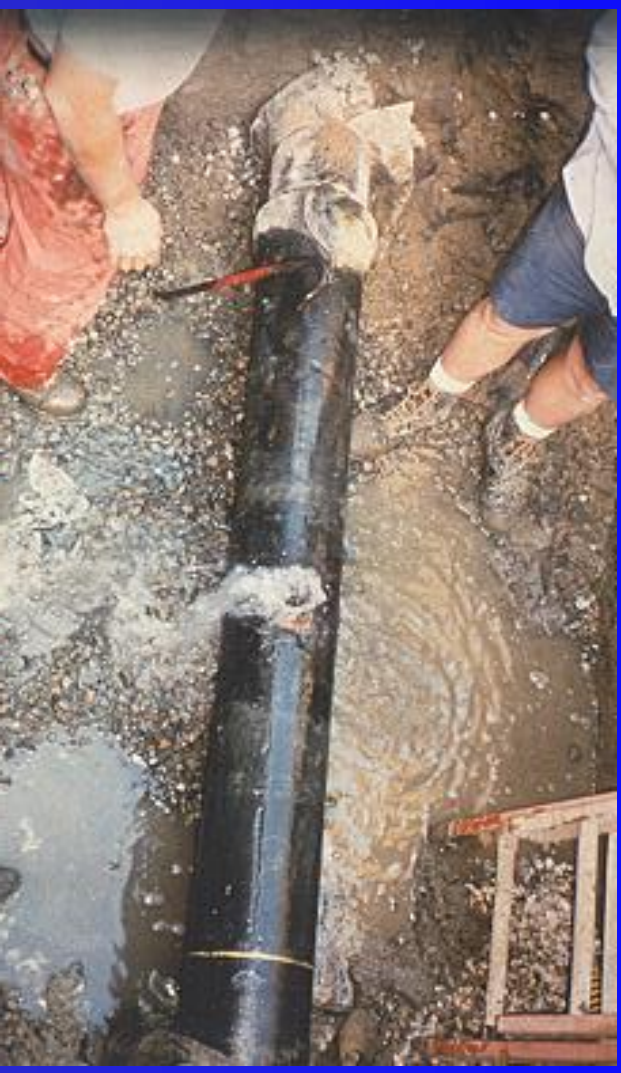
Pitting (concentrated)  
corrosion attack on ductile iron  
pipe.

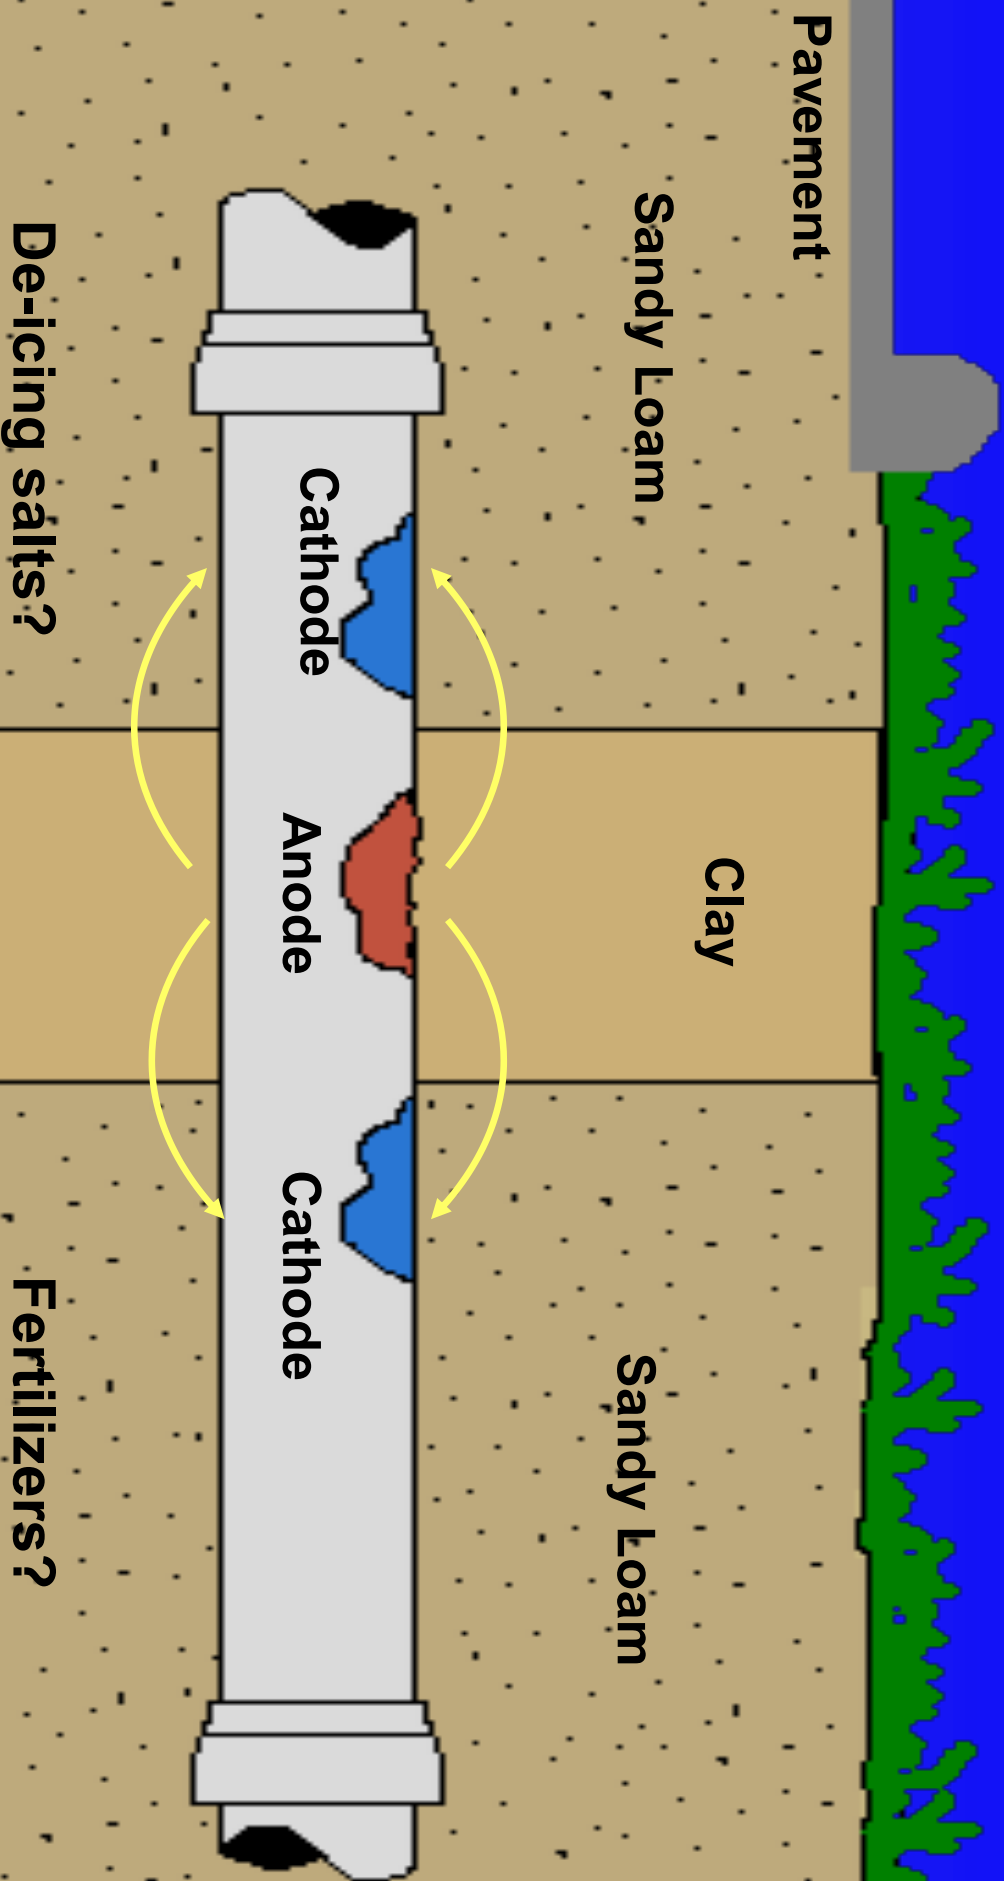
# Dissimilar Soils

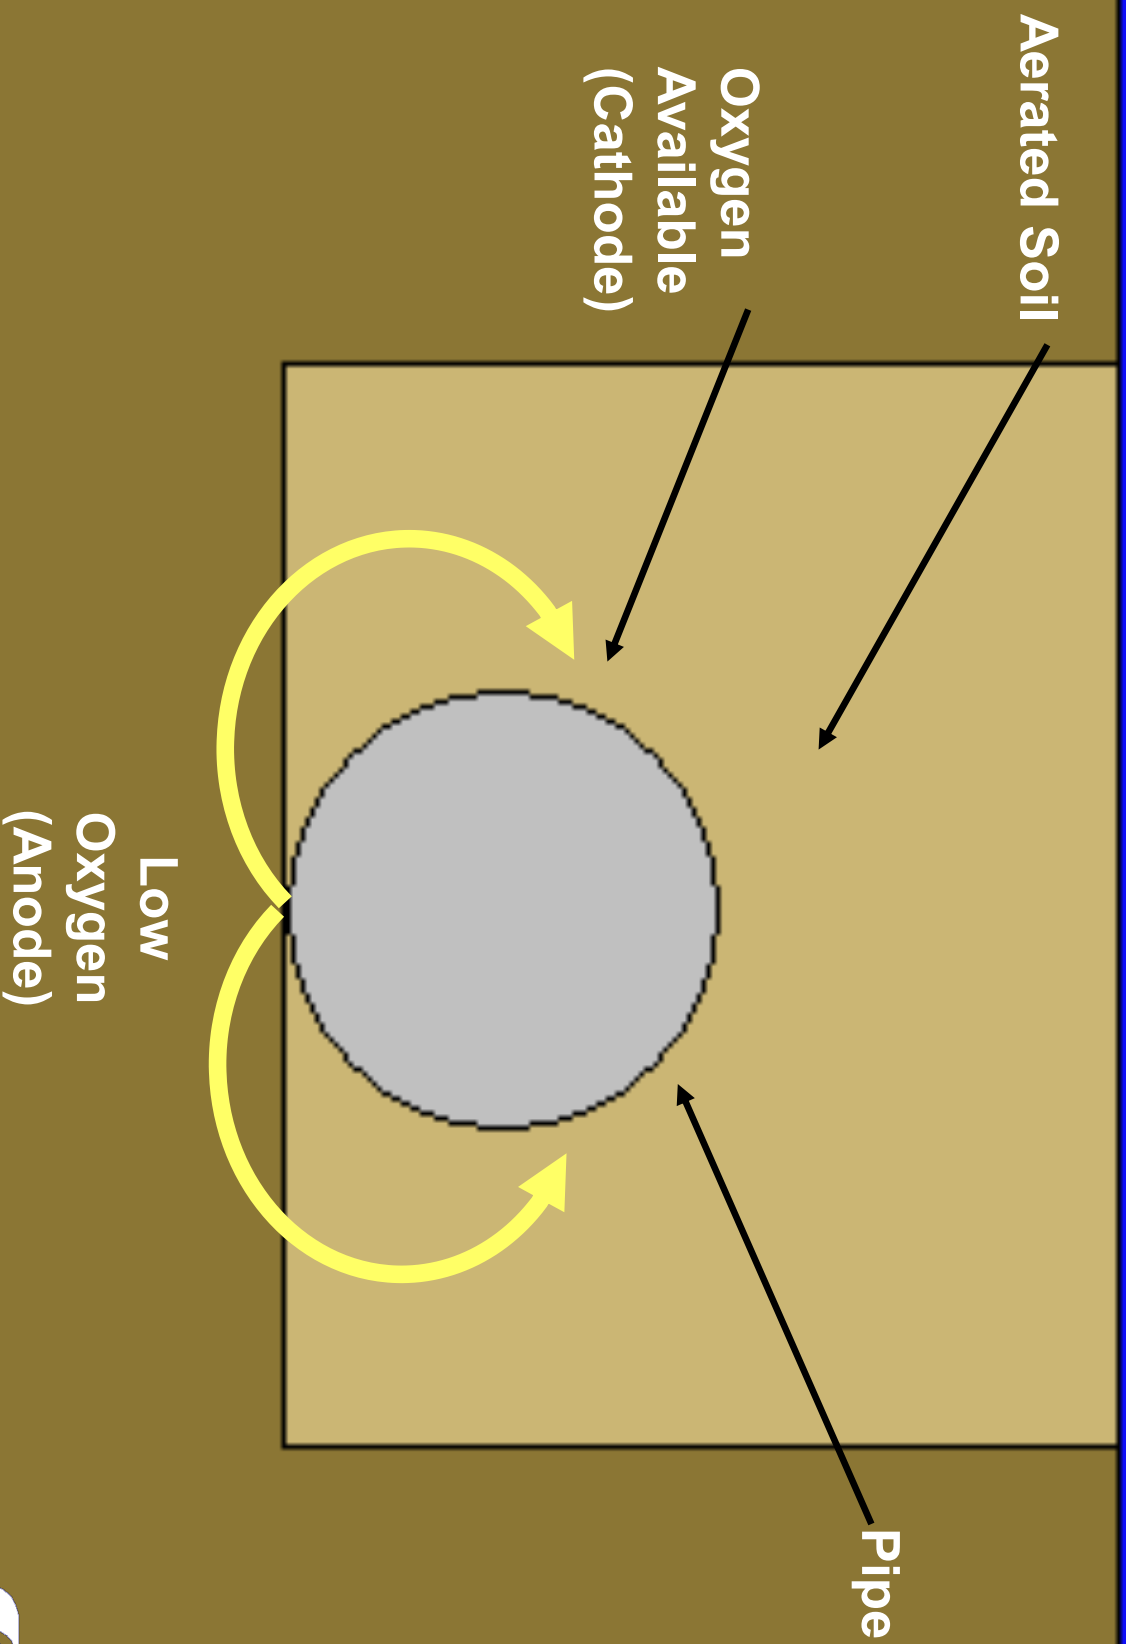
# Corrosion Caused by Differential Aeration

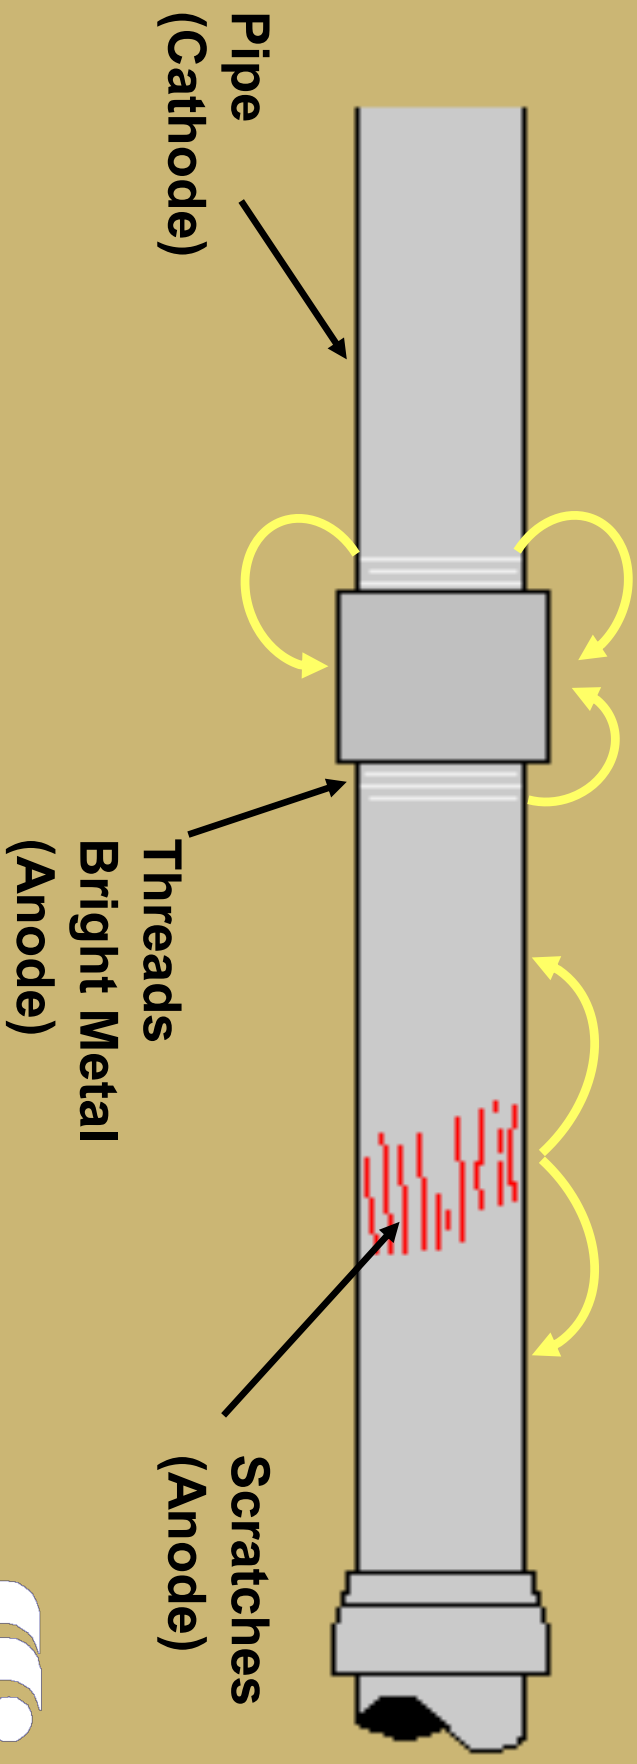
# Dissimilar Surface Conditions

# Dissimilar Surface Conditions

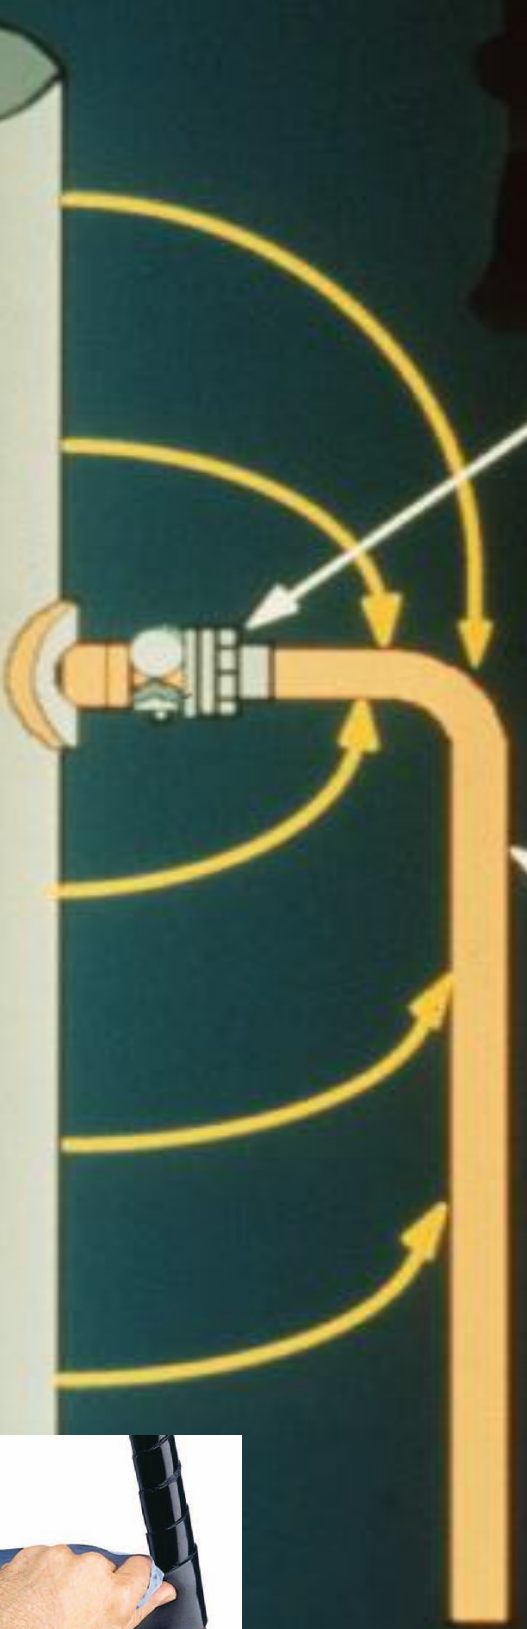
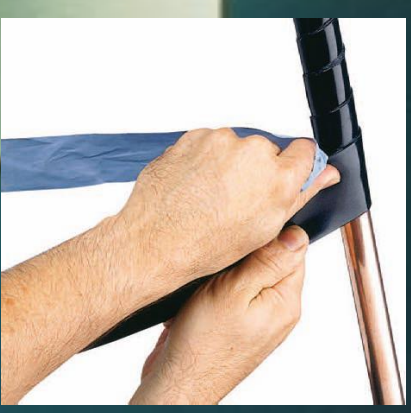
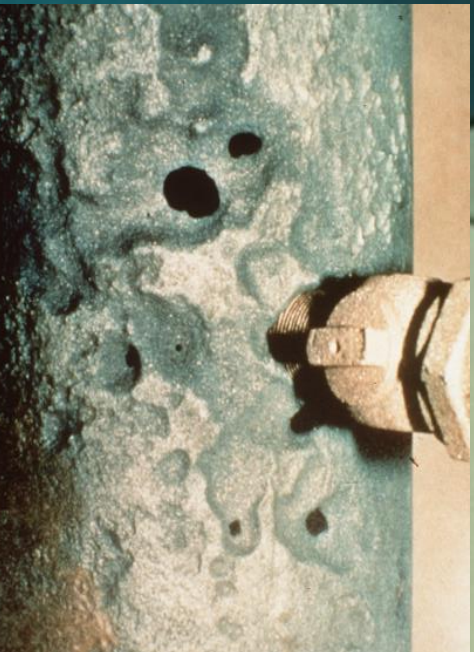
**Metallic  
Connection**

**Copper service (Cathode)  
- 300mV**

**Iron pipe (Anode)  
- 500mV**

Corrosion of iron when coupled to copper service line.

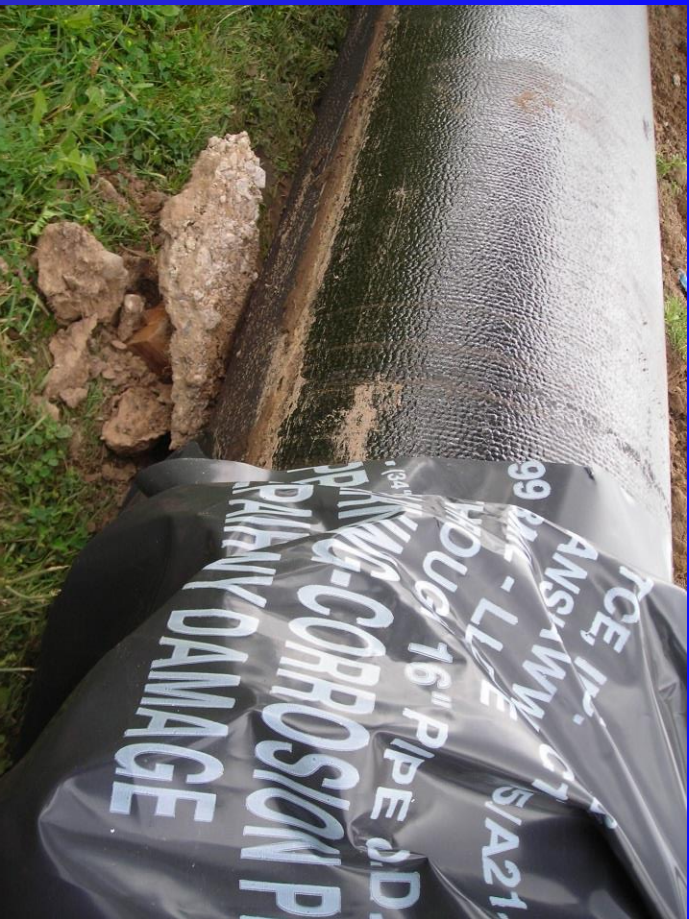
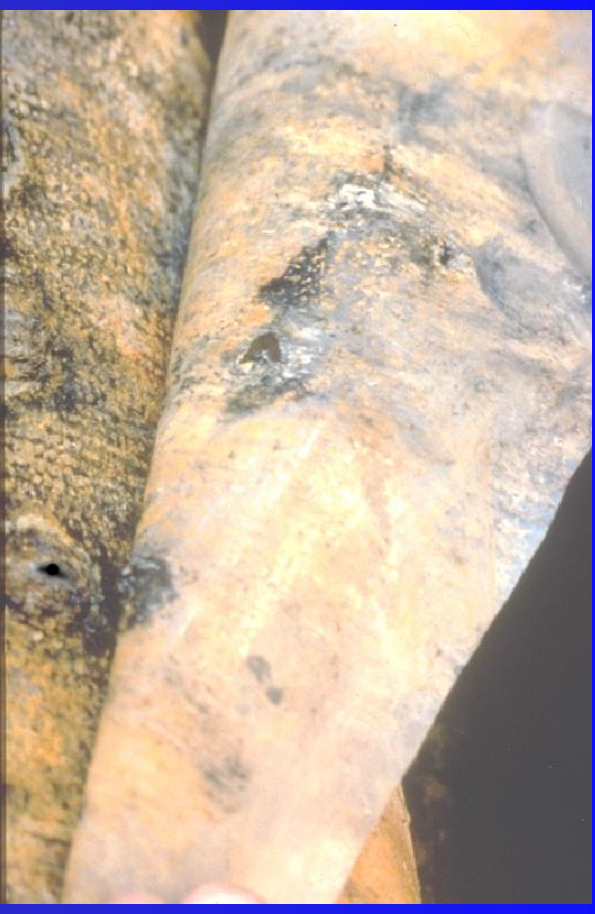
# Polyethylene Encasement of Ductile Iron Pipe

- Follow DIPRA installation procedures
- Clean pipe before installing polywrap
- Repair tears or damage to encasement
- Engage an inspector to oversee installation

- Follow manufacturer's and AWWA recommendations to insure proper installation of polyethylene encasement.

- In extremely corrosive areas, additional methods (bonding of joints, cathodic protection, may be required).

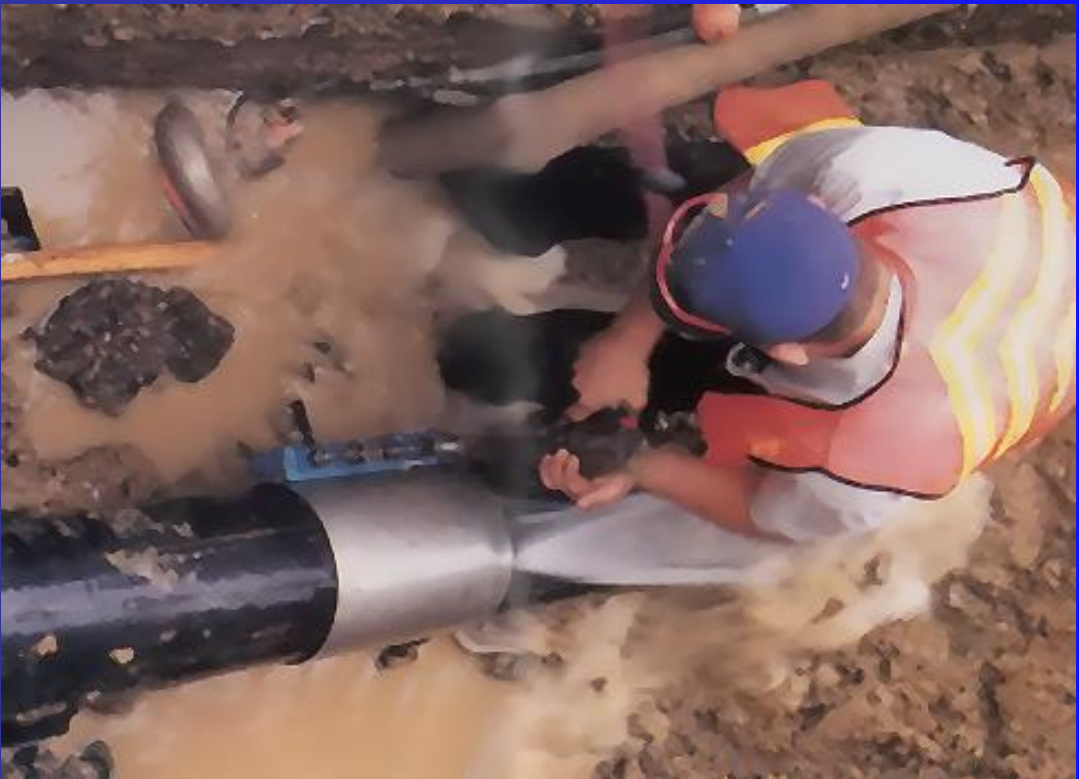
**Incomplete**

# Repair of Break Should Include Anode Installation

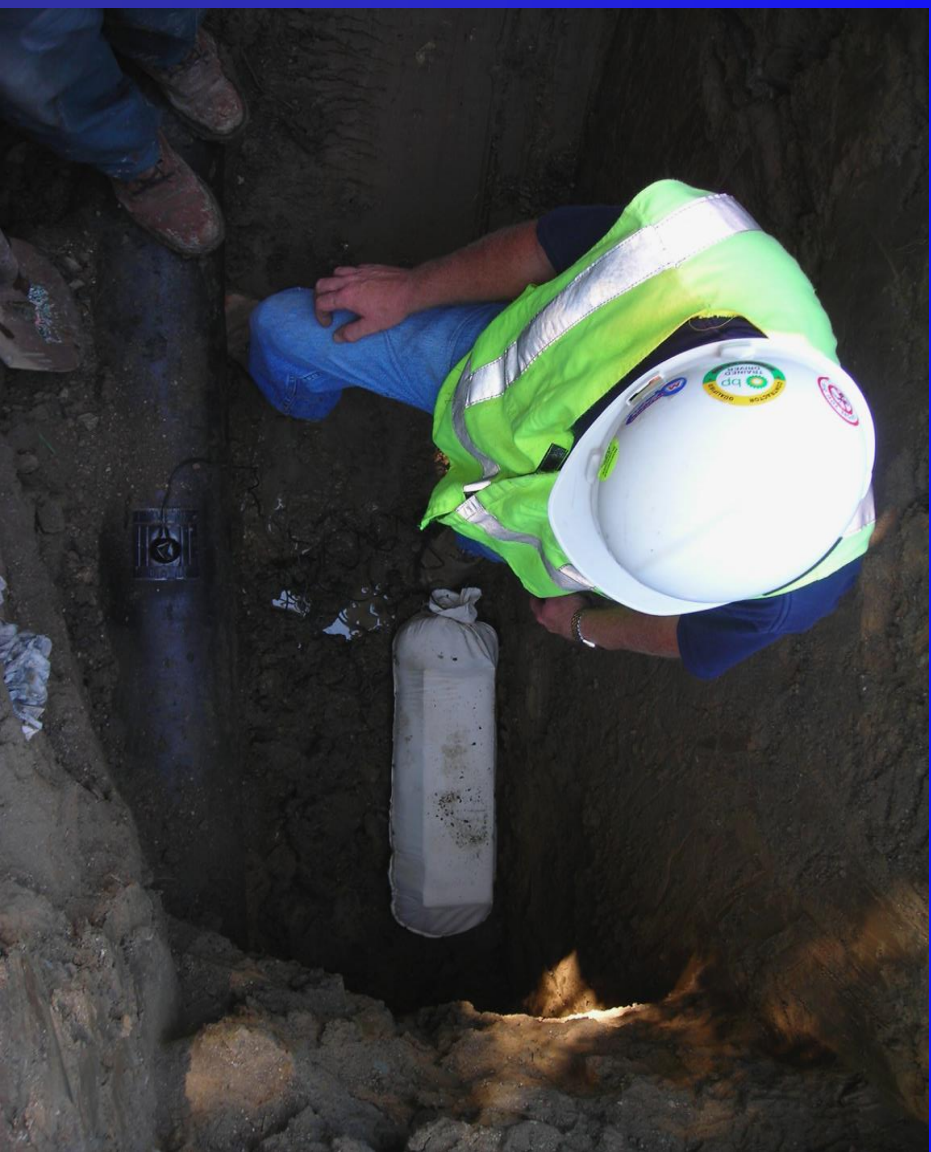
**Complete**

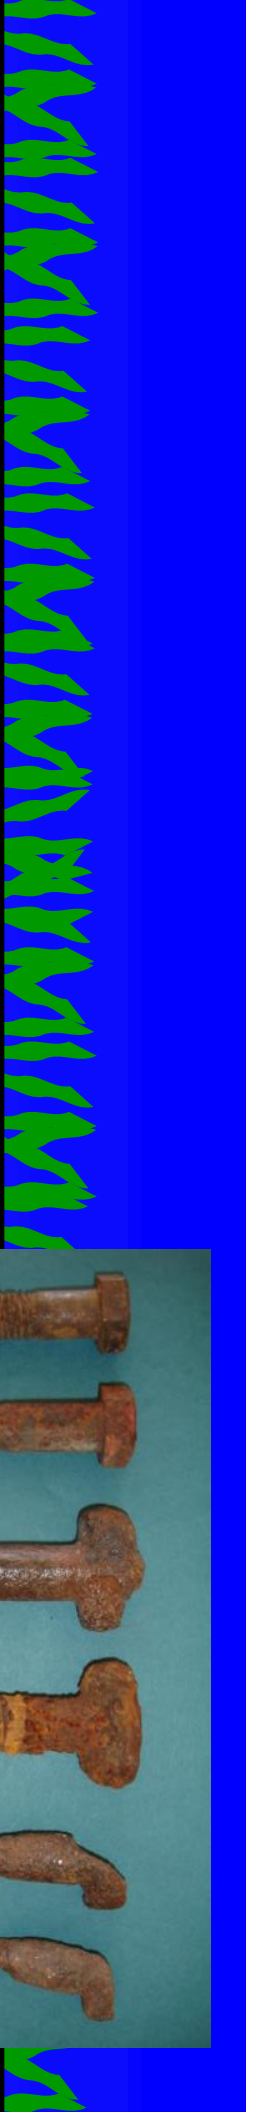
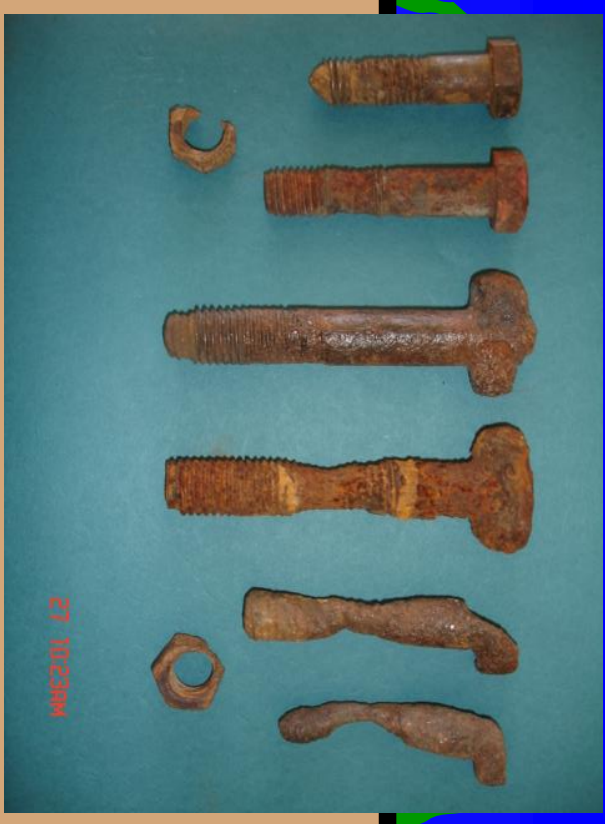
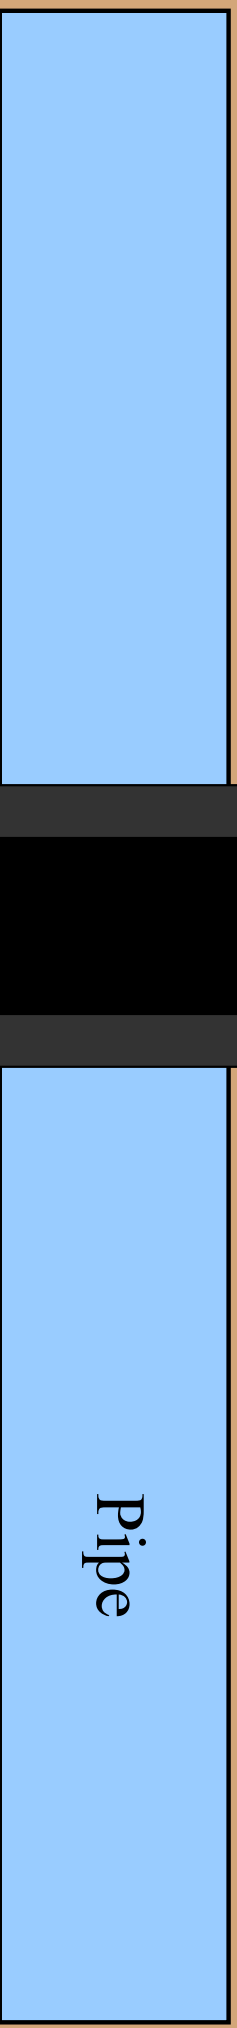
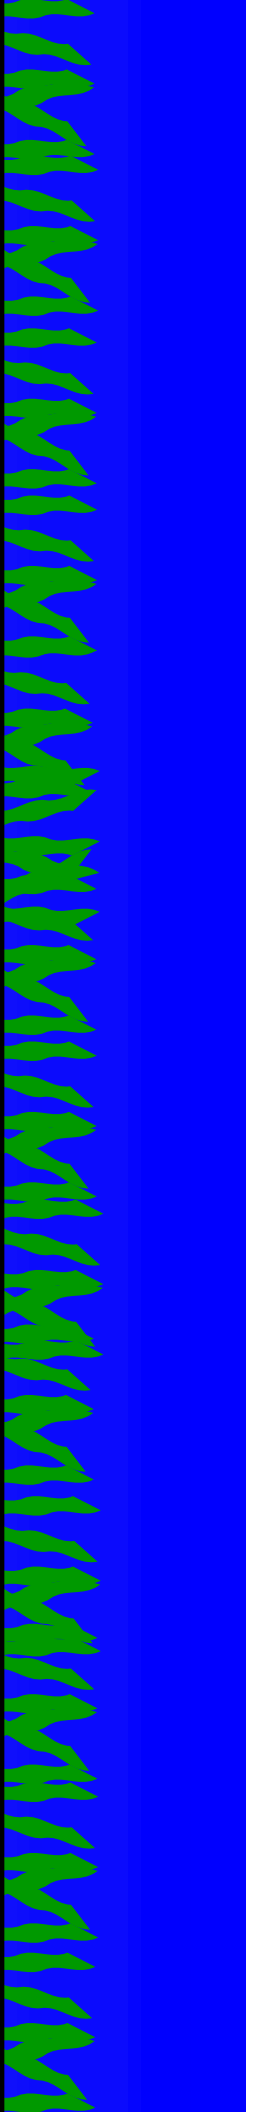
Stress Corrosion

Lower Stress Area  
(Cathode)

Threaded Bolt  
Higher Stress Area  
(Anode)

Metallic Coupling

Pipe

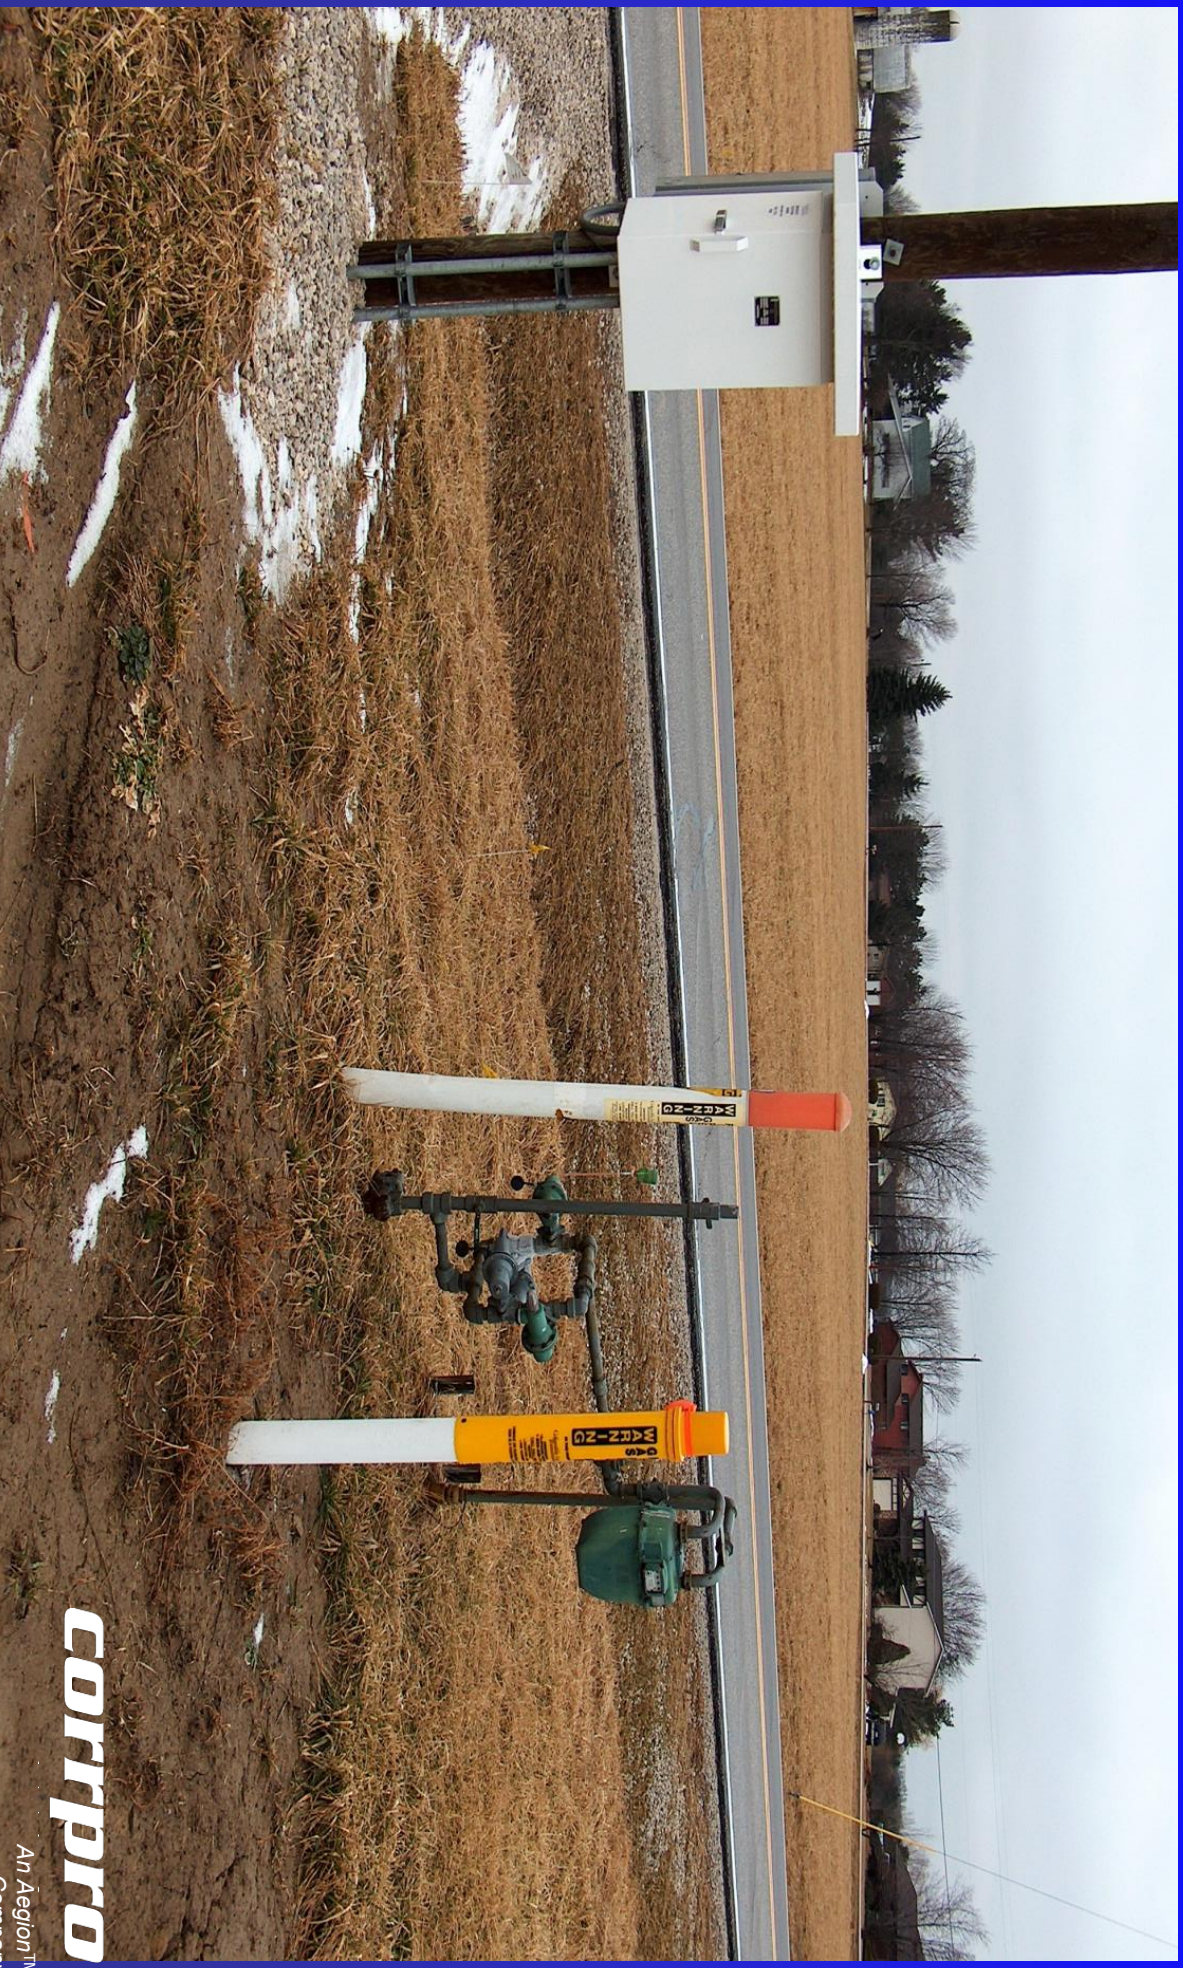
# Impressed Current CP System on Oil/Gas Lines can Create Stray Current Problem on Water Lines

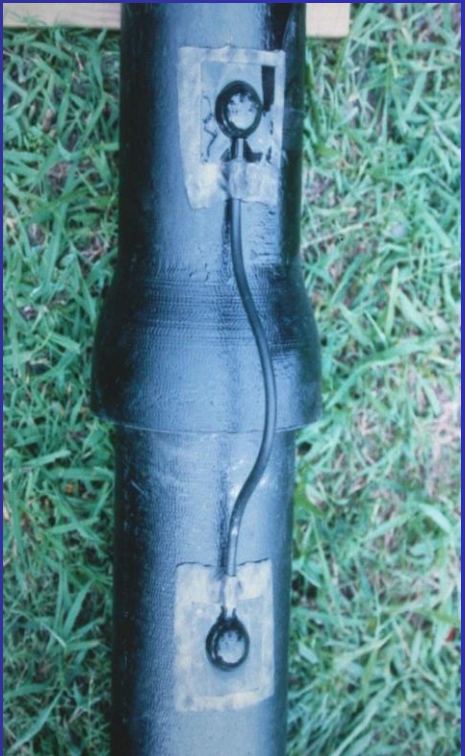
# Bonding Across a Bell and Spigot or Slip-joint

Thermite brazed  
connection coated with  
bitumous compound

Copper wire with  
direct burial insulation

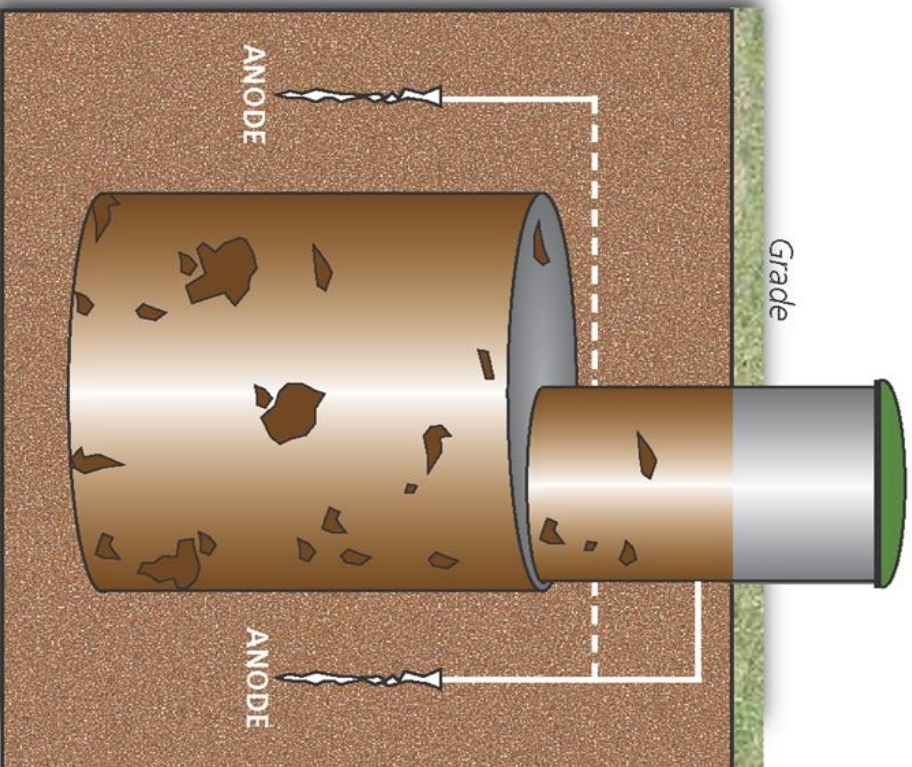
# Depleted & Refurbished Cathodic Protection for Lift Stations

Depleted cathodic protection system allows corrosion to occur.

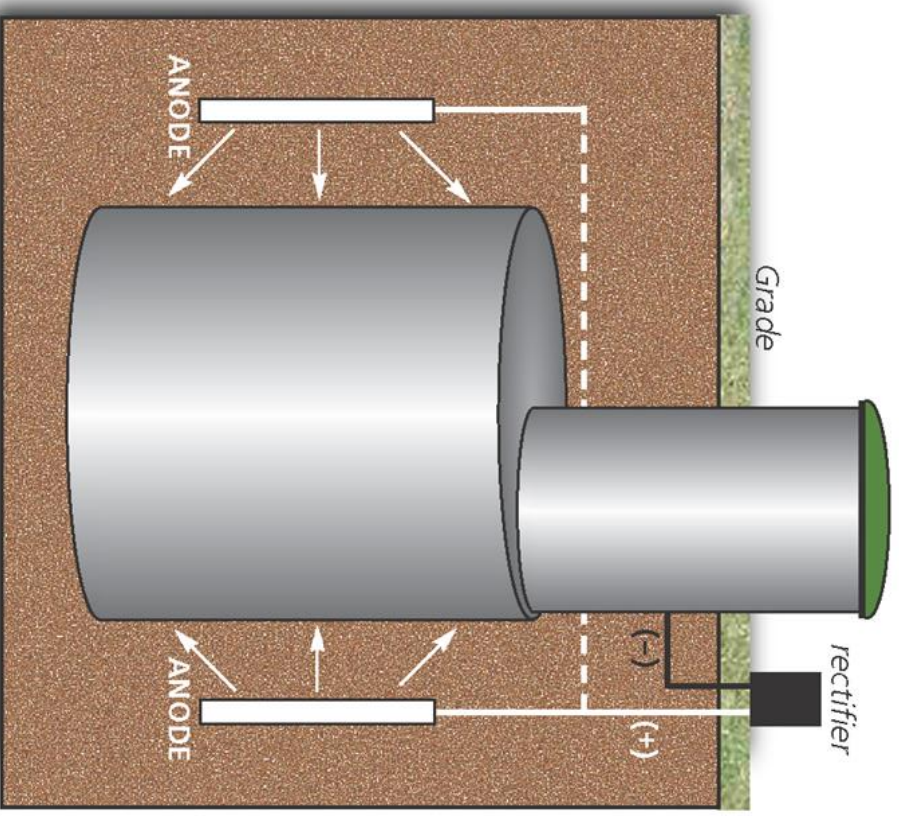
Effective cathodic protection system prevents corrosion and extends life of lift station.
