# Corrosion Control of Buried Piping

**James T Lary**

**Corrpro**

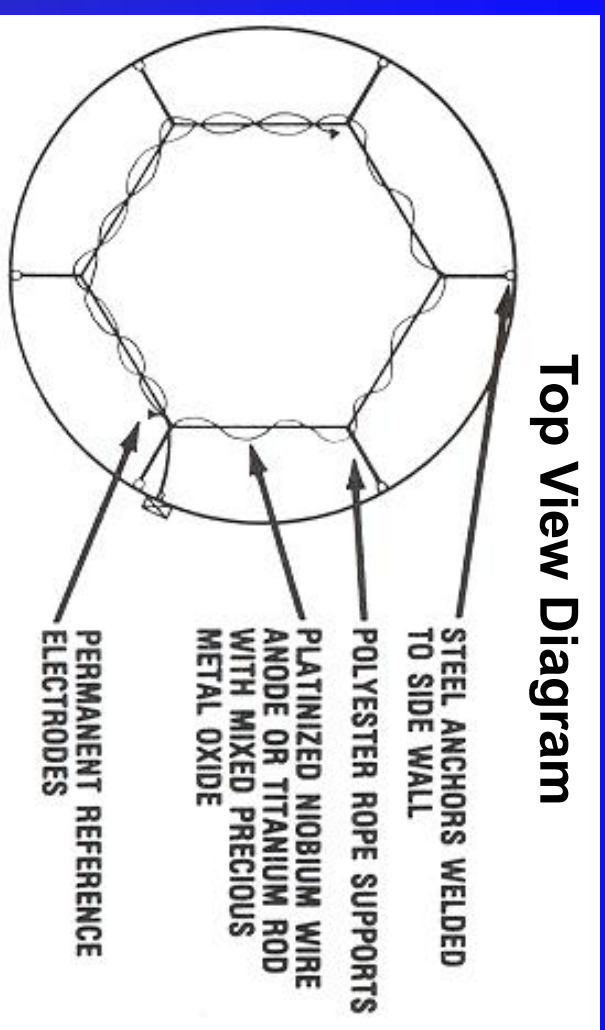
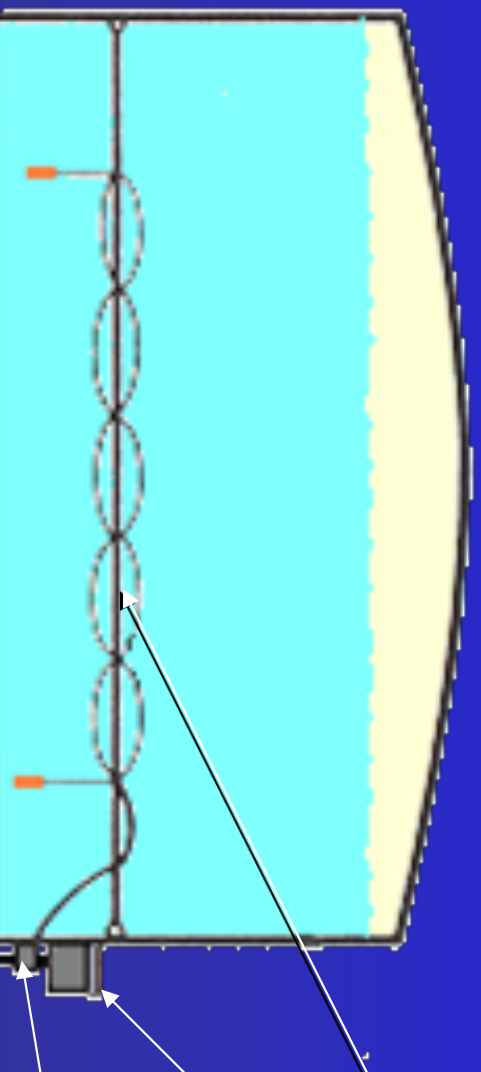
# Suspended Horizontal Anode System

- Submerged Anode Support System
- Automatic Potential Control Rectifier
- Pressure Entrance Fitting

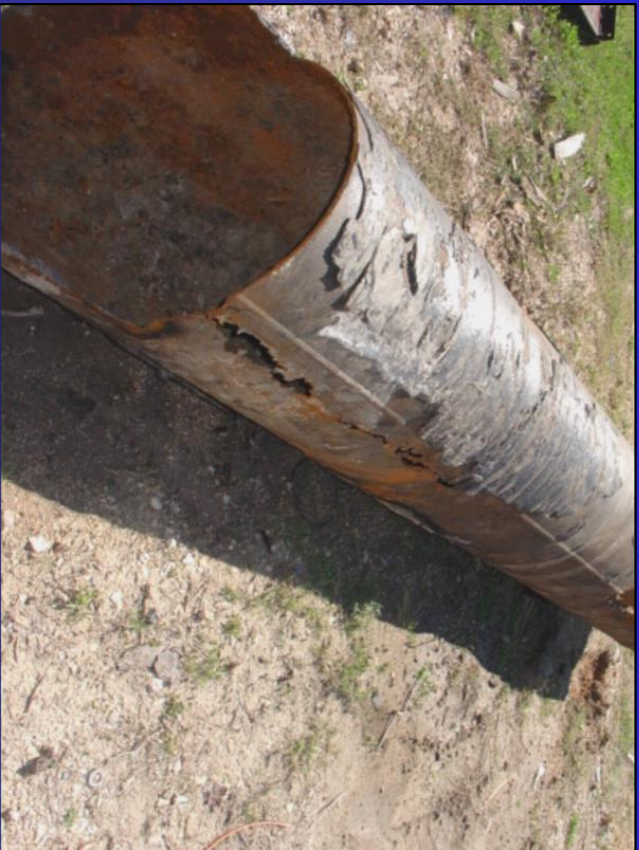
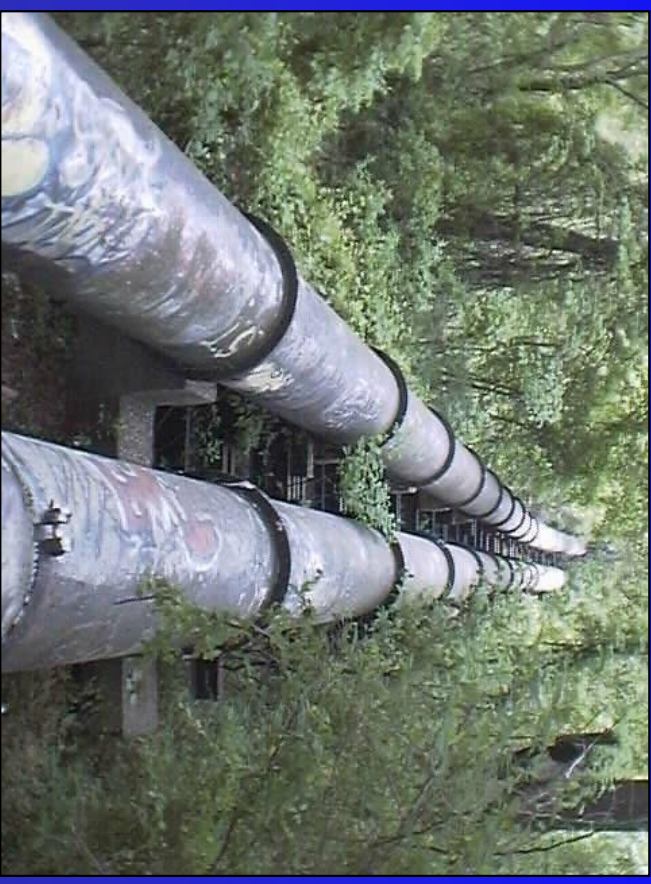
# 36" Above Ground Crossing

- Failure of force main at above ground crossing
- Crown of pipe attacked by hydrogen sulfide gas

- Failure of force main at above ground crossing
- Crown of pipe attacked by hydrogen sulfide gas

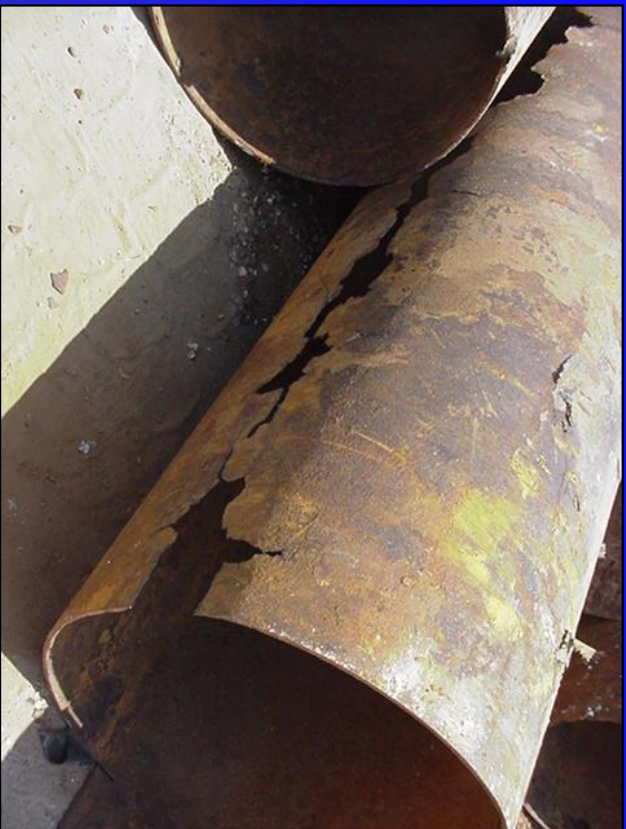
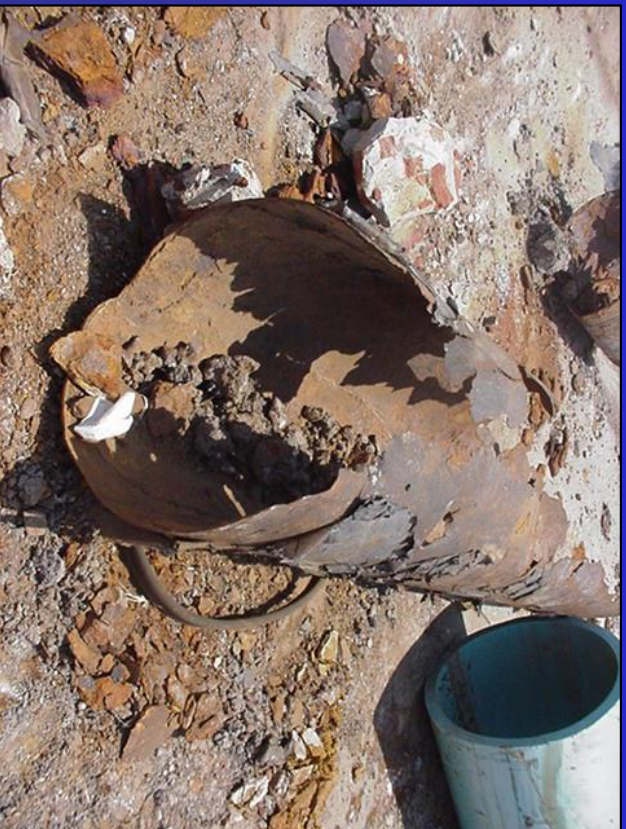
# 24" Ductile Iron Force Main

- Internal failure following loss of internal mortar lining
- Failure was along top of pipe due to formation of hydrogen sulfide gas

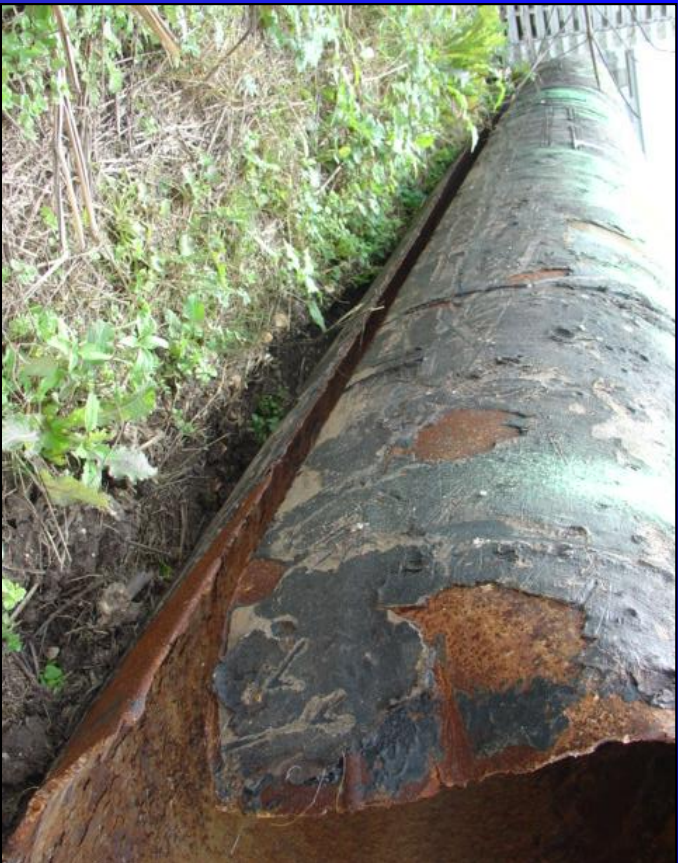
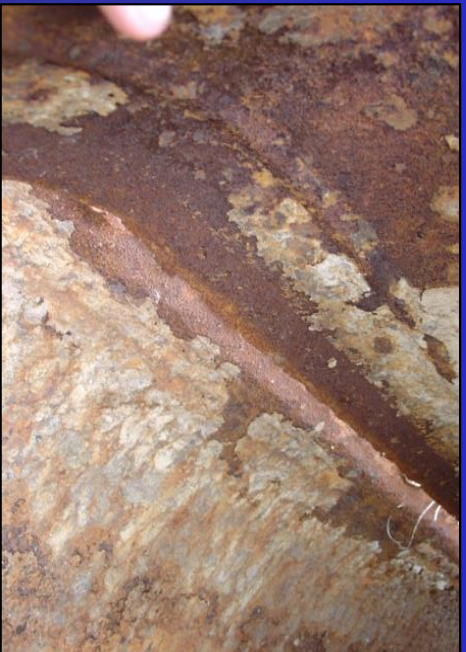
# Dual 26" Force Mains

- Internal failures at bottom of pipe
- Failure following loss of internal mortar lining
- Failures concentrated at low areas (dips) in pipeline alignment
- Cause is corrosion under accumulated solids

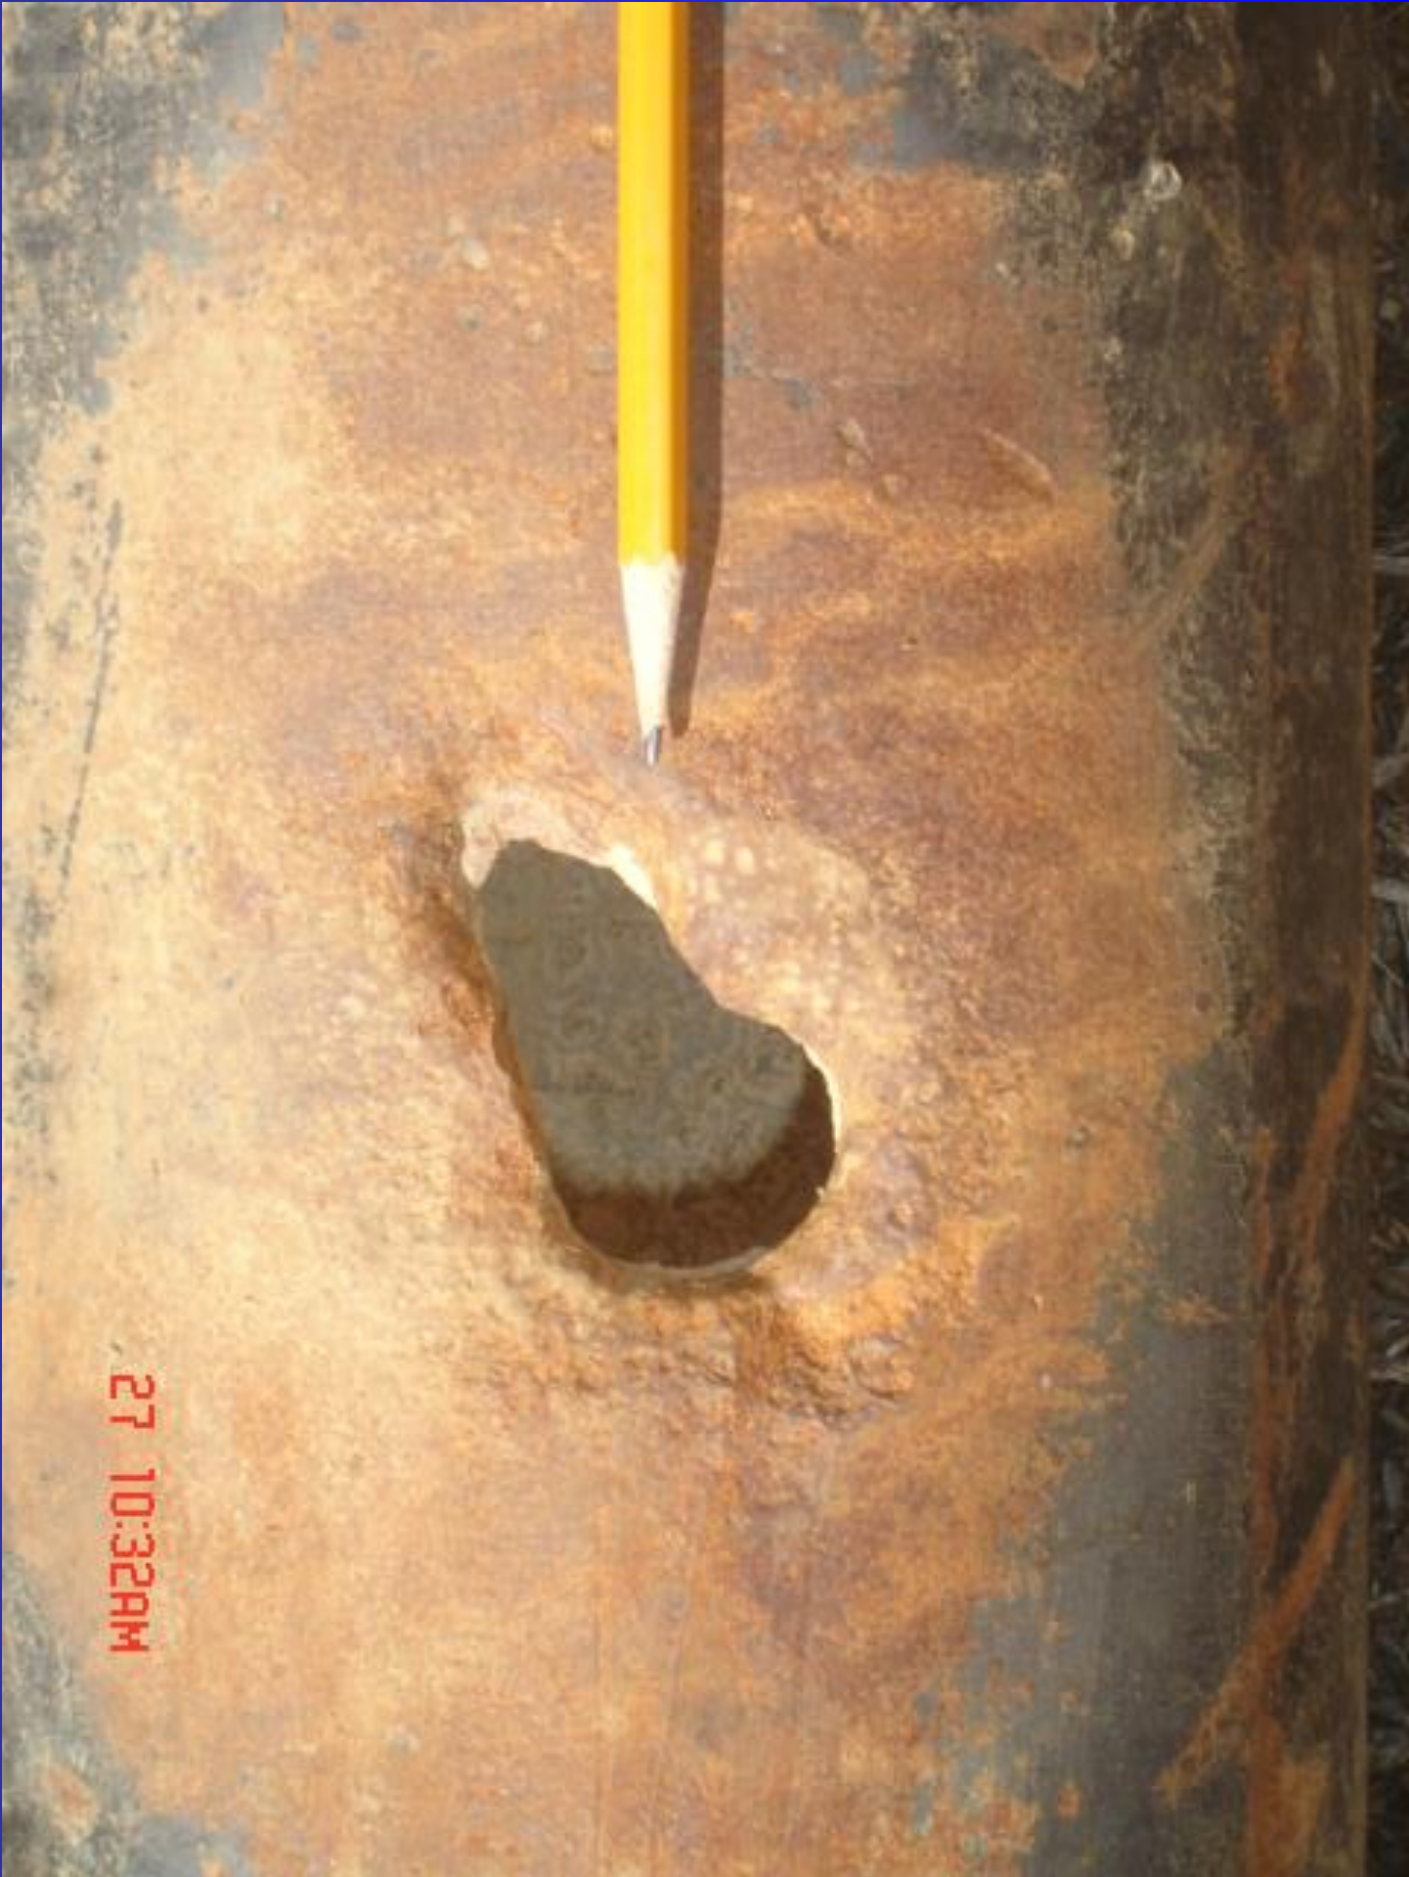
# Impressed Current CP System on Oil/Gas Lines can Create Stray Current Problem on Water Lines

**Transformer Rectifier**

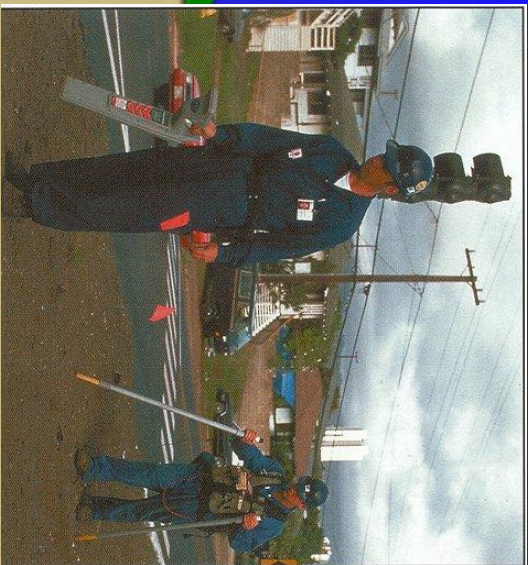
# Computerized Potential Logging Survey

Test Station

Backpack  
Computer Unit  
Chainer/Wire  
Dispenser &  
Counter

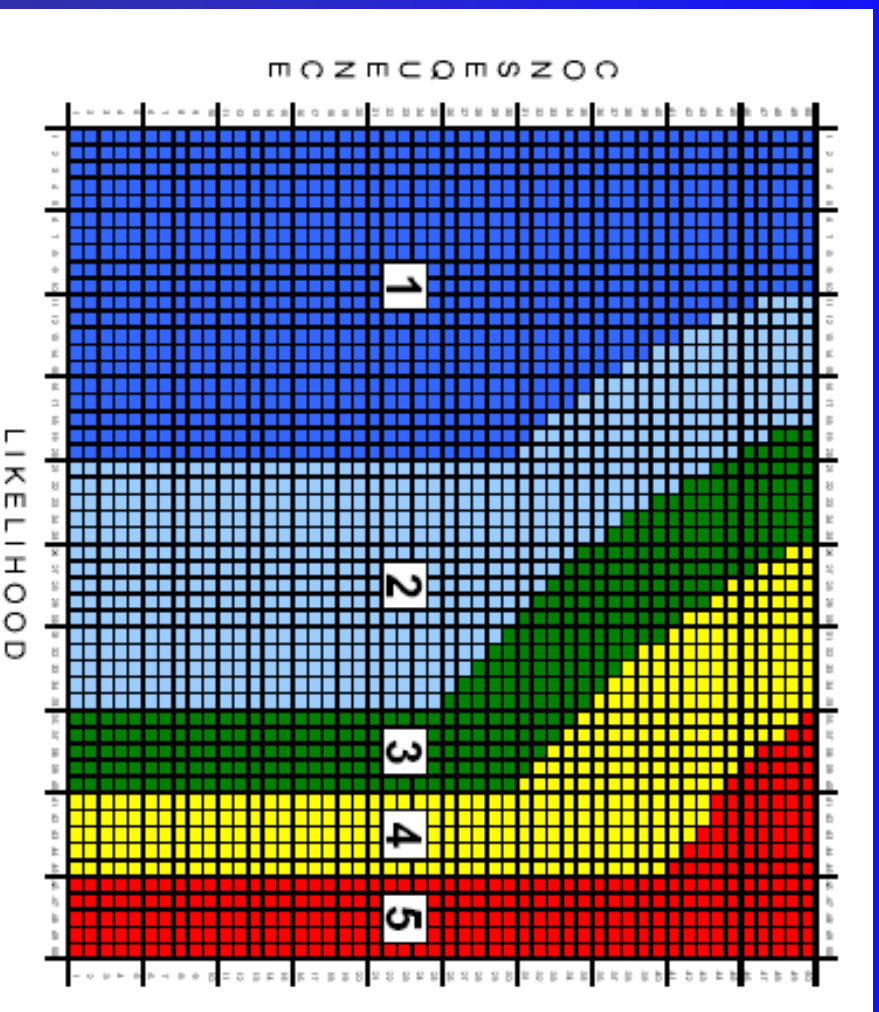
# Design Decision Model

*For Ductile Iron Pipe*

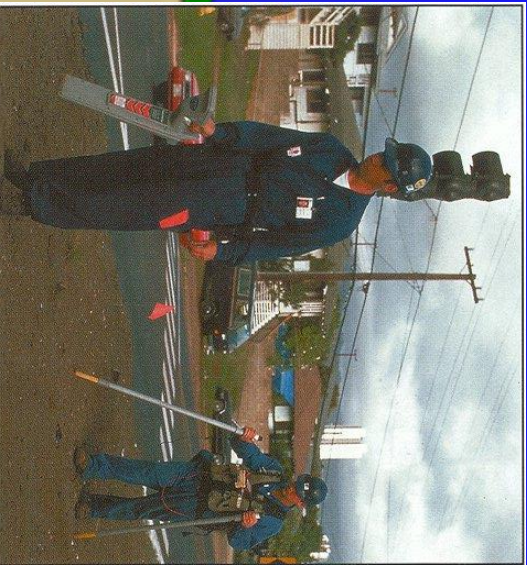
# Computerized Potential Logging Survey

Test Station

Backpack Computer Unit

Chainer/Wire Dispenser & Counter

Reference Cells

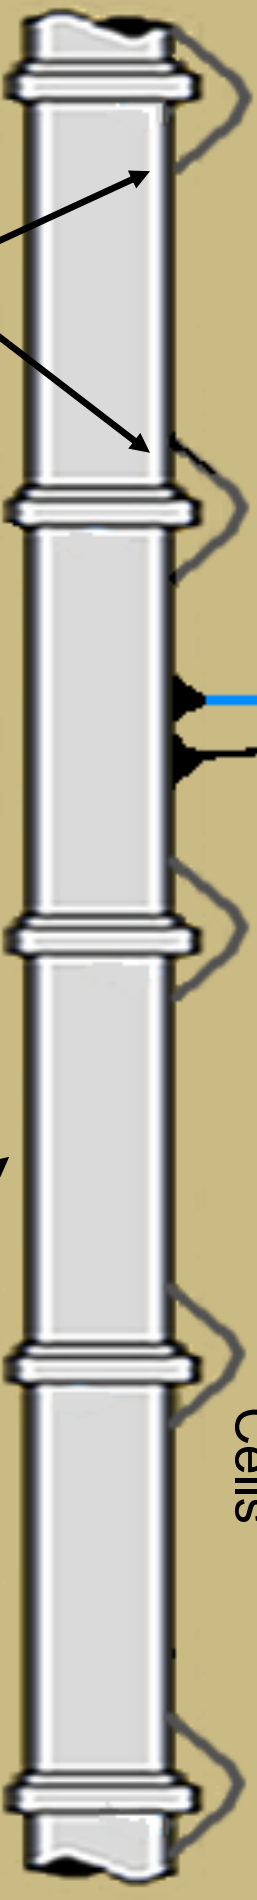
Bonded Joints

Pipeline

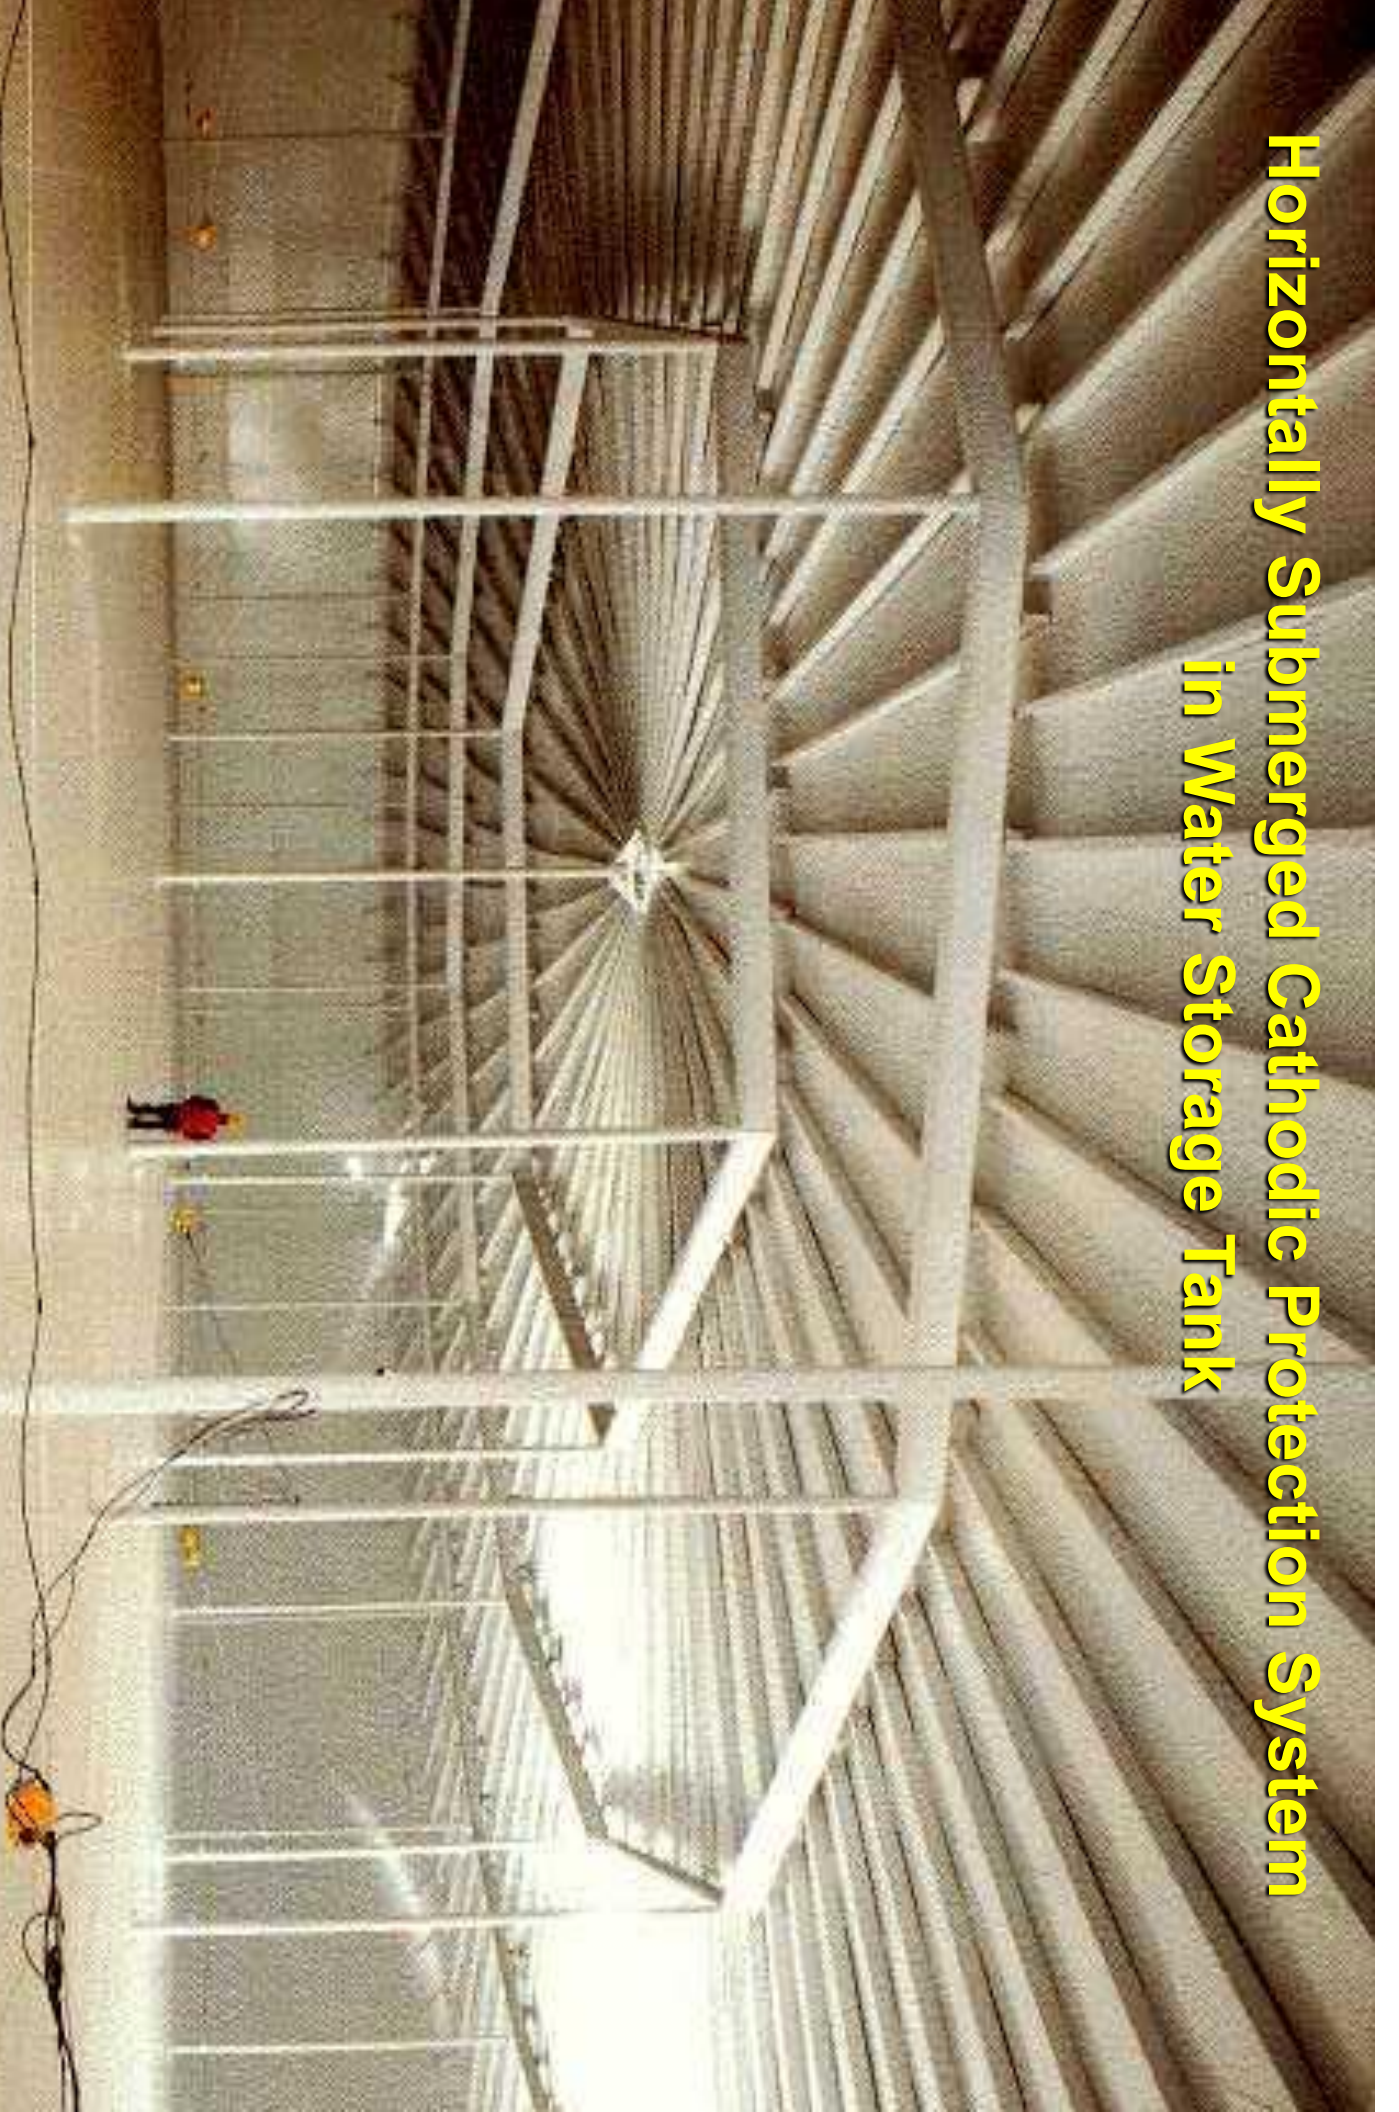
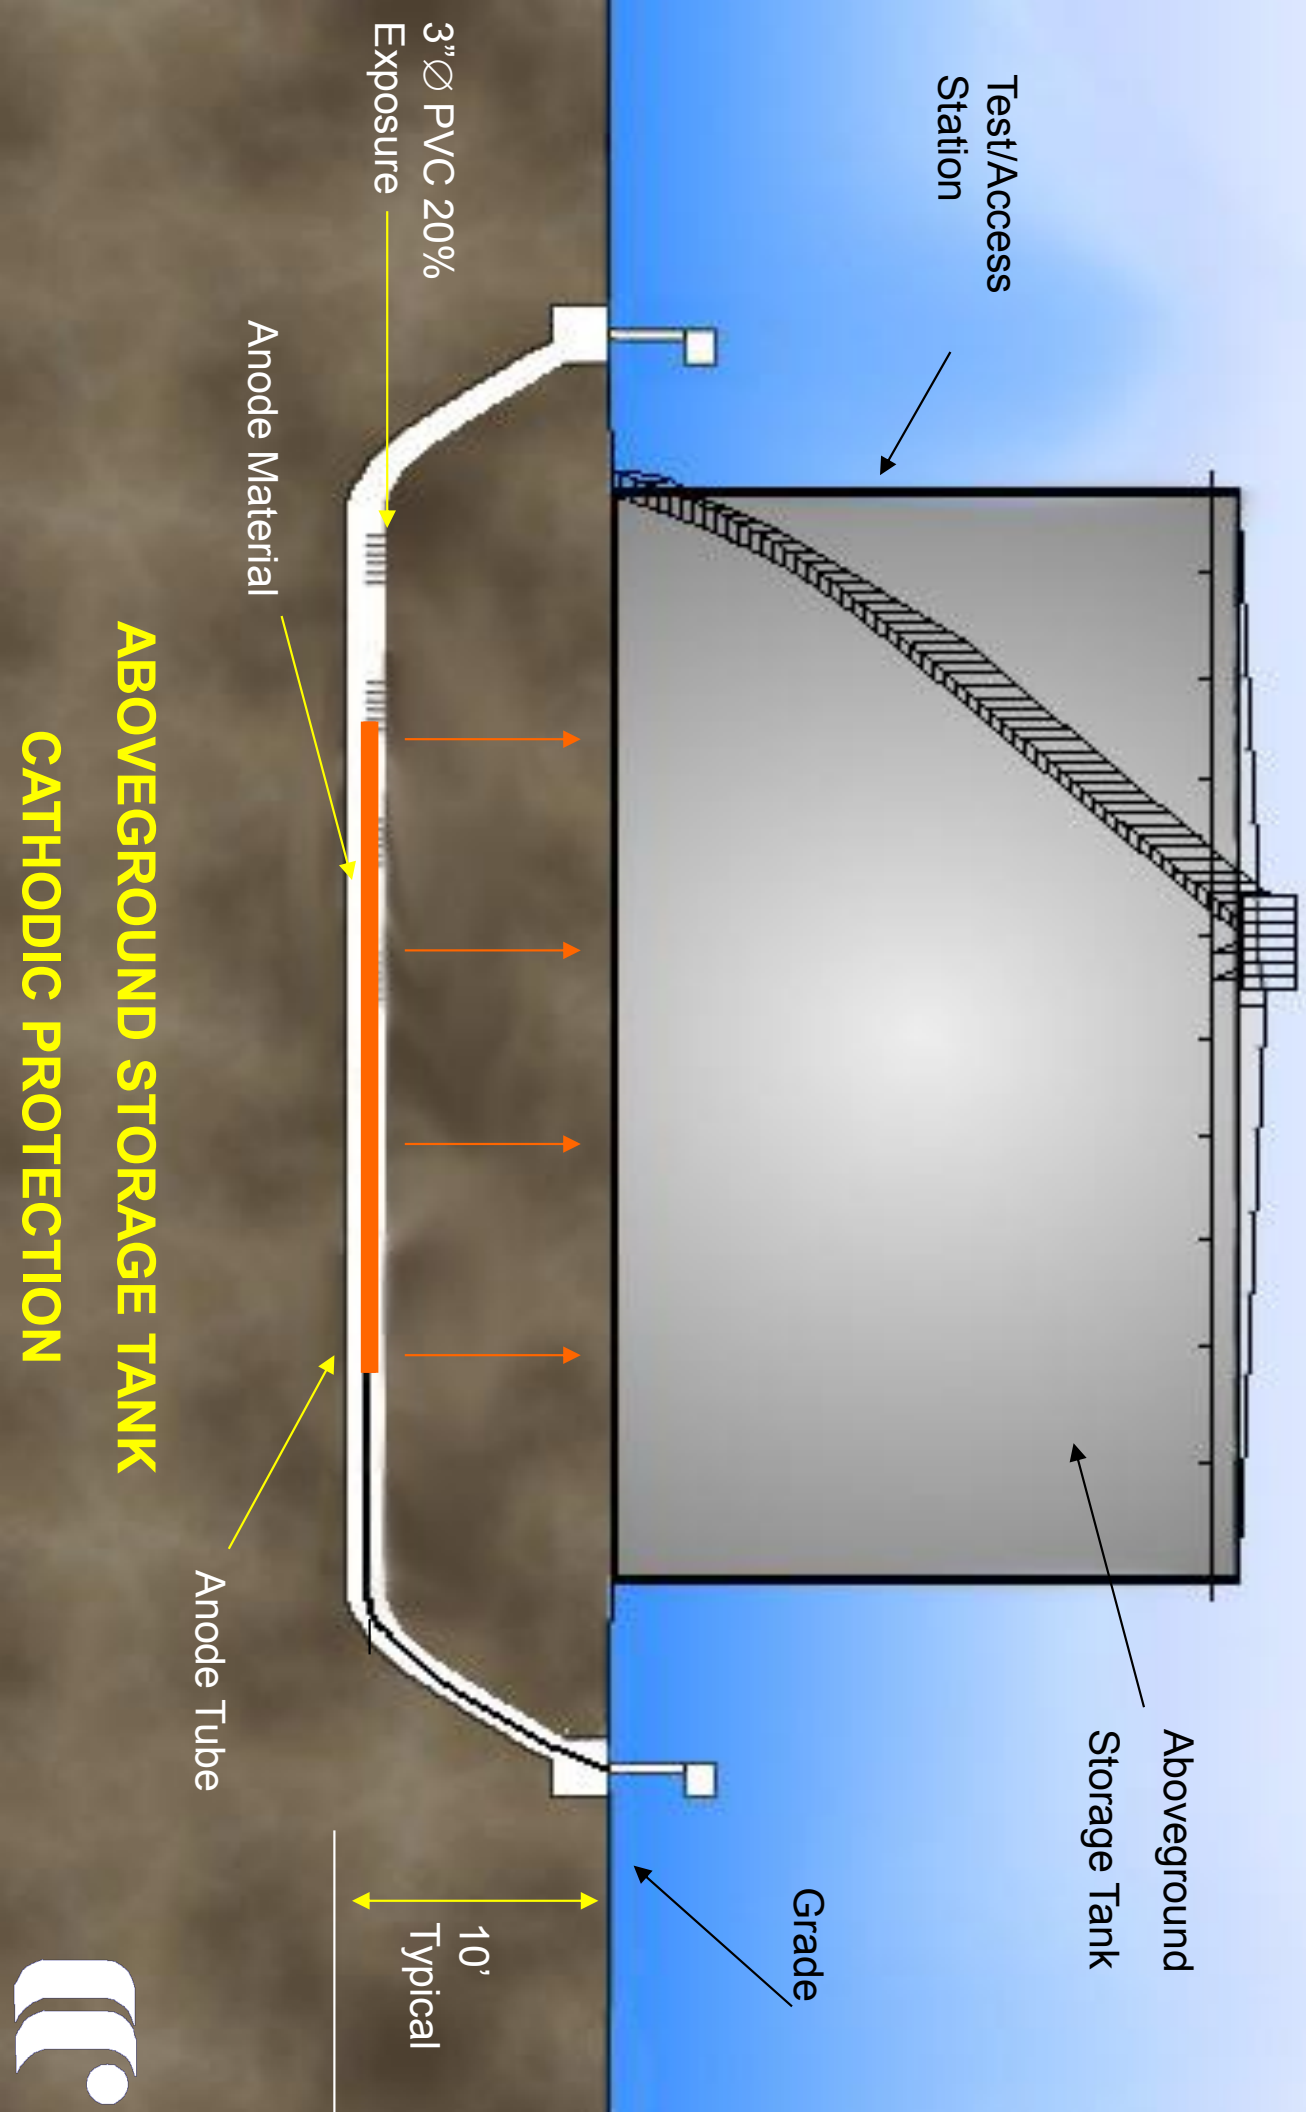
# Horizontally Submerged Cathodic Protection System in Water Storage Tank

**ABOVEGROUND STORAGE TANK  
CATHODIC PROTECTION**

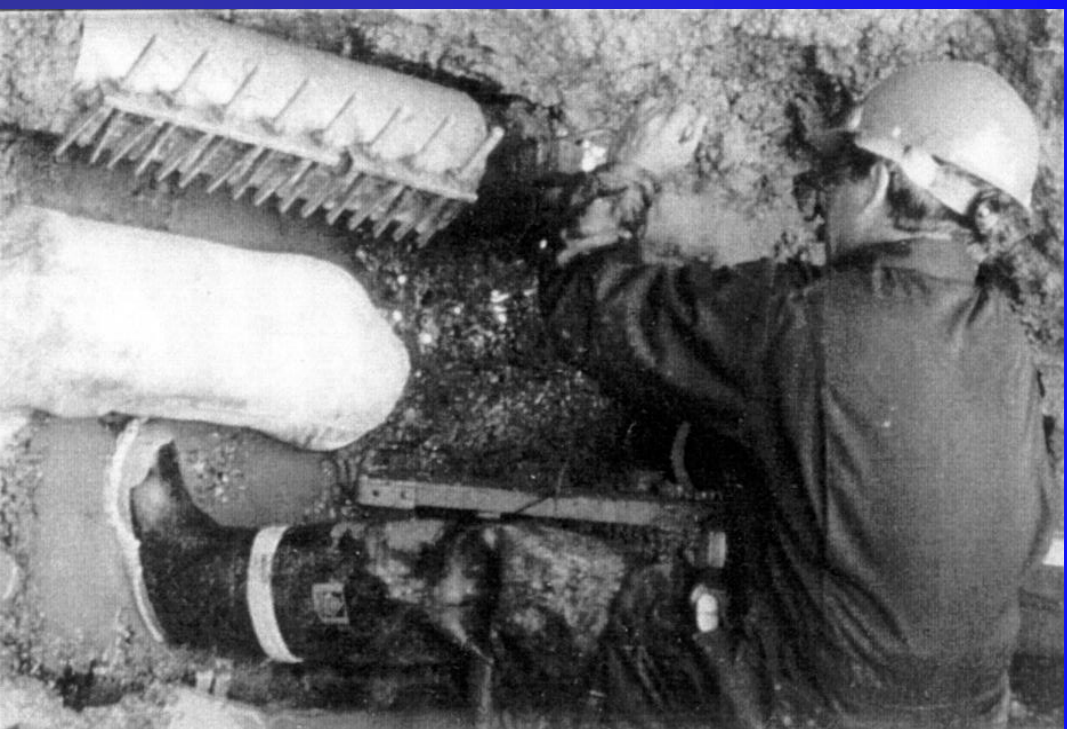
**Incomplete**

**Complete**

# Repair of Break Should Include Anode Installation

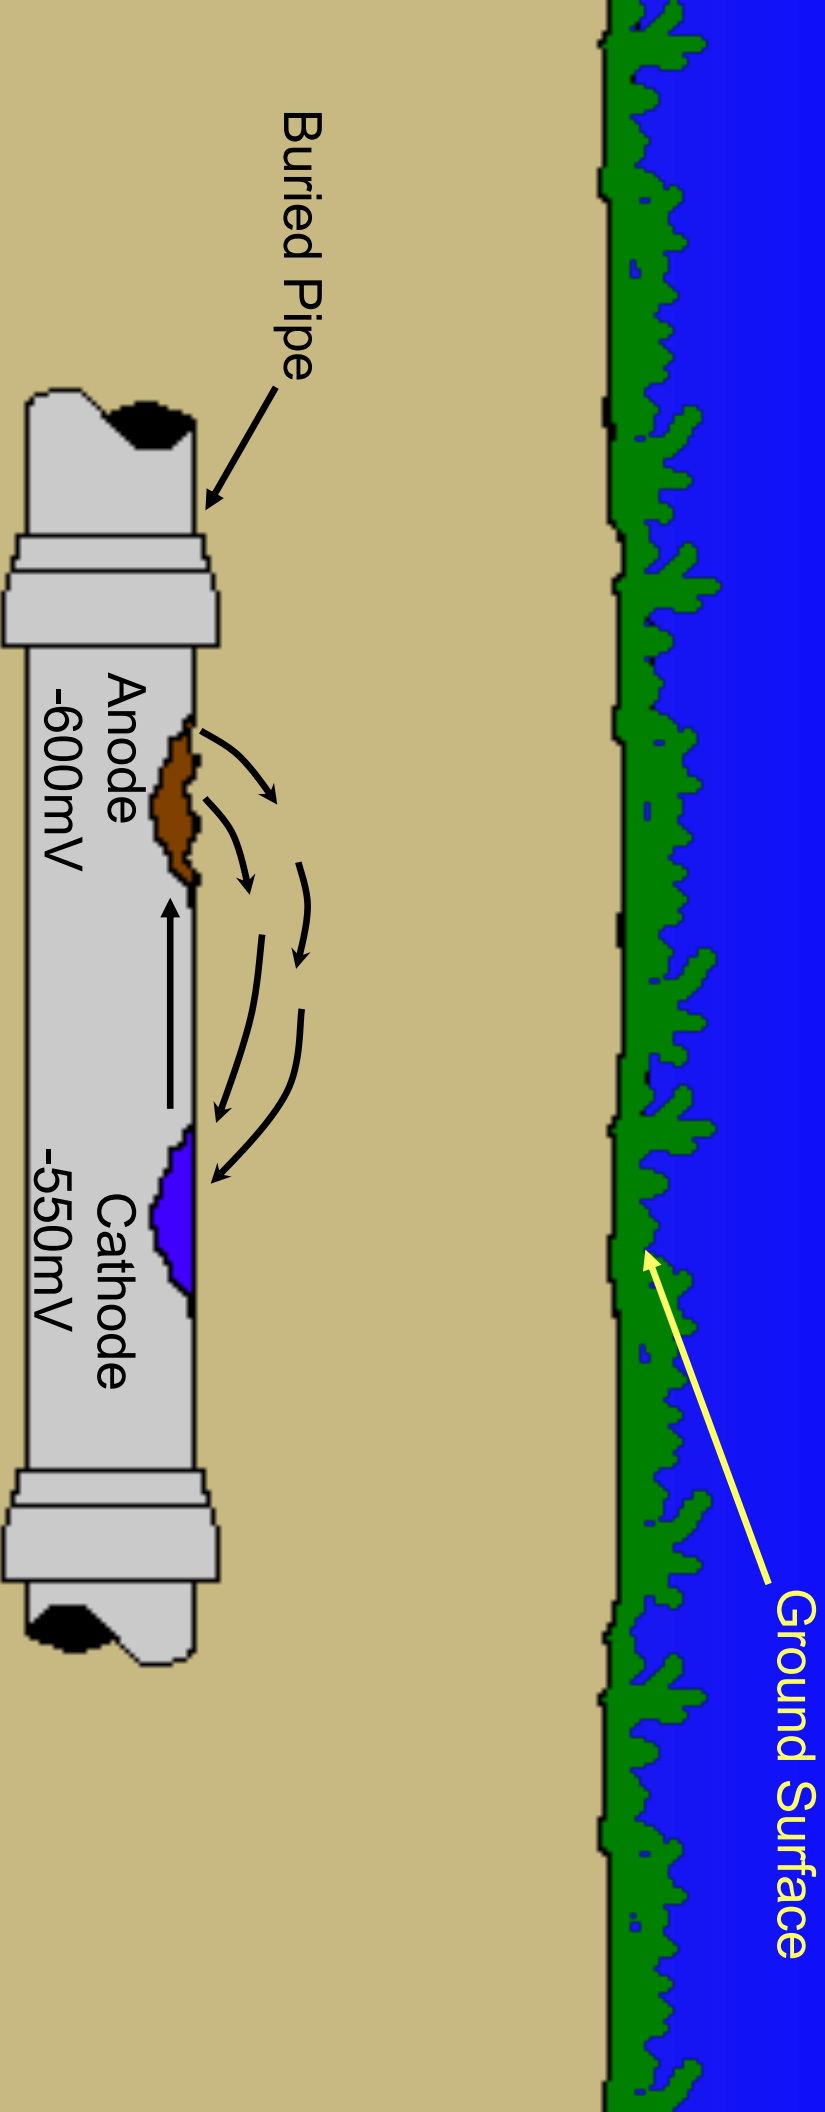
# Basic Corrosion Cell

- 1) Anode
- 2) Cathode
- 3) Electrolyte
- 4) Electrical Connection

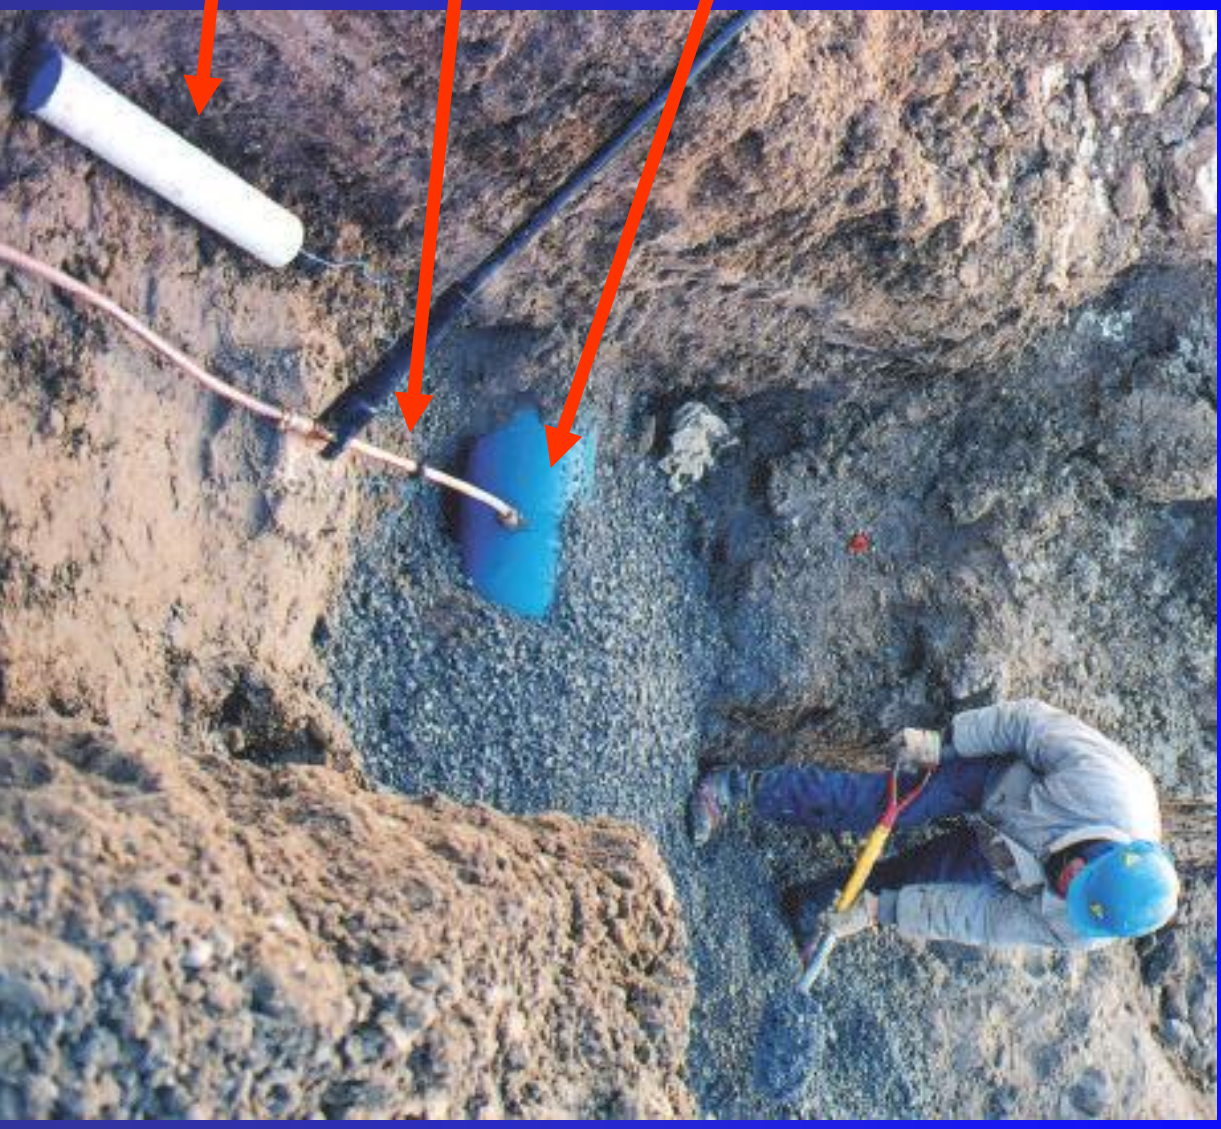
# Anode Installation Prevents Corrosion on Copper Service Line

Non metallic or  
Polyethylene Encased  
Ductile Iron Main

Anode Connection to Line

Anode

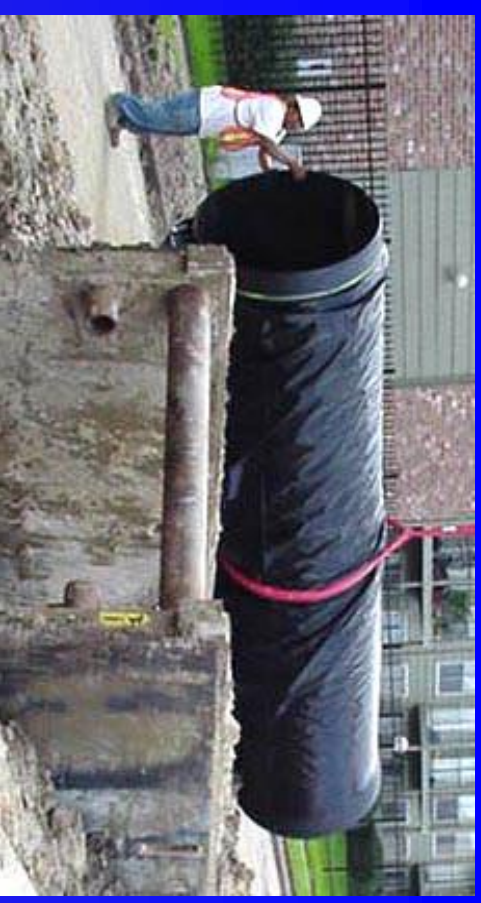
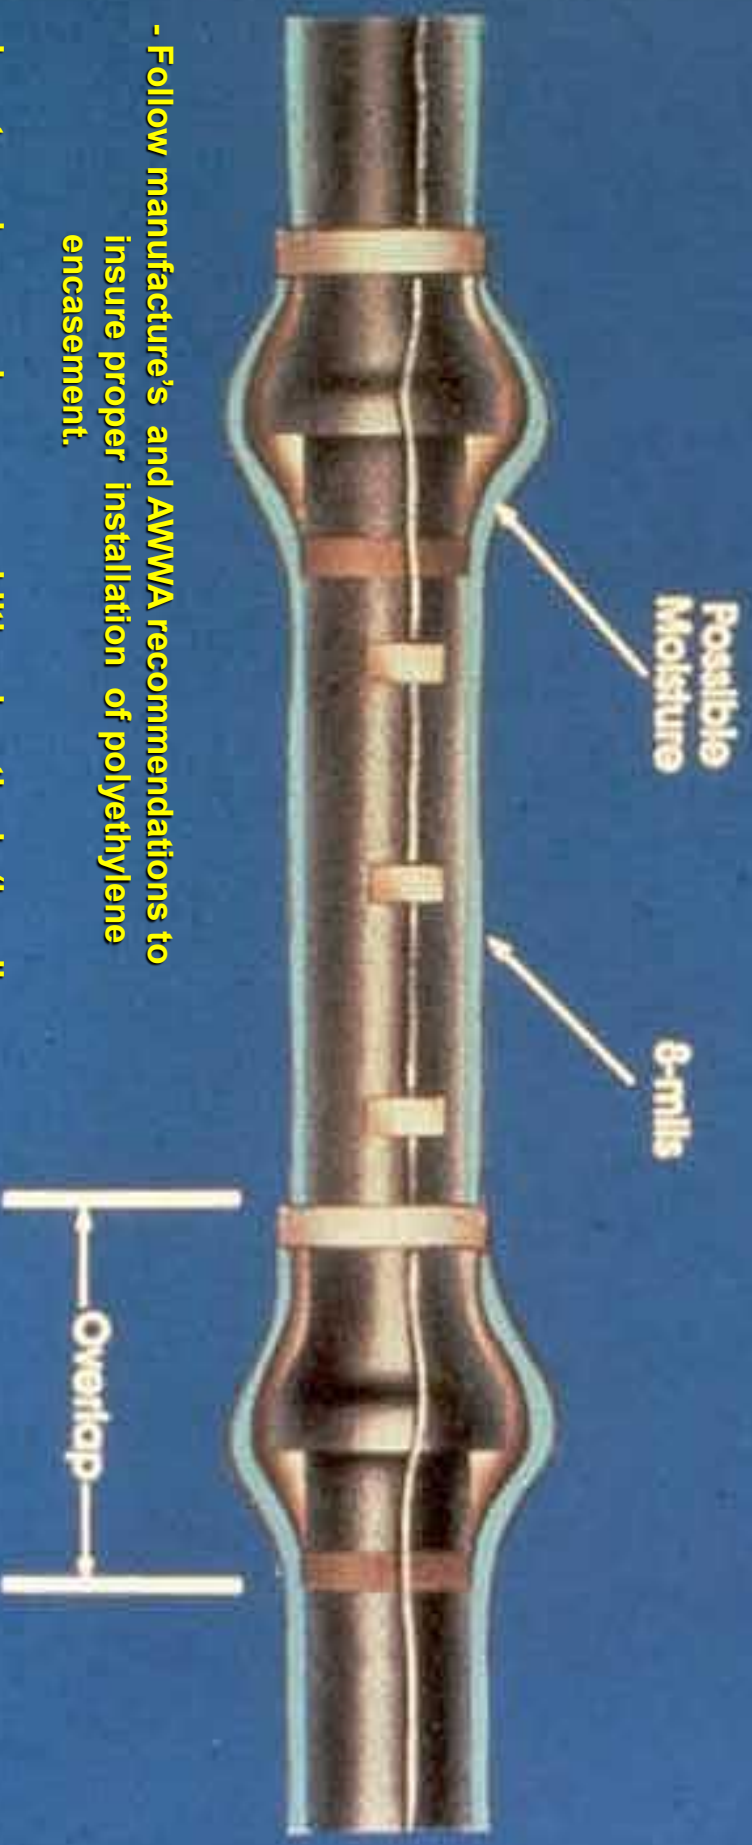
# Polyethylene Encasement

- Follow manufacturer's and AWWA recommendations to insure proper installation of polyethylene encasement.

- In extremely corrosive areas, additional methods (bonding of joints, cathodic protection, may be required).

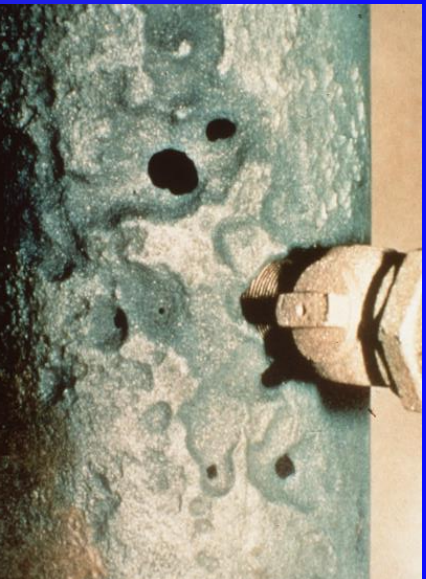
Corrosion of iron when coupled to copper service line.

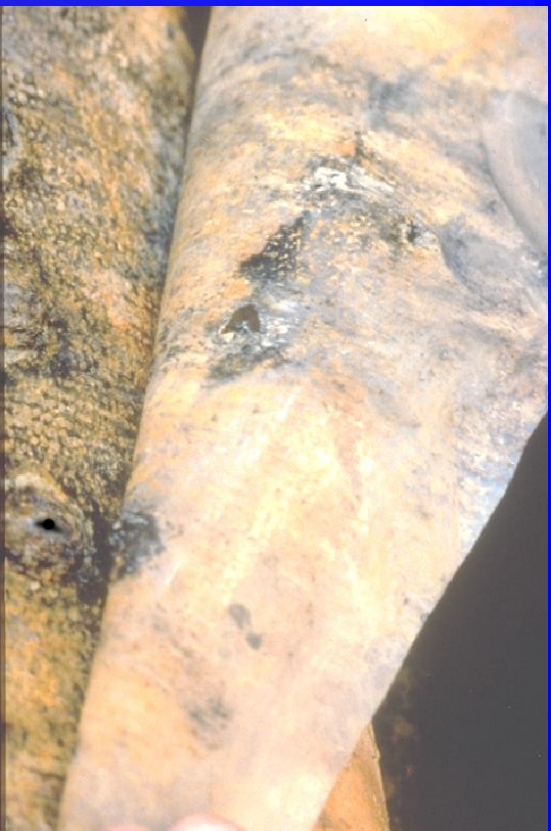
Corrosion on damaged polyethylene encased pipe.

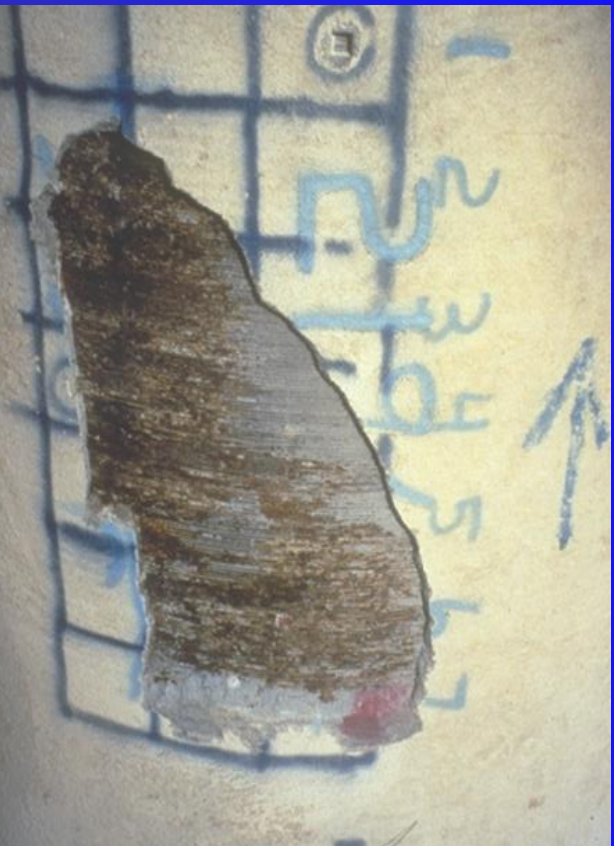
Corrosion of pre-stressed concrete cylinder pipe (P.C.C.P.).

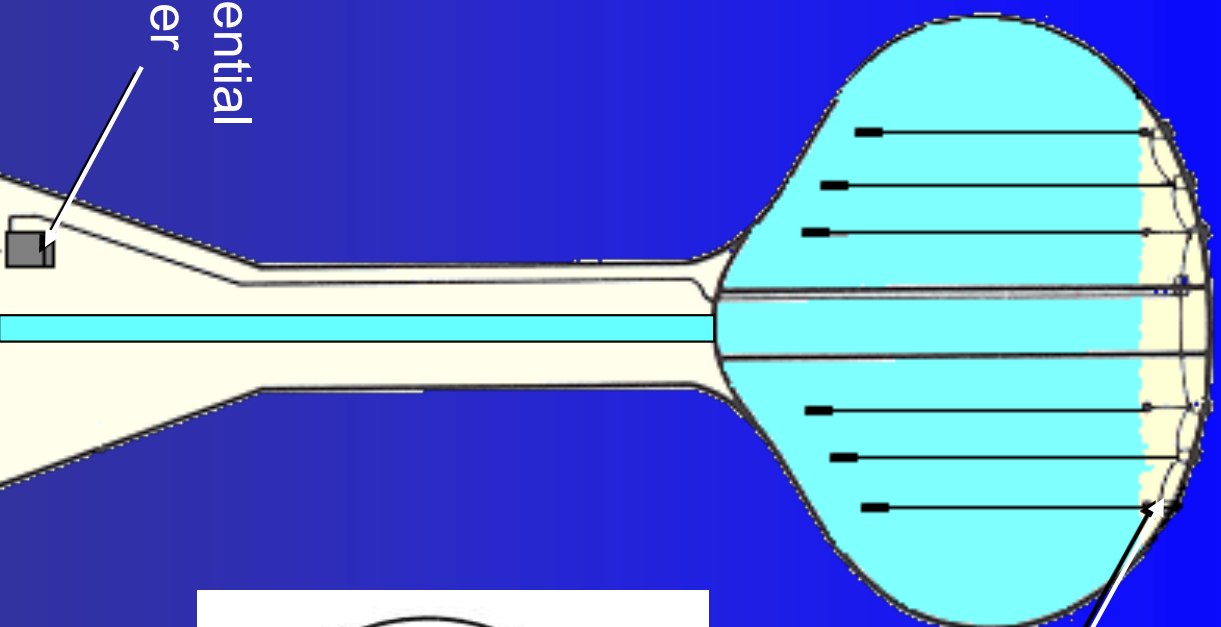
# Suspended Vertical Anode System

Support System Bolted to Roof for Bowl Anodes and Reference Electrodes
