# Corrosion Control of Buried Piping

**James T Lary**

**Corrpro**

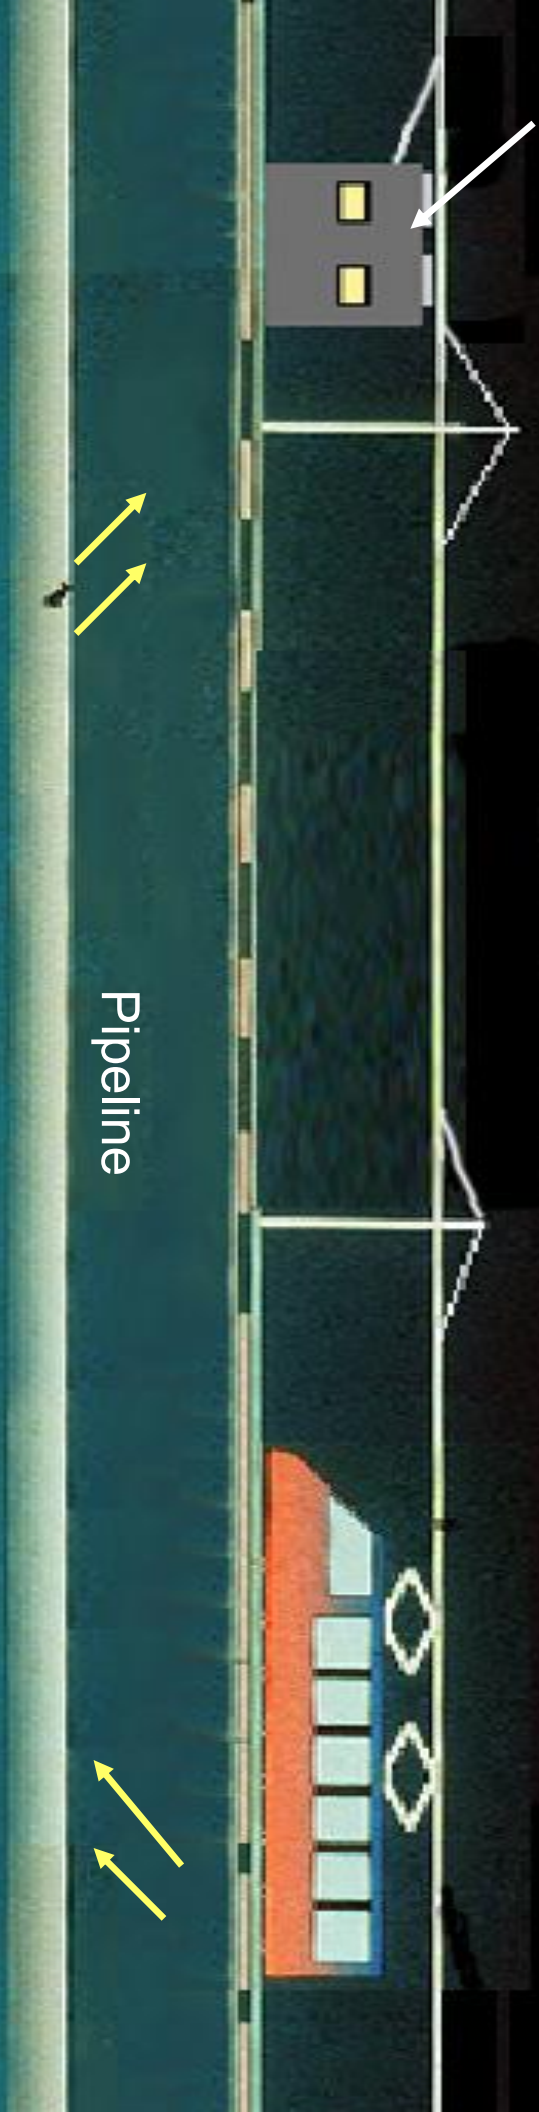
# Stray Current by DC Operated Transit Systems

Power  
Station

Pipeline

Current exit (Anode)

Current entrance (Cathode)

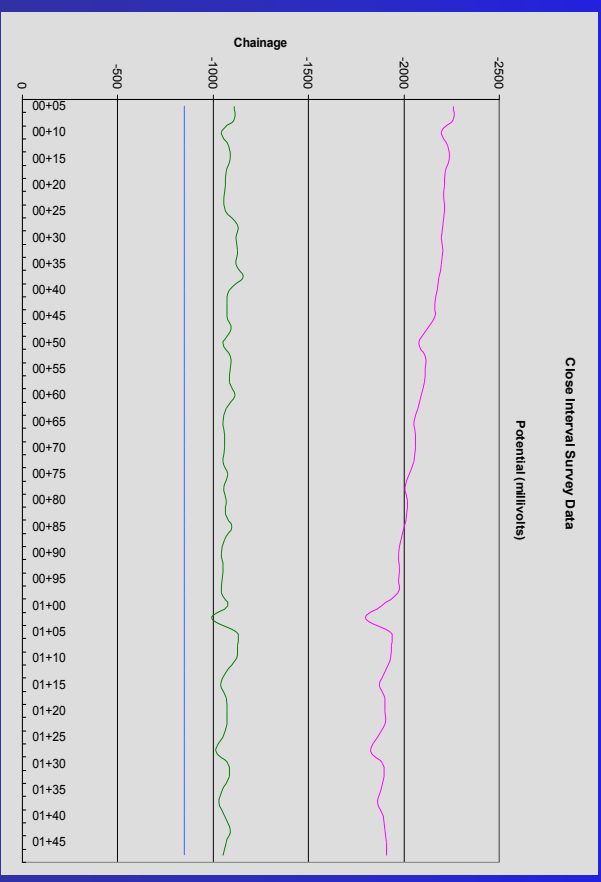
Close Interval Data  
Interrupted Survey

Close Interval Data  
PG/WFA Survey

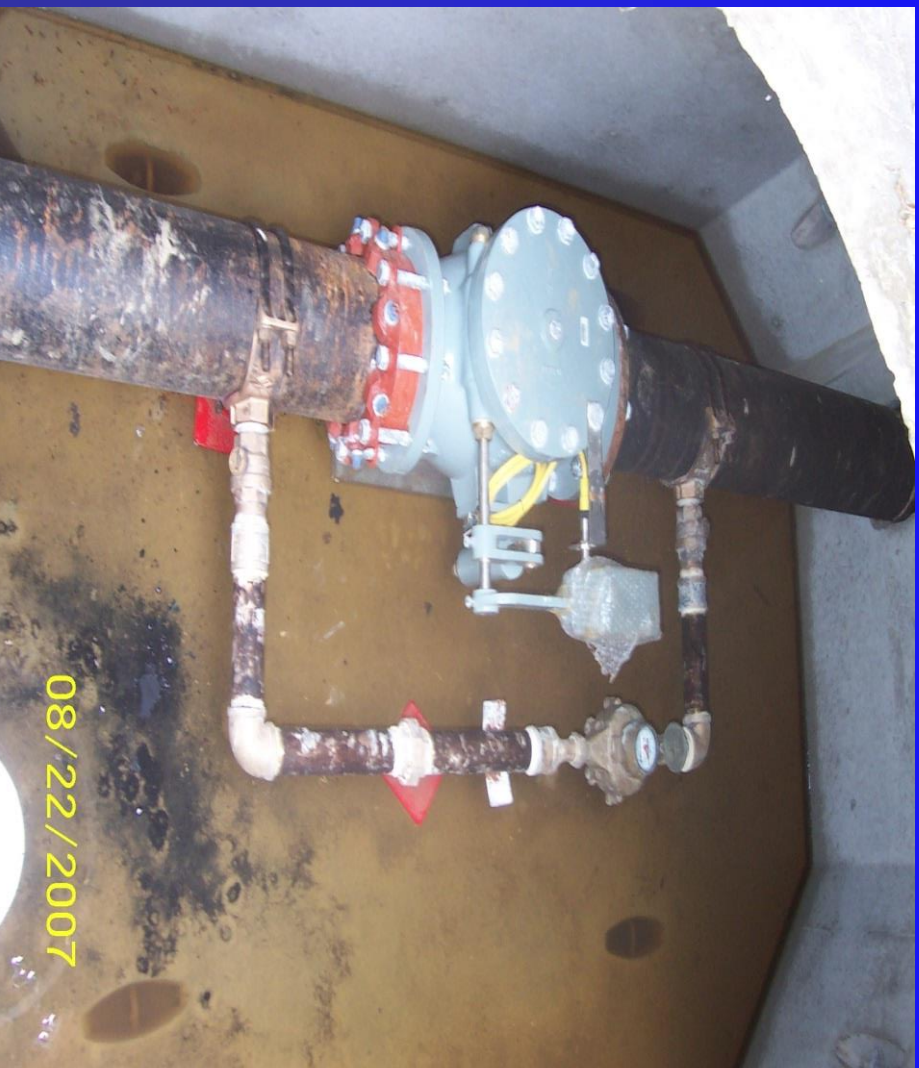
# Meter Vaults

*(Keep dry if possible)*
