**Client:** Telling Architectural Ltd  
10 Worthington Road  
Suite K  
Cranston  
RI 02920  
p. 401/632-4577  
c. 401/787-8551

**Job Number:** 11-0045D  
**Test Date(s):** 6/30-7/1/11  
**Report Date:** 7/22/11

### Rainscreen System: **Corium Brick System**

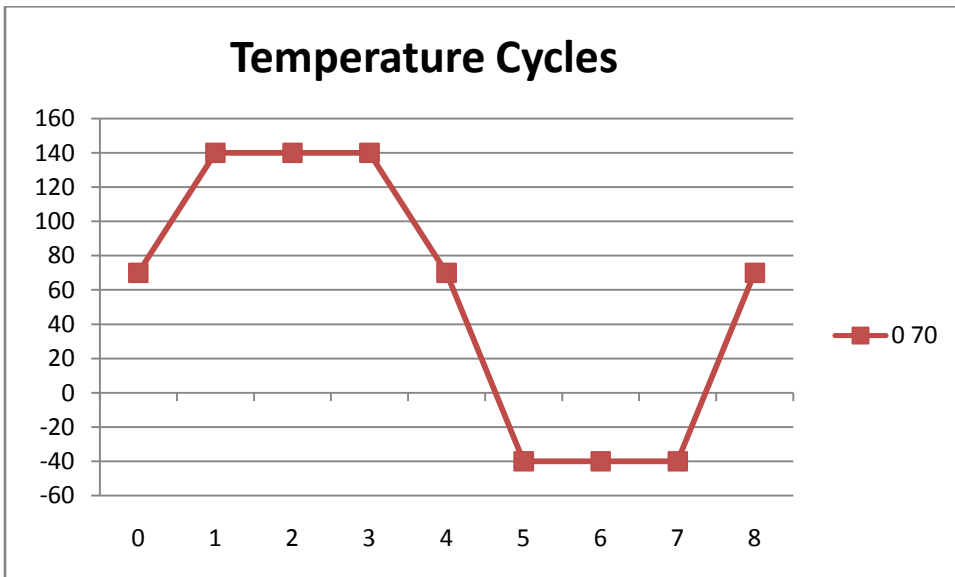
**Thermal Cycling**

**AAMA 501.5 (Three (3) cycles -40°F – +140°F)**

Phase 1: During the first hour, the temperature was increased on the weather side condition to the specified high temperature conditions of 140°F. These conditions were maintained for two hours.

Phase 2: Weather side temperature decreased to 75°F in one hour.

Phase 3: Weather side conditions were lowered to specified low temperature conditions -40°F over the next hour. These conditions were maintained for two hours.

Phase 4: Weather side temperature increased to 75°F in one hour.

*(The temperatures were average readings based on thermocouples placed six (6) inches from the top, center and six (6) inches from the bottom.)*
