## **GEOTECHNICAL STUDY**

Shoshana Ranch  
Larimer County, Colorado

**Project No. 21.3092  
January 31, 2022**

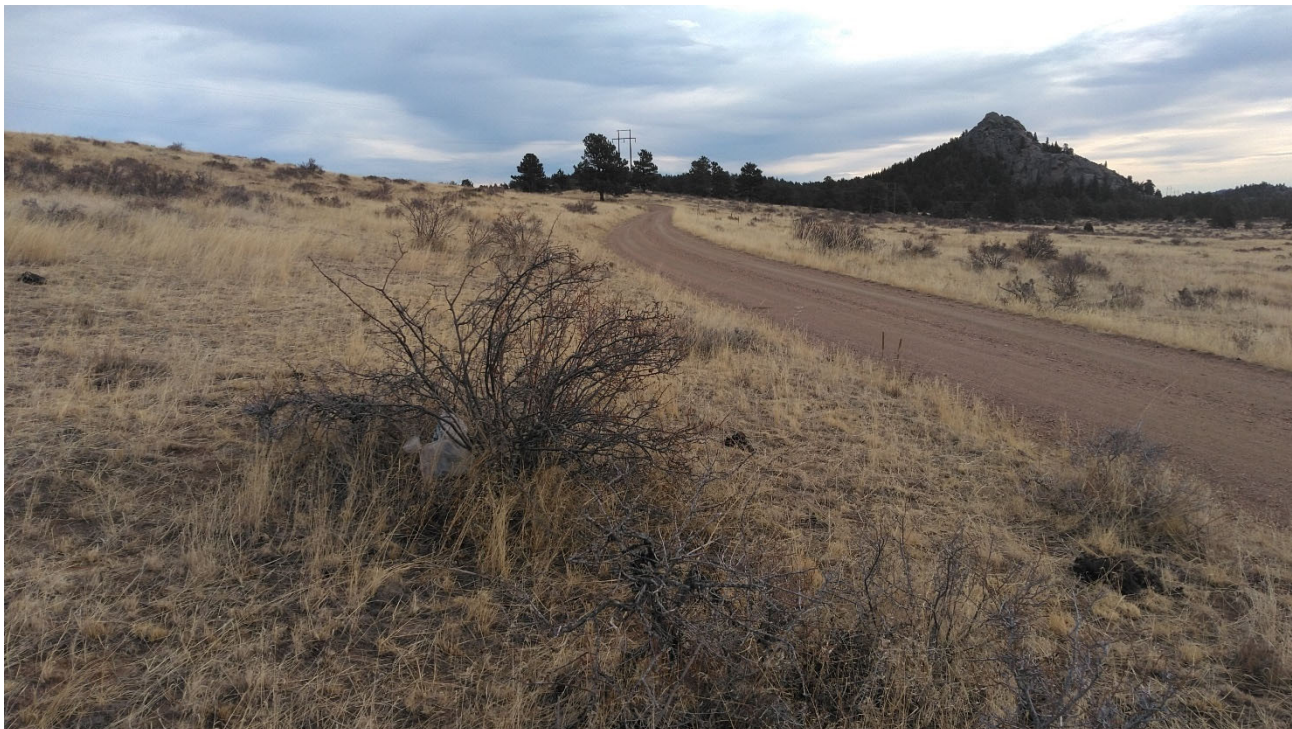
Photo 1. View looking northeast at Haystack Butte from Pit TP-1.

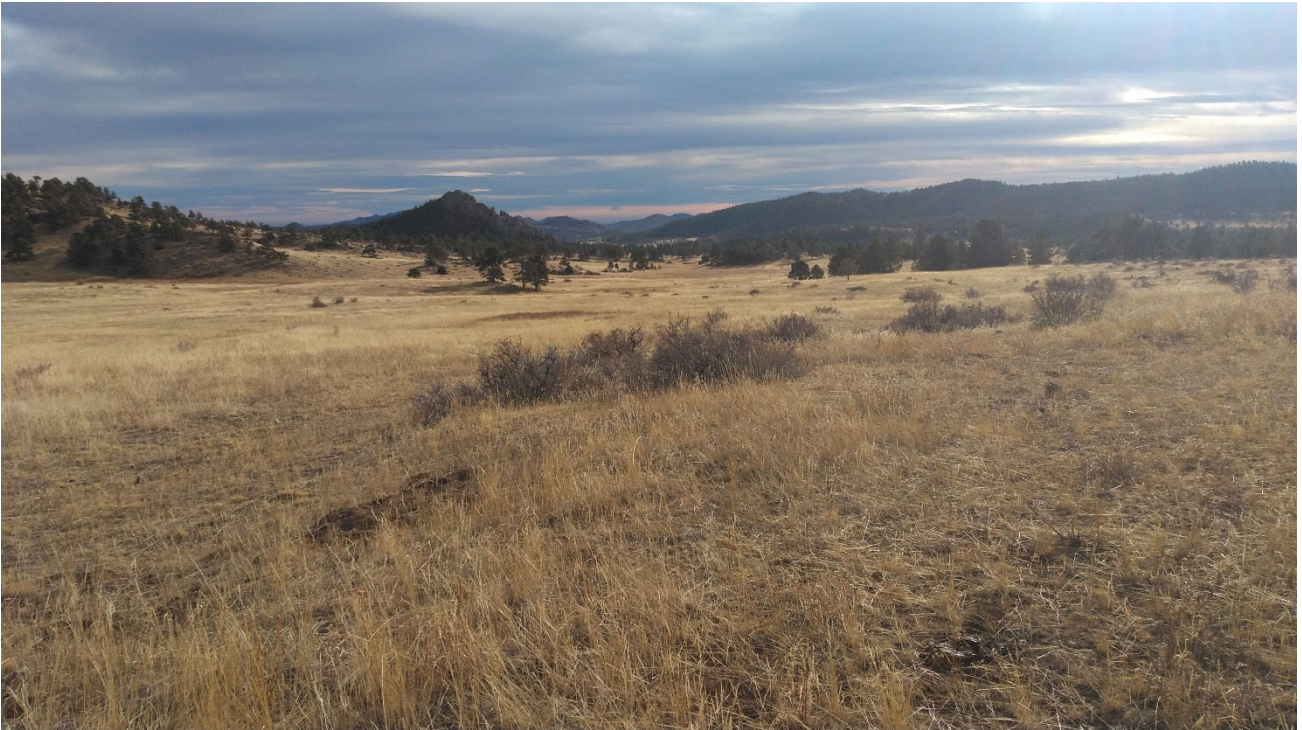
Photo 2. View looking southeast from Pit TP-3.

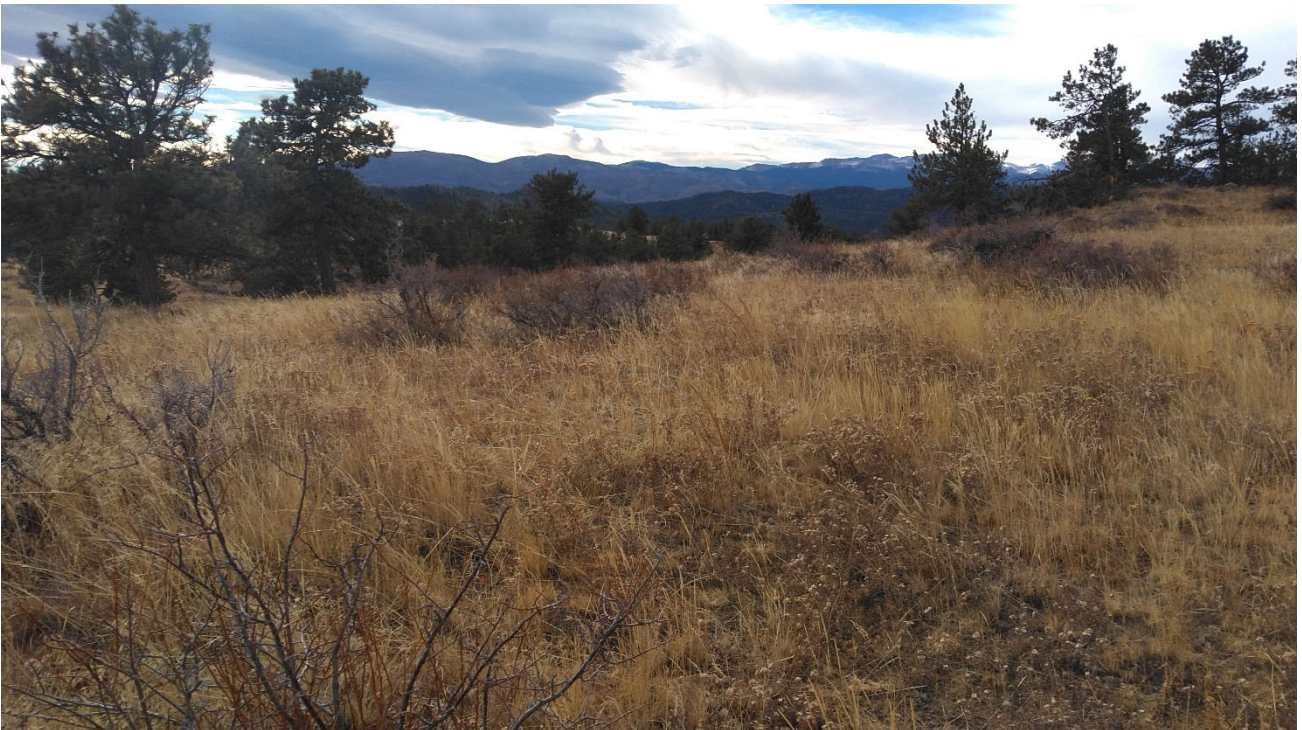
Photo 3. View looking northwest from Pit PT-6.

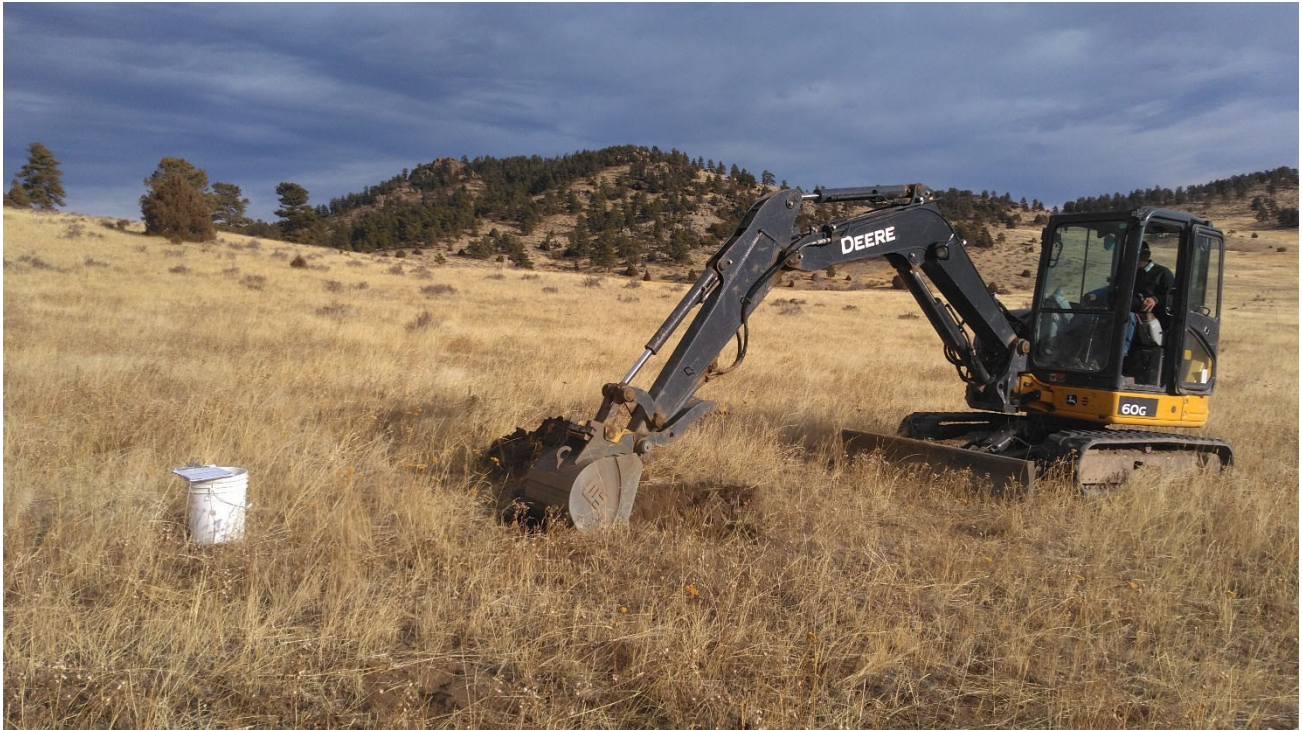
Photo 4. View looking north at Exploratory Pit TP-3.

Subsurface conditions were explored on December 13, 2021 by excavating ten exploratory pits to depths of about 2 to 6-1/2 feet at the locations indicated in the exploratory pit location plan presented in Appendix B. Small bulk samples were recovered of major material types exposed. Graphical logs depicting the subsurface conditions observed, locations of sampling, and further explanation of the exploration are presented in Appendix A.

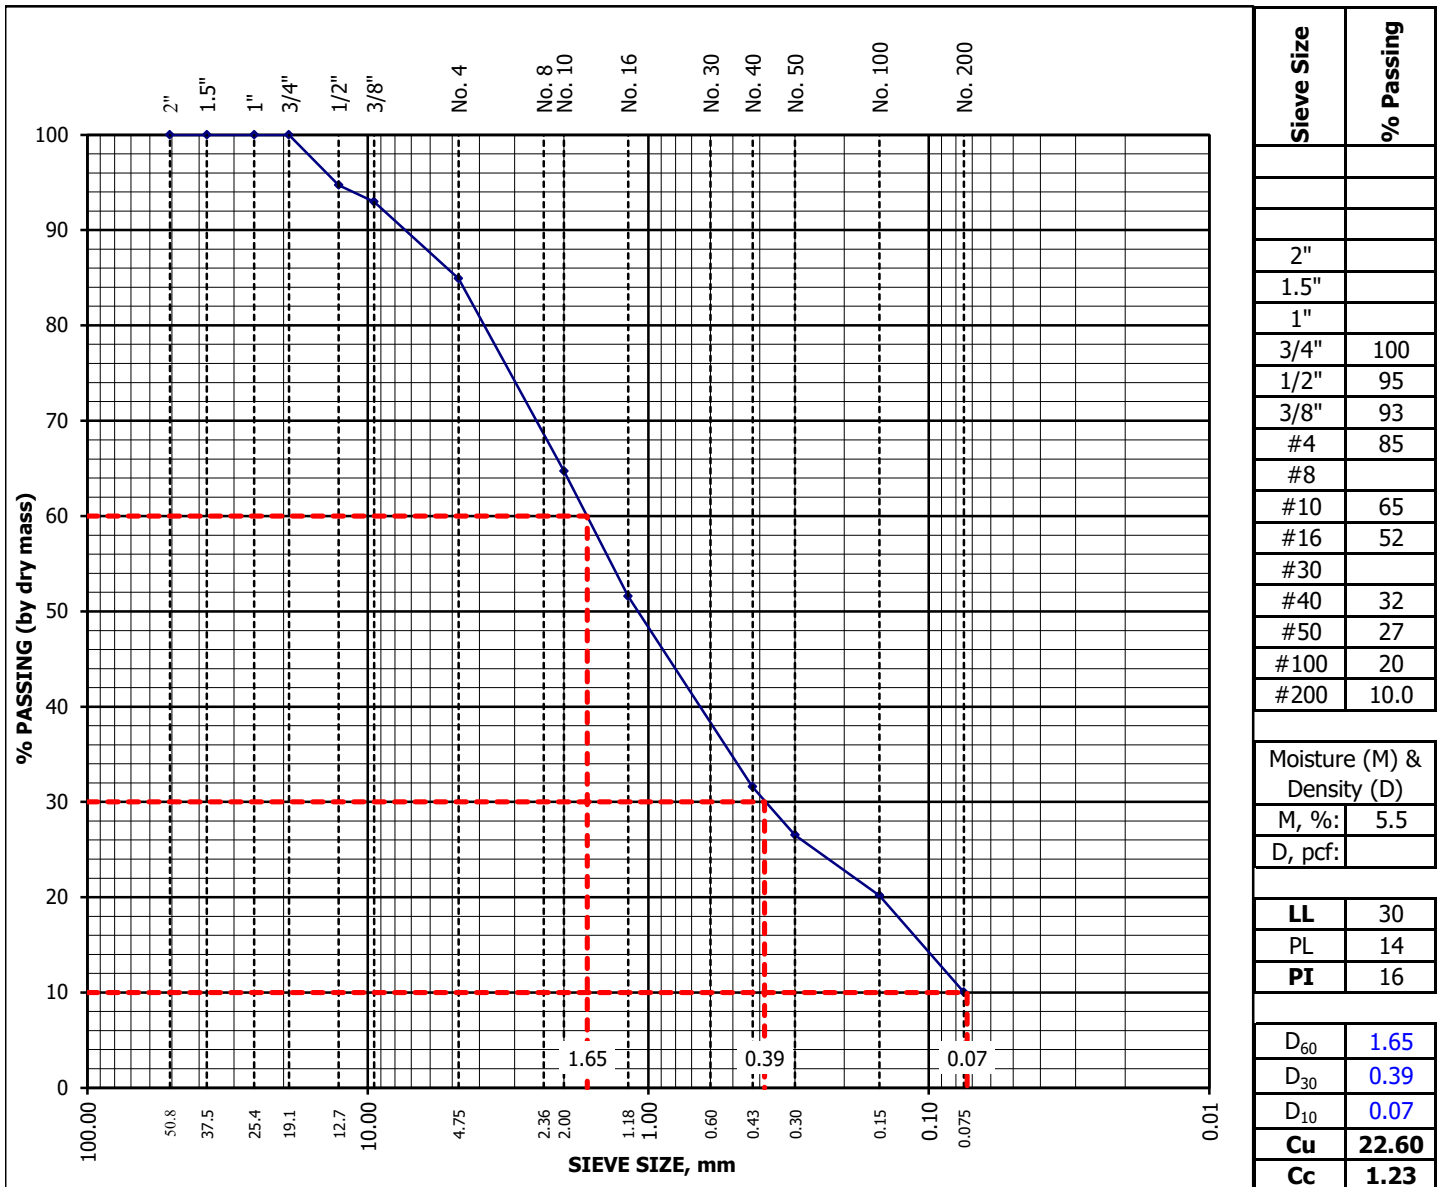
Project Number: <u>21.3092</u>	Date: <u>4-Jan-22</u>
Project Name: <u>Shoshana Ranch</u>	Technician: <u>C. Kilcullen</u>
Lab ID Number: <u>2121838</u>	Reviewer: <u>G. Hoyos</u>
Sample Location: <u>TP-1 at 2' to 3'</u>	
Visual Description: <u>SAND, with clay, and gravel, brown</u>

**AASHTO M 145 Classification: A-2-6 Group Index: (0)**  
**Unified Soil Classification System**  
**(ASTM D 2487): (SW-SC) Well graded sand with clay and gravel**

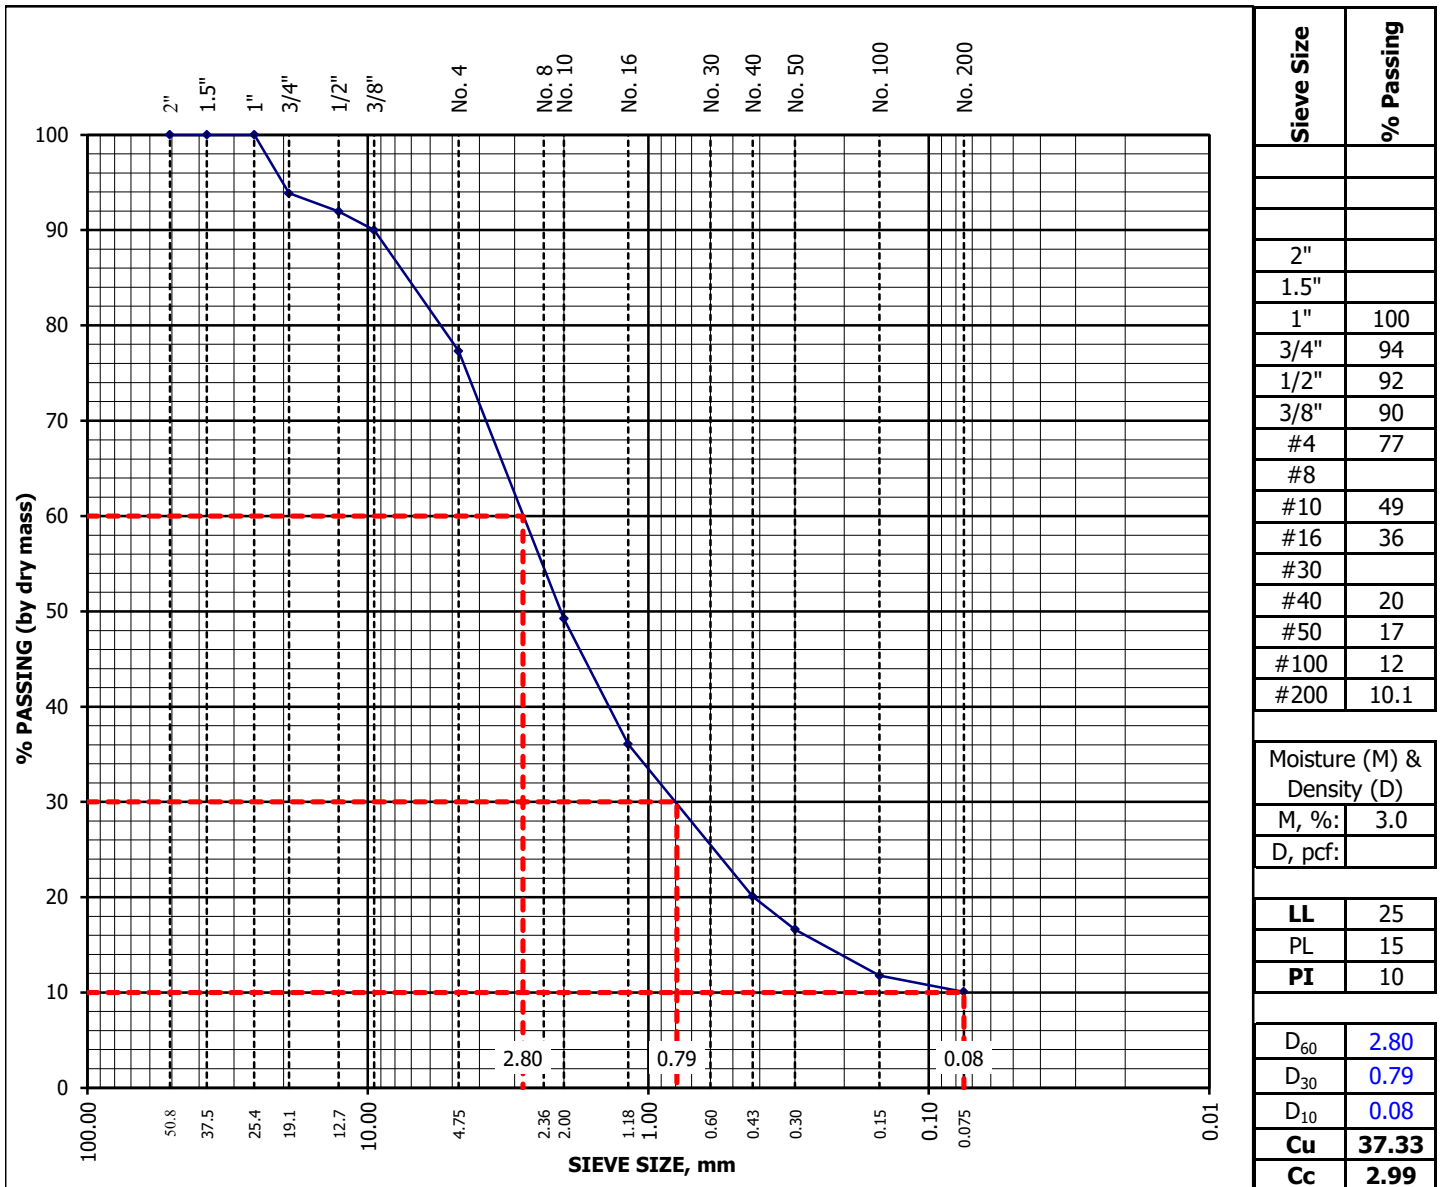
Project Number: <u>21.3092</u>	Date: <u>4-Jan-22</u>
Project Name: <u>Shoshana Ranch</u>	Technician: <u>C. Kilcullen</u>
Lab ID Number: <u>2121839</u>	Reviewer: <u>G. Hoyos</u>
Sample Location: <u>TP-2 at 1' to 3'</u>	
Visual Description: <u>SAND, with clay, and gravel, brown</u>

**AASHTO M 145 Classification: A-2-4 Group Index: (0)**  
**Unified Soil Classification System**  
**(ASTM D 2487): (SW-SC) Well graded sand with clay and gravel**

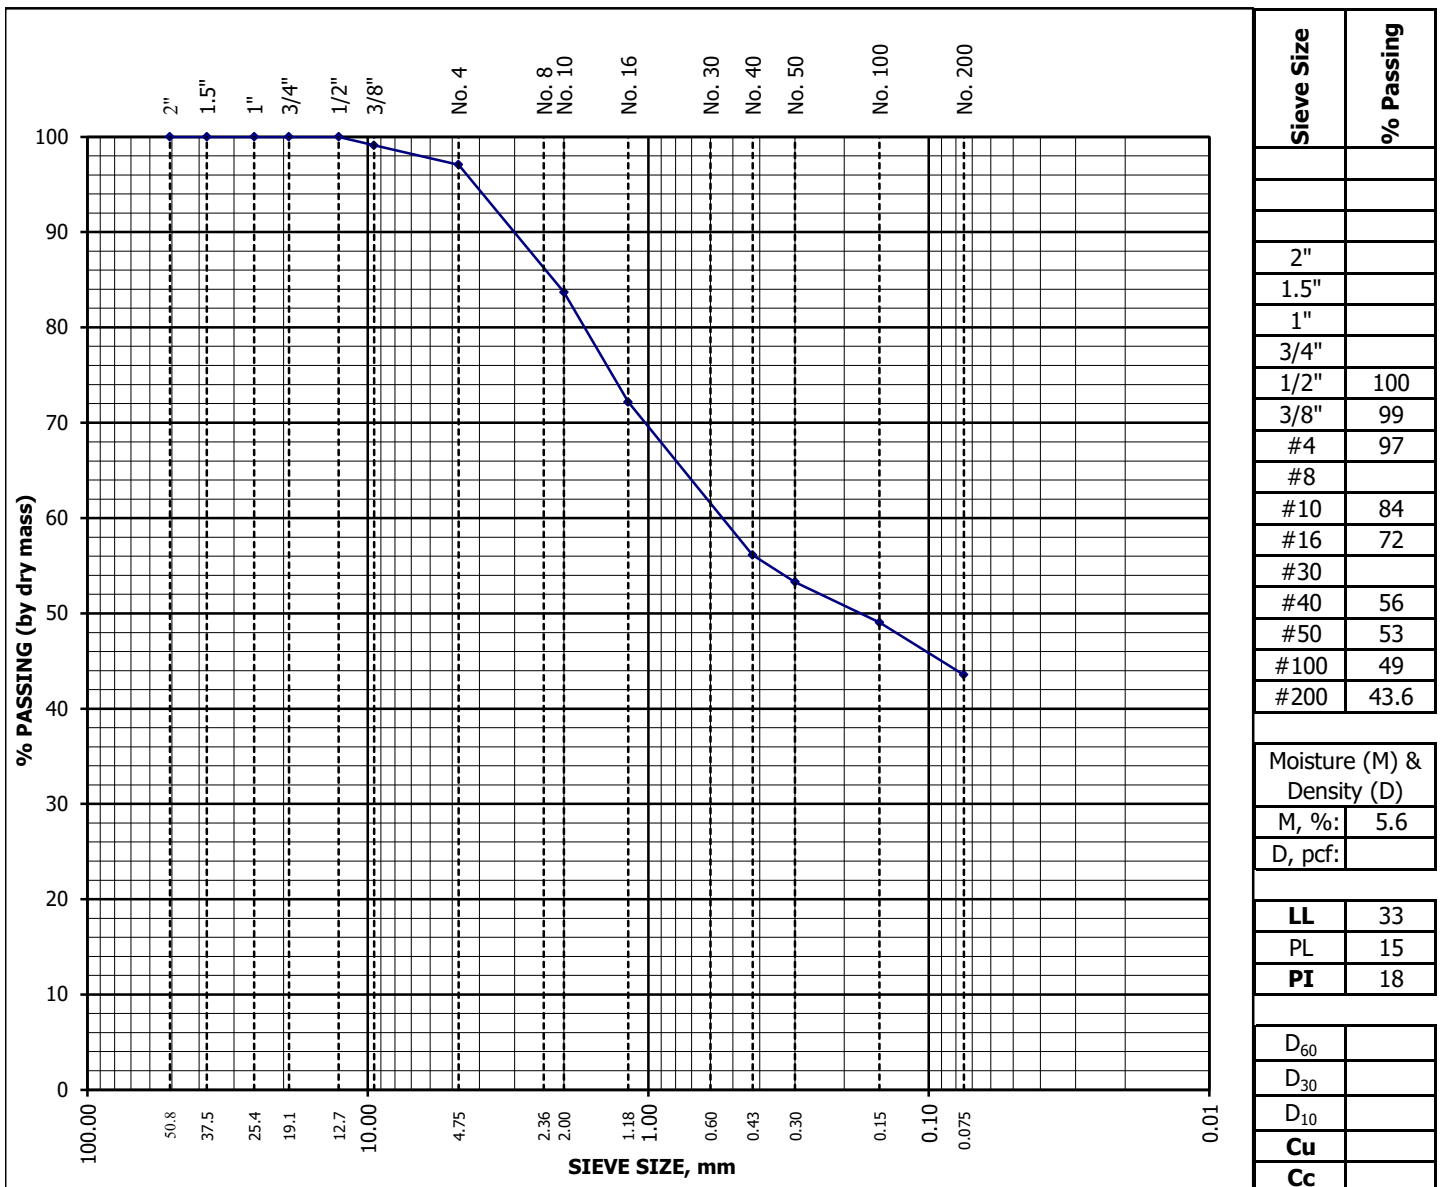
Project Number: 21.3092 Date: 4-Jan-22  
 Project Name: Shoshana Ranch Technician: C. Kilcullen  
 Lab ID Number: 2121840 Reviewer: G. Hoyos  
 Sample Location: TP-3 at 1' to 3'  
 Visual Description: SAND, clayey, brown

**AASHTO M 145 Classification:** A-6 **Group Index:** 4  
**Unified Soil Classification System**  
**(ASTM D 2487):** (SC) Clayey sand

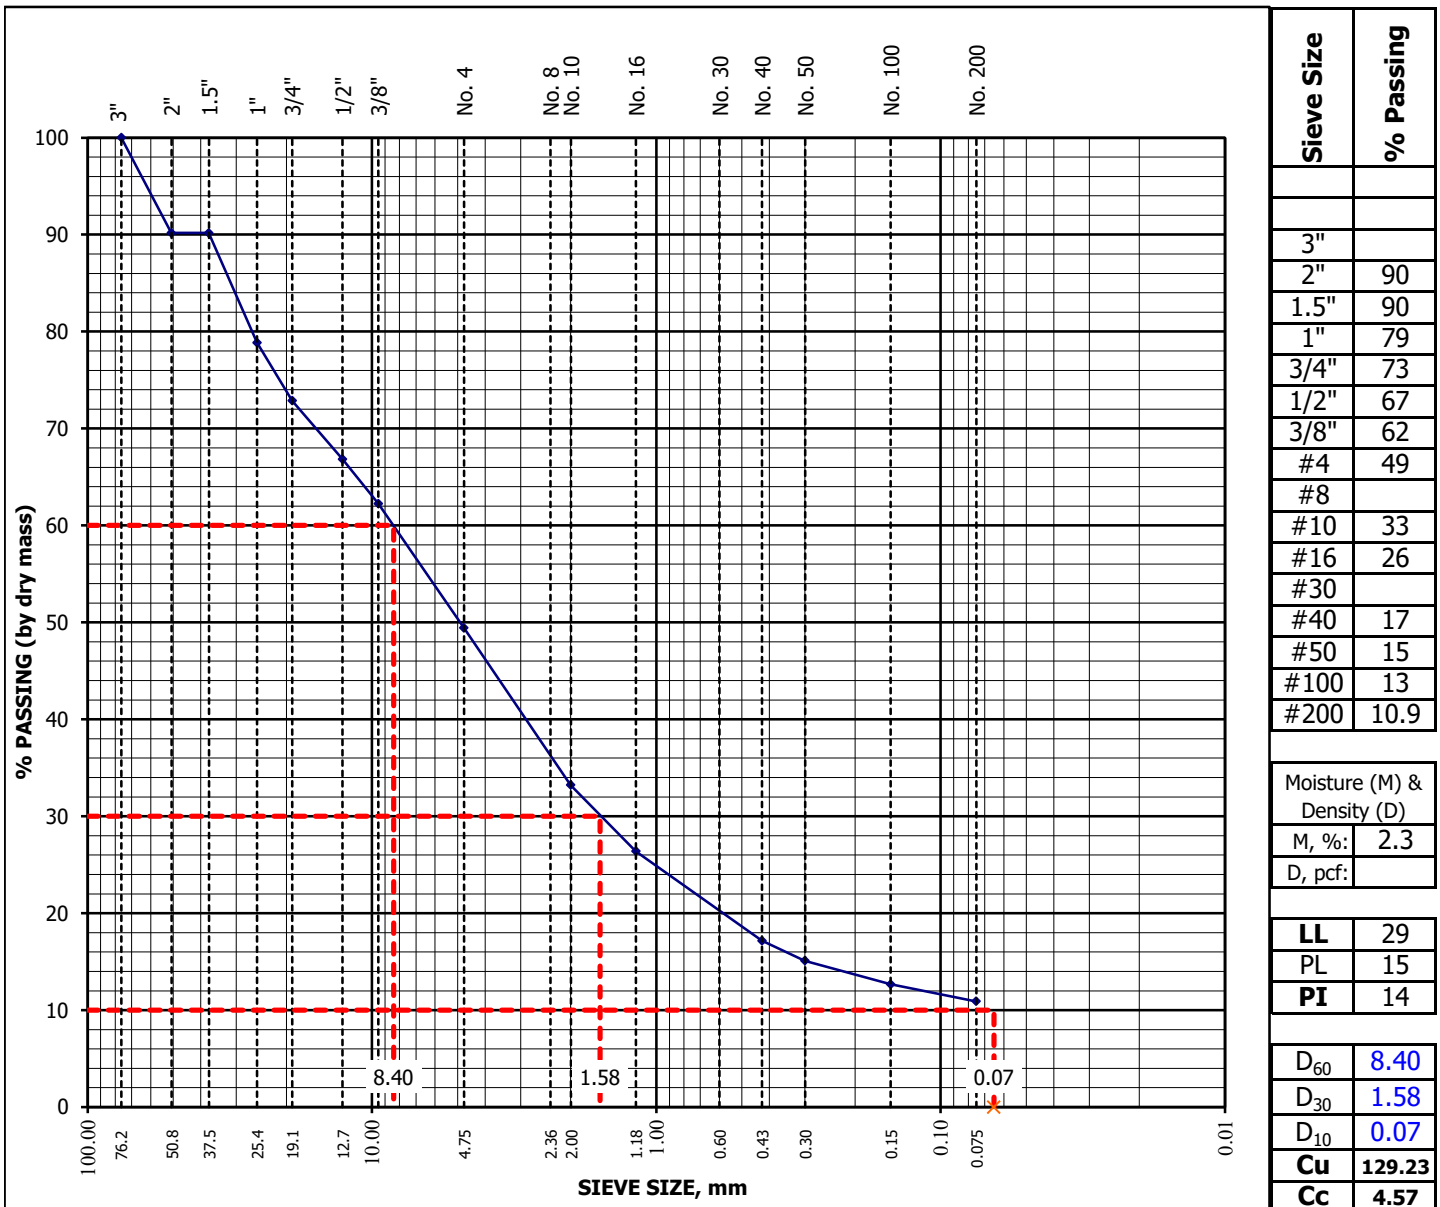
Project Number:	21.3092	Date:	4-Jan-22
Project Name:	Shoshana Ranch	Technician:	C. Kilcullen
Lab ID Number:	2121841	Reviewer:	G. Hoyos
Sample Location:	TP-4 at 0.5' to 2'		
Visual Description:	GRAVEL, with clay, and sand, brown

**AASHTO M 145 Classification:** A-2-6    **Group Index:** (0)  
**Unified Soil Classification System**  
**(ASTM D 2487):** (GP-GC) Poorly graded gravel with clay and sand

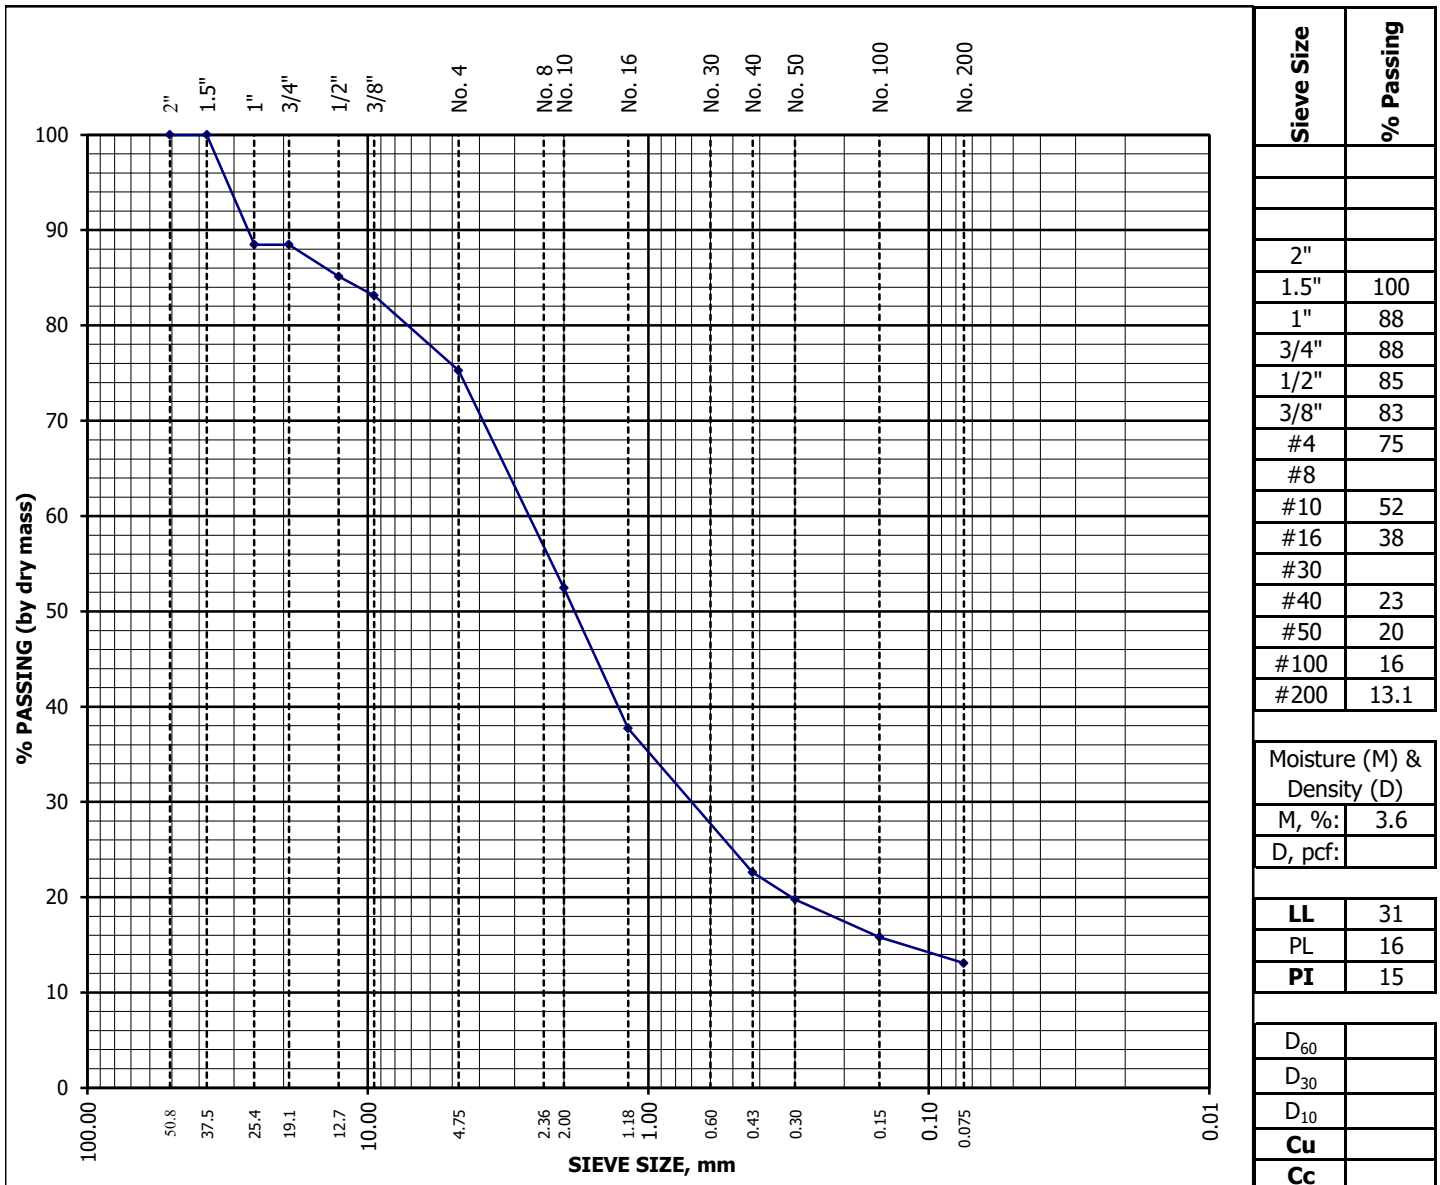
Project Number: <u>21.3092</u>	Date: <u>4-Jan-22</u>
Project Name: <u>Shoshana Ranch</u>	Technician: <u>C. Kilcullen</u>
Lab ID Number: <u>2121842</u>	Reviewer: <u>G. Hoyos</u>
Sample Location: <u>TP-5 at 1 to 3 feet</u>	
Visual Description: <u>SAND, clayey, with gravel, brown</u>

**AASHTO M 145 Classification:** A-2-6    **Group Index:** (0)  
**Unified Soil Classification System**  
**(ASTM D 2487):** (SC)    **Clayey sand with gravel**

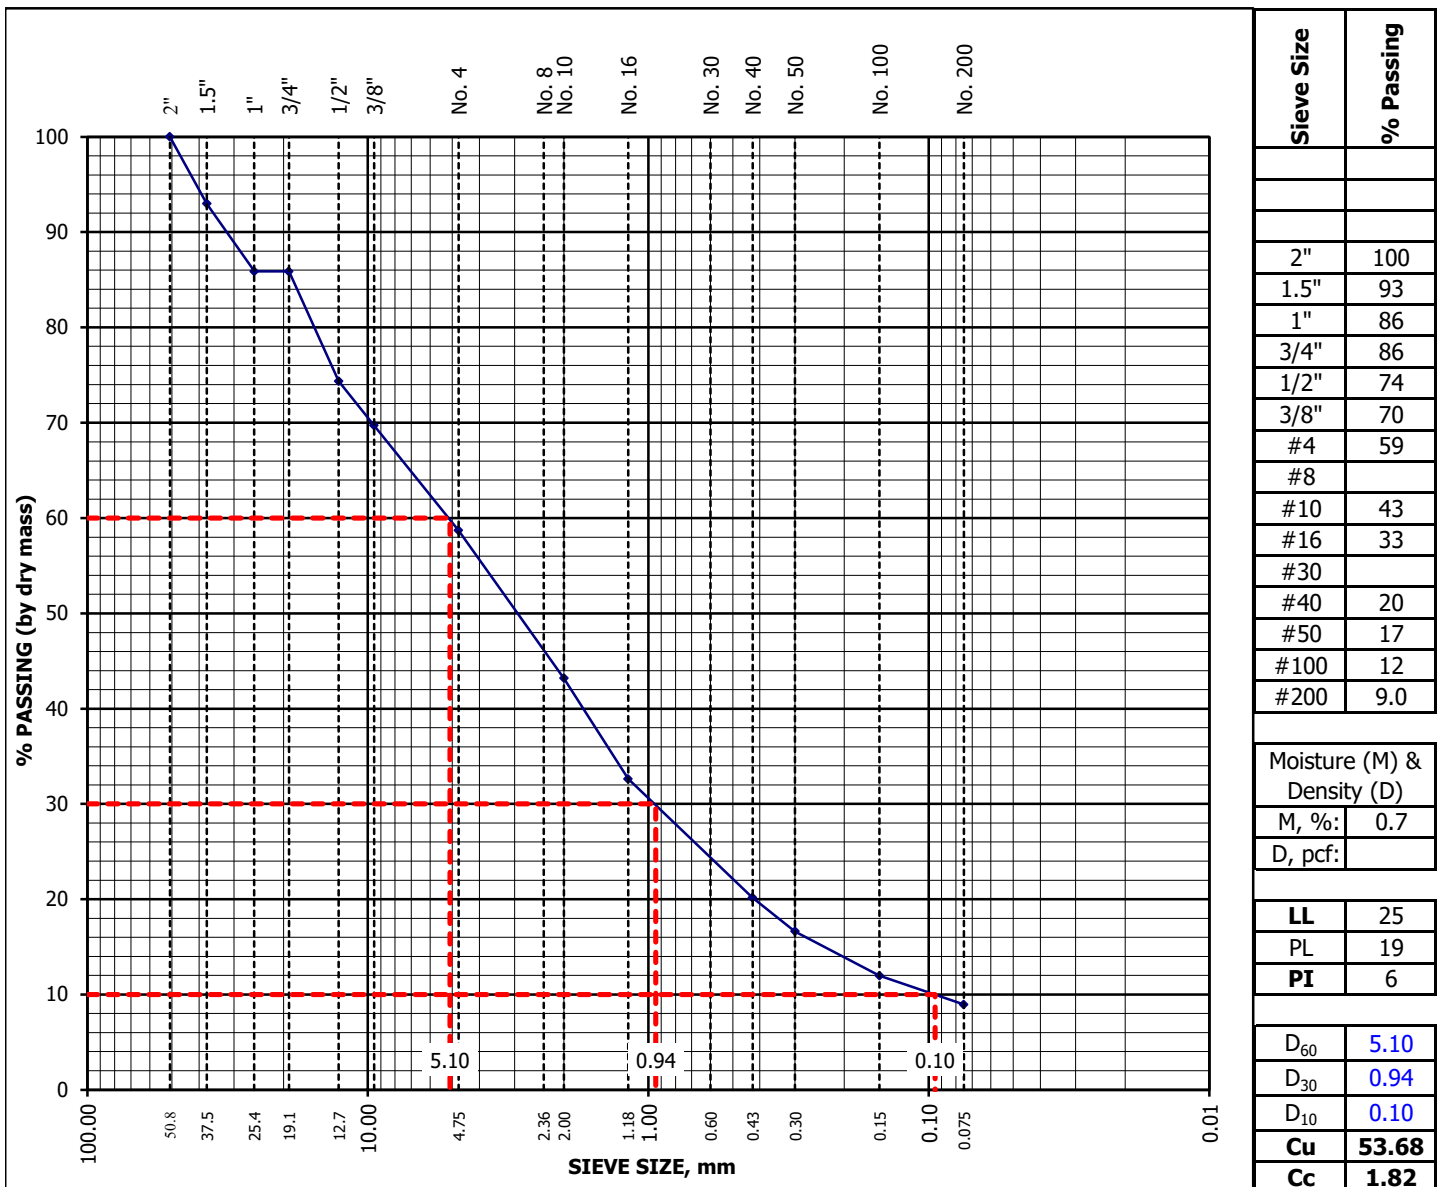
Project Number: <u>21.3092</u>	Date: <u>4-Jan-22</u>
Project Name: <u>Shoshana Ranch</u>	Technician: <u>C. Kilcullen</u>
Lab ID Number: <u>2121843</u>	Reviewer: <u>G. Hoyos</u>
Sample Location: <u>TP-6 at 0.5' to 2'</u>	
Visual Description: <u>SAND, with silt, and clay, and gravel, brown</u>

**AASHTO M 145 Classification: A-1-a Group Index: (0)**  
**Unified Soil Classification System**  
**(ASTM D 2487): (SW-SC) Well graded sand with silty clay and gravel**

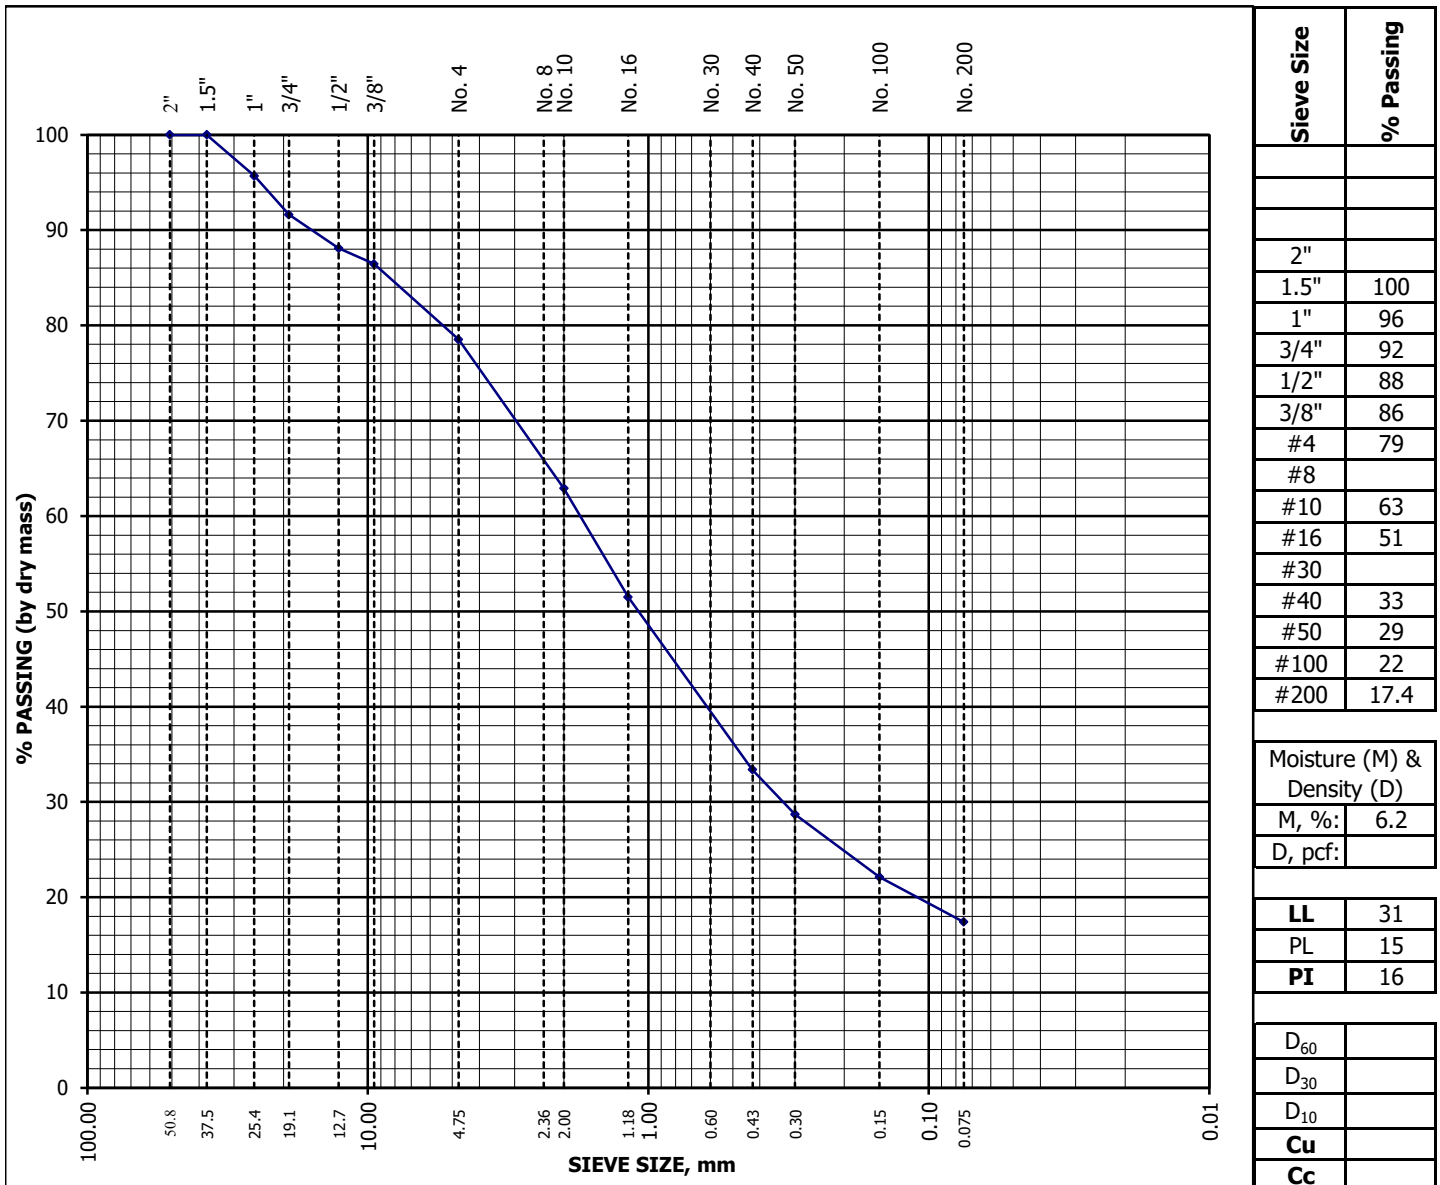
Project Number: <u>21.3092</u>	Date: <u>4-Jan-22</u>
Project Name: <u>Shoshana Ranch</u>	Technician: <u>C. Kilcullen</u>
Lab ID Number: <u>2121844</u>	Reviewer: <u>G. Hoyos</u>
Sample Location: <u>TP-7 at 1' to 3'</u>	
Visual Description: <u>SAND, clayey, with gravel, brown</u>

**AASHTO M 145 Classification: A-2-6 Group Index: (0)**  
**Unified Soil Classification System**  
**(ASTM D 2487): (SC) Clayey sand with gravel**

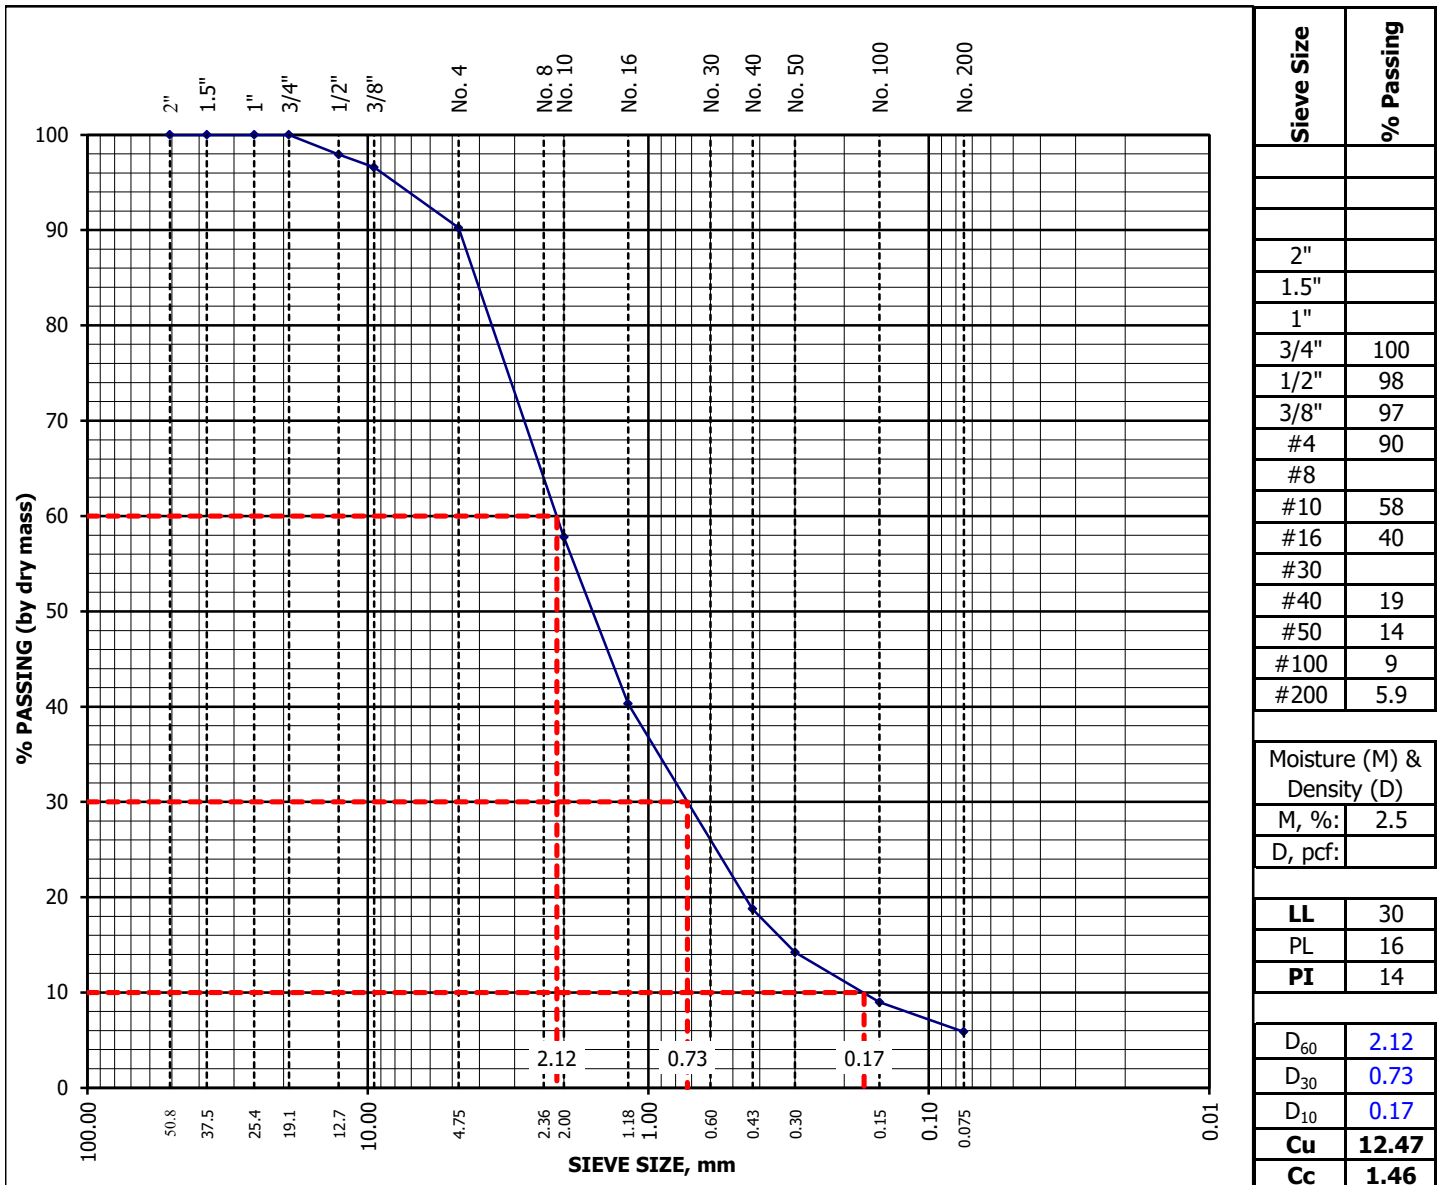
Project Number: <u>21.3092</u>	Date: <u>4-Jan-22</u>
Project Name: <u>Shoshana Ranch</u>	Technician: <u>C. Kilcullen</u>
Lab ID Number: <u>2121845</u>	Reviewer: <u>G. Hoyos</u>
Sample Location: <u>TP-8 at 1' to 2'</u>	
Visual Description: <u>SAND, with clay, brown</u>

**AASHTO M 145 Classification: A-2-6 Group Index: (0)**  
**Unified Soil Classification System**  
**(ASTM D 2487): (SW-SC) Well graded sand with clay**

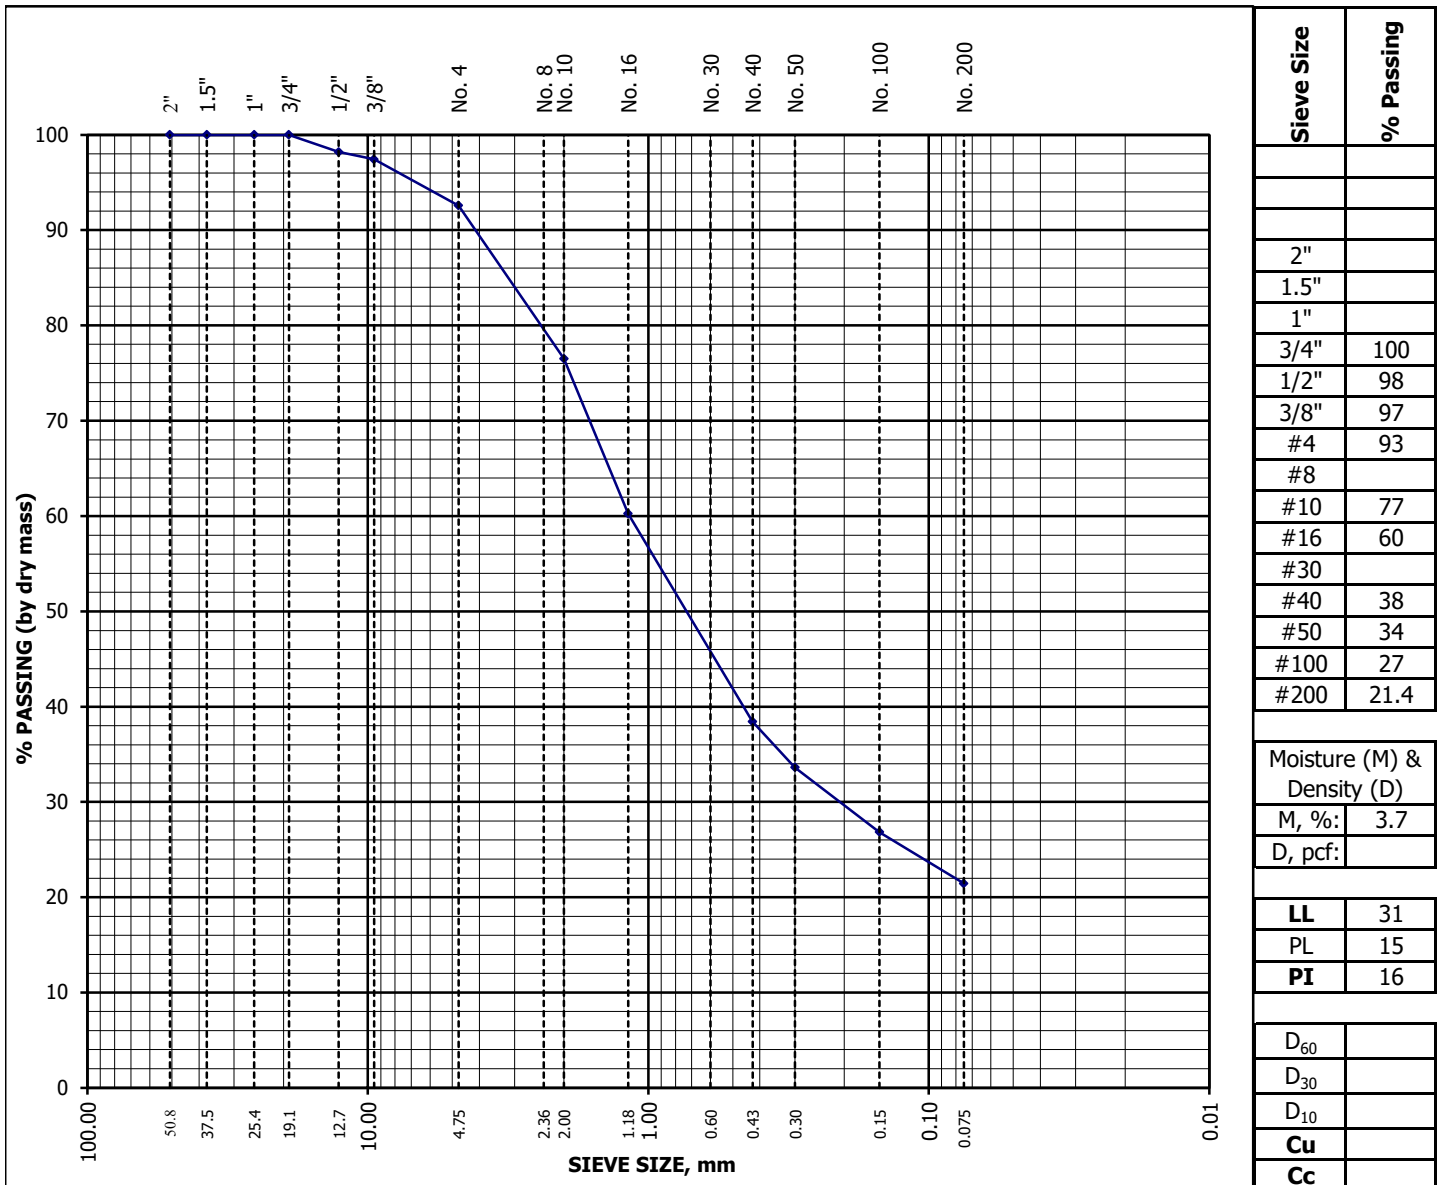
Project Number: <u>21.3092</u>	Date: <u>4-Jan-22</u>
Project Name: <u>Shoshana Ranch</u>	Technician: <u>C. Kilcullen</u>
Lab ID Number: <u>2121846</u>	Reviewer: <u>G. Hoyos</u>
Sample Location: <u>TP-9 at 1' to 3'</u>	
Visual Description: <u>SAND, clayey, brown</u>

**AASHTO M 145 Classification:** A-2-6    **Group Index:** (0)  
**Unified Soil Classification System**  
**(ASTM D 2487):** (SC)    **Clayey sand**

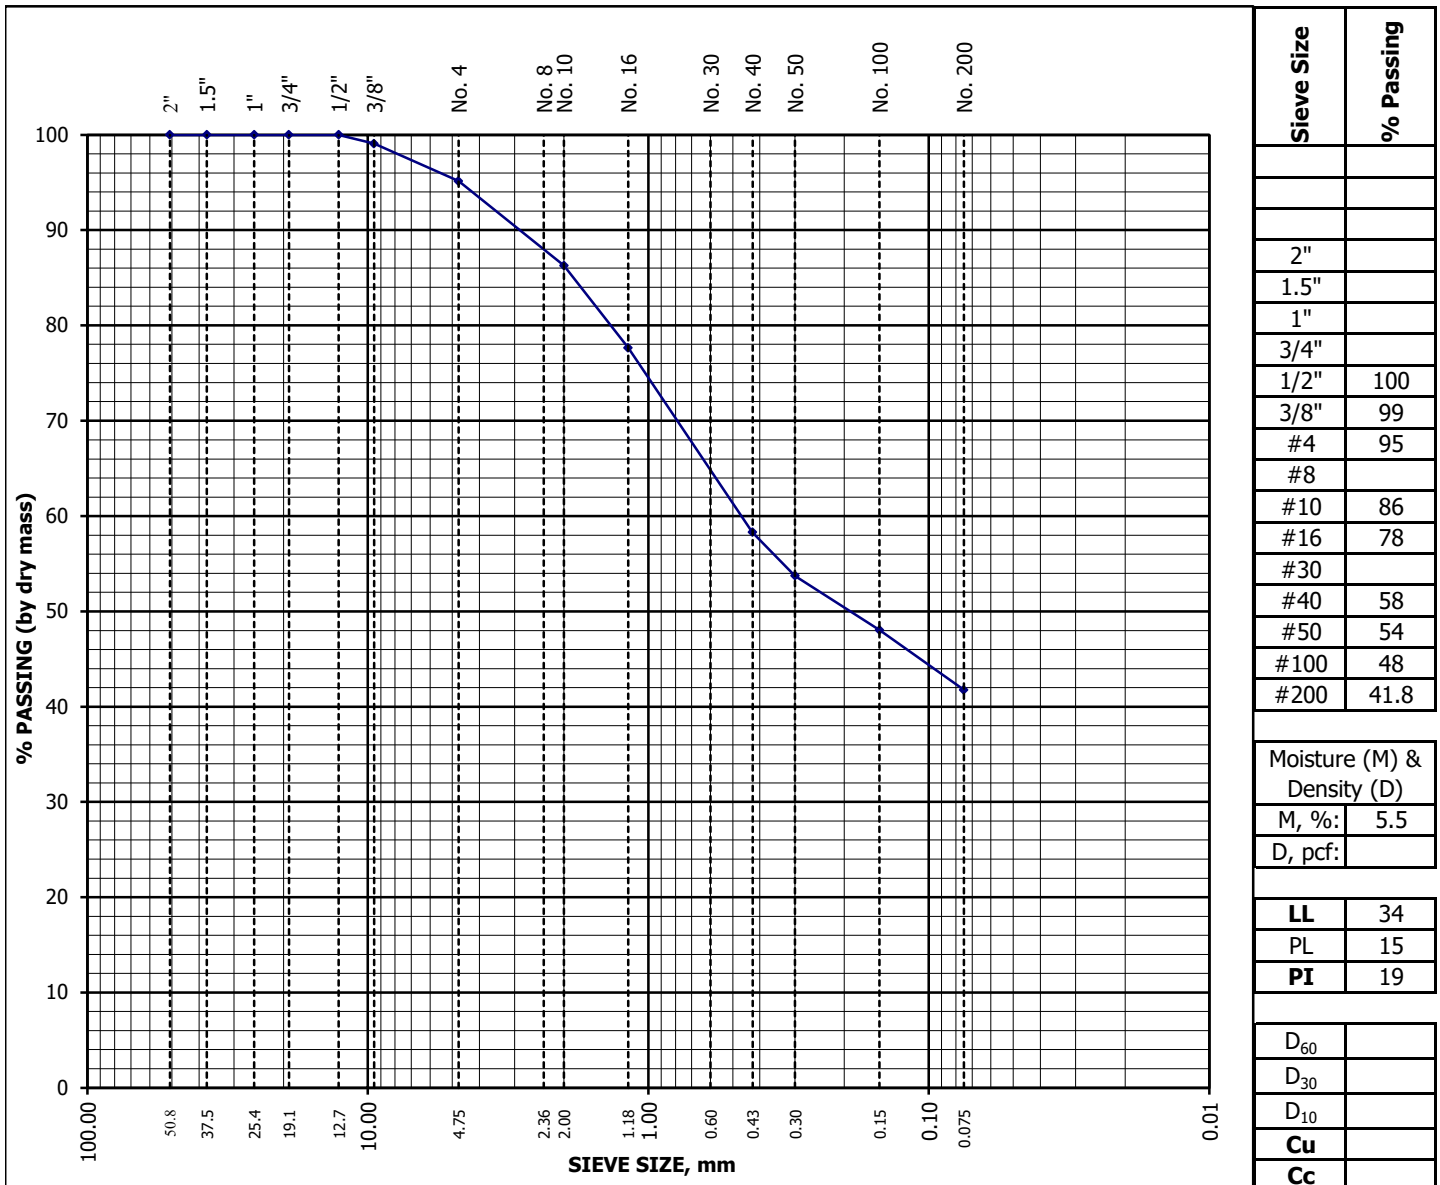
Project Number: <u>21.3092</u>	Date: <u>4-Jan-22</u>
Project Name: <u>Shoshana Ranch</u>	Technician: <u>C. Kilcullen</u>
Lab ID Number: <u>2121847</u>	Reviewer: <u>G. Hoyos</u>
Sample Location: <u>TP-10A at 1.5' to 3.5'</u>	
Visual Description: <u>SAND, clayey, brown</u>

**AASHTO M 145 Classification:** A-6    **Group Index:** 4  
**Unified Soil Classification System**  
**(ASTM D 2487):**    (SC)    Clayey sand
