## **GEOTECHNICAL STUDY**

Shoshana Ranch  
Larimer County, Colorado

**Project No. 21.3092  
January 31, 2022**

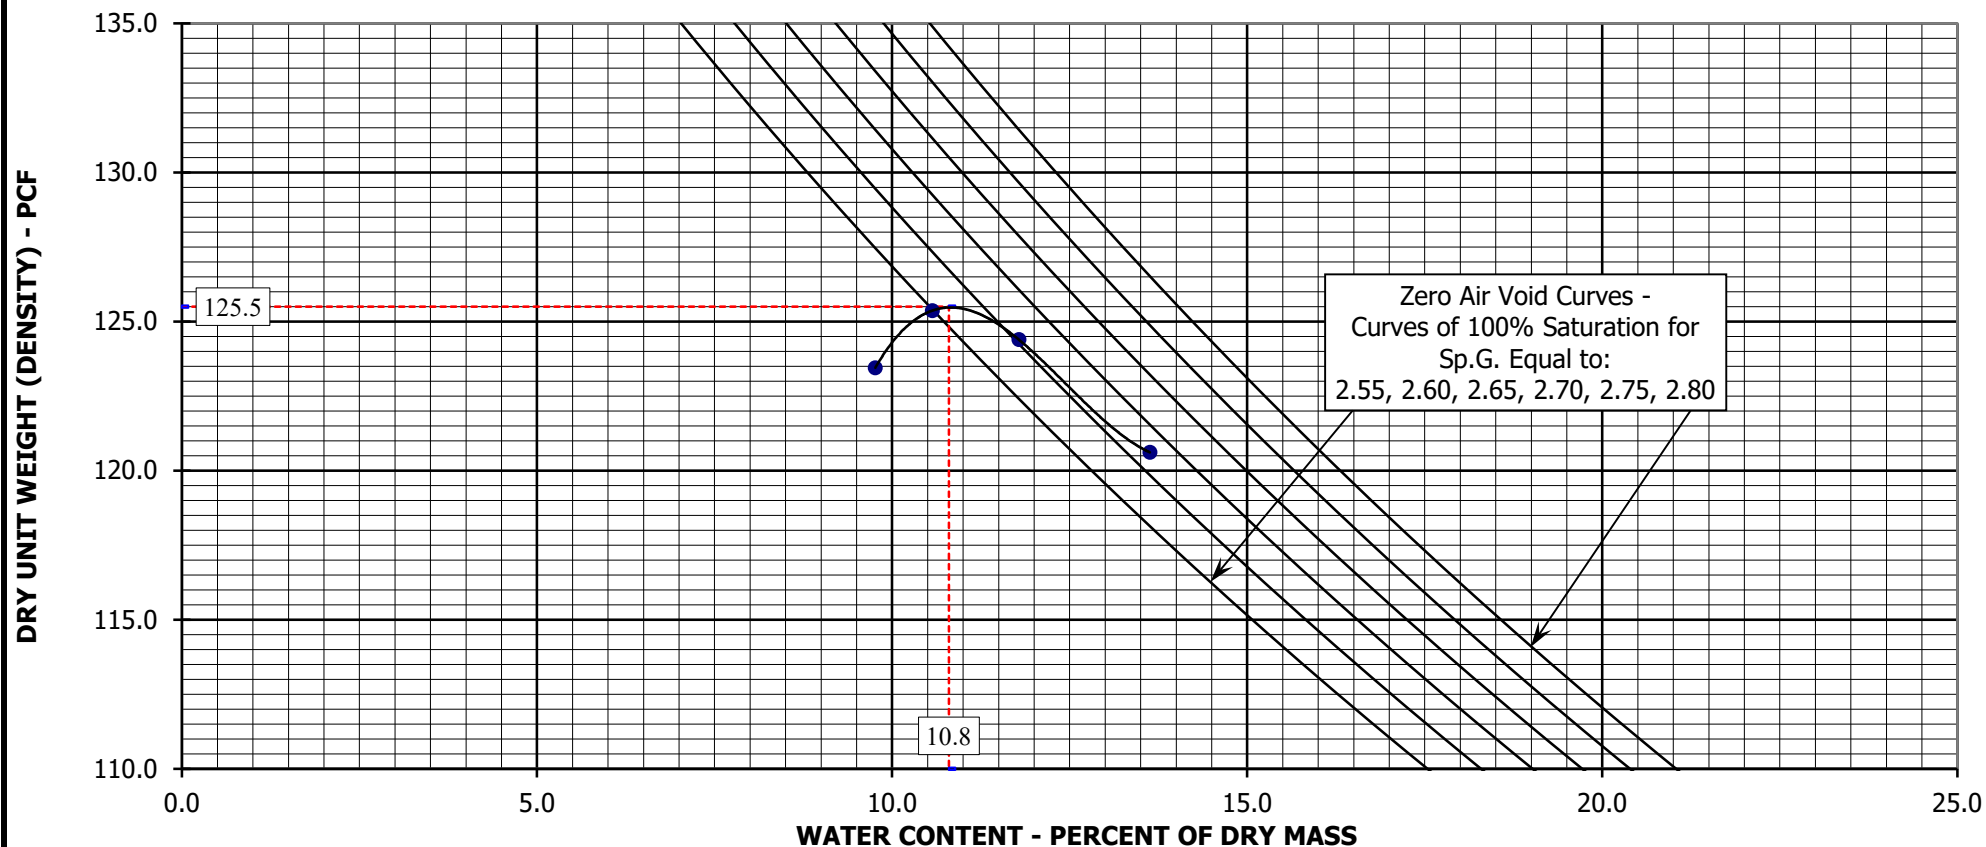
Sample Location	Depth (ft)	LL	PL	PI	-#200 (%)	Soil Description/Classification	Moisture/Density Relationship (Proctor) Test
TP-6	0.5 to 2	25	19	6	9.0	SAND, clayey, with gravel, red brown Visual: SAND, clayey, with gravel, red brown AASHTO: A-1-a (0) (SW-SC) Well-graded sand with silty clay and gravel USCS:	Project Number 21.3092 Project Name: Shoshana Ranch Drawn By: A. Wright Checked By: G. Hoyos Date: 28-Jan-22 Tested by: K. McNally Date: 27-Jan-22 Lab ID Number: 222073

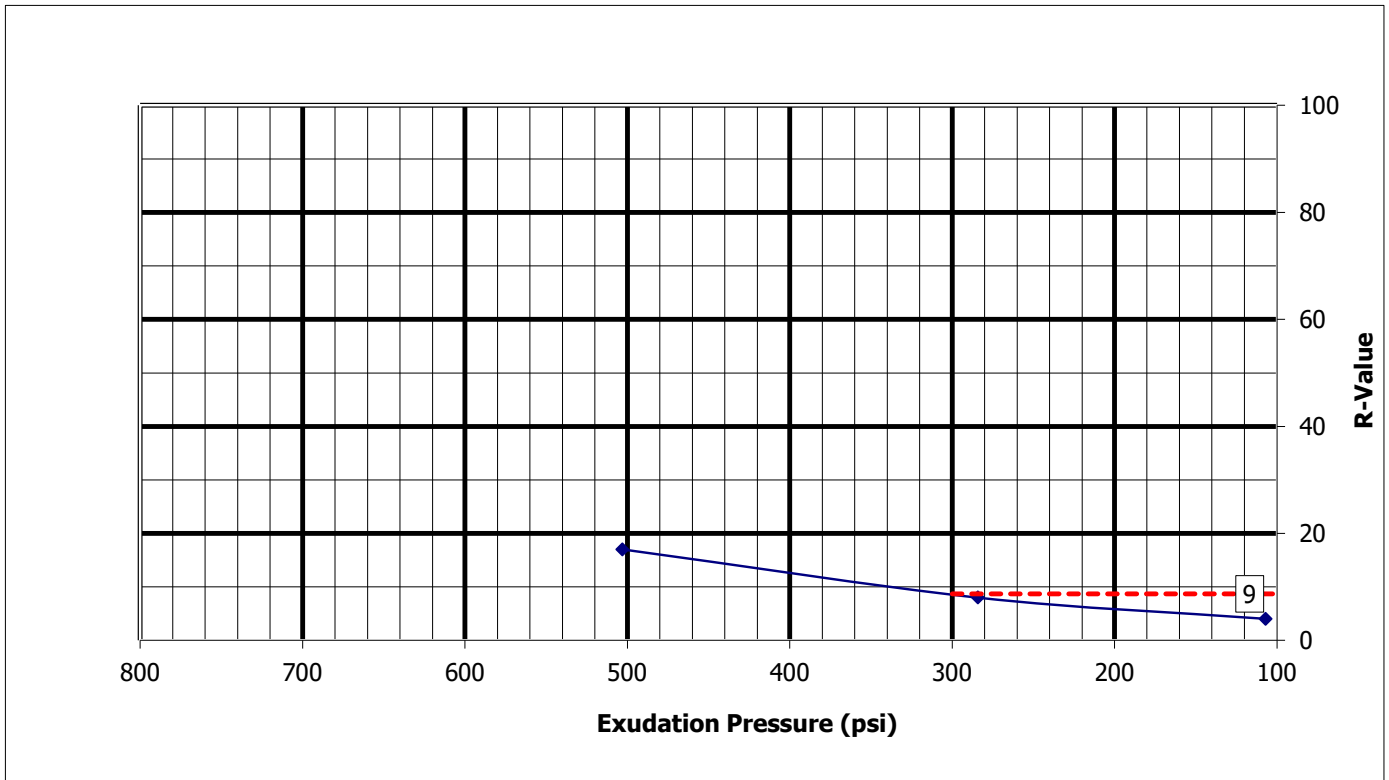
**R-VALUE TEST GRAPH (ASTM D2844)**

Project Number:	21.3092	Date:	12-Jan-22
Project Name:	Shoshana Ranch	Technician:	J. De Los Santos
Lab ID Number:	222020	Reviewer:	G. Hoyos
Sample Location:	Composite: TP-3, TP-10, TP-10a at 1' to 3.5'		
Visual Description:	SAND, clayey, brown

**R-Value @ Exudation Pressure 300 psi:**   
**Specification:**

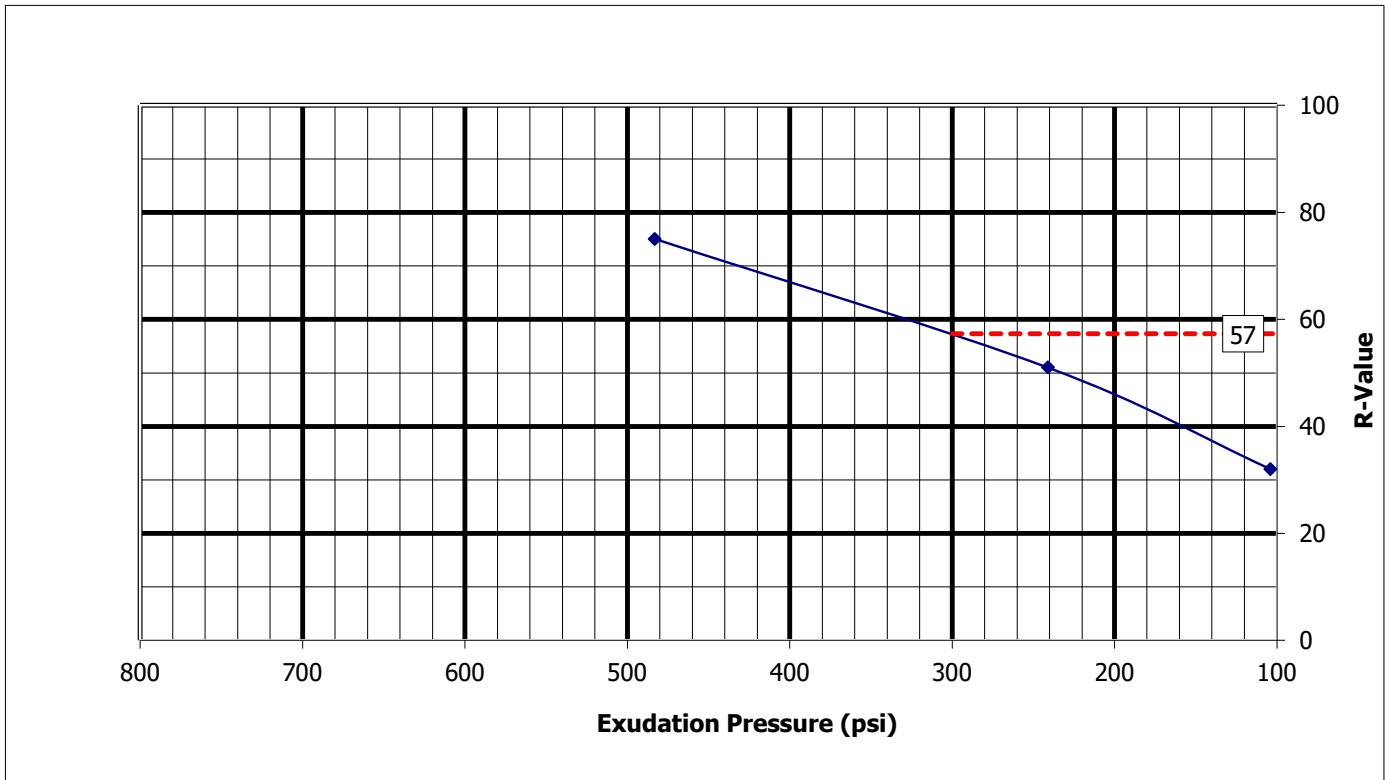
**R-VALUE TEST GRAPH (ASTM D2844)**

Project Number:	21.3092	Date:	25-Jan-22
Project Name:	Shoshana Ranch	Technician:	J. Holiman
Lab ID Number:	222073	Reviewer:	G. Hoyos
Sample Location:	TP-6 at 0.5' to 2'		
Visual Description:	SAND, with silt, and clay, and gravel, brown

**R-Value @ Exudation Pressure 300 psi:** 57  
**Specification:**
