RESTORATION PLAN
for the Cambria Chinese Temple
2264 Center Street, Cambria, California

July 22, 2005

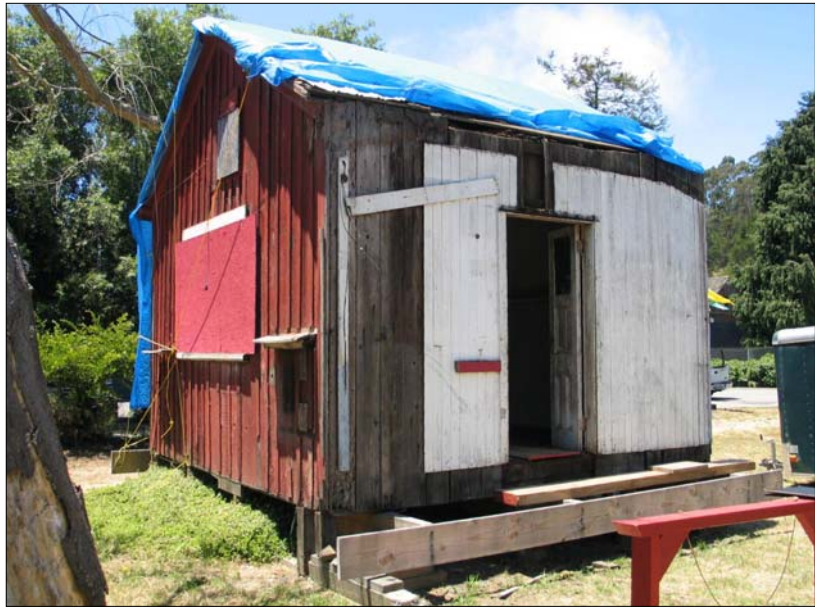
Figure 2. Cambria Joss House, present appearance.

A comprehensive analysis and evaluation of the Cambria Chinese Temple and the ca. 1900 residential structure, known locally as the Red House, into which it was formerly integrated was completed by Greenwood and Associates in April 2001 (Greenwood, Slawson, and Bentz). Subsequently, an Action Plan for treatment of historical resources on the property was also prepared (Greenwood 2001). Since those documents were submitted, the highly deteriorated residential elements that engulfed the temple were demolished, leaving only the small freestanding gabled structure (Figure 2).

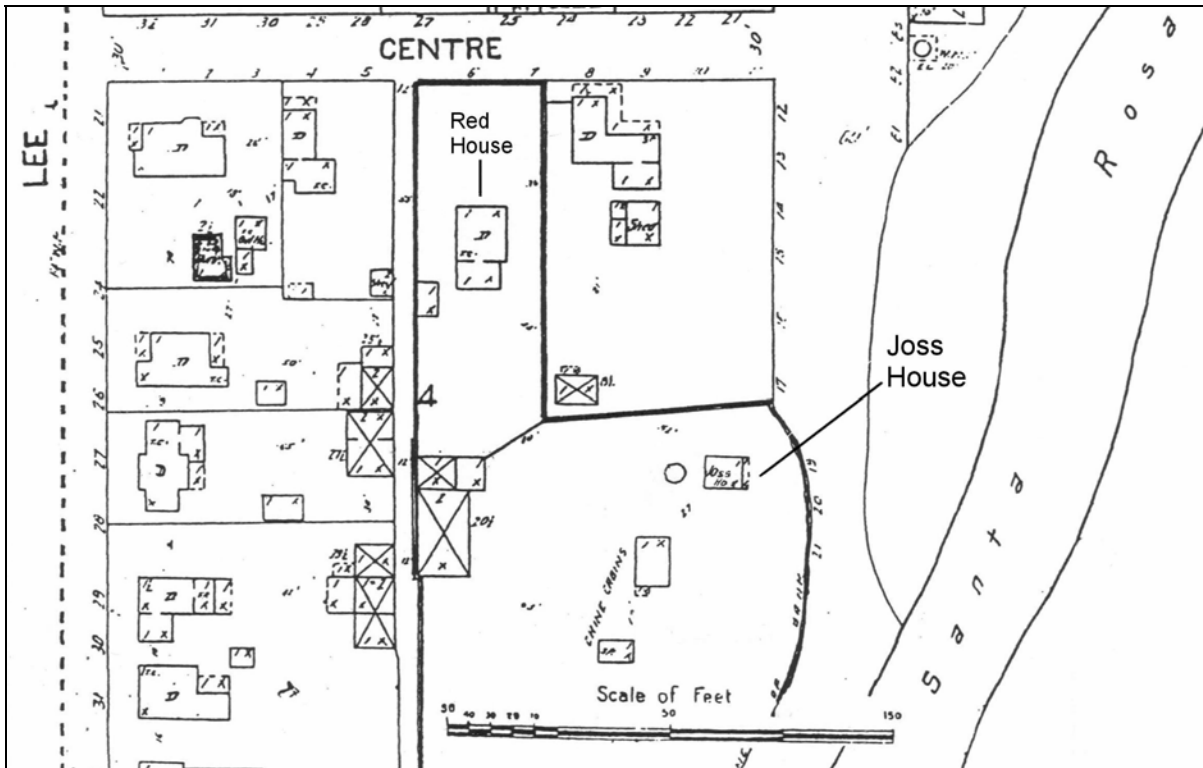
Figure 3. 1913 Sanborn map showing Joss House location.

In 1913, the Chinese laundry is no longer outlined on the Sanborn map at 19 and 20 Bridge Street. Instead, the same or another Joss House is shown at 19 Bridge Street, seemingly reoriented toward the creek (Figure 3). This building almost certainly corresponds with the surviving structure. Two new buildings labeled Chinese Cabins are drawn south of 21 Bridge Street, a distance apart and situated diagonally from each other. All of the buildings are colored yellow and keyed as wood frame, one-story, and roofed with shingles. The number and positioning of both the Chinese and Euroamerican structures correspond closely to buildings visible on a photograph ascribed to 1906 (Figure 4). Where the Chinese structures are visible, the one called the joss house on the Sanborn

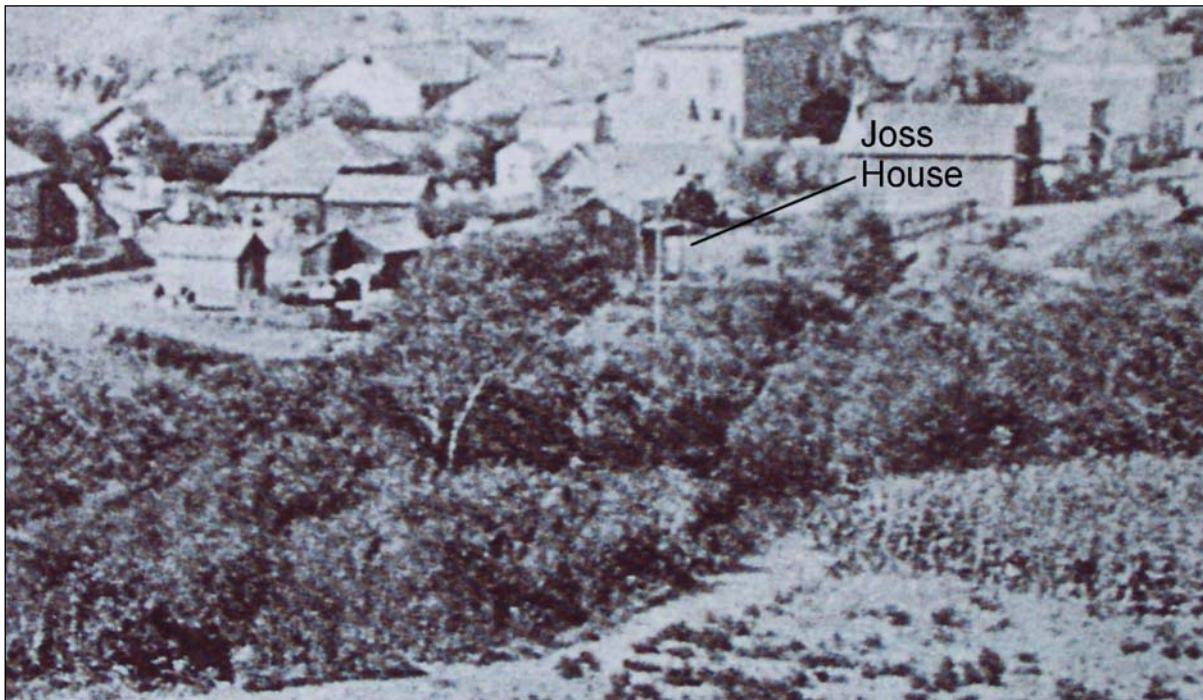
Figure 4. 1906 photograph showing Joss House in its earlier location.

map has a porch, asymmetrical vents under the gables, and a parapet, or false front. Given the small and transient nature of the population, there would not be the need or financial support for a grandiose building, and the temple would have served many social and integrating functions for persons who worked and lived along the coast in some degree of isolation.
