## Land off Sandy Lane, Ystradowen, Cowbridge

### SAB COMPLIANCE STRATEGY

Document ref no. 19351-R-601-SAB COMPLIANCE STRATEGY

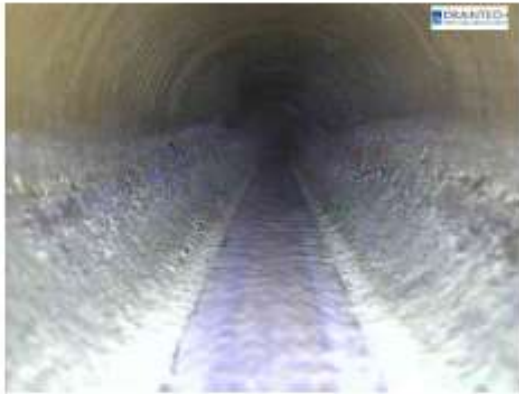
1, 00:02:52, 2.02 m

**Section Pictures - 21/03/2022 - ST01774835X**

Survey abandoned, Line needs cleaning - Spinning on grease

2.02	F01	Attached deposits, grease from 7 o'clock to 5 o'clock, 10% cross-sectional area loss, finish: Patchy	00:02:50			3		
	2.02	SA	Survey abandoned: Line needs cleaning - Spinning on grease	00:02:52		1			
Construction Features				Miscellaneous Features					
Structural Defects				Service & Operational Observations					
STR No. Def	STR Peak	STR Mean	STR Total	STR Grade	SER No. Def	SER Peak	SER Mean	SER Total	SER Grade
0	0.0	0.0	0.0	1.0	1	4.0	5.9	12.0	5.0

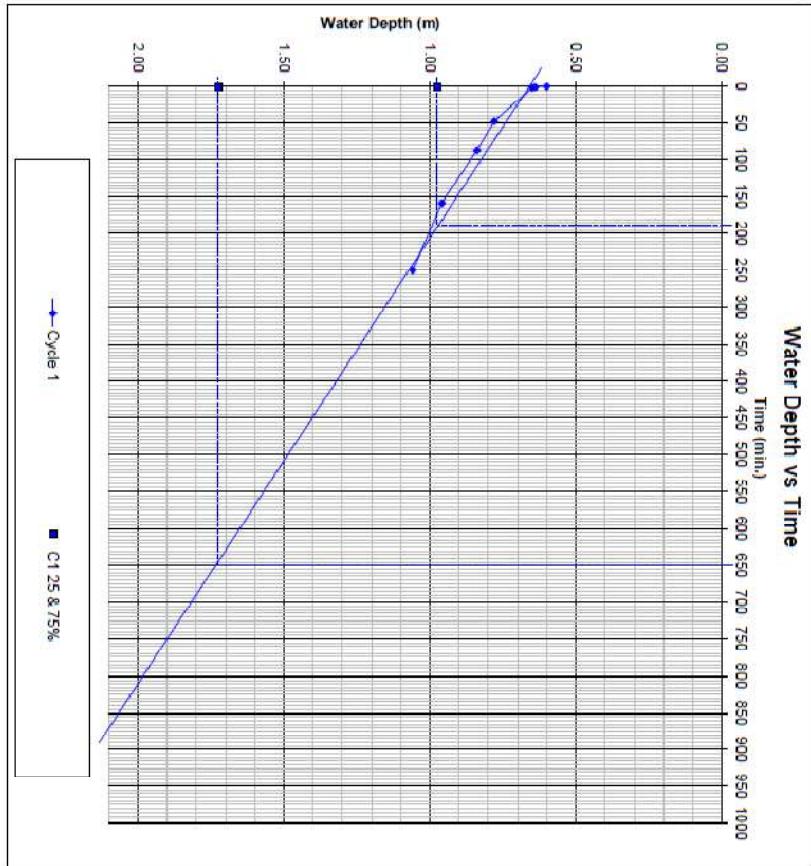
Time (min)	Cycle 1			Cycle 2			Cycle 3		
	Time (min)	Depth (m)	Time (min)	Time (min)	Depth (m)	Time (min)	Time (min)	Depth (m)	
1	0.53								
2	0.65								
48	0.78								
88	0.84								
159	0.95								
250	1.05

Final Excavation Depth (m)			
At end of test	Cycle 1	2.18	
At end of cycle			
Water depth at start of test		0.65	
Water depth at end of test		1.06	
Effective depth (measured)		0.46	
% Effective storage depth		0.31	
Effective Storage Depths (m)			
Effective storage depth (100%)		1.50	
Effective storage depth (75%)		1.13	
Effective storage depth (50%)		0.75	
Effective storage depth (25%)		0.38	
Outflow Time (min)			
Time for measured outflow		250	
Time for 100% outflow		970	
Time for 75-25% outflow		480	
Volume of Outflow (m <sup>3</sup> )			
Over 100% effective depth		0.53	
Over 75% - 25% effective depth		2.94	
Surfactant Area (m <sup>2</sup> )		1.47	
For 100% effective storage			
Over measured depth	Cycle 1	12.46	
Over 75% - 25% effective depth		7.21	
Soil Infiltration Rate (m/s)			
Over 100% effective depth	Cycle 1	5.18	
Over 75% - 25% effective depth	4.5E-06		
	1.2E-05		
	7.4E-06

Infiltration tests have been carried out by Integral Geotechnique, Initial results have proved inconclusive, rates between  $1.0 \times 10^{-6}$  and  $1.2 \times 10^{-5}$  have been noted and may offer a partial allowance for direct discharge to ground as part of the wider strategy.

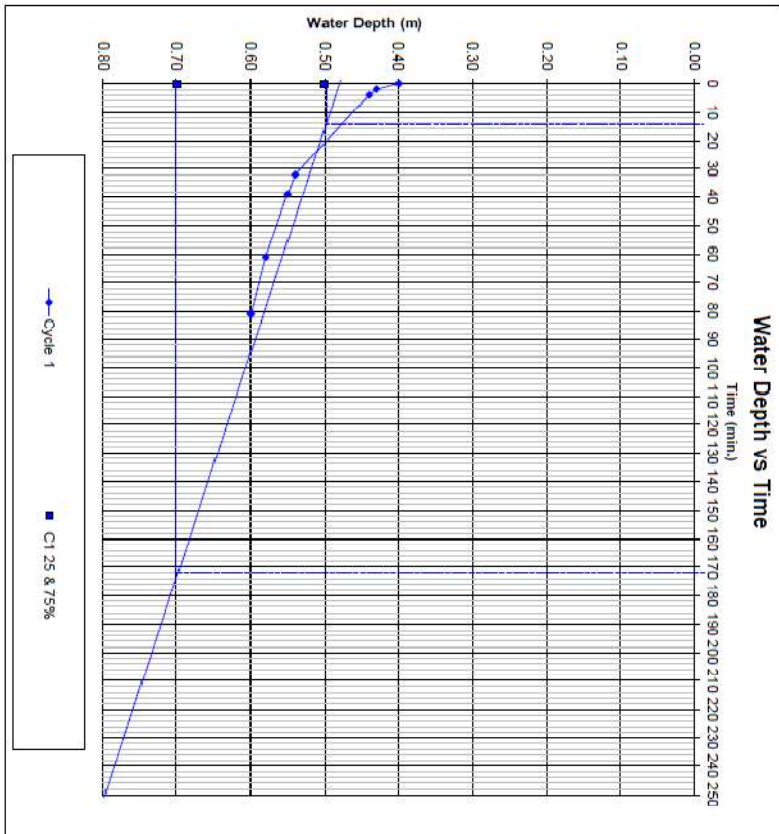
**BRE365 SOIL INFILTRATION RATE TEST - TP05A**  
 12604 Sandy Lane, Ystradowen

Trial pit information	
Length (m)	2.50
Width (m)	0.70
Depth (m)	1.50
Groundwater	1.5
Weather conditions	02-11-20
Time	09:30

Cycle 1		Cycle 2		Cycle 3	
	Time (min)	Depth (m)	Time (min)	Depth (m)	Time (min)	Depth (m)
Final excavation Depth (m)	0:00	0.80				
At end of testing Cycle						
Water Depth (m)	0:40	0.40				
Water depth at start of test	0:00	0.70				
Effective depth (measured)	0:20	0.20				
% Effective storage depth	0:50	0.50				
Effective Storage Depth (m)	0:40	0.40				
Effective storage depth (100%)	0:30	0.30				
Effective storage depth (75%)	0:20	0.20				
Effective storage depth (50%)	0:10	0.10				
Effective storage depth (25%)						
Outflow Time (min)						
Time for measured outflow		81				
Time for 75% outflow		29				
Time for 50% outflow		15				
Volume of Outflow (m <sup>3</sup> )						
Over measured effective depth		0.36				
Over 100% effective depth		0.70				
From 75% - 25% effective depth		0.25				
Surface Area (m <sup>2</sup> )						
For 100% effective storage		4.31				
For 50% effective storage		3.03				
Over measured depth		3.02

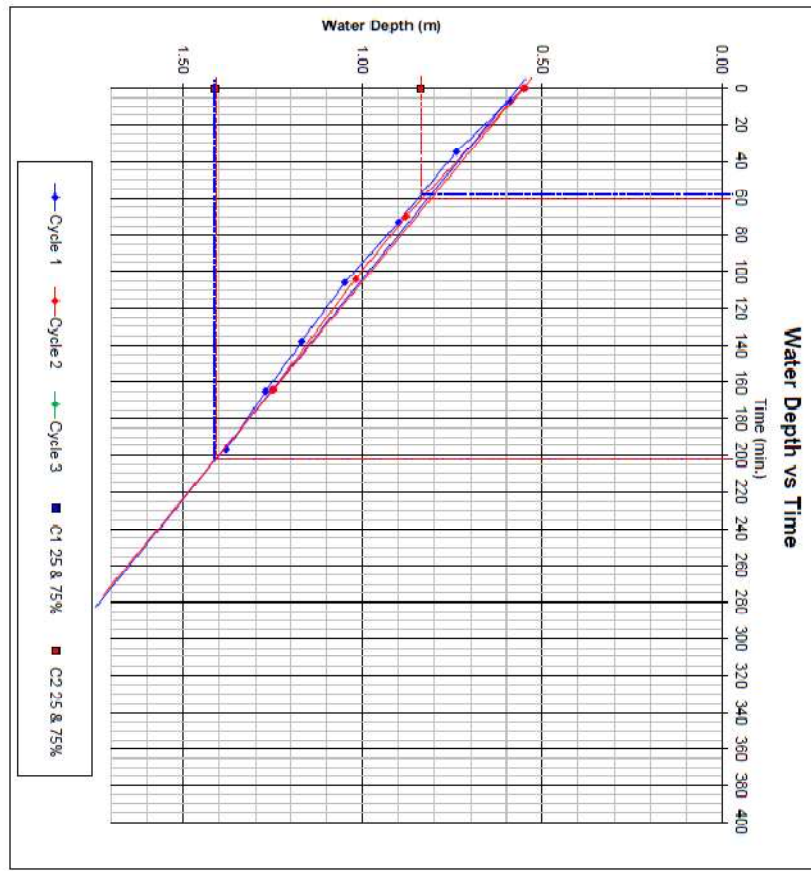
**BRE365 SOIL INFILTRATION RATE TEST - TP07**  
12604 Sandy Lane, Ystradowen

Trial Pit Information	
Length (m)	1.50
Width (m)	0.70
Depth (m)	1.70
Groundwater	Dry
Weather Conditions	21.02.20
Date

Final Excavation Depth (m)	Cycle 1		Cycle 2		Cycle 3	
	Time (min)	Depth (m)	Time (min)	Depth (m)	Time (min)	Depth (m)
At end of testing cycle						
Water depth at start of test		0.55		0.55		0.55
Water depth at end of test		0.55		0.55		0.55
Effective storage depth		0.85		0.85		0.85
% Effective storage depth		0.72		0.61		0.61
Effective storage depth (m)	1.15		1.15		1.15	
Effective storage depth (75%)	0.85		0.85		0.85	
Effective storage depth (50%)	0.55		0.55		0.55	
Effective storage depth (25%)	0.29		0.29		0.29	
Outflow Time (min)	197		154		154	
Time for measured outflow	270		270		270	
Time for 100% outflow	140		140		140	
Volume of Outflow (m <sup>3</sup> )		1.10		0.93		0.93
Over measured effective depth		1.30		1.30		1.30
Over 100% effective depth		0.78		0.78		0.78
Over 75% effective depth		0.78		0.78		0.78
Over 50% effective depth		0.78		0.78		0.78
Over 25% effective depth		0.78		0.78		0.78
Soil infiltration rate (mm)		7.31		7.31		7.31

For 100% effective storage		4.32		4.32		4.32
For 75% effective storage		5.65		4.97		4.97
Over measured depth		1.3E-05		1.3E-05		1.3E-05
Over 100% effective depth		1.7E-05		1.9E-05		1.9E-05
Over 75% - 25% effective depth		2.1E-05		2.1E-05		2.1E-05

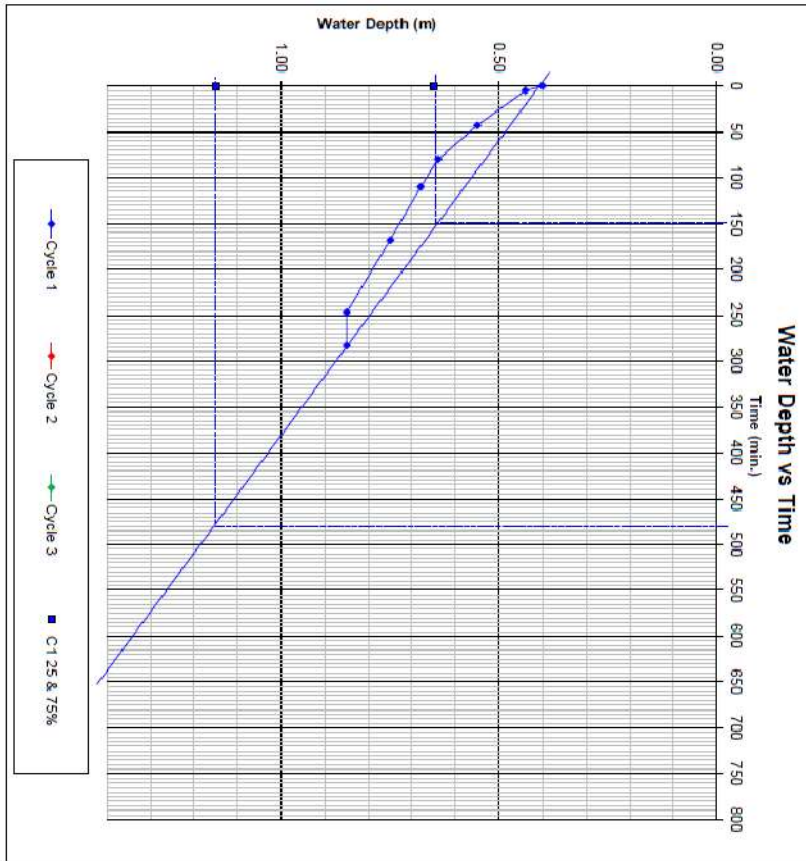
**BRE365 SOIL INFILTRATION RATE TEST - TP08**  
 12604 Sandy Lane, Ystradowen

Trial pit information	
Length (m)	1.80
Width (m)	0.55
Depth (m)	1.40
Groundwater	1
Weather Conditions	21.02.20
Date

Final Excavation Depth (m)	Cycle 1	Cycle 2	Cycle 3
At end of testing Cycle	1.40		
Water depths (m)			
Water depth at start of test	0.45		
Water depth at end of test	0.85		
Effective depth (measured)	0.45		
% Effective storage depth	0.45		
<b>Effective Storage Depths (m)</b>			
Effective storage depth (100%)	1.00		
Effective storage depth (75%)	0.75		
Effective storage depth (50%)	0.50		
Effective storage depth (25%)	0.25		
<b>Outflow Time (min)</b>			
Time for measured outflow	293		
Time for 100% outflow	640		
Time for 75-25% outflow	330		
<b>Volume of Outflow (m<sup>3</sup>)</b>			
Over measured effective depth	0.33		
Over 50% effective depth	1.00		
Over 75% effective depth	0.50		
<b>Surface Area (m<sup>2</sup>)</b>			
For 100% effective storage	6.07		
For 80% effective storage	3.62		
Over measured depth	3.38		
<b>Soil Infiltration Rate (mm/s)</b>			
Over 100% effective depth	5.0E-06		
Over measured depth	9.2E-06

Over 75% - 25% effective depth	8.2E-06

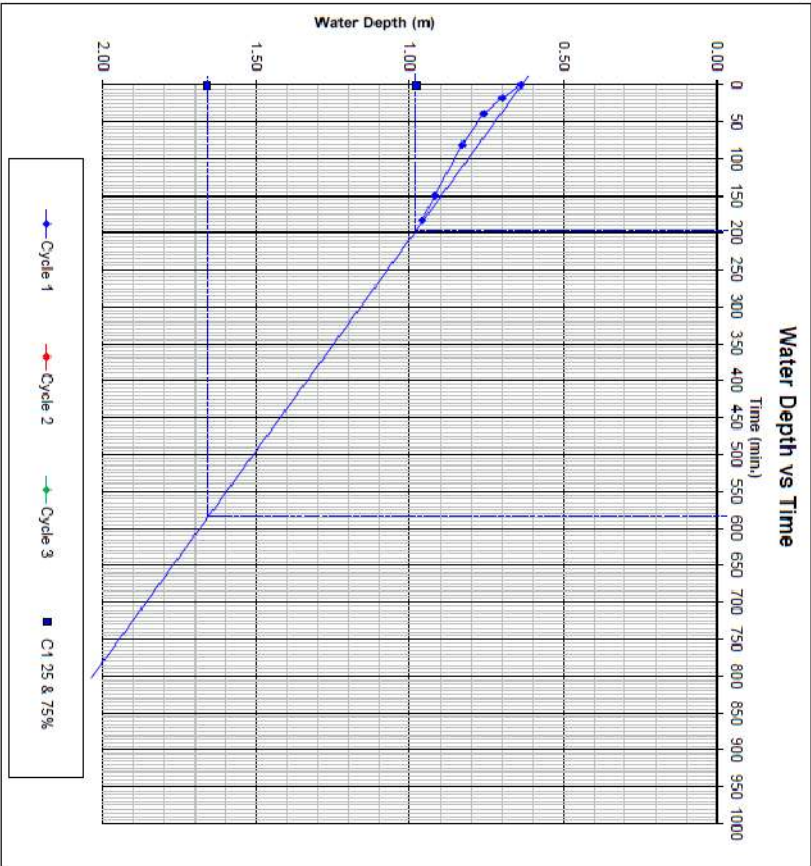
**BRE365 SOIL INFILTRATION RATE TEST - TP12**  
 12604 Sandy Lane, Ystradowen

Trial Parameters	
Length (m)	2.00
Width (m)	0.65
Depth (m)	2.00
Groundwater	Dry
Weather Conditions	
Date	21.02.20

At end of testing cycle	Cycle 1		Cycle 2		Cycle 3	
	Time (min)	Depth (m)	Time (min)	Depth (m)	Time (min)	Depth (m)
Water depth at start of test	0	0.64				
Water depth at end of test	18	0.70				
Effective depth (measured)	39	0.75				
% Effective storage depth	61	0.63				
Effective Storage Depth (m)	150	0.92				
Effective storage depth (100%)	183	0.95

Final Excavation Depth (m)		Cycle 1	Cycle 2	Cycle 3
At end of testing cycle	2.00			
Water Depth (m)	0.64			
Water depth at start of test	0.95			
Water depth at end of test	0.32			
% Effective storage depth	0.24			
Effective Storage Depth (m)	1.35			
Effective storage depth (100%)	1.02			
Effective storage depth (50%)	0.68			
Effective storage depth (25%)	0.34			
Time for measured outflow	183			
Time for 100% outflow	280			
Time for 75-25% outflow	380			
Volume of Outflow (m <sup>3</sup> )	0.42			
Over measured effective depth	1.77			
Over 100% effective depth	0.89			
From 75% - 25% effective depth				
Surface Area (m <sup>2</sup> )	8.51			
For 100% effective storage	4.90			
For 50% effective storage	2.00			
Soil Infiltration Rate (mm)	Cycle 1: 4.4E-06	Cycle 2:	Cycle 3:	
Over measured depth	1.35E-05			
Over 75% - 25% effective depth	7.2E-06
