REMEDIAL ACTION WORKPLAN

Former Newport School
7456 East Street
Newport, New York

HRP Associates, Inc.
1 Fairchild Square, Suite 110
Clifton Park, NY 12065

Issued On: October 2024

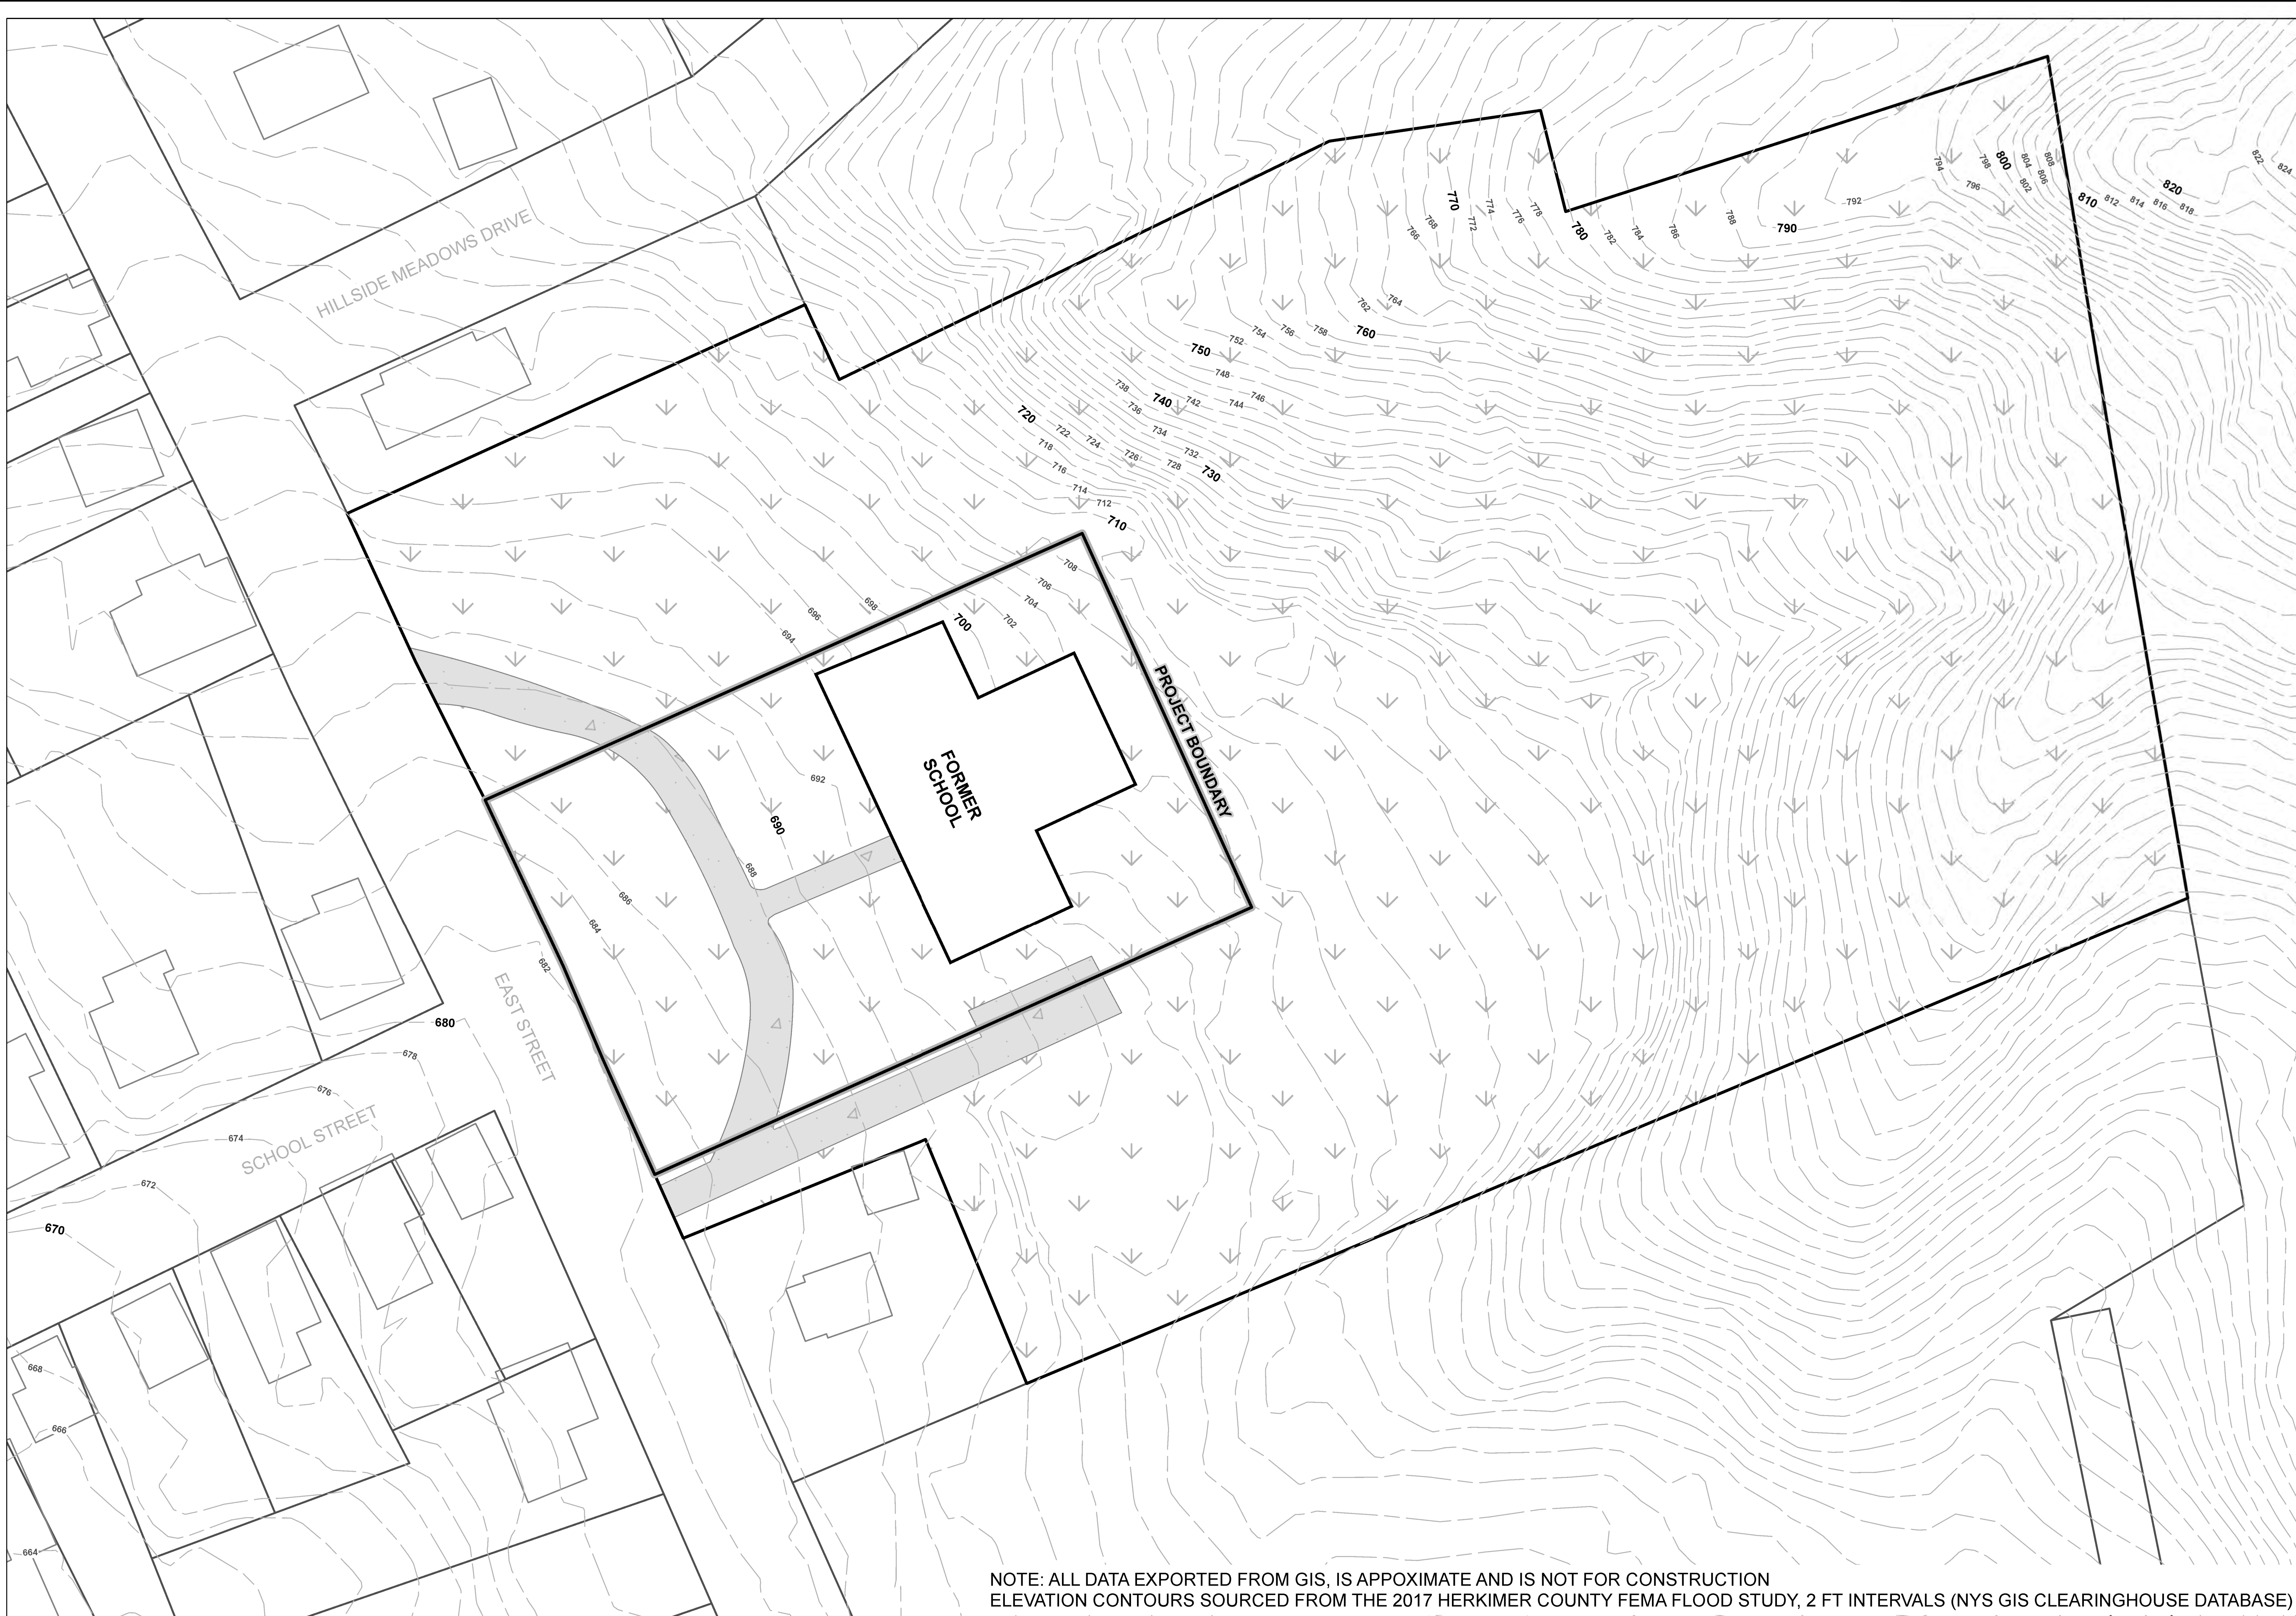
SHEET NO.
2

NOTE: ALL DATA EXPORTED FROM GIS, IS APPROXIMATE AND IS NOT FOR CONSTRUCTION
ELEVATION CONTOURS SOURCED FROM THE 2017 HERKIMER COUNTY FEMA FLOOD STUDY, 2 FT INTERVALS (NYS GIS CLEARINGHOUSE DATABASE)

SITE FEATURES

The Village of Newport requested HRP Associates, Inc. (HRP) prepare a Remediation Action Workplan for the former Newport School located at 7456 East Street in the Village of Newport, New York (see Figure 1, Site Location), **herein referred to as "the Site"**. This Workplan includes the demolition, with asbestos containing materials in place and offsite disposal, of the on-site vacant and dilapidated three-story school building totaling 24,584 square feet (Figure 2).
