Environmental Impact of Asbestos Cement Pipe Renewal Technologies

Web Report #4465

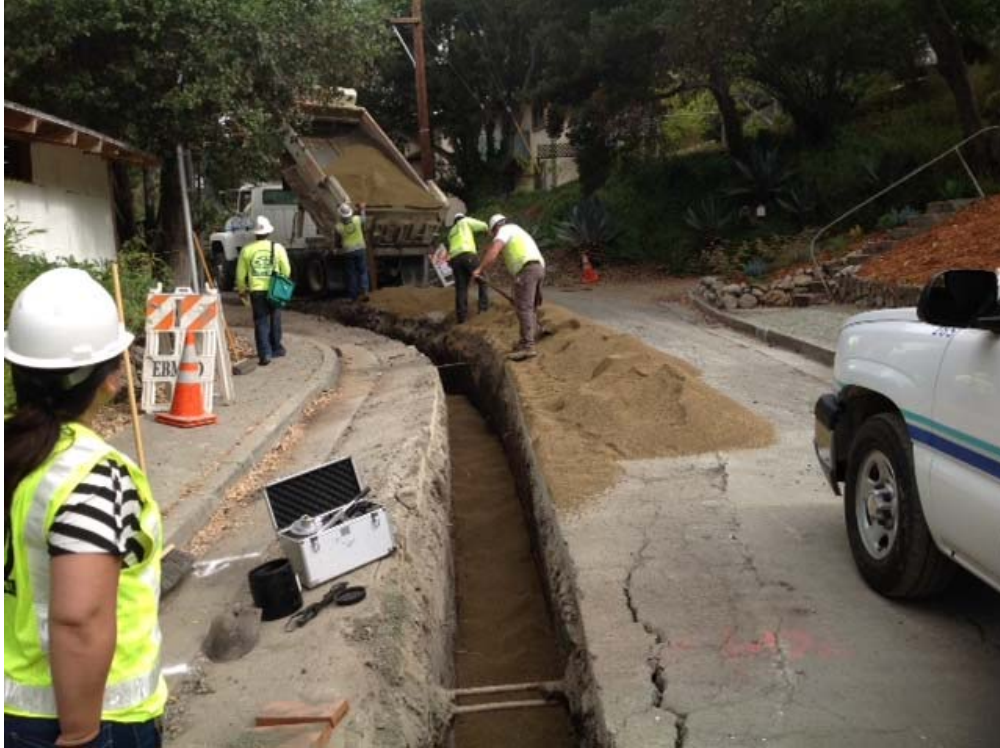
Figure 2-1 Typical open cut installation site

For years, the primary way to renew AC pipe was to dig it up and replace it. A trench is dug to expose the AC pipe (Figure 2-1), which is then cut into manageable-size pieces, placed into containers or wrapped in plastic (Figure 2-2), and transported to a landfill that accepts asbestos waste. During the cutting process, the asbestos in the pipe has a high probability of becoming friable and, therefore, is regulated under NESHAP. Wetting of the pipe during cutting is needed to prevent the asbestos fibers from becoming airborne. All the activities are typically performed by certified asbestos abatement contractors. To help owners and operators of facilities with asbestos cement products, EPA (2013) has provided the following statement on the removal of asbestos cement products and their applicability to NESHAP:

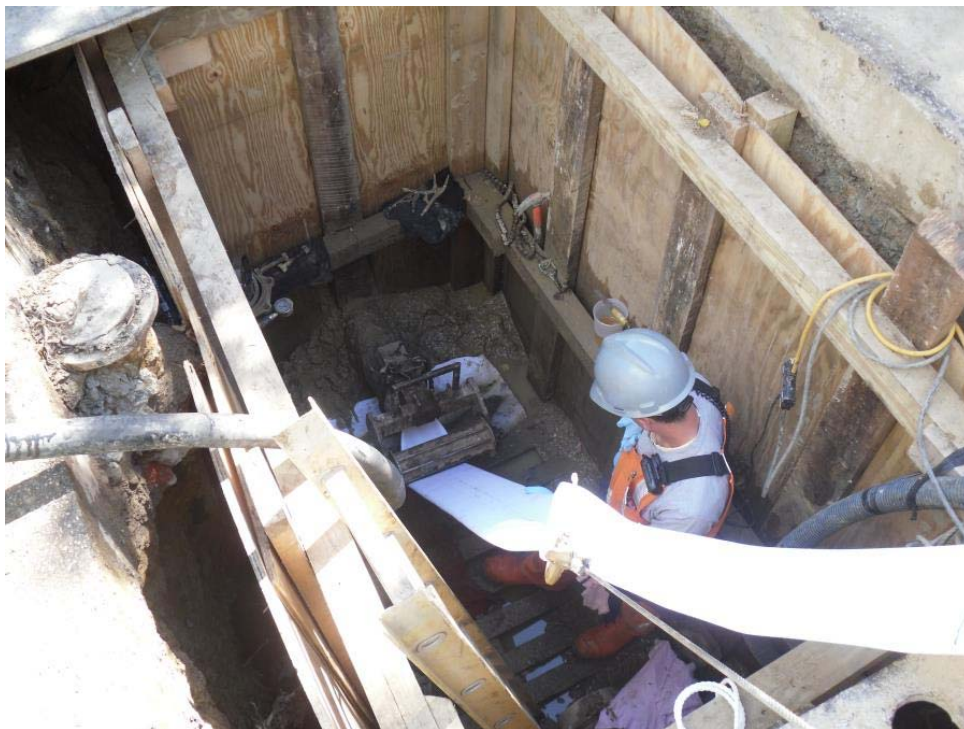
Figure 2-3 CIPP used to renew a 6-in water main

CIPP is a well-established lining method for wastewater pipe rehabilitation and over the past decade modified versions have been adapted to pressure applications and water distribution systems. CIPP uses a resin-saturated tube that is inserted into a cleaned pipe by inversion or with a winch, and expanded using air or water pressure (Figure 2-3). For water applications, the tube can be made from polyethylene (PE) or polyurethane (PU) coated fabric of woven polyester or glass-fiber, or non-woven felt and glass reinforcement. The resin used for water applications is typically epoxy, and the product must be certified to meet NSF/ANSI Standard 61 requirements for contact with potable water. Equipment used for the installation is dedicated for the water application to minimize risks of cross-contamination from other non-drinking water pipeline applications (Morrison et al. 2013).

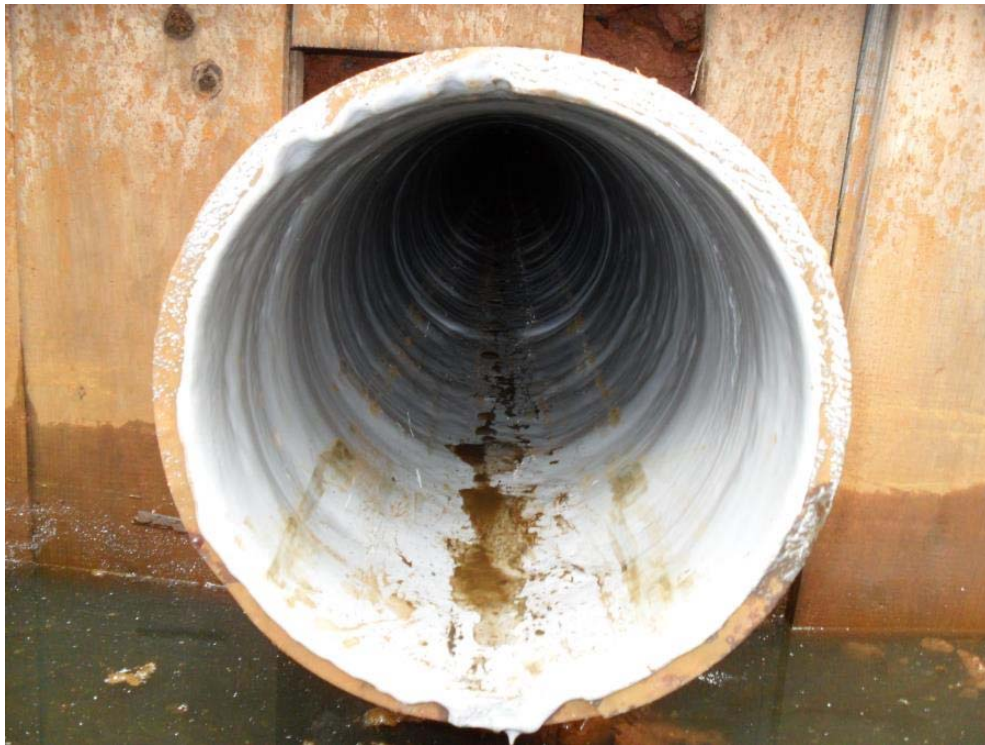
Figure 2-4 SIPP used to renew a 10-in water main

Polymeric SIPP is an innovative alternative for water main rehabilitation capable of achieving AWWA semi-structural properties. In this process, polymeric materials (i.e., polyurea or polyurethane) are pumped through a hose to a rotating spray head that directly applies it onto the interior of a cleaned pipe (Figure 2-4). The thickness of the applied layer is controlled by the flowrate of material and the speed of the lining rig through the pipe. After inspection by camera, the main is disinfected and flushed, and service connections are reopened. The pipe is then returned to service (Kulkarni et al. 2010). This technology has been used predominately in the U.K., Australia, and Canada, but initial demonstrations and pilot projects have begun in the United States over the past few years (Matthews et al. 2012).

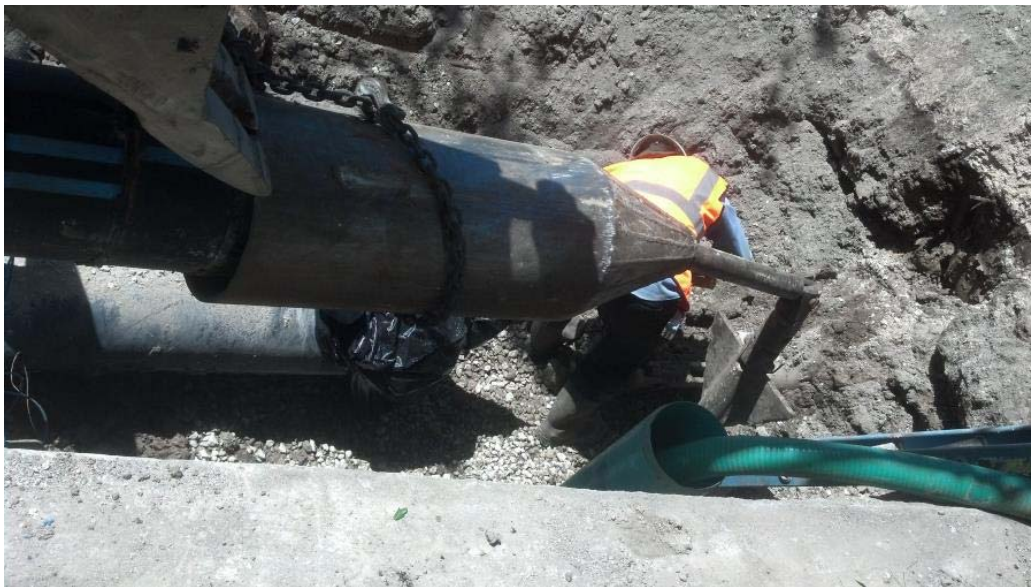
Figure 2-5 Pipe bursting used to renew an 8-in AC water main

Pipe bursting uses specialized equipment to fracture brittle pipes and displace the existing pipe into the soil while forming a cavity in the soil large enough to place a new pipe of equivalent or larger size in the ground (Morrison et al. 2013). Pipe bursting has the advantage of the installation of a new pipe, often an upsized diameter, and eliminates any need for detailed condition assessment (Figure 2-5). However, prior to pipe bursting, a good deal of information about the old pipe and its construction, in particular the placement and surroundings including the existence of other buried utilities and adjacent building foundations, is required. Removal of service connections is required before bursting to minimize collateral damage and the service connections will often be replaced by trenching or, if lengthy and under the road pavement, by impact moling. While pipe bursting has become a popular method of trenchless replacement of water mains (Deb et al. 1999), concerns over the environmental impact has limited its use on AC pipes.

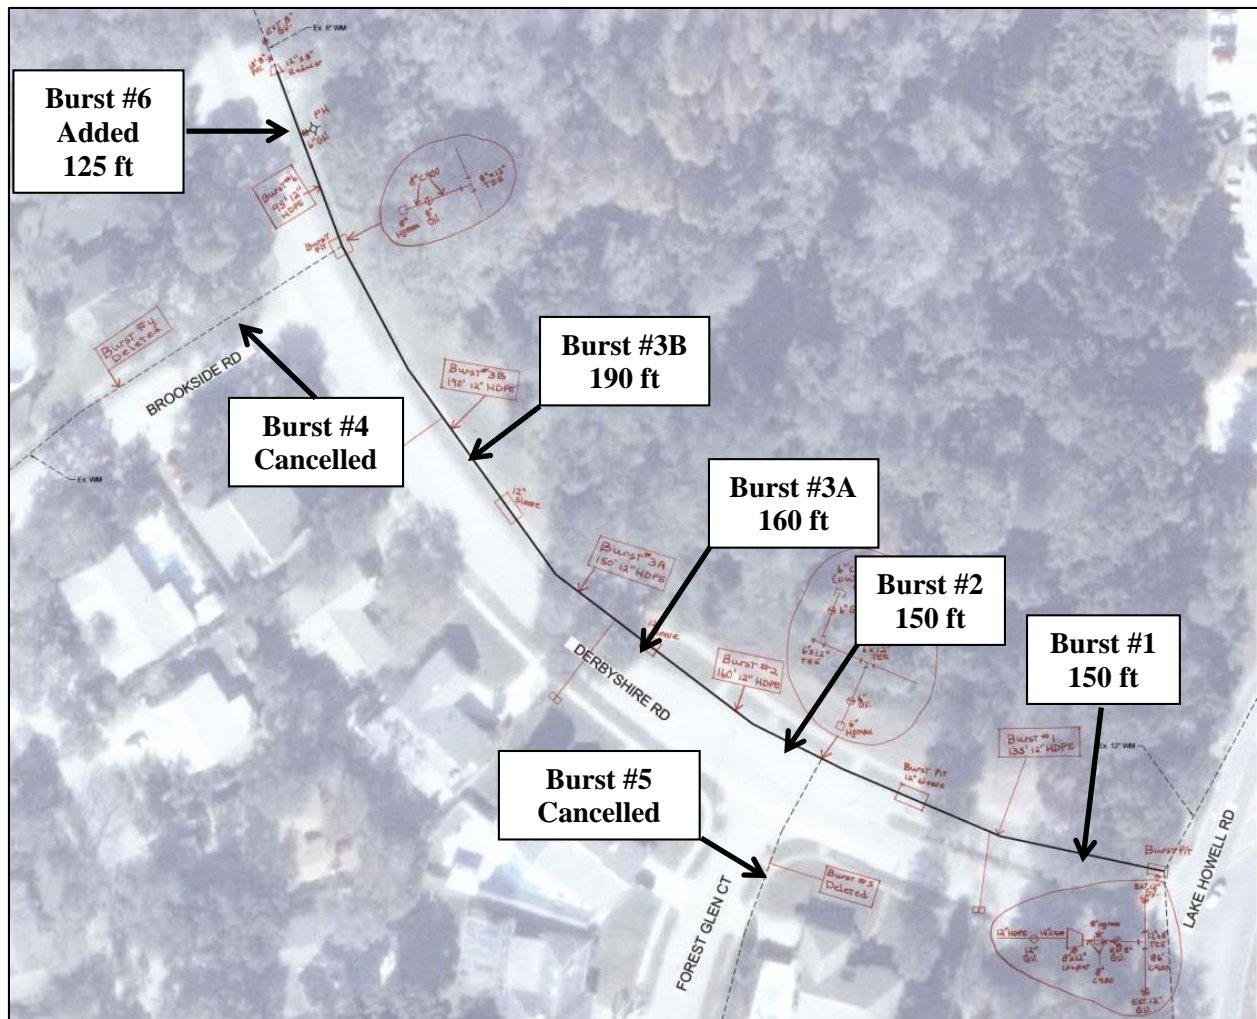
Figure 3-1 Map of pipe bursting locations in Casselberry, FL

A total of five bursts across Derbyshire Road, Brookside Road, and Forest Glen Court were originally planned for a total length of 1,020 ft. The size of the existing AC ranged in diameter from 8-in to 12-in and was entirely replaced with 12-in high-density polyethylene (HDPE) pipe. Due to unforeseen circumstances in the field, modifications to the original plans had to be made. Bursts #4 (185 ft) and #5 (185 ft) on Brookside Road and Forest Glen Court, respectively, were cancelled and Burst #6 (125 ft) along Derbyshire Road was added (see [Figure 3-2](#)). Burst #3 was divided into two (2) runs – #3A (160 ft) and #3B (190 ft) – due to difficult soil conditions experienced while performing runs #1 and #2. To accommodate runs #3A and #3B an additional pit (#4A) between pits #4 and #5 had to be excavated. As a result of the modifications, the total length of AC pipe burst and replaced decreased from 1,020 ft. to 775 ft. The locations of the actual five bursts that occurred in the field are shown in [Figure 3-1](#) and summarized in [Table 3-3](#).

water main that runs underneath Forest Glen Court (see [Figure 3-1](#)); and one pit was required for the removal and installation of a new fire hydrant. Only the pits required for that day's scheduled bursting run are excavated. The average dimensions of the eight pits were approximately 14 ft (L) x 10 ft (W) x 5 ft (D). The pits were outlined and "de-rocked" by cutting through the pavement with a demolition saw ([Figure 3-6](#)) and removing the pavement above the soil with an excavator. The broken-up pavement was placed in a temporary debris pile prior to being loaded into a truck for disposal. After the pits were "de-rocked", an excavator was used to excavate the soil and gain access to the pipe ([Figure 3-6](#)). All excavated soil was kept onsite and used to backfill the pits at the end of each day.

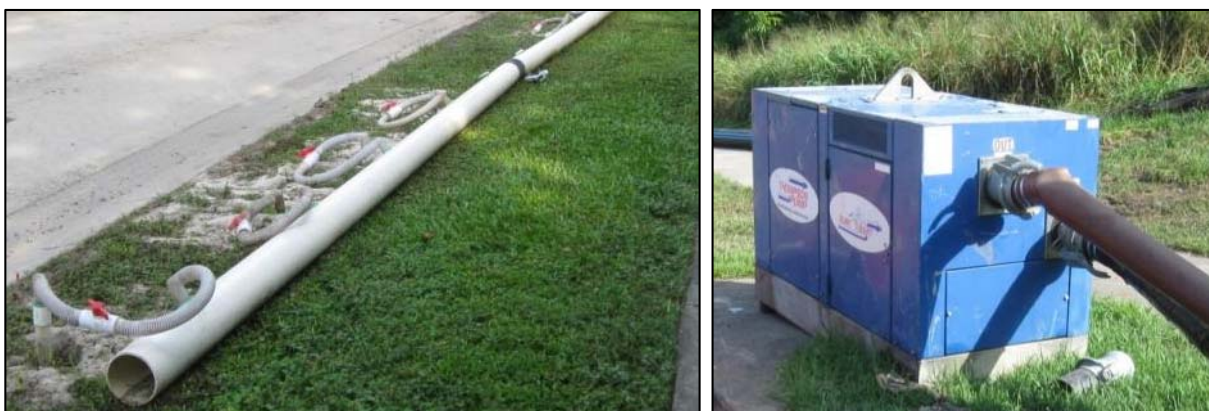
Figure 3-2 Dewatering system (left) and pump (right)

Due to the sandy soil conditions in the area, dewatering systems were installed near each pit. One week prior to the start of work, a crew drilled a series of 1.5-in holes approximately 2-3 ft apart beside the planned pit locations. A section of slotted 1.5-in. diameter polyvinyl chloride (PVC) was inserted into each hole and connected to a larger PVC pipe (i.e., 6-in diameter x 10 ft length) by a short hose (Figure 3-2). Approximately five 1.5-in slotted PVC sections were connected to each 12 ft section of 6-in PVC. The 12 ft section was connected to a pump, which pumped the water to a nearby storm sewer that has been fitted with an external filter to prevent sand and debris from entering.

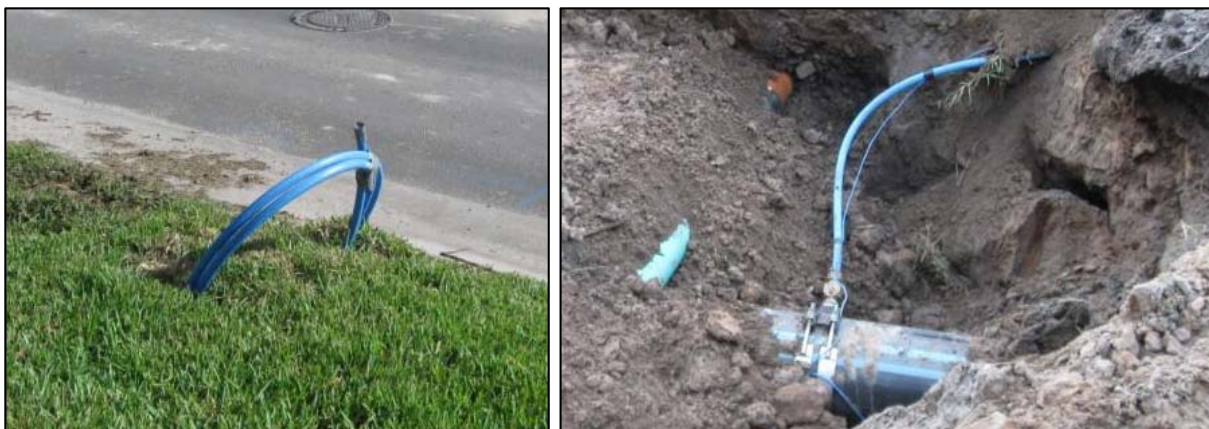
Figure 3-3 New HDPE service (left) and service connected to new HDPE main (right)

As a result of the bursting process, new service connections for each residence had to be installed. Had open cut been used to replace the main in the same trench, the existing services would likely have been used and re-tapped into the new main. A week prior to the start of scheduled work, existing service connections were located and new service connections (i.e., 1-in. HDPE) were directionally drilled using a micro rig (Figure 3-3). The new services were connected after the existing AC pipe had been burst and the new HDPE pipe was inserted. More than one residence could be supplied by a single connection, which reduces the number of taps into the main.

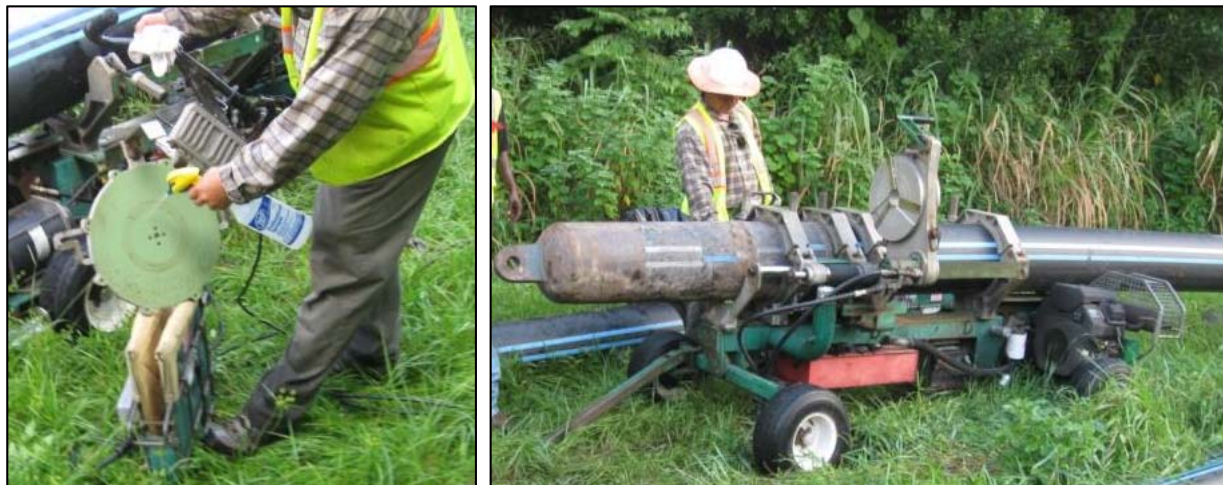
Figure 3-4 Flat iron with heating element (left) and pipe fuser (right)

HDPE was selected by the City as the replacement pipe for the current AC water line. The pipe string for each burst run was prepared at the site up to two weeks in advance. Specialized equipment was used to fuse the sections of HDPE pipe. The equipment first shaved down each end of the pipes to be fused to ensure they were perfectly flush. Next, a flat iron larger than the diameter of the pipe was heated to 400°F (Figure 3-4) and inserted between the two sections of pipe that were to be fused. The pipe ends were pulled together against the iron to heat up. After the ends

heated up, becoming deformable, the iron was removed and the pipe ends were pulled together and locked in place causing the ends to fuse while simultaneously cooling down (Figure 3-4).

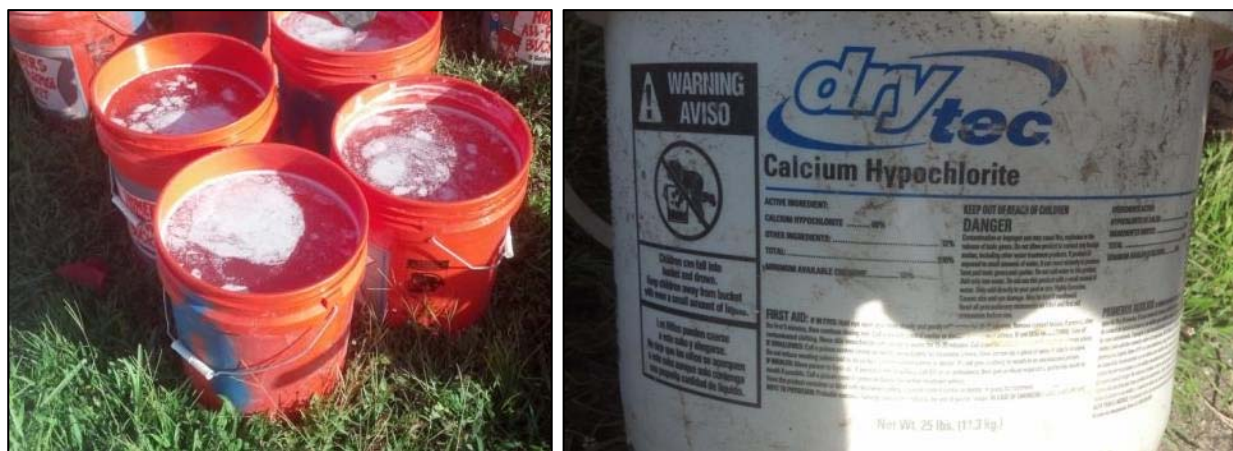
Figure 3-5 Buckets of super-chlorinated water (left) and calcium hypochlorite (right)

After all required sections of HDPE pipe were fused the string of pipe was rinsed with clean water and pressure tested to 150 psi for two hours as instructed by the manufacturer to check for any leaks at the fused seams. Upon successful completion of the pressure test, the string of pipe was completely filled with super-chlorinated water (approximately 2% by weight as hypochlorite [OCl_2]). The super-chlorinated water was made by putting approximately eight ounces of calcium hypochlorite ($\text{Ca}(\text{OCl})_2$) powder (65% available chlorine) into five gallons of water (Figure 3-5). The super-chlorinated water remained in the pipe up until the time the string was to be used. The water was then drained prior to insertion.

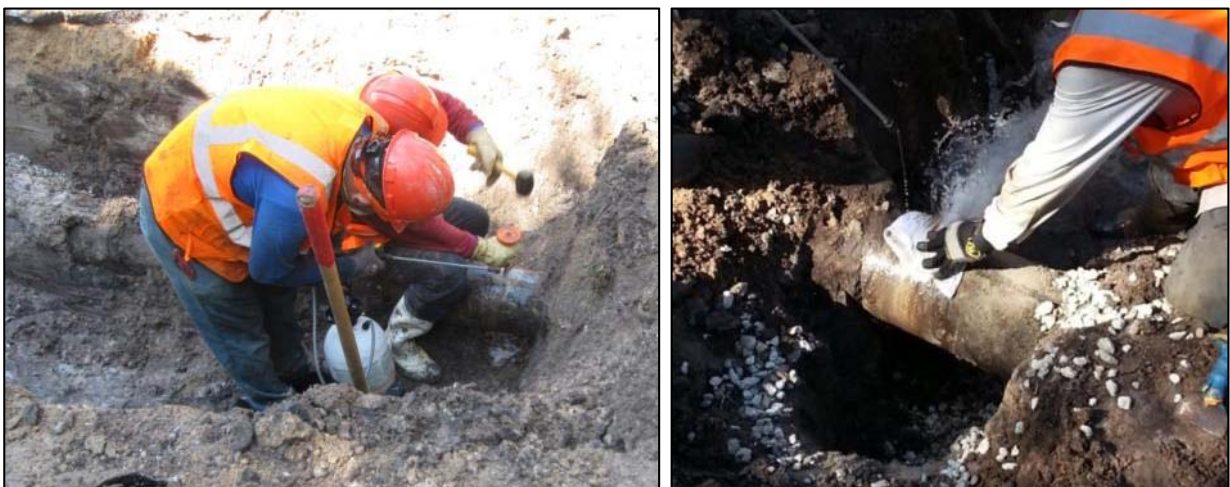
Figure 3-7 Workers cutting AC pipe

The section of AC pipe exposed in each pit was removed so the crew could gain internal access to the pipe. To remove the exposed pipe, a cut was made near each pipe and pit wall interface. The cuts were made either using a small sledgehammer or hammer and chisel, depending if a clean edge (result of using a chisel) was needed or not (result of using a sledgehammer). Clean edges were needed to make the temporary connections between the newly inserted HDPE pipe and existing AC pipe. The cutting process involved two workers with dust masks – one worker was responsible for making the cut while the other worker maintained a wet cutting area using a sprayer ([Figure 3-7](#)).

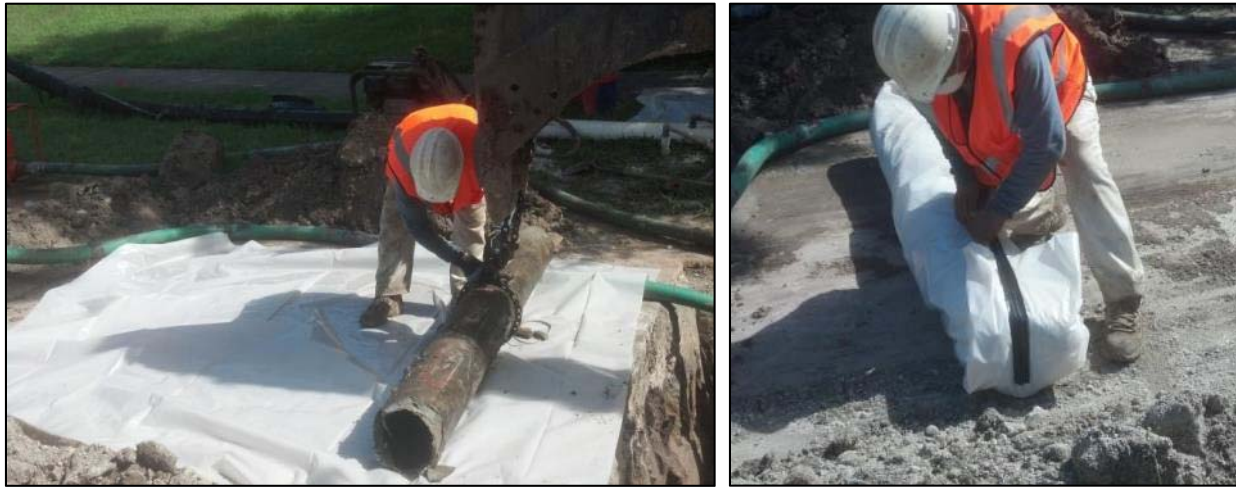
Figure 3-8 Wrapping and taping of the AC pipe

The City and its contractor follow the practices in *Work Practices for Asbestos-Cement Pipe* (AWWA 1995). In addition, the cutting area on the pipe was wrapped with wet rags to prevent pieces of the pipe becoming airborne and potentially causing injury. Once the cuts were finished, the pipe was connected to the boom of the excavator with a chain and lifted out of the pit. The AC pipe was then lowered on to a large plastic sheet on the ground where it was completely wrapped and taped by a worker (Figure 3-8). The exposed ends of the AC pipe protruding into the pit were also wrapped with plastic until the start of bursting. If the section of pipe being removed contained a joint or a valve, only the exposed ends of the pipe were wrapped with plastic and taped – not the entire piece. The wrapped section of pipe was loaded onto a truck for transport to a landfill that accepted asbestos waste.

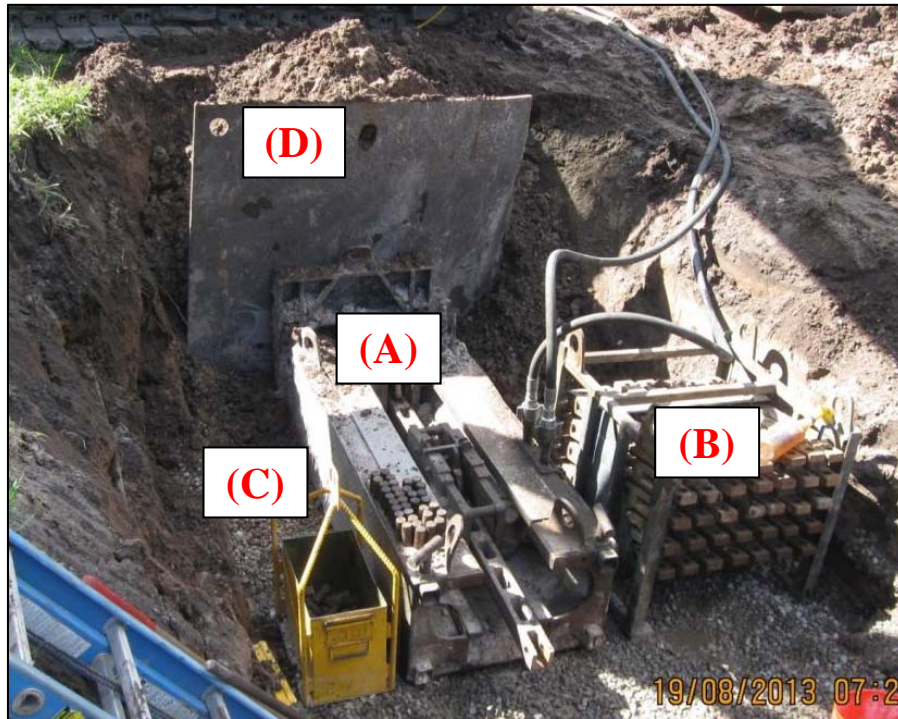
Figure 3-9 Machine pit containing bursting equipment

bursting machine was placed against the plate for stability. The hydraulic bursting machine (A), linkage basket (B), pin basket (C), and steel plate (D) are shown in [Figure 3-9](#).

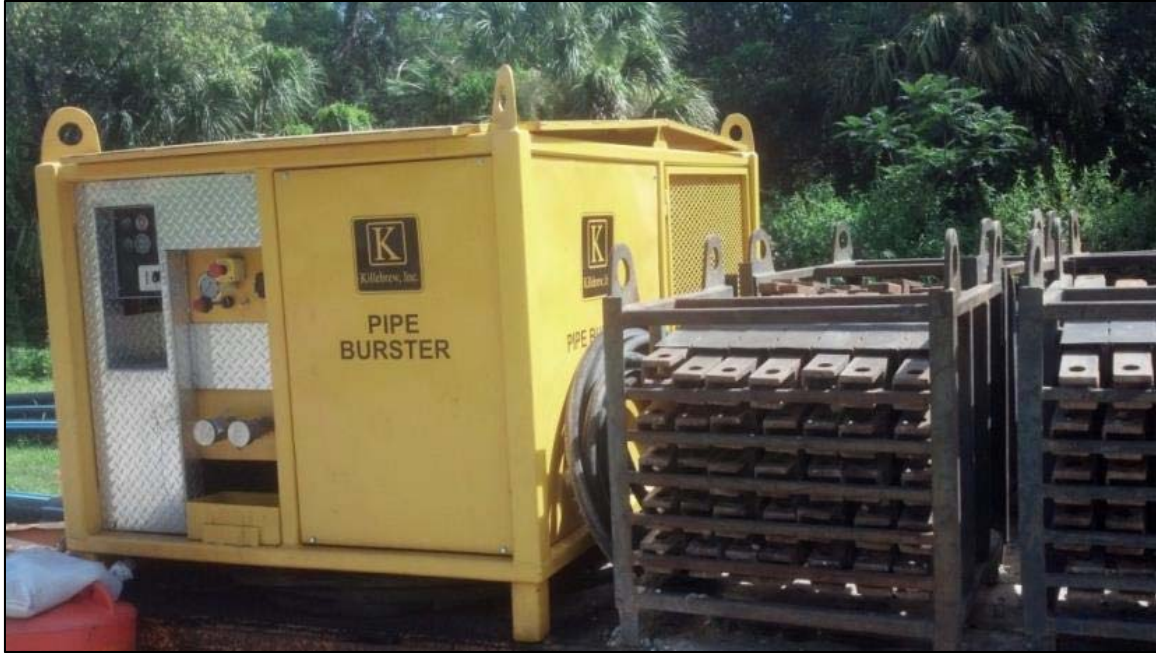
Figure 3-10 Hydraulic pump and linkages on a trailer

Power to the bursting machine was provided by a large hydraulic pump located on a nearby flatbed trailer and was connected by two (2) hoses ([Figure 3-10](#)). A three-person crew was required in the machine pit. The roles of the crew were as follows:

Each linkage was approximately 3 ft in length and was connected to another linkage using a pin. The linkages were stored in baskets that held approximately 30 linkages. Prior to being connected, each end of the linkage was sprayed with oil to prevent sticking while disconnecting during the bursting process.

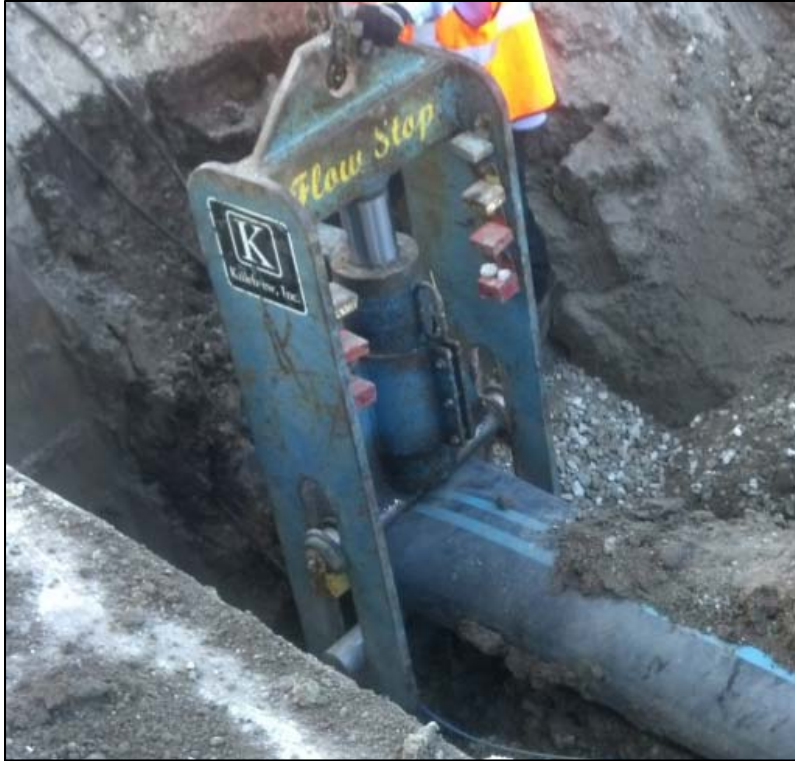
Figure 3-11 Hydraulic pipe clamp

1. If the new HDPE pipe was going to be connected to a water main that was not going to be rehabilitated, a valve was turned off to isolate the existing pipe section.
2. If the new HDPE pipe was going to be connected to another section of new HDPE pipe from a previous burst, a large hydraulic clamp was used (Figure 3-11).

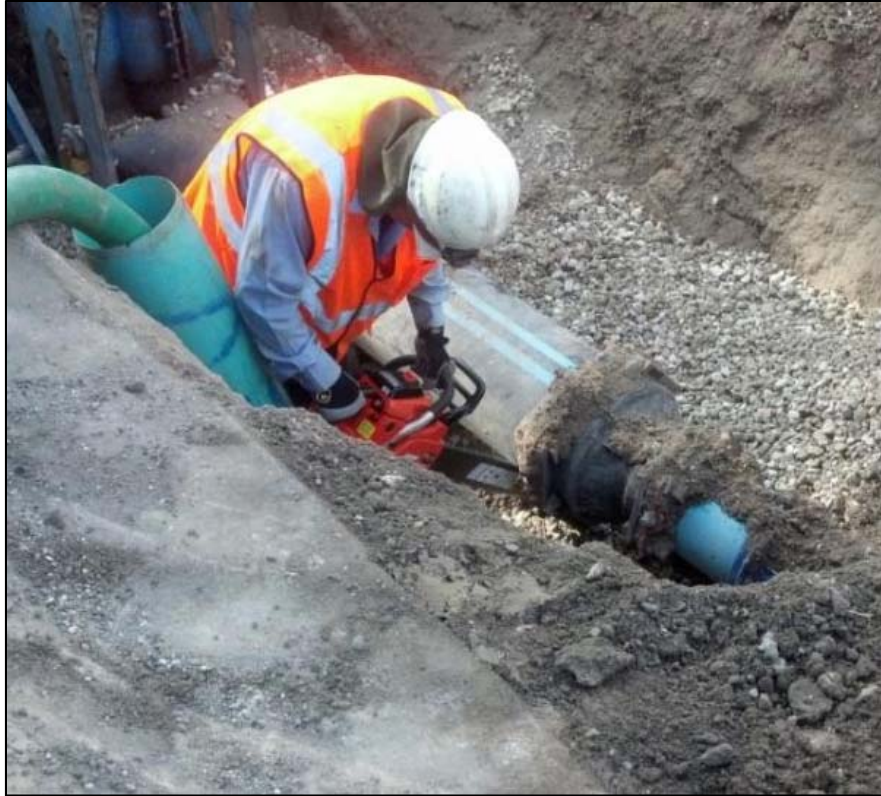
Figure 3-12. Removal of temporary connection

Since one burst run was performed per day and runs were made consecutively, temporary connections were made between new HDPE pipe and the existing AC pipe. Temporary connections were typically made in the machine pit while permanent connections were made in the insertion pit. Because a pit that served as a machine pit on one run would serve as the insertion pit on the next run, the temporary connection established when the pit was a machine pit was removed using a chainsaw to allow access to the AC pipe. [Figure 3-12](#) shows a worker starting to make a cut in the HDPE side of the connection.

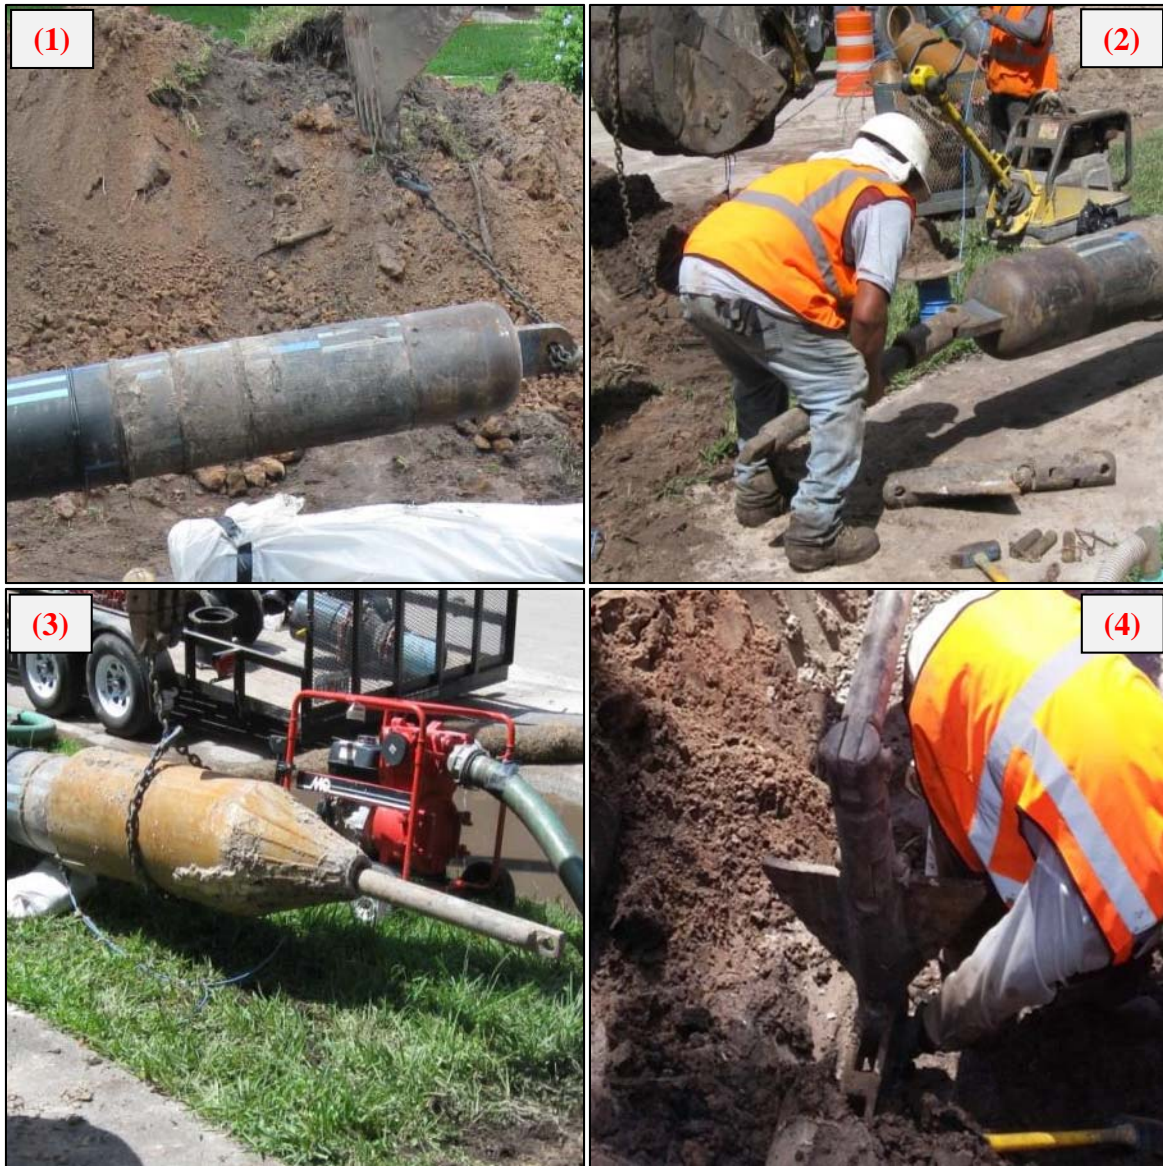
Figure 3-13 Elements of the bursting head

Once the temporary connection was removed, the string of pipe to be used for the run was lined up with the insertion pit using an excavator and a front-end loader with equipped with forks. Next, the bursting head was connected to the front-end of the pipe string. The bursting head (Figure 3-13) consisted of four (4) distinct elements:

1. Connector Head – round metal cap with a connection that was fused to the front of the pipe.
2. Extender Rod – metal rod (approximately 3 ft) that connected to the connector head with a pin.
3. Expander Head – metal cylinder with a conical front slightly used to create the void space the new pipe will occupy. Slid over the extender rod and connector head.
4. Splitter Head – metal rod with two joints that allowed for horizontal and vertical movement and two fins on each side used to split the existing pipe. The rear connected to the extender rod while the front connects to the linkages. Both connections used pins.

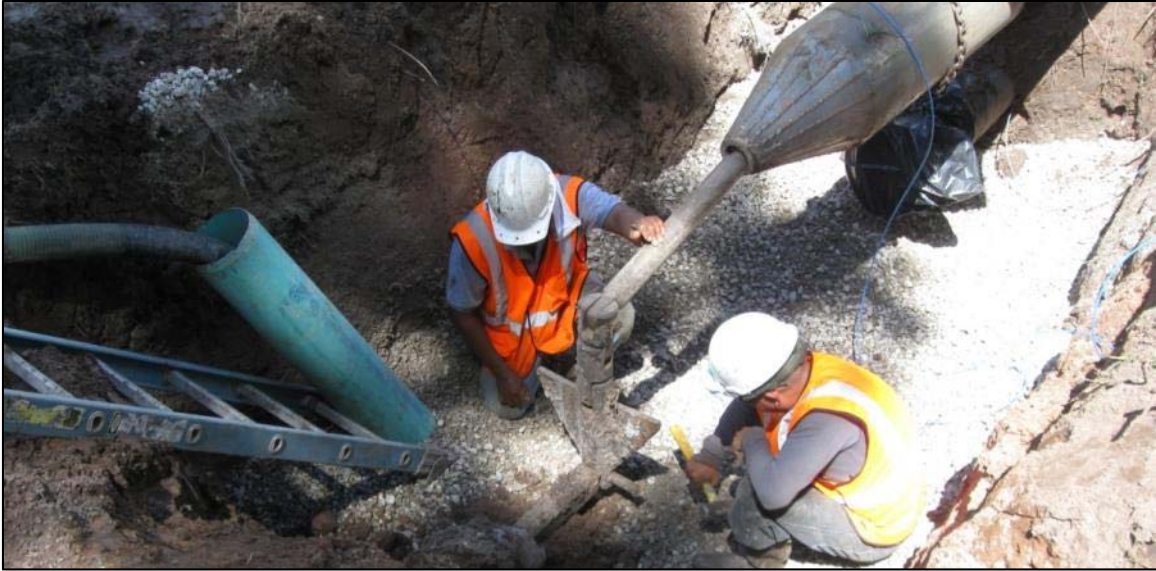
Figure 3-14 Fully-assembled bursting head connected to linkage at insertion pit

Upon connection of the bursting head to the linkage at the insertion pit ([Figure 3-14](#)), the crew in the machine pit began pulling the pipe string and bursting the AC pipe. The pipe string was moved in a series of short pulls as the bursting machine pulled back the linkages. The average pull rate was approximately 6 ft/min. This equates to one basket (30 linkages) every 15 minutes. As the linkages returned to the machine pit they were disconnected by the workers in the pit and placed in the basket. When the bursting head reached the machine pit, the splitter head, extender rod, and expander head were removed, leaving only the connector head still attached. The equipment (i.e., bursting machine, linkage basket, pin basket, and steel plate) was then raised from the machine pit. The connector head was chained to the boom of the excavator, which finished pulling through the pipe string.

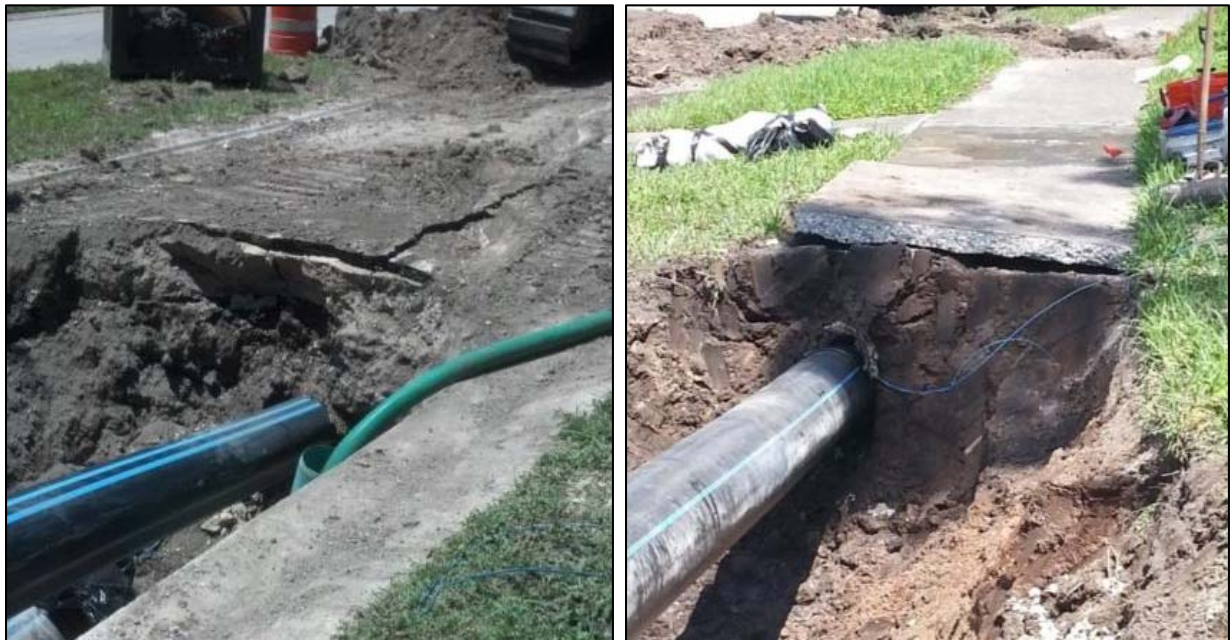
Figure 3-15 Upheaval of roadways and sidewalks during runs #2 (left) and #6 (right)

During the demonstration, instances of upheaval were observed on bursting runs #2 and #6. [Figure 3-15](#) shows the upheaval at run #2 and #6, respectively. In both instances the shallow depth of the pipes (i.e., approximately 2.5-3 ft) combined with enlargement of the original pipe (i.e., 8-in to 12 in) resulted in the upward displacement of soil and roadway/sidewalk. Any damage to roadways, sidewalks, and/or grass was repaired during site restoration.

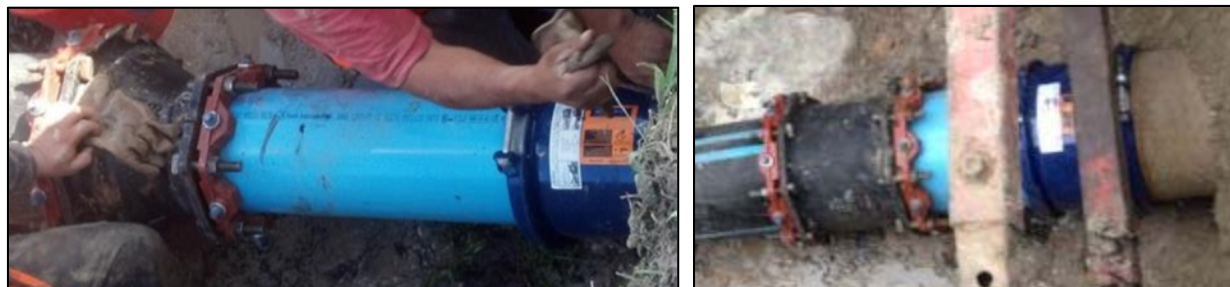
Figure 3-16 Connection between HDPE and AC with reducer (left) and sleeve (right)

After the pipe was in place and cut to length, connections to the existing water mains were made in each pit. Typically, a temporary connection was made at the machine pit and a permanent connection was made at the insertion pit. A temporary connection was one that was made between the new HDPE pipe and the existing AC pipe. This connection consisted of a ductile iron reducer that connected the 12-in HDPE to an 8-in PVC section, which was connected the existing 8-in AC pipe using a coupling. The HDPE and PVC were connected to the reducer by Megalug® mechanical joints. When temporary connections were made between pipes of the same diameter, a ductile iron sleeve was used instead of a reducer. Note that an aluminum insert was placed in each pipe end connected to the sleeve to ensure a proper connection between the sleeve and Megalug®. The temporary connection was removed in order to gain access to the AC pipe for the next bursting run. [Figure 3-16](#) shows two finished temporary connections – one with a ductile iron reducer and one with a ductile iron sleeve.

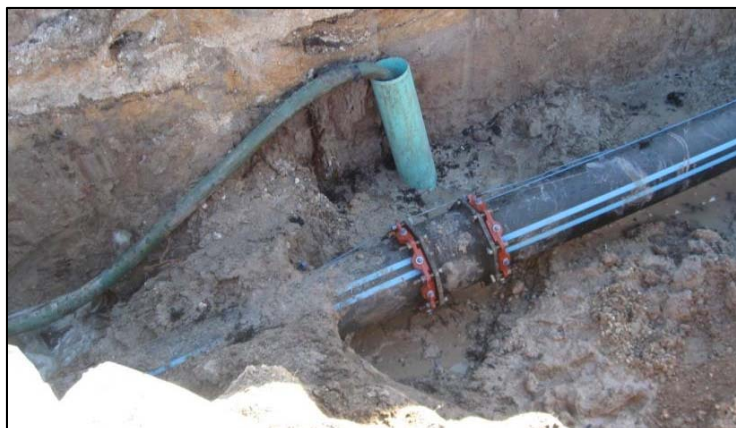
Figure 3-17 Permanent connection between HDPE pipes

A permanent connection was one that was made between two new HDPE pipe ends. The two sections of the same diameter (i.e., 12-in) were connected using a ductile iron sleeve and Megalug® mechanical joints. A permanent connection between HDPE pipes is shown in [Figure 3-17](#). Note that an aluminum insert was placed in each pipe end connected to the sleeve to ensure a proper connection between the sleeve and Megalug®. To prevent the introduction of bacteria into the super-chlorinated, clean HDPE pipe, all tools, pipe sections, and fittings were thoroughly washed in chlorinated water before being used.

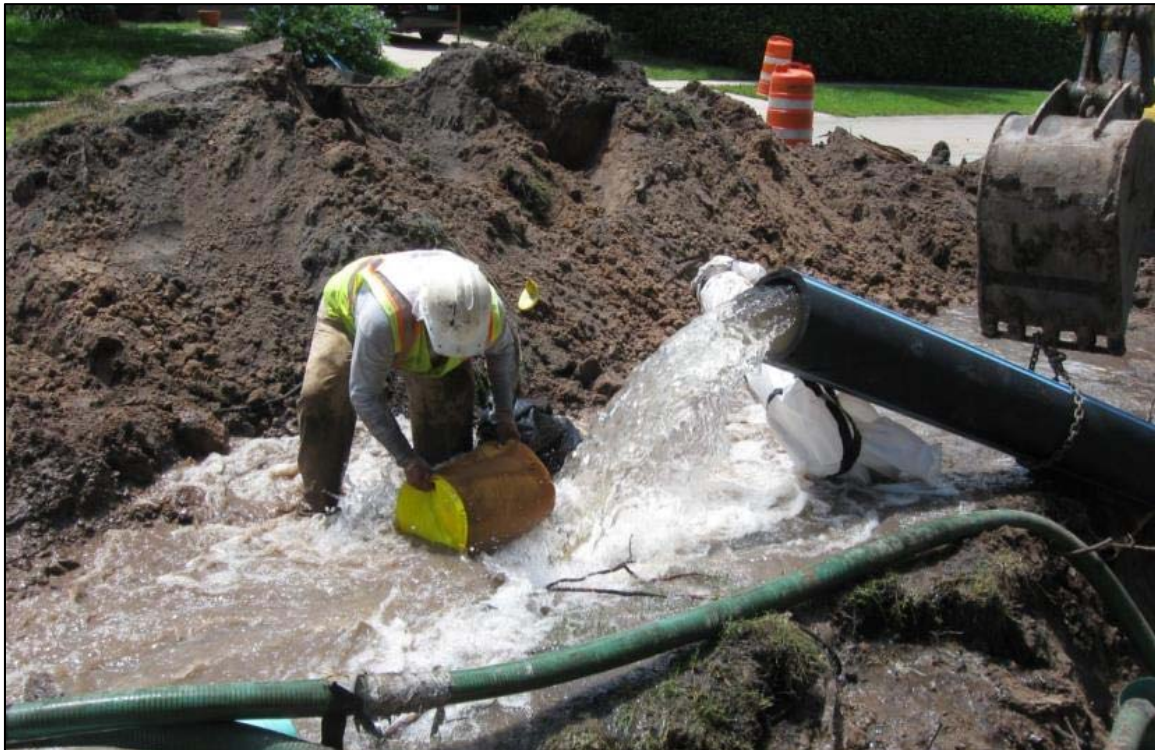
Figure 3-18 Cleaning of HDPE pipe using super-chlorinated water and polyswab

Prior to making the temporary connection, super-chlorinated water was loaded into the HDPE pipe followed by a polyswab (also known as a pig). After the temporary connection was complete, but before the permanent connection was made, water was introduced to the pipe by opening a valve on the AC side. The water propelled the polyswab and the slug of super-chlorinated water through the new pipe cleaning it as it travelled along. The polyswab was recovered from the other end of the pipe located at the machine pit, as shown in [Figure 3-18](#). Following the polyswab, the permanent connection was then made using chlorinated tools and fittings.

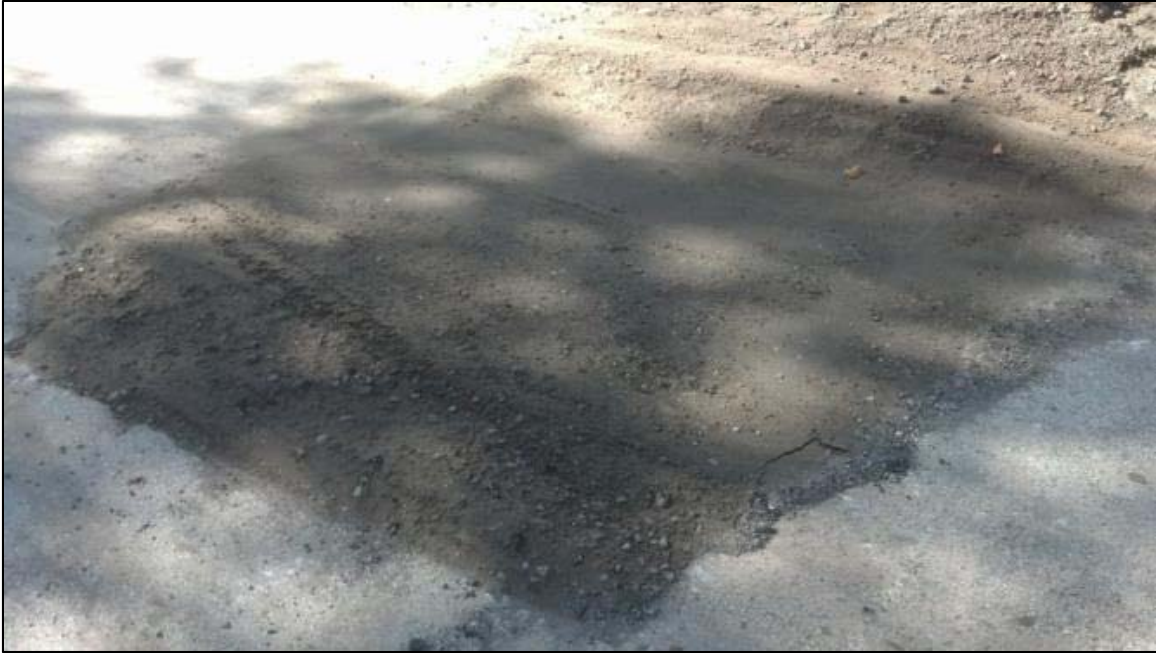
Figure 3-19 Backfilled excavation pit

Site restoration activities customarily took place on Thursdays and Fridays (i.e., August 15-16 and August 22-23, 2013) while bursting activities occurred Mondays through Wednesdays (i.e., August 12-14 and August 19-21, 2013). Restoration activities were performed by the same contractor, but a different crew. Backfilling of the excavation pits was performed by the bursting crew. All excavated soil was used to backfill the pits at the end of each work day ([Figure 3-19](#)).

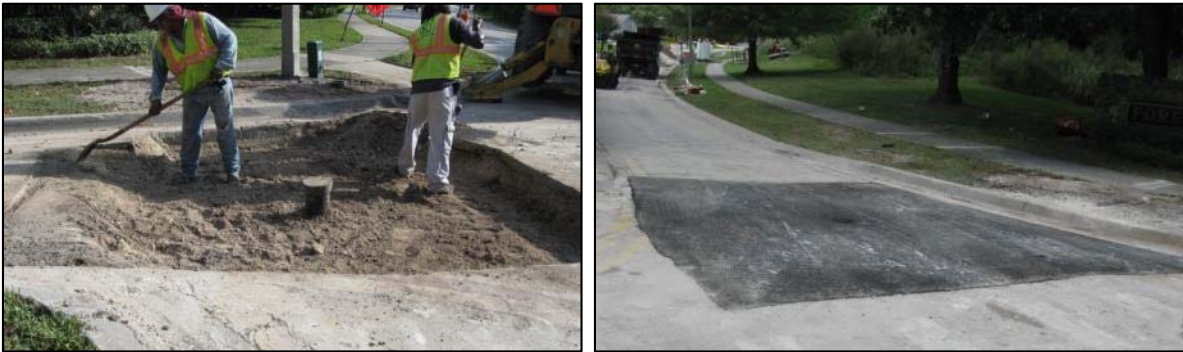
Figure 3-20 Preparation and repaving of pit #1 by restoration crew

Activities performed by the restoration crew included the repaving of asphalt roadways, pouring of concrete curbs and sidewalks, and the replanting of grass. The preparation and repaving of Pit #1 is shown below in [Figure 3-20](#).

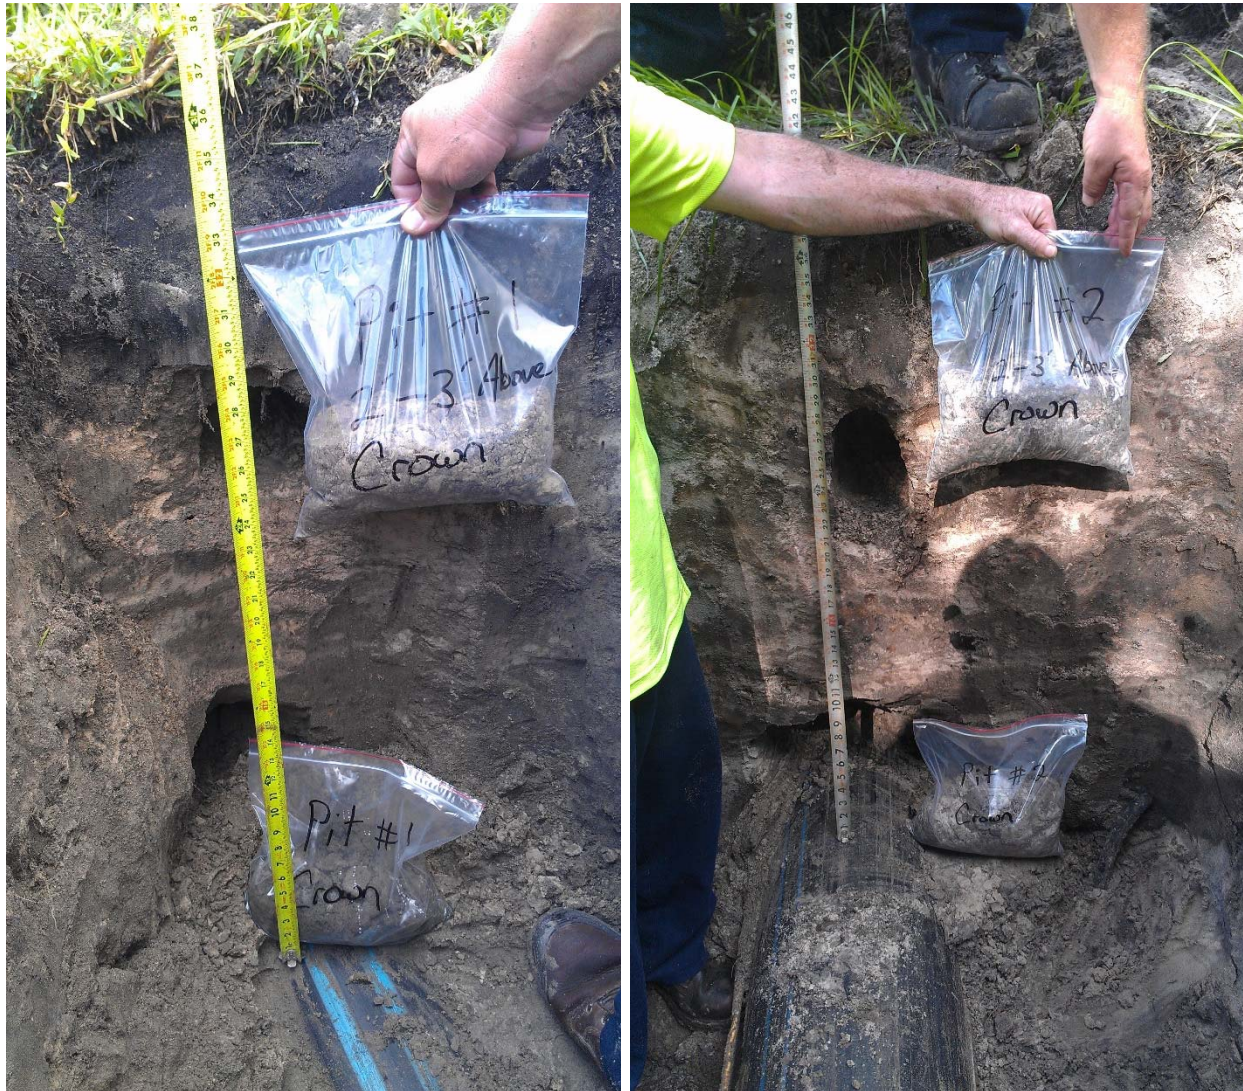
Figure 3-21 Retrospective soil samples from AC pipe bursting site

September 2014, with one sample near the crown and one sample 2 to 3 ft above the crown in each pit (Figure 3-21). All four samples showed either trace levels of asbestos or were non-detectable, which suggests there has been no increase in asbestos released in the ground since the pipe bursting occurred five years ago.
