Environmental Impact of Asbestos Cement Pipe Renewal Technologies

Web Report #4465

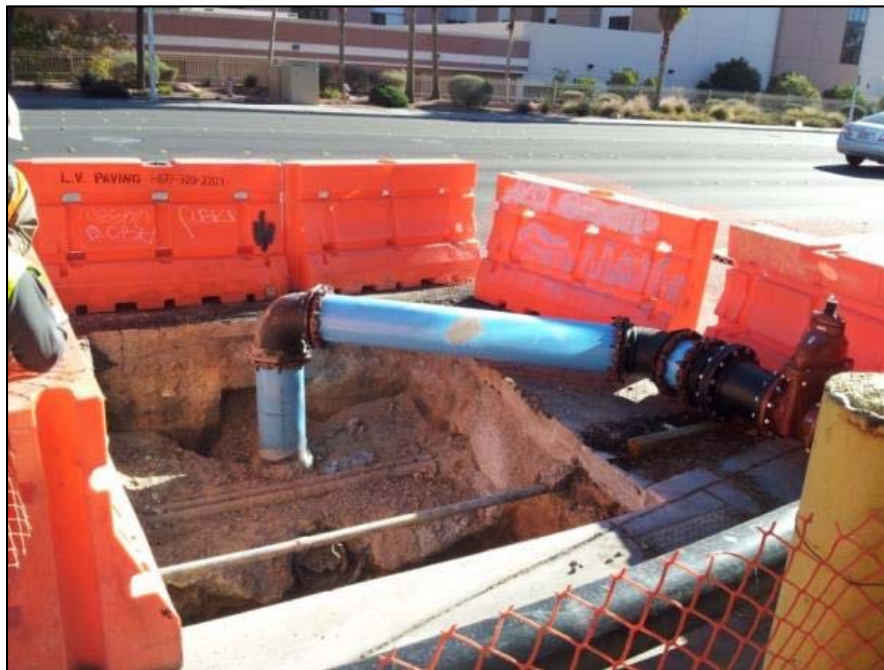
Figure 4-1 Access pit along roadway barricaded and fenced off

In addition to the permits, the utility also coordinated with the local natural gas, phone, cable, and sewer utilities that had infrastructure in the area. Open pits (i.e., pits in use) were marked with orange barricades, fencing, and signs. All other pits not in use were covered with steel plates or barricaded. At the end of each work day, all open pits were either covered with steel plates or barricaded and fenced off (see [Figure 4-1](#)) to avoid accidents during the evenings and weekends.

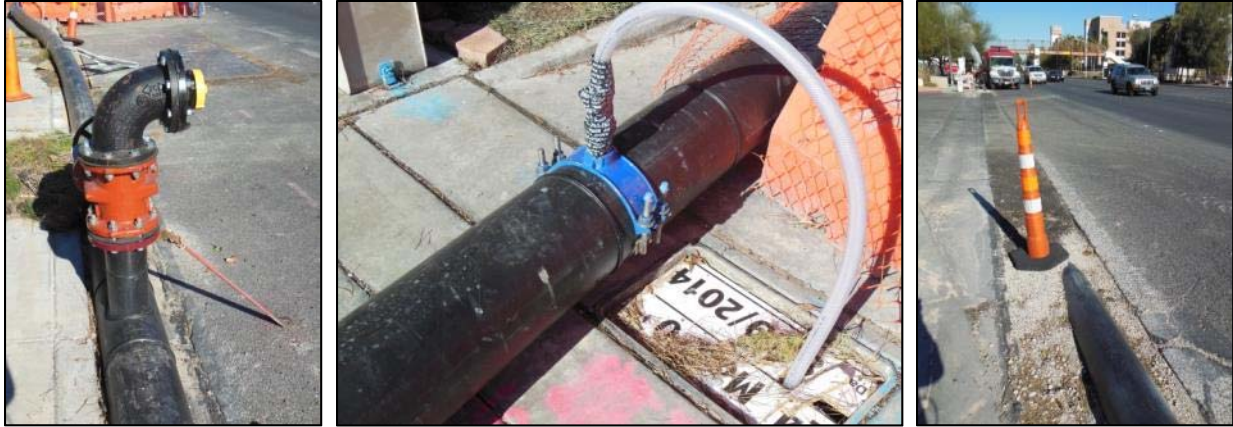
Figure 4-2 Bypass system: hydrant (left), service (center), and buried entrance (right)

To continue uninterrupted water service to customers during the course of the project a bypass was installed. The bypass started on the south side of the southernmost pit and ended at the north side of the northernmost pit, and was constructed of approximately 3,100-ft of 10-in HDPE. The bypass had 31 service and 14 fire hydrant connections, and, per code, was buried below grade at all roadway entrances and exits. [Figure 4-2](#) shows elements of the bypass.

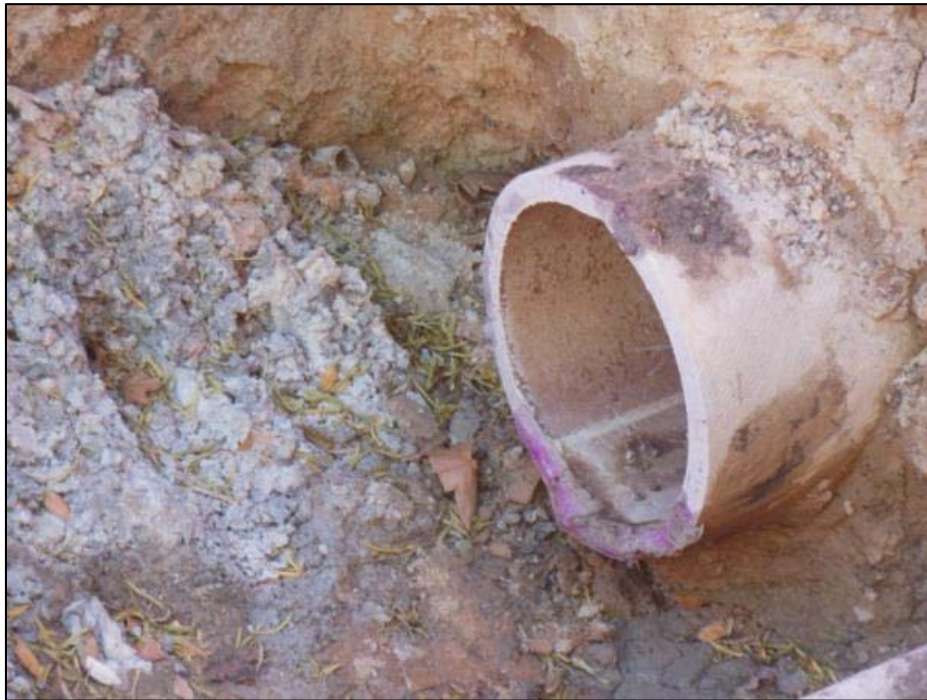
Figure 4-3 Cut AC pipe protruding from the pit wall

Following the installation of the bypass, the pipe was drained and the sections of AC pipe exposed during the pit excavations were removed to gain access to the inside of the pipe. The exposed AC pipe was removed using a wet-cutting technique to prevent the unintentional release of asbestos fibers to the air and surrounding soil. The AC pipe sections removed from the pits were wrapped in plastic and disposed of according to applicable regulations. For convenience, approximately 1-ft of AC pipe was left protruding from the end of each pit wall (Figure 4-3).

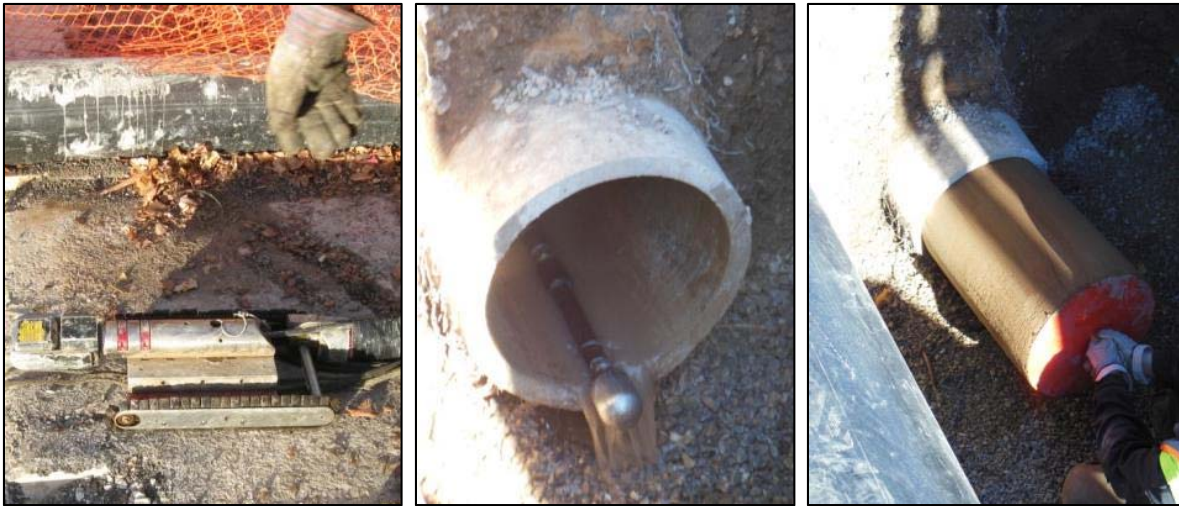
Figure 4-4 Equipment: camera (left), water jet (center), and squeegee (right)

The AC pipe line was inspected using a robotic camera and CCTV to determine its condition and locate all service connections. The robot was tethered by an umbilical to a truck where it was controlled by an operator. All CCTV footage was recorded. After inspection the interior of the pipe line was cleaned using pressurized water and dried using a squeegee. A water jet was connected to a hose which was connected to a truck, which provided the pressurized water. The water jet was inserted at one end of the pipe and travelled down the pipe spraying water in the opposite direction of travel until it reached the other end of the pipe in the next pit. The water jet was then shut off and a squeegee, slightly larger than the inner diameter of the pipe, was attached to it. The water jet hose was then retracted by the truck pulling the squeegee back through pipe to the pit where the water jet was originally inserted. [Figure 4-4](#) shows the camera, water jet, and squeegee equipment used to inspect and prepare the pipe for lining.

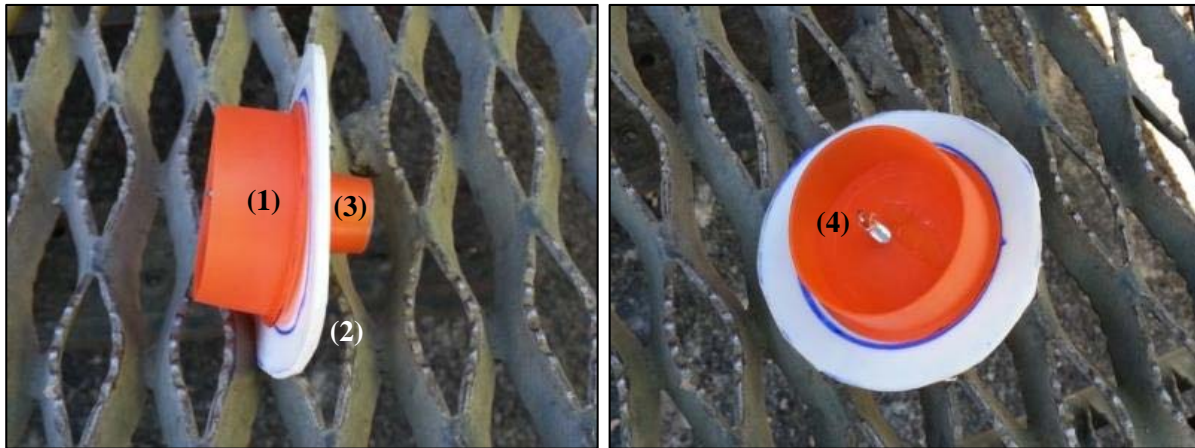
Figure 4-5 Typical service connection plug

The final step in preparing the inside of the pipe for lining was plugging the existing service connections. All service connections up to 2-in could be plugged using a robot equipped with a camera and controllable arm. The plugs were assembled onsite and were comprised of four pieces: (1) a large plug; (2) a flange; (3) a small plug; and (4) a screw. All pieces of the assembled plug are shown and identified in [Figure 4-5](#).

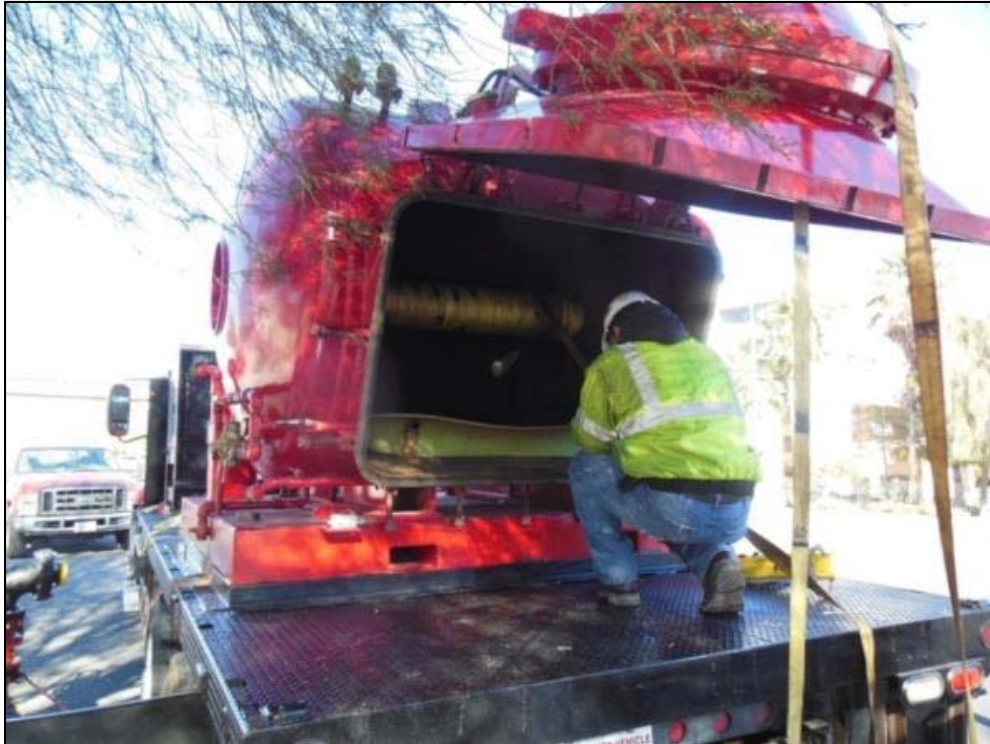
Figure 4-6 Pressure vessel mounted on the inversion truck

A staging area was setup off-site where the section of liner was prepared for that day's run. The liner was impregnated with epoxy resin and the end was tied-off with a black rope which connected to a yellow strap that was used to reel the liner onto a spool inside a pressure vessel mounted on the back of the inversion truck (Figure 4-6). In addition, a short length of yellow nylon rope (3-4 ft) was tied to the same end as the black rope, but was put inside the liner. The yellow rope was used as a gauge in the field to know when the end of the liner had completely made it through the pipe. The truck then headed to location where the liner was to be installed.

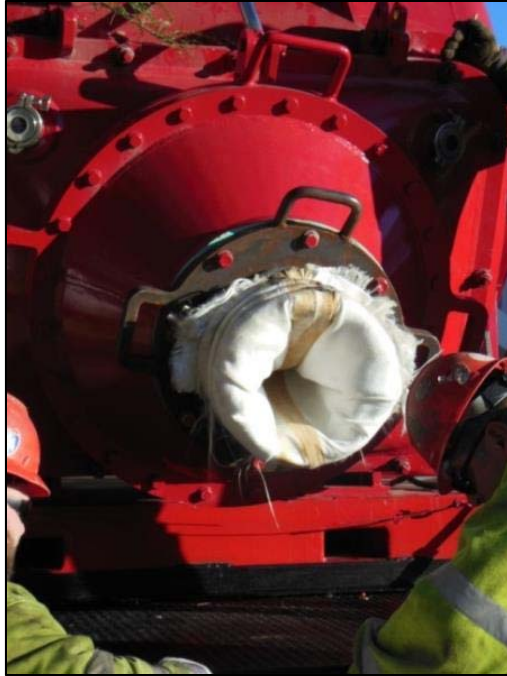
Figure 4-7 Inverted liner end attached to pressure vessel opening

Insertion of the Liner. The pit where the liner was inserted into the pipe from the inversion truck was designated as Station A. When the inversion truck arrived at Station A, it was positioned at the pit end opposite the end of the pipe segment to be lined. Once in position, a short length of liner was pulled through the opening of the pressure vessel, inverted, and attached to the sidewalls of the opening using screw clamps (Figure 4-7). A sleeve was used between the pressure vessel and pipe to protect the liner from dirt and ultraviolet (UV) light, which can prematurely activate the resin causing it to harden. The protective sleeve was slid over the liner end that was attached the sidewalls of the pressure vessel opening and secured in place with screw clamps. The unattached end was put inside the end of the pipe segment where it acted like a guide for the liner (Figure 4-8).

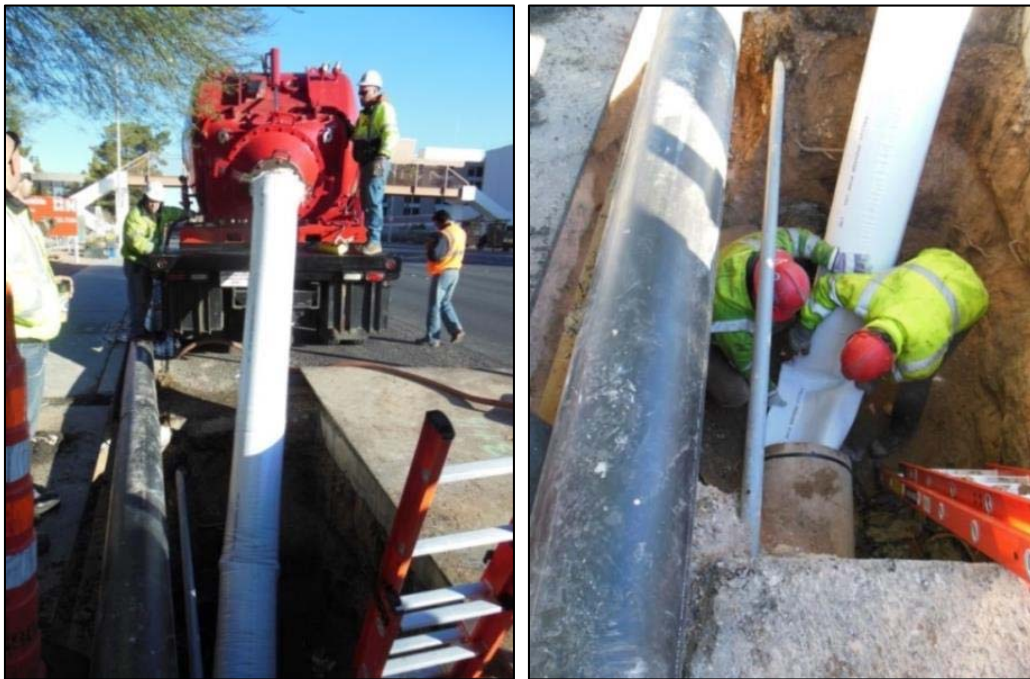
Figure 4-8 Protective sleeve and pressure vessel (left) and guiding the liner in (right)

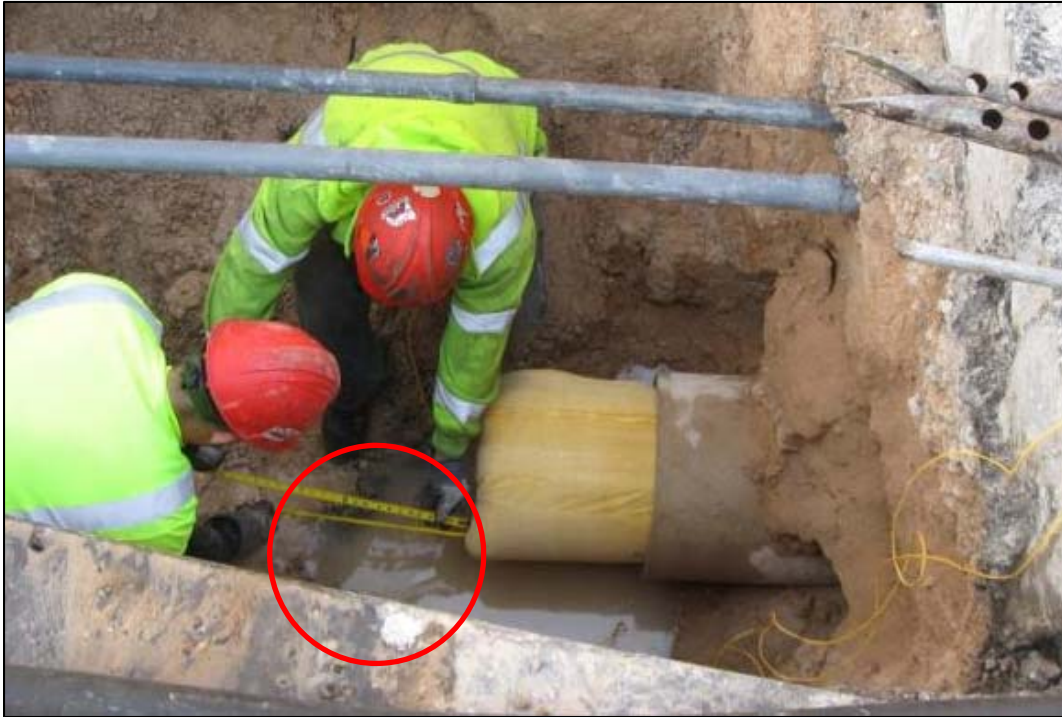
Figure 4-9 End of liner with rope arriving at Station B

to the spool. Regulating the speed also helped prevent unnecessary stretching of the liner. Once approximately 3-ft of the yellow nylon rope that was attached to the liner end was visible at Station B the entire liner for that pipe segment was in place. [Figure 4-9](#) shows a worker measuring the length of the yellow nylon rope.

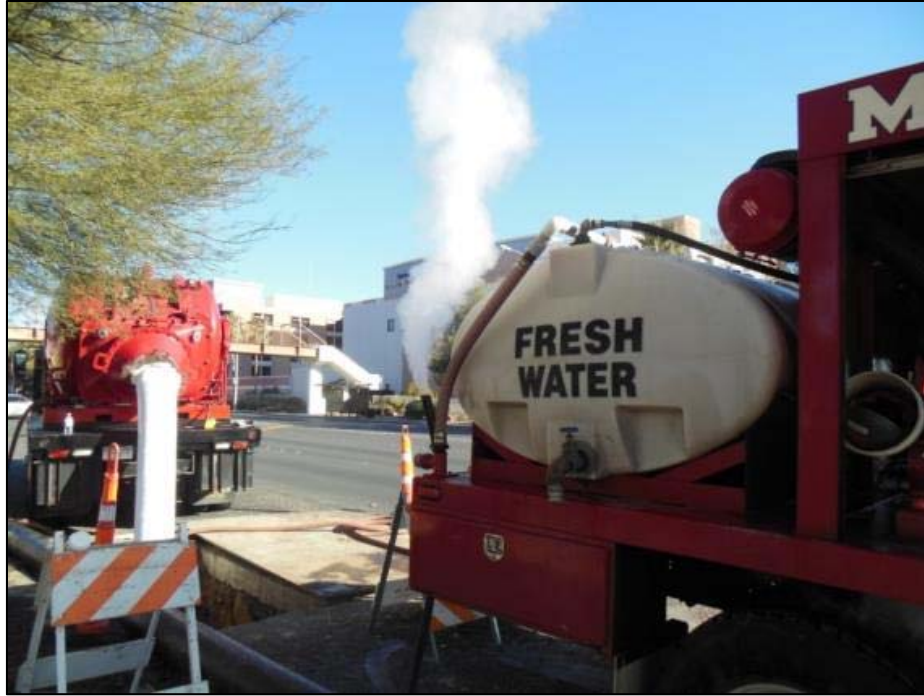
Figure 4-10 Steam truck (foreground) connected to inversion truck (background)

Curing of Liner. The liner was cured with steam generated onsite by a steam truck connected to the inversion truck and pumped into the liner via the pressure vessel ([Figure 4-10](#)). The steam was delivered into the liner at a pressure of 10 psi with the temperature ranging between 180 and 210°F. Curing typically took around three hours once the temperature at Station B was the same as the delivery temperature at Station A. After curing, the liner required a one hour cooling period.

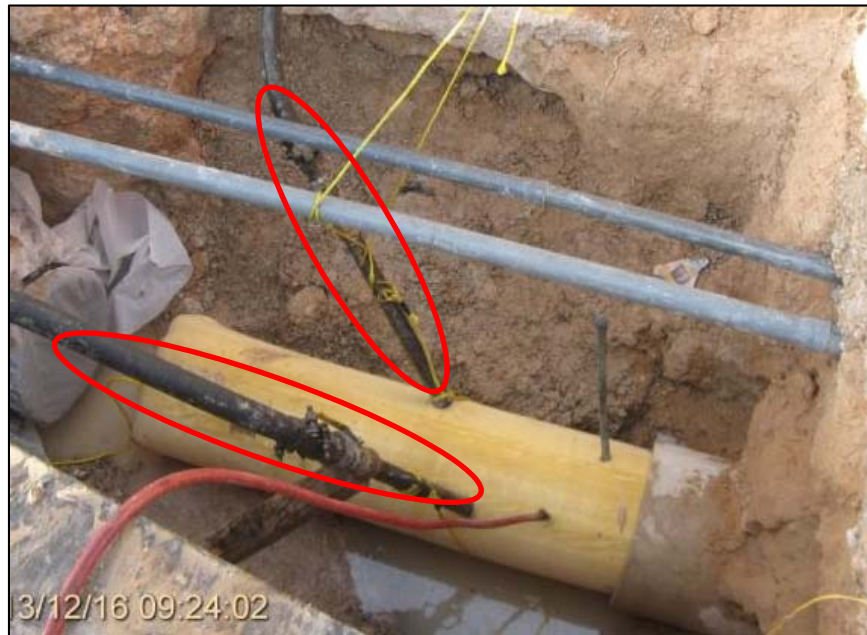
Figure 4-11 End of liner with stingers at Station B

To prepare the liner for curing, two metal spikes, also known as “stingers”, were first inserted into the section of liner protruding from the pipe at Station B as shown in [Figure 4-11](#). Each spike was connected by a hose to the input side of an apparatus containing pressure and temperature gauges ([Figure 4-12](#)).

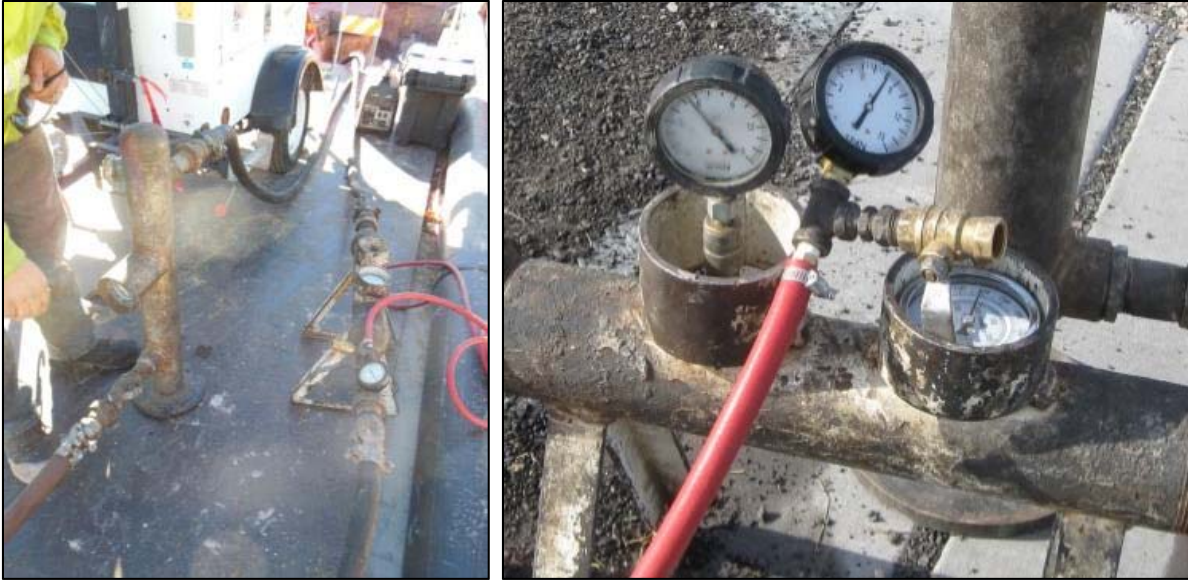
Figure 4-12 Pressure and temperature apparatuses with gauges

Valves located on the output side of each pressure and temperature apparatus were adjusted to maintain steam pressure at 10 psi inside in the liner. Hoses connected to the output side of the pressure and temperature apparatuses were used to vent the steam (Figure 4-13).

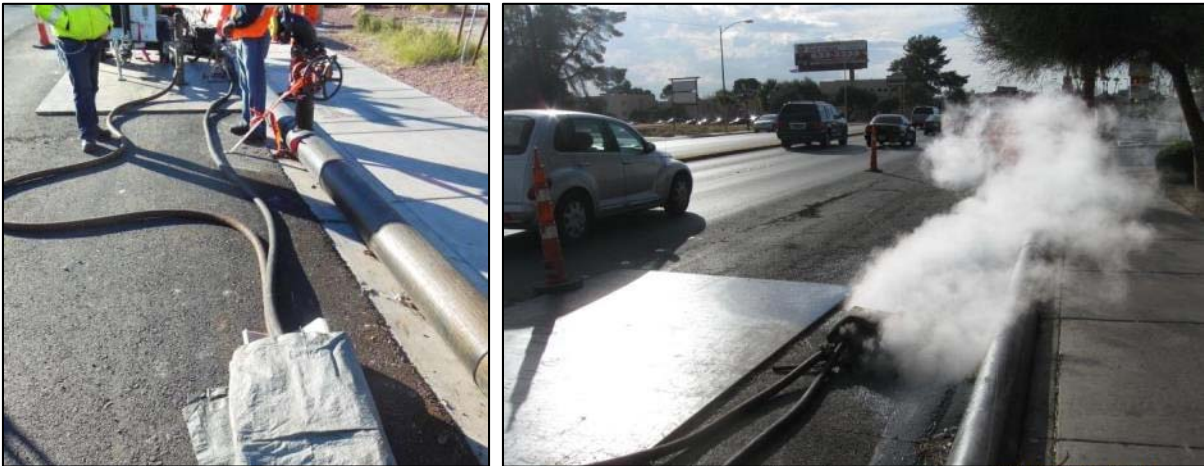
Figure 4-13 Hoses used to vent steam during the curing process

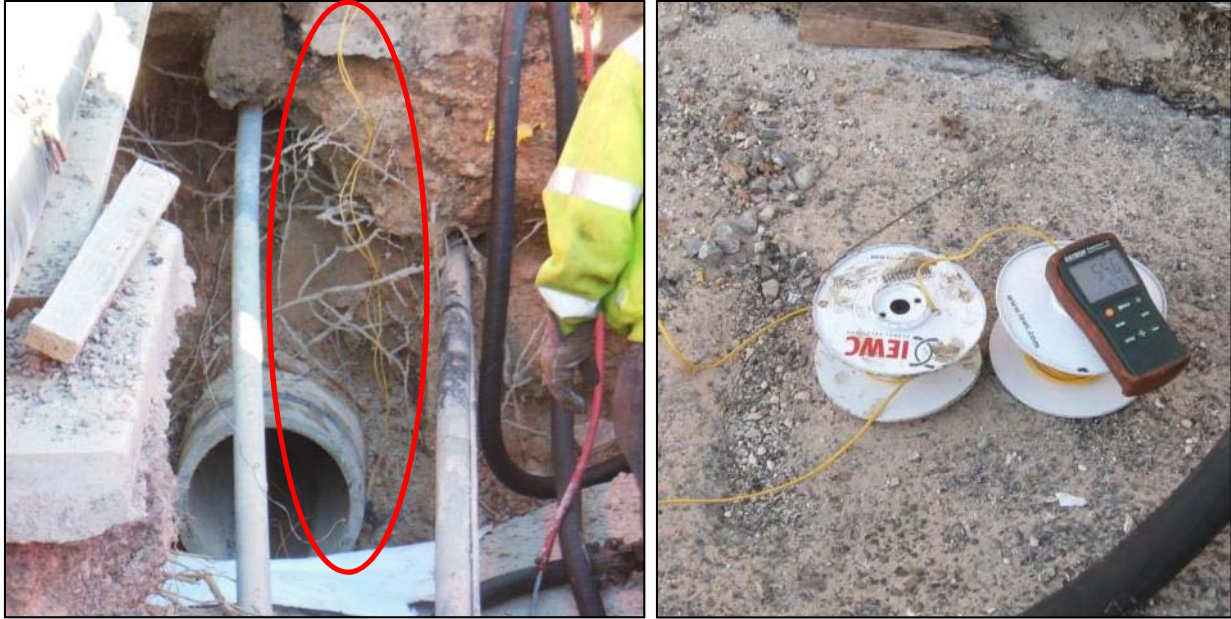
Figure 4-14 Yellow thermocouple wire inside pipe (left) and digital thermometer (right)

Prior to the insertion of the liner, thermocouple wires were temporarily affixed to the inside bottom of each pipe end. As shown in Figure 4-14, each set of wires were connected to a digital thermometer, which was used as the official temperature measurement at each pipe end. The 3-hour curing time did not start until the temperature at Station B was approximately the same as the delivery temperature (i.e., 180-210°F) at Station A.

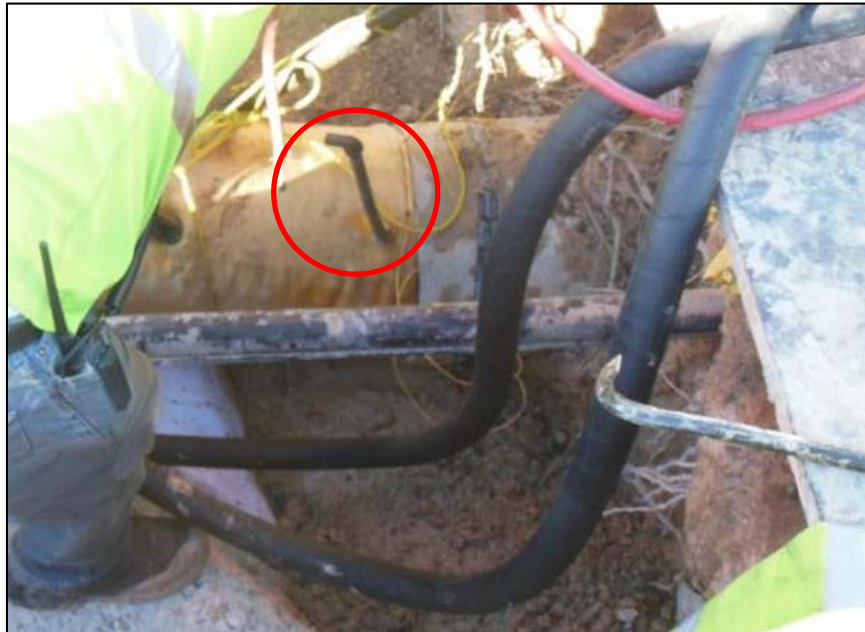
Figure 4-15 Condensation vent extending from the liner at Station B

To remove any condensation (i.e., water) that formed during the curing process, a small diameter pipe with a 90-degree elbow was inserted into the liner at Station B (Figure 4-15). The end of the pipe rested on the bottom of the liner and provided a pathway for the water out of the liner.

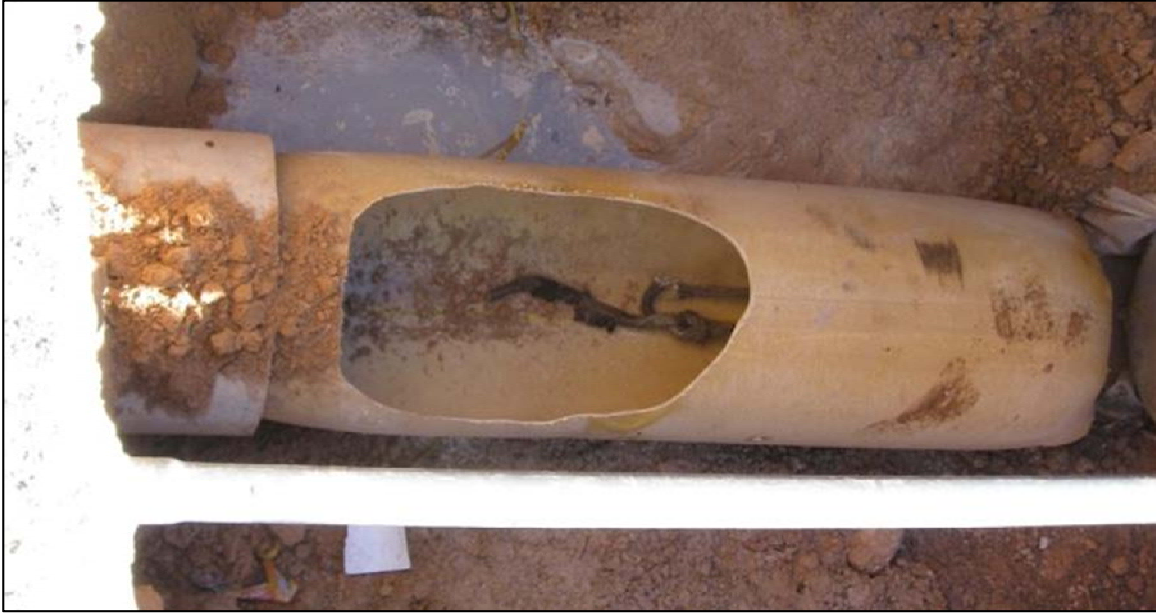
Figure 4-16 Cured liner with section removed to gain internal access to black rope

Following the three hour curing, the liner underwent cooling for approximately one hour. Cooling occurred at ambient temperature and was the final step in the curing process. The two metal spikes that vented the steam and the condensation vent were removed after the liner had cooled. After the spikes and condensation vent were removed, a section of the protruding liner was cut out to gain access inside the liner and cut the black rope from the yellow strap, which was then reeled back onto the spool in the pressure vessel. [Figure 4-16](#) shows the section of liner removed and the remaining piece of black rope tied to the end of the liner.

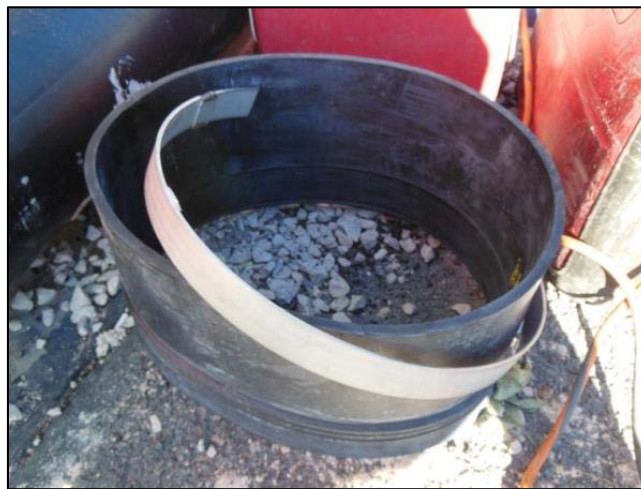
Figure 4-17 End seal consists of a rubber gasket and steel rings

End seals were installed at each end of the lined pipe to prevent water from getting behind the liner once the pipe was back in service. The seals were installed the day after the pipe was lined and consisted of a 1-ft wide rubber gasket and two stainless steel rings (Figure 4-17).

Figure 4-17, the rings were not closed, but open. Once the ring is correctly positioned on the gasket, a hydraulic ring opener is used to open the ring and put it under the correct tension (Figure 4-18). A precisely cut piece of steel is then fitted into the space between the ring ends locking the ring securely into place (Figure 4-18). The same process is then followed for the outer ring. Once both rings are installed the end seal is complete.

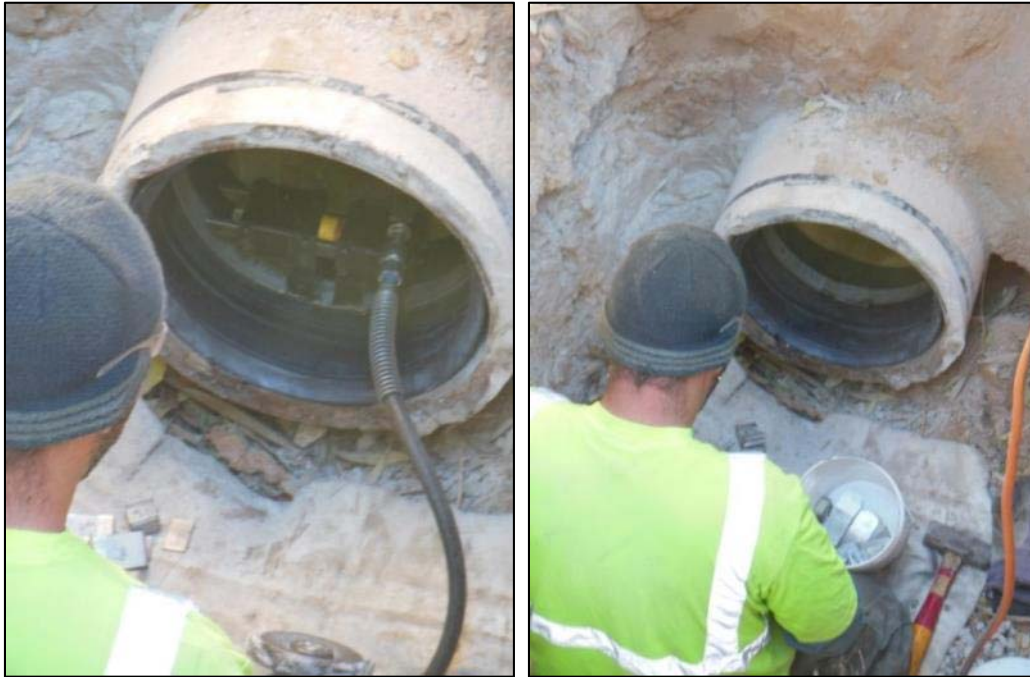
Figure 4-18 Hydraulic ring opener (left) and finished inner ring on end seal (right)

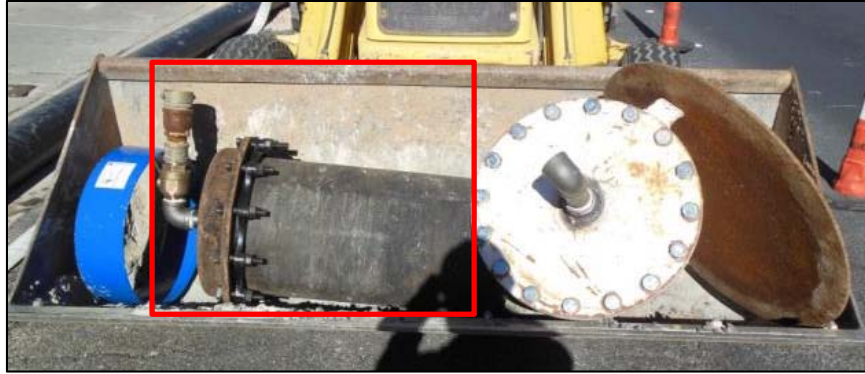
Figure 4-19 End cap assembly used for pressure testing

The caps, which came to the site already assembled, consisted of a section of iron pipe bolted to a metal cap that was fitted with a hose connection at the center (Figure 4-19). The outer diameter of the iron pipe was slightly smaller than the inner diameter of the AC pipe to allow for insertion into the AC pipe.

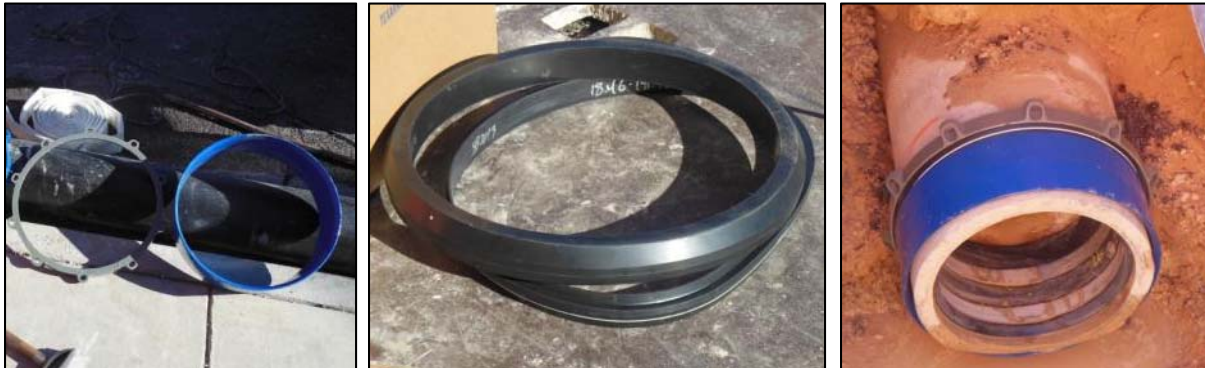
Figure 4-20 Sleeve and flange (left); rubber gasket (center); connection fitting (right)

Before the end caps could be attached connection fittings were installed on each end of the pipe. The connection fittings included a blue metal sleeve, a gray metal flange, and a black rubber gasket which held the flange in place. The parts are shown individually and assembled in [Figure 4-20](#).

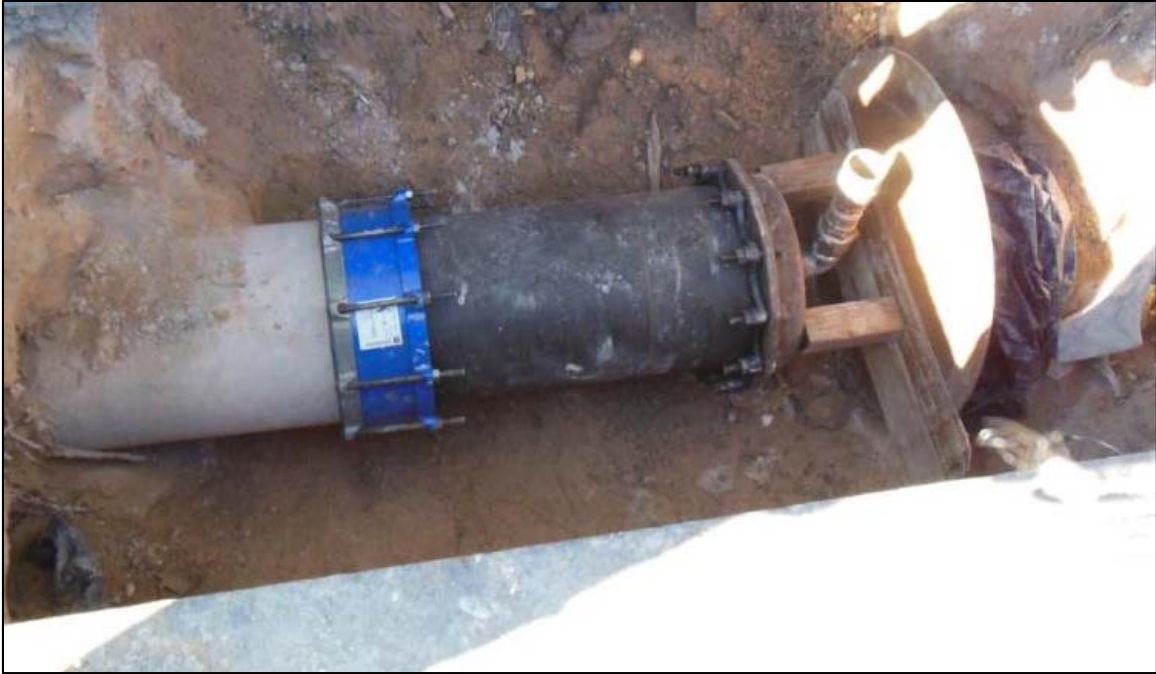
Figure 4-21 End cap assembly connected to AC pipe for a pressure test

To connect the end caps to the pipe end, each one was fitted with a blue metal flange and a black rubber gasket. The iron pipe portion of the cap was inserted into the AC pipe and then bolted together through the openings in the flanges. The connected end cap assembly is shown in [Figure 4-21](#).

Due to the high pressure of the pressure test (i.e., 150 psi) reinforcement was need to prevent the end cap from dislodging from the AC pipe. Two pieces of wood (2-in x 4-in) were positioned between the end cap and a round steel plate that rested up against the AC pipe on the other side of the pit. This setup provided enough reinforcing strength to the end cap to prevent dislodgement.

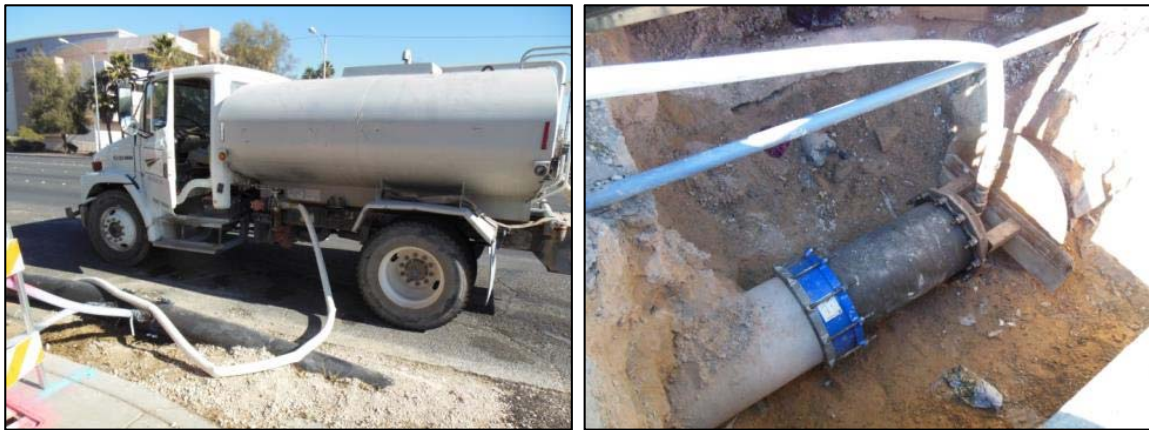
Figure 4-22 Truck pumping water in the pipe through an end cap for a pressure test

When both end caps were securely connected and reinforced, water was pumped from a small tanker truck at approximately 50 psi into the pipe via the end cap with the 1- $\frac{3}{4}$ in hose connection (Figure 4-22). The size of the hose connection on each cap was different. One end cap had a 1- $\frac{3}{4}$ in connection while the other end cap had a standard garden hose connection (Figure 4-23).

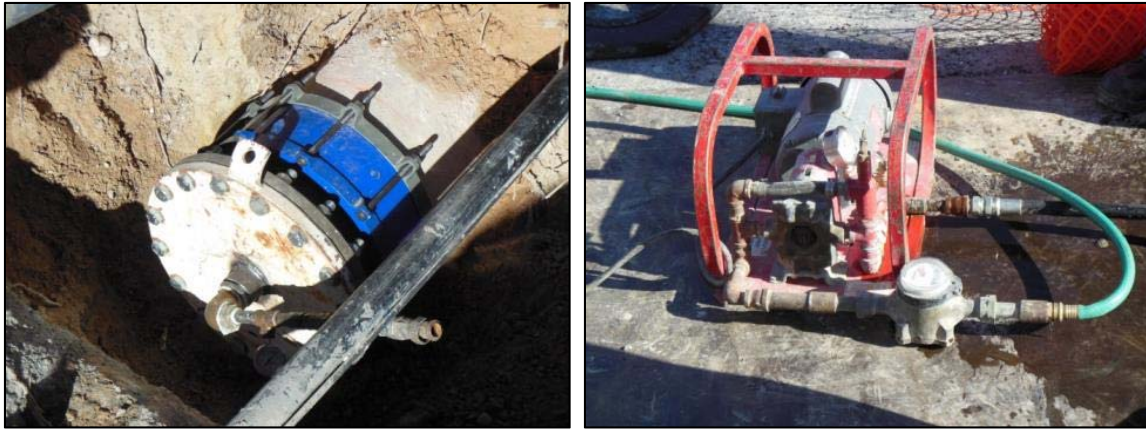
Figure 4-23 End cap with garden hose connection (left) and small electric pump (right)

Just before the pipe was completely full, the tanker truck stopped pumping water. A small electric pump was then connected to other end cap with the standard garden hose connection and used to bring the pressure inside the pipe to 150 psi (Figure 4-23). Once the pressure reached 150 psi inside the pipe, the pump was stopped and the one hour pressure test was started. If no pressure loss was observed after an hour the liner was deemed free of leaks.

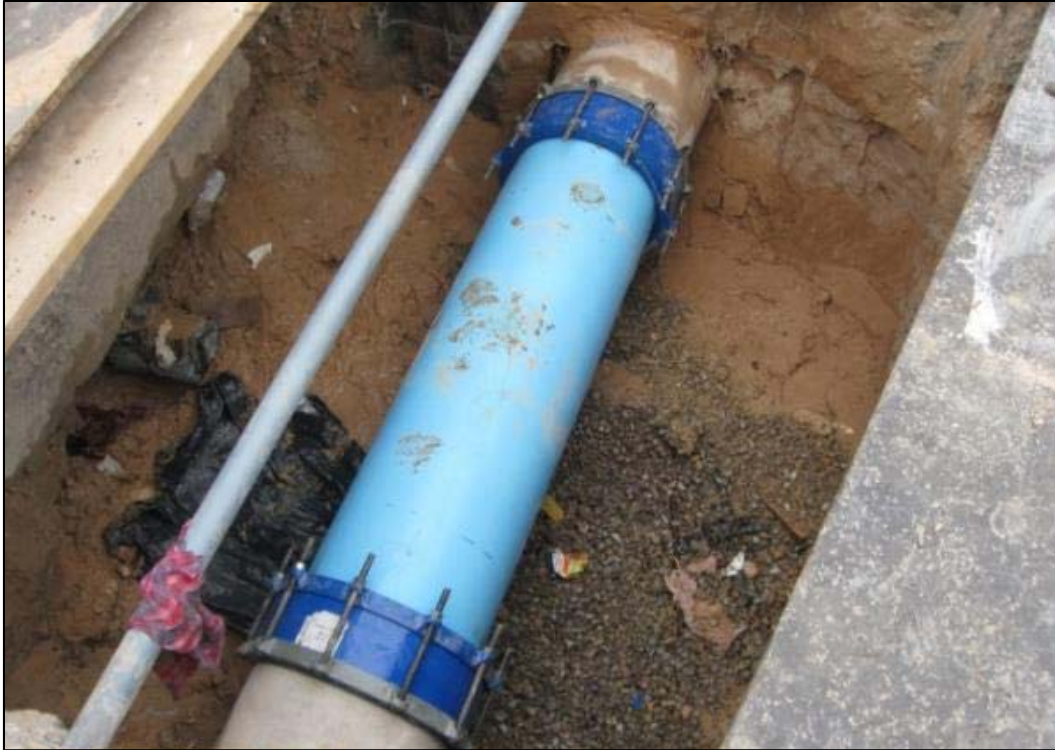
Figure 4-24 Lined AC pipe sections connected by a 16-inch PVC pipe

The lined sections of AC pipe were connected using 16-in DR-18 PVC pipe that are NSF-61 certified. The AC pipe was connected to the new PVC pipe using metal collars with rubber gaskets that were bolted together. The connected AC pipe sections are shown in [Figure 4-24](#).
