CLIENT CBH Resources		PROJECT Rasp Mine TSF Design	
DRAWN JE	DATE 14-Feb-20	BW CPTu 02	
CHECK 0	DATE 00-Jan-00		
SCALE NTS	A4	PROJECT No.	1896230

Slope Stability Outputs

Ground Control Engineering Pty Ltd (GCE) was engaged by Broken Hill Operations Pty Ltd (BHOP) to undertake a preliminary slope stability assessment for the pit slope in the Kintore Pit which is comprised of historic tailings. The slope forms the northern end-wall in the existing Kintore Pit and as such, will form the northern bounding wall during the proposed future placement of 'new' filtered, dry tailings in the Kintore Pit.

Ground Control Engineering
Report G0197_RE01_VE01
Kintore Pit Waste Rock Slope
Stability Assessment, dated 20
August 2019.

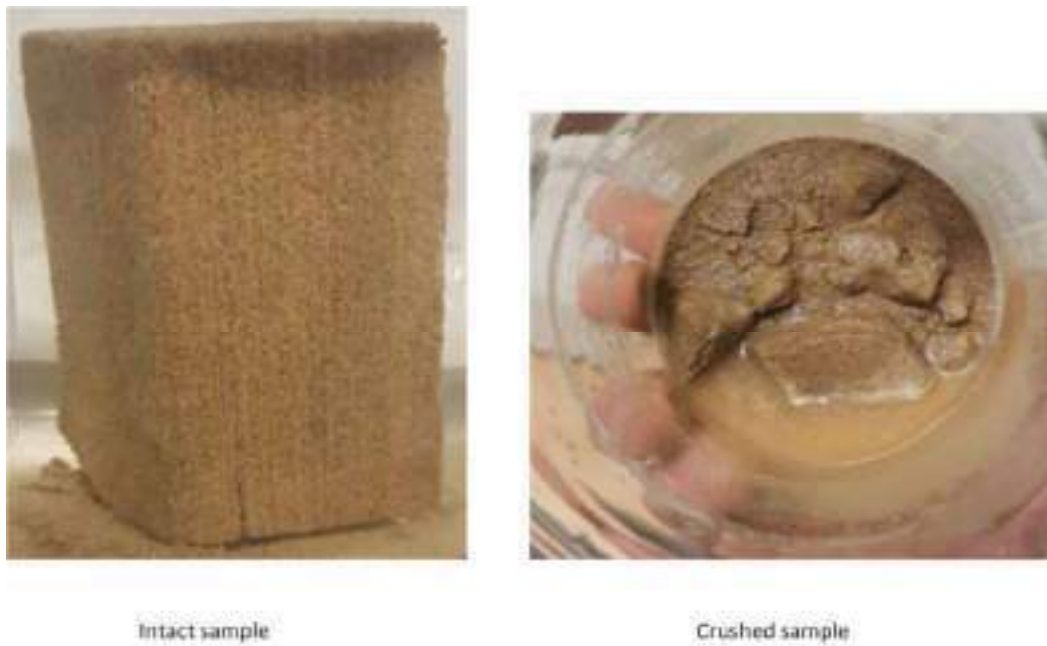
**Figure 6 Saturated UCS test results**

The insitu material was successfully tested under dry conditions, however, total disintegration and strength loss was observed under saturated conditions.

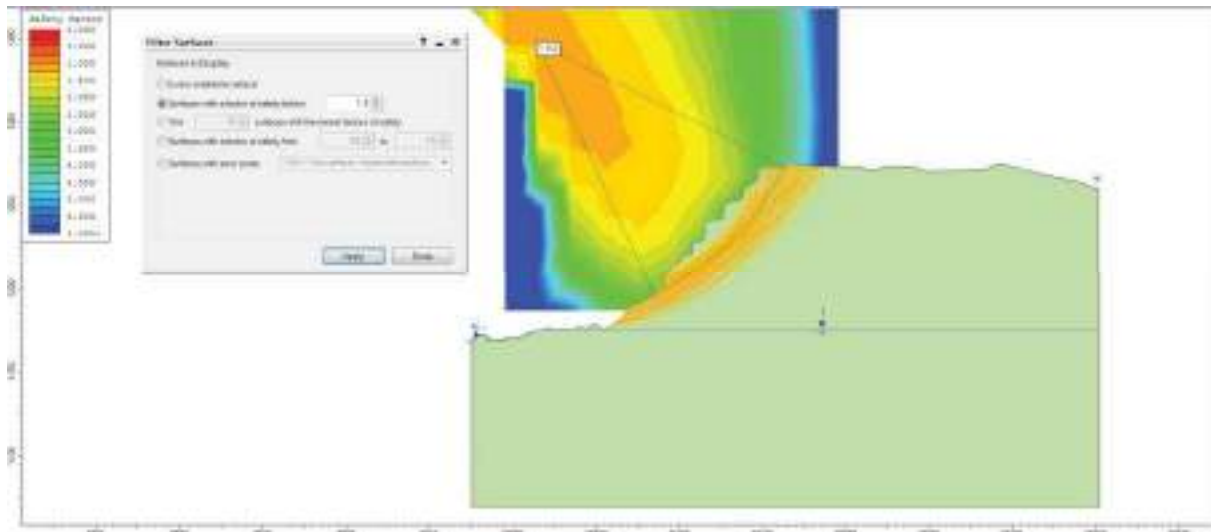
B. No tailings, horizontal water table at base of pit

- FOS min = 1.142, multi-batter slope scale failure.
- FOS < 1.3, numerous failure surfaces indicating significant slope scale failure potential.
- No material change from dry condition.

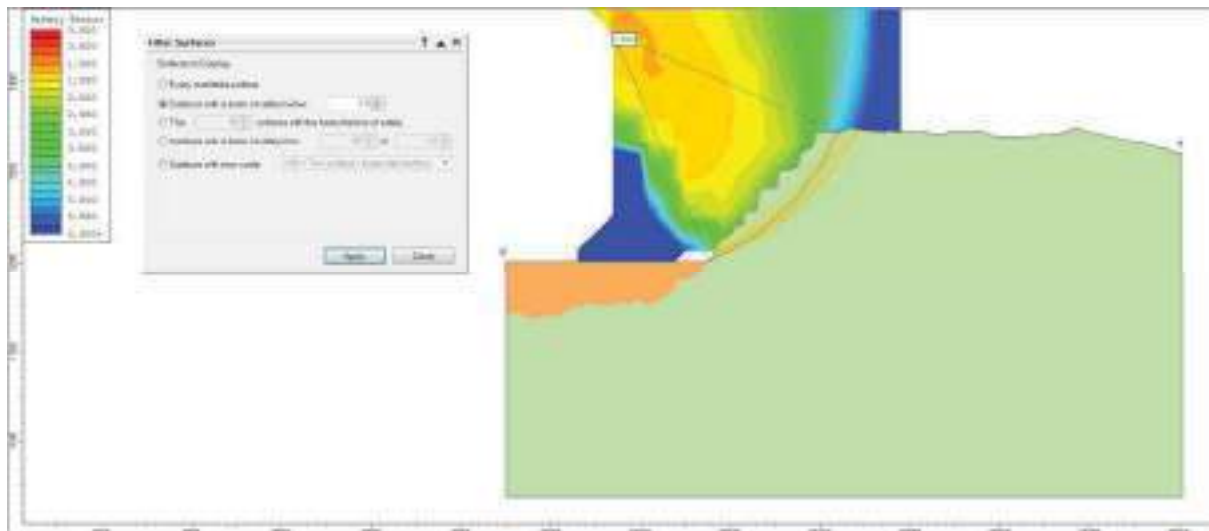
A. 25m tailings, no water

- FOS min = 1.164, slope scale failure
- FOS < 1.3, significant slope scale failure indicated. However, stability slightly increased from 'no tailings' case. i.e. current slope configuration.

- Dry case and horizontal piezometric surface case
 - No failure surfaces are indicated at $FOS < 1$.
 - Minimum $FOS = 1.164$, corresponding to a multi-batter slope scale failure surface from the top of the 'new' tailings to the pit crest. This indicates that, with the estimated material properties applied, the slope is relatively close to the threshold of instability.
 - At $FOS < 1.3$, numerous potential multi-batter slope scale failure surfaces are indicated. However, slope stability is somewhat increased from slope configuration #1 - no 'new' tailings case.
- Sloped piezometric surface case
 - Significant slope scale instability at $FOS = 1.116$. In this case, potential for circular failure resulting in significant floor heave through the tailings is indicated at $FOS < 1.3$.

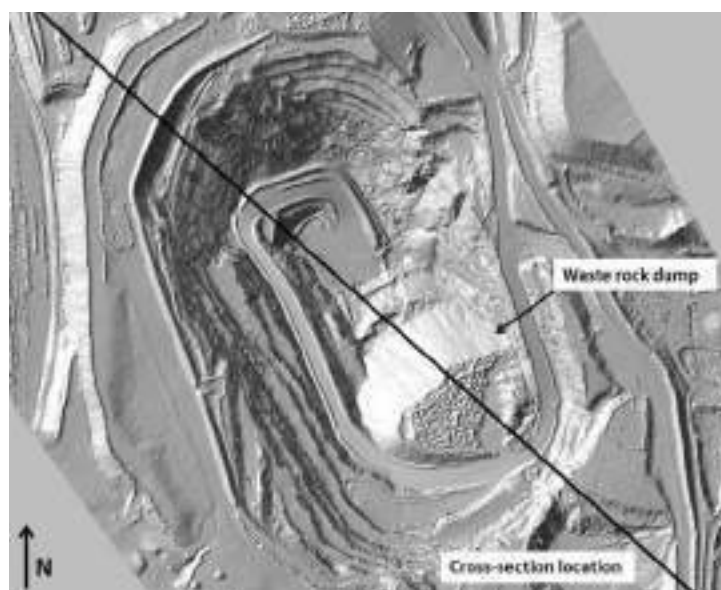
Figure 1 Section line location with respect to existing as-built pit and waste rock dump

The location of the section line where the cross-sections were generated for the analyses is shown in Figure 1. The location was selected by GCE to evaluate the 'worst case' slope configurations, approximately perpendicular to the waste rock slope and with consideration of the most likely failure mechanism.

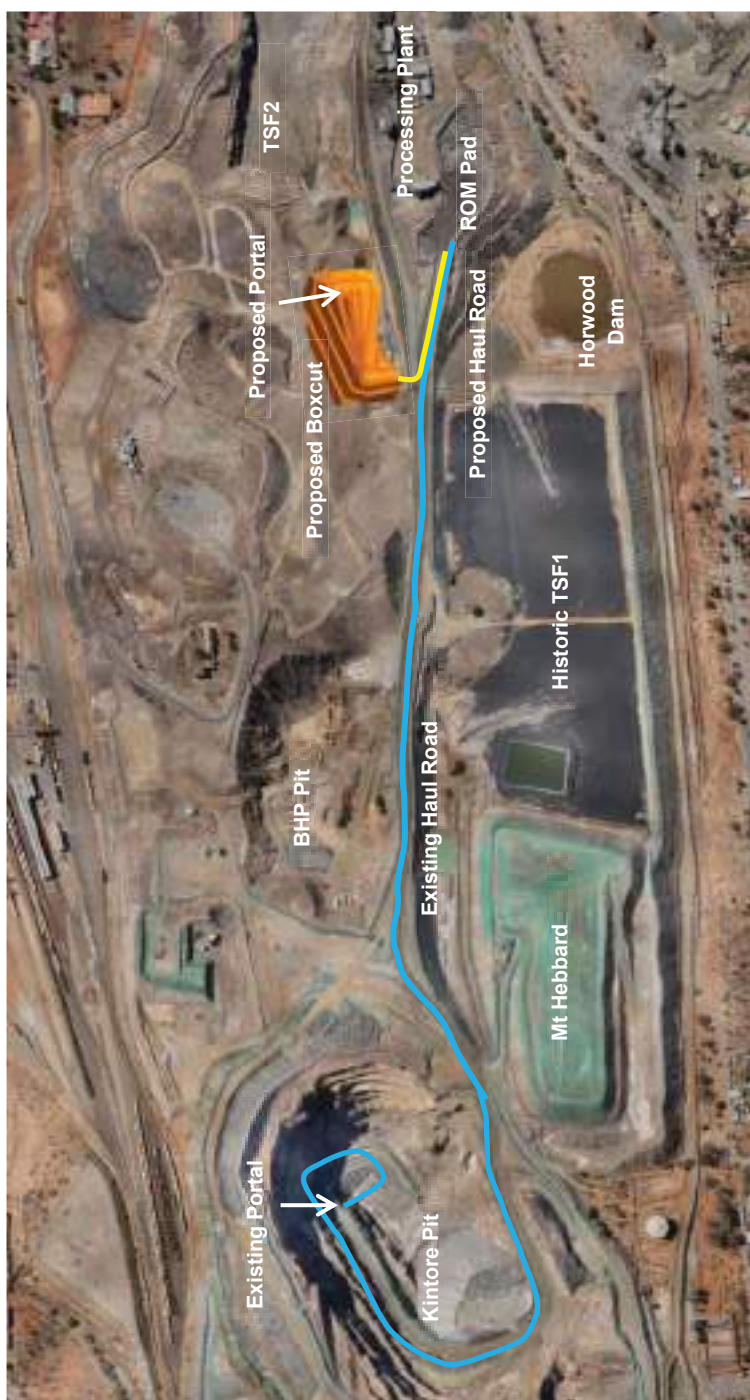
It is proposed to access underground mine workings via a new portal to be located adjacent to the Haul Road north-west of TSF1, **Figure 2-2**.

Figure 2-2 Indicative Proposed Portal Location

This will require the construction of a boxcut to obtain the required depth to connect to competent rock. The Haul Road will be realigned to meet this boxcut. The decline will be located to the northeast of the boxcut heading northwest to join existing and planned underground development.

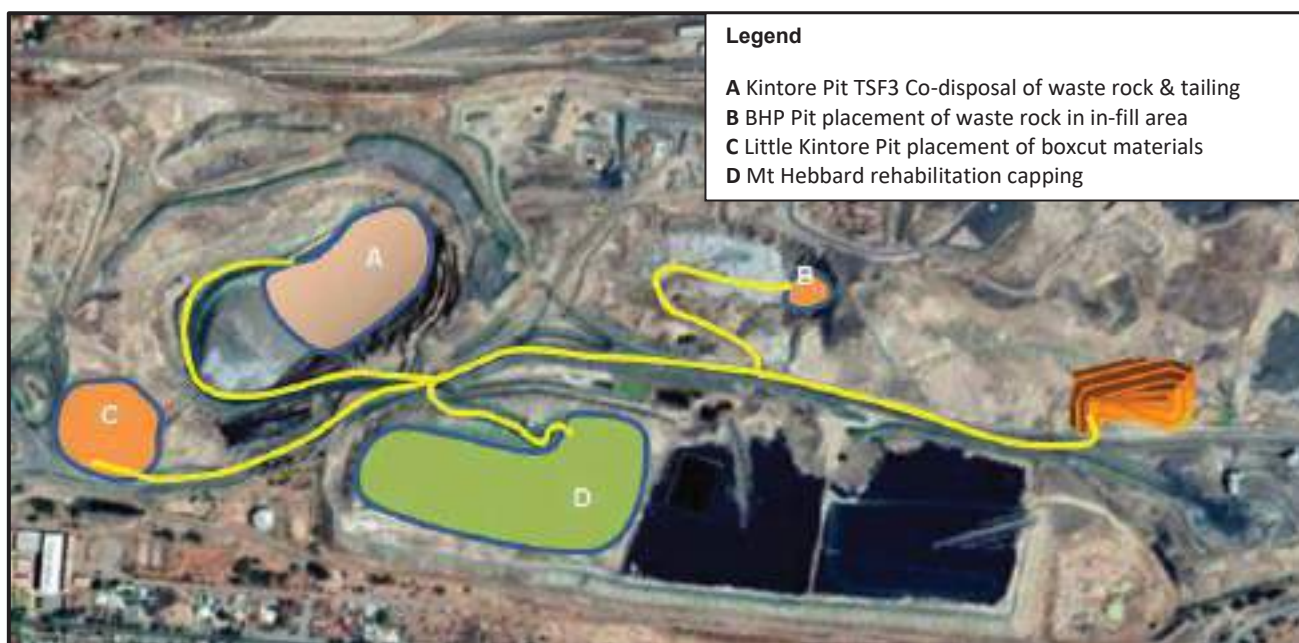
Table 2-1 provides a summary of the proposed placement for waste rock and quantities to be used for progressive rehabilitation capping. **Figure 2-3** indicates the proposed locations.

Figure 2-3 Indicative Location Options for Waste Rock Placement and Rehabilitation Capping

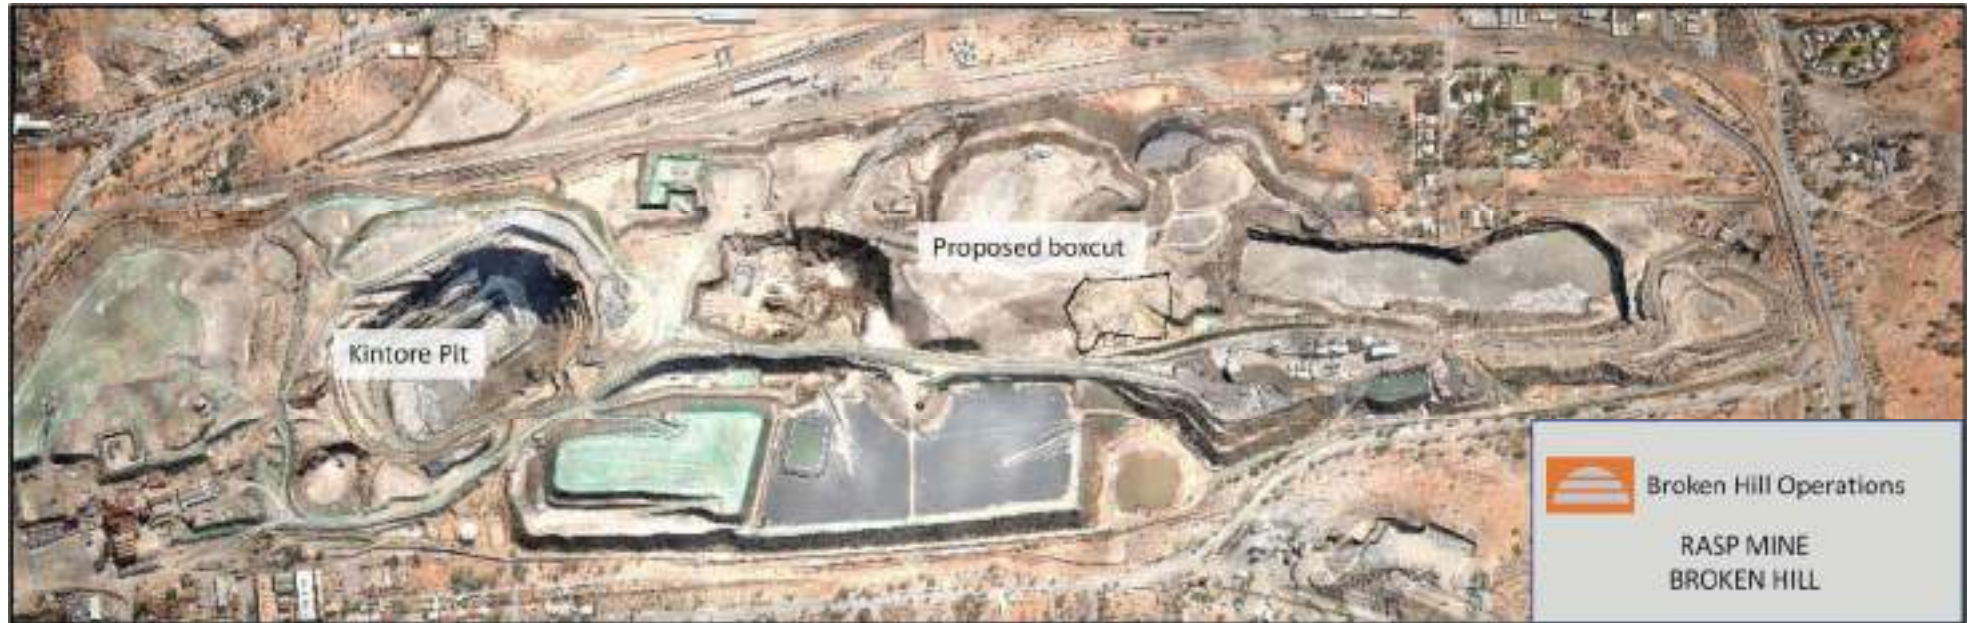
Figure 1 shows the location of the current portal location and proposed boxcut excavation

Figure 1 Kintore pit and box cut design outline within existing topography.

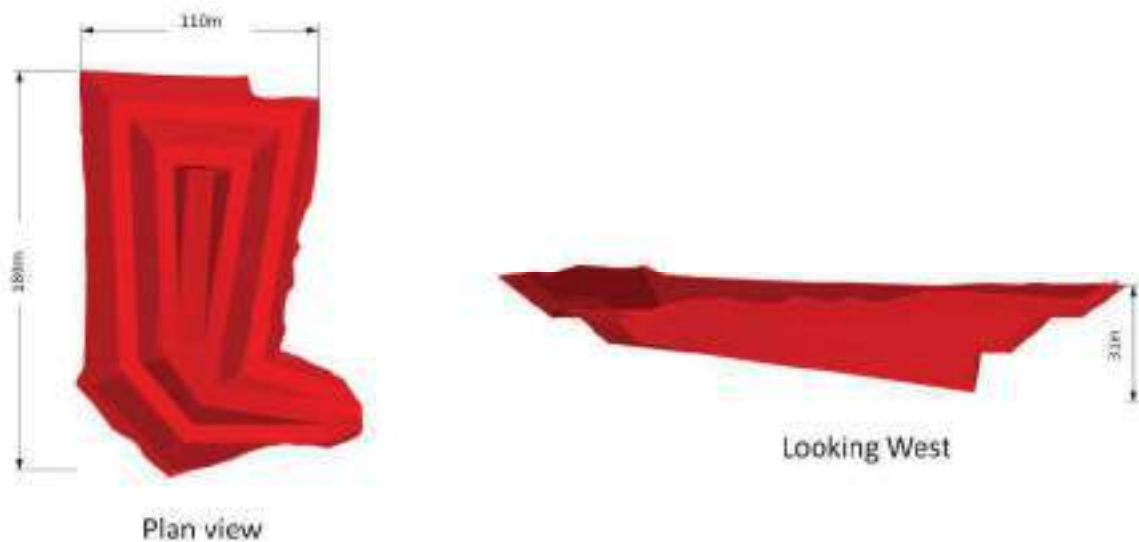
The proposed boxcut design dimensions are shown in Table 1 and Figure 2. The width of the box cut is constrained by the location of Rasp mine infrastructure on the eastern side of the boxcut and the mine boundary

Boxcut dimension	Unit	No
Length	m	180
Width	m	110
Maximum depth	m	31
Excavation volume	m ³	181,000

Figure 2 Boxcut design dimensions, plan view and looking west.

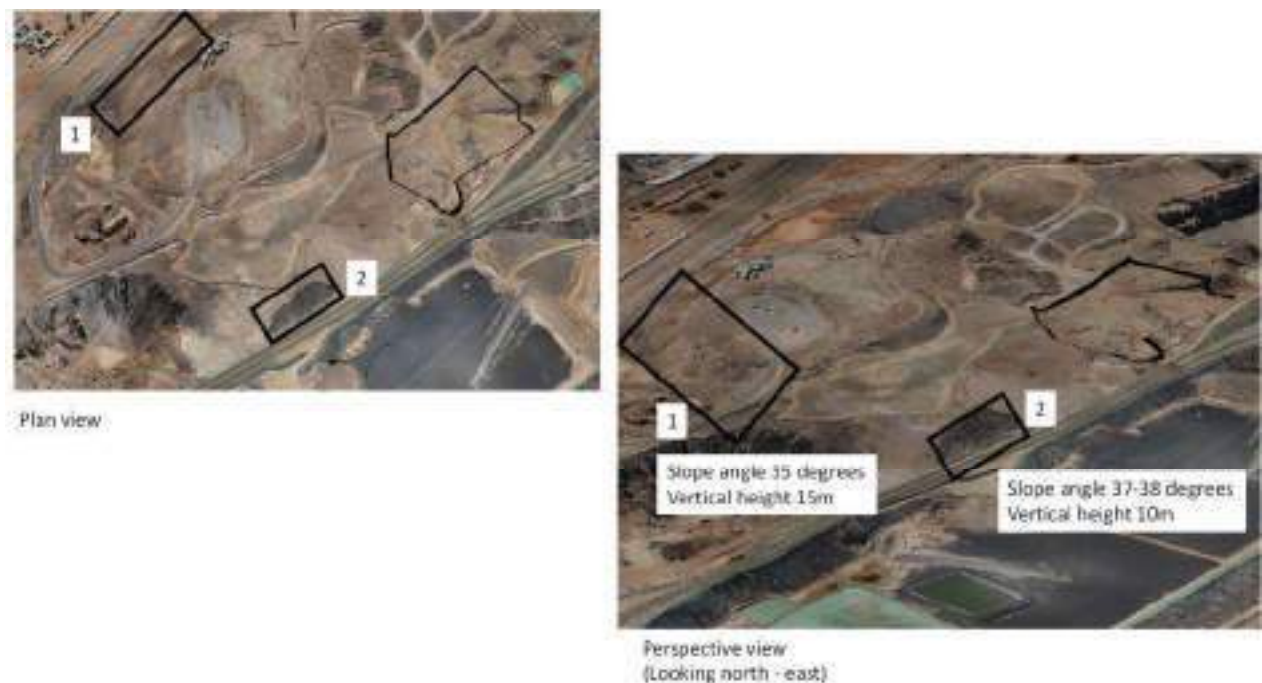
There are several historically stable slopes in the immediate area of the boxcut that were constructed using waste rock and fill material during the mining of the Blackwood Pit. Figure 3 shows the location of the fill slopes in relation to the proposed boxcut location.

Figure 3 Existing fill slopes in the boxcut area

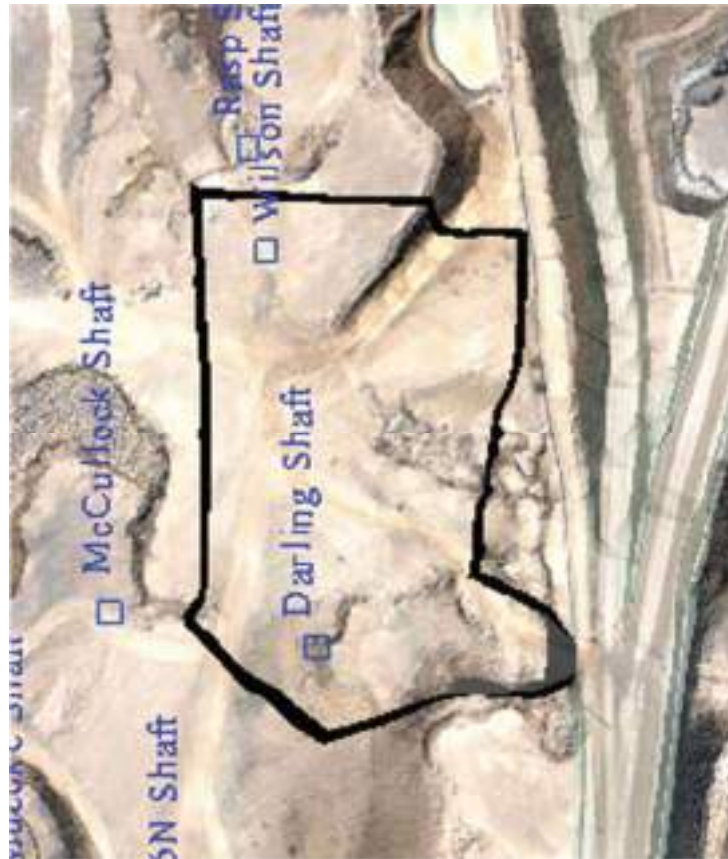
The location for the boxcut does not intersect known underground workings apart from the Wilson and Darling Shafts located on what will be the western wall of the boxcut. These shafts originally connected the underground workings to the surface; however, it is believed that these shafts were filled after abandonment. The location of the Wilson and Darling Shafts is shown in Figure 4.

Figure 4 Wilson and Darling Shaft locations – plan view

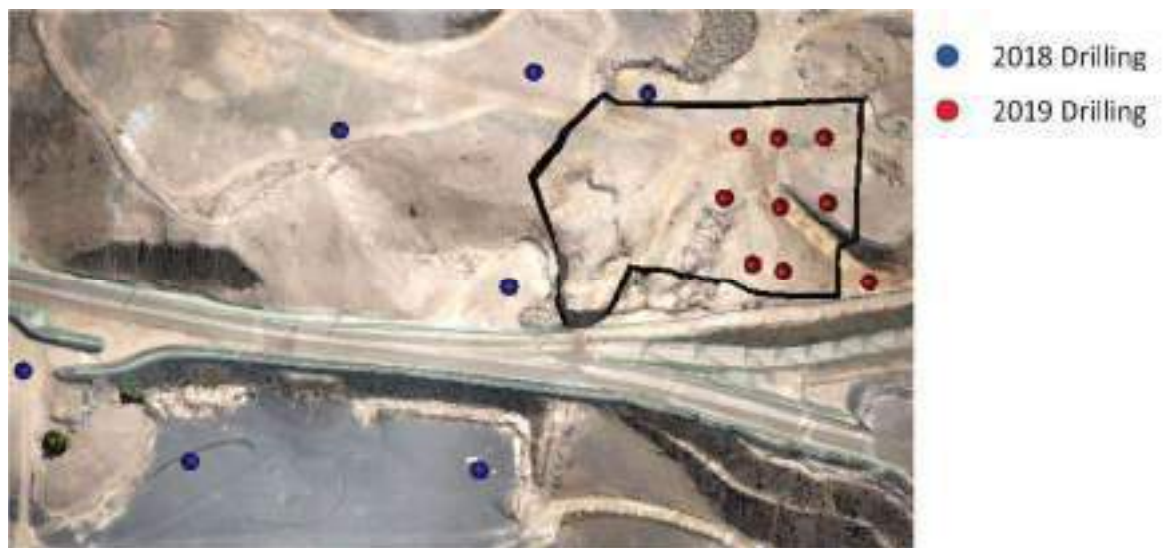
Figure 5 Plan view of diamond drill investigation holes

Seven diamond drill holes were completed in 2018, followed by 9 diamond drill holes in 2019, spaced over the boxcut surface area. The purpose of the drilling was to locate the base of the historic fill material that overlies the surface of the intended boxcut location and to characterise the weathering profile of the rock below the historic fill material. The details of the drill holes are provided in Table 2. The information gained from the geotechnical logging also formed the basis of the empirical analyses that was used in the determination of the portal batter and initial decline ground support design. A plan view of the hole locations is shown in Figure 5.

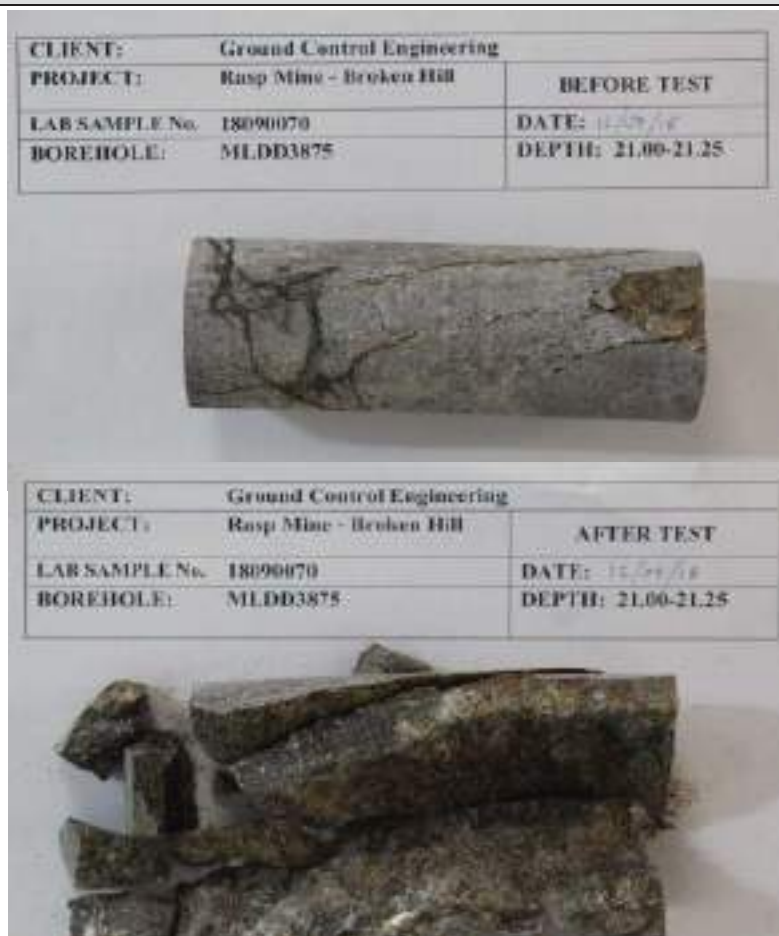
UCS (MPa) 24.3

Before and After Photo's

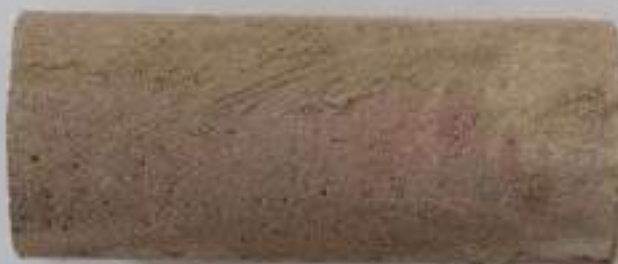
CLIENT:	Ground Control Engineering	
PROJECT:	Rasp Mine - Broken Hill	BEFORE TEST
LAB SAMPLE No.	18090073	DATE: 11/09/18
BOREHOLE:	MLDD3874	DEPTH: 18.70-19.00

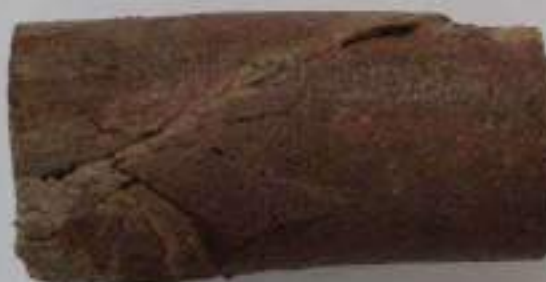
CLIENT:	Ground Control Engineering	
PROJECT:	Rasp Mine - Broken Hill	AFTER TEST
LAB SAMPLE No.	18090073	DATE: 05/10/18
BOREHOLE:	MLDD3874	DEPTH: 18.70-19.00

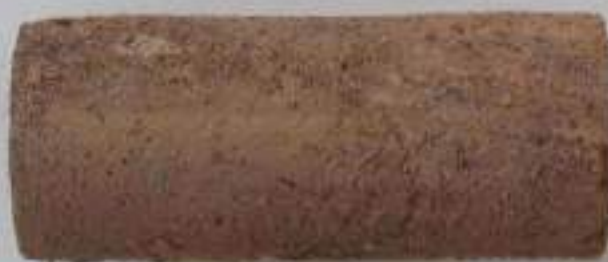
CLIENT:	Ground Control Engineering	
PROJECT:	Rasp Mine - Broken Hill	BEFORE TEST
LAB SAMPLE No.	18090074	DATE: 11/09/18
BOREHOLE:	MLDD3876	DEPTH: 31.40-31.60

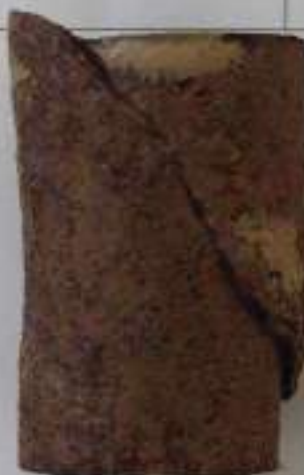
CLIENT:	Ground Control Engineering	
PROJECT:	Rasp Mine - Broken Hill	AFTER TEST
LAB SAMPLE No.	18090074	DATE: 03/10/18
BOREHOLE:	MLDD3876	DEPTH: 31.40-31.60

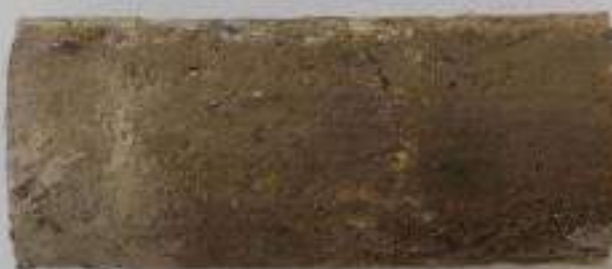
CLIENT:	Ground Control Engineering	
PROJECT:	Rasp Mine - Broken Hill	BEFORE TEST
LAB SAMPLE No.	18090075	DATE: 11/09/18
BOREHOLE:	MLDD3877	DEPTH: 48.60-48.80

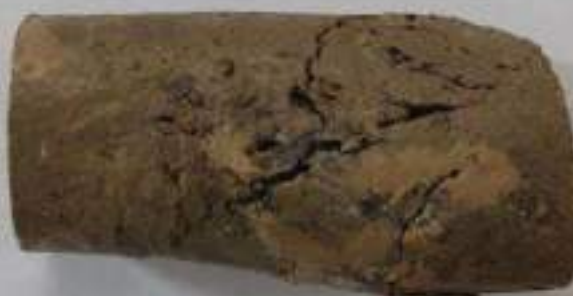
CLIENT:	Ground Control Engineering	
PROJECT:	Rasp Mine - Broken Hill	AFTER TEST
LAB SAMPLE No.	18090075	DATE: 08/10/18
BOREHOLE:	MLDD3877	DEPTH: 48.60-48.80
