# Rasp Mine

## Annual Review Revised

**1 January 2022 – 31 December 2022**

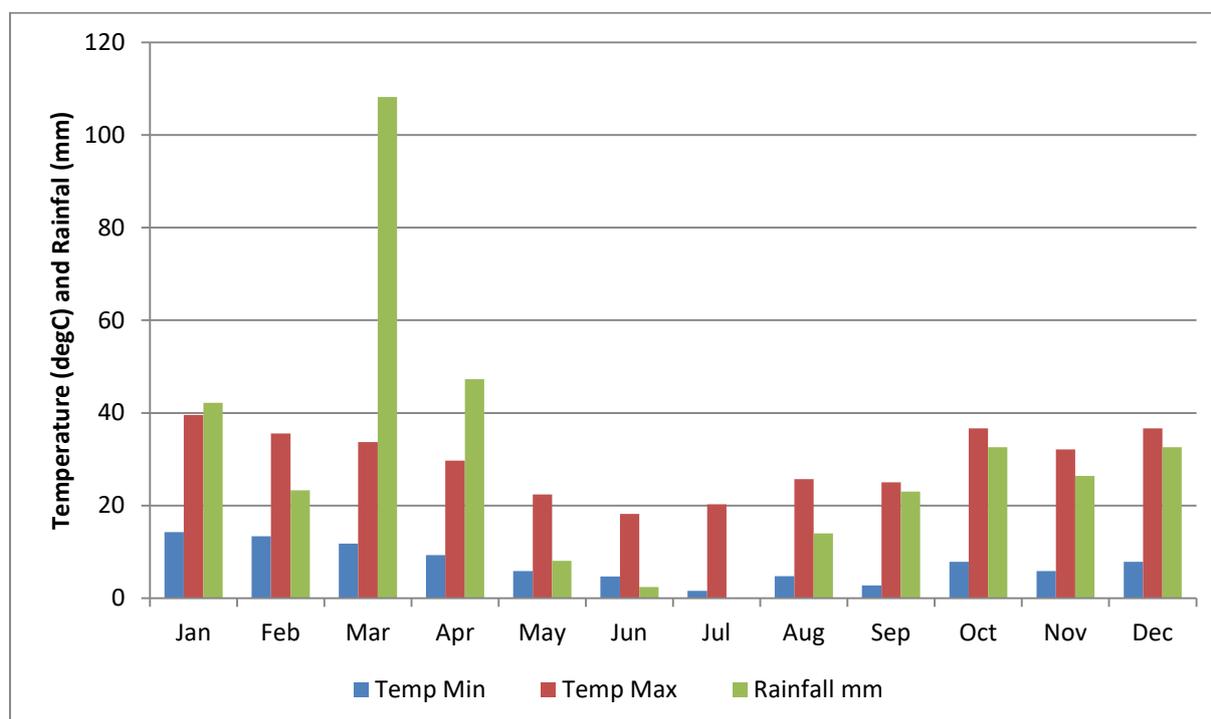
Figure 5-5-1 Weather Data for the Reporting Period

Temperatures and rainfall in the reporting period remained consistent with the BoM's long-term averages, with rainfall (373.6mm) for the period was higher than the BoM's long-term annual average of 246mm. There were 59 rain days for the period. Winds were predominantly from the south with high winds experienced throughout the year.

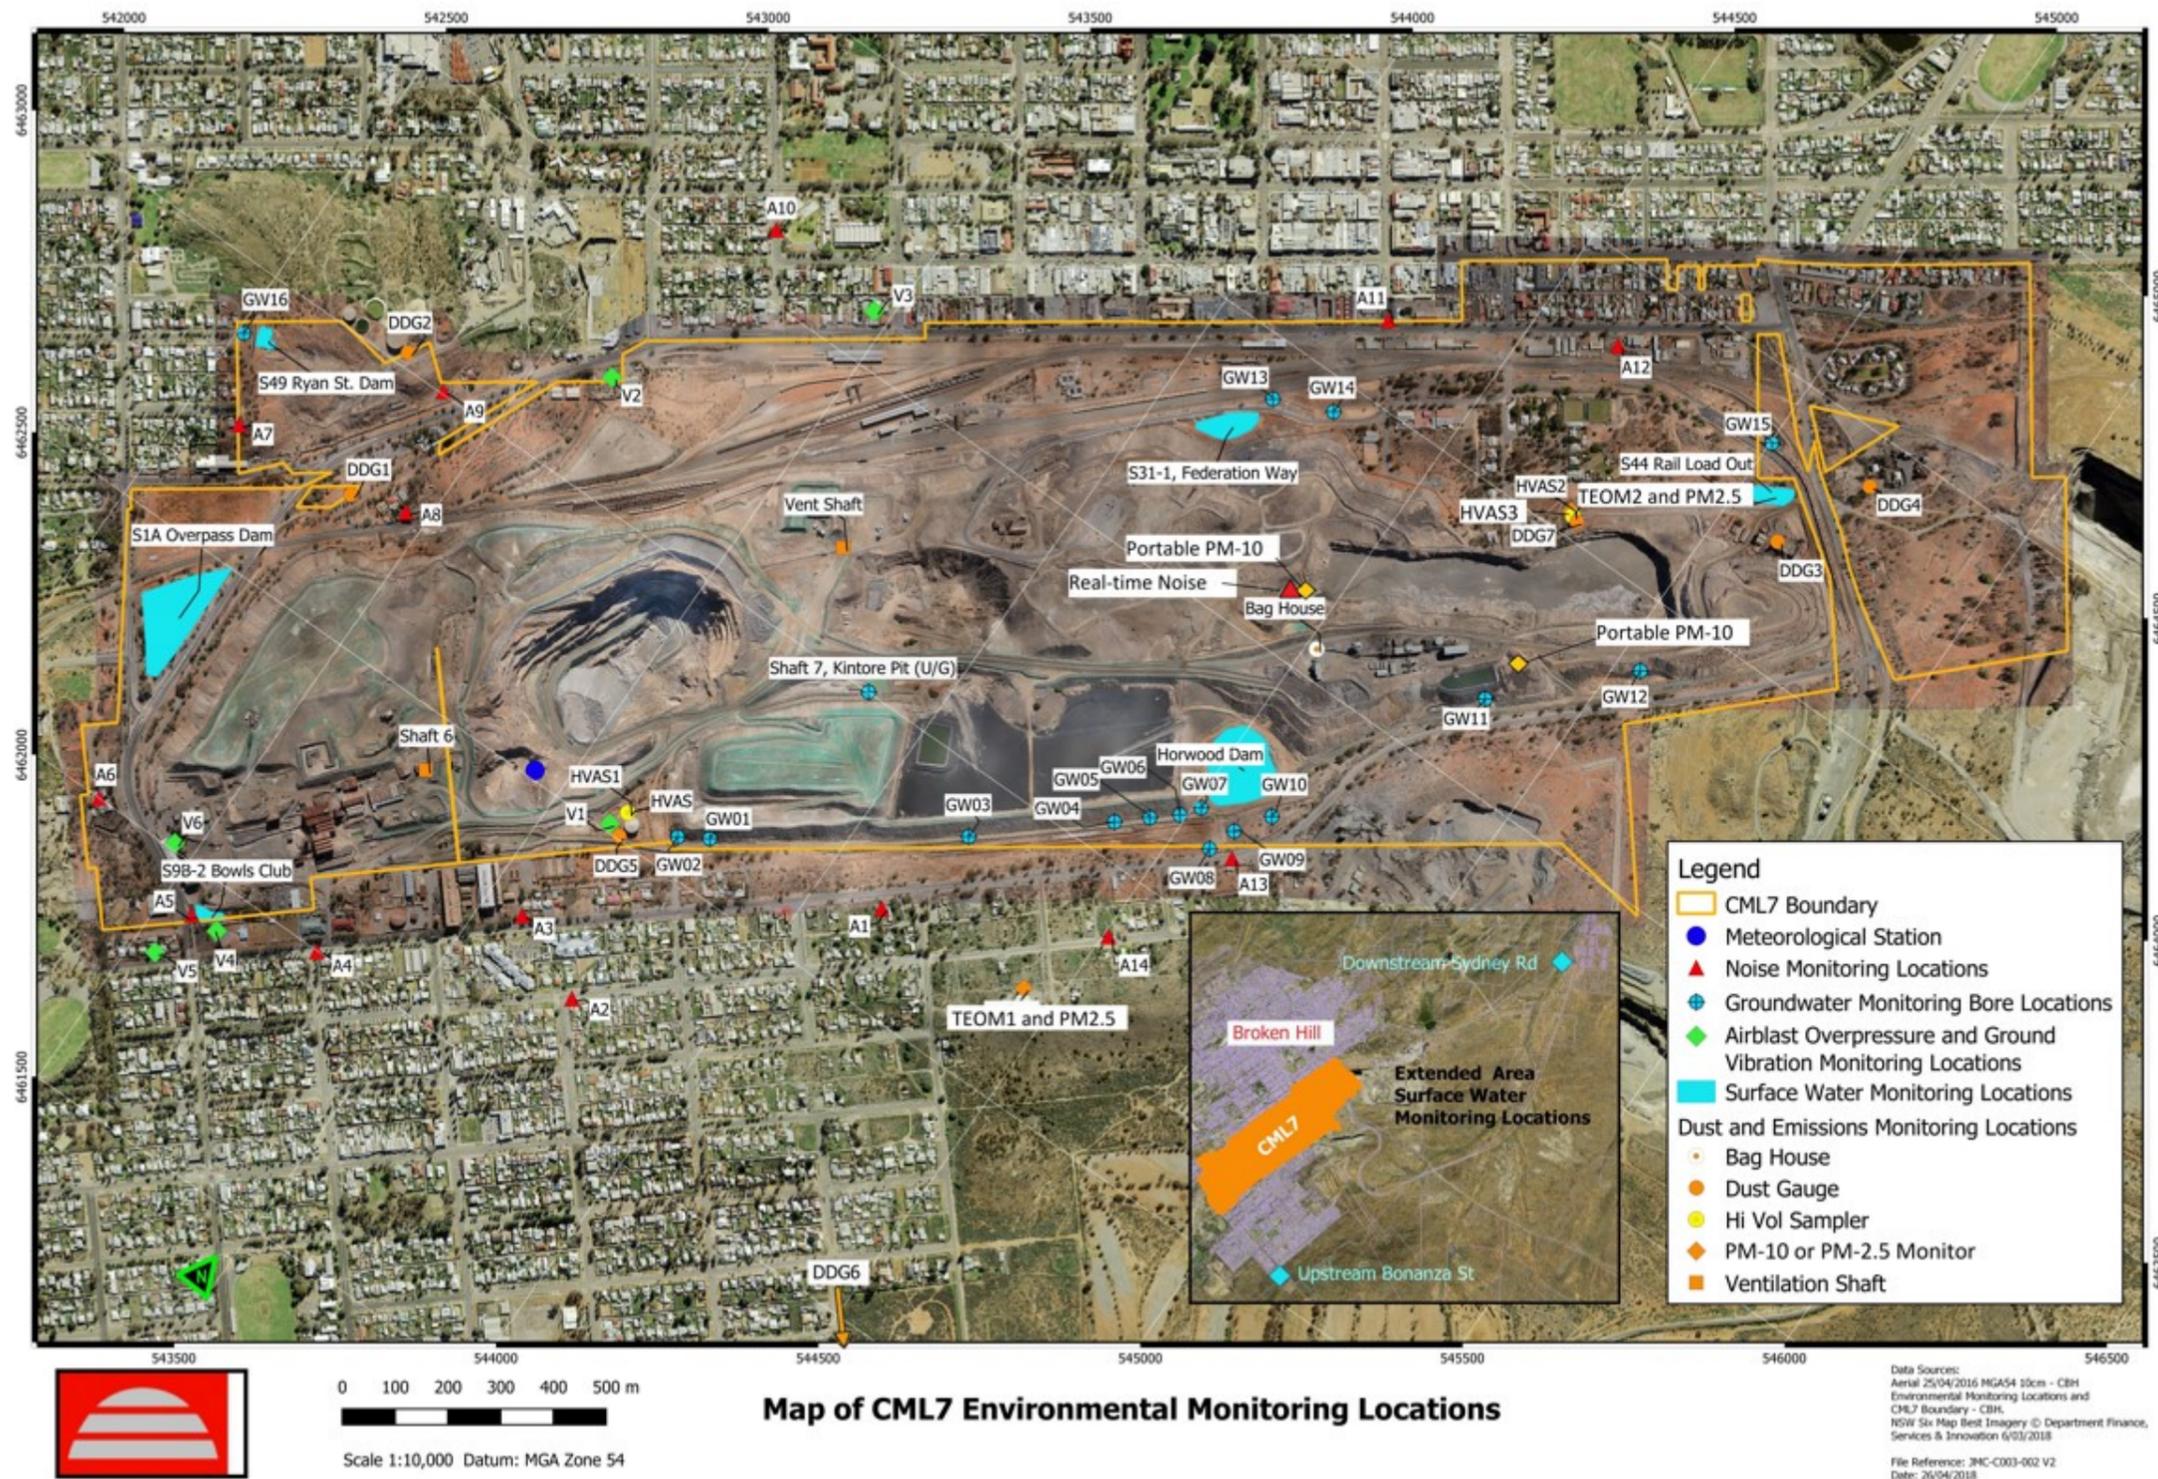
Figure 5-2 Location of Monitoring / Sampling Points

**Figure 5-2** shows the sampling locations for all air quality monitoring units.

The BHO site environmental monitoring program is summarised in **Table 5-2**, locations for sampling/monitoring points are shown in **Figure 5-2**. A new weather station was installed on site in January 2019 as the previous weather station could not calculate Sigma Theta, a requirement of EPL 12559.

The Rasp Mine has two Tapered Element Oscillating Microbalance (TEOM) air quality monitors, which record real time PM<sub>10</sub> and PM<sub>2.5</sub> data. Figure 5-2 shows the location of these monitors.

There are seven sampling locations for surface water, these include surface water basins located on the mine lease to capture and retain rainfall and two locations up and down stream of an ephemeral creek located south of the mine lease boundary. Sampling requirements are provided in **Table 5-7** and locations of sampling points are shown in **Figure 5-2**.

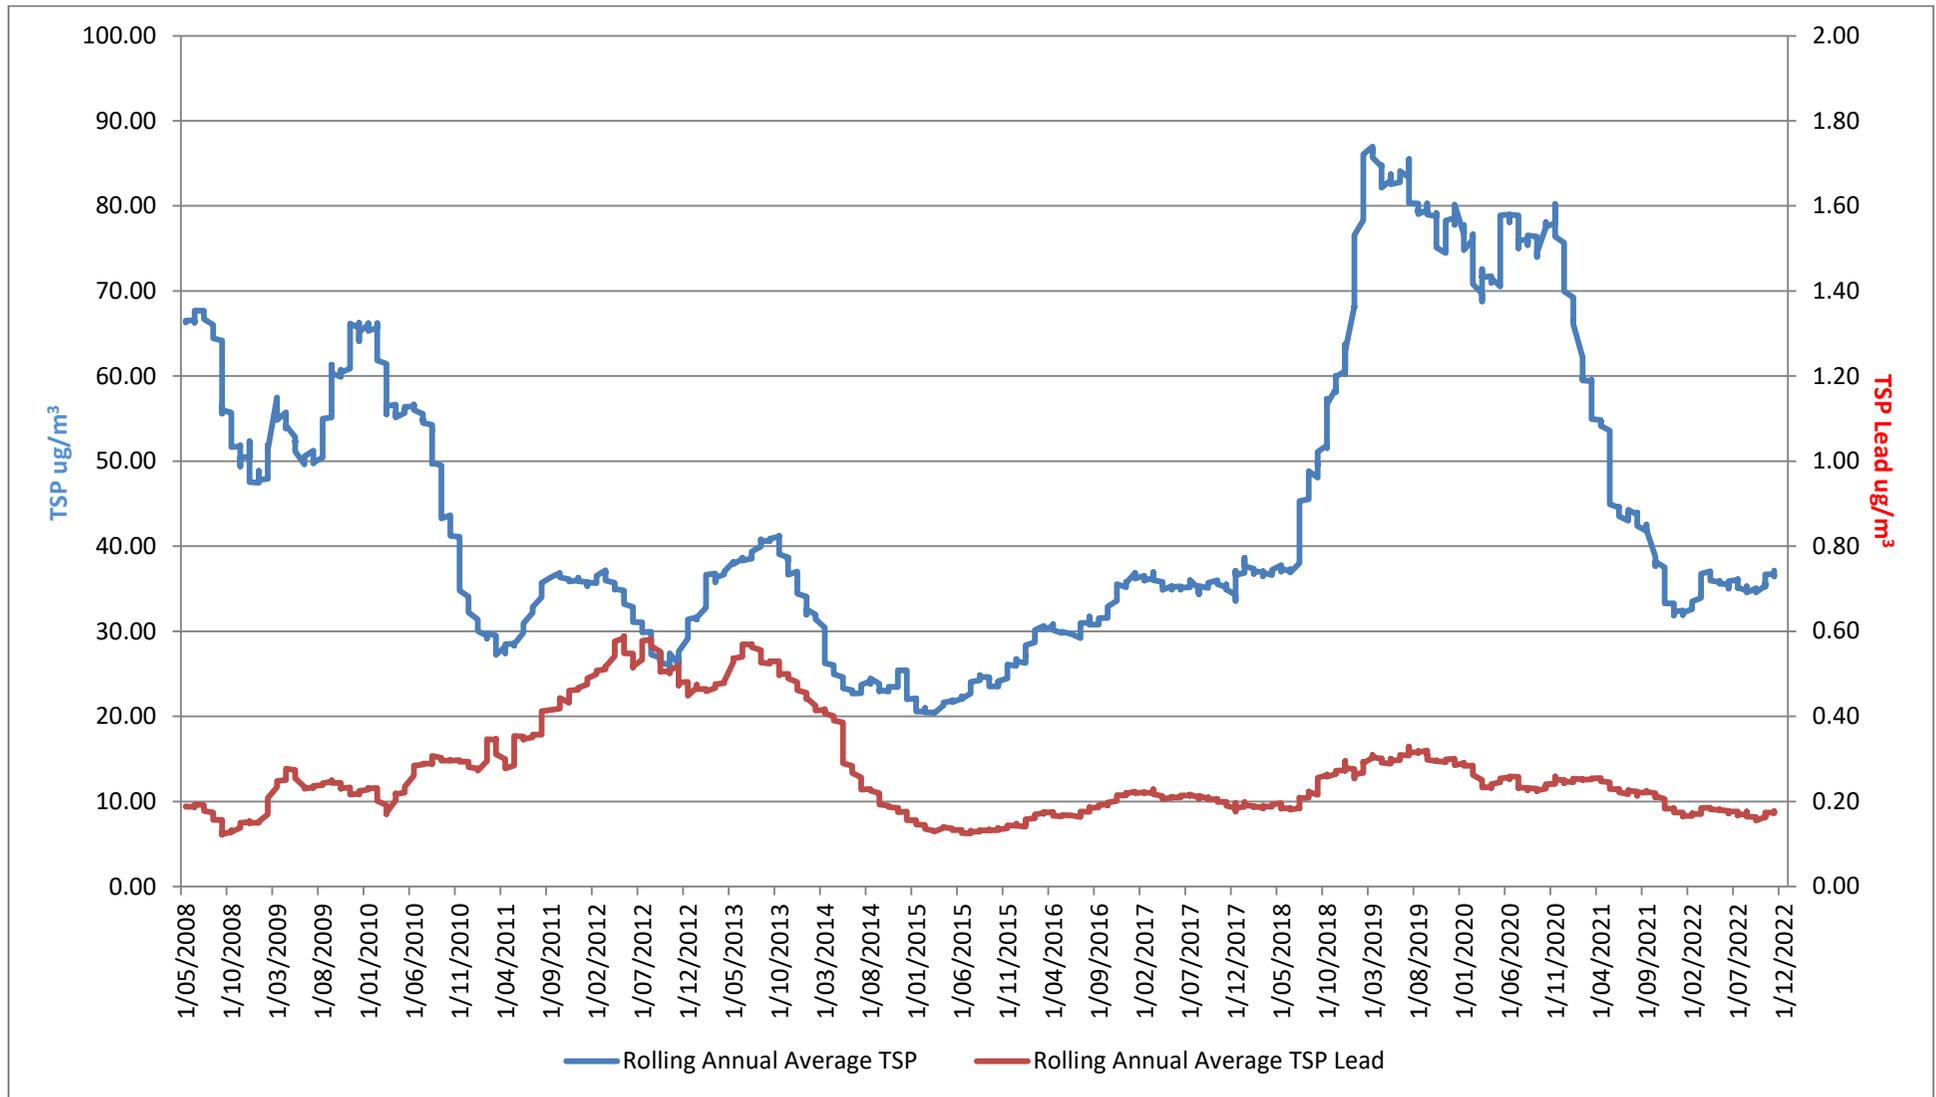
Figure 5-9 HVAS TSP and TSP-Lead Results for the Period 2008 to 2022

As can be seen in **Figure 5-9**, there is an increase in dust levels recorded in HVAS after 2016 due to the period of drought. Dust levels decreased at the beginning of 2022 due to the heavy rainfall and increased towards the end of the reporting period due to the hotter and windier weather. Lead levels have fallen with slight elevation in levels towards the end of the period. This can indicate contribution from site activities but it has been found that lead levels can be elevated at this location on the southern boundary of the site when winds are predominantly from the South.

**Figure 5-9** provides a summary of TSP and TSP-lead results from 2008 to 2022. Rolling annual averages for TSP are well below the annual average criteria of 90µg/m<sup>3</sup> and EPA threshold of 0.5 µg/m<sup>3</sup> for TSP-lead.

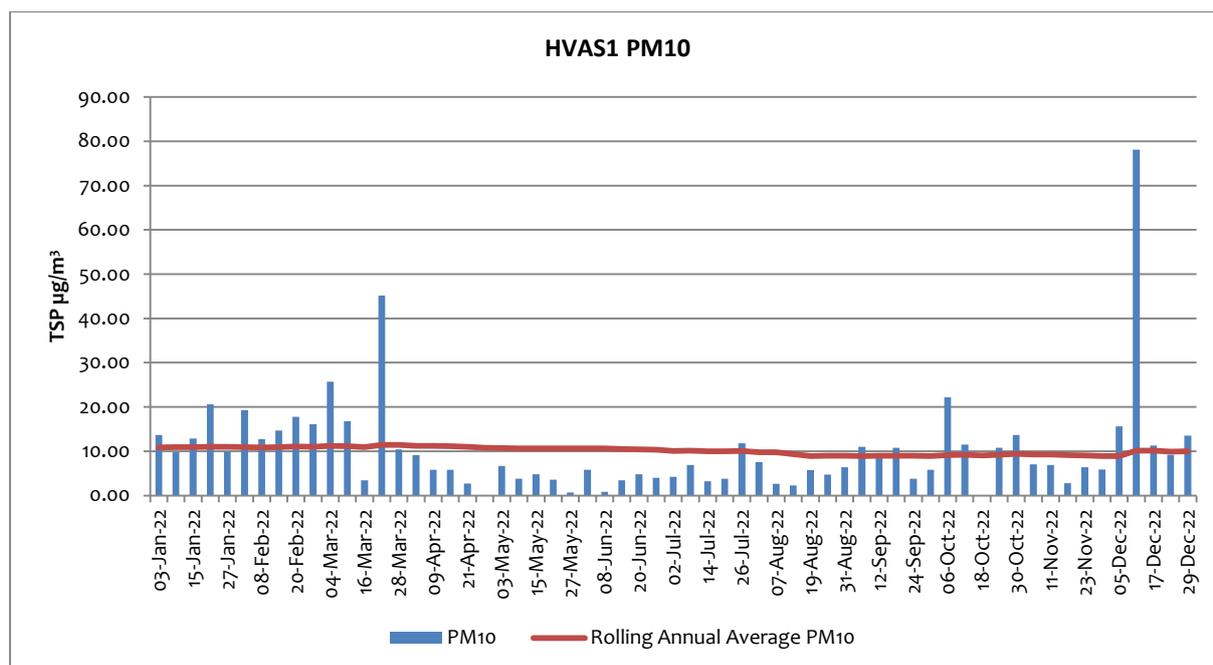
**Figure 5-10 HVAS1 PM<sub>10</sub> Results for the Reporting Period**

The highest PM<sub>10</sub> dust level for December was 78.10 µg/m<sup>3</sup> on 11 December when winds were predominantly from the SW and a dust storm moved through the region.

HVAS1 is used for sampling PM<sub>10</sub> and PM<sub>10</sub>-lead. The average annual PM<sub>10</sub> level recorded at this monitoring point at the end of the reporting period was 10.0 µg/m<sup>3</sup>, which has decreased from the previous reporting period of 11.0 µg/m<sup>3</sup> and is well below the background level of 29.1µg/m<sup>3</sup> reported in the EA. The average annual PM<sub>10</sub> level calculation includes data collected during extreme events. Results for the reporting period are shown in **Figure 5-10** which indicates that the rolling annual average for PM<sub>10</sub> is below the criteria of 25 µg/m<sup>3</sup>, and has remained consistently low during the reporting period.

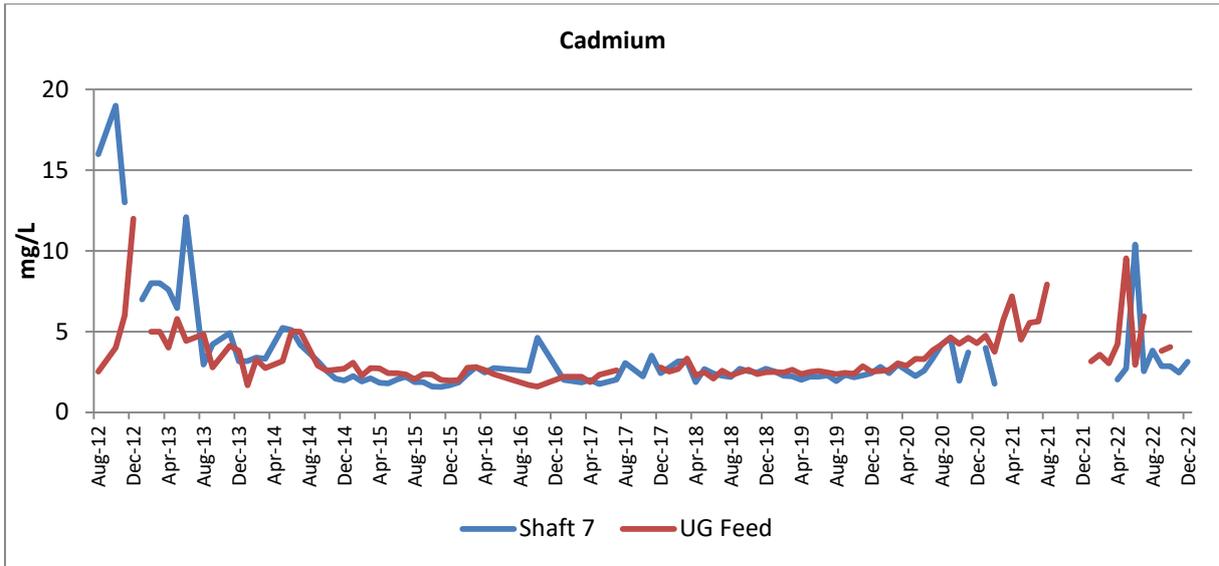
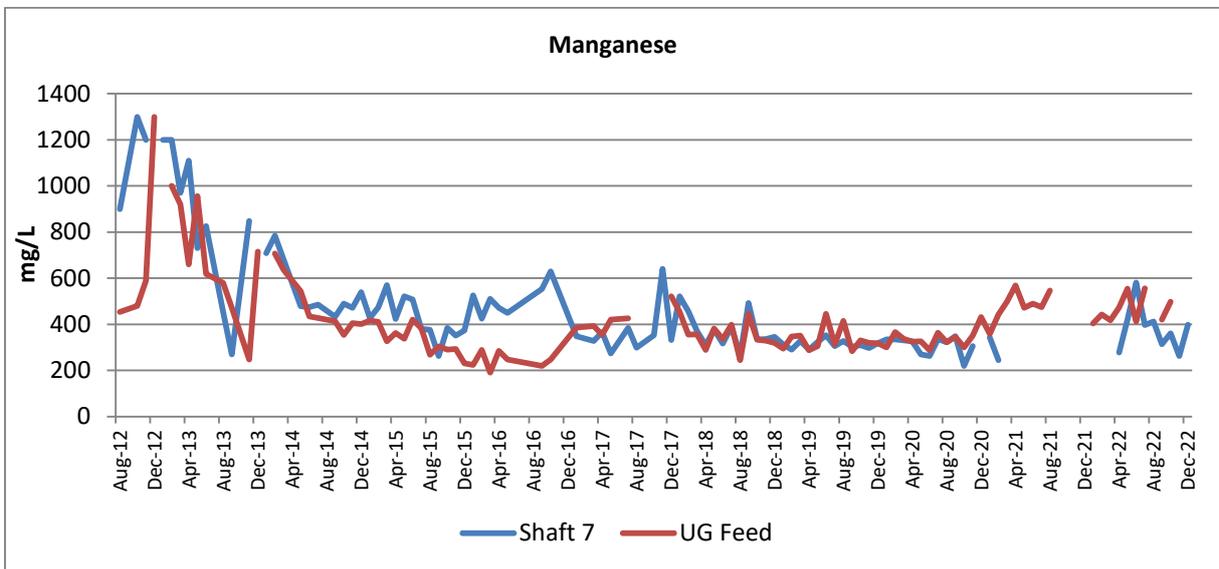
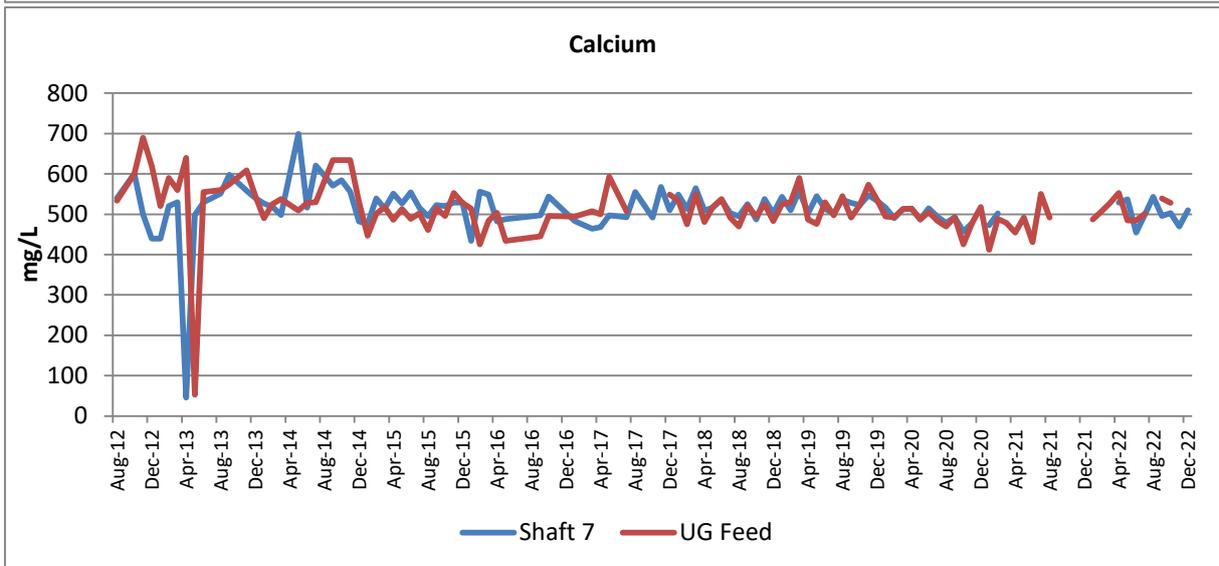
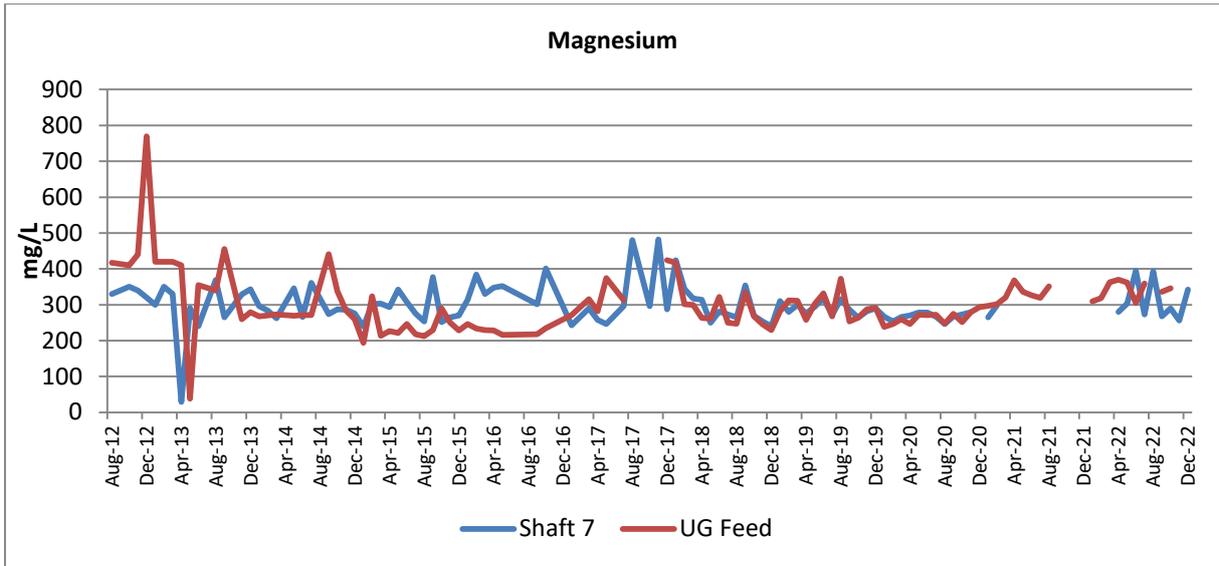
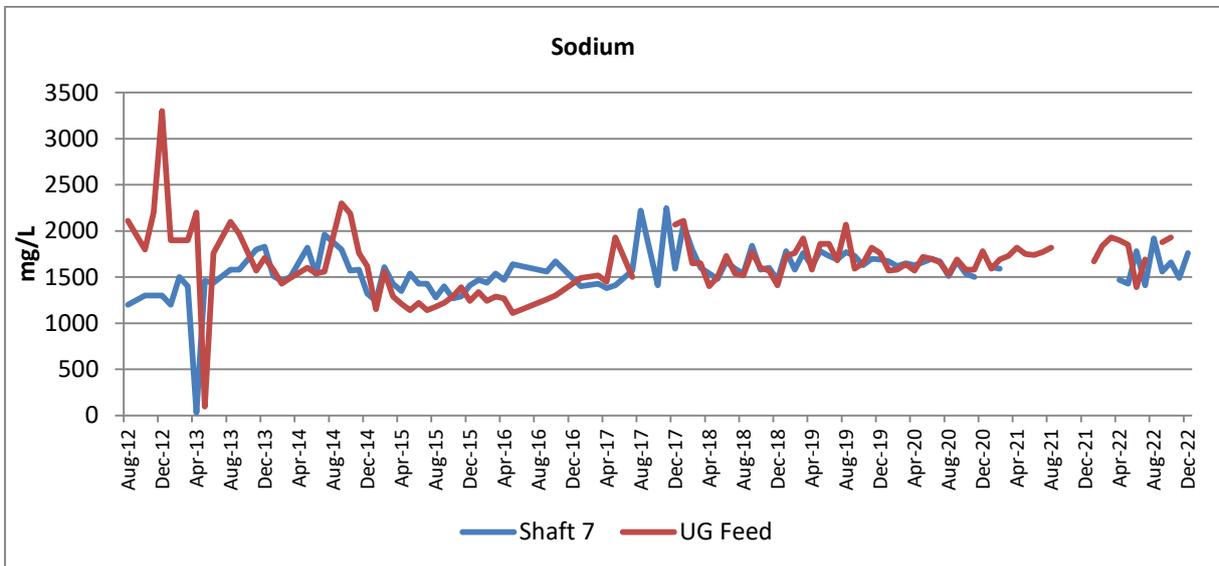
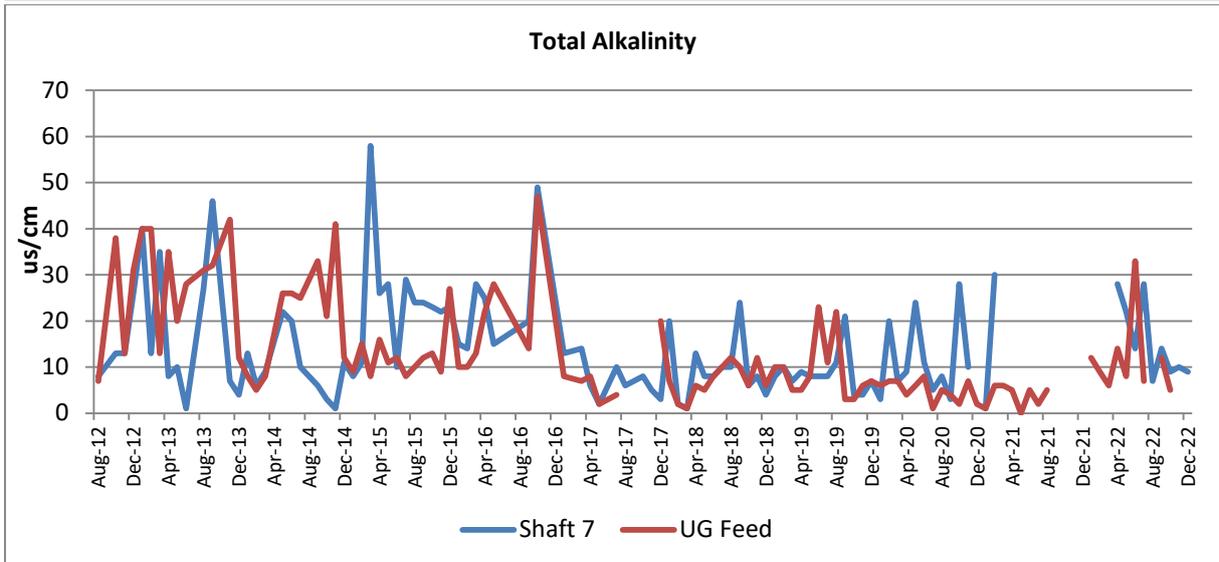
Figure 5-27 Shaft 7 & Mine Dewatering Results for Sampled Parameters - Period 2012 to Dec 2022

**Figure 5-27** provides a series of graphs indicating results from commencement of operations to present (2012-2022). Results are within the historic range for all parameters.

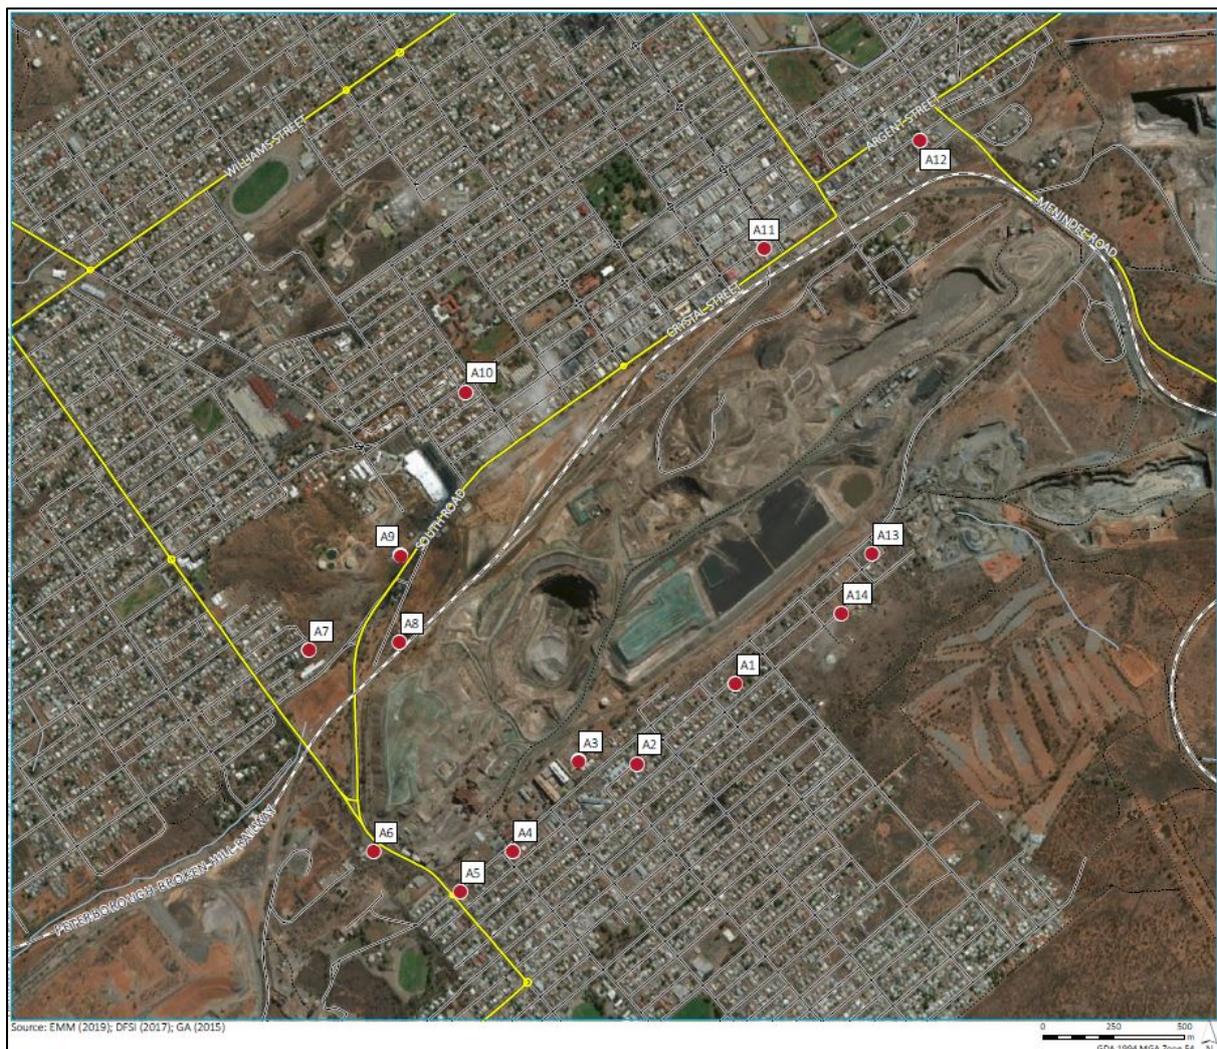
**Figure 5-28 Noise Receptors**

During the reporting period EMM Consulting Pty Ltd conducted a noise assessment for these receptors, **Figure 5-28**. Attended noise monitoring was conducted during two consecutive night-time periods from 27 to 29 October 2022 to quantify off-site noise levels from the Rasp Mine. While the EPL nominates noise limits for day, evening and night, attended monitoring was completed during the night-time period to minimise the contamination of monitoring data by extraneous noise sources (e.g. domestic and road traffic noise).

Rasp Mine LAeq,15min noise contributions (including the addition of the relevant modification factor) satisfied the relevant night-time noise limits at all assessment locations, including during attended measurements when noise limits did not apply due to adverse weather conditions
