Issued by	Hydrock Consultants Limited 4 Lakeside Festival Park Stoke on Trent Staffordshire ST1 5RY United Kingdom	T +44 (0)1782 261919 F +44 (0)1782 262020 E stoke@hydrock.com		
Client	Fig Power			
Project name	Walbottle Road, Newburn			
Project title	Coal Mining Risk Assessment			
BIM reference	29911-HYD-XX-XX-RP-GE-0002			
Project reference	29911			
Date	16/02/2024

Consultants Coal Mining Report

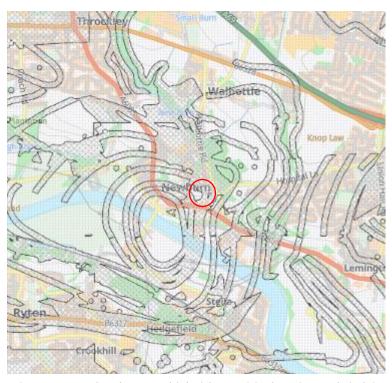
Figure 2.7: CA development high risk area (site location-red circle)

- » The majority site is classified as a high risk development area, due to the potential for workings associated with subcropping Harvey Coal Seam and offsite subcropping Tilley and Top Busty coal seams which are likely to be beneath the site (shown in Figure 2.7);

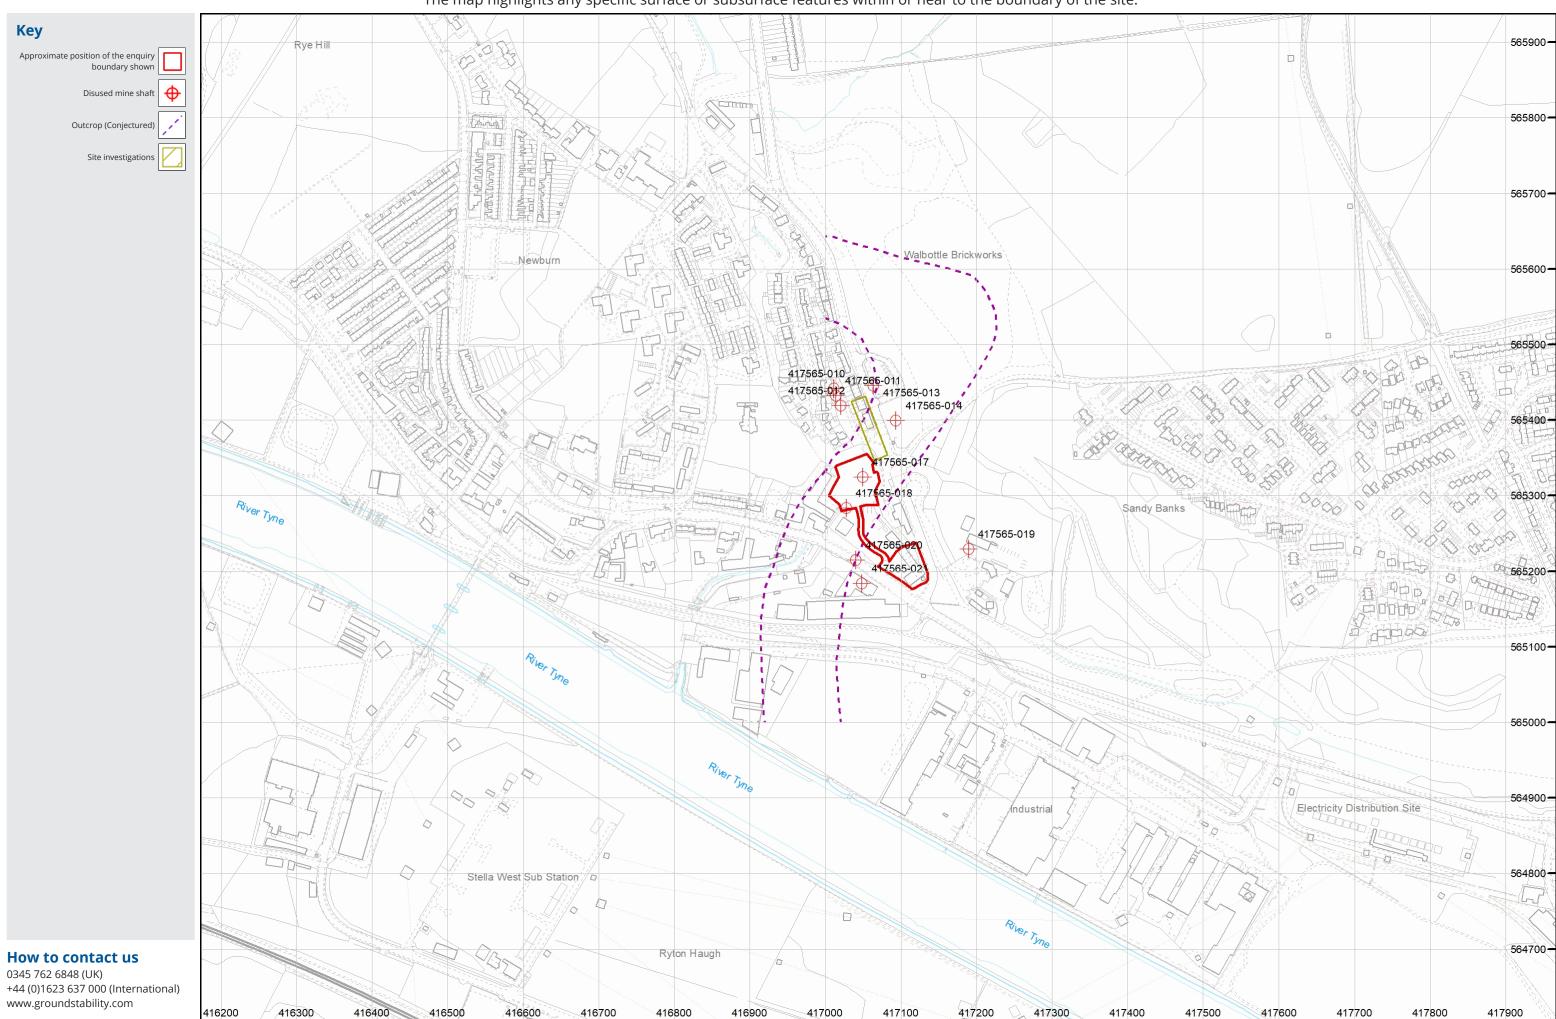
Summary of findings

The map highlights any specific surface or subsurface features within or near to the boundary of the site.
