**Re: Supplemental Geotechnical Letter Report – Rock Investigation  
North Broadway Assemblage  
Yonkers, New York**

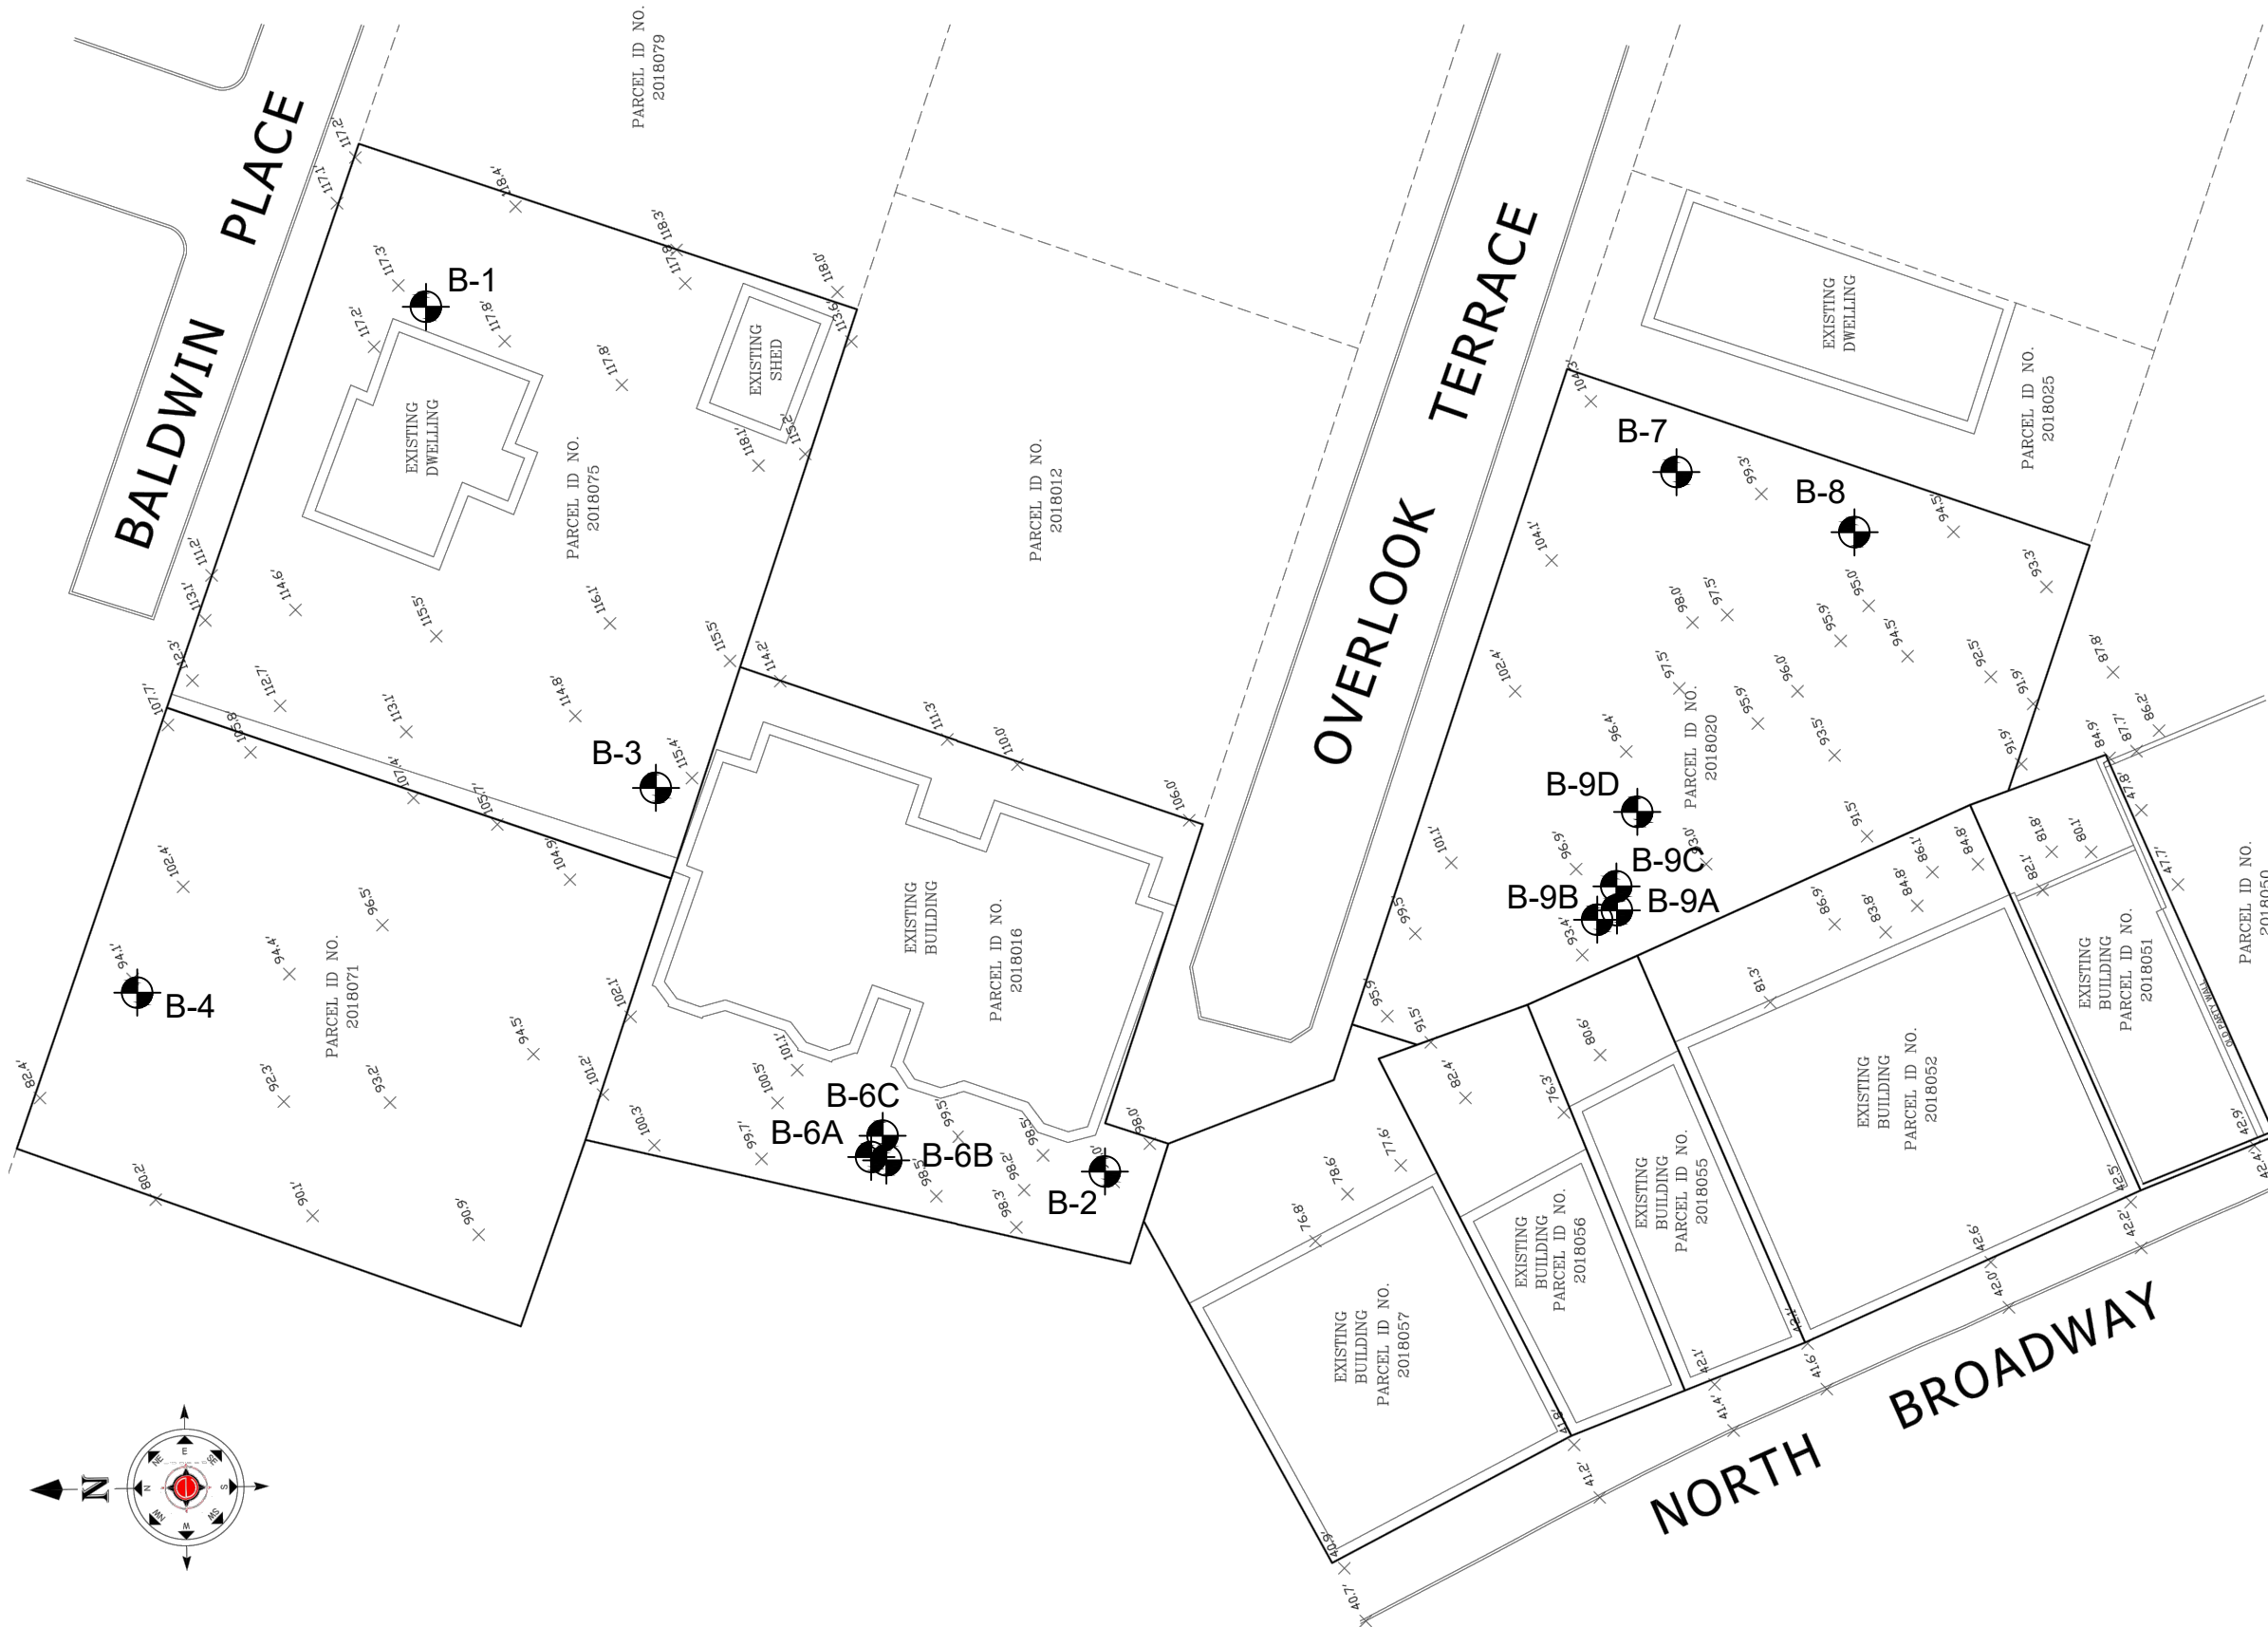
- Drawing No. B-101.01 – Boring Location Plan
- Geotechnical Boring Logs

Borings were performed at a total of seven (7) locations, referred to as B-3 through B-9. Several attempts were made to reach top of rock in Borings B-6 and B-9, which have been noted in this report as B-6A, B-6B, B-6C, and B-9A, B-9B, B-9C, and B-9D. Multiple attempts at each borehole became necessary as rock was not encountered prior to the borehole collapsing. Therefore, a total of twelve (12) borings were performed at the locations shown in updated Boring Location Plan attached to this letter report. This plan also includes the borings performed during our preliminary geotechnical investigation in April 2019. Borings B-3 through B-5 are geotechnical borings drilled by Big Apple Testing of Ozone Park, New York utilizing an Acker Soil Scout Track Drill Rig from November 5 to 7, 2019. Borings B-6 through B-9 are open-hole borings were drilled by Siteworks, Inc. of New York, New York, utilizing a Furukawa Rock Drill from November 12 to 13, 2019. All borings were inspected on a full-time basis by Messrs. Daniel George, P.E. and Michael Torino, P.E. of GES.
