Peace of Mind Automotive Inspection Report.

Site conducted	Unanswered
Customer name	Luis Imj auto motor sales
Date / Time	Dec 26th
Payment method	Invoice
Inspection cost	Fleet
Vehicle Year / Make / Model / Color	2007 Mazda mx5 Miata

VIN	39587 last 5

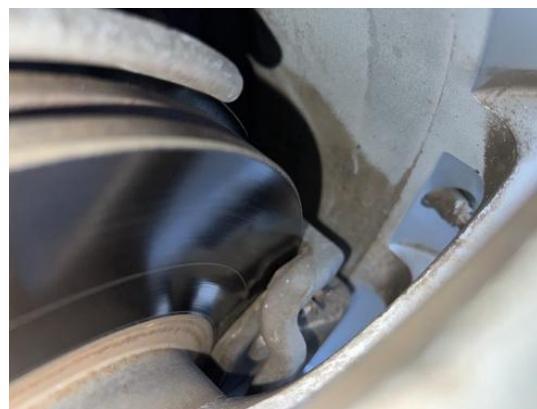
Brake fluid condition	Healthy
Brake fluid level	Healthy
Brake fluid leaks	None
Moisture content in brake fluid	None
Brake lines	Healthy
Brake calipers front	Healthy
Brake calipers rear	Healthy
Brake drums rear	N/A
Brake rotors front	Healthy
Brake rotors rear	Healthy
Front brake pad life remaining	25-50% remaining

Photo 161
