# Peace of Mind Automotive Inspection Report.

Score	4 / 4 (100%)	Flagged items	0	Actions	0
<b>Site conducted</b>					Unanswered
<b>Customer name</b>					LMJ auto motor sales
<b>Date / Time</b>					May 18th
<b>Payment method</b>					Invoice
<b>Inspection cost</b>					Fleet
<b>Vehicle Year / Make / Model / Color</b>					2019 jeep wrangler
<b>VIN</b>					78681 last 5

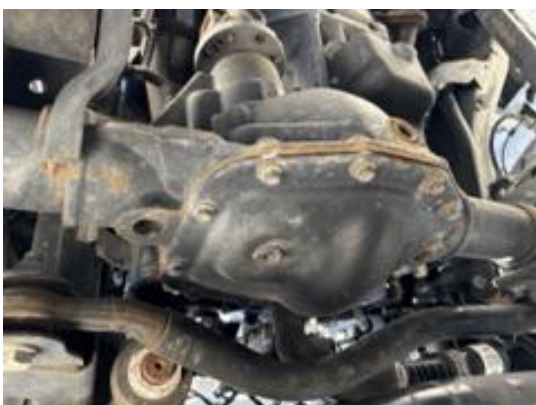
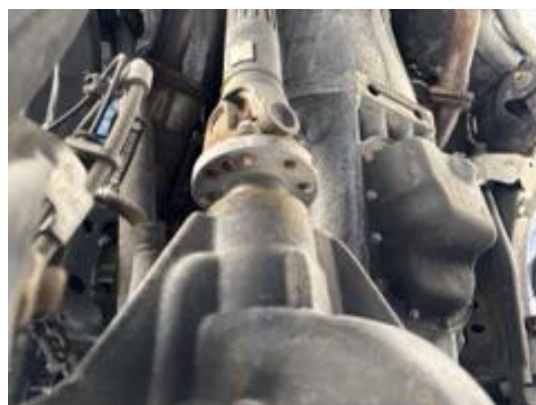
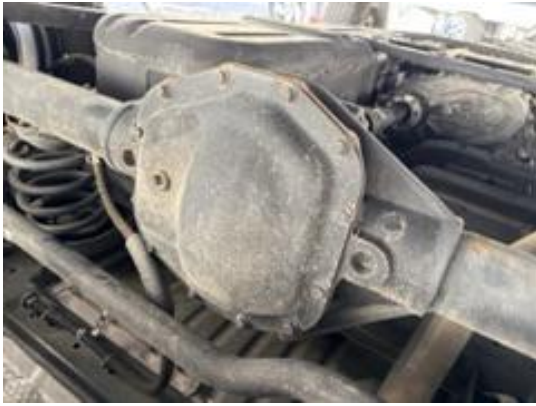
Photo 140

<b>Transmission cooler / lines</b>	Healthy
<b>Front differential condition</b>	Healthy
<div style="display: flex; justify-content: space-around;"> <div style="text-align: center;">

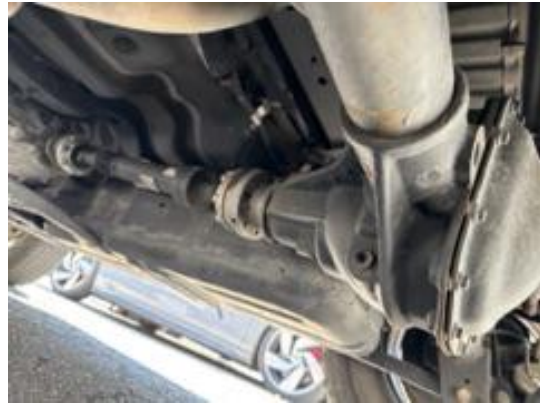
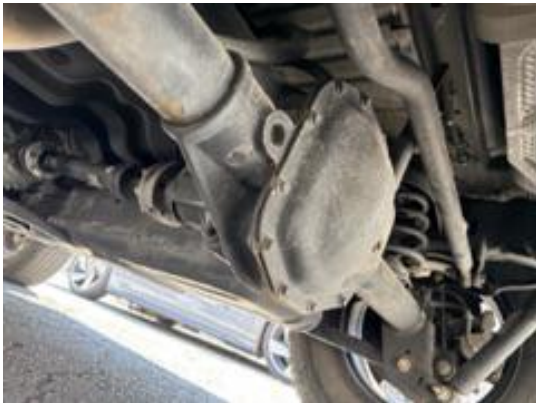
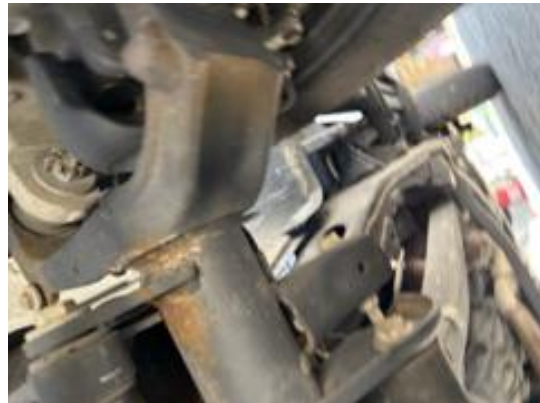
Photo 143

<p>Photo 142</p> </div> </div>	
<b>Center differential condition</b>	Healthy
<b>Rear differential condition</b>	Healthy
<div style="display: flex; justify-content: space-around;"> <div style="text-align: center;">

<p>Photo 145</p> </div> </div>	
<b>Differential leaks</b>	None
<b>4x4 function / engagement</b>	Healthy
<b>Clutch engagement</b>	Healthy
<b>Gear engagement</b>	Healthy
<b>Shift transitions</b>	Healthy

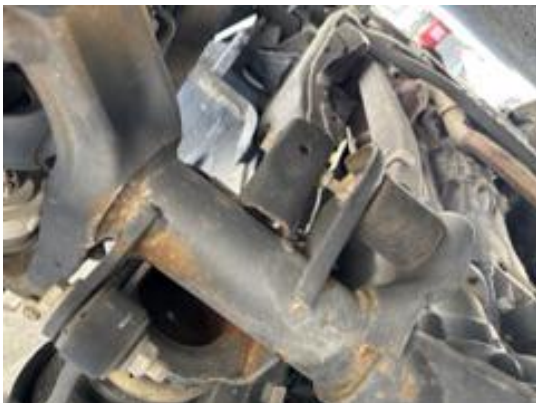
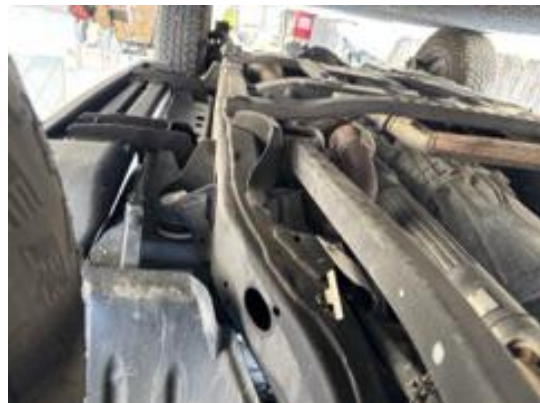
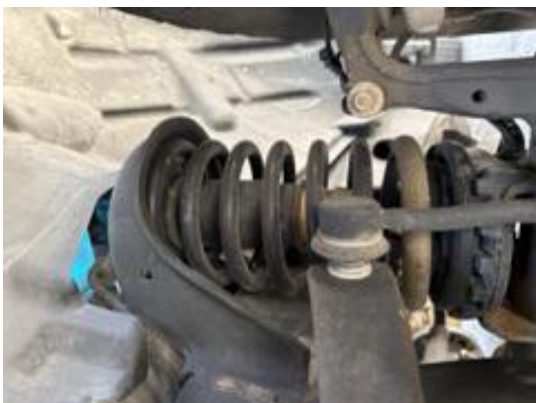
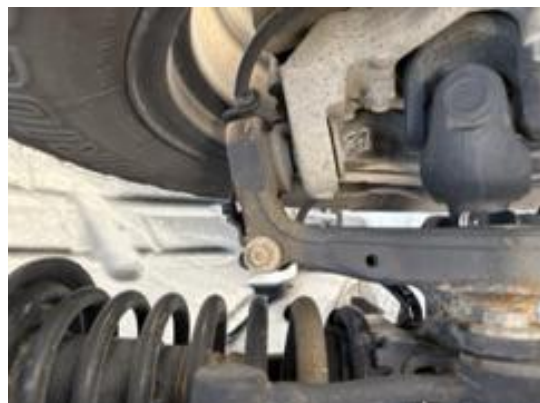
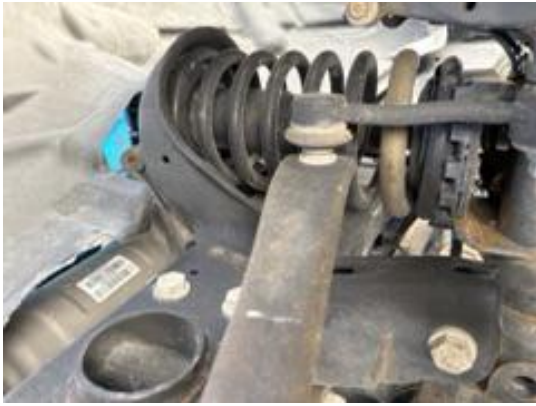
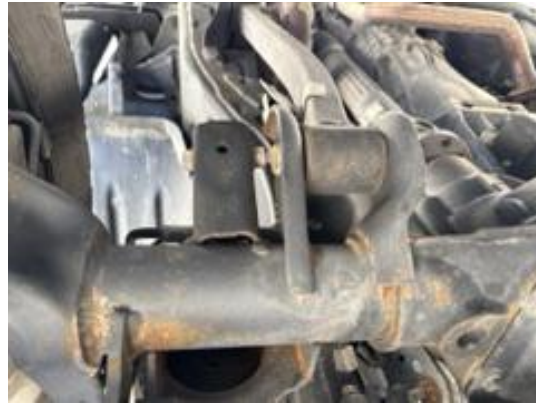
Photo 146

Normal fatigue notice to the suspension components. All of the suspension components seem to be original. None of the suspension components are blown out and due form the replacement. The No excessive surface rust on the exposed metal. No abnormal noise or feedback from the suspension while out on the road. All of the rubber in relation to the mounts, joints and bushings has decent texture.

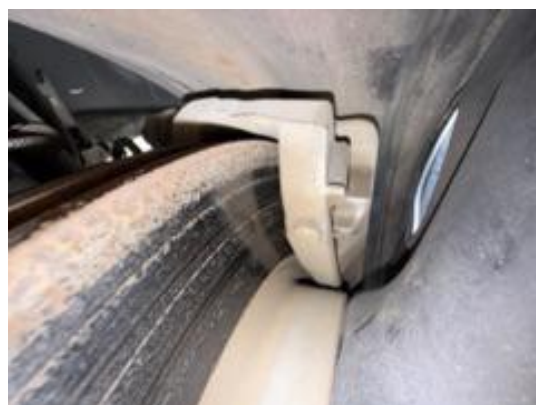
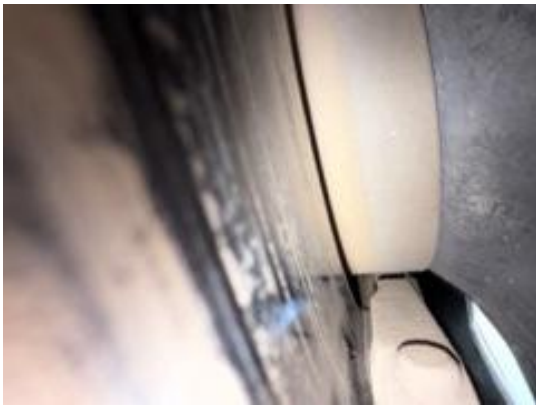
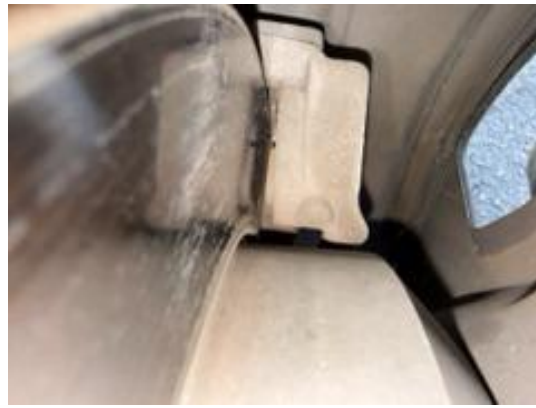
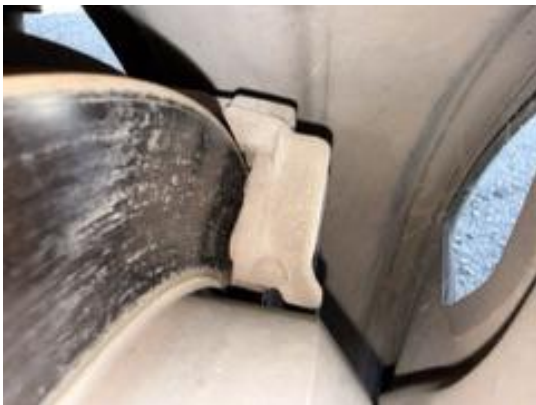
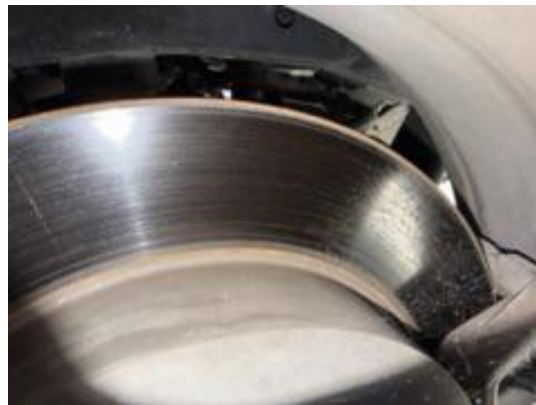
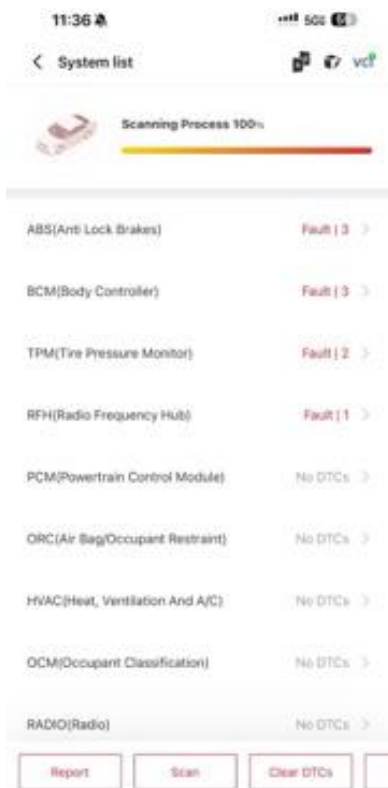
<b>Braking system condition</b>	0 / 0 (0%)
<b>Brake fluid condition</b>	Healthy
<b>Brake fluid level</b>	Healthy
<b>Brake fluid leaks</b>	None
<b>Moisture content in brake fluid</b>	None
<b>Brake lines</b>	Healthy
<b>Brake calipers front</b>	Healthy
<b>Brake calipers rear</b>	Healthy
<b>Brake drums rear</b>	N/A
<b>Brake rotors front</b>	Healthy
<b>Brake rotors rear</b>	Healthy
<b>Front brake pad life remaining</b>	50-75% remaining
<p>Write about 55% brake pad light remaining on the front brake system, right about 60% brake pad life remaining on the rear brake system</p>

<p>Photo 167</p>	
<b>Rear brake pad life remaining</b>	50-75% remaining
