# Peace of Mind Automotive Inspection Report.

| Vehicle Year / Make / Model / Color | | | | | 2021 jeep wrangler |

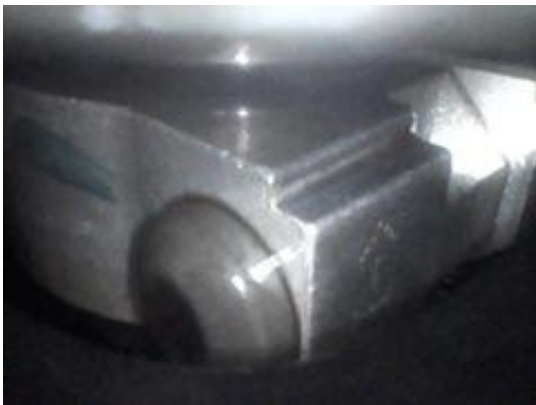
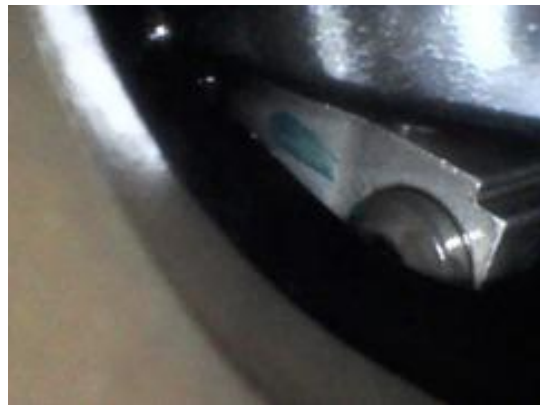
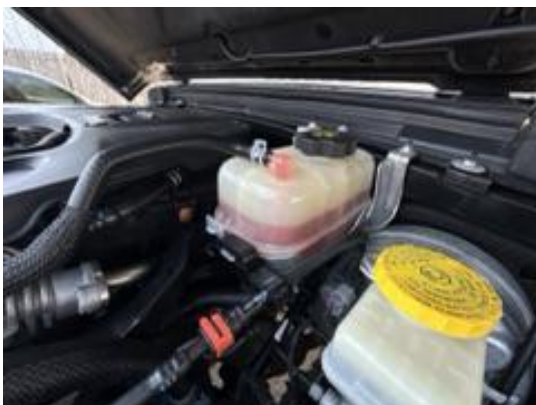
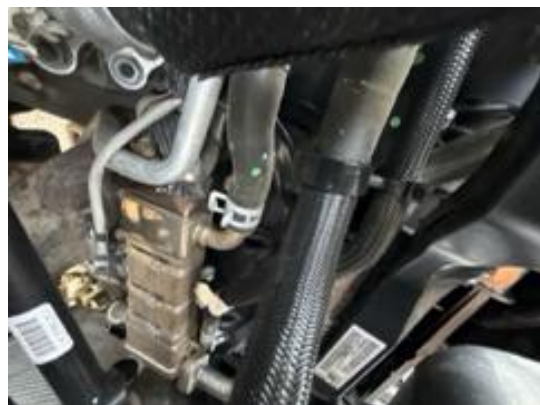
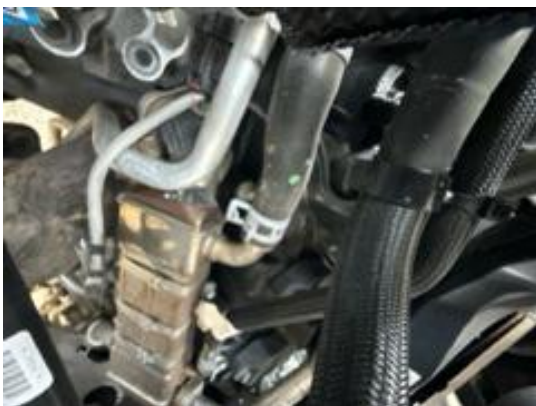
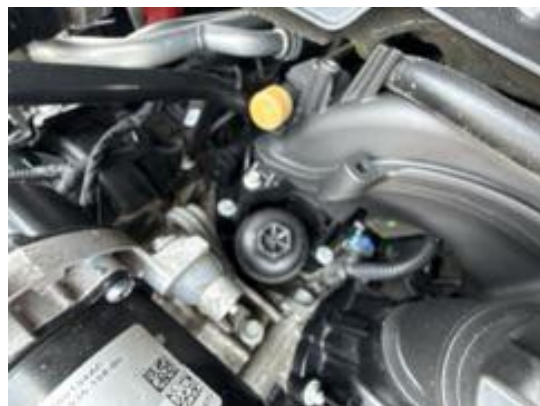
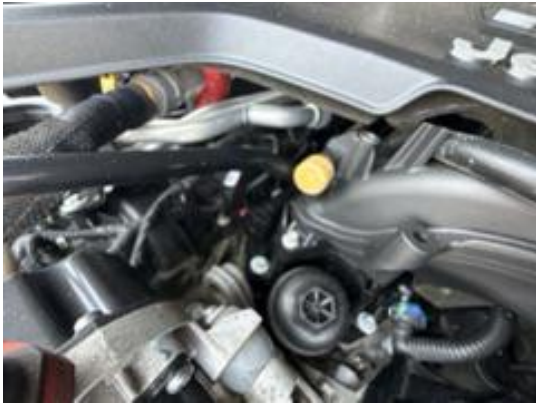
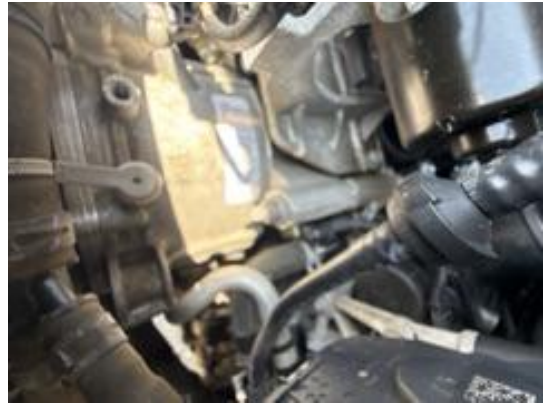
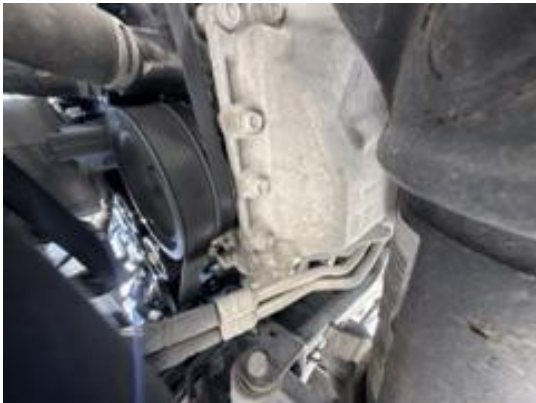
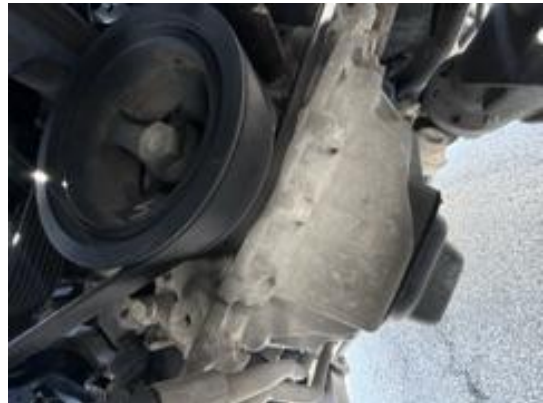
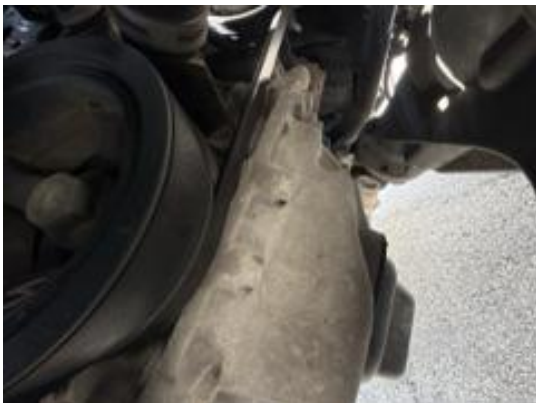
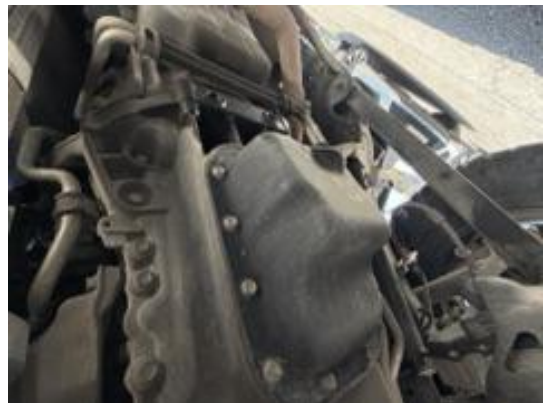
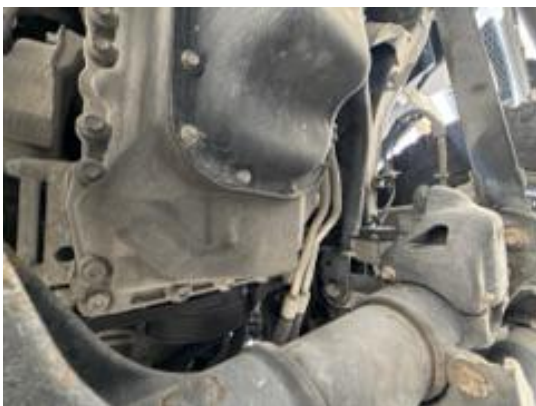
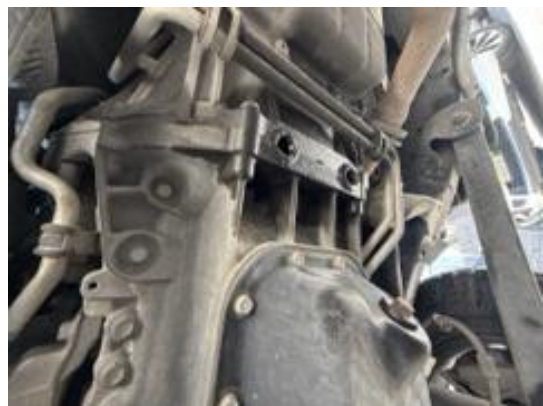
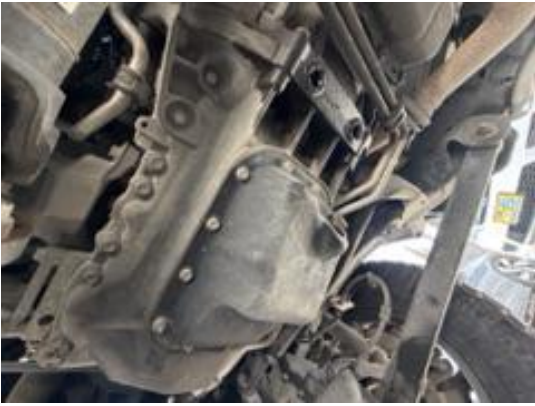
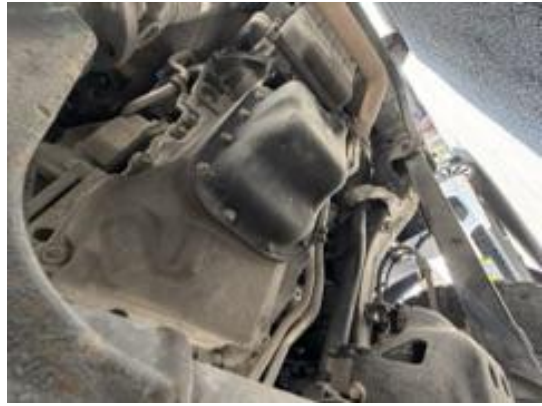
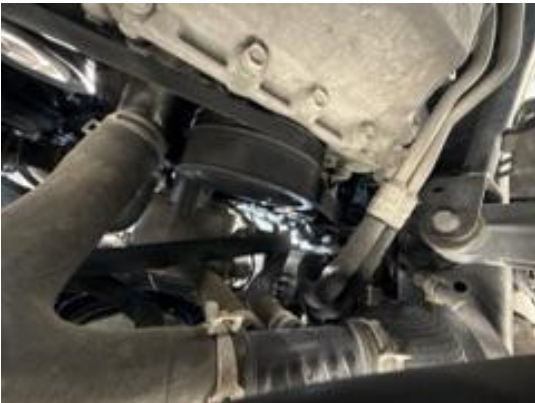
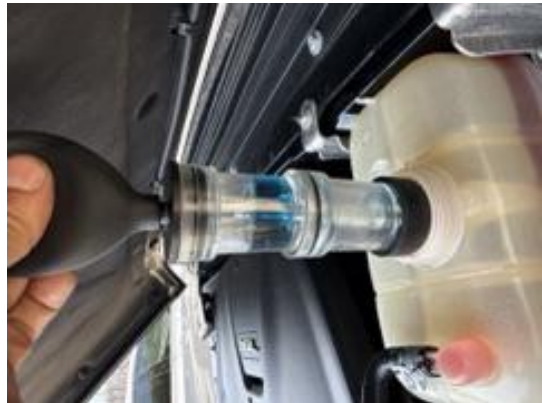
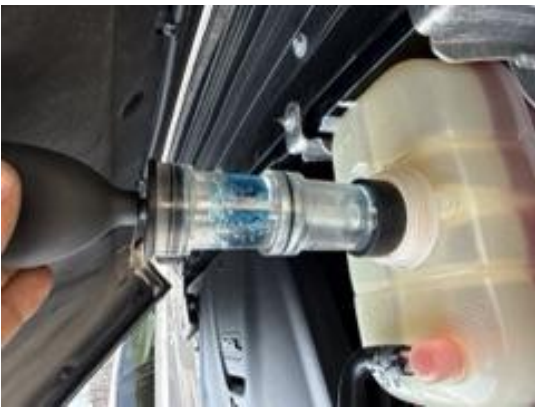
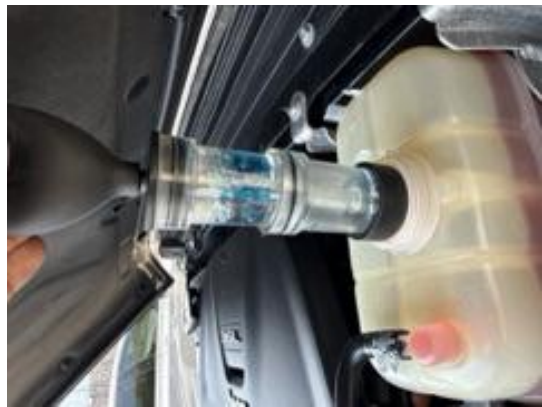
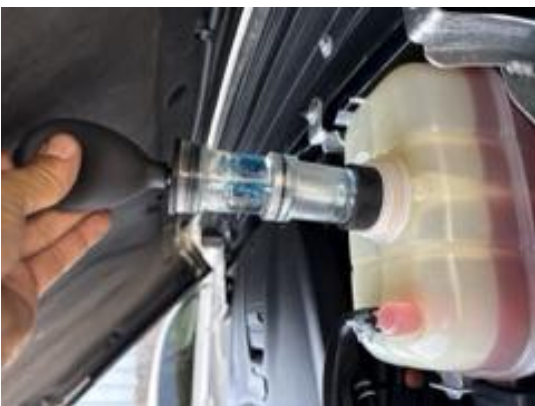
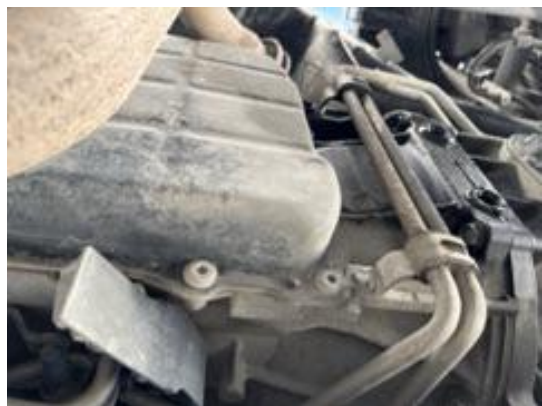
Engine clean internally, no gunk or sludge presents. Proper signs of maintenance present. Block test passed, no internal combustion leak out. Coolant mixture correct and cooling system functionality is healthy. All external engine accessories in good working. No leaks or seepage from anywhere on the engine. External drive belts in decent condition. Currently no concern in mechanical issues present in relation to the engine or related accessories.

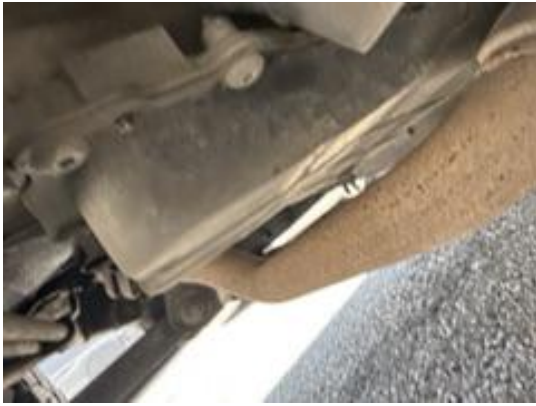
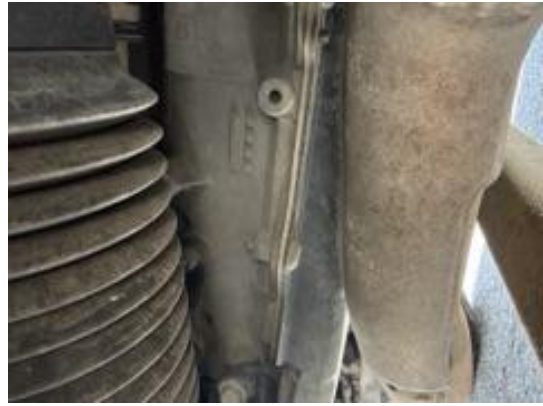
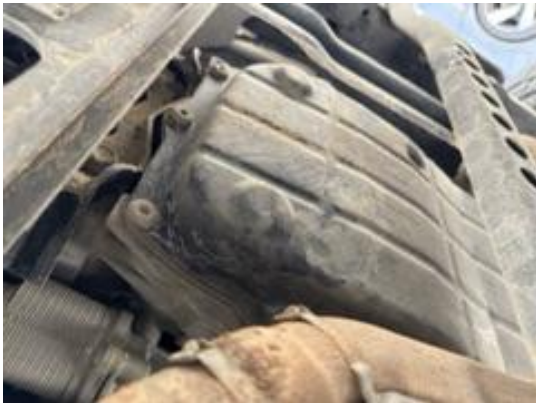
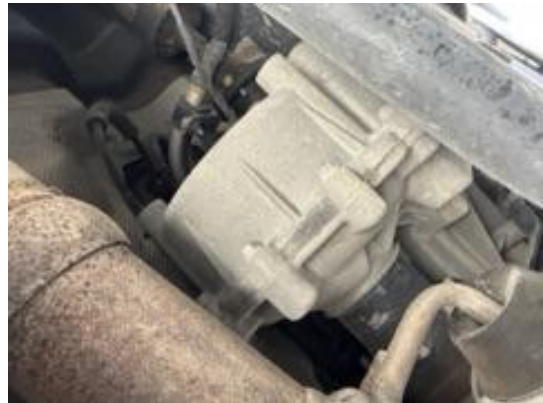
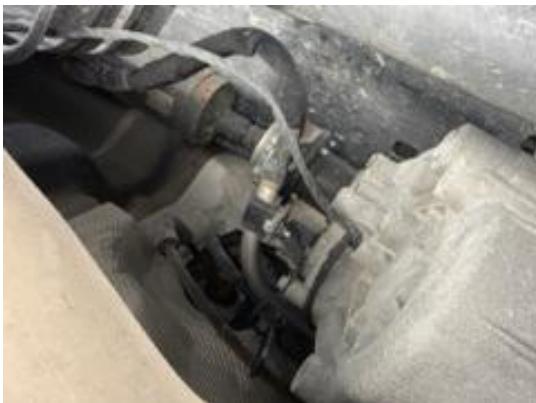
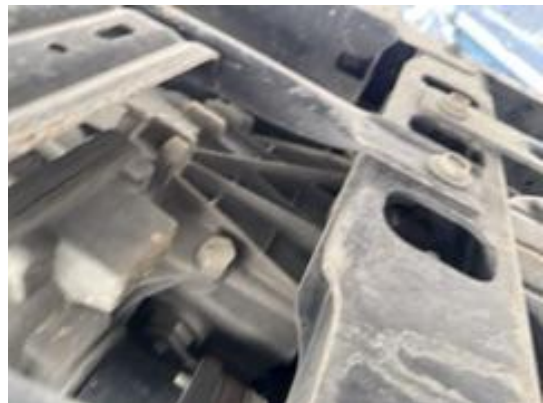
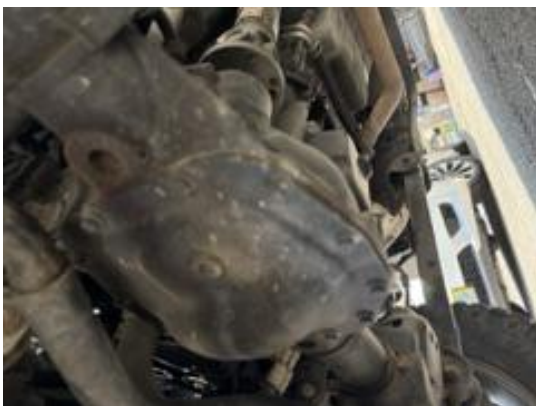
| Transmission / Differentials | | 0 / 0 (0%) |
|---|---|---|
| <p>No transmission fluid leaks from the transmission casing or the transmission pan area. The tail shaft seal is free of any fluid leaks. The driveshaft is in healthy condition. Shift transitions out on the road are correct across the board. No fluid leak out from the rear differential. 4 x 4 system functionality is correct.</p> | | |

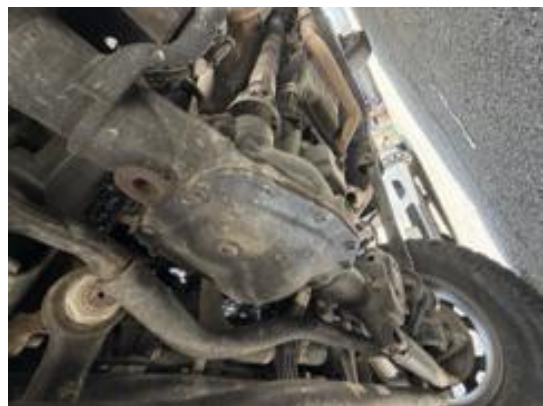
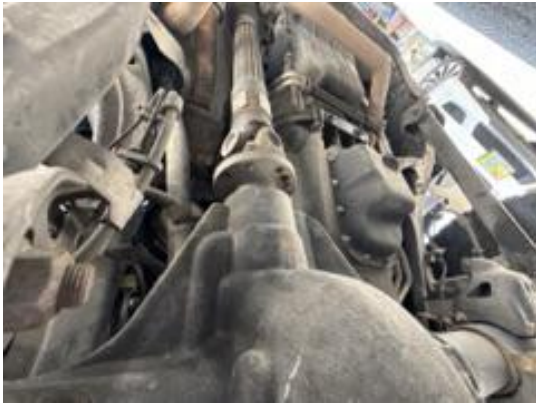
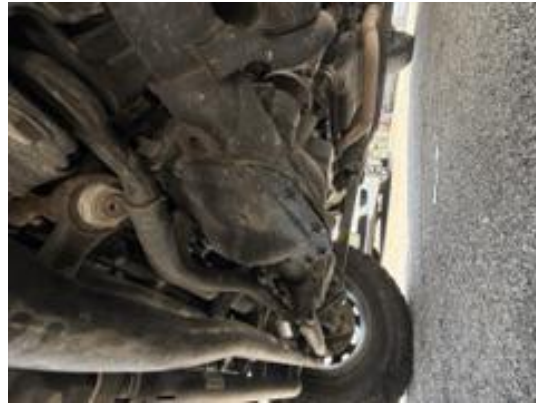
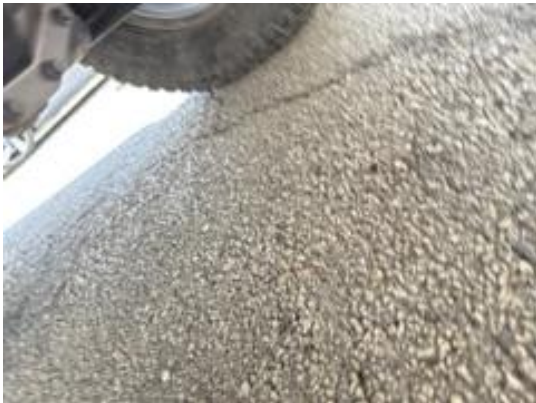
| Transmission / Differentials | | 0 / 0 (0%) |
|---|---|---|
| Front differential condition | | Healthy |

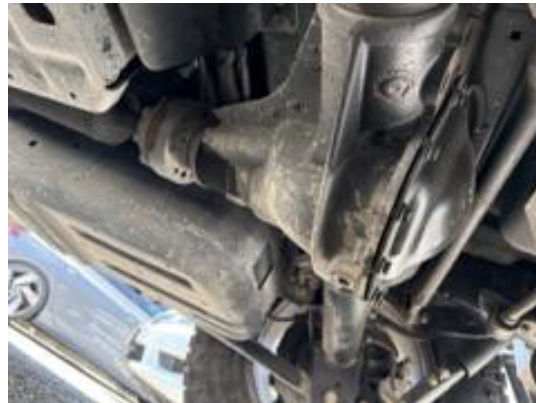
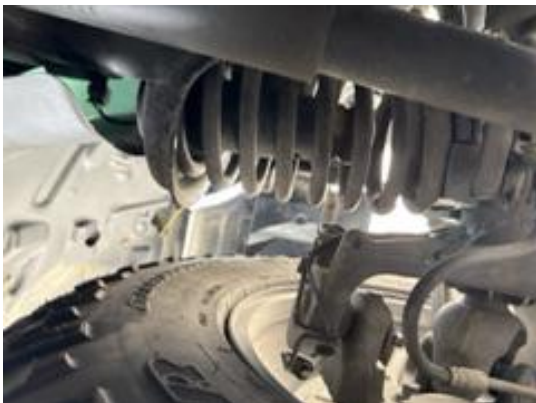
| Transmission / Differentials | | 0 / 0 (0%) |
|---|---|---|
| Center differential condition | | Healthy |
| Rear differential condition | | Healthy |

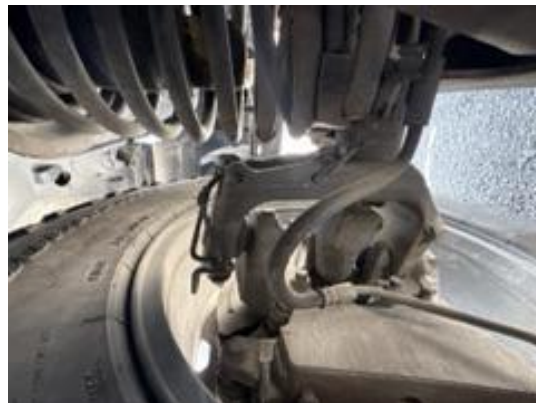
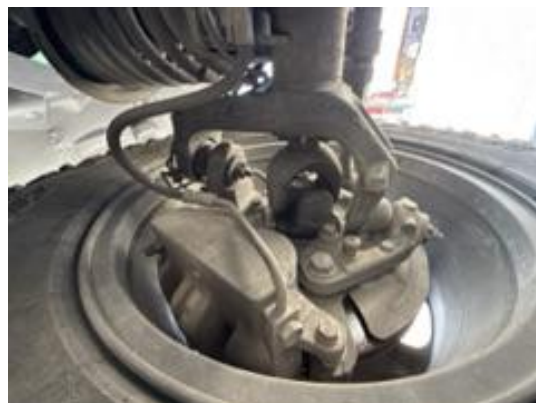
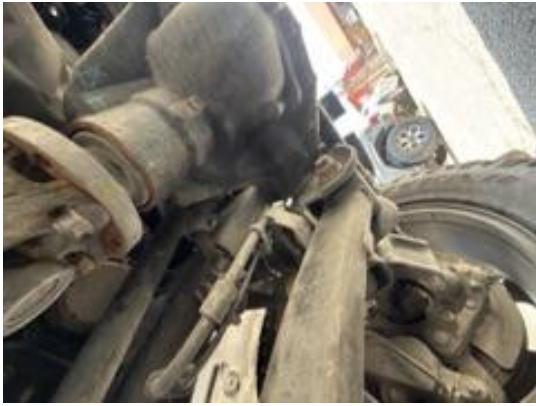
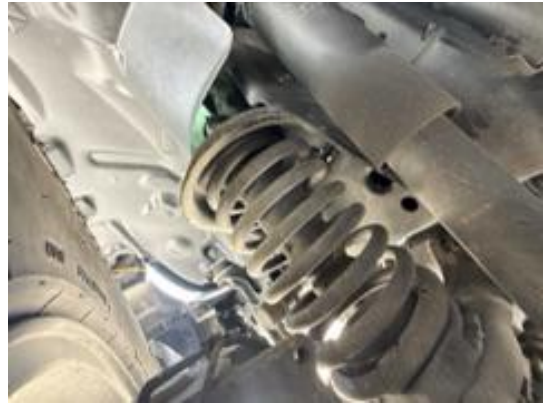
Normal fatigue notice to the suspension components. All of the suspension components seem to be original. None of the suspension components are blown out and due from the replacement. The No excessive surface rust on the exposed metal. No abnormal noise or feedback from the suspension while out on the road. All of the rubber in relation to the mounts, joints and bushings has decent texture.

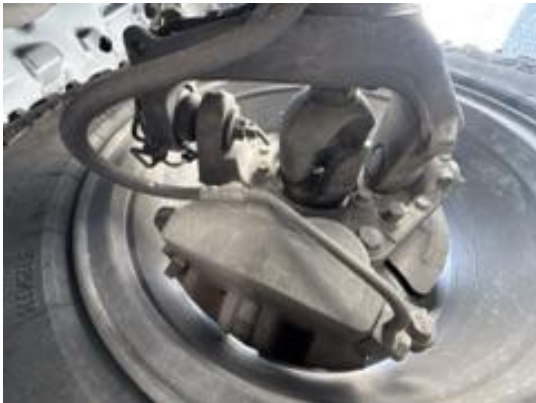
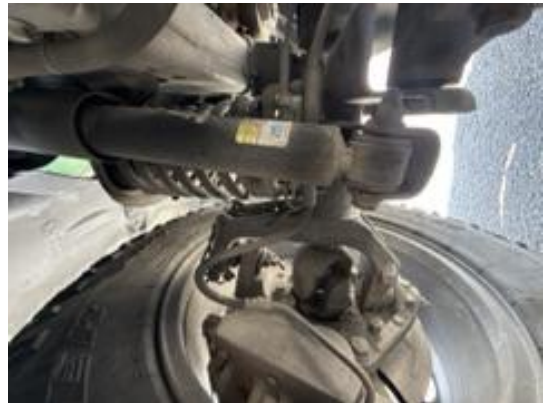
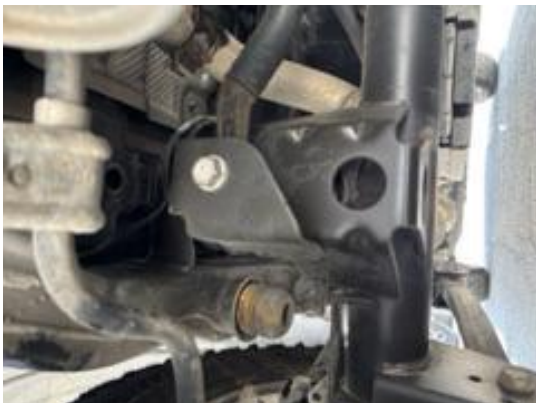
**Suspension condition**

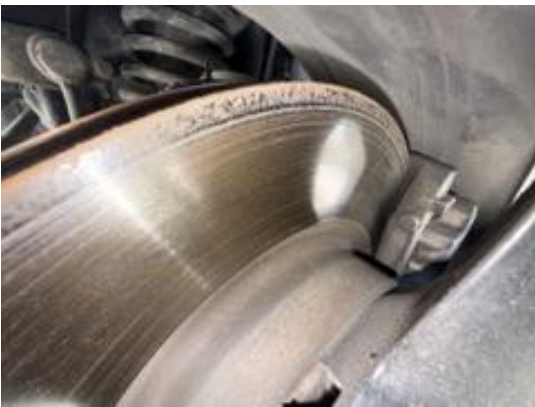
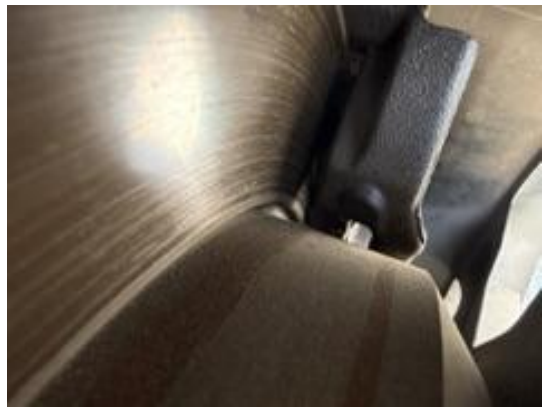
| <p>Right about 60% brake pad life remaining on the front brake system, right about 65% brake pad light remaining on the rear brake pad system</p> <div> </div> <div> <p>Photo 170</p> <p>Photo 171</p> </div> | |
