**Results of the Town of Holden Beach
2024 Pavement Condition Survey**

**Final Report
August 2024**

Right Angle Engineering
212 Princess Street
Wilmington, NC 28401
Phone (910) 251-8544
Fax (910) 251-2208

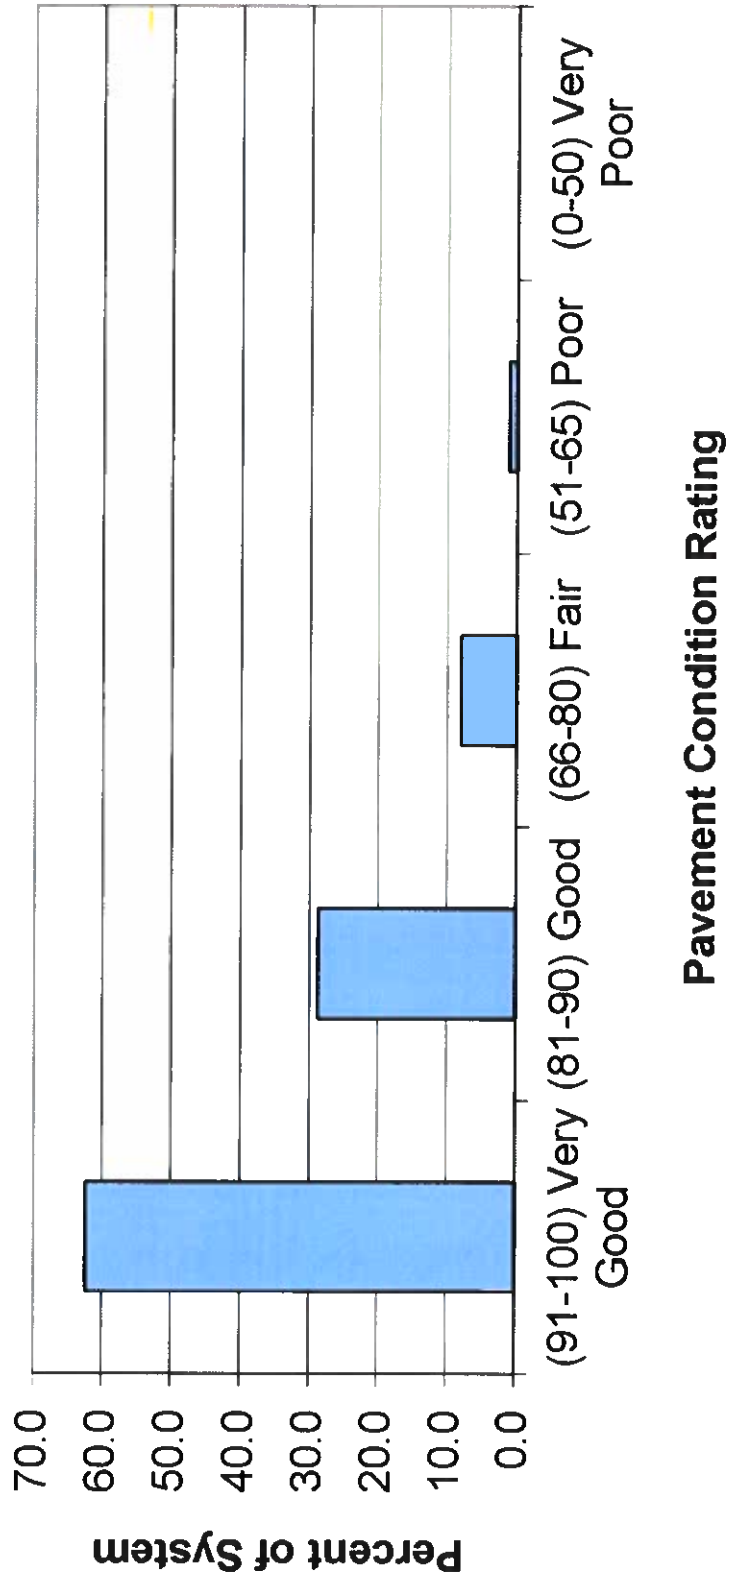
Figure 1 - General Condition of Total Asphalt Street System

The priority listing provided in Appendix C lists the streets from lowest to highest PCR value. This listing permits the engineering staff to easily visualize the critical streets within their street system. It also identifies critical street problems where engineering inspection and analysis is needed. The bar graph shown on the next page in Figure 1 illustrates the percentage of streets in the Town of Holden Beach that had PCR's within each severity category. The graph shows that approximately 91% of the streets were found to be in good or very good condition, while approximately 1% were noted to be in poor or very poor condition.

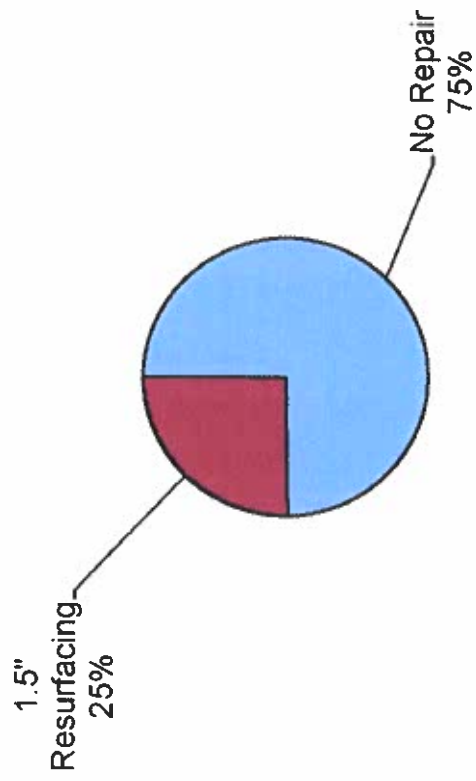
Town of Holden Beach, NC
Figure 2

Figure 2 on page 11 illustrates the amount of each maintenance activity as a percentage of the total street system mileage. Approximately 25% of the system is in need of resurfacing.

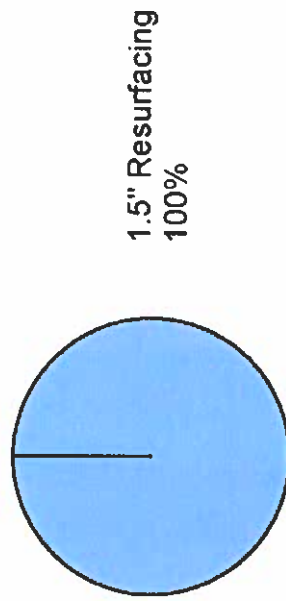
Town of Holden Beach, NC
Figure 3

Figure 3 on page 12 illustrates how the total cost is distributed among the various types of maintenance activities. Each of the streets in need of repair require asphalt resurfacing. However, asphalt patching may also be required on a street before it can be resurfaced. The cost of this patching is included in the resurfacing cost estimates.

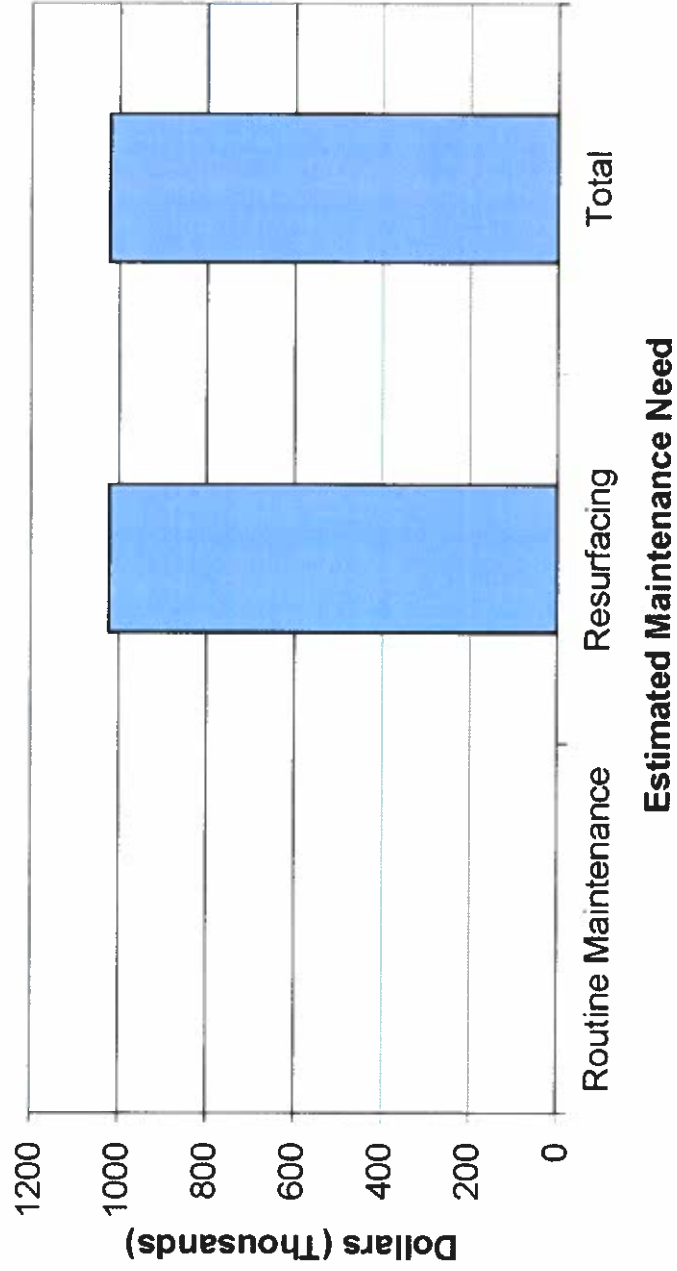
Figure 4 on page 13 shows a breakdown of total estimated maintenance cost by routine maintenance and resurfacing. Resurfacing accounts for approximately all of the total maintenance cost. Again, patching will be required on individual streets prior to resurfacing.
