Dam Owner Annual Inspection Form Earthen Dams

Dam Name: Lake Kayak Dam	
County: Snohomish	State Dam No. SN07-0199
Owner Name: Mountain View Park Community Club	
Owner Address: MVPCC PO Box 926 Duvall, WA 98019	Telephone No.: N/A E-mail address: info.mvpcc@gmail.com
Inspected by: Andy Quast, Kacie Ciske, Audrey Spence, Molly Graham, Doug Linman	
Inspection Date: October 2, 2022	Weather: Dry, Clear weather

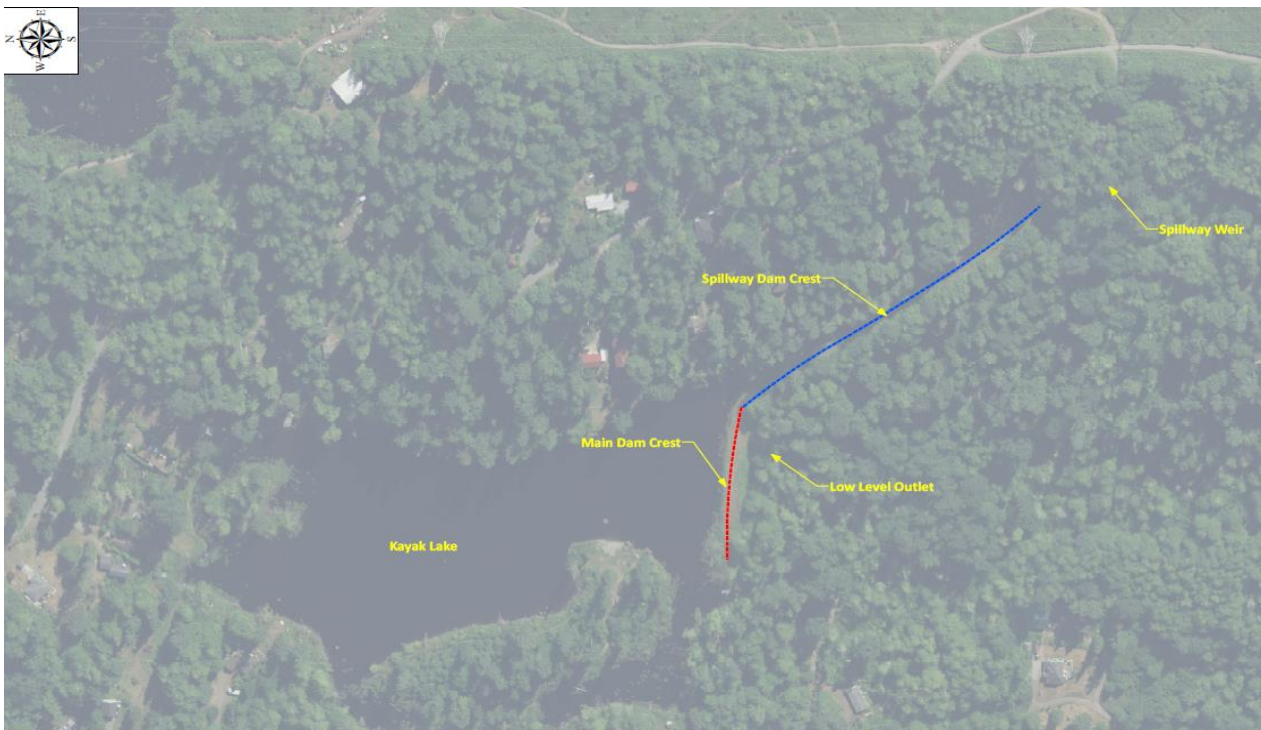
Drawing showing locations of hydraulic elements

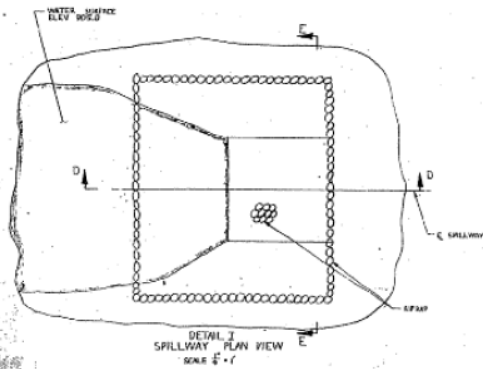
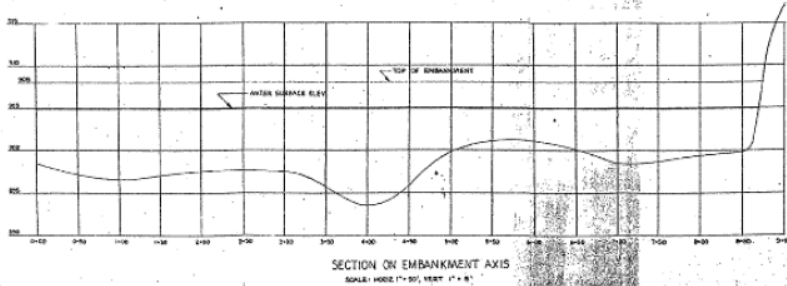
Drawing C-2

SPILLWAY DESIGN CRITERIA

1. $Q = 9.4$ CFS (DOWN FLOOD)
2. $H = 5.75$ TO 6.0 FT (6\"/>
