Montana Department of Transportation

Memorandum

To:	Bob Vosen, P.E. – Missoula District Administrator
From:	Stan Brelin II, P.E. – Traffic Operations Engineer SB
Date:	March 1, 2024
Subject:	Speed Limit Recommendation US 93 (N-5) - Lakeside

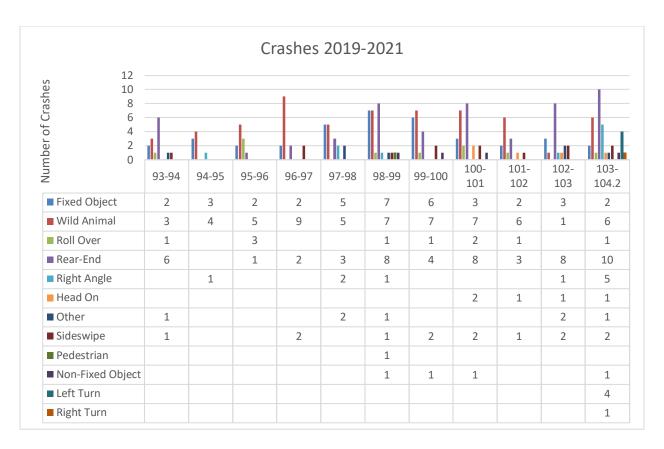
Crash history was reviewed for a three-year period from January 1, 2019 to December 31, 2021. A total of 205 crashes were reported along the 11-mile study segment – 13 suspected serious injury, 33 suspected minor injury, 12 possible injury, 144 no apparent injury, and 3 unknown injury crashes. A majority of the crashes were recorded from milepost 98 to milepost 99 (28 crashes) which includes some of Lakeside, milepost 100 to milepost 101 (25 crashes) between Lakeside and Somers, and in the last mile of the study (34 crashes) which includes the intersection with Montana 82. Wild animal crashes were the most common (60) followed by rear-ended crashes (53) and fixed-object crashes (37). There were also greater than 10 crashes considered roll-over, right-angle, and sideswipe. Of these 205 crashes, about a third occurred under adverse road conditions (ice/frost, snow, slush, wet). There were 55 crashes related to intersections or driveways. Based on officer narratives, the intersections with the highest number of recorded crashes were Montana 82 (11), Marco Bay (3), and Deer Creek (2). A total of 14 crashes throughout the study involved pedestrians.

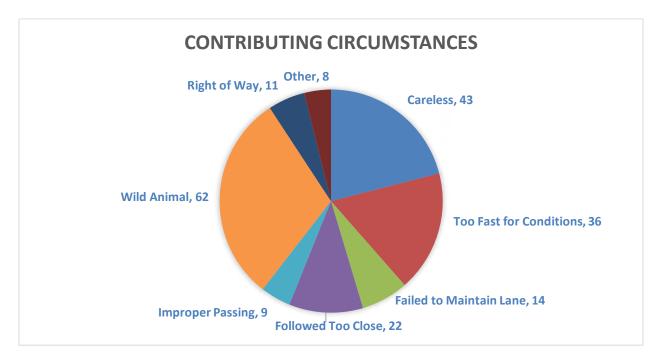
Speed played a role in at least 36 of the recorded crashes. The primary contributing circumstance was wild animals in the roadway (62) followed by careless driving (43). Of the 36 crashes where the contributing circumstance was driving too fast for conditions all but three occurred under adverse road conditions (ice/frost, snow, slush, wet). Other contributing circumstances of note include following too close (22), right-of way violations (11), and improper passing (9).

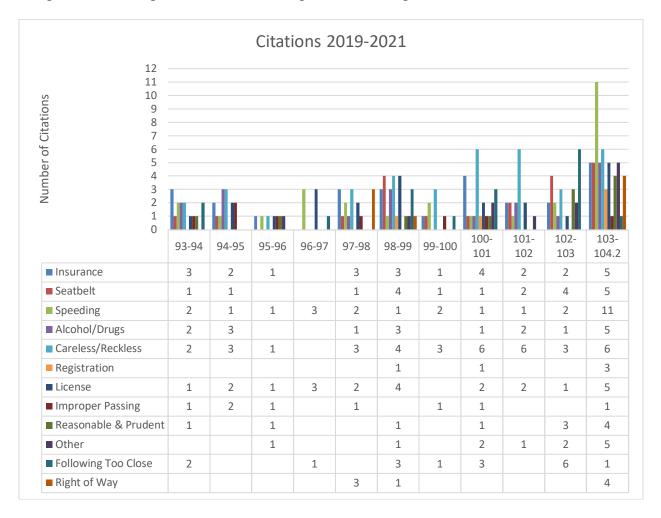
During the same period, the Montana Highway Patrol made 153 traffic stops and issued 212 citations. Thirteen percent (27 of 212) of the citations involved speeding throughout the study segment. Speeding citations were relatively evenly distributed throughout the study with about two occurring per mile except in approximately the last mile of the study where there were 11 speeding citations. On average speeding citations were written for about 13-mph above the posted speed limit. Speeding citations were about 1-mph to 2-mph higher on average in the 55-mph and 45-mph speed zones. Secondary offences make up about 35-percent of the citations. Excluding speeding citations and secondary offences the peak number of citations occurred in the last mile of the study (26) with elevated citations form milepost 98 to milepost 99 (13), milepost 100 to milepost 101 (14), and milepost 102 to milepost 103 (15).
