Test Report For:
SPIG Industries, LLC
SGET End Terminal

TESTED TO:
Manual for Assessing Safety Hardware (MASH 2016)
Test 3-31

TEST REPORT NUMBER:
TR-P38108-01-NC

16. Abstract One (1) Test Level 3, Test 31 (3-31) was performed on the subject SPIG Industries, LLC SGET end terminal. The terminal was impacted by a 2012 RAM 1500 4-door pickup truck. Testing was conducted by KARCO Engineering, LLC. in Adelanto, CA on June 8, 2018. The test vehicle impacted the SGET end terminal at a velocity of 62.53 mph (100.63 km/h) and an impact angle of 0.6°. The vehicle forced the impact head down the rail and allowed the vehicle to exit to the traffic side. The system brought the vehicle to a stop in a controlled manner. The system was damaged from post 1 through post 7. The test vehicle sustained damage to its front end and passenger side. The front bumper and frame rails were damaged. The passenger front wheel broke off the vehicle. The occupant compartment was not penetrated and the deformation limits were not exceeded. The SPIG Industries, LLC SGET met all the requirements for MASH 2016 Test 3-31.

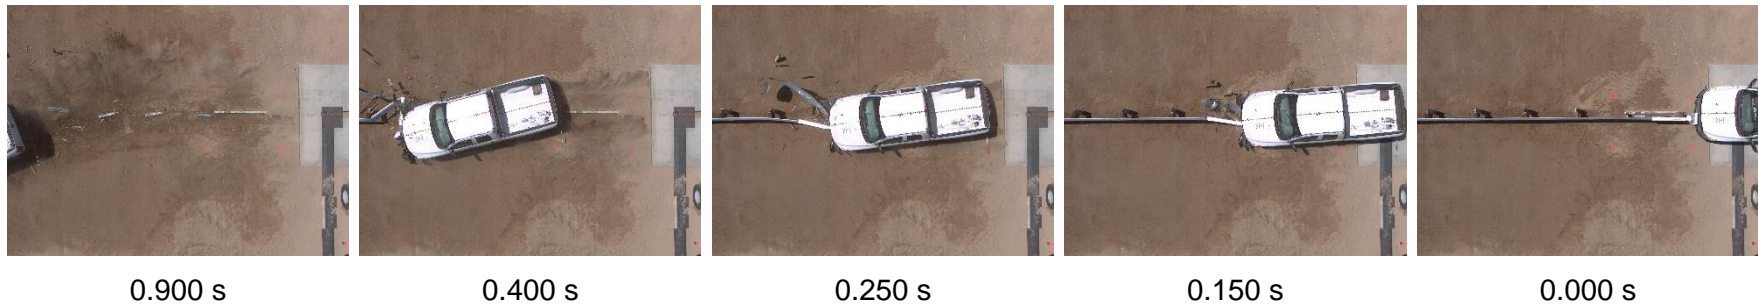
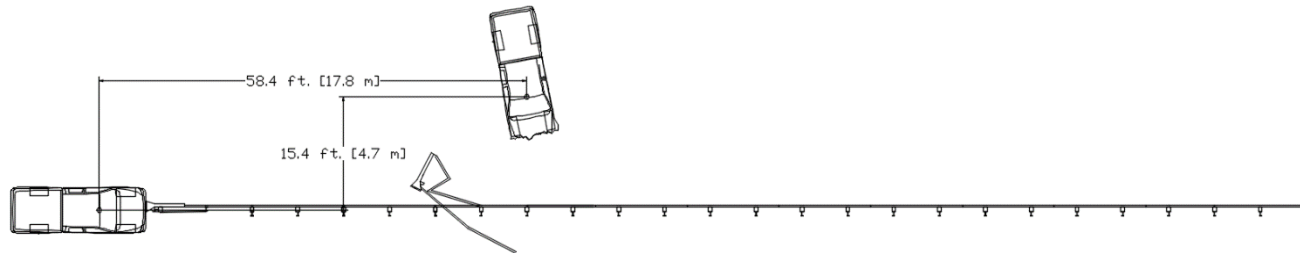
Figure 2 Summary of Test 3-31

MASH 2016 Test 3-31 Summary

GENERAL INFORMATION	
Test Agency.....	KARCO Engineering, LLC.
KARCO Test No.....	P38108-01
Test Designation.....	3-31
Test Date.....	6/8/18
TEST ARTICLE	
Name / Model.....	SGET End Terminal
Type.....	End Terminal
Installation Length.....	156.3 ft. (47.6 m)
Terminal Length.....	50.0 ft. (15.2 m)
Road Surface.....	Medium to Fine Silty Soil
TEST VEHICLE	
Type / Designation.....	2270P
Year, Make, and Model....	2012 RAM 1500
Curb Mass.....	5,080.5 lbs (2,304.5 kg)
Test Inertial Mass.....	4,989.0 lbs (2,263.0 kg)
Gross Static Mass.....	4,989.0 lbs (2,263.0 kg)

Impact Conditions	
Impact Velocity.....	62.53 mph (100.63 km/h)
Impact Angle.....	0.6°
Location / Orientation.....	1.2 in. (30 mm) right of terminal CL
Kinetic Energy.....	652.1 kip-ft (884.1 kJ)
Exit Conditions	
Exit Velocity.....	N/A
Exit Angle.....	N/A
Final Vehicle Position.....	58.4 ft. (17.8 m) Downstream 15.4 ft. (4.7 m) Left
Exit Box Criteria Met.....	N/A
Vehicle Snagging.....	None
Vehicle Pocketing.....	None
Vehicle Stability.....	Satisfactory
Maximum Roll Angle.....	12.0 °
Maximum Pitch Angle.....	-6.4 °
Maximum Yaw Angle.....	-29.6 °

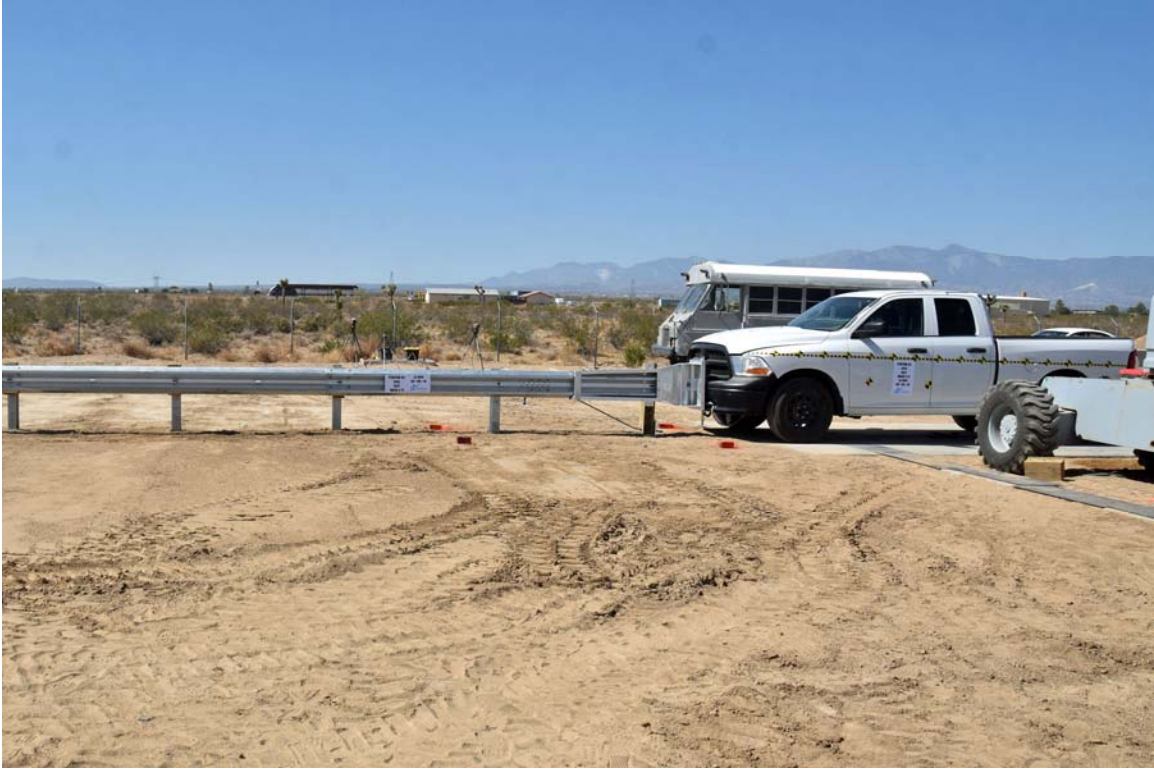
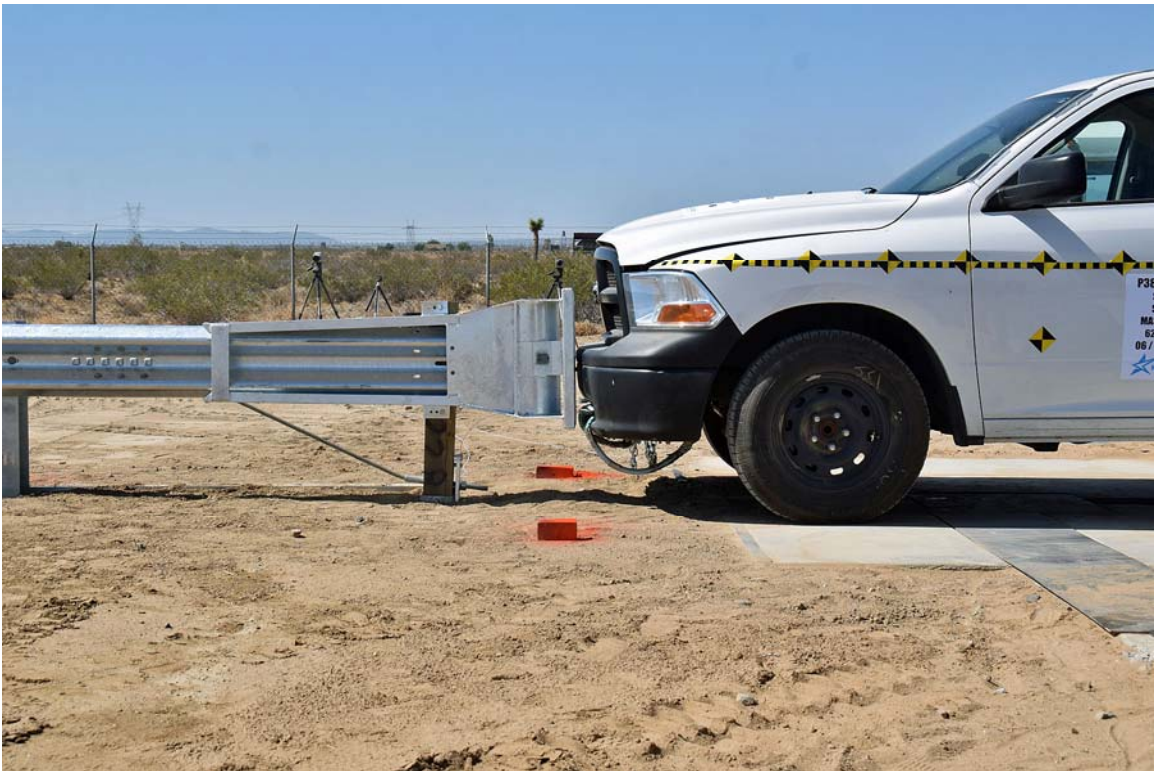
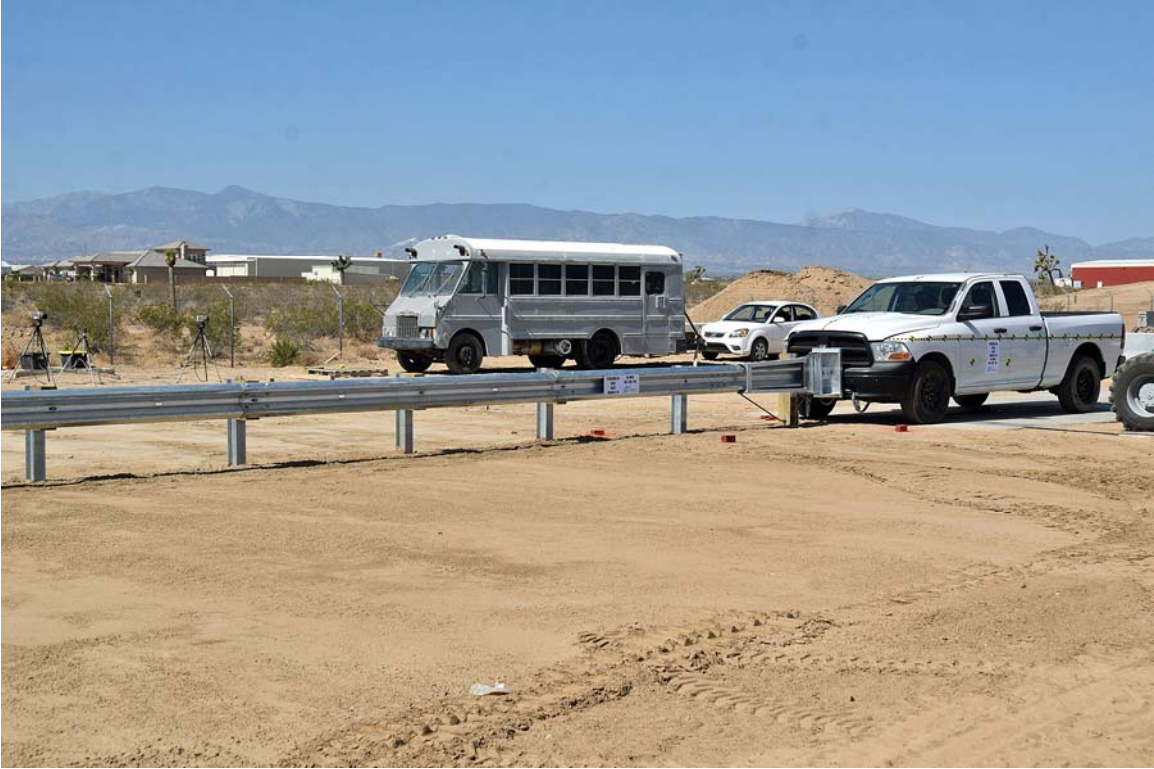
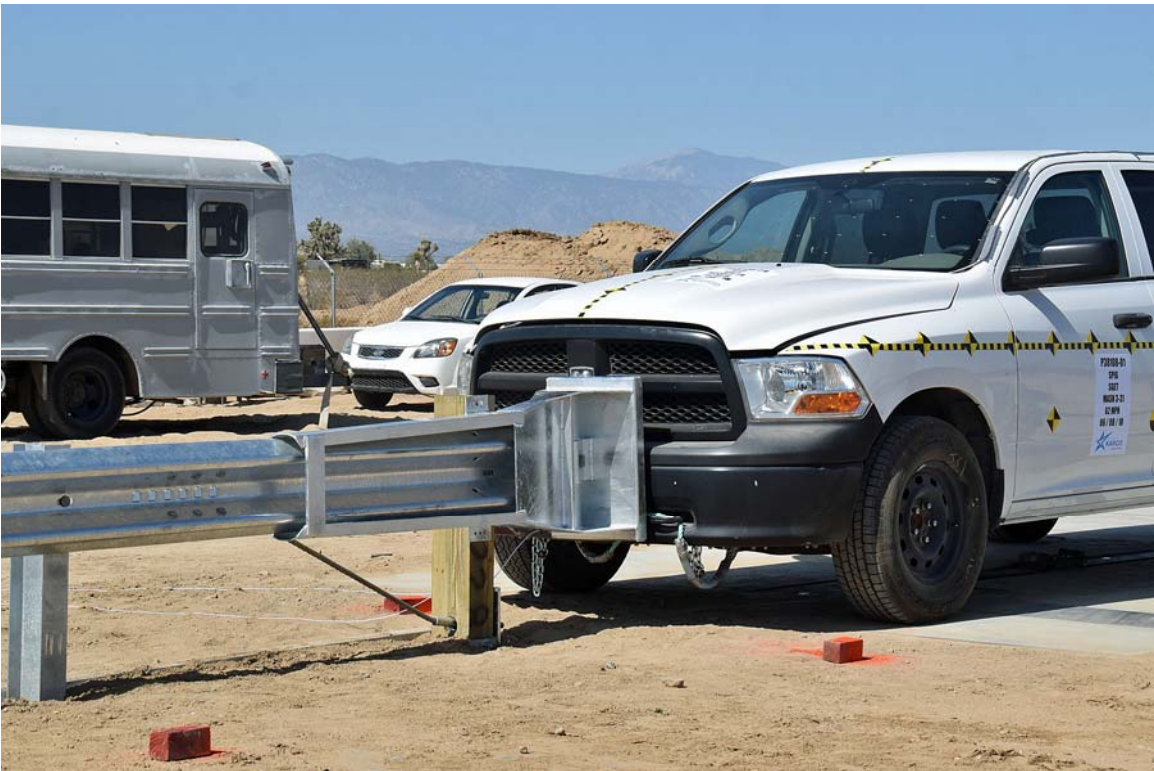
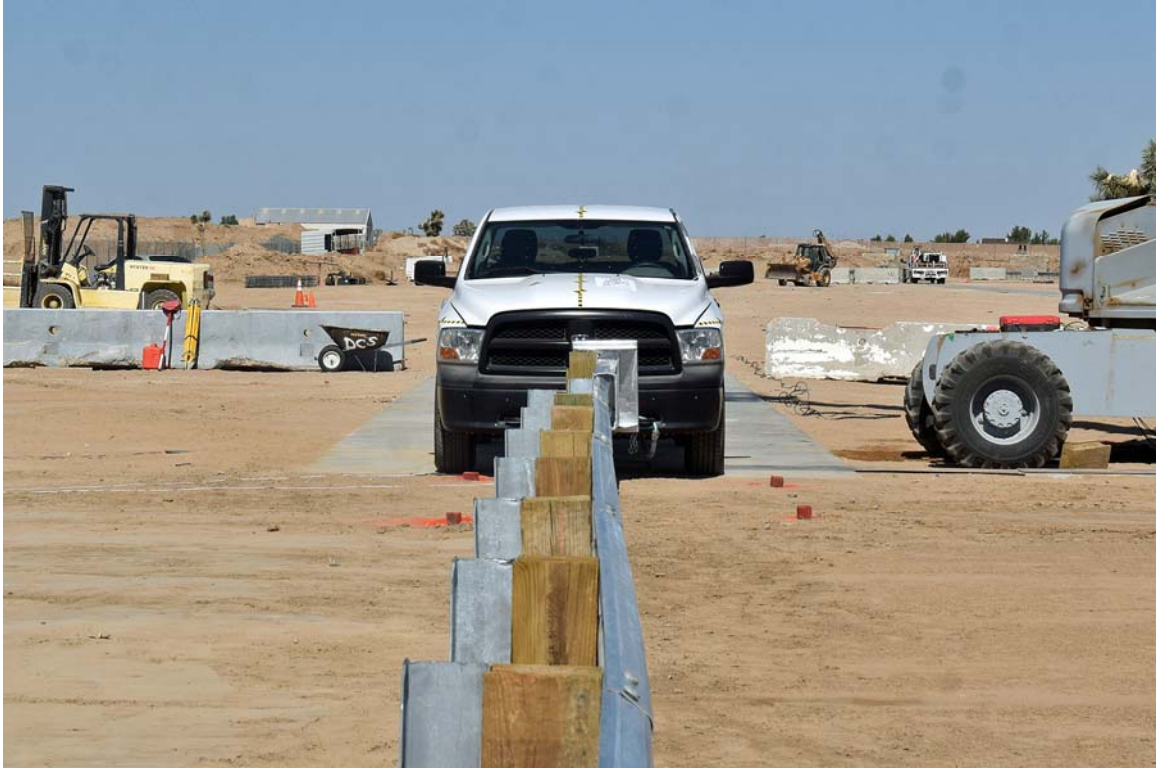
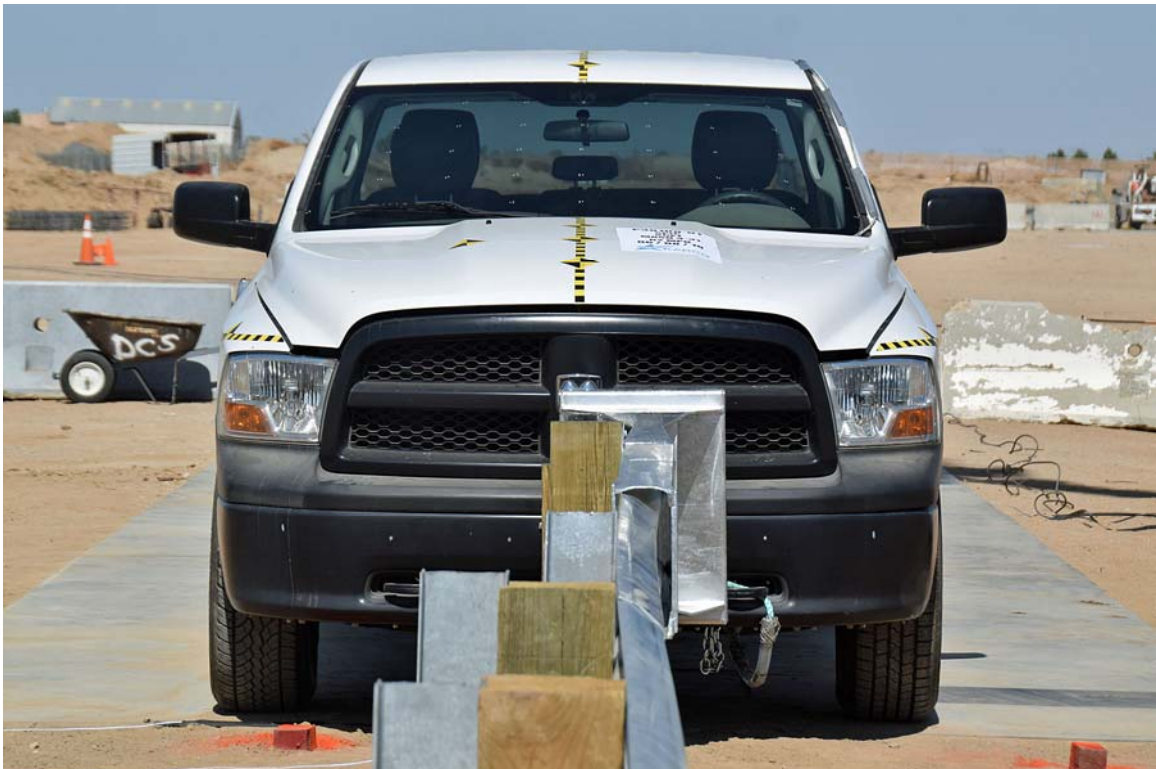
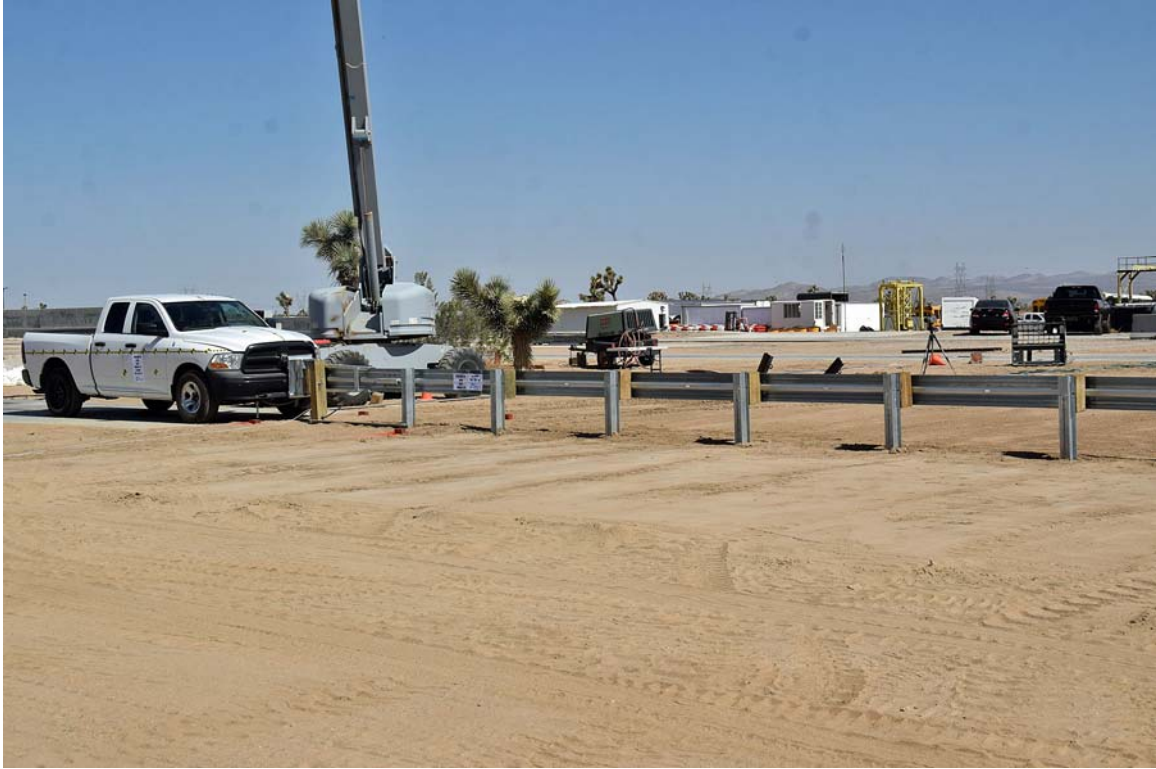
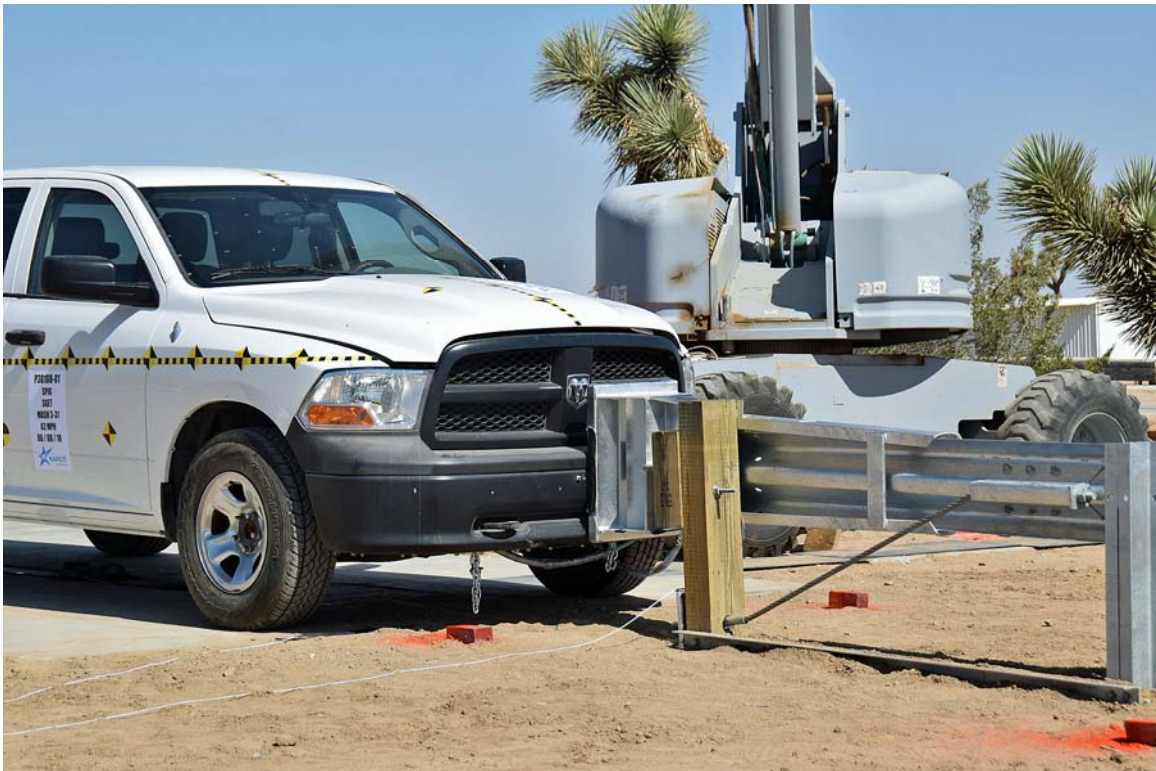
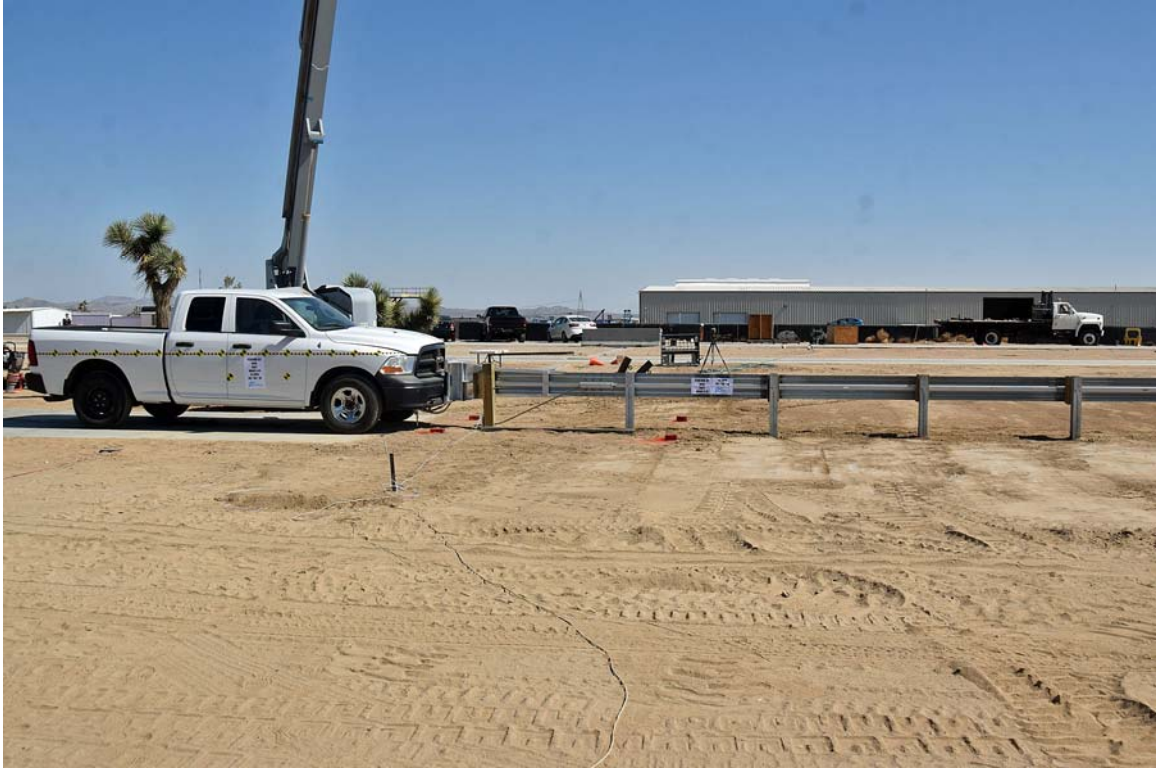
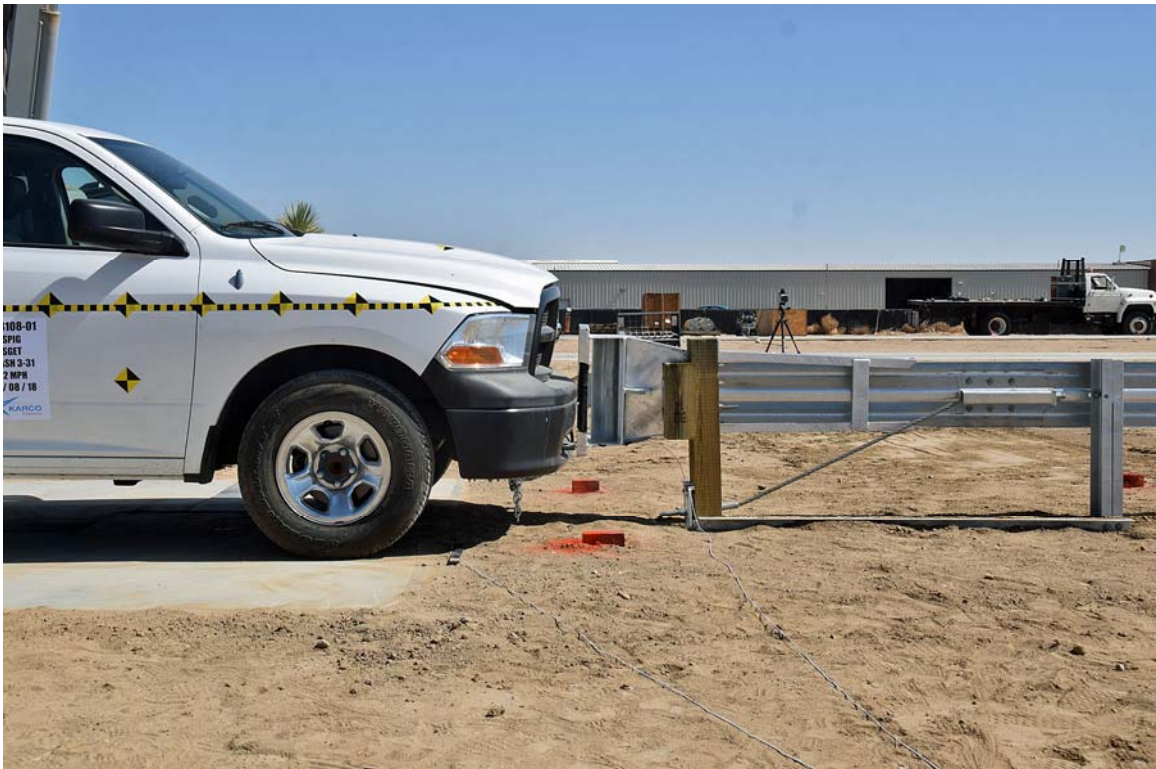
FIGURE 1. Test Setup

FIGURE 2. Test Setup, Close-Up

FIGURE 3. Test Setup

FIGURE 4. Test Setup, Close-Up

FIGURE 5. Test Setup

FIGURE 6. Test Setup, Close-Up

FIGURE 7. Test Setup

FIGURE 8. Test Setup, Close-Up

FIGURE 9. Test Setup

FIGURE 10. Test Setup, Close-Up

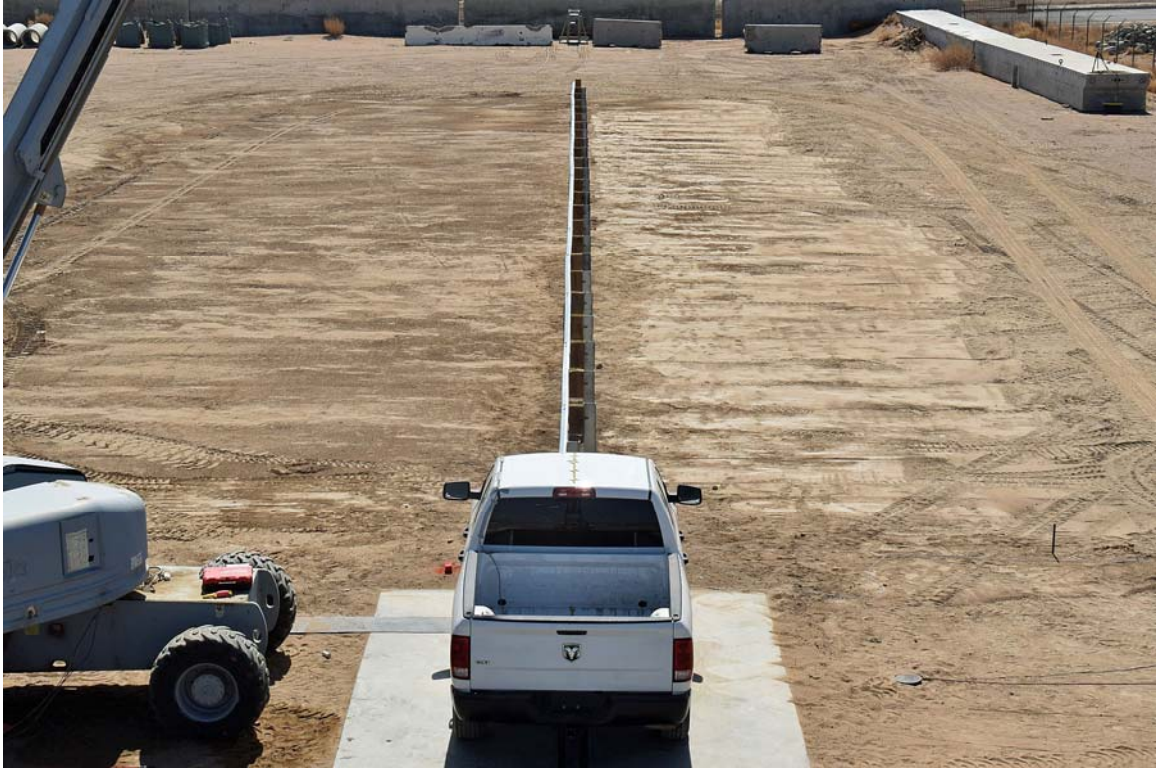
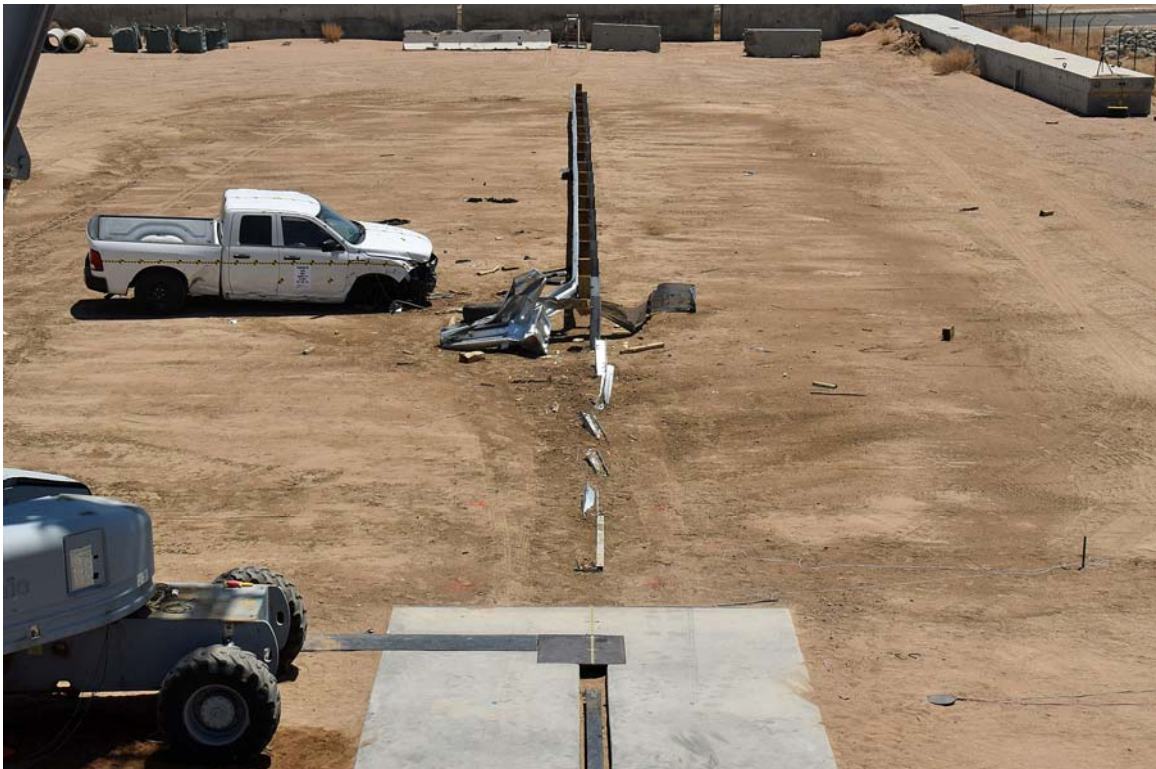
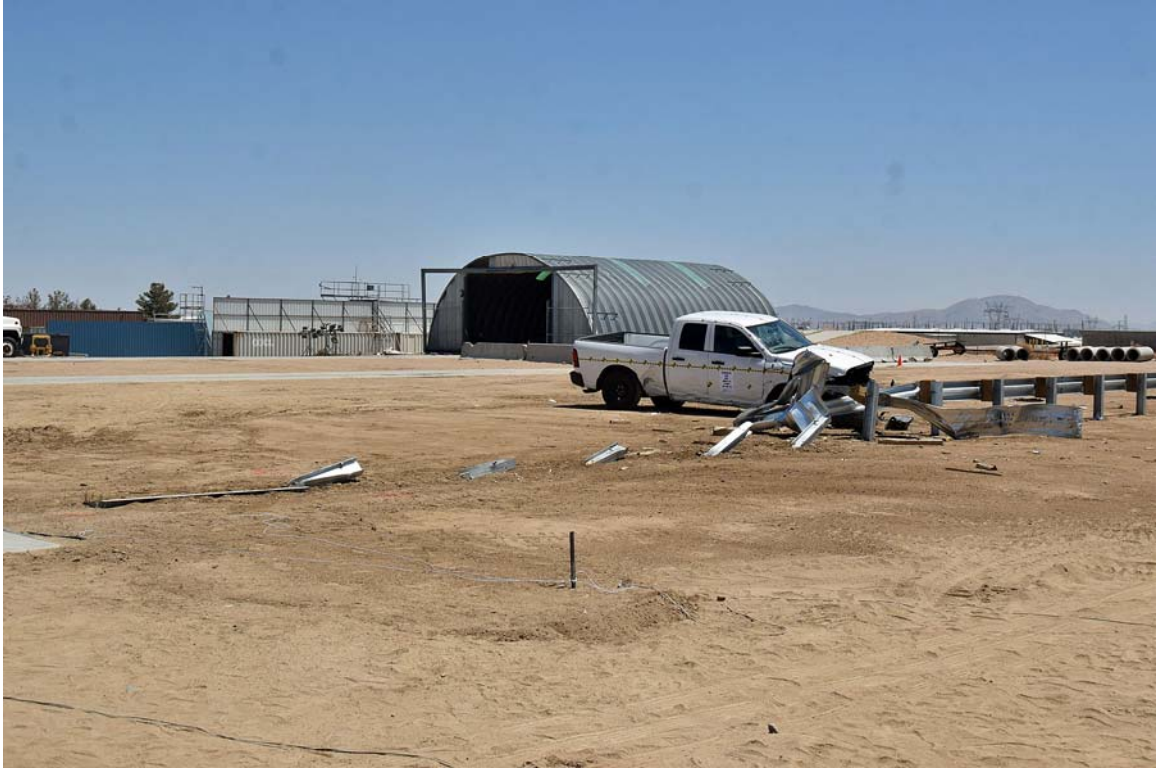
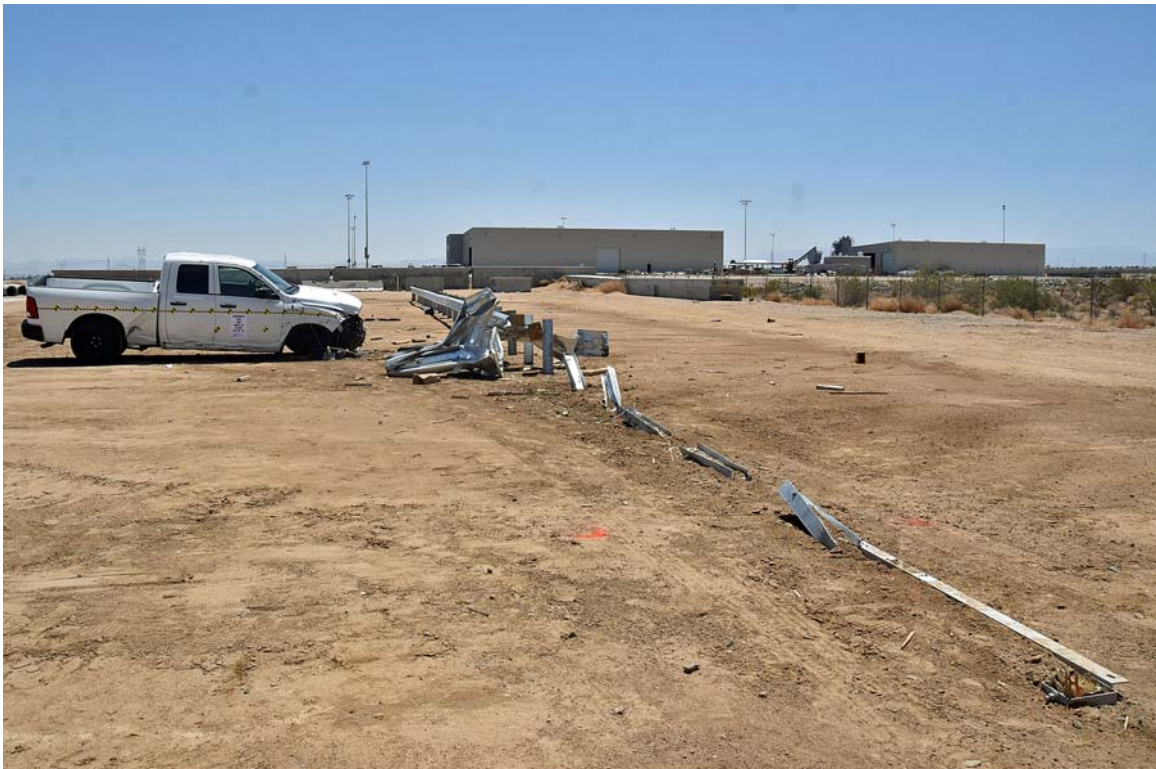
FIGURE 11. Pre-Test

FIGURE 12. Post-Test

FIGURE 13. Post-Test

FIGURE 14. Post-Test
