Test Report For:
SPIG Industries, LLC
SGET End Terminal

TESTED TO:
Manual for Assessing Safety Hardware (MASH 2016)
Test 3-31

TEST REPORT NUMBER:
TR-P38108-01-NC

16. Abstract One (1) Test Level 3, Test 31 (3-31) was performed on the subject SPIG Industries, LLC SGET end terminal. The terminal was impacted by a 2012 RAM 1500 4-door pickup truck. Testing was conducted by KARCO Engineering, LLC. in Adelanto, CA on June 8, 2018. The test vehicle impacted the SGET end terminal at a velocity of 62.53 mph (100.63 km/h) and an impact angle of 0.6°. The vehicle forced the impact head down the rail and allowed the vehicle to exit to the traffic side. The system brought the vehicle to a stop in a controlled manner. The system was damaged from post 1 through post 7. The test vehicle sustained damage to its front end and passenger side. The front bumper and frame rails were damaged. The passenger front wheel broke off the vehicle. The occupant compartment was not penetrated and the deformation limits were not exceeded. The SPIG Industries, LLC SGET met all the requirements for MASH 2016 Test 3-31.

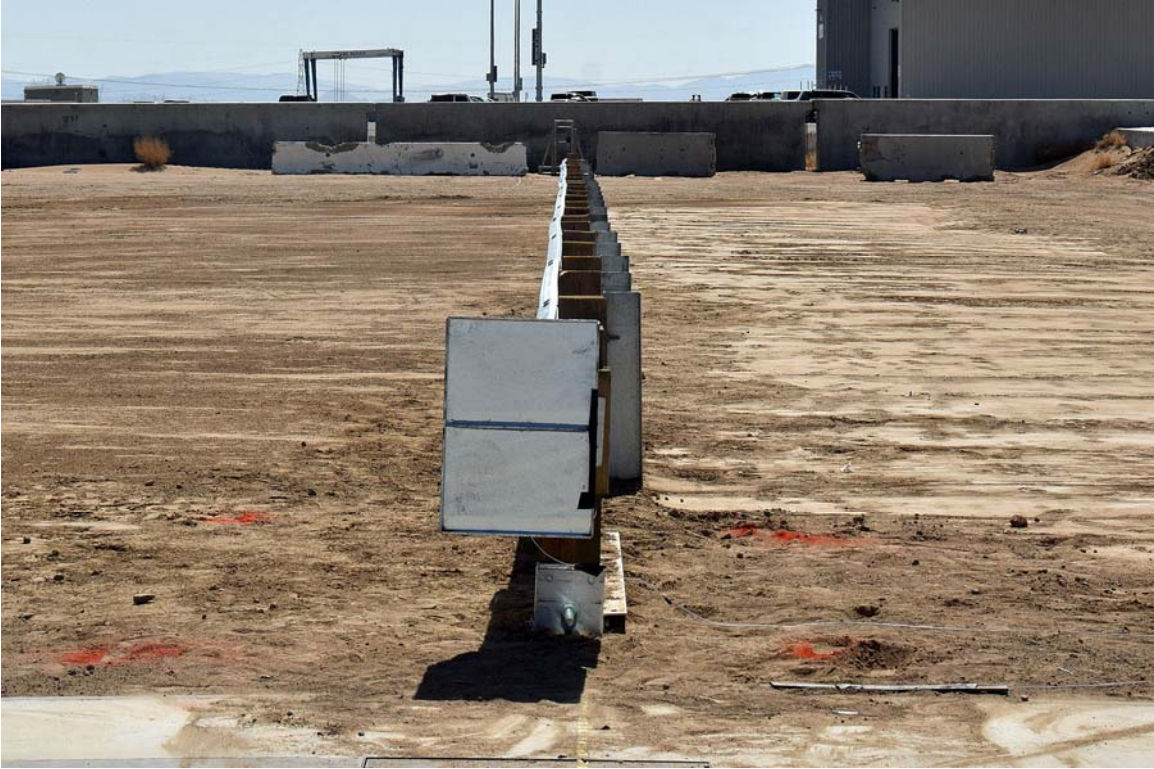
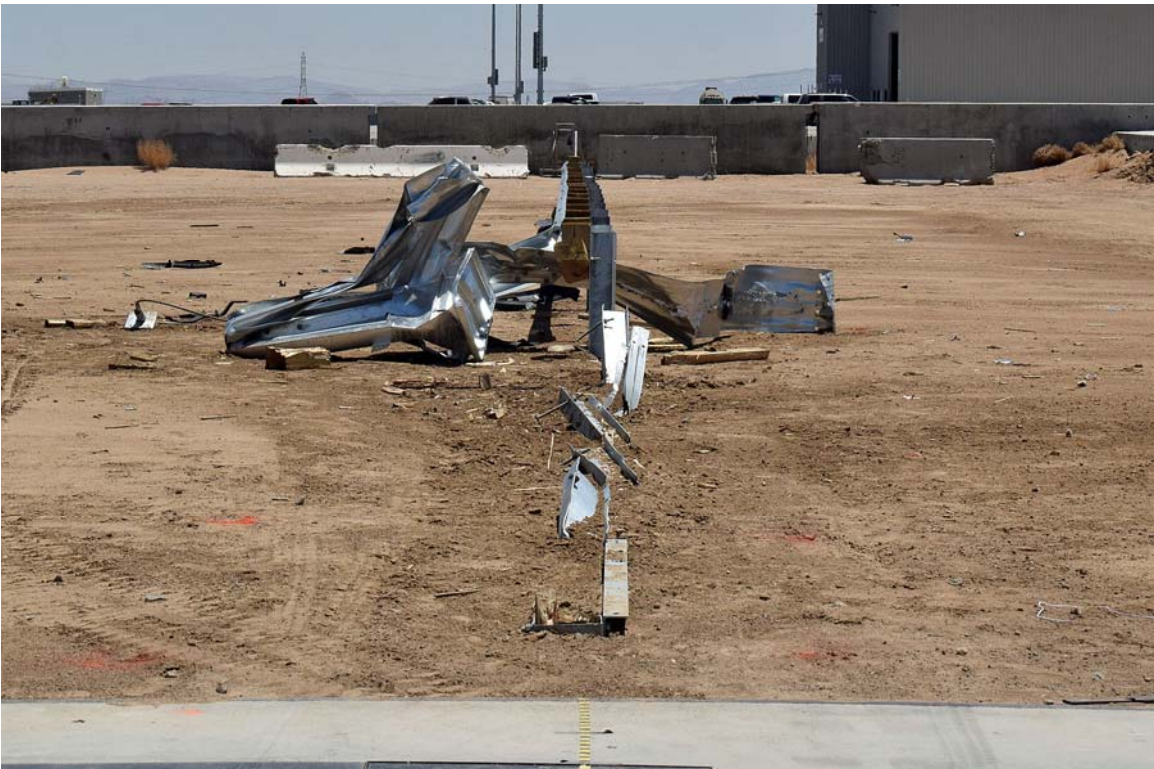
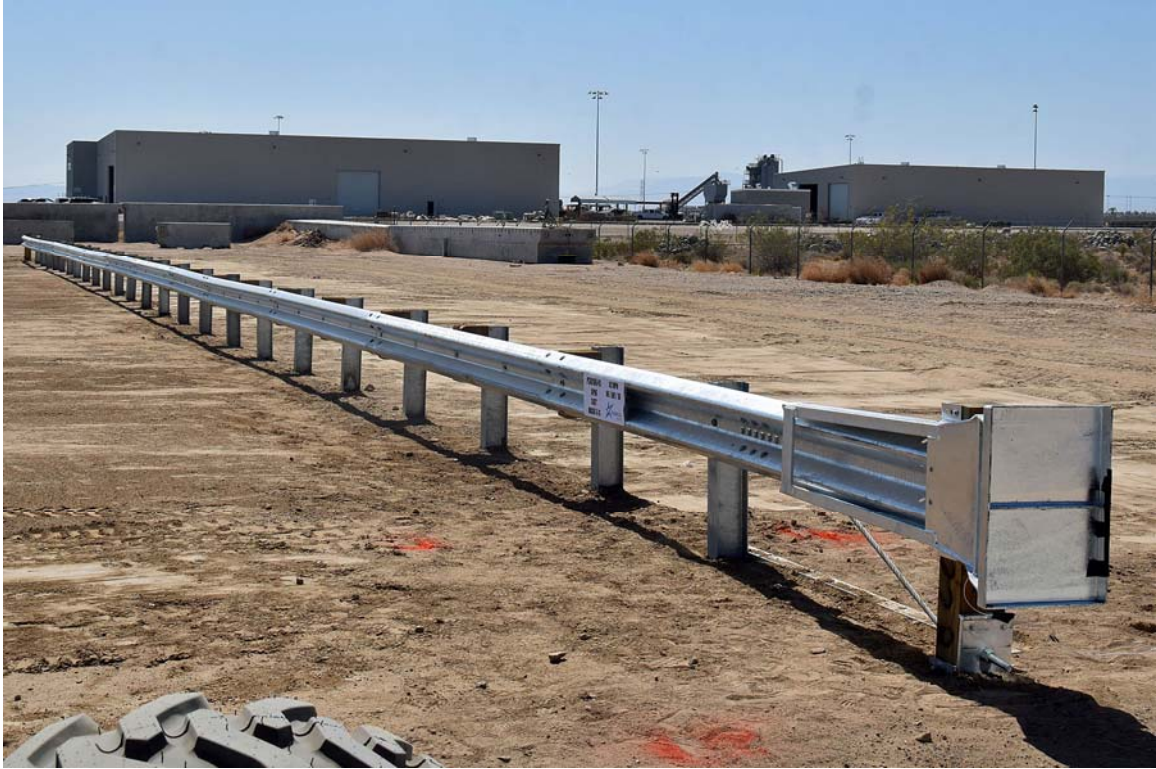
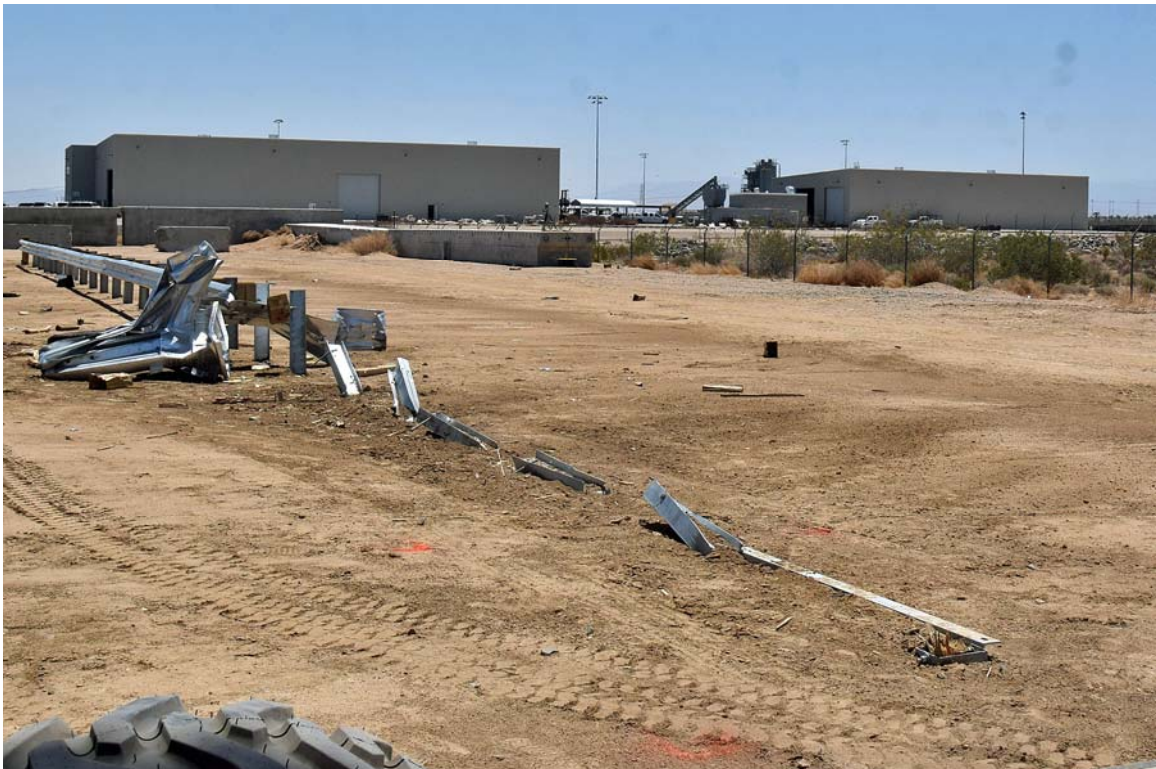
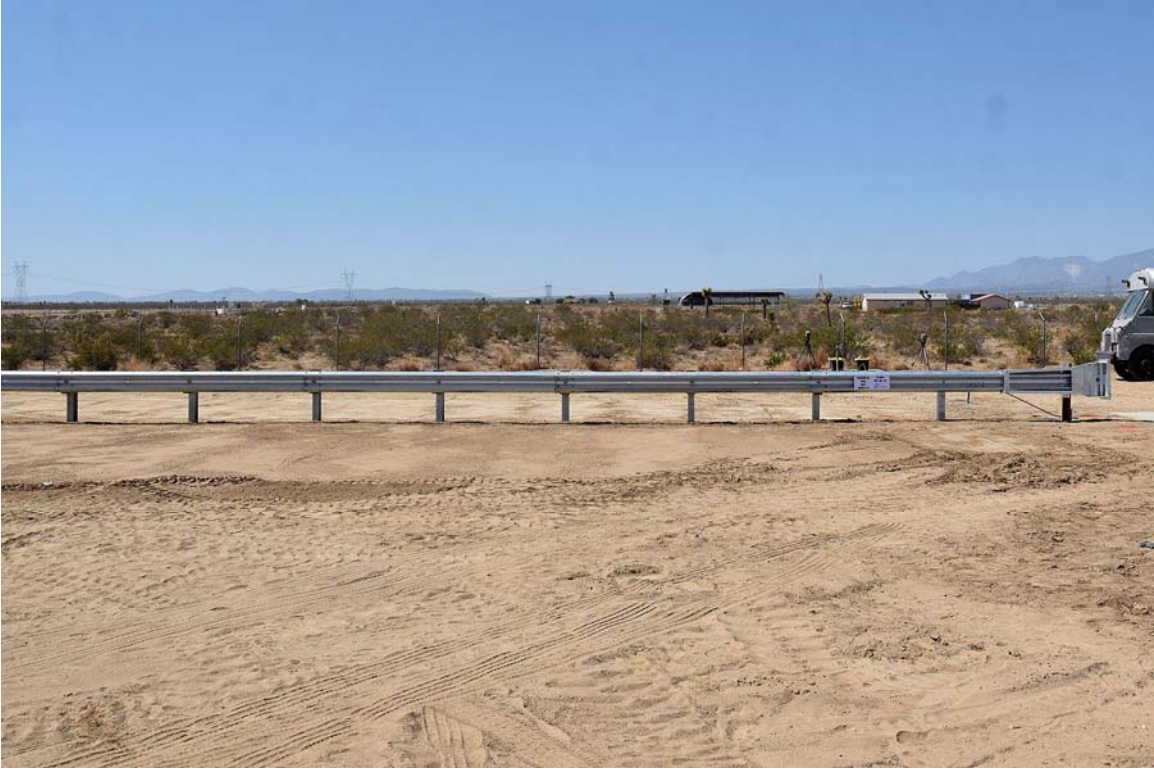
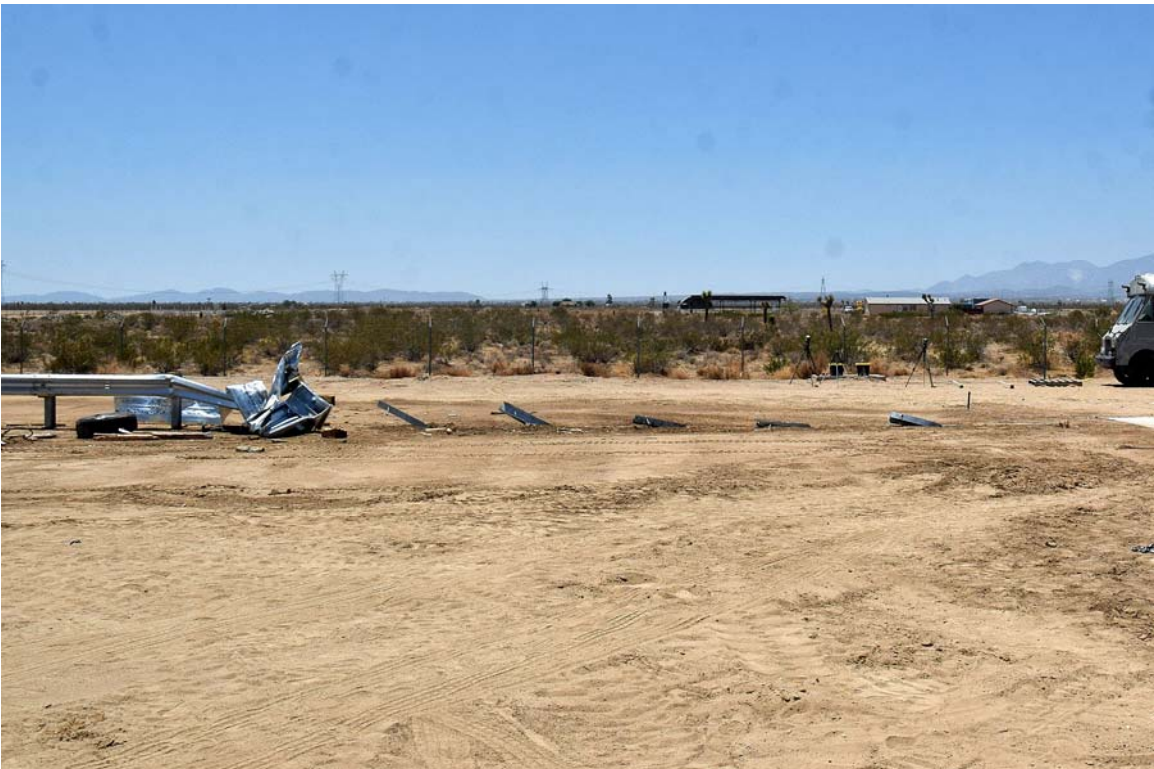
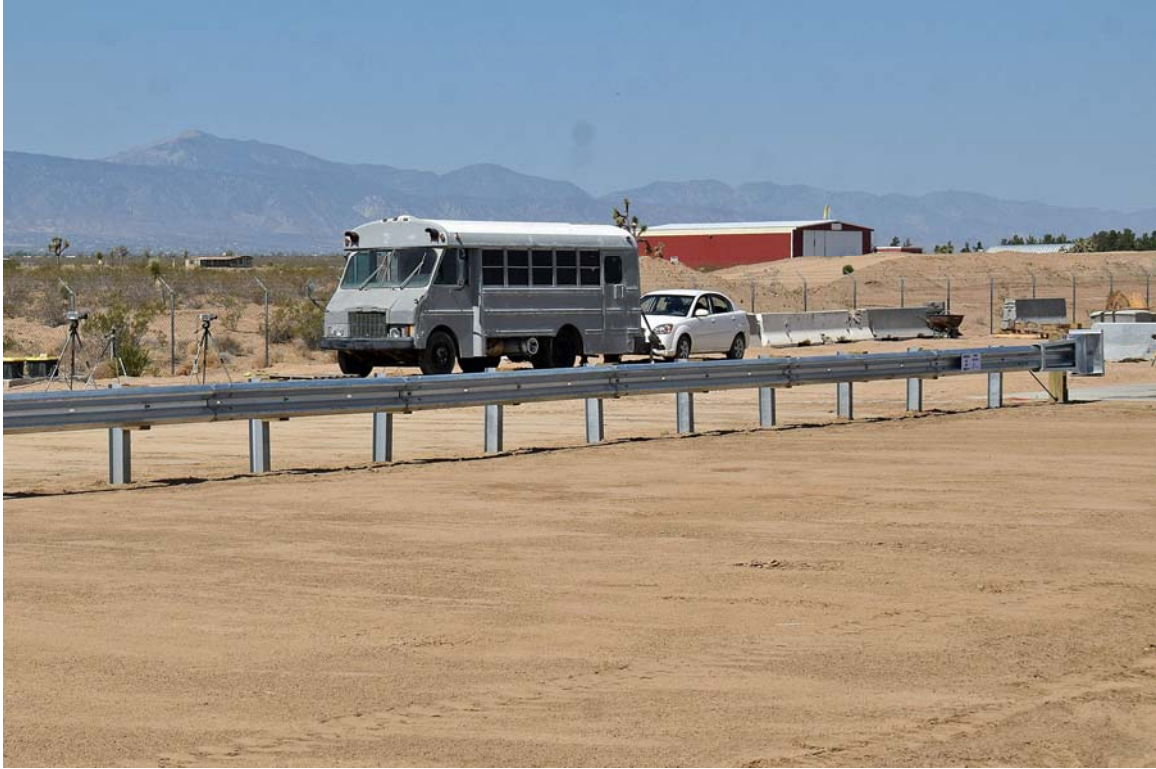
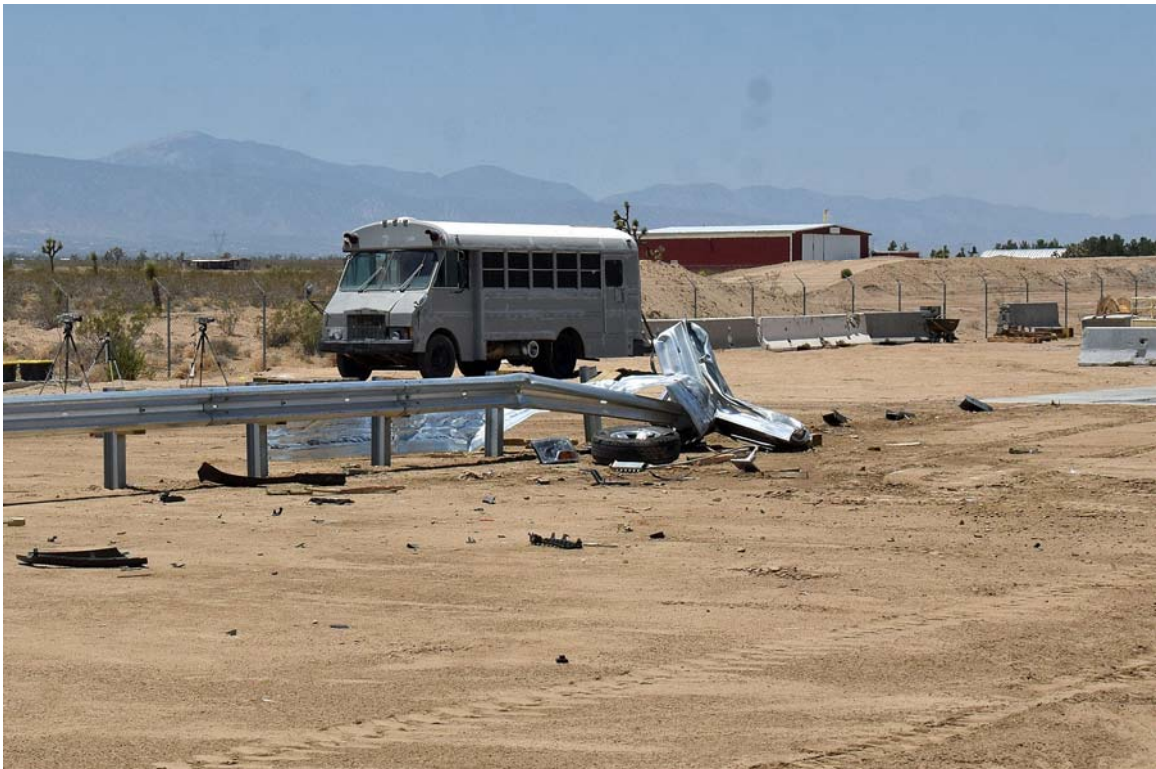
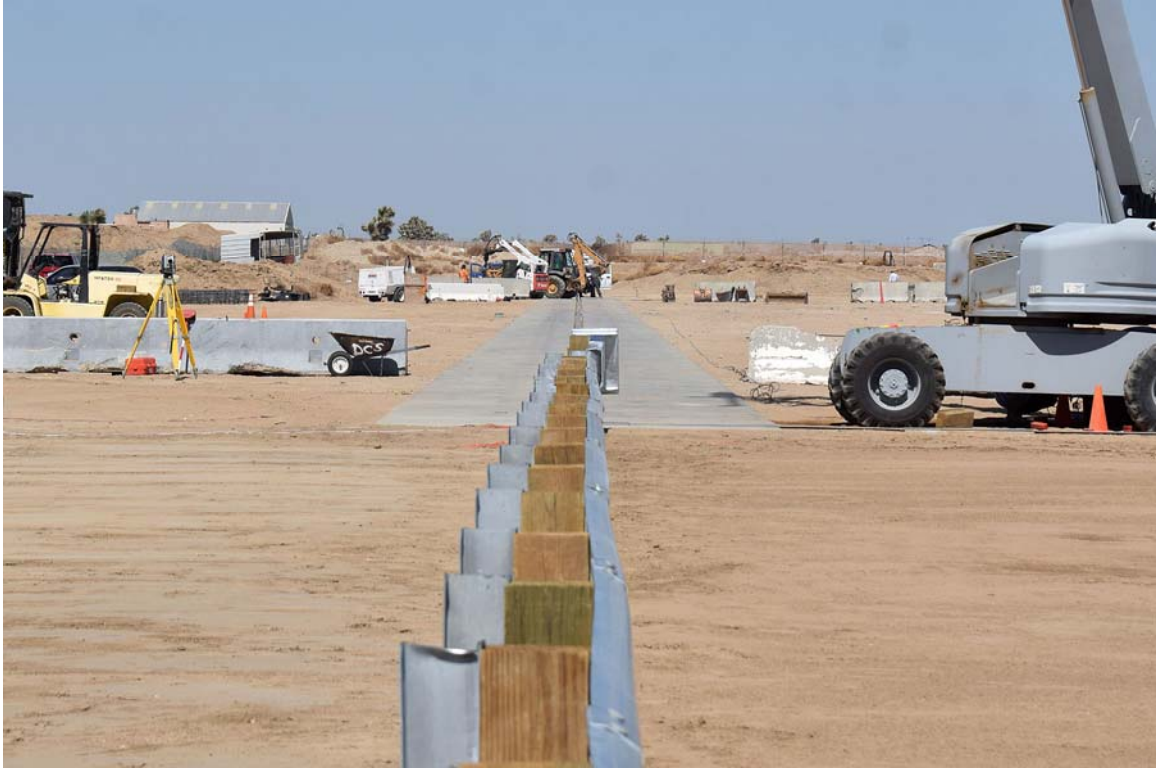
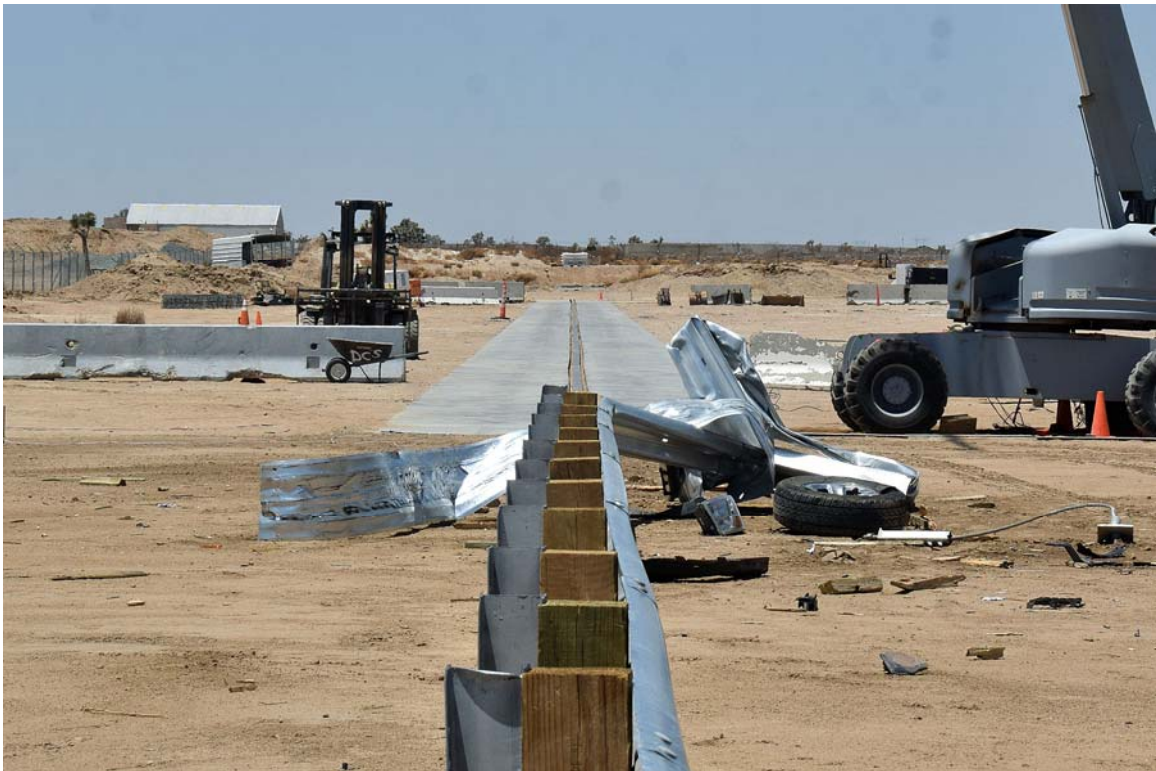
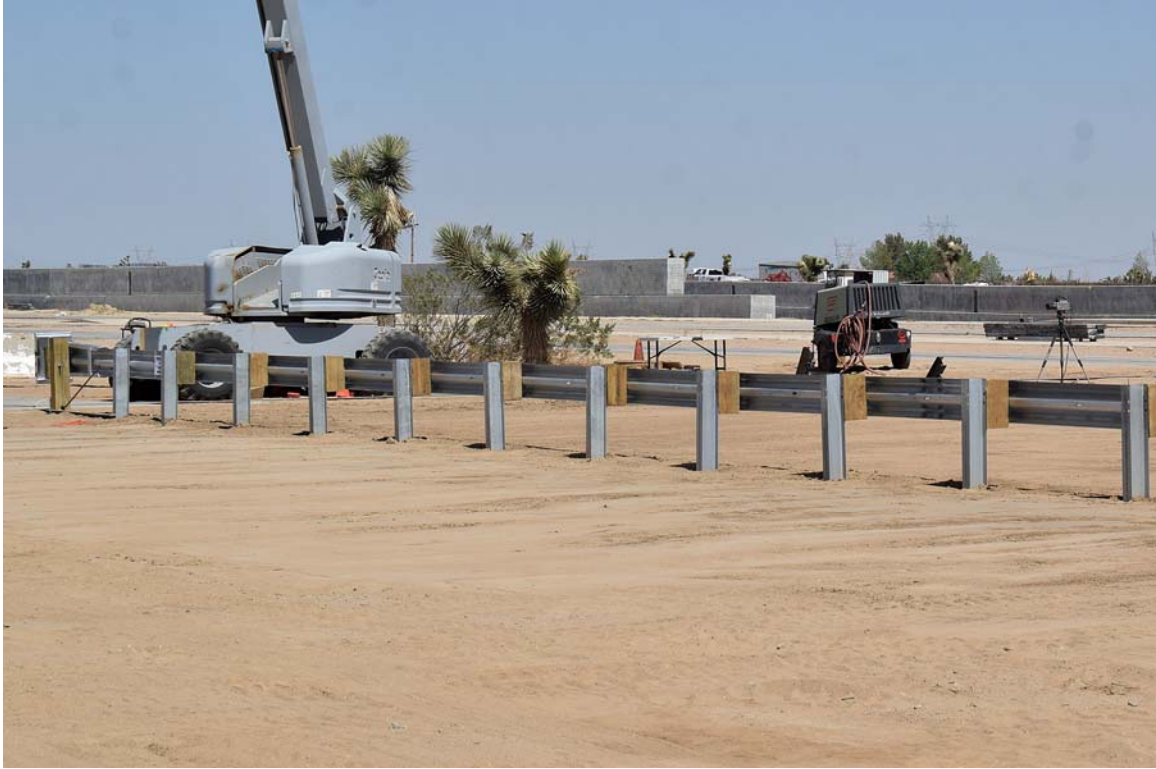
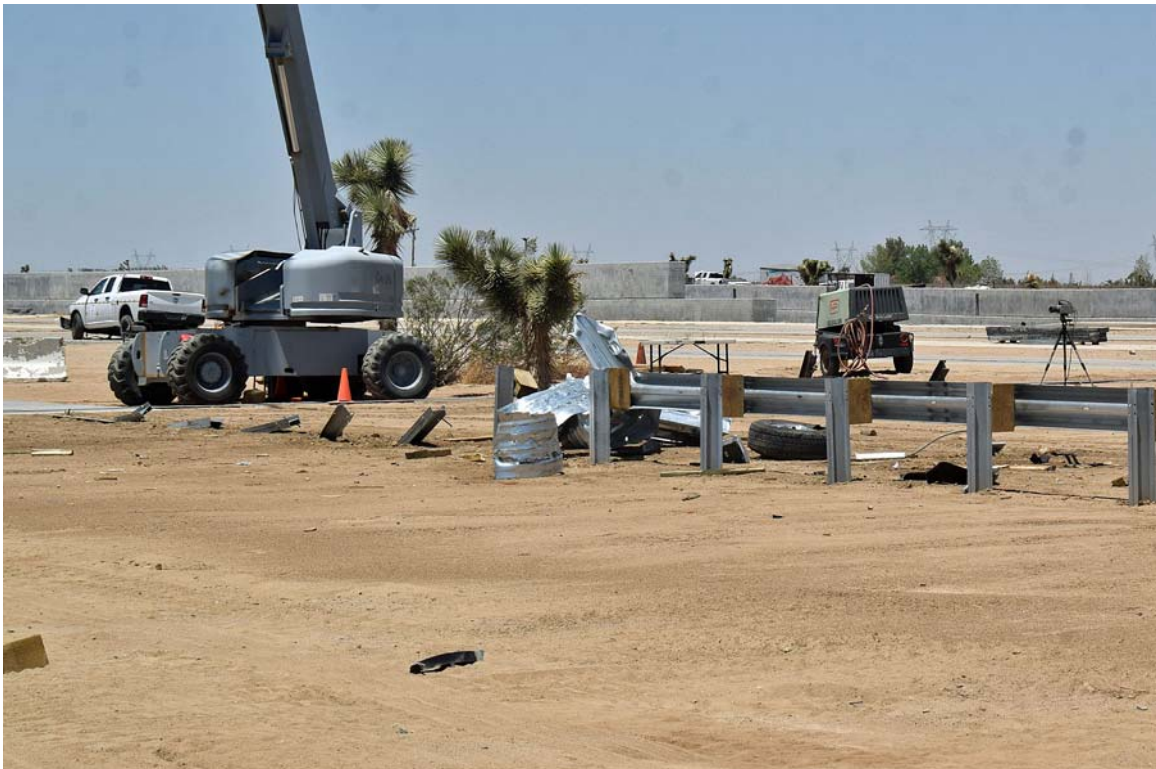
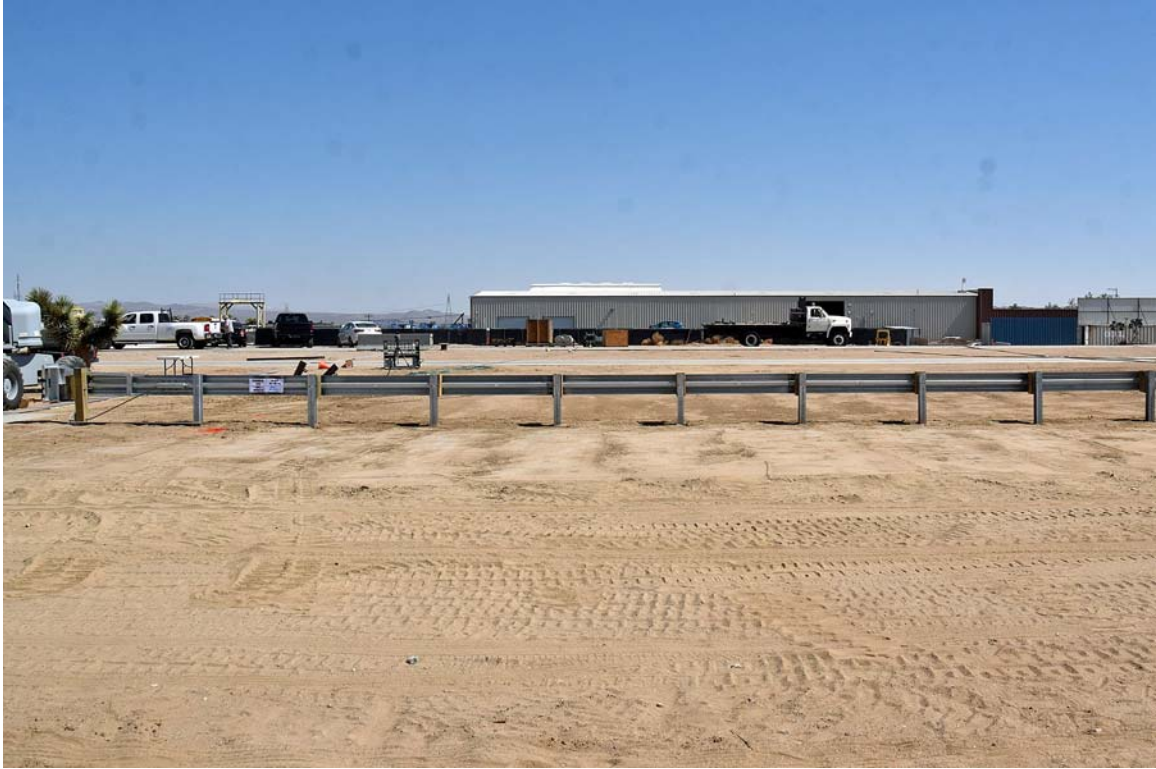
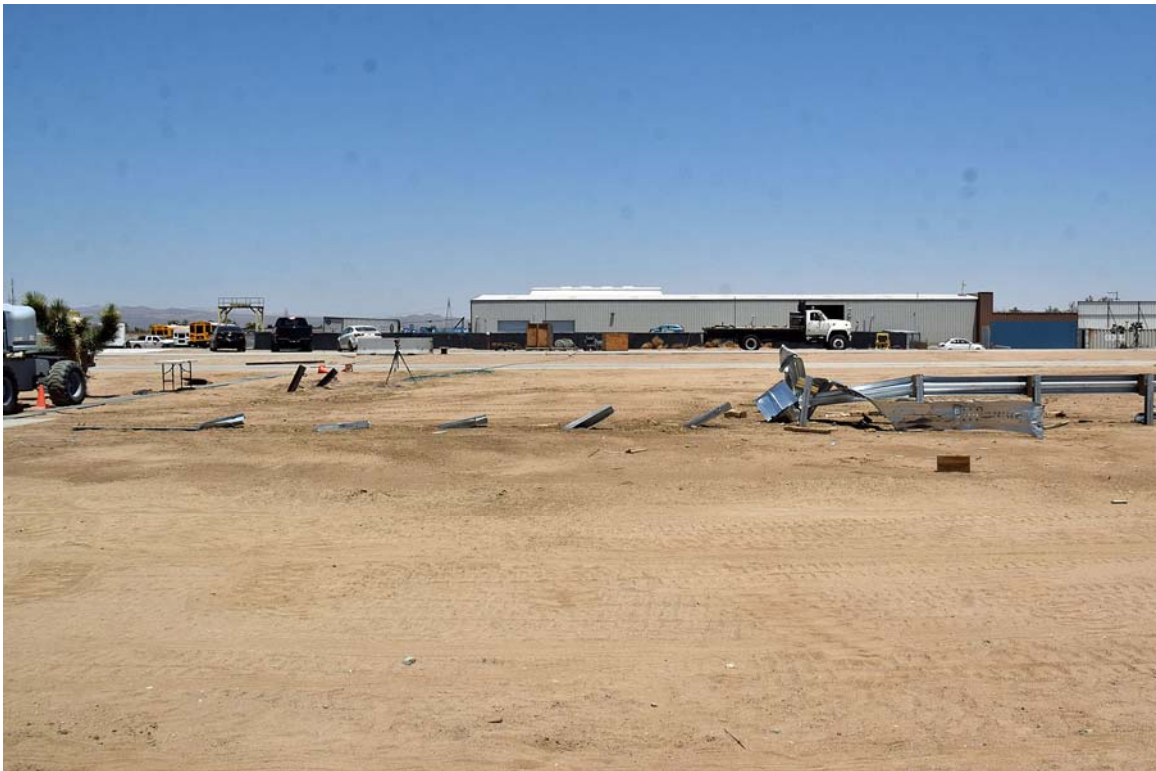
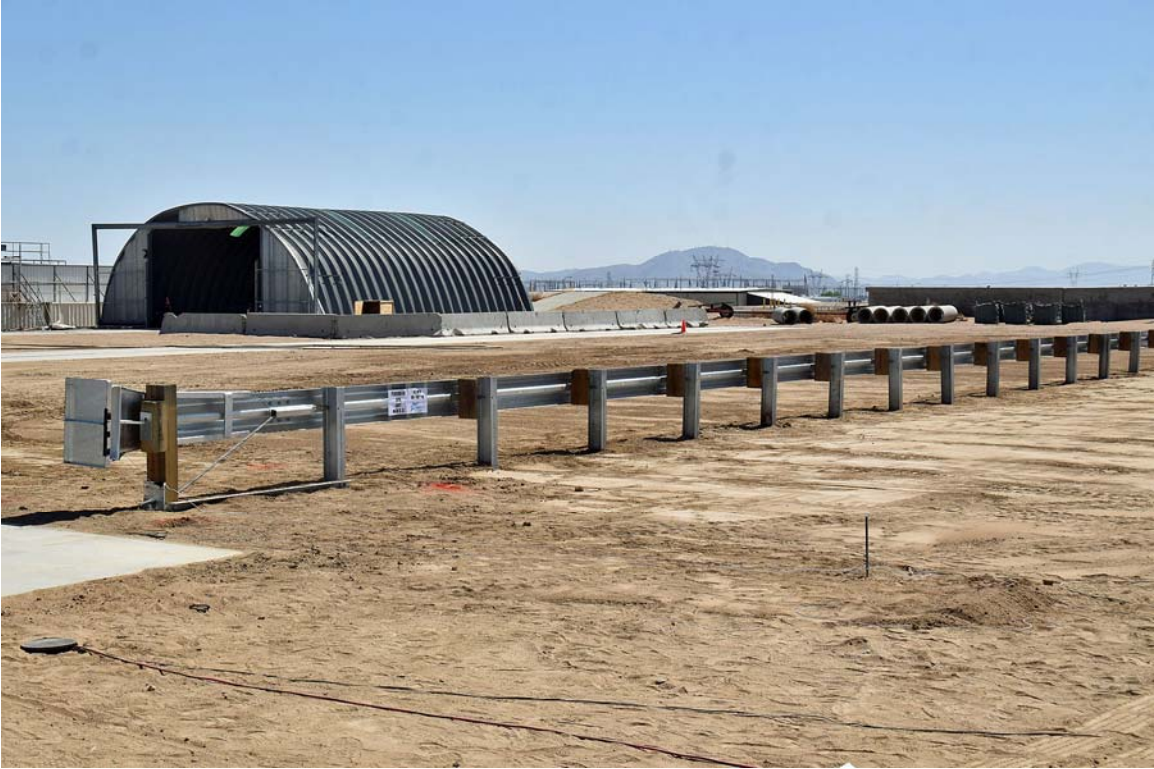
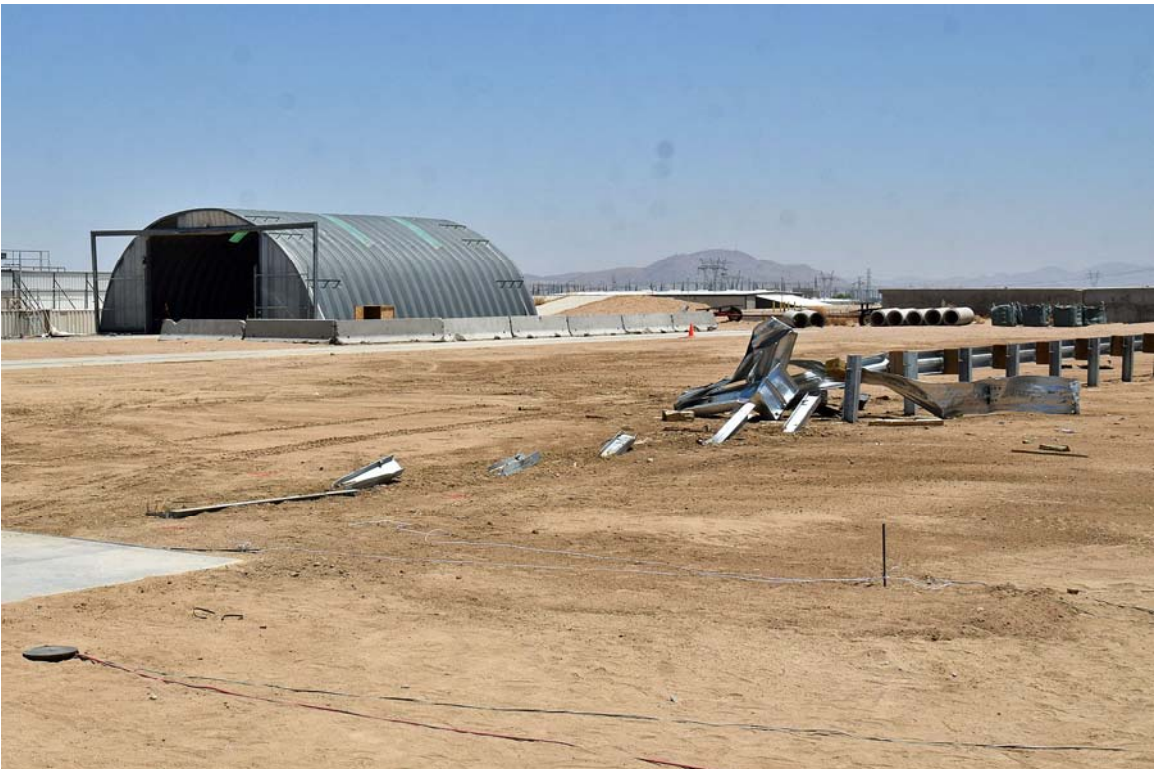
FIGURE 15. Pre-Test Front View of Test Article

FIGURE 16. Post-Test Front View of Test Article

FIGURE 17. Pre-Test Right Front $\frac{3}{4}$ View of Test Article

FIGURE 18. Post-Test Right Front $\frac{3}{4}$ View of Test Article

FIGURE 19. Pre-Test Right View of Test Article

FIGURE 20. Post-Test Right View of Test Article

FIGURE 21. Pre-Test Right Rear $\frac{3}{4}$ View of Test Article

FIGURE 22. Post-Test Right Rear $\frac{3}{4}$ View of Test Article

FIGURE 23. Pre-Test Rear View of Test Article

FIGURE 24. Post-Test Rear View of Test Article

FIGURE 25. Pre-Test Left Rear $\frac{3}{4}$ View of Test Article

FIGURE 26. Post-Test Left Rear $\frac{3}{4}$ View of Test Article

FIGURE 27. Pre-Test Left View of Test Article

FIGURE 28. Post-Test Left View of Test Article

FIGURE 29. Pre-Test Left Front $\frac{3}{4}$ View of Test Article

FIGURE 30. Post-Test Left Front $\frac{3}{4}$ View of Test Article

5.5 Test Article Damage

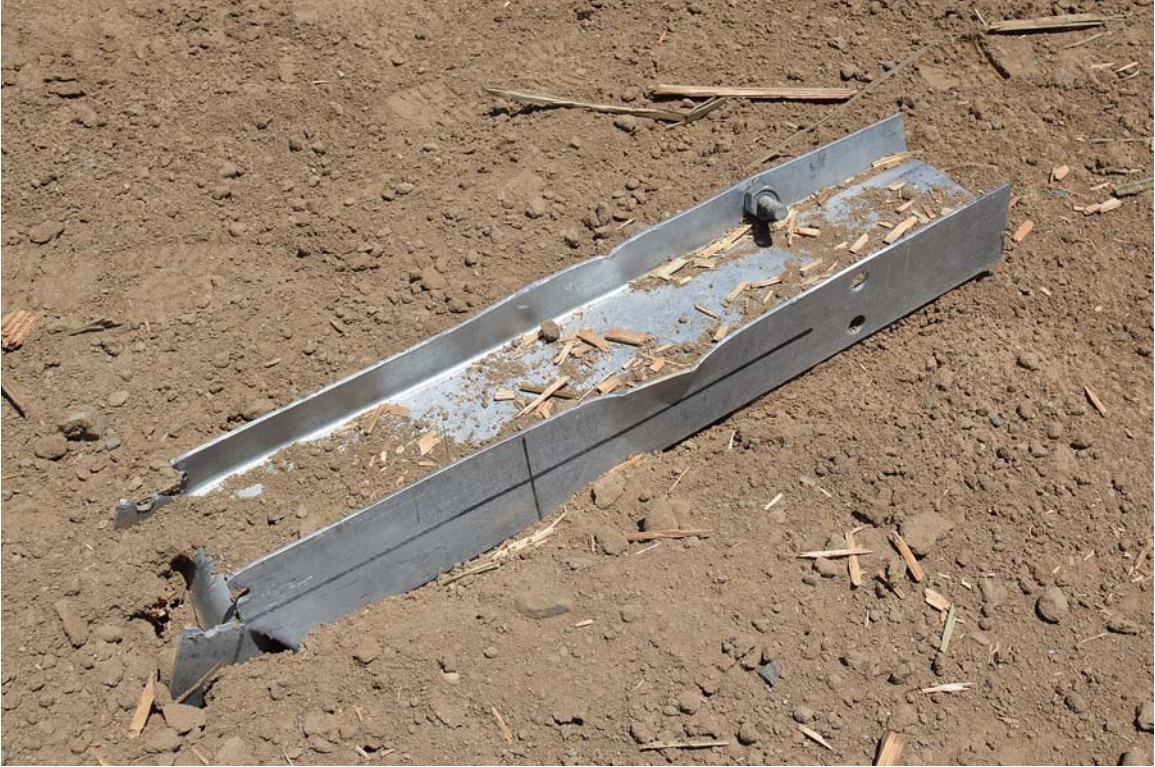
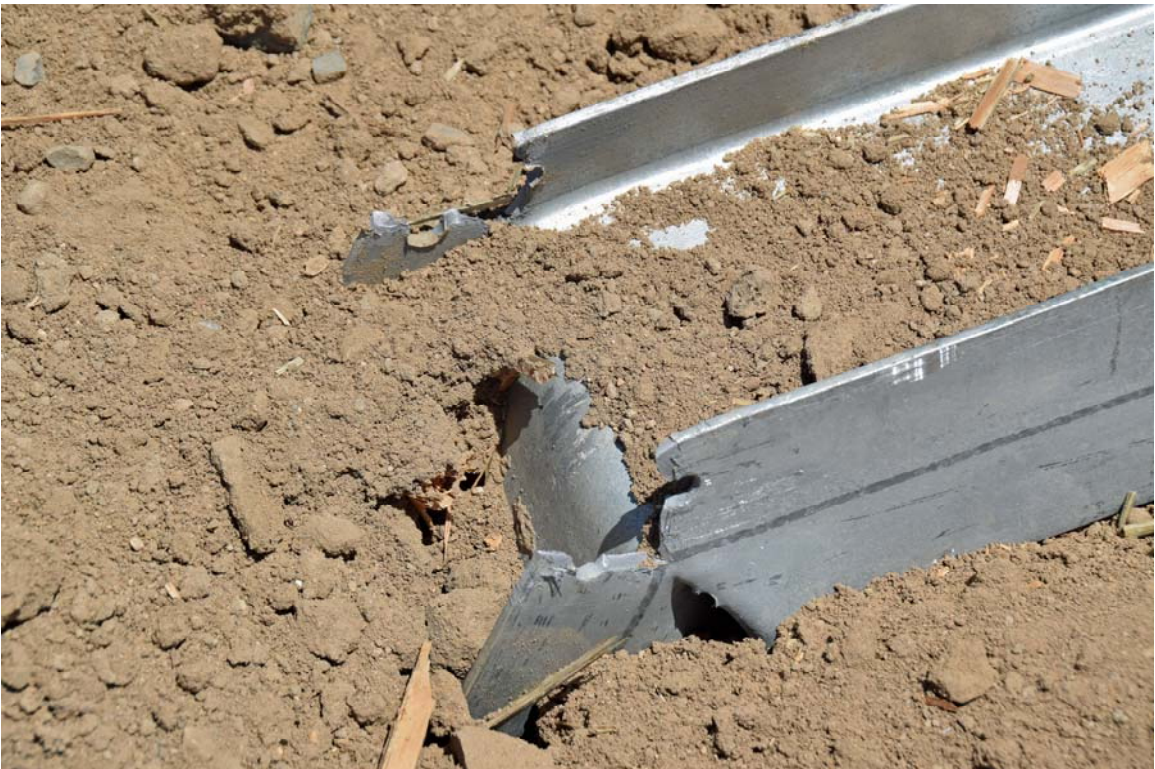
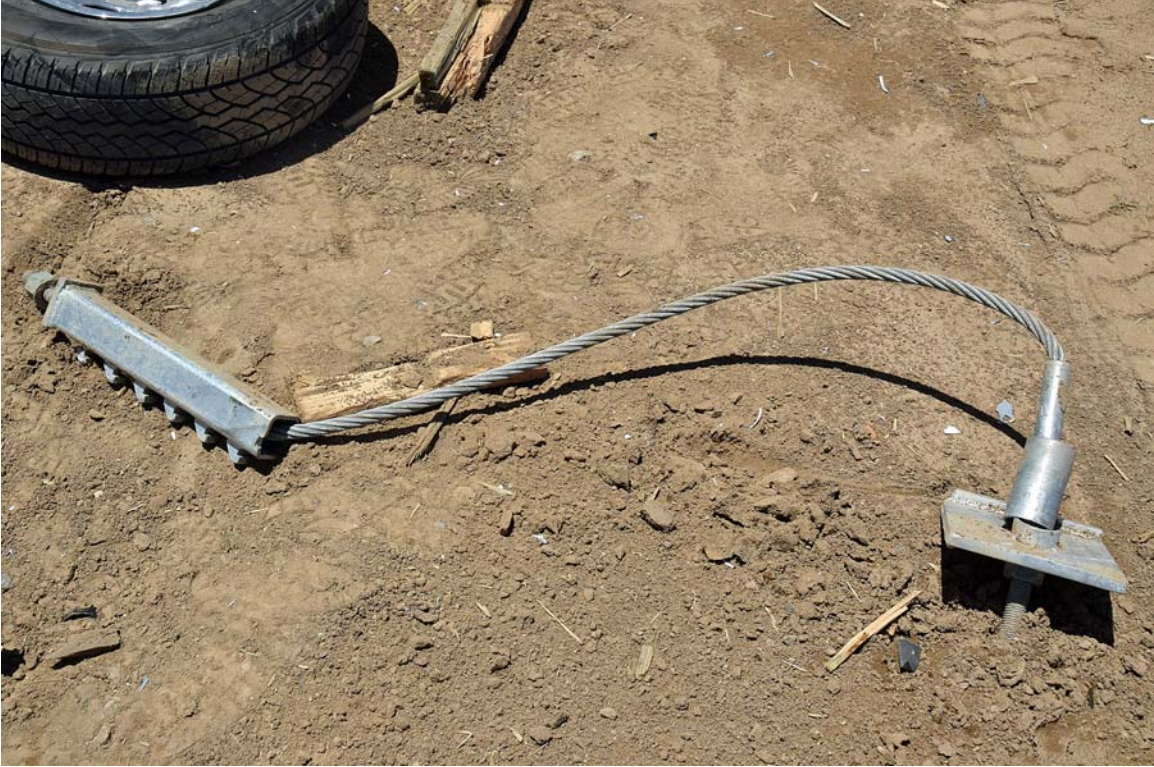
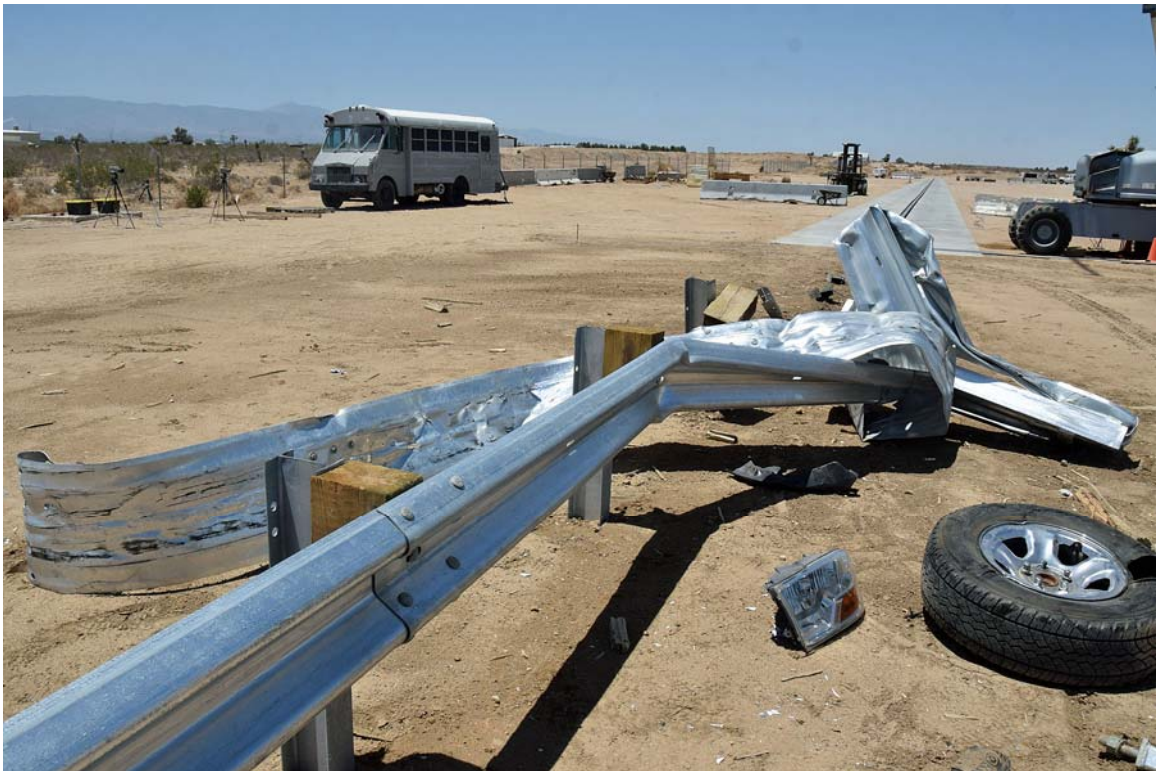
FIGURE 31. Test Article Damage

FIGURE 32. Test Article Damage

FIGURE 33. Test Article Damage

FIGURE 36. Test Article Damage

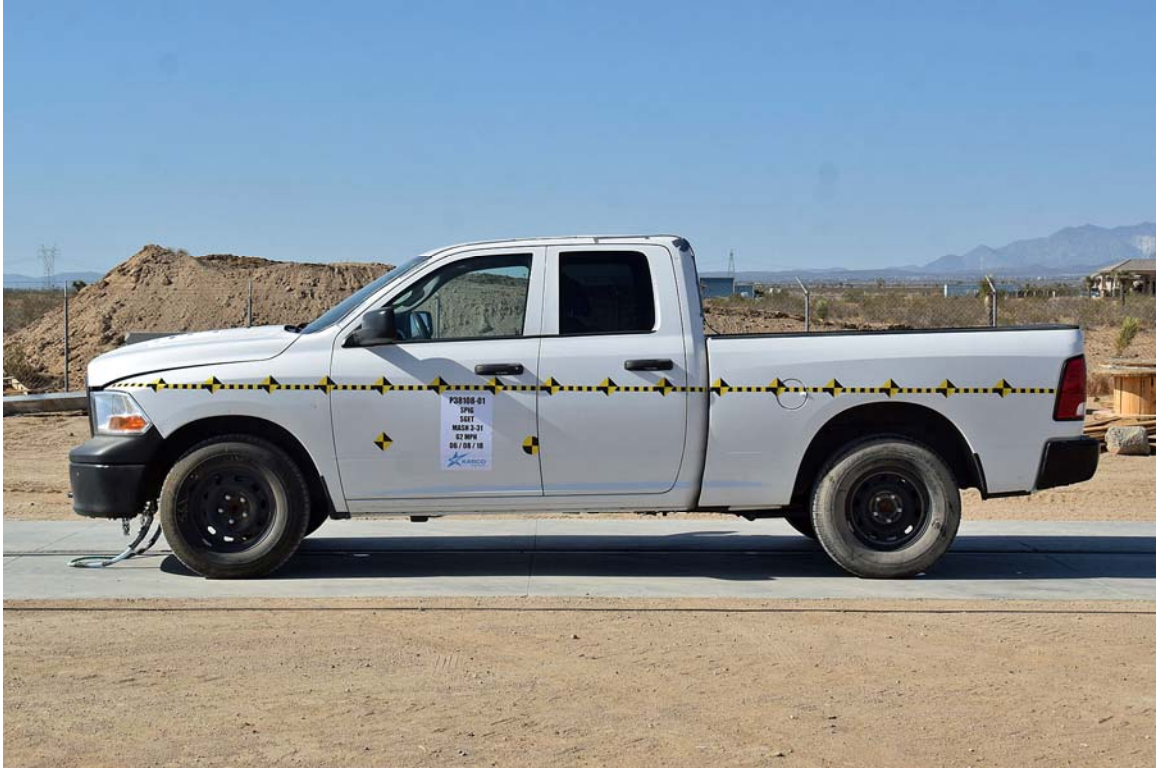
FIGURE 37. Pre-Test Left View of Test Vehicle

5.6 Test Vehicle Damage

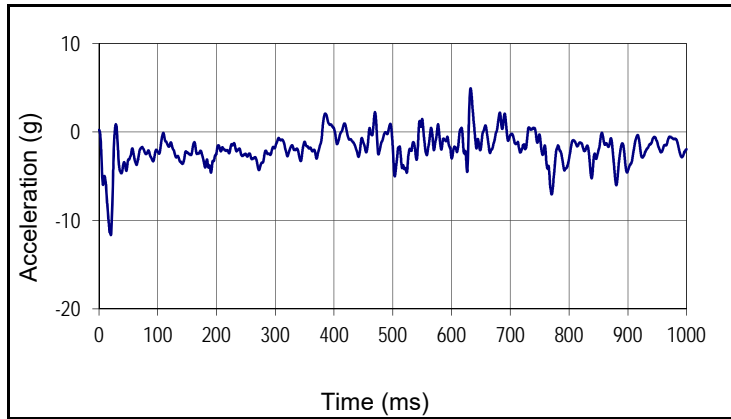
Curve Description			
Test Vehicle CG X			
Plot No.		SAE Class	Units
001		60	g
Max	Time	Min	Time
4.9	632.4	-11.6	20.3

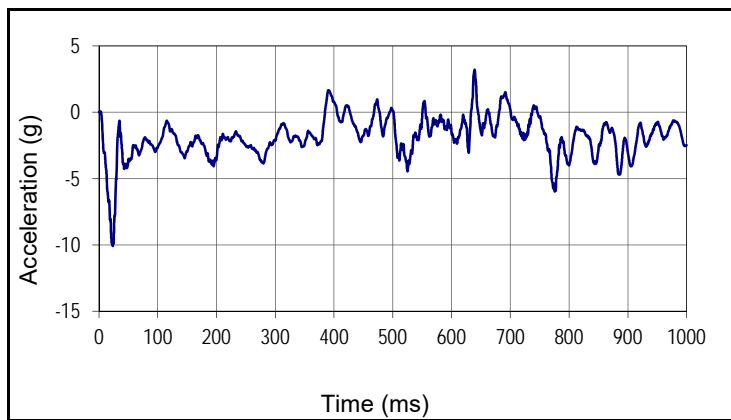
Curve Description			
Test Vehicle CG X Moving Average			
Plot No.		SAE Class	Units
002		180	g
Max	Time	Min	Time
3.2	639.3	-10.1	23.5

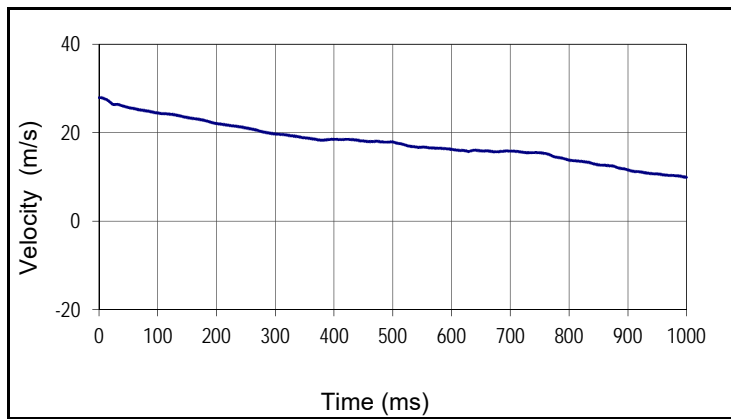
Curve Description			
Test Vehicle CG X Velocity			
Plot No.		SAE Class	Units
003		180	m/s
Max	Time	Min	Time
27.9	2.9	9.9	999.9

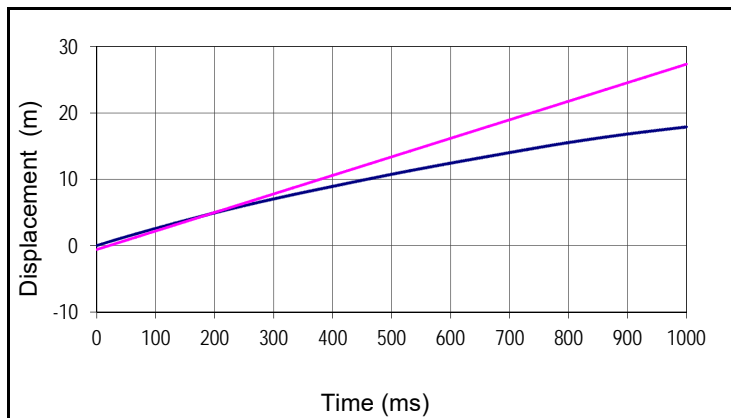
Curve Description			
Test Vehicle CG X Displacement			
Plot No.		SAE Class	Units
004		180	m
Max	Time	Min	Time
17.9	999.9	0.0	0.0

— Vehicle CG X Displacement
 — Occupant X Displacement

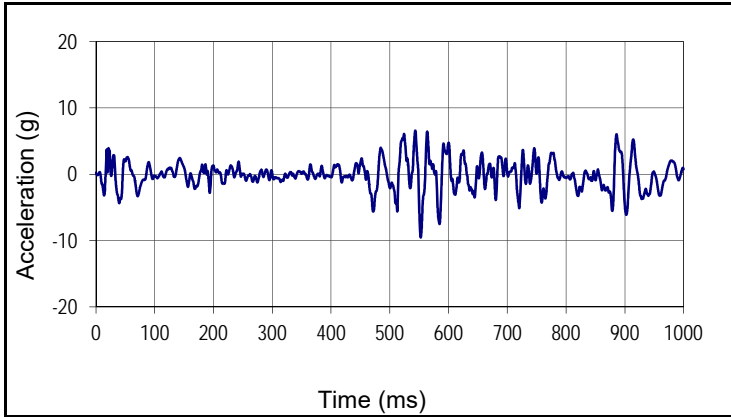
Curve Description			
Test Vehicle CG Z			
Plot No.		SAE Class	Units
009		60	g
Max	Time	Min	Time
6.6	543.4	-9.5	552.6

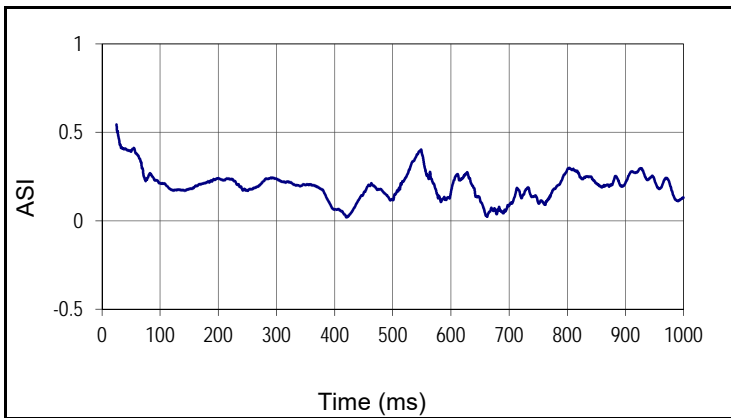
Curve Description			
Test Vehicle Accident Severity Index			
Plot No.		SAE Class	Units
010		180	ASI
Max	Time	Min	Time
0.5	25.0	0.0	420.0

Occupant Risk	
Longitudinal OIV.....	18.4 ft/s (5.6 m/s)
Lateral OIV.....	1.3 ft/s (0.4 m/s)
Longitudinal RA.....	-6.0 g
Lateral RA.....	-4.4 g
THIV.....	18.7 ft/s (5.7 m/s)
PHD.....	6.0 g
ASI.....	0.54
Test Article Deflections	
Static.....	6.3 ft. (1.9 m)
Dynamic.....	7.6 ft. (2.3 m)
Working Width.....	7.6 ft. (2.3 m)
Debris Field.....	49.6 ft. (15.1 m) Downstream 18.2 ft. (5.5 m) Right
Vehicle Damage	
Vehicle Damage Scale.....	12-FR-3
CDC.....	12FZEW1
Maximum Intrusion.....	0.3 in. (8 mm)

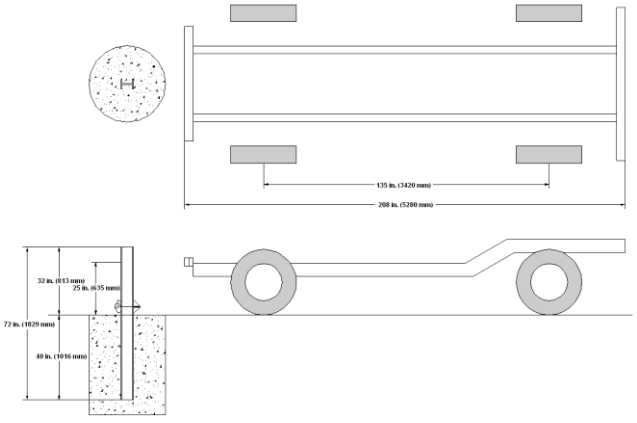
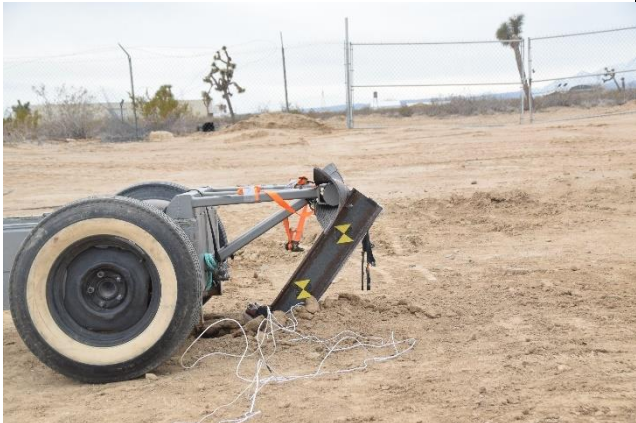
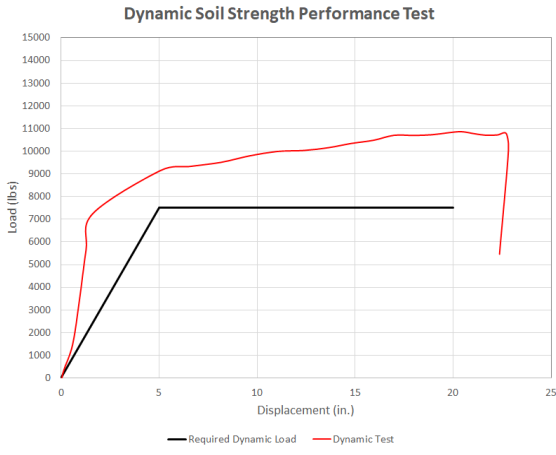
Figure 1: Dynamic Soil Strength Data

Dynamic Test Setup	Dynamic Test/Installation Details

Post-Test Photo of Post	Comparison of Load vs. Displacement

Certification Date	02/06/17
Test Facility and Site Location	KARCO, Track 4
In Situ Soil Description (ASTM D 2487)	Medium to fine silty sand
Description of Fill Placement Procedure	8.0 in. (203 mm) lifts compacted with pneumatic tamper
Bogie Weight	2,044.8 lbs (927.5 kg)
Impact Velocity	20.74 mph (33.38 km/h)
