Test Report For:
SPIG Industries, LLC
SGET End Terminal

TESTED TO:
Manual for Assessing Safety Hardware (MASH 2016)
Test 3-31

TEST REPORT NUMBER:
TR-P38108-01-NC

16. Abstract One (1) Test Level 3, Test 31 (3-31) was performed on the subject SPIG Industries, LLC SGET end terminal. The terminal was impacted by a 2012 RAM 1500 4-door pickup truck. Testing was conducted by KARCO Engineering, LLC. in Adelanto, CA on June 8, 2018. The test vehicle impacted the SGET end terminal at a velocity of 62.53 mph (100.63 km/h) and an impact angle of 0.6°. The vehicle forced the impact head down the rail and allowed the vehicle to exit to the traffic side. The system brought the vehicle to a stop in a controlled manner. The system was damaged from post 1 through post 7. The test vehicle sustained damage to its front end and passenger side. The front bumper and frame rails were damaged. The passenger front wheel broke off the vehicle. The occupant compartment was not penetrated and the deformation limits were not exceeded. The SPIG Industries, LLC SGET met all the requirements for MASH 2016 Test 3-31.

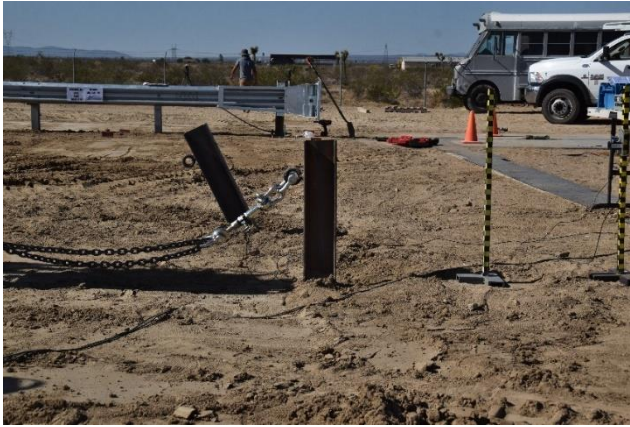
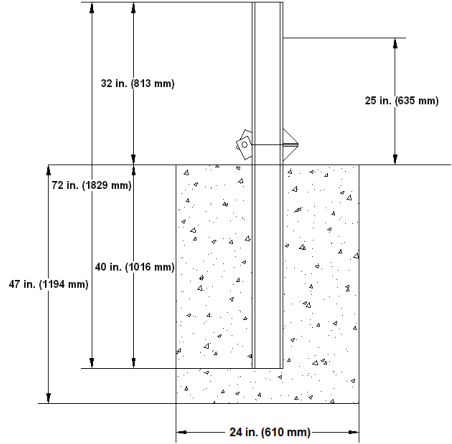
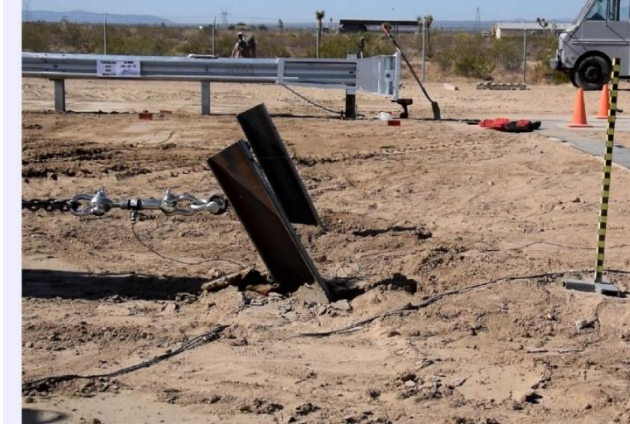
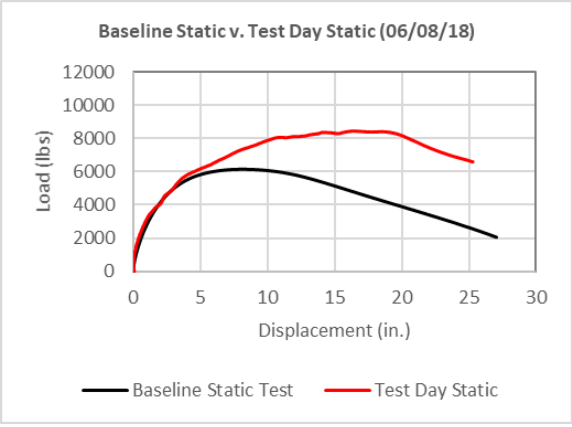
Figure 2: Static Soil Strength Data

Static Load Test Setup	Static Test/Installation Details

Post-Test Photo of Post	Comparison of Load vs. Displacement

Date	06/08/18
Test Facility and Site Location	KARCO, Track 4
In Situ Soil Description (ASTM D 2487)	Medium to fine silty sand
Description of Fill Placement Procedure	8.0 in. (203 mm) lifts compacted with pneumatic tamper

Prior to full scale crash test P38108-01, a static soil test was conducted to ensure the soil condition was acceptable for full-scale crash testing. The static test results at 5.0 in. (127 mm), 10.0 in. (254 mm) and 15.0 in. (381 mm) were above 90% of the baseline established during soil certification. Static test results can be found in Appendix C of this test report.

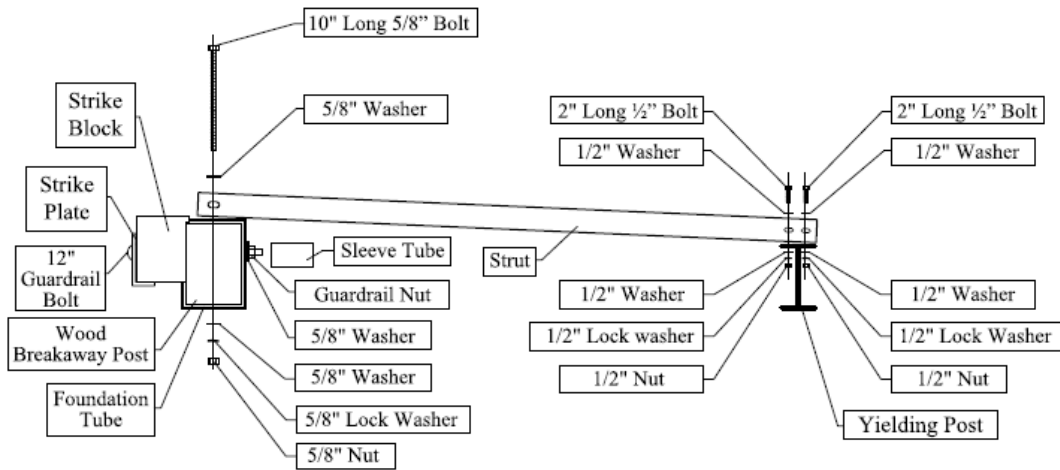
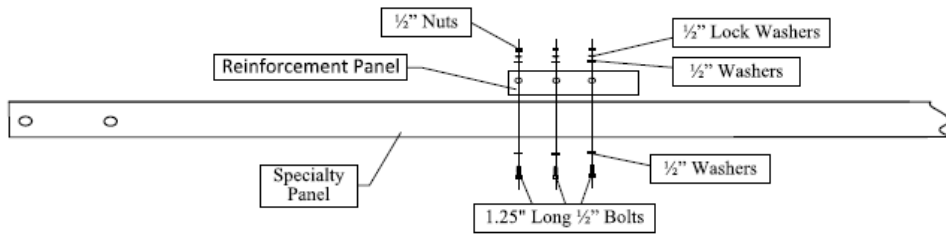
Figure 1: SGET System Parts

POST PARTS	QTY
12" Guardrail Bolt – 5/8 X 12 307A HDG	1
Strike Plate	1
Strike Block	1
Guardrail Nut – 5/8-11 Nut A563 HDG	1
Wood Breakaway Post – 5-1/2 X 7-1/2 X 50 BCT	1
Foundation Tube – 6" X 8" X 6' Rectangular Tube	1
10" long 5/8" Bolt – 5/8-11 X 10 A325 HDG	1
5/8" Nut – 5/9-11 A563 Hex Nut Galvanized	1
5/8" Washer – 5/8 F436(A325) HDG Flatwasher	3
5/8" Lock Washer Galvanized	1
2" long 1/2" Bolt – 1/2-13 X 2 A325 HDG	2
1/2" Washer – 1/2 F436(A325) HDG Flatwasher	4
1/2" Nut – 1/2-13 A563 Hex Nut Galvanized	2
1/2" Lock Washer Galvanized	2
Yielding Post – Modified W6 X 8.5 Guardrail Post	7
Strut – 3" X 3" X 80" Angle	1
Sleeve Tube – 2-3/8 OD X 4-1/4	1

SPECIALTY PANEL PARTS	QTY
Specialty Panel	1
1.25" Long 1/2" Bolt – 1/2-13 X 1-1/4 A325 HDG	6
1/2" Washer – 1/2 F436(A325) HDG Flatwasher	12
1/2" Nut – 1/2-13 A563 Hex Nut Galvanized	6
1/2" Lock Washer Galvanized	6
Reinforcement Plate	1

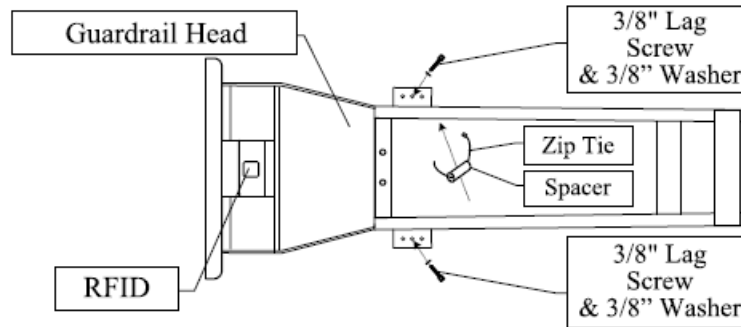
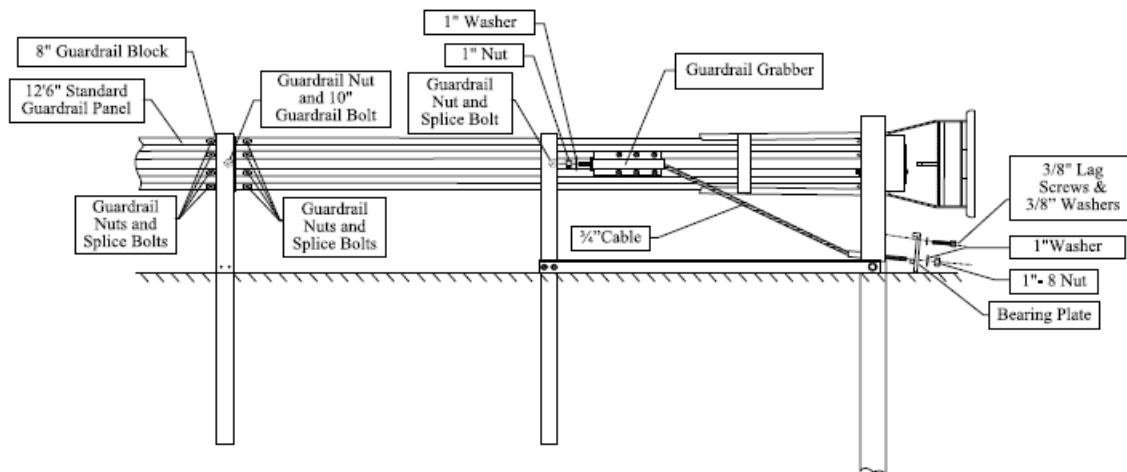
Figure 2: SGET System Parts

GUARDRAIL HEAD PARTS

PARTS	QTY
Guardrail Head	1
3/8" Lag Screw – 3/8 X 3 GR5 HDG Hex Lag Screw	2
3/8" Washer Galvanized F844	2
Spacer – 4" Long X 1-1/2 SCH-40 PVC PIPE	1
Zip Tie – 18"-24" Long Rated at 175-200 lbs.	1
RFID chip rated MIL-STD-810F (e.g. Omni-ID EX0750)	1

RAIL AND CABLE PARTS

PARTS	QTY
3/4" Cable – 81" Long BCT Cable	1
1" Nut – 1- 8 Hex Nut UNC Galvanized A563DH	2
1" Washer Galvanized F436	2
Guardrail Splice Bolt – 5/8 X 1-1/4 307A HDG	25
10" Guardrail Bolt – 5/8 X 10 307A HDG	6
Guardrail Nut– 5/8-11 Nut A563 HDG	31
8" Guardrail Block	6
12' 6" Standard Guardrail Panel – W-Beam M-180	3
Bearing Plate	1
3/8" Lag Screw – 3/8 X 3 GR5 HDG Hex Lag Screw	2
3/8" Washer Galvanized F844	2
Guardrail Grabber	1
