Test Report For:
SPIG Industries, LLC
SGET End Terminal

TESTED TO:
Manual for Assessing Safety Hardware (MASH 2016)
Test 3-35

TEST REPORT NUMBER:
TR-P38032-01-NC

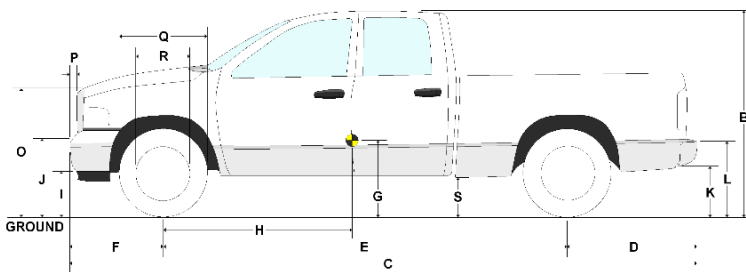
Figure 1 Test 3-35 Vehicle Information

For test 3-35, a 2270P test vehicle was used. The vehicle was a 2012 RAM 1500 4-door pickup truck with a front mounted engine, automatic transmission, and rear wheel drive. The 2270P test vehicle had a curb and test inertial weight of 4,968.0 lbs (2,253.5 kg) and 5,006.6 lbs (2,271.0 kg), respectively. An Anthropomorphic Test Device (ATD) was not used for this test. The test vehicle information can be found in Figure 1.

Test Date..... 03/12/18 Project No..... P38032-01 Year..... 2012
 Make..... RAM Model..... 1500 Color..... White
 Tire Size..... P265/70R17 Vehicle Vin #..... 1C6RD6FP2CS281365
 Tire Inflation..... 40 psi Odometer..... 145,818 mi

No.	Inches	mm	No.	Inches	mm	No.	Inches	mm	No.	Inches	mm
A	78.7	2000	F	40.9	1040	K	18.1	460	P	5.1	130
B	73.6	1870	G	28.3	720	L	29.1	740	Q	30.5	775
C	228.7	5810	H	64.6	1640	M	68.3	1734	R	18.5	470
D	47.4	1205	I	12.4	315	N	67.9	1725	S	13.1	334
E	140.4	3565	J	23.6	600	O	44.1	1120	T	79.5	2020

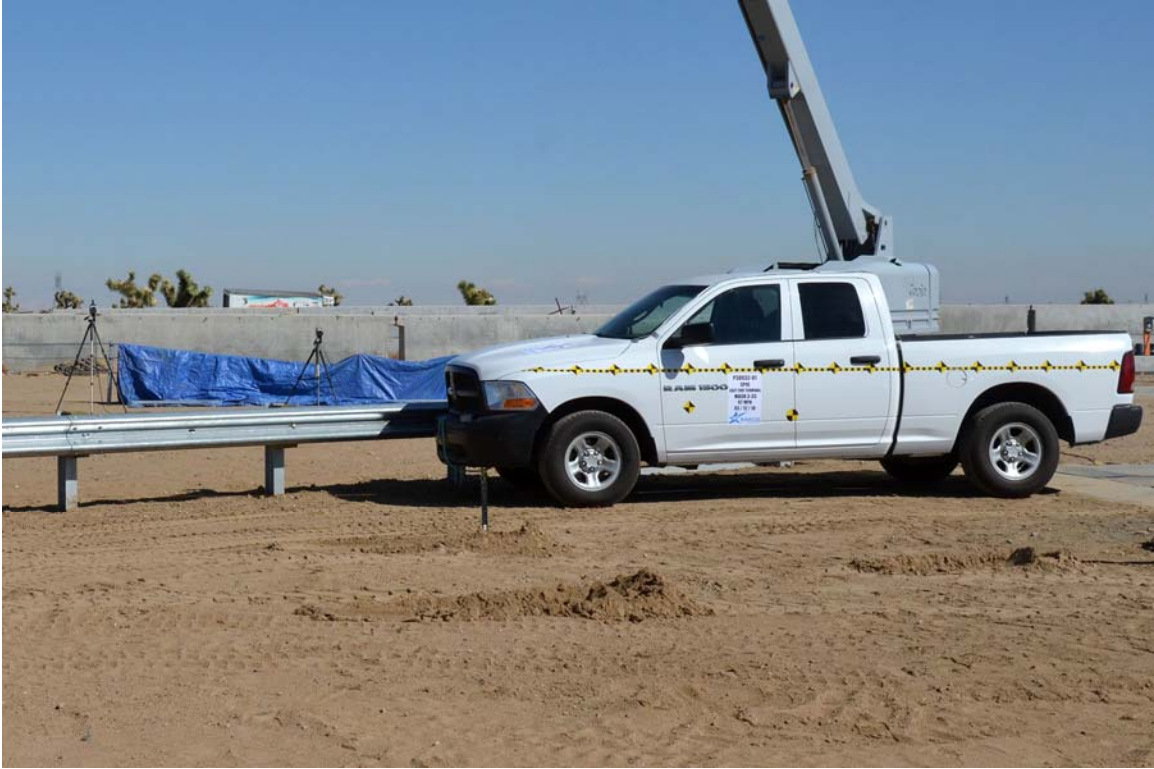
FIGURE 1. Test Setup

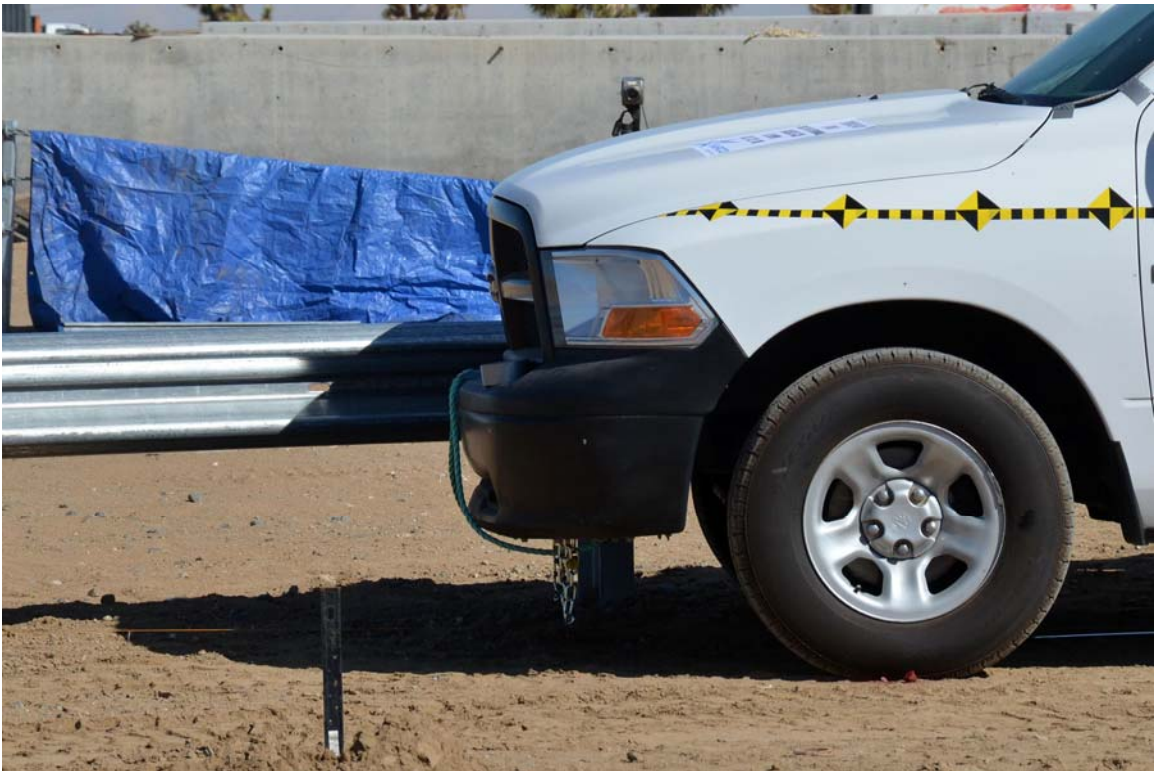
FIGURE 2. Test Setup, Close-Up

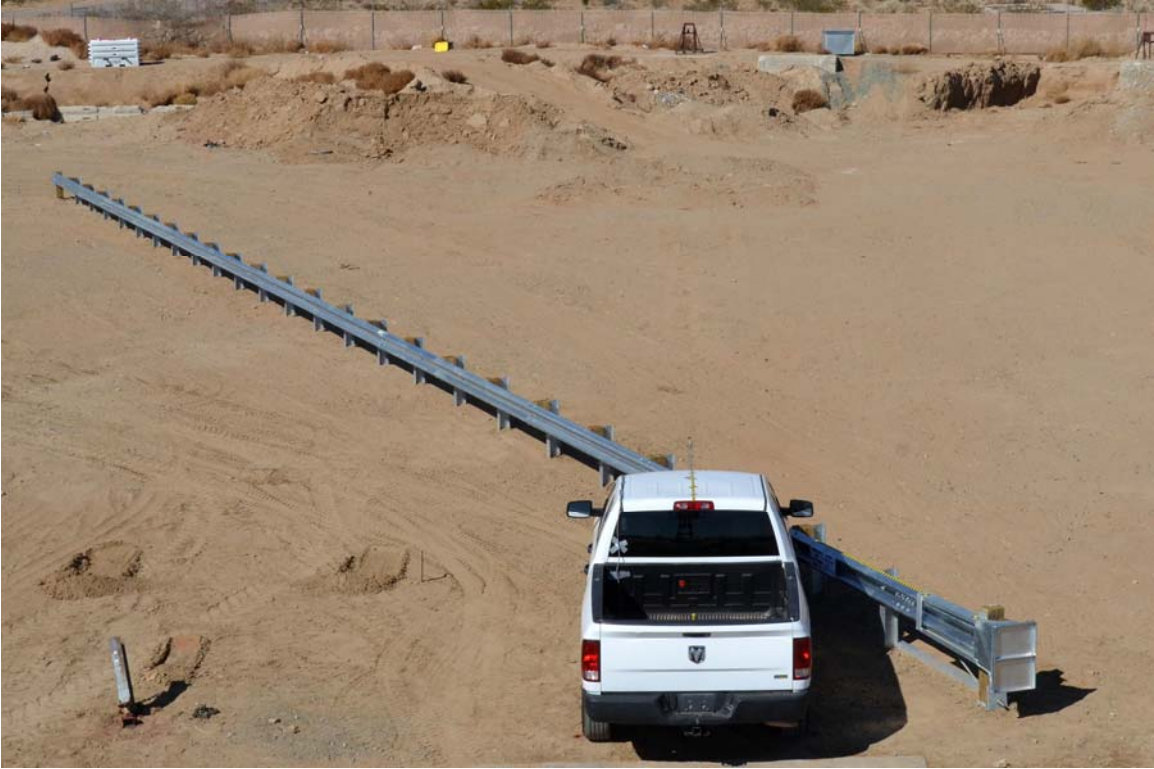
FIGURE 11. Pre-Test

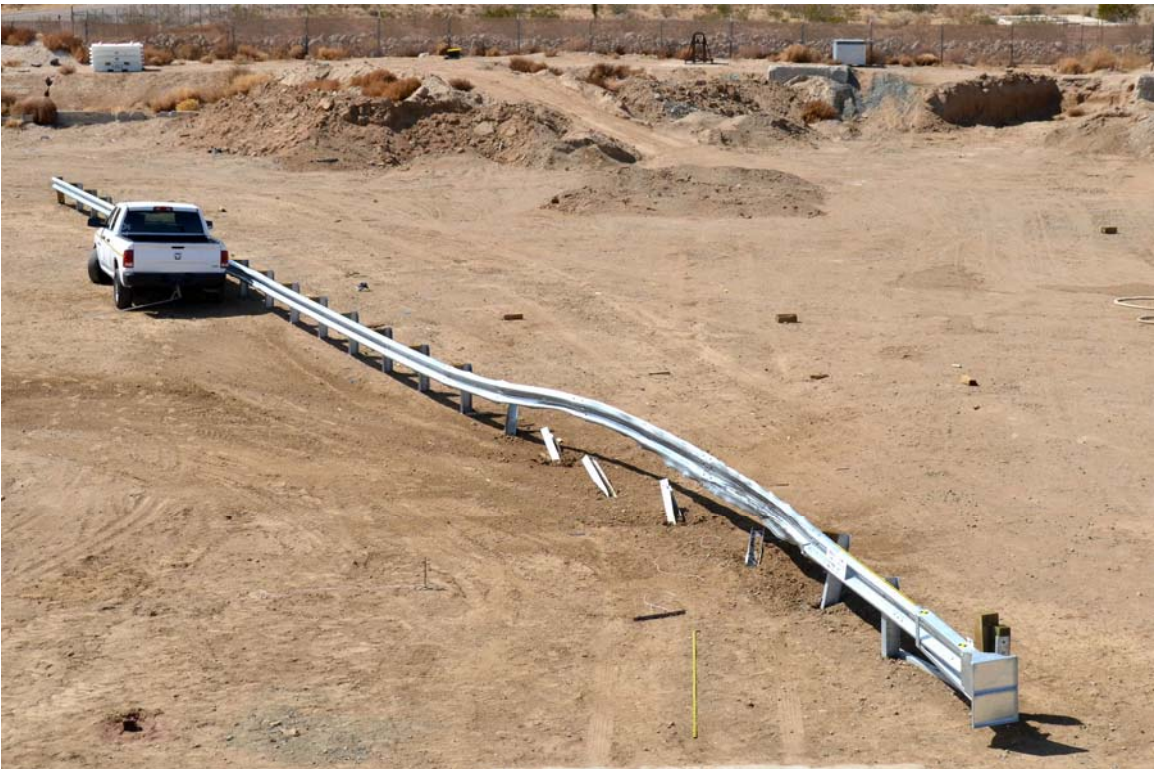
FIGURE 12. Post-Test

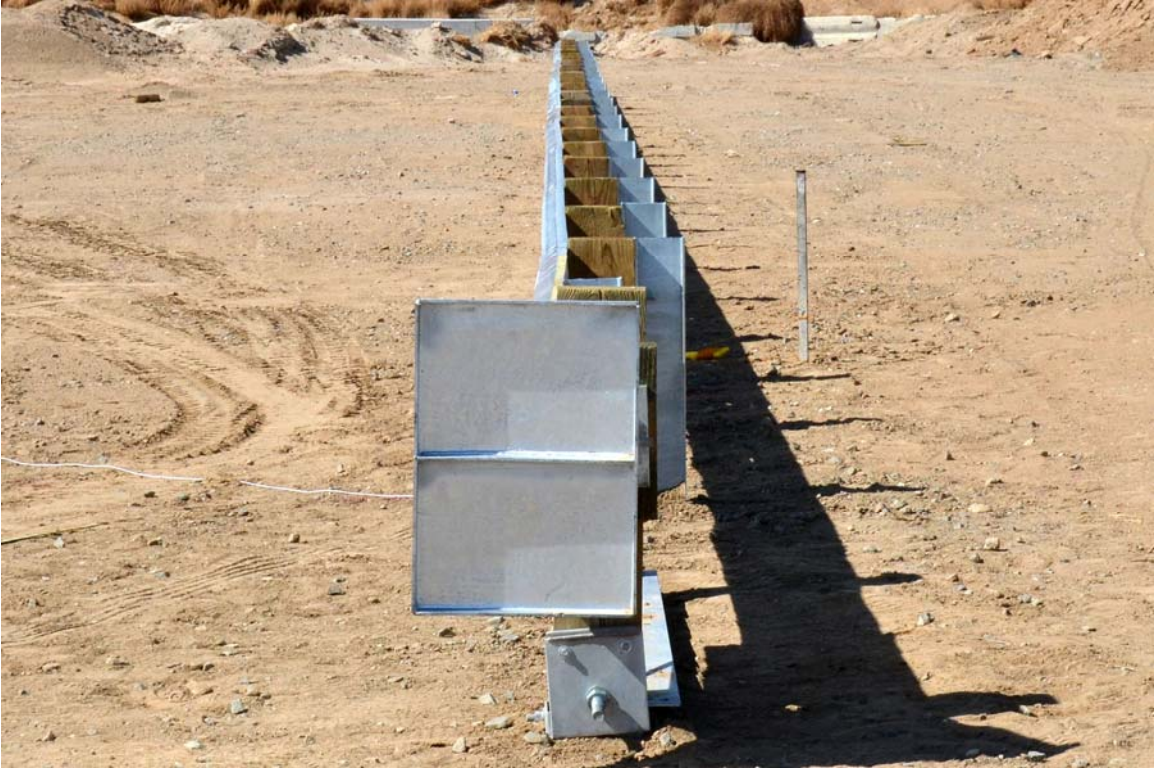
FIGURE 15. Pre-Test Front View of Test Article

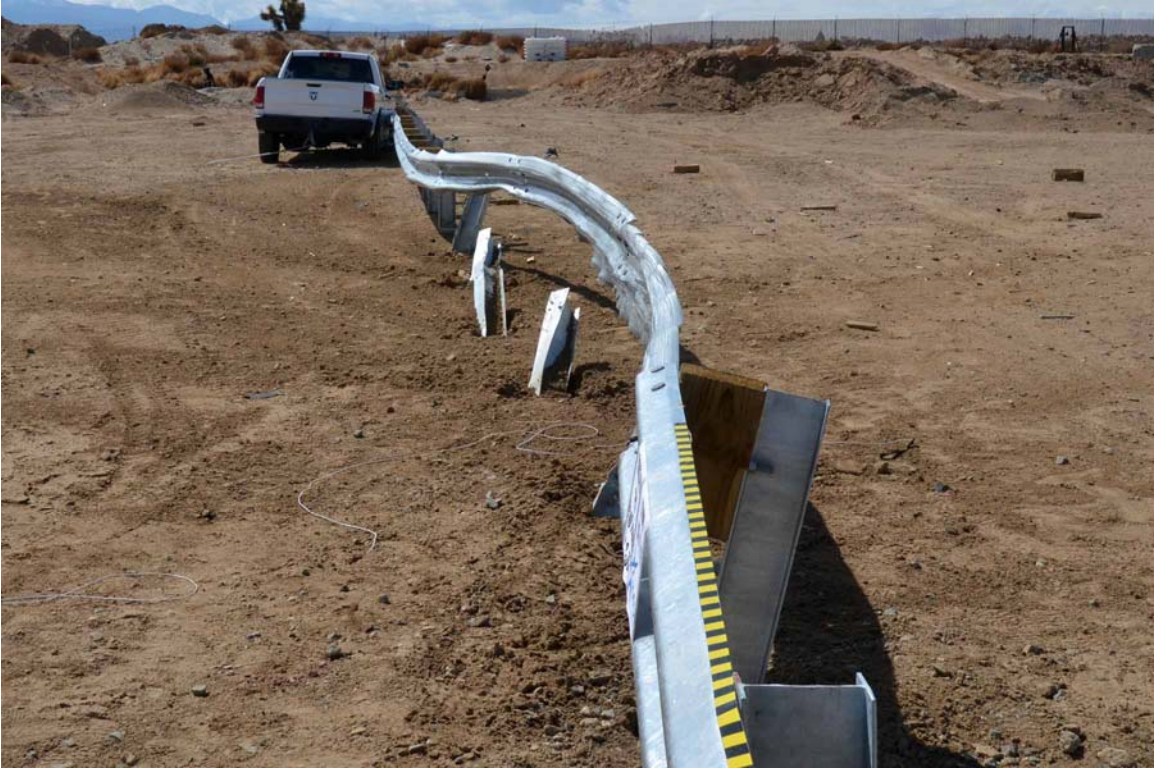
FIGURE 31. Test Article Damage

5.5 Test Article Damage

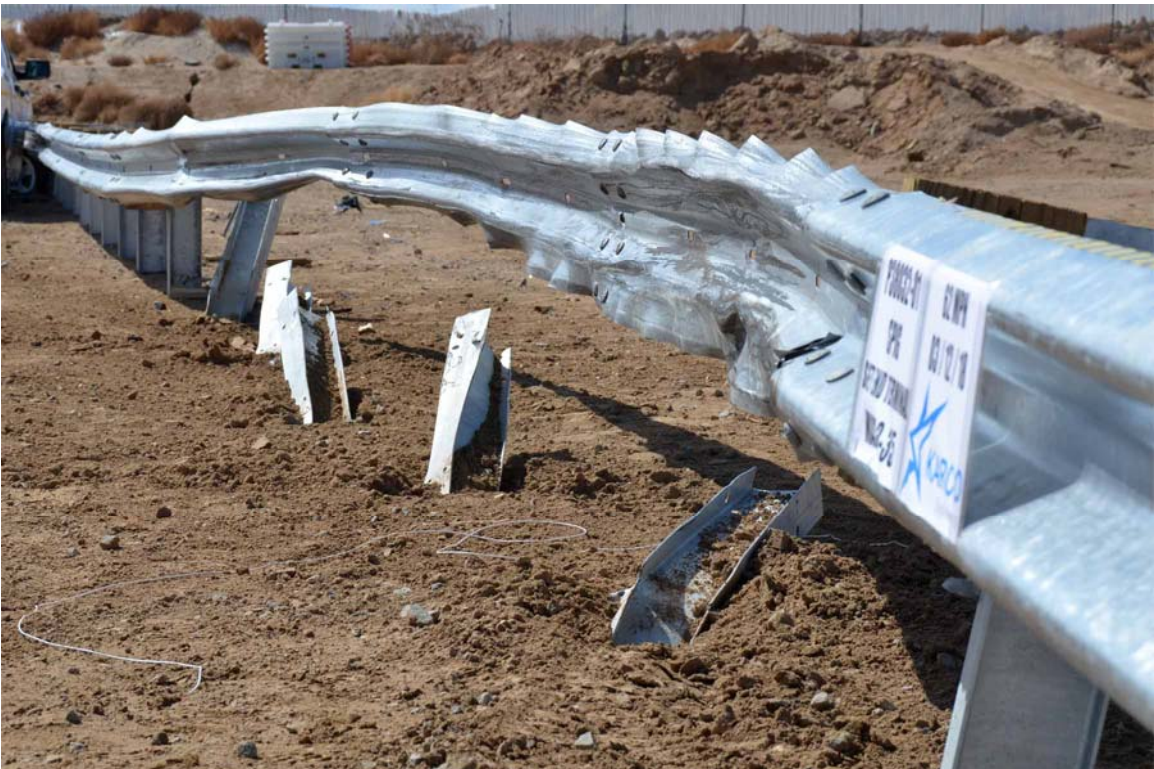
FIGURE 32. Test Article Damage

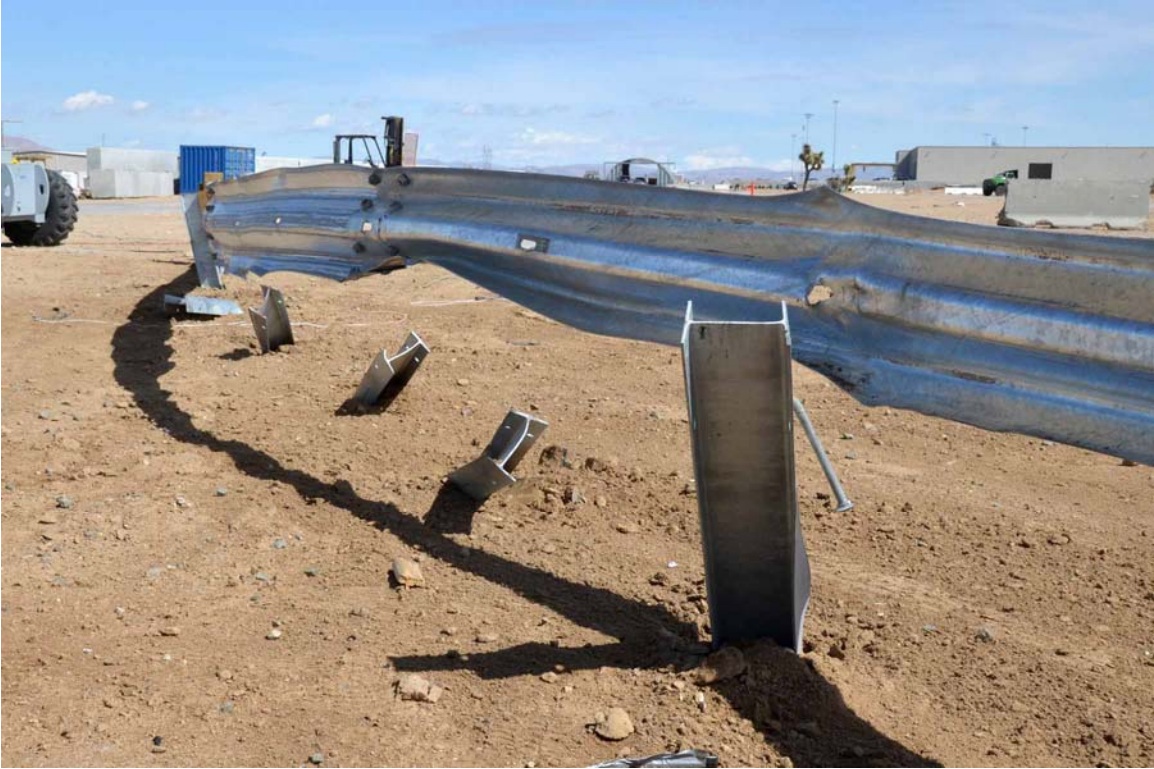
FIGURE 33. Test Article Damage

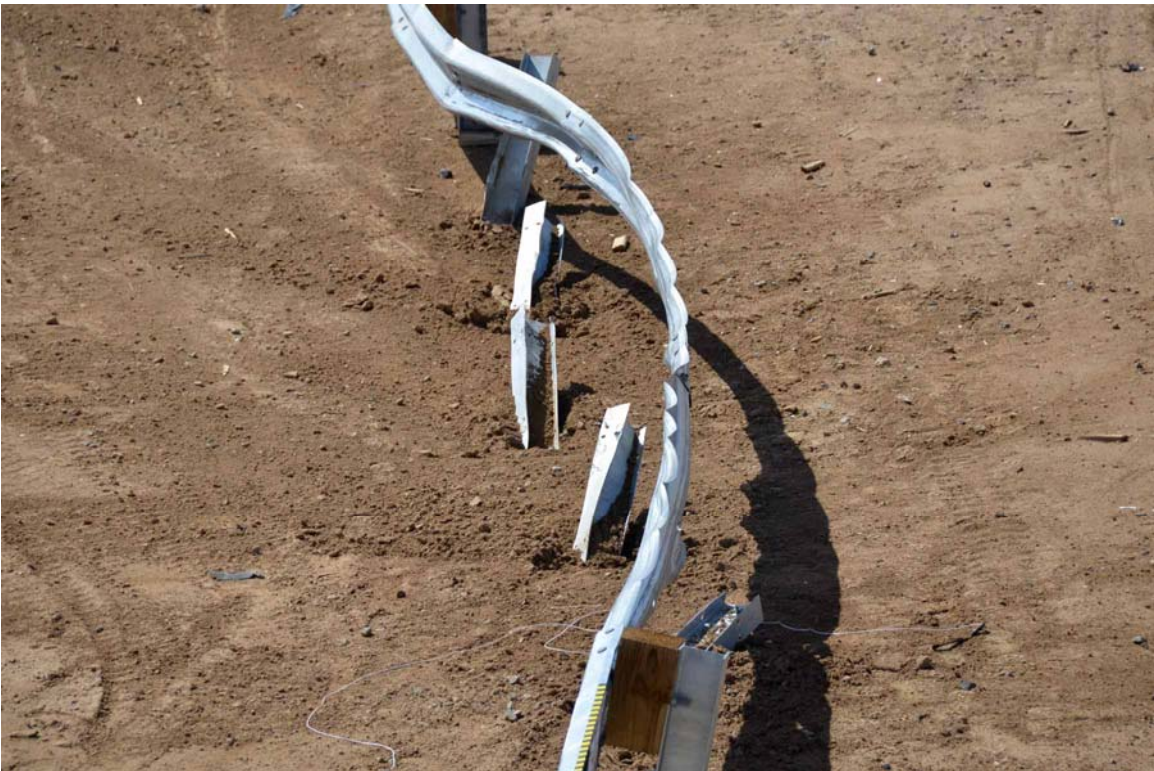
FIGURE 34. Test Article Damage

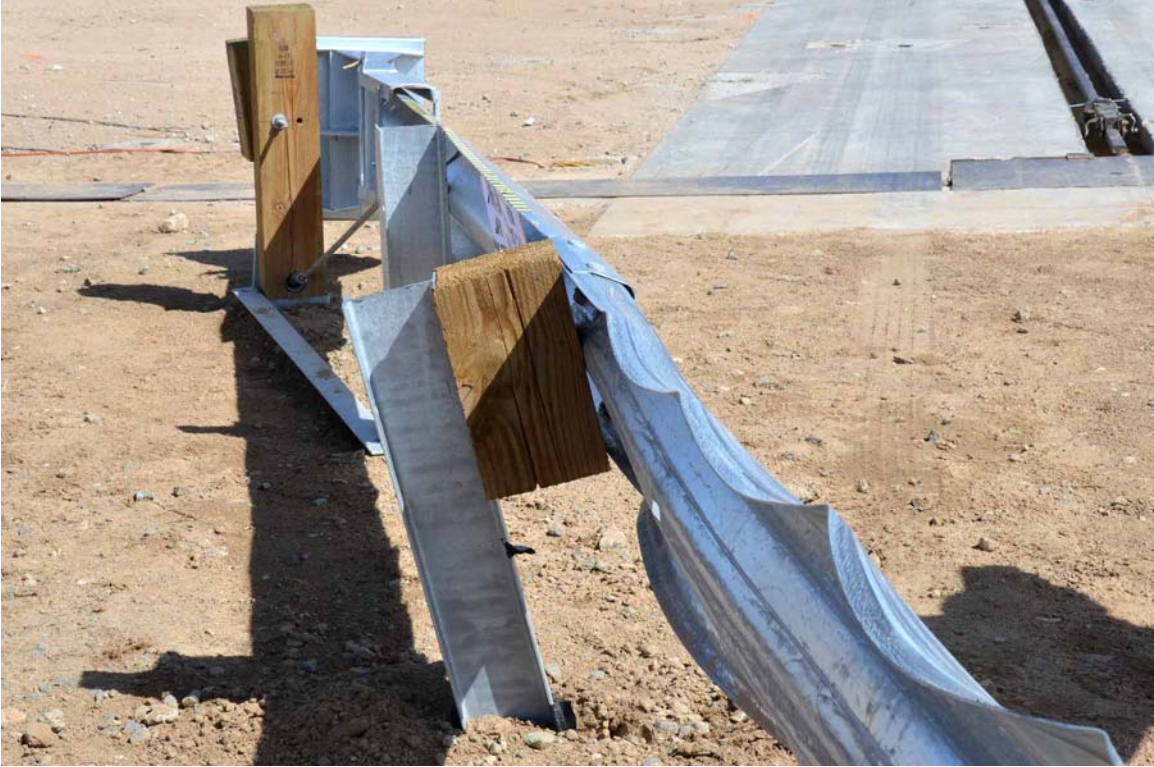
FIGURE 35. Test Article Damage

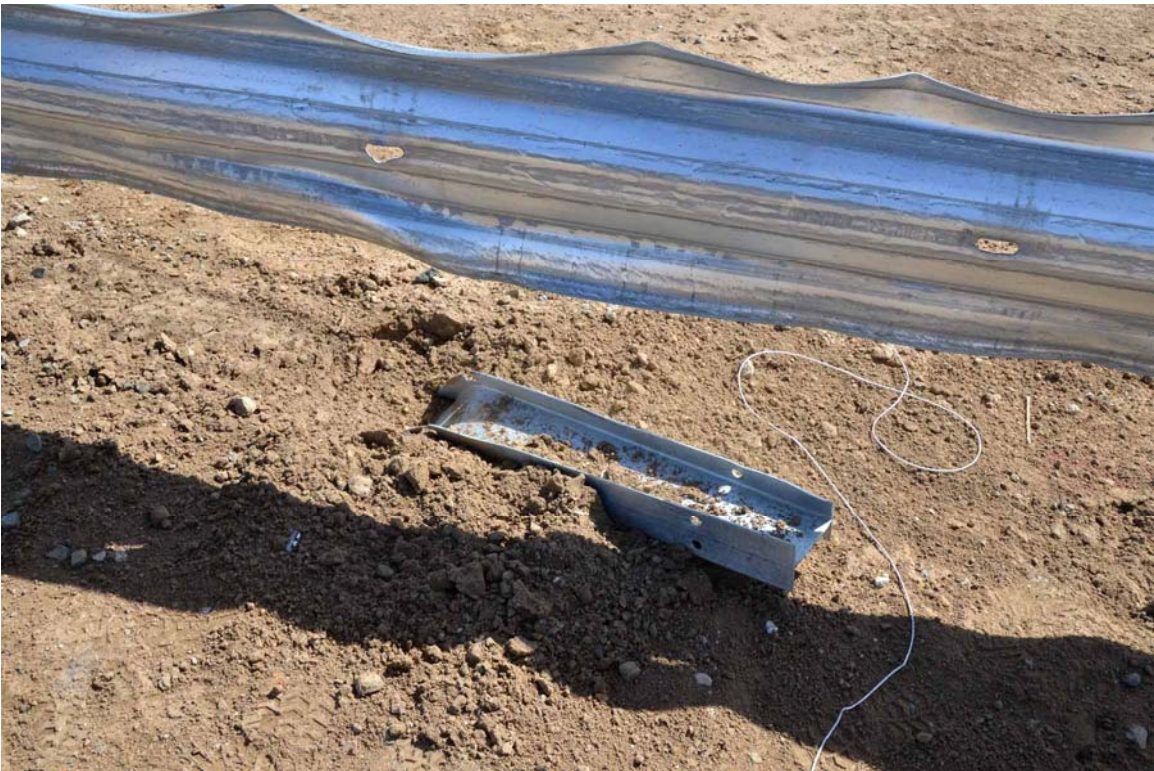
FIGURE 36. Test Article Damage

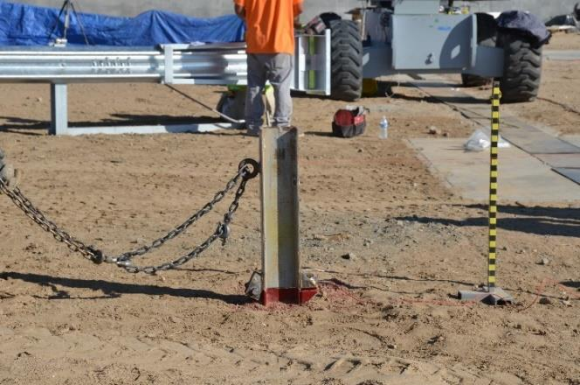
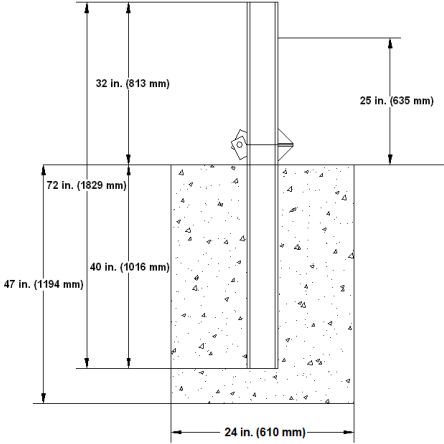
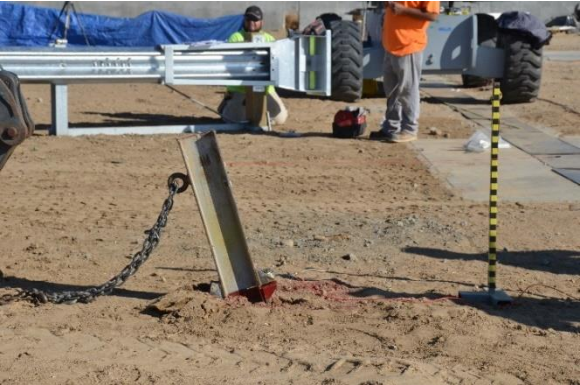
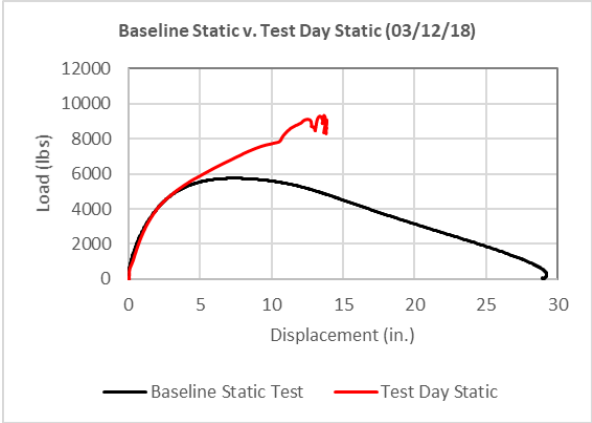
Figure 2: Static Soil Strength Data

Static Load Test Setup	Static Test/Installation Details

Post-Test Photo of Post	Comparison of Load vs. Displacement

Date	03/12/18
Test Facility and Site Location	KARCO, Track 4
In Situ Soil Description (ASTM D 2487)	Medium to fine silty sand
Description of Fill Placement Procedure	8.0 in. (203 mm) lifts compacted with pneumatic tamper

Prior to full scale crash test P38032-01, a static soil test was conducted to ensure the soil condition was acceptable for full-scale crash testing. The static test results at 5.0 in. (127 mm) and 10.0 in. (254 mm) were above 90% of the baseline established during soil certification. The hydraulic ram stopped pulling the post at 13.8 in. (350 mm) and the load was 8,581.2 lbs. (38.2 kN) which is 3,764.7 lbs higher than the minimum requirement at this point. Based on the fact that there was only 1.2 in. left of displacement and the significantly stronger soil, approximately a 50% increase in strength from the requirement, the soil was deemed as acceptable for testing. The baseline value at 13.8 in. (351 mm) of displacement value is 4816.5 lbs (21.4 kN), the added strength can be attributed to the extended amount of time the installation was in the ground. KARCO deemed the soil acceptable for testing based on the assumption that the soil was acceptable from 0 to 13.8 in. (351 mm) and the remaining 1.2 in. (30 mm) of deflection should also be acceptable if the hydraulic ram had added capacity. Static test results can be found in Appendix C of this test report.

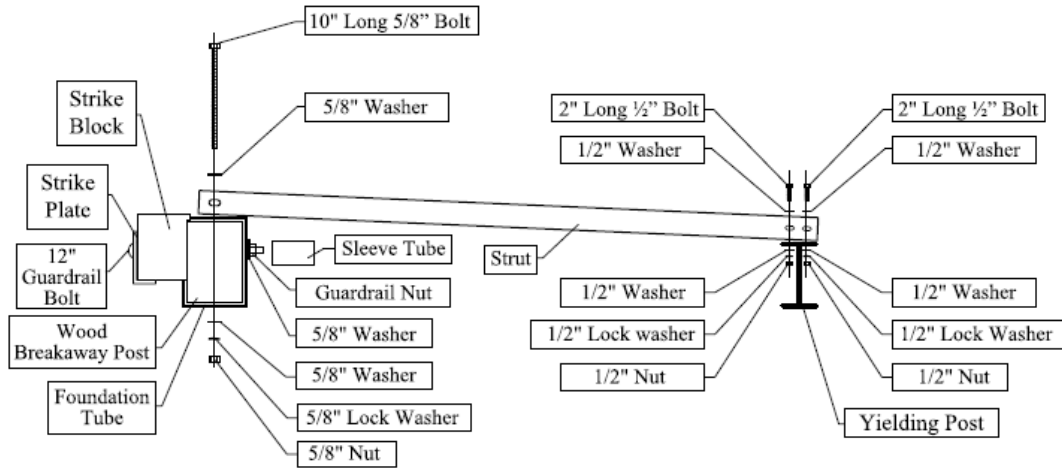
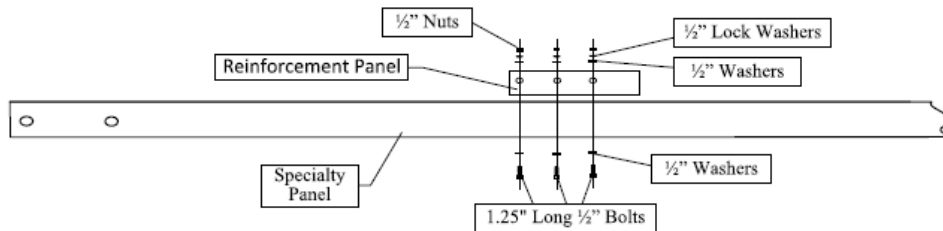
Figure 1: SGET System Parts

POST PARTS

PARTS	QTY
12" Guardrail Bolt – 5/8 X 12 307A HDG	1
Strike Plate	1
Strike Block	1
Guardrail Nut – 5/8-11 Nut A563 HDG	1
Wood Breakaway Post – 5-1/2 X 7-1/2 X 50 BCT	1
Foundation Tube – 6" X 8" X 6' Rectangular Tube	1
10" long 5/8" Bolt – 5/8-11 X 10 A325 HDG	1
5/8" Nut – 5/9-11 A563 Hex Nut Galvanized	1
5/8" Washer – 5/8 F436(A325) HDG Flatwasher	3
5/8" Lock Washer Galvanized	1
2" long 1/2" Bolt – 1/2-13 X 2 A325 HDG	2
1/2" Washer – 1/2 F436(A325) HDG Flatwasher	4
1/2" Nut – 1/2-13 A563 Hex Nut Galvanized	2
1/2" Lock Washer Galvanized	2
Yielding Post – Modified W6 X 8.5 Guardrail Post	7
Strut – 3" X 3" X 80" Angle	1
Sleeve Tube – 2-3/8 OD X 4-1/4	1

SPECIALTY PANEL PARTS

PARTS	QTY
Specialty Panel	1
1.25" Long 1/2" Bolt – 1/2-13 X 1-1/4 A325 HDG	6
1/2" Washer – 1/2 F436(A325) HDG Flatwasher	12
1/2" Nut – 1/2-13 A563 Hex Nut Galvanized	6
1/2" Lock Washer Galvanized	6
Reinforcement Plate	1
