Test Report For:
SPIG Industries, LLC
SGET End Terminal

TESTED TO:
Manual for Assessing Safety Hardware (MASH 2016)
Test 3-37b

TEST REPORT NUMBER:
TR-P38033-01-A

1. Report No. TR-P38033-01-A	2. Government Accession No.	3. Recipients Catalog No.	
4. Title and Subtitle Final Test Report SPIG Industries, LLC SGET End Terminal MASH 2016 Test 3-37b		5. Report Date August 17, 2018

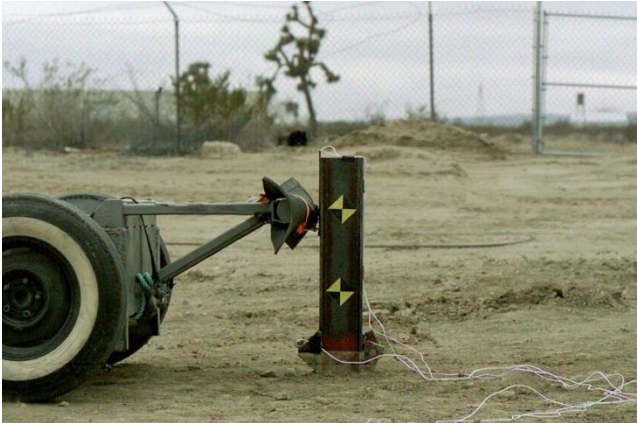
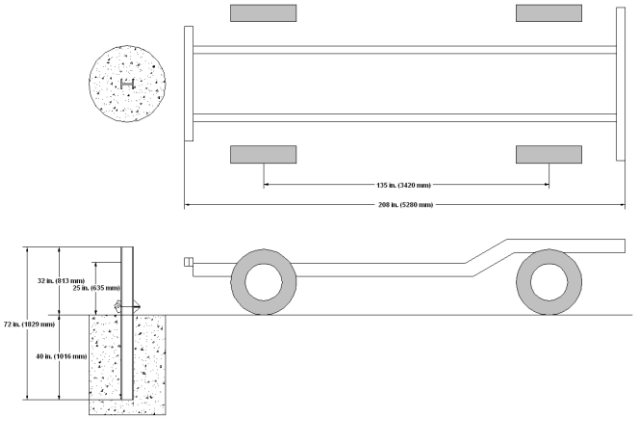
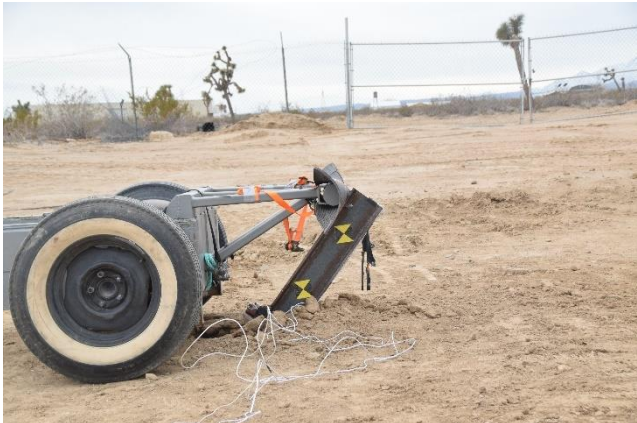
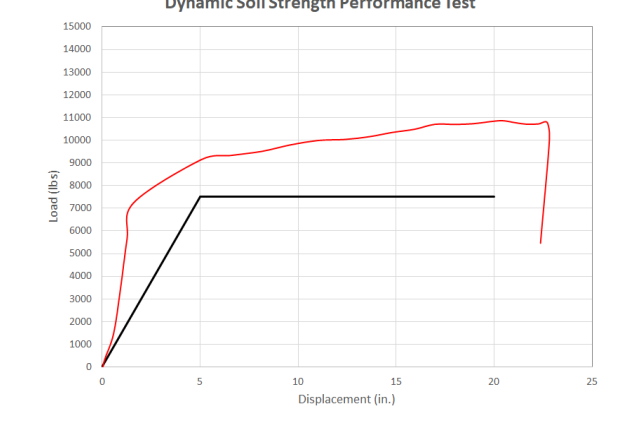
Figure 1: Dynamic Soil Strength Data

DYNAMIC SOIL STRENGTH TEST DATA

Dynamic Test Setup	Dynamic Test/Installation Details

Post-Test Photo of Post	Comparison of Load vs. Displacement

Certification Date	02/06/17
Test Facility and Site Location	KARCO, Track 4
In Situ Soil Description (ASTM D 2487)	Medium to fine silty sand
Description of Fill Placement Procedure	8.0 in. (203 mm) lifts compacted with pneumatic tamper
Bogie Weight	2,044.8 lbs (927.5 kg)
Impact Velocity	20.74 mph (33.38 km/h)

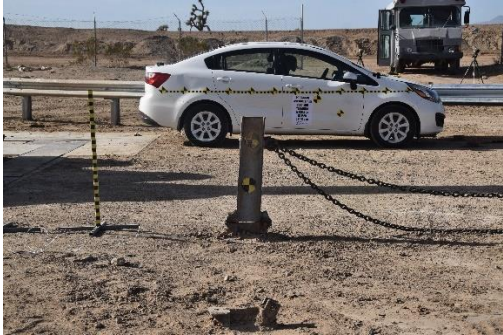
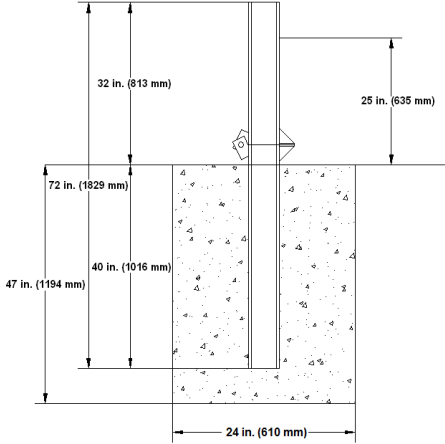
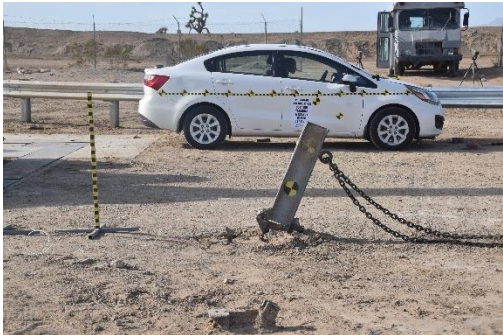
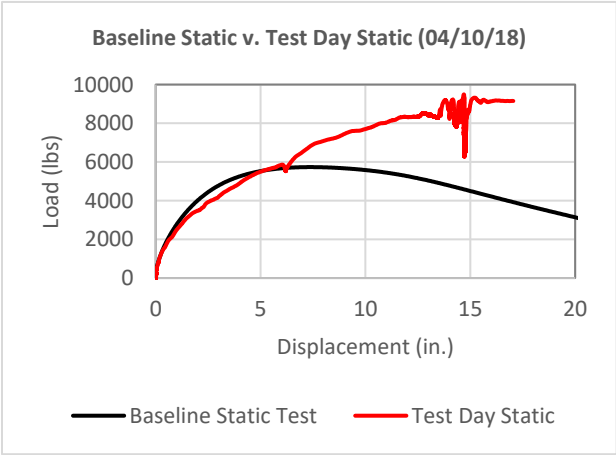
Figure 2: Static Soil Strength Data

STATIC SOIL VERIFICATION TEST DATA

Static Load Test Setup	Static Test/Installation Details

Post-Test Photo of Post	Comparison of Load vs. Displacement

Date	04/10/18
Test Facility and Site Location	KARCO, Track 4
In Situ Soil Description (ASTM D 2487)	Medium to fine silty sand
Description of Fill Placement Procedure	8.0 in. (203 mm) lifts compacted with pneumatic tamper

Prior to full scale crash test P38033-01, a static soil test was conducted to ensure the soil condition was acceptable for full-scale crash testing. The static test results at 5.0 in. (127 mm), 10.0 in. (254 mm) and 15.0 in. (381 mm) were above 90% of the baseline established during soil certification. Static test results can be found in Appendix C of this test report.
