Resort Village of Cochin Hunts Cove Crescent

Erosion Control
Cochin, SK

Clifton Associates

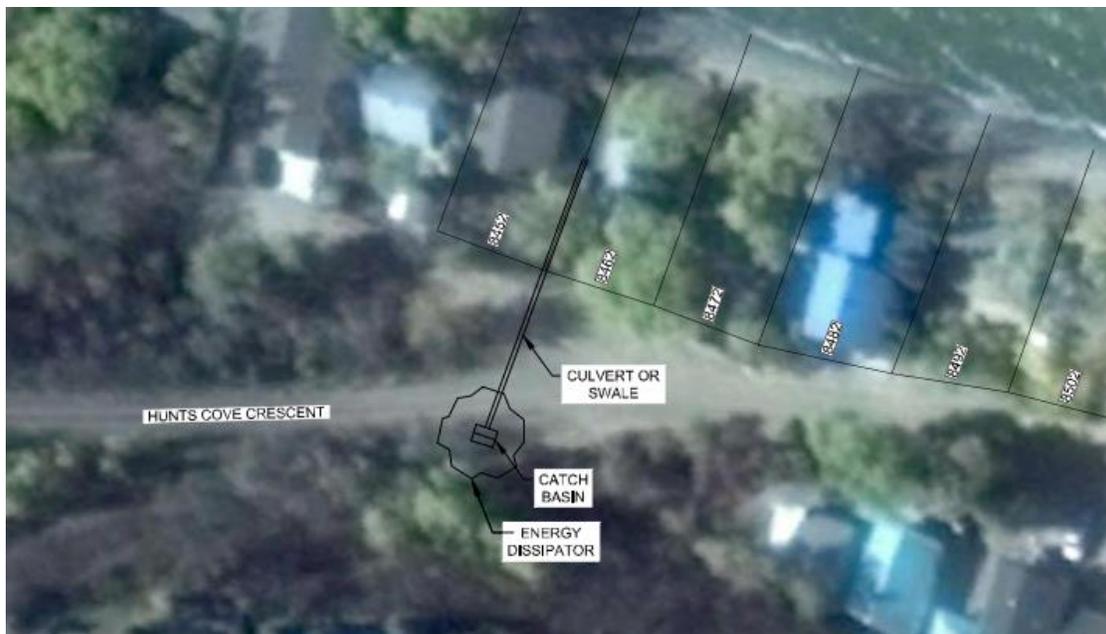
The first option is to install a catch basin at the bottom of the hill, shown below in Figure 5.1 and Figure 5.2. The basin would collect excess water and would be routed between the cabins west of the intersection at the bottom of the hill via drainage swale or a steel or high density polyethylene culvert. The immediate area surrounding the catch basin would need to be sloped inwards. Also, this option would necessitate an easement from the applicable property owners.

Figure 5.1: Catch Basin Option

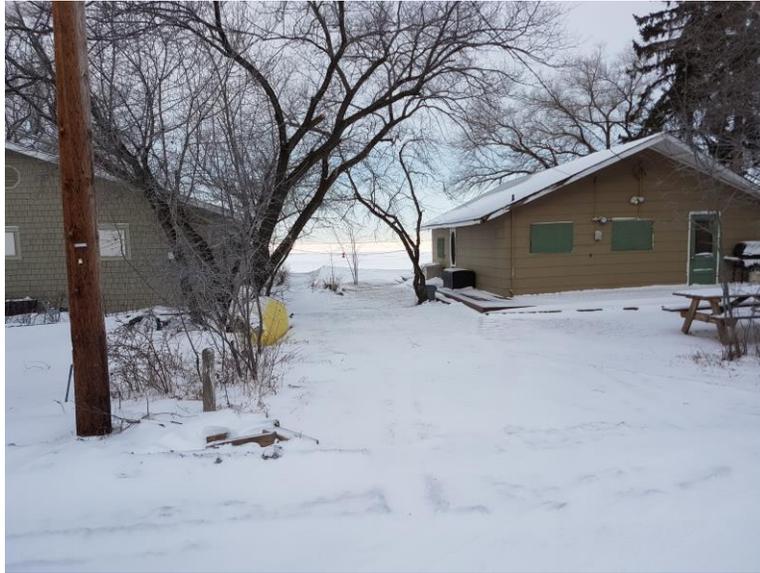
Figure 5.2: Location of proposed drainage culvert between address numbers 8452 and 8462 on Hunts Cove Crescent

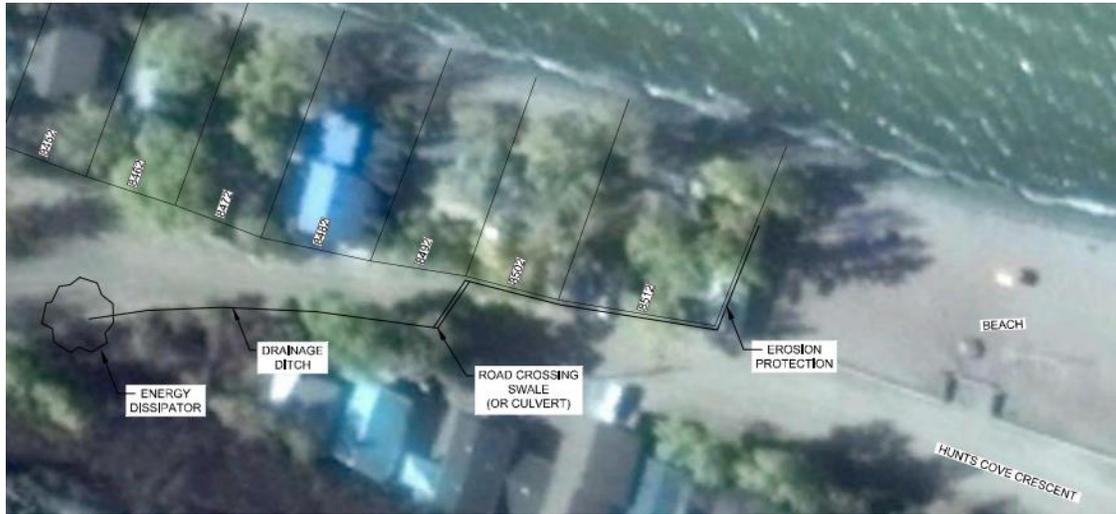
Figure 5.4: Drainage Ditch Option, crossing at 8502 Hunts Cove Crescent

outlined in Figure 5.3 and Figure 5.4, as well as in Appendix A. At the beach discharge point, erosion protection measure such as grass or energy dissipating rocks should be implemented. The Location for the proposed discharge point is shown in Figure 5.5.

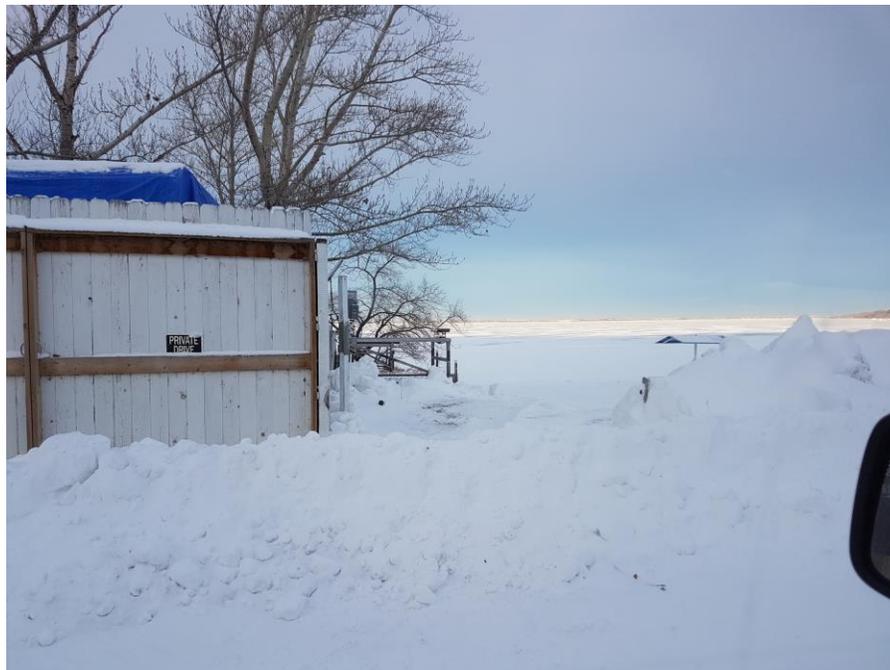
Figure 5.5: Location of proposed discharge point of drainage swale, north of address number 8512 on Hunts Cove Crescent

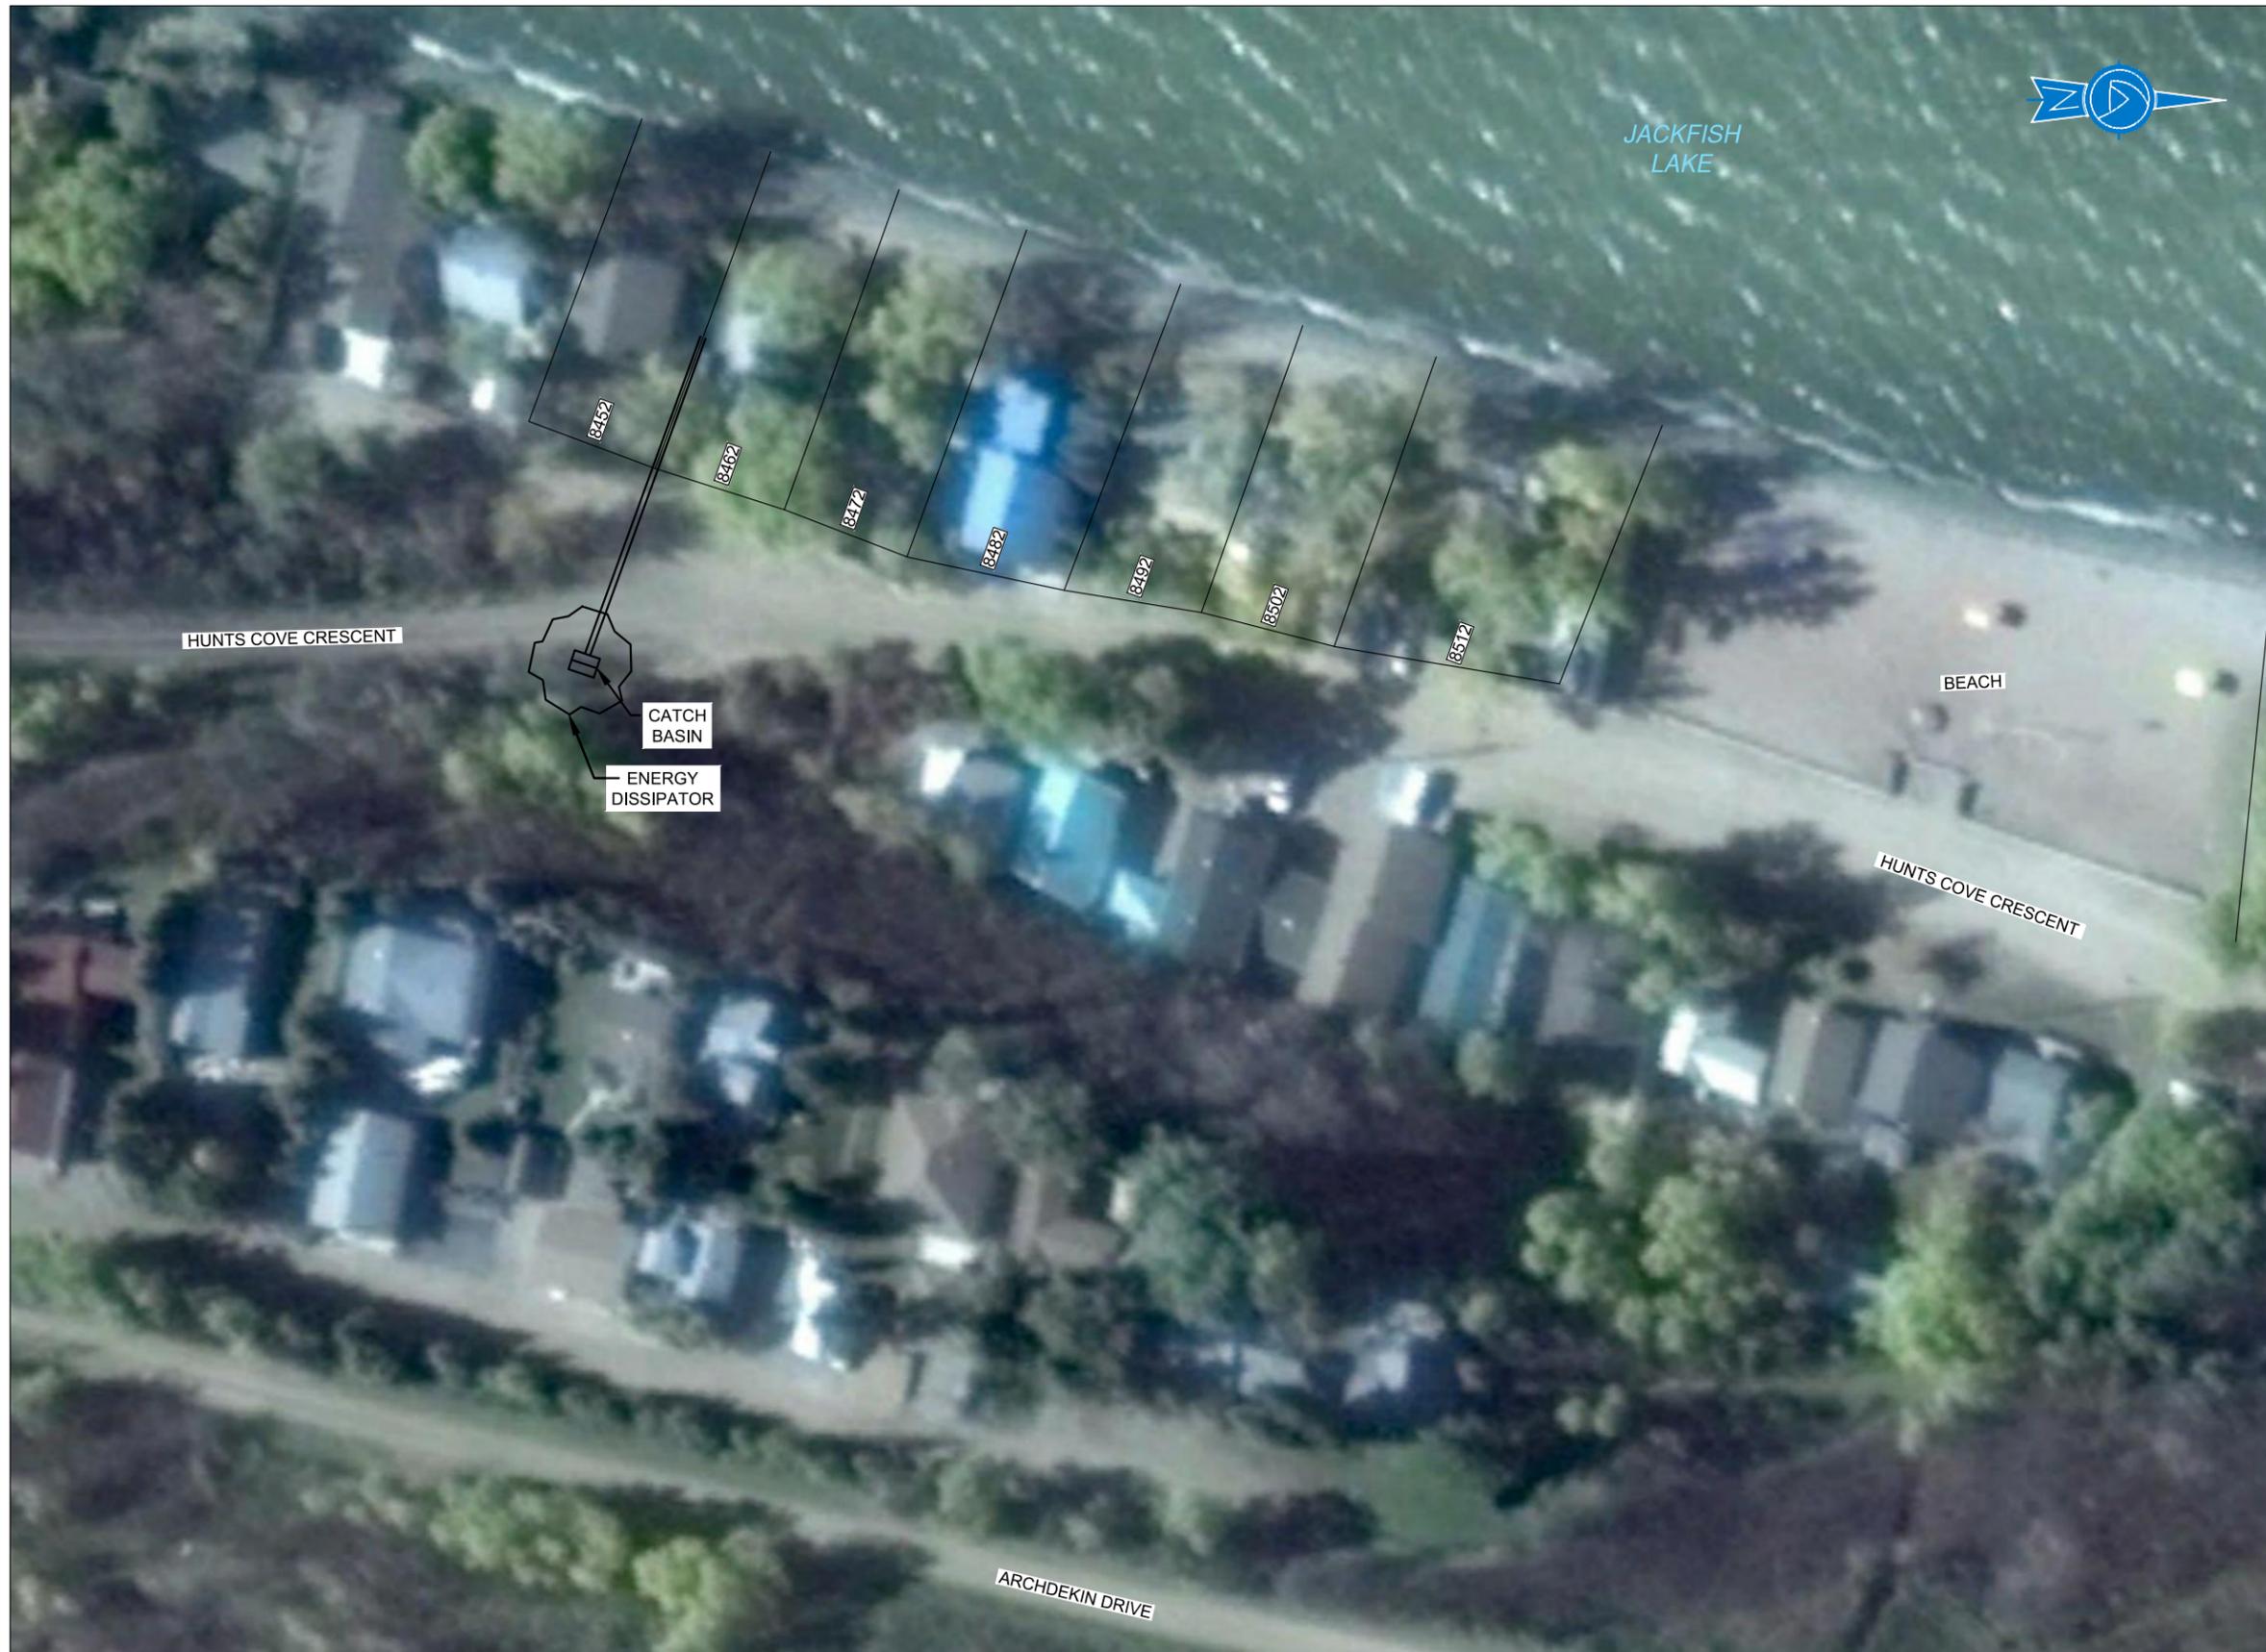
TITLE
 OPTION 1

SITE PLAN
 SCALE: 1:25,000

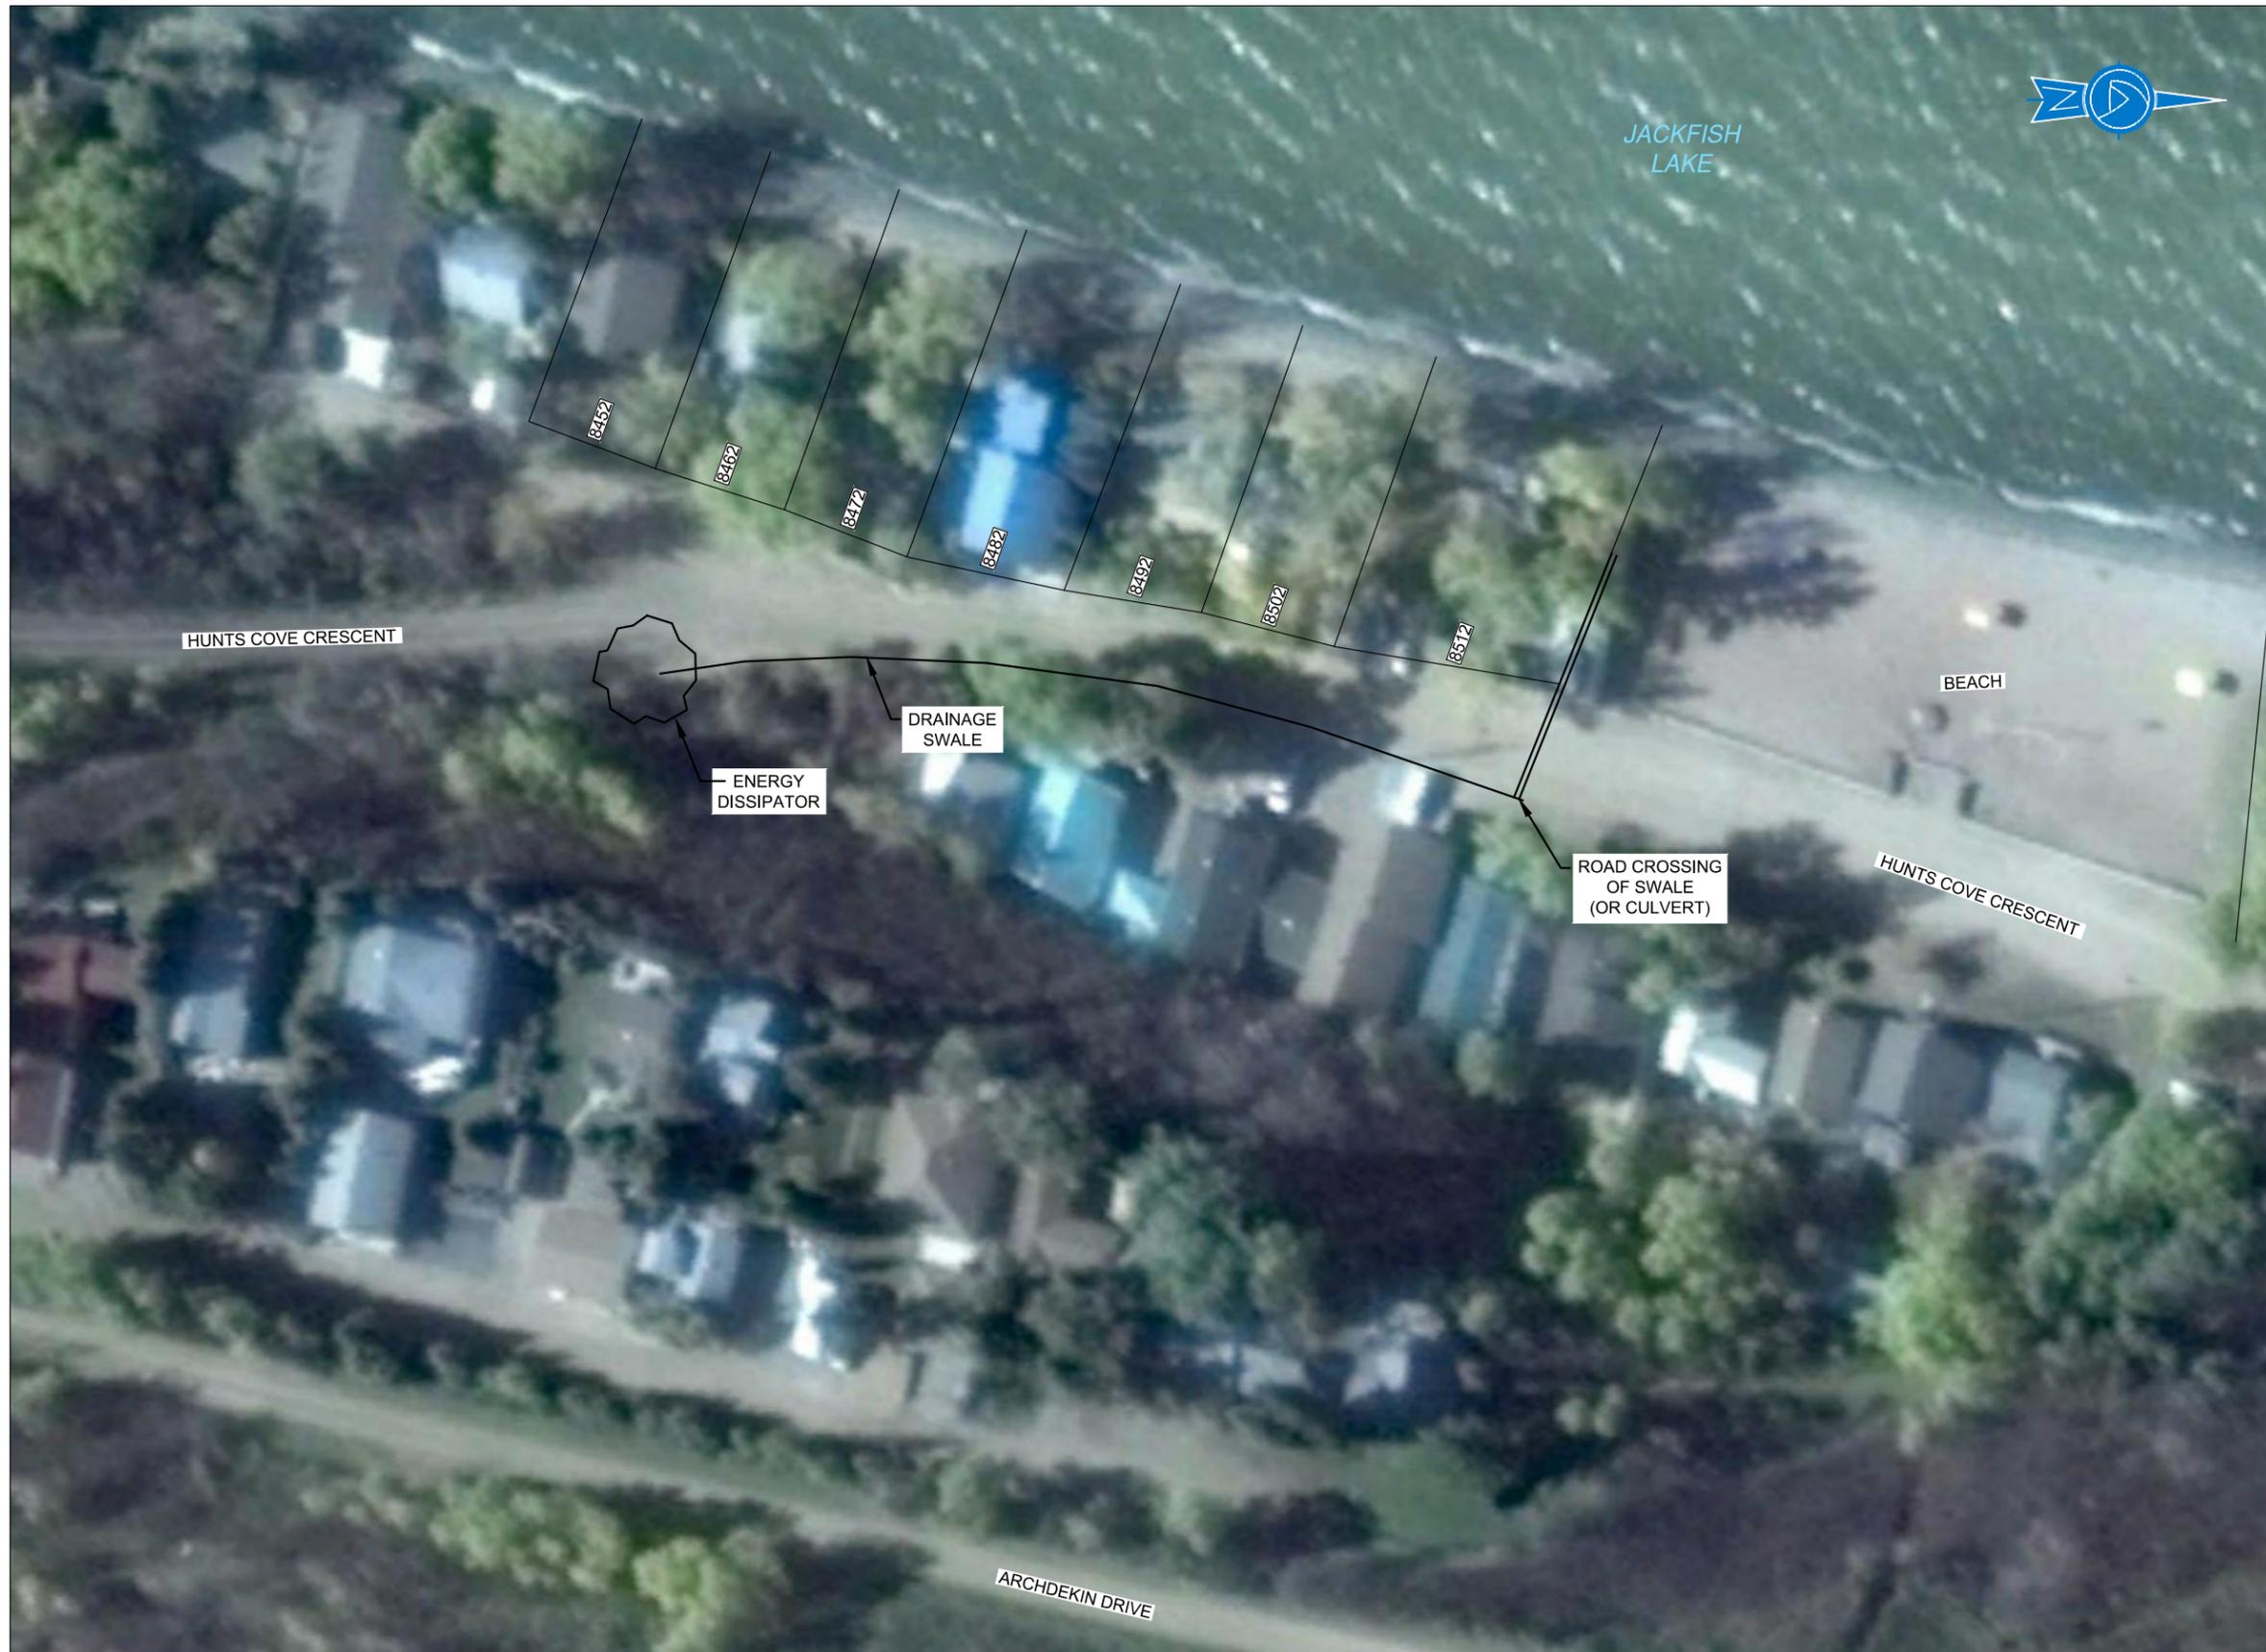
TITLE
 OPTION 2

SITE PLAN
SCALE: 1:25,000

Another solution to handle runoff from the hillside would be to create a drainage ditch from the bottom of the hill, north to the beach. This would involve approximately 100 m of ditch in the east side of Hunts Cove Crescent. Because of development, the ditch may need to be modified in areas along the distance to the swale.

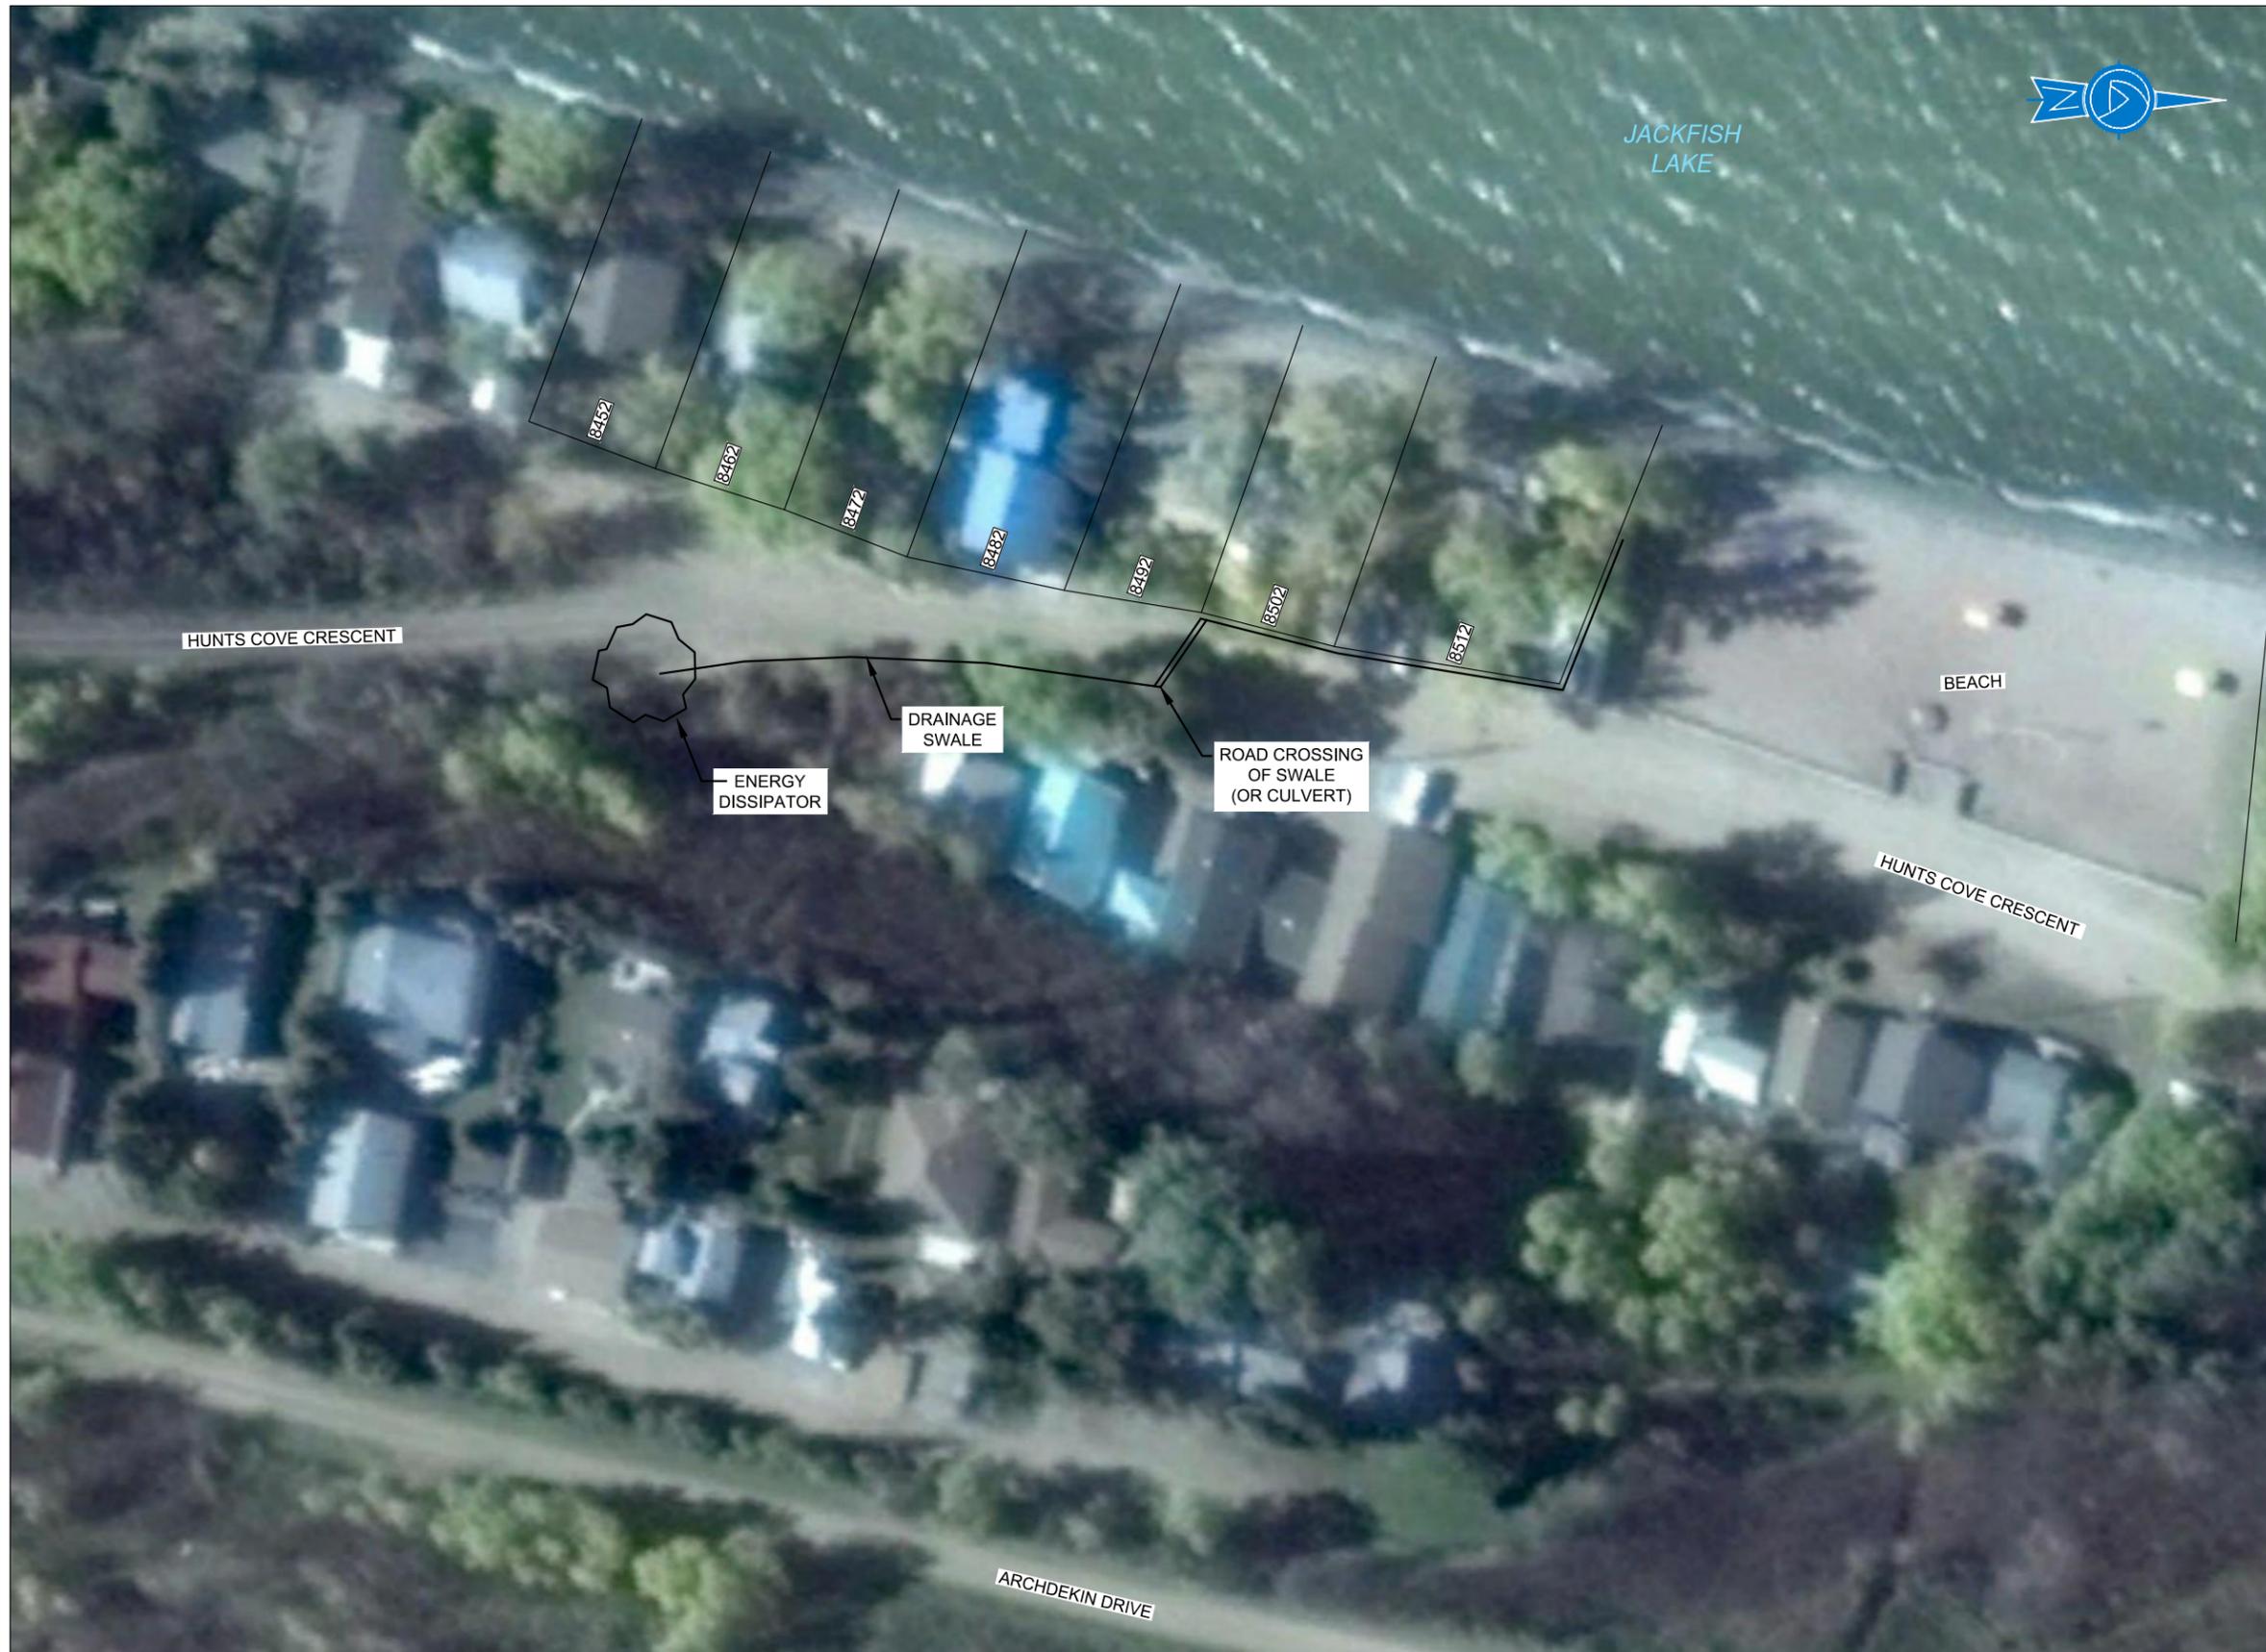
TITLE
 OPTION 3

SITE PLAN
SCALE: 1:25,000
