## Water in Somerset Estates

March 2025

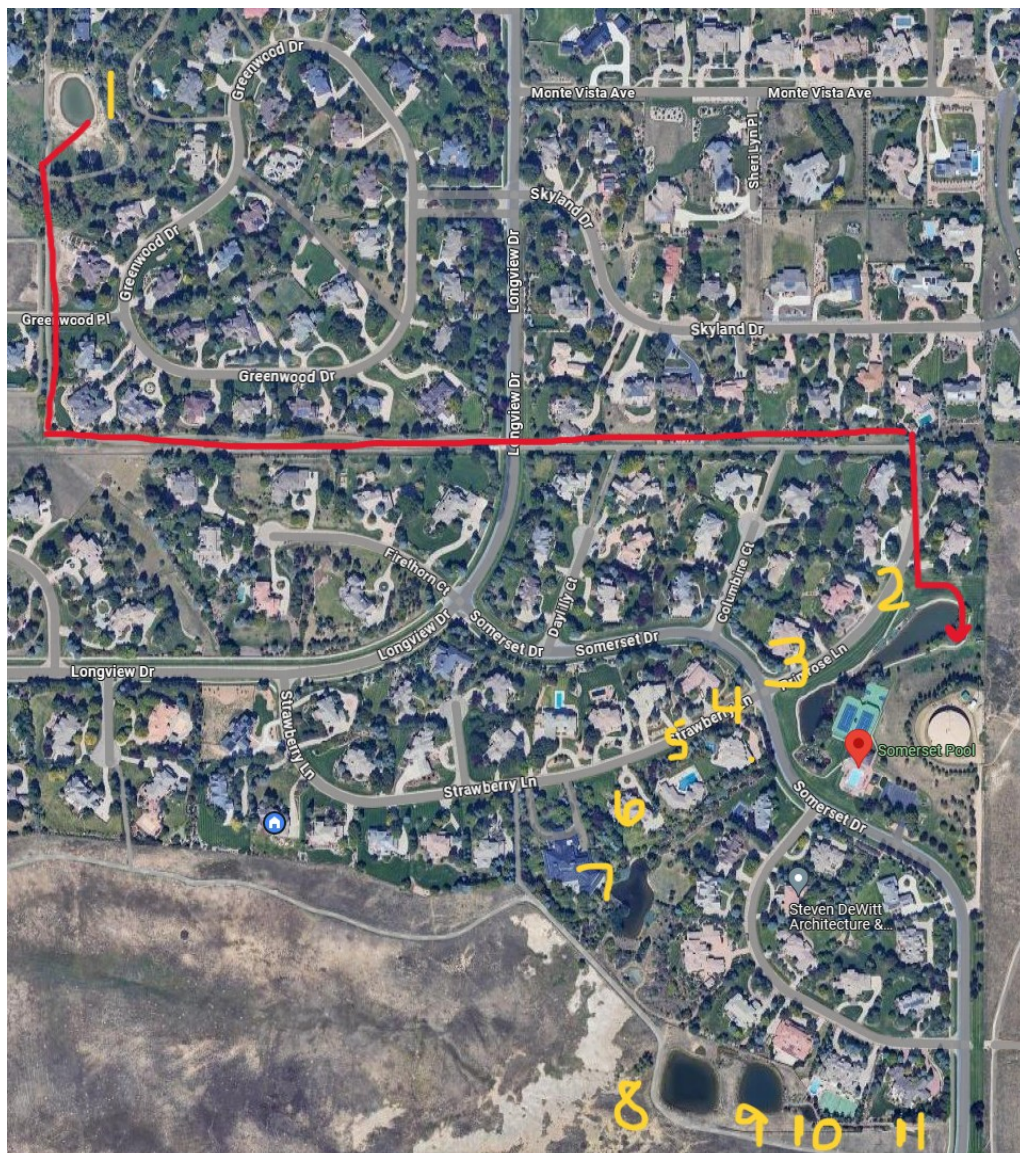
Below is a map that shows the main components of the water infrastructure in SHOA and SEHOA. The ponds are labeled in yellow. The ditches run by pond 1 in SHOA. The red line represents the dedicated transfer line to SEHOA from pond 1 to the east end of pond 2 (location is approximate).

Ponds 2 and 3 are on Outlot D, ponds 8-10 are on Outlot C, and pond 11 is on Outlot B, all owned by SEHOA as common areas. The location and current owners (in parentheses – all public information) of ponds 4-7, referred to as the “Easement Ponds” in SEHOA’s Lot Easement Policy, are as follows: Pond 4 is split between Block 4/Lot 11 (Thramann) and Block 5/Lot 1 (McPherson). Pond 5 is split between Block 4/Lot 10 (Thramann), Block 5/Lot 1 (McPherson), and Block 5/Lot 2 (Shear). Pond 6 is split between Block 4/Lot 9 (Lindau) and Block 5/Lot 2 (Shear). Pond 7 is split between four Lots: Block 4/Lot 9 (Lindau), Block 4/Lot 8 (Stull), Block 5/Lot 3 (Harris), and Block 5/Lot 4 (Shellan).

In 2022, the dedicated transfer line from pond 1 to pond 2 was completed allowing more precise measurement of SEHOA’s water use. SEHOA demand in 2022 was 35.6 AF, in 2023 was 39 AF, and in 2024 was 46.8 AF. **The average water demand over the past three years was 40.5 AF with the current infrastructure.** The higher demand in 2024 was likely due to a hot, dry summer and pond leaks. The 2024 demand of 46.8 AF was over 84 days (0.56 AF/day) compared to 39 AF over 107 days in 2023 (0.36 AF/day). Because 2024 was a drier year, the ditch companies shut off access in early September compared to early October in 2023.
