Agency finds sinking at Gold Hill Mesa, calls for more testing

By Conrad Swanson conrad.swanson@gazette.com Sep 22, 2019 Updated 1 hr ago

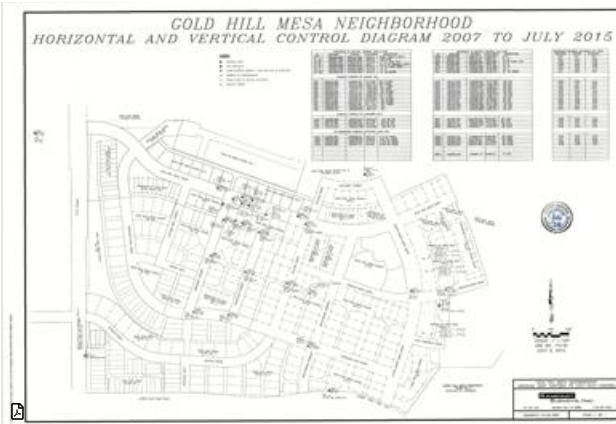
GOLD HILL MESA CONTROL POINT MONITORING - AUGUST 2019

Gold Hill Mesa ground survey
 Courtesy of Gold Hill Mesa Updated 20 hrs ago
