**The death of a Yachtsman  
during the**

***"Big Bay Race -  
December 2000"***

**Inquest into the death of  
Lindsay Dack**

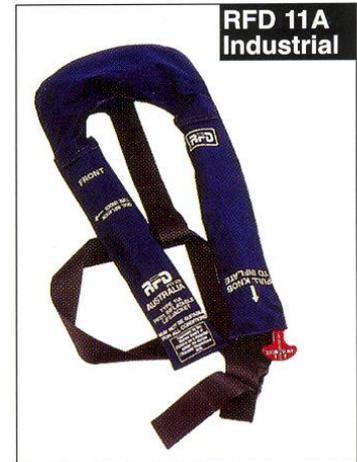
**RFD TYPE 11A  
Approved to  
Australian Standards  
AS1512**

RFD constant wear lifejackets are designed to allow maximum comfort and freedom of movement at all times. Light weight with guaranteed quality and durability the RFD range of inflatable lifejackets are available with manual or automatic operating heads for a variety of recreational and commercial applications.

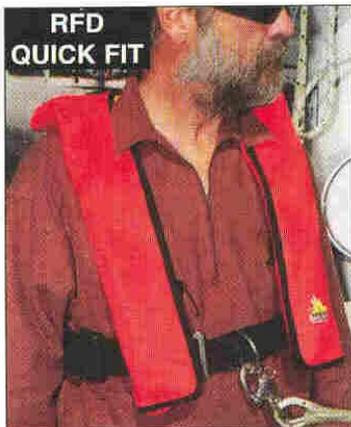
**2. RFD Quick Fit**

Model	Colour (When Inflated)	Colour (outer)	Inflation System	Light	Whistle	Meets AS1512	Size	Weights	Special Features
RFD Quick Fit	Yellow	Red	Manual or Auto	No	Yes	Yes	Adult	35kg over	Crutch Strap & in-built harness (opt.) AYF Accepted

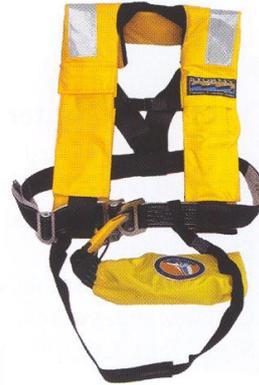
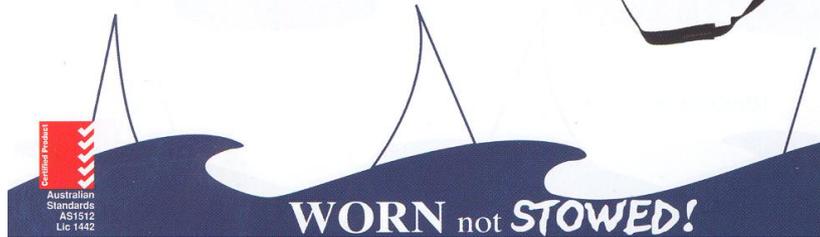
### 3. Stormy Seas Offshore Yoke

#### Offshore Yoke

- AS1512 PFD Type 1
- CO2 and oral inflation
- Reflective tape, signal whistle
- Lightweight, ideal in hot climates
- Colours: red, yellow
- Sizes: One size fits all
- Integrated AS2227 accredited Safety Harness and Tether
- Crotch Strap

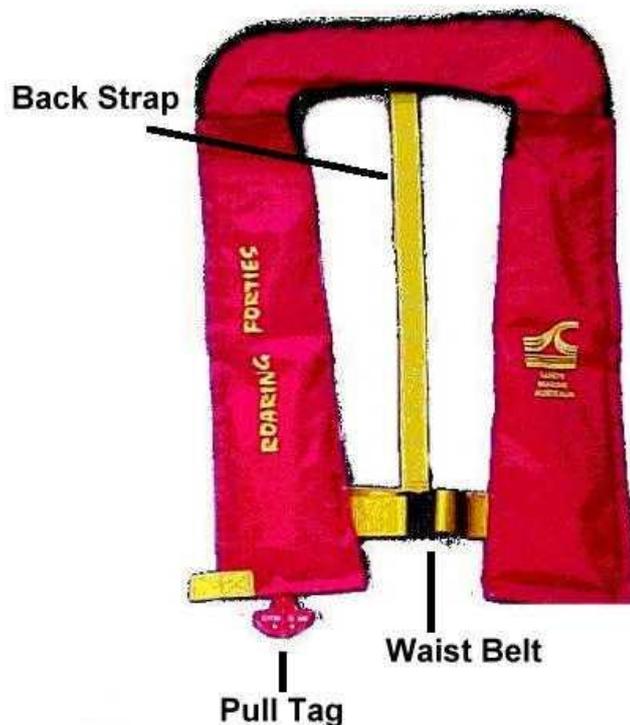
### 4. Safety Marine SMA 1090

## SMA1090 in Valise
