Inspecting Underground Pipeline Coating
Eagle Ford Case Study

ANSI/NACE SP0502-2010, Pipeline
External Corrosion Direct Assessment
Methodology using Alternating Current-
Current Attenuation

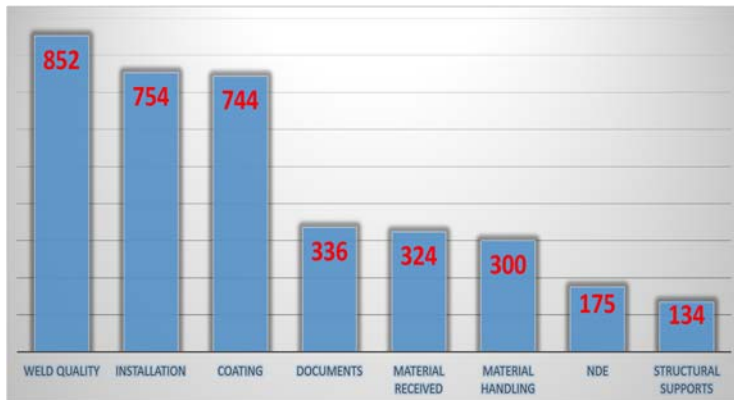
During a pre-backfill quality assurance interrogation led by a leading engineering company, the defects listed in the above chart were detected.

This thorough quality assurance inspection discovered 744 potential defects that would have been backfilled and put into service. After burial was complete on this same project, ScanTegrity uncovered another 50 more anomalies. These anomalies were the total of a) mechanical damage during install/backfill, and b) poor coating application at the butt welds.

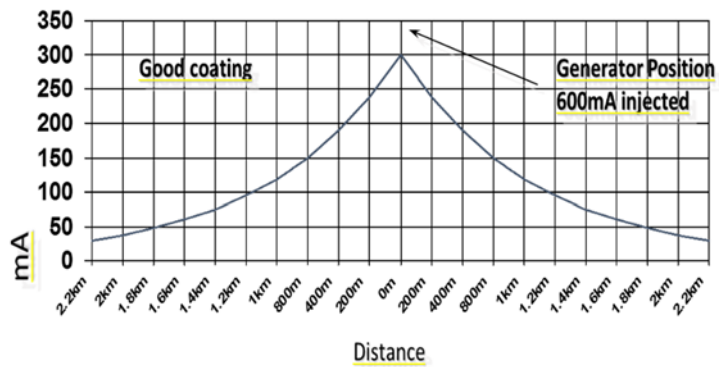
ScanTegrity functions by measuring the attenuation of a low frequency AC signal impressed upon the pipeline.

The AC signal is gradually lost to the surrounding soil through the pipeline resistive coating as it passes along the buried pipeline. This is the Rate of Attenuation as seen below.

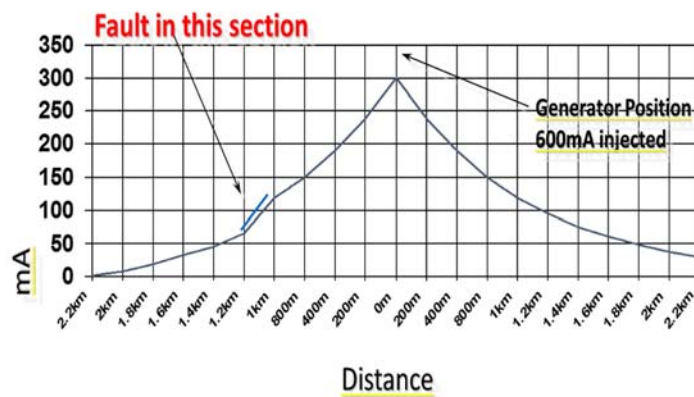
Where the coating is decaying or damaged, there is a significant increase in the rate of current loss. This is an increase in the Rate of Attenuation. In the figure below you can see a slight step change in the exponential curve of the AC signal.

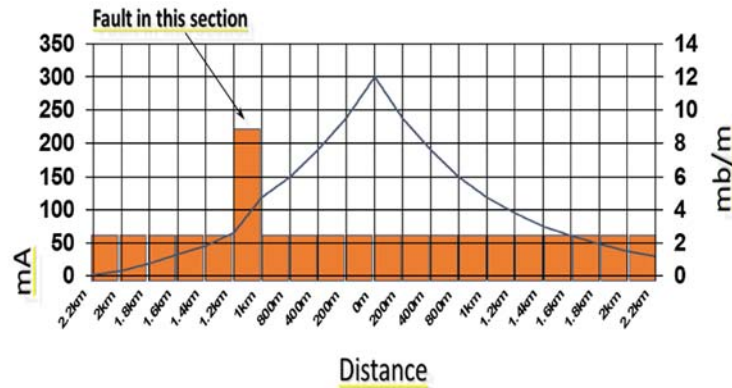
The fault clearly seen below, in the logarithmic chart. The rate of current loss over any section of pipeline measured in millibels per meter (mB/m), is an absolute measure of the average quality of the coating over that section.

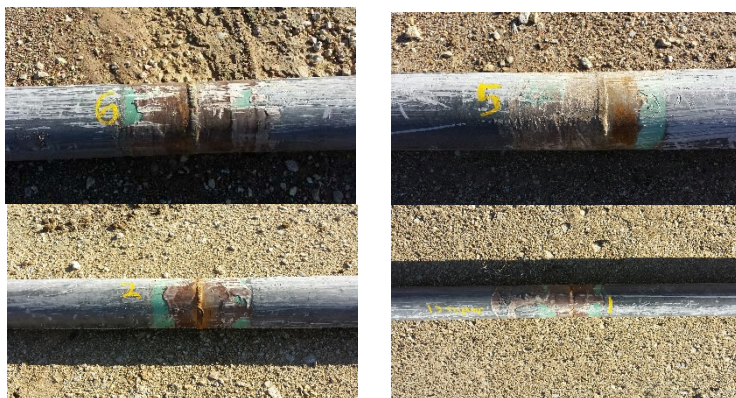
Due to the conflicting recommendations by the two technologies utilized to assess the line and the owner's previous 87% success rate verifying ScanTegrity ACCA findings, the owner pulled the bore. As seen in the photos below, the damage was extensive.

The bore consisted of six pipe segments, each averaging forty-two feet. Abrasion-resistant coating and girth weld wrapping were used to protect the pipe during installation. The wrap was wiped off the pipe during the horizontal directional drilling (HDD) installation, leaving bare the entire heat affected zone. Severe metal loss was found from 3-6 o'clock positions on the girth weld location number 3 (see left photo below). Weld number 4 (see right photo below) had a corrosion cell that measured .187 in deep on a .237 in wall pipe.

The bores were approximately 300 to 400 feet in length and were electrically isolated. The line in question, a four inch liquids line, was independently surveyed using ACCA. The survey indicated a large anomaly in the range of 40 millisiemens at the crossing. A bore profile drawing was provided by the owner/user which indicated the pipe depth to be in the 12-15 foot range. It was determined the line would be taken out of service and further evaluated before a repair would be scheduled. The bore was exposed on both sides and a cut was made so a "smart pig" could be deployed to further assess the line. ScanTegrity ACCA surveys the coating integrity but not wall loss, while the internal tool examines wall loss, but not coating anomalies.
