Report of Marine Survey

Vessel: 2009 Chaparral 350 Signature

Purpose: Pre-purchase and Evaluation

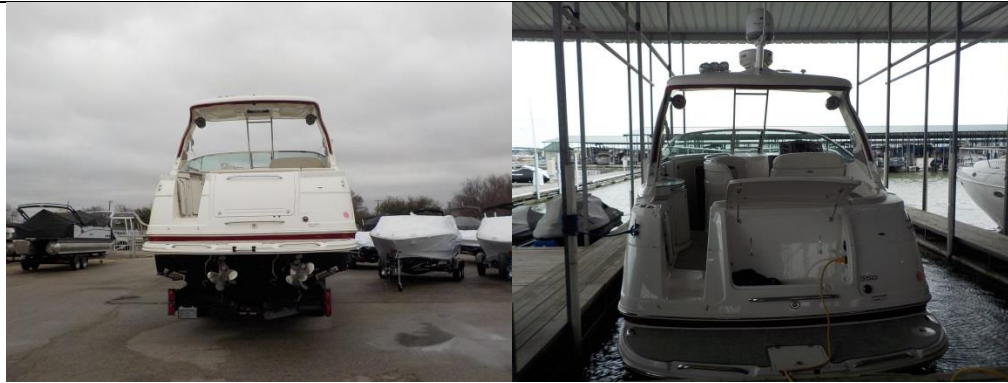
Hull Construction Material:	Fiberglass with maroon/white gelcoat surface. No damages sighted.
Swim Platform:	Yes. Fiberglass, attached onto hull. Stainless retractable boarding ladder. Operational with no damages sighted.
Rub Rail:	Stainless steel on white rubber backing.
Transom:	Conventional transom with attached swim platform and storage hatch. No damage sighted. Shore power inlets and battery nodes for jump-starting located in transom hatch.

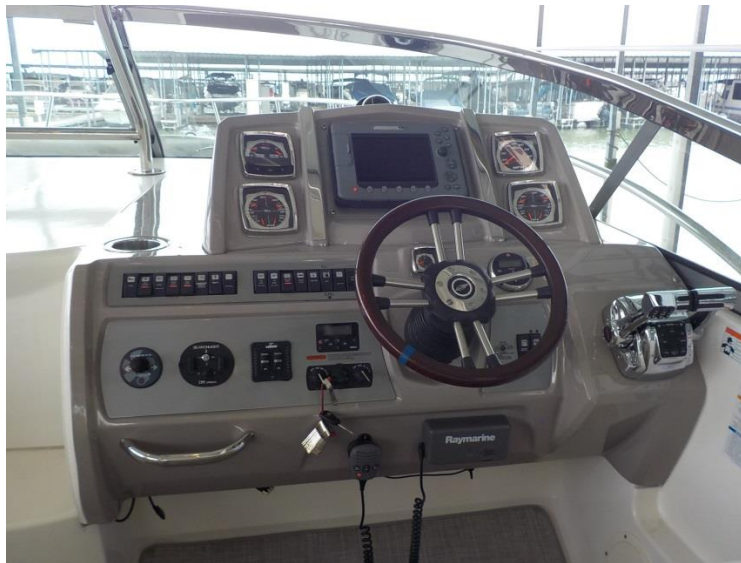
Single DTS Mercury "Smartercraft" control box(s) for throttle and shift controls. Controls work and are operational.

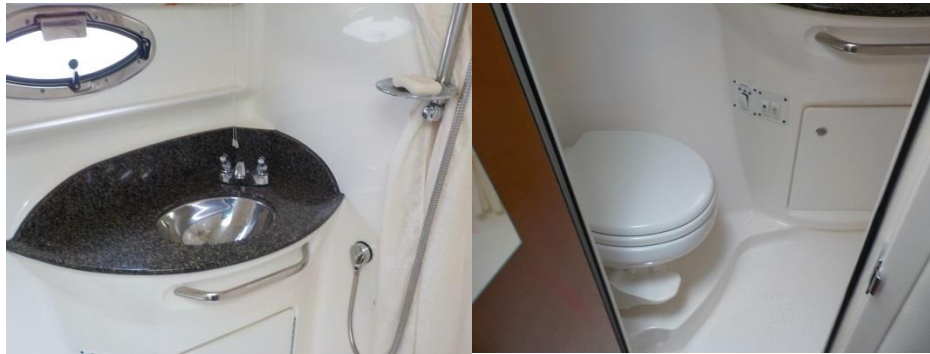
Shower & Sump Box/Pump: One shower sump box located under salon sole. Operational with float switch. No leaks or damages sighted.

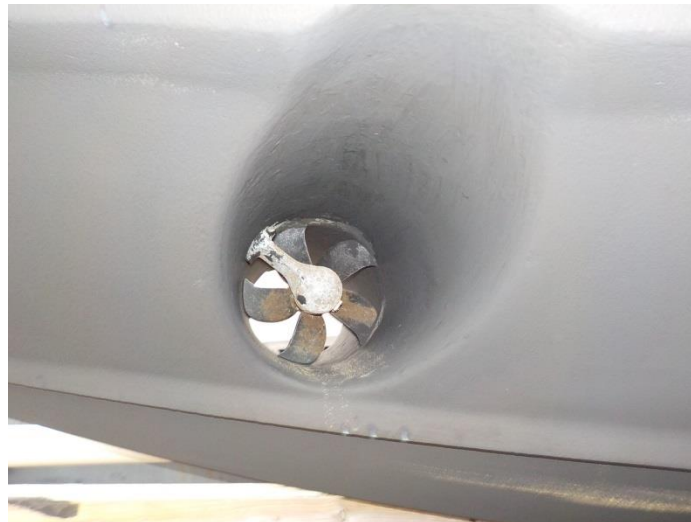
Yes. Lewmar tunnel thruster controlled via helm joystick. Minimal corrosion sighted. Blades are in good condition. Clean of debris.
