Report of Marine Survey

Vessel: 1997 Silverton Aft Cabin 39'

Purpose: Condition and Valuation

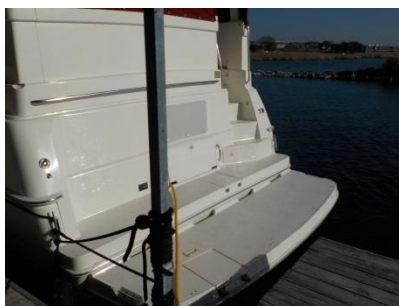
Hull Construction Material:	Fiberglass with white gelcoat surface. NOTE: Hull needs buffing. Buff and wax for cosmetic purposes and to preserve gelcoat finish.
Swim Platform:	Yes. Fiberglass, attached. Boarding ladder on port side, no damages sighted, well secured.
Rub Rail:	Stainless steel on white plastic backing.
Transom:	Conventional aft cabin transom with attached swim platform. Storage hatch and shore power inlet on port side. No damages sighted. Securely mounted.

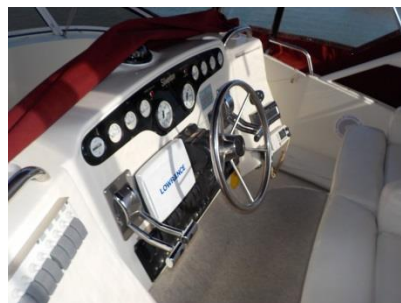
Engine Status/Multifunction: All Engine instrument controls are OEM and operational.

Engine Tachometers: Engine tachometers are OEM and operational.

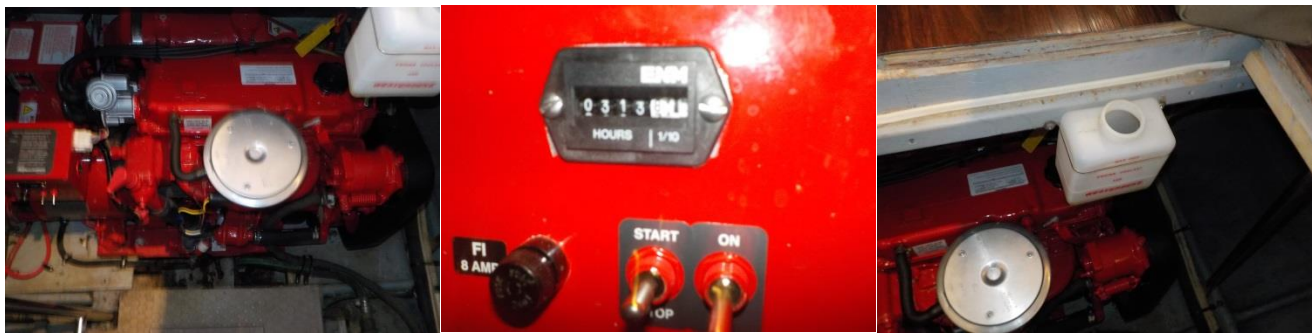
Exhaust Piping: Side hull exhaust. Double clamped as per ABYC recommendations. Flex hose with FRP is in good condition with no cracks sighted.

Generator Tested: Yes. Generator started and ran, and was tested with load for thirty minutes. Operational.
