OVERVIEW

IET was retained by the homeowner to determine the cause of extensive mold growth and beginning decay in the ventilated crawlspace of his 10 year old home.

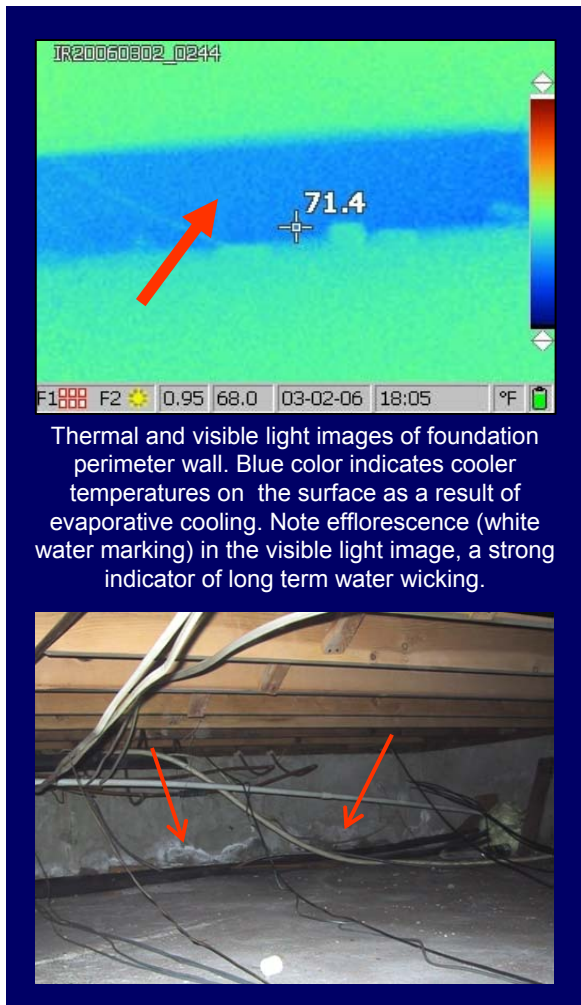
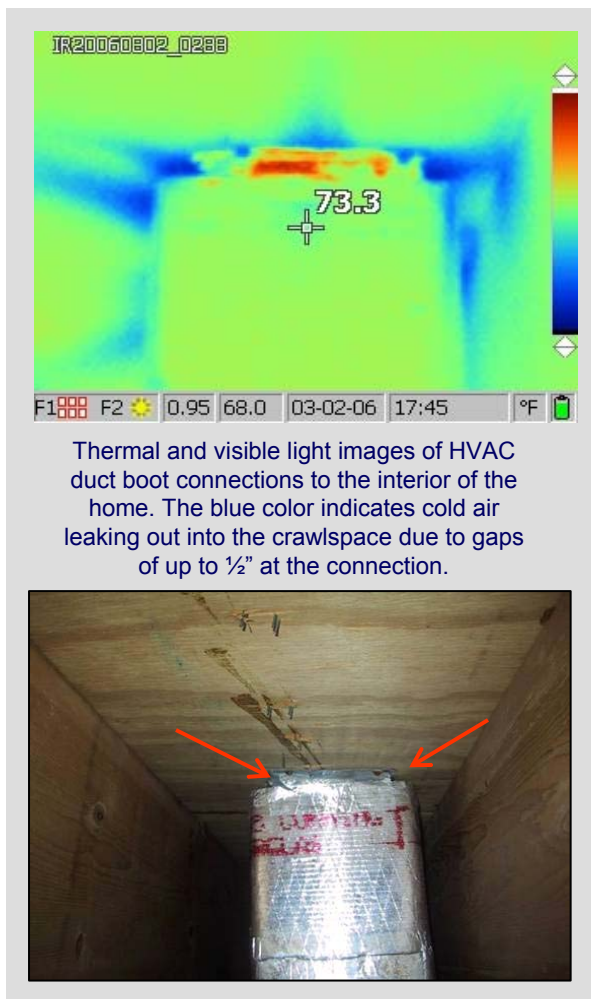
IET performed visual inspection inside and outside, as well as thermal imaging and moisture mapping in the crawlspace.

Results of inspection: Landscaping deficiencies had resulted in foundation perimeter walls being

saturated with water. When this water evaporated to the interior, the relative humidity of the crawlspace went up. The situation was worsened by multiple HVAC supply line leaks into the crawlspace from a recently installed duct system. Little effort had been made to seal the duct boots to the sub-floor. Cold air leaking into the crawlspace reduced the temperature of that area, raising the relative humidity.

Recommendations for correction: Carefully seal all duct boot connections. Modify landscaping and site drainage to divert water well away from foundation.
